FIELD PERFORMANCE EVALUATIONS OF ILLINOIS AGGREGATES FOR SUBGRADE REPLACEMENT AND SUBBASE—PHASE II

Research Report FHWA-ICT-12-021

Illinois Center for Transportation
Project R27-81
Field Performance Evaluations of Illinois Aggregates for
Subgrade Replacement and Subbase-Phase II

April 2013

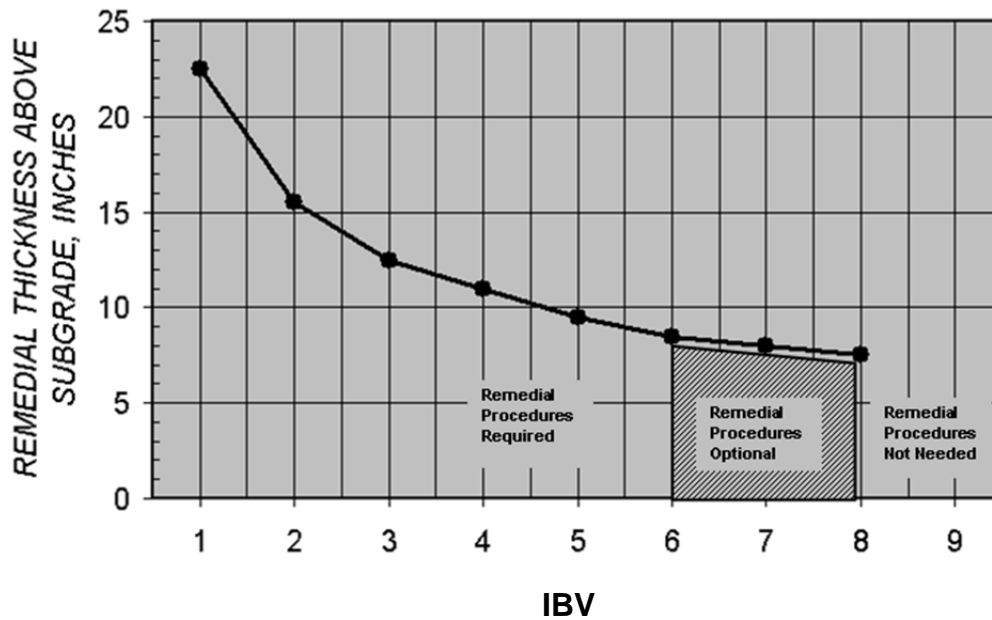
Figure 1.1. IBV-based remedial action (IDOT SSM 2005).

The current Illinois Department of Transportation (IDOT) Subgrade Stability Manual (SSM) recommends the remedial aggregate thickness above subgrade based on the immediate bearing value (IBV) as a performance index of the subgrade soil (IDOT SSM 2005). The required cover thickness is determined from the subgrade IBV using Figure A-2 in the IDOT SSM (Figure 1.1). However, it is important to note that Figure A-2 of the IDOT SSM does not distinguish between among aggregate types when specifying the required subgrade cover thickness.

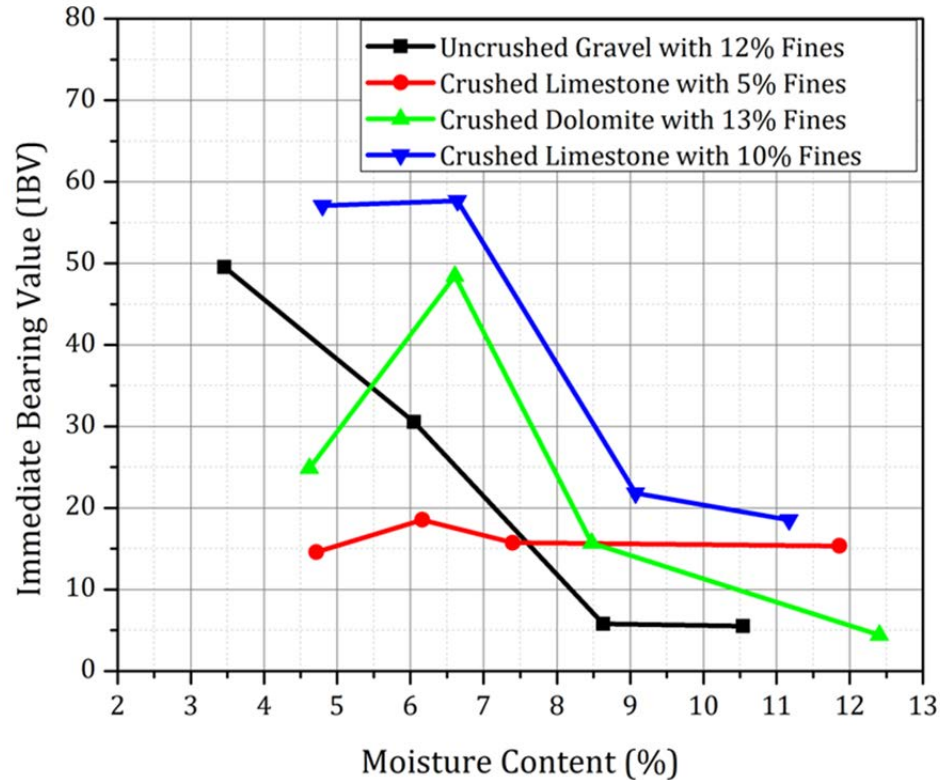
Figure 3.1. Variations in immediate bearing values (IBV) for the four aggregate materials under standard compaction conditions.

Two important observations can be made from Figure 3.1, which shows the change in IBV values of the four aggregate materials with moisture content under standard compaction conditions. Firstly, the IBV for the uncrushed gravel with 12% fines (material 1) decreased rapidly with an increase in moisture content even on the dry side of OMC. This reinforced findings from the laboratory tests reported in Phase I regarding the high moisture sensitivities of uncrushed aggregates with high fines. Secondly, material 2 (crushed limestone with 5% fines) did not show any significant change in IBV with increasing moisture content. This was attributed to the free-draining nature of the material, and will be referred to later in Chapter 4 when analyzing the effect of flooding on the performance trends of full-scale test sections constructed using this material. Moreover, the lack of fines in material 2 resulted in an unstable aggregate matrix under standard compaction conditions. This was clearly apparent from the low IBV (14-19%) as shown in Figure 3.1.

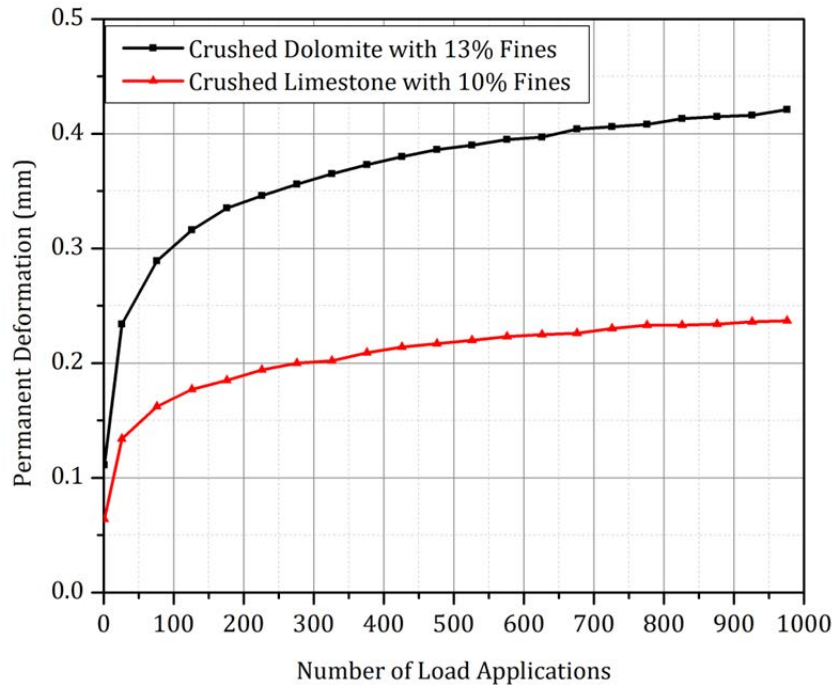
Figure 3.2. Effect of material quality on permanent deformation behavior under standard compactive effort OMC and MDD conditions.

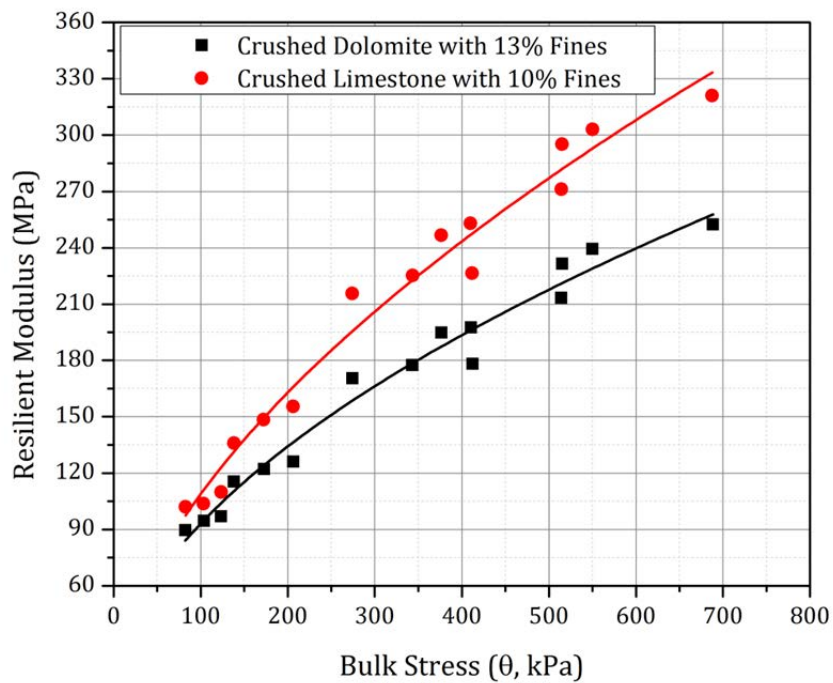
Figure 3.3. Effect of material quality on resilient modulus behavior at standard compactive effort OMC and MDD.

showed higher modulus values compared with material 3, as a result of a lower amount of fines in the matrix (see Figure 3.3).

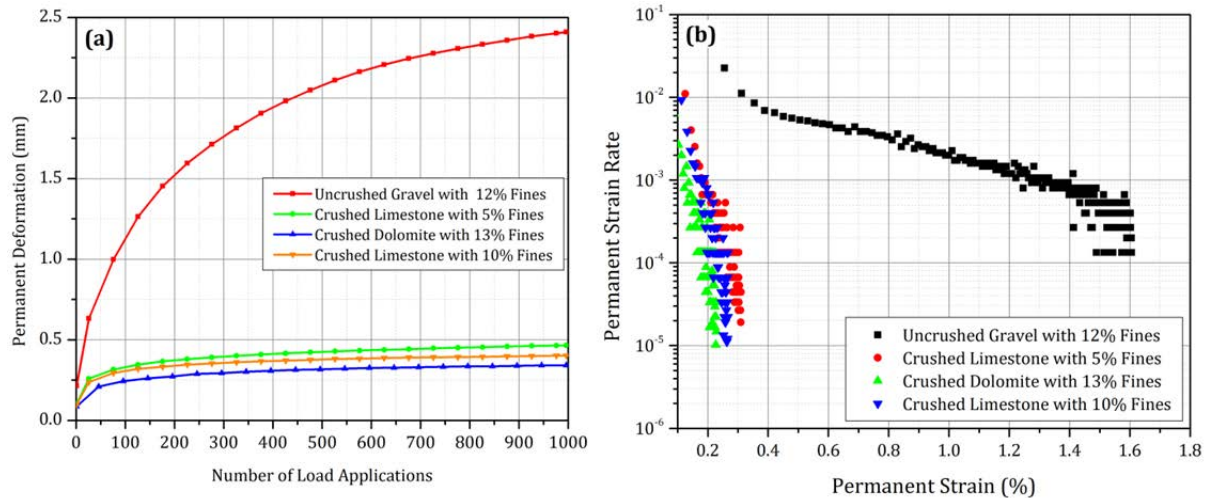
Figure 3.4. Permanent deformation trends for different aggregate types under modified compactive effort OMC and MDD.

The effect of aggregate quality on modulus and deformation characteristics was further investigated by testing specimens compacted to modified compactive effort OMC and MDD values. Figure 3.4a shows the permanent deformation trends in the four aggregate types as determined from the conditioning phase of AASHTO T 307 resilient modulus test protocol. From the figure, it is clearly apparent that the uncrushed gravel with 12% fines (material 1) showed significantly higher permanent deformation accumulation compared with the crushed aggregates (materials 2, 3 and 4). This was consistent with the findings from Phase I research study. Figure 3.4b shows the non-stabilizing behavior (non-decreasing permanent strain rates) of the uncrushed gravel material even after the accumulation of high permanent strain values.

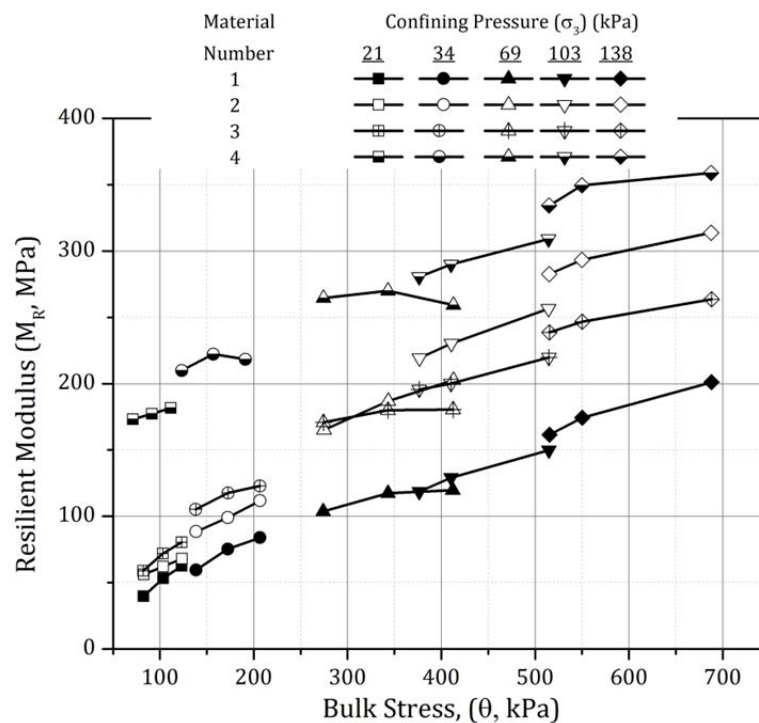
Figure 3.5. Resilient modulus trends for different aggregate types under modified compactive effort OMC and MDD conditions.

unbound granular layers. Similarly, the effect of fines content on resilient modulus can be studied by close inspection of materials 2, 3 and 4. A direct comparison of materials 3 and 4 highlights the detrimental effect of excessive fines on resilient modulus behavior (reflected by lower moduli for material 3). The excess fines in material 3 resulted in the lower resilient modulus values when compared with those of materials 2 and 4. This is in agreement with findings by Jorenby and Hicks (1986), who observed that well-graded aggregates exhibited high resilient modulus values up to the point where the fines content of the mixture displaced the coarse particles and the properties of the fines dominated. Although material 2 showed unstable matrix behavior under standard compaction conditions, its performance at modified compaction was significantly better (higher modulus values than material 3) as a result of increased particle interlock. Material 4 contained 10% fines and showed slightly higher moduli values than material 2. However, the changes in modulus values were insignificant as the fines content increased from ~5% (material 2) to 10% (material 4).

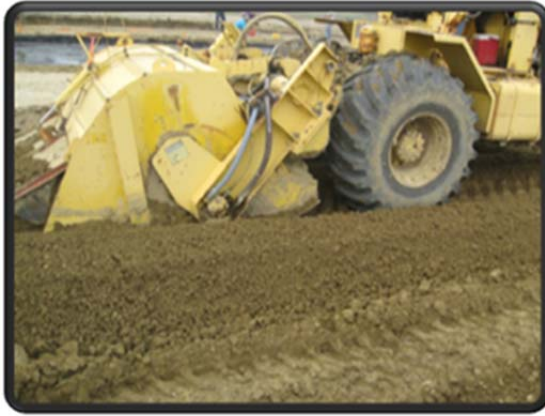
Figure 3.9. (a) Subgrade tilling, (b) wetting, (c) compaction, and (d) field IBV measurement.

This procedure was repeated until the in-place IBV for the top 12 in. (305 mm) of the subgrade (as determined from Equation 3.1) was reasonably close to the target value. Figure 3.9 shows the process of subgrade tilling, moisture addition, compaction, and DCP testing on the engineered subgrade layer. Figure 3.10 shows an example in-place subgrade IBV profile determined from DCP testing, for a test cell subgrade of target IBV = 3%. As seen from Figure 3.10, the subgrade tilling and moisture addition proved to be an effective procedure for achieving a uniform subgrade of controlled IBV.

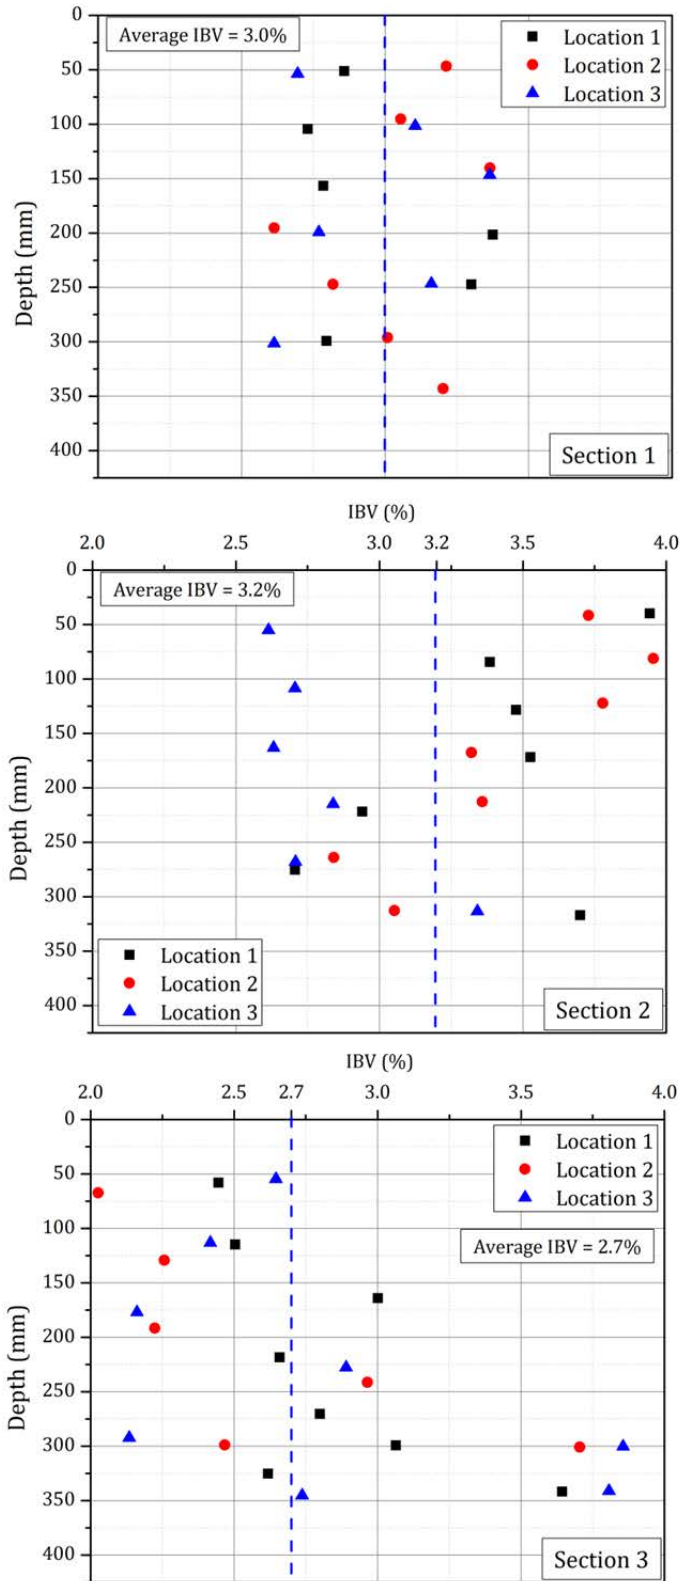
Figure 3.10. Example of in-place subgrade IBV profile determined from DCP testing for a test cell with target IBV = 3%.

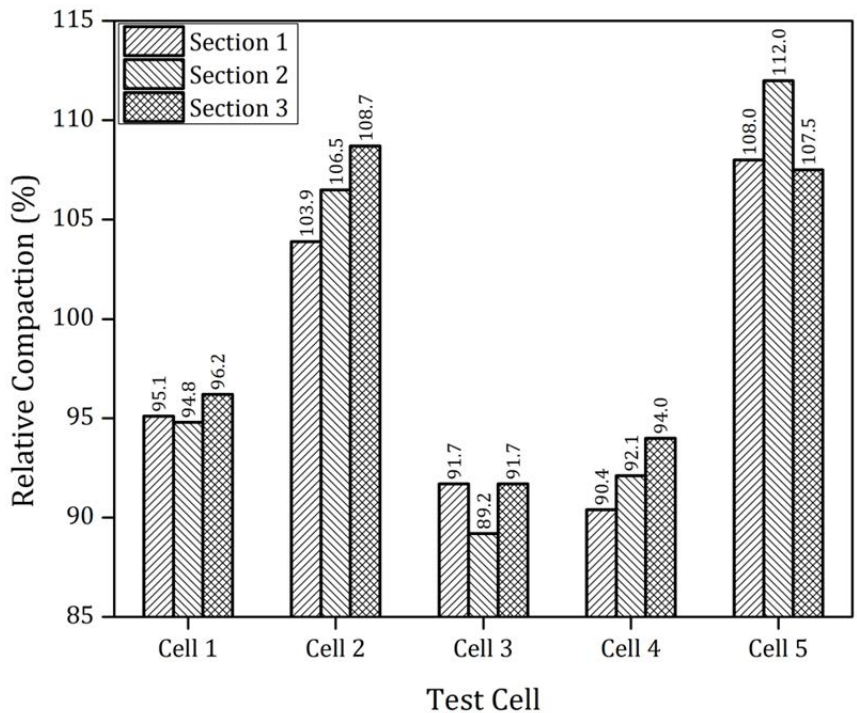
Figure 3.11. Relative compaction (ASTM D 698) levels achieved for aggregate sections.

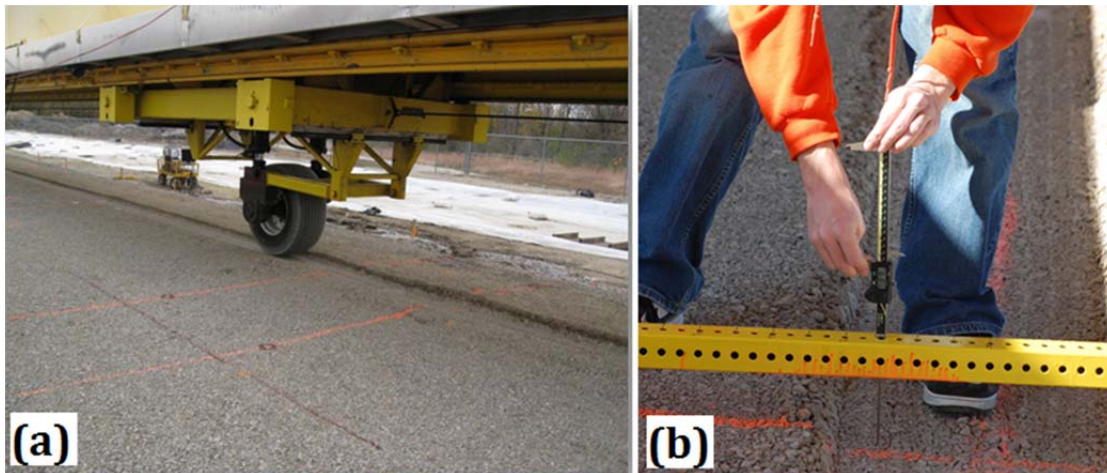
Figure 4.1. Photos showing unidirectional accelerated pavement testing and rut measurement.

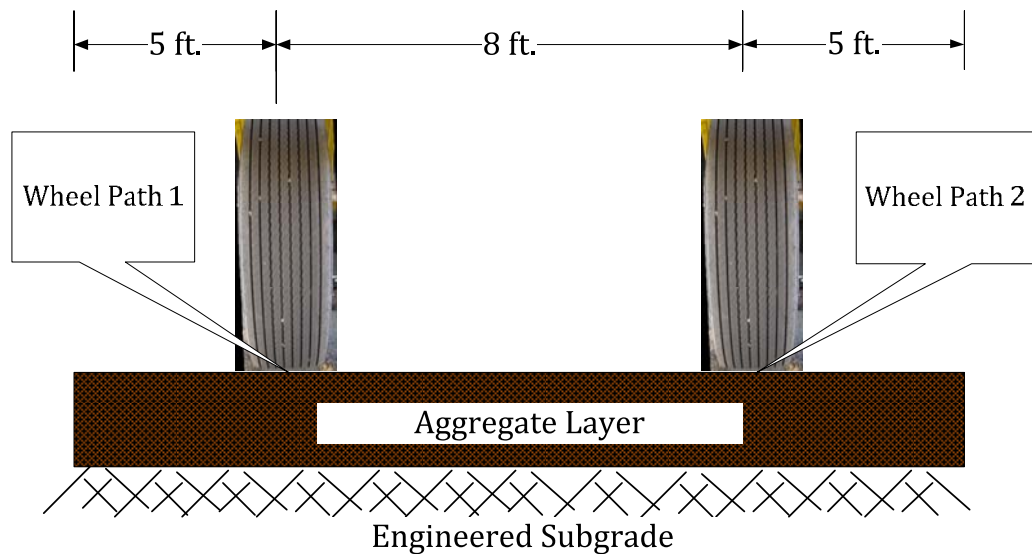
Figure 4.2. Trafficking wheel path locations 1 and 2 separated by 8 ft.

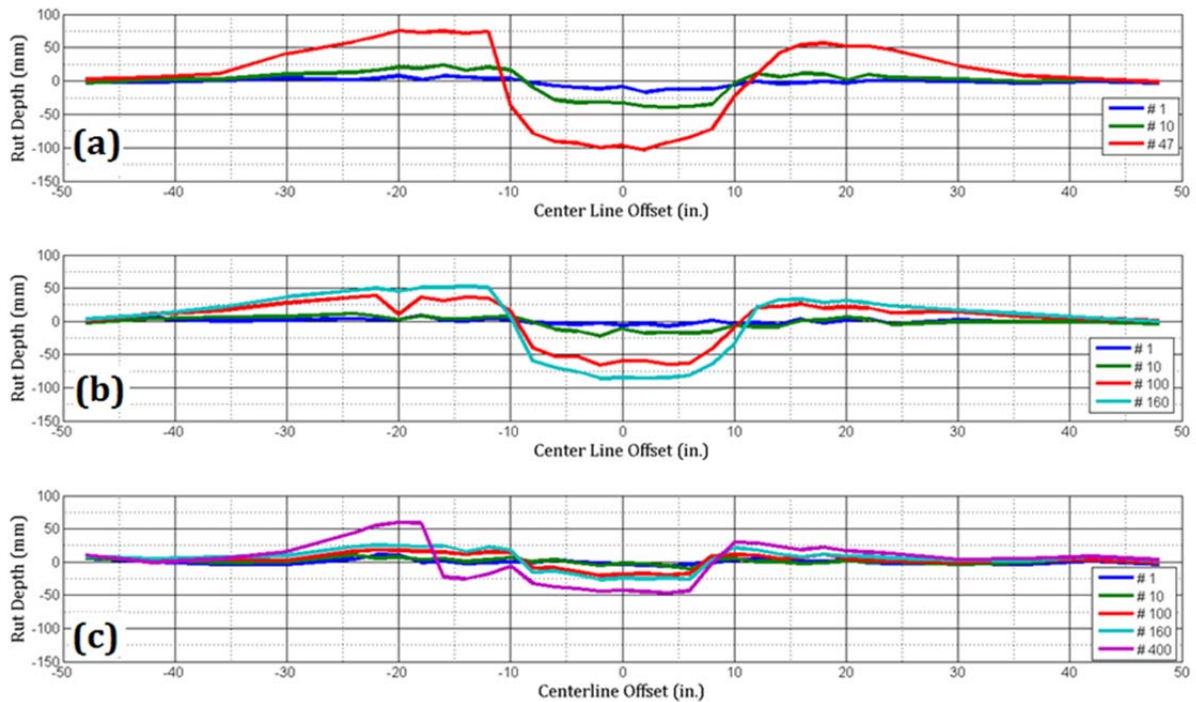
Figure 4.3. Rut developments in uncrushed gravel sections: (a) 1 (14-in.-thick aggregate layer), (b) 2 (12-in.-thick aggregate layer), and (c) 3 (8-in.-thick aggregate layer) resulting from unidirectional ATLAS loading under near-optimum aggregate moisture conditions (1 in. = 25.4 mm).

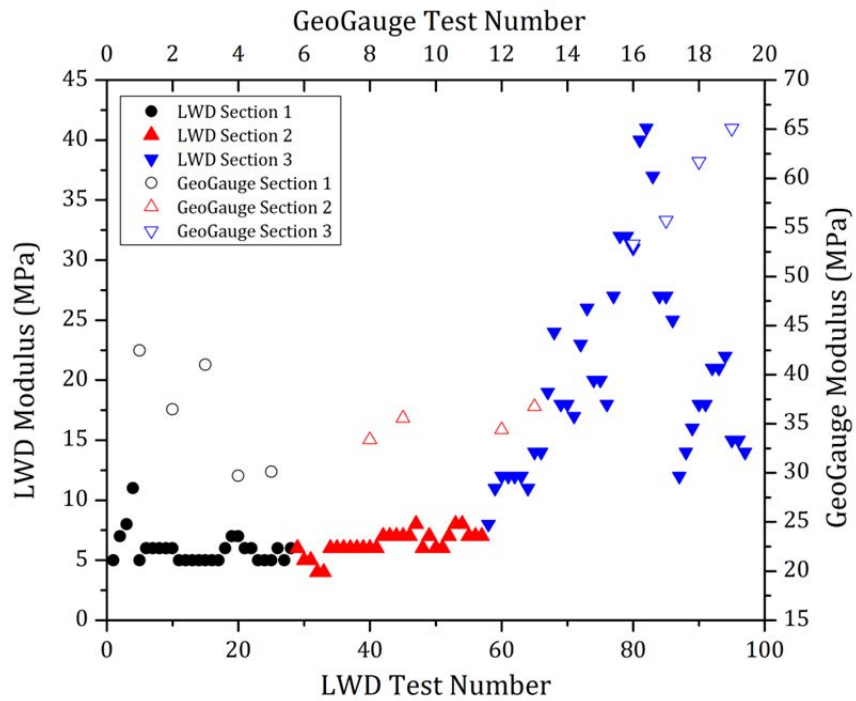
Figure 4.7. Measured field moduli for Cell 1 indicating stronger subgrade constructed in Section 3 when compared with Sections 1 and 2.

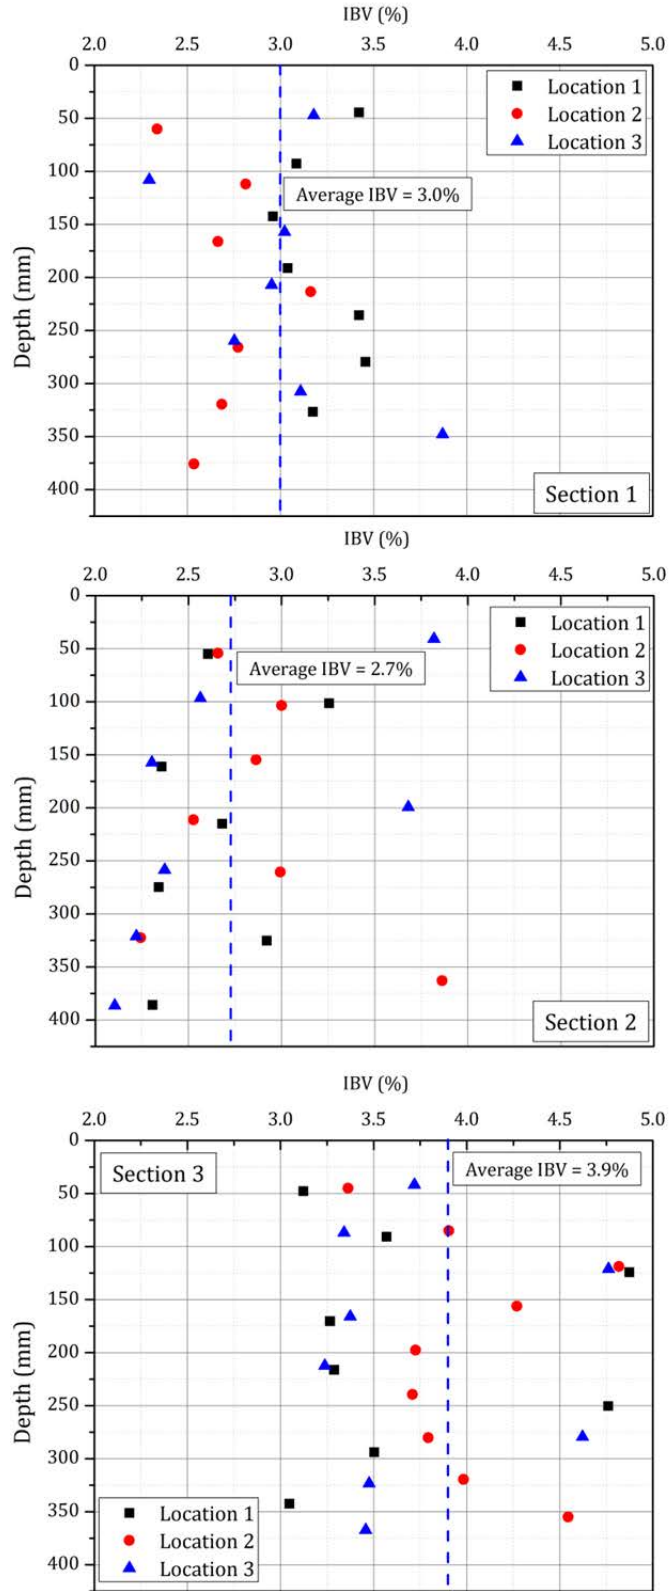
Figure 4.8. DCP measured subgrade IBV profiles for Cell 1 showing stronger subgrade conditions in Section 3.

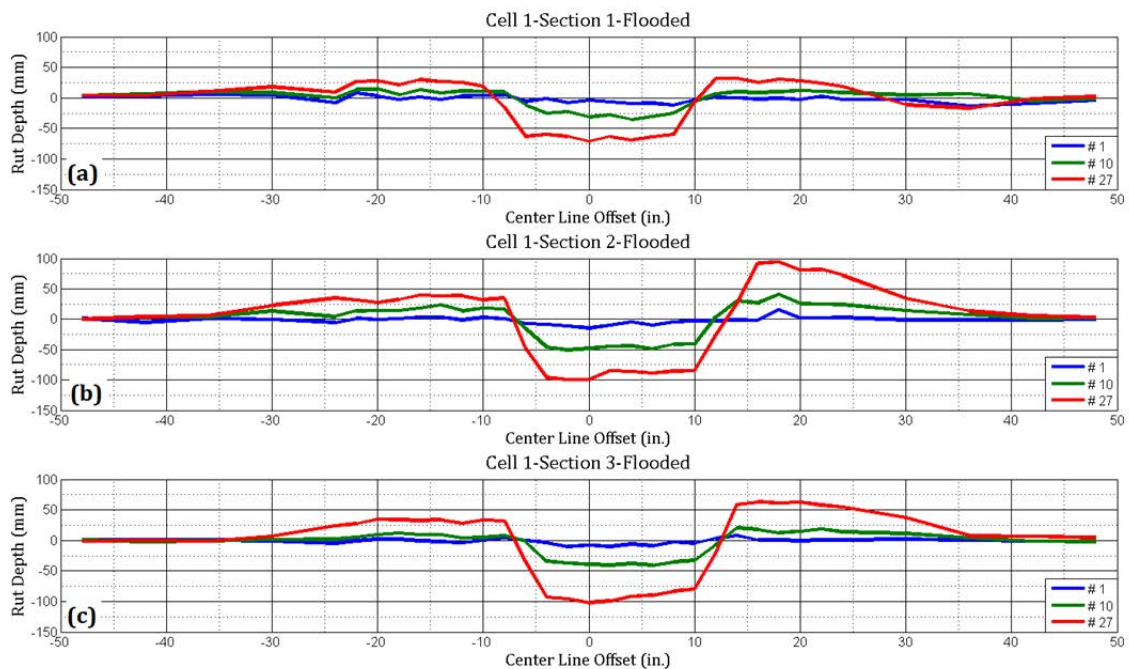
Figure 4.9. Rut developments in uncrushed gravel sections (a) 1 (14-in.-thick aggregate layer), (b) 2 (12-in.-thick aggregate layer), and (c) 3 (8-in.-thick aggregate layer) resulting from unidirectional ATLAS loading under flooded conditions (1 in. = 25.4 mm).

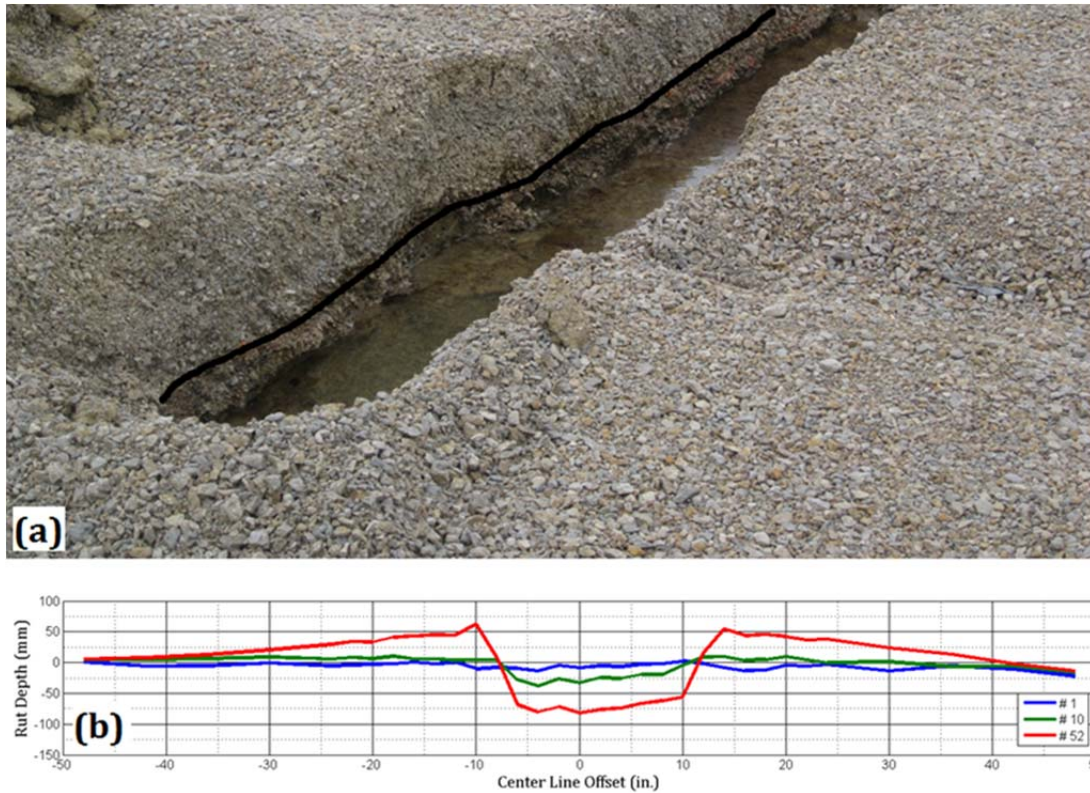
Figure 4.10. (a) Excavated trench and (b) surface rut profile of the 14-in.-thick crushed limestone section in Cell 2 (1 in. = 25.4 mm).

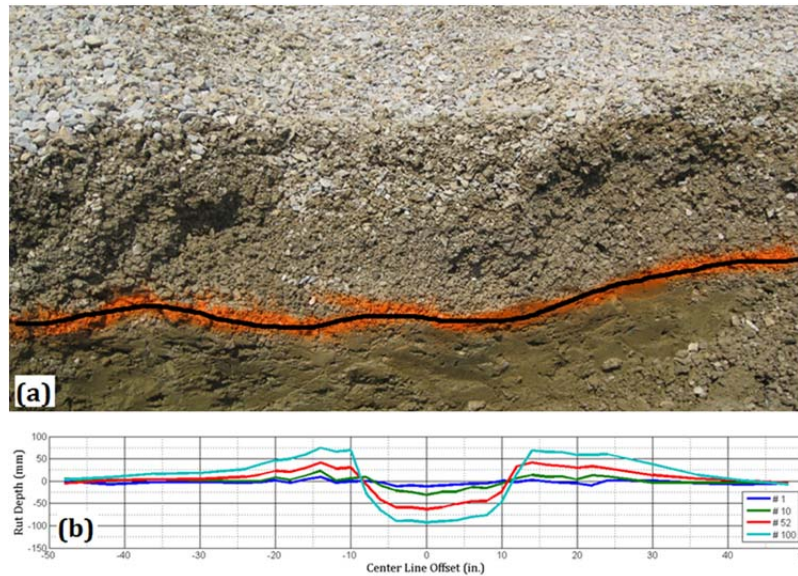
Figure 4.11. (a) Excavated trench and (b) surface rut profile of the 12-in.-thick crushed limestone section in Cell 2 (1 in. = 25.4 mm).

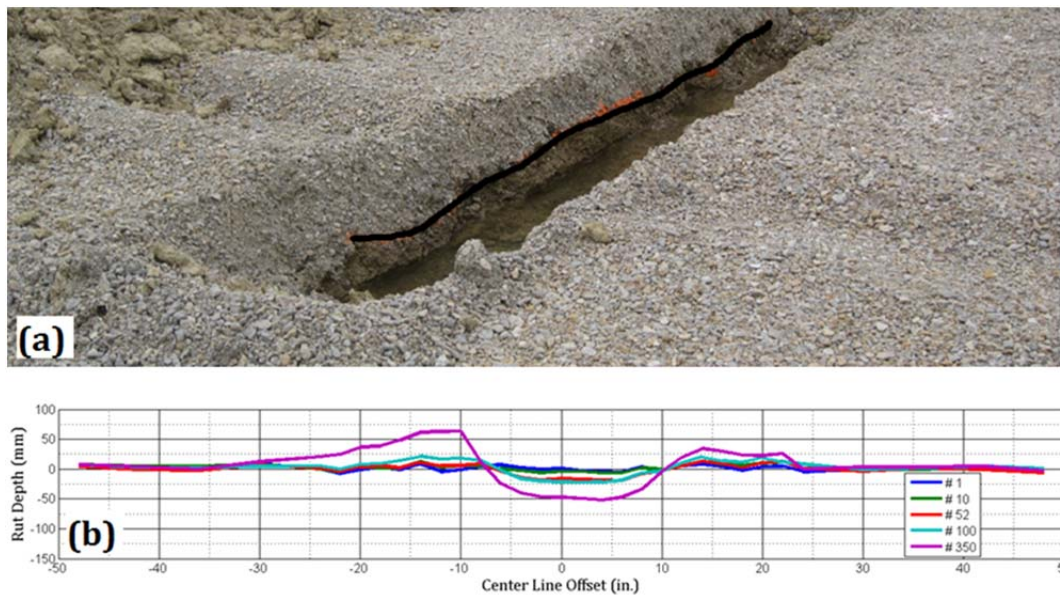
Figure 4.12. (a) Excavated trench and (b) surface rut profile of the 8-in.-thick crushed limestone section in Cell 2 (1 in. = 25.4 mm).

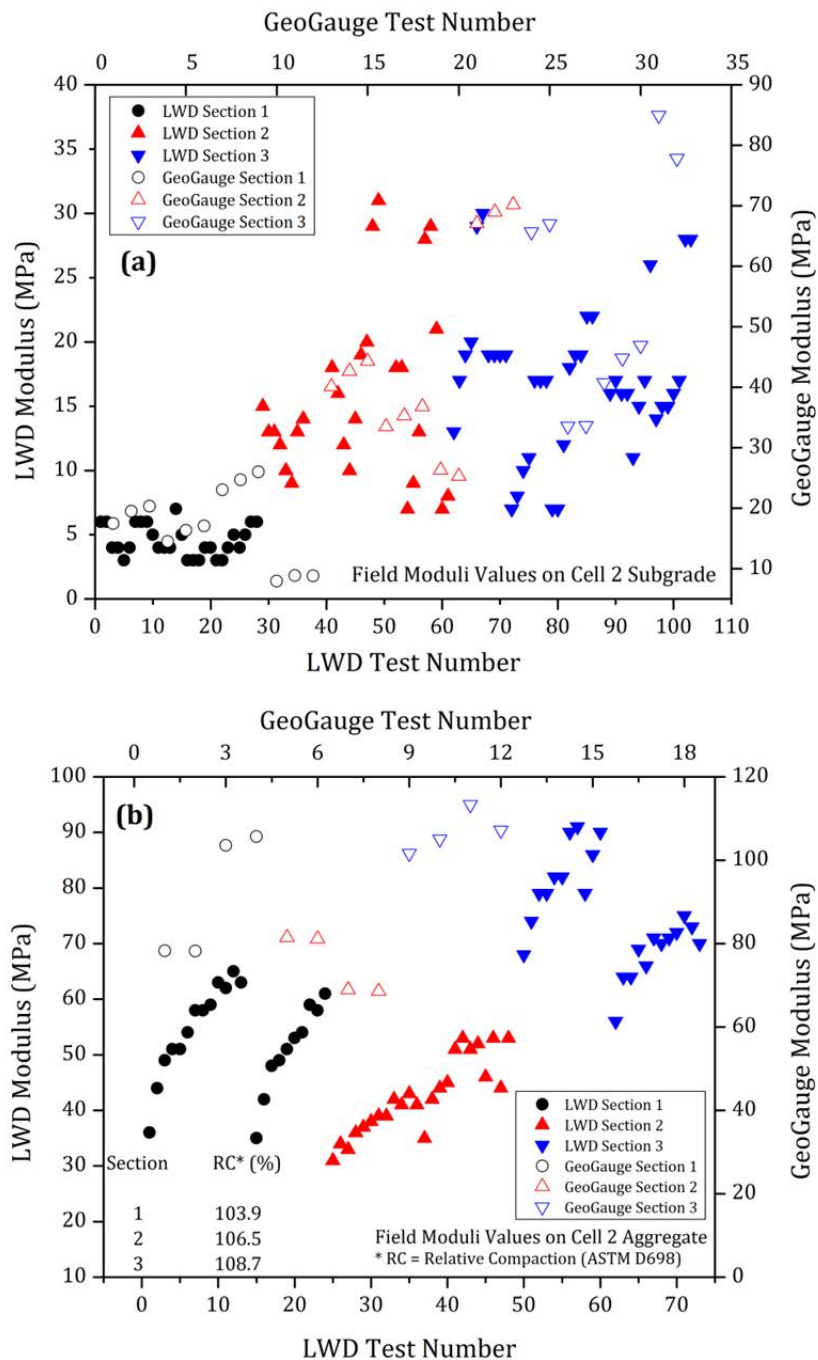
Figure 4.13. Field modulus values measured by LWD and GeoGauge™ on (a) compacted subgrade and (b) aggregate layers in Cell 2. (Sections 1, 2, and 3 correspond to aggregate layers of thicknesses 14, 12, and 8 in., respectively).

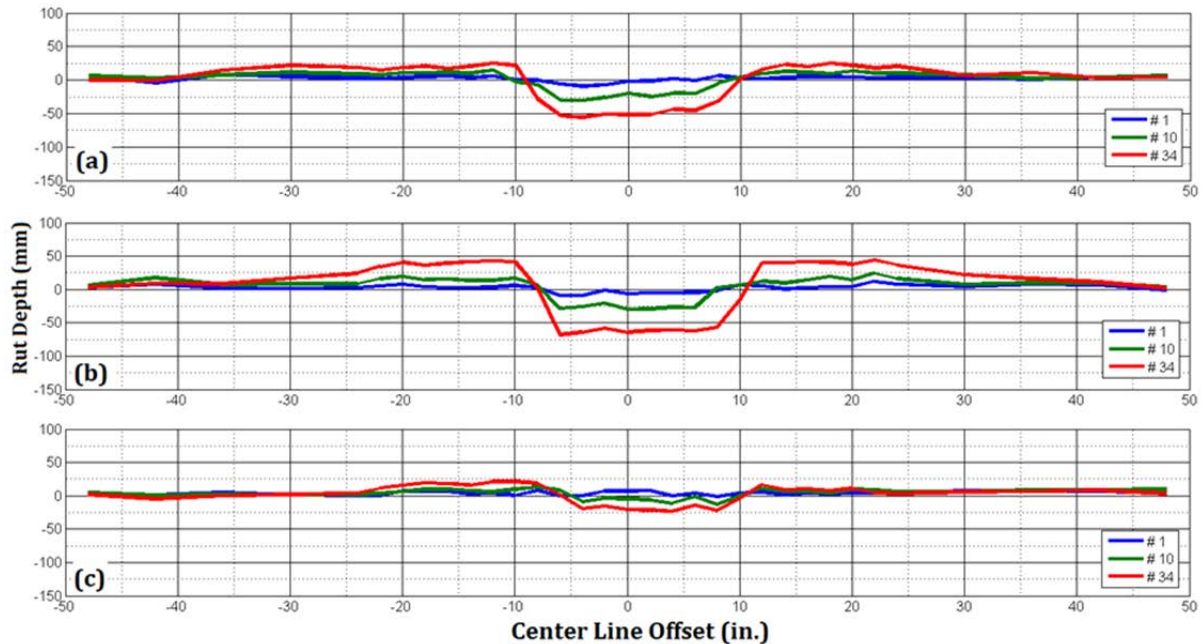
Figure 4.14. Rut developments in Cell 2 sections (a) 1 (14-in.-thick aggregate layer), (b) 2 (12-in.-thick aggregate layer), and (c) 3 (8-in.-thick aggregate layer) resulting from unidirectional ATLAS loading under flooded conditions (1 in. = 25.4 mm).

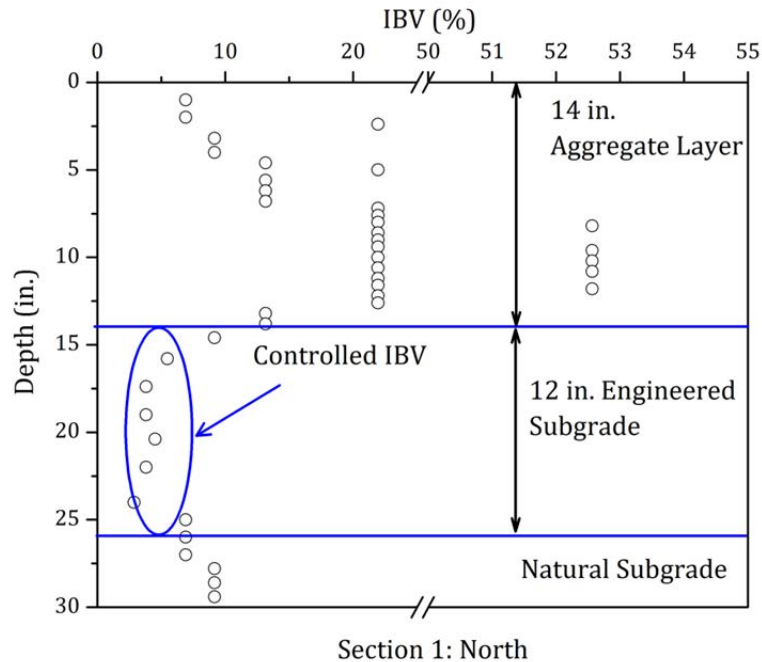
Figure 4.15. Cell 3 IBV profile with depth along the north wheel path of Section 1 (1 in. = 25.4 mm).

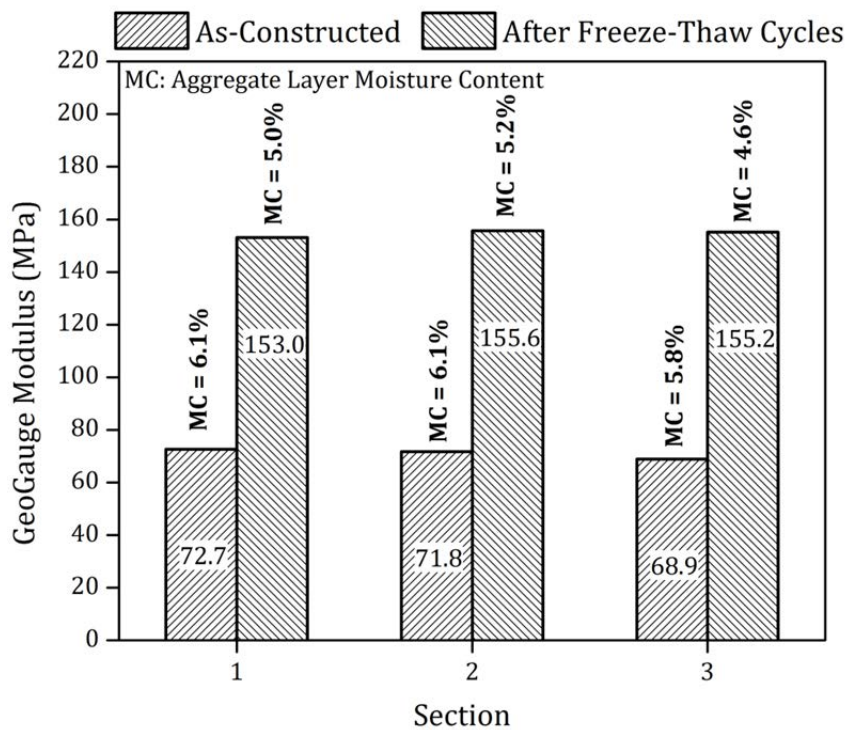
Figure 4.16, Comparisons of Cell 3 aggregate layer moduli before and after freeze-thaw cycles (Sections 1, 2, and 3 correspond to aggregate layers of thicknesses 14, 12, and 8 in., respectively).

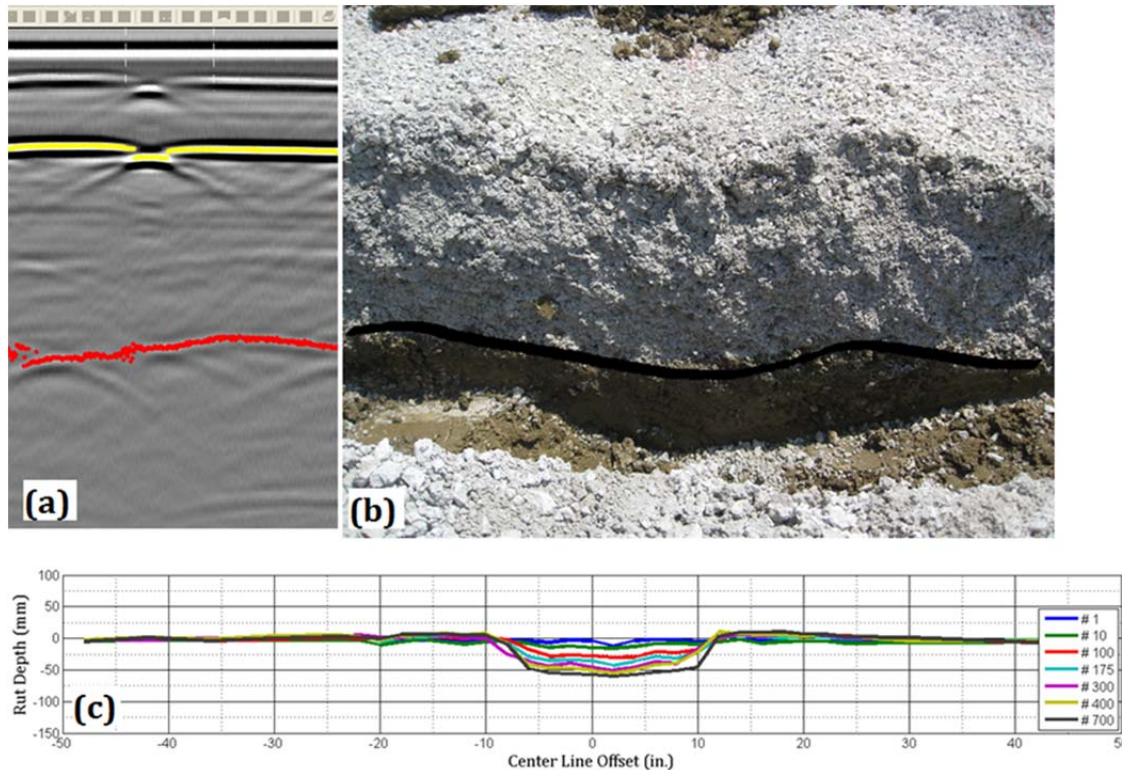
Figure 4.17. (a) GPR scan, (b) excavated trench, and (c) surface rut profile of the 14-in. (356-mm) thick crushed dolomite section in Cell 3 (1 in. = 25.4 mm).

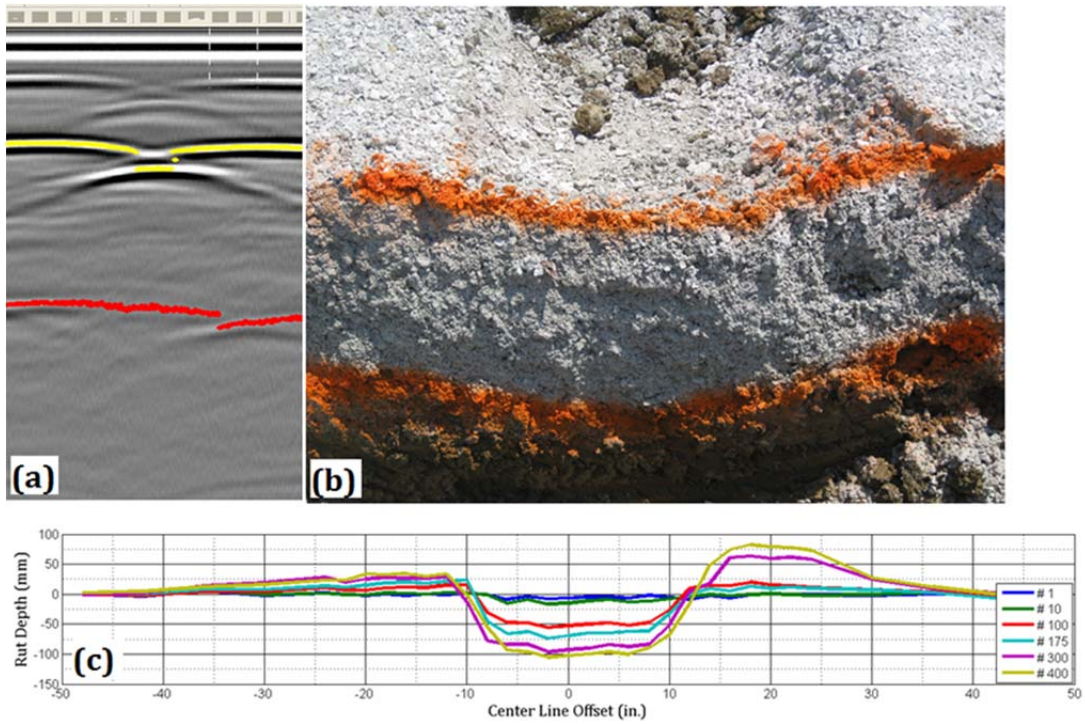
Figure 4.18. (a) GPR scan, (b) excavated trench, and (c) surface rut profile of the 12-in. (305-mm) thick crushed dolomite section in Cell 3 (1 in. = 25.4 mm).

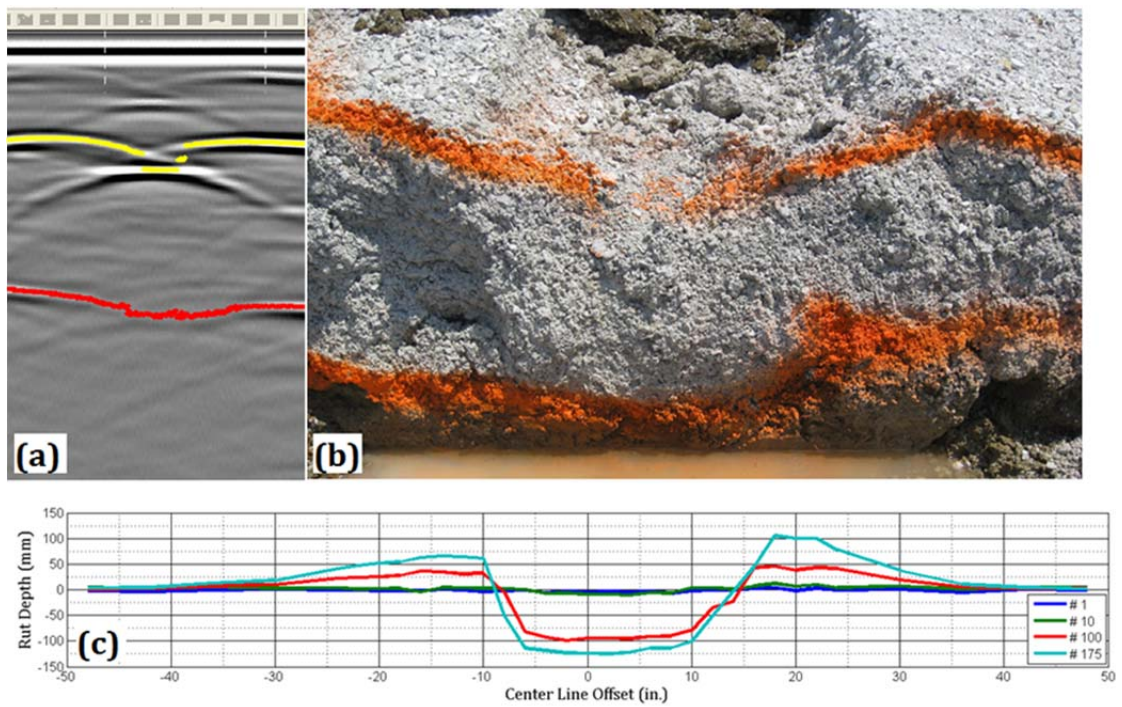
Figure 4.19. (a) GPR scan, (b) excavated trench, and (c) surface rut profile of the 8-in. (203-mm) thick crushed dolomite section in Cell 3 (1 in. = 25.4 mm).

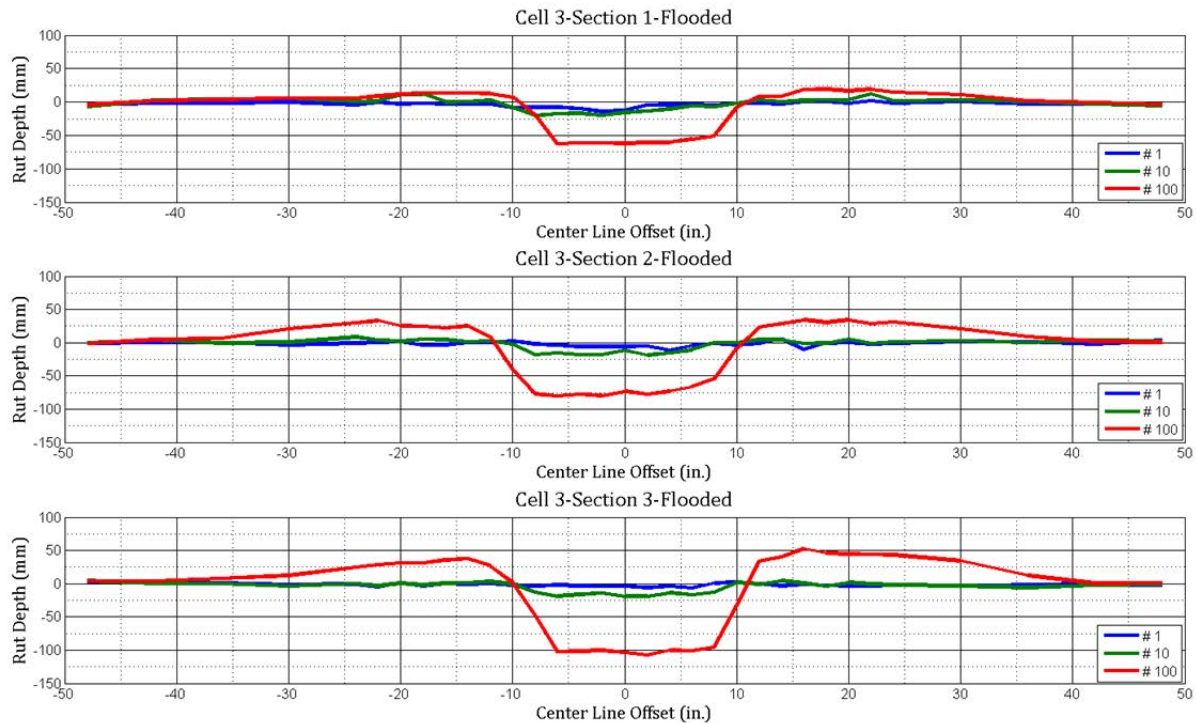
Figure 4.20. Rut developments in crushed dolomite sections in Cell 3 resulting from unidirectional ATLAS loading under flooded conditions. Sections 1, 2, and 3 correspond to aggregate layers of thicknesses 14, 12, and 8 in., respectively (1 in. = 25.4 mm).

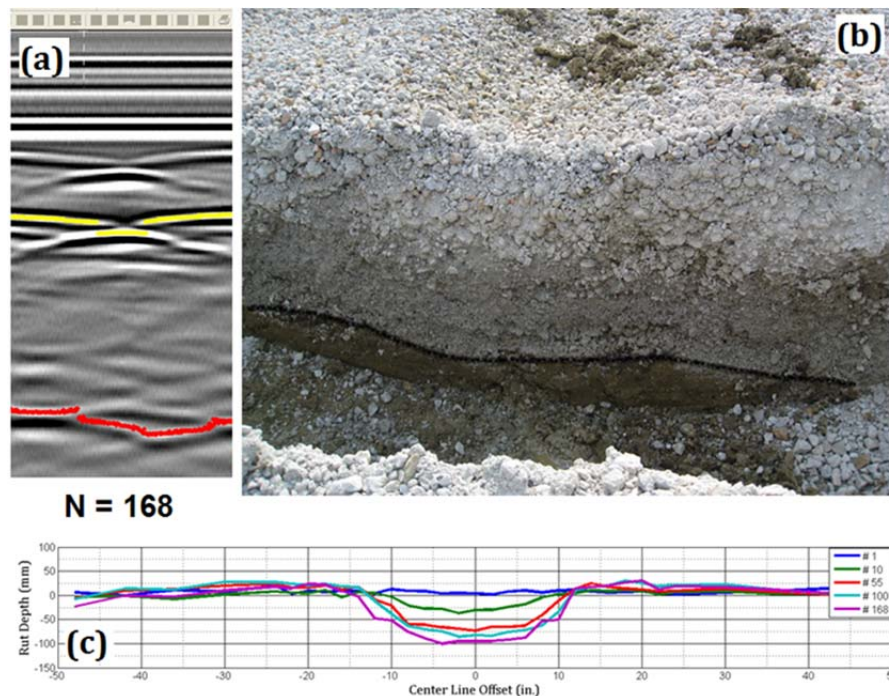
Figure 4.21. (a) GPR scan, (b) excavated trench, and (c) surface rut profile of the 14-in. (356-mm) thick crushed limestone section in Cell 4 (1 in. = 25.4 mm).

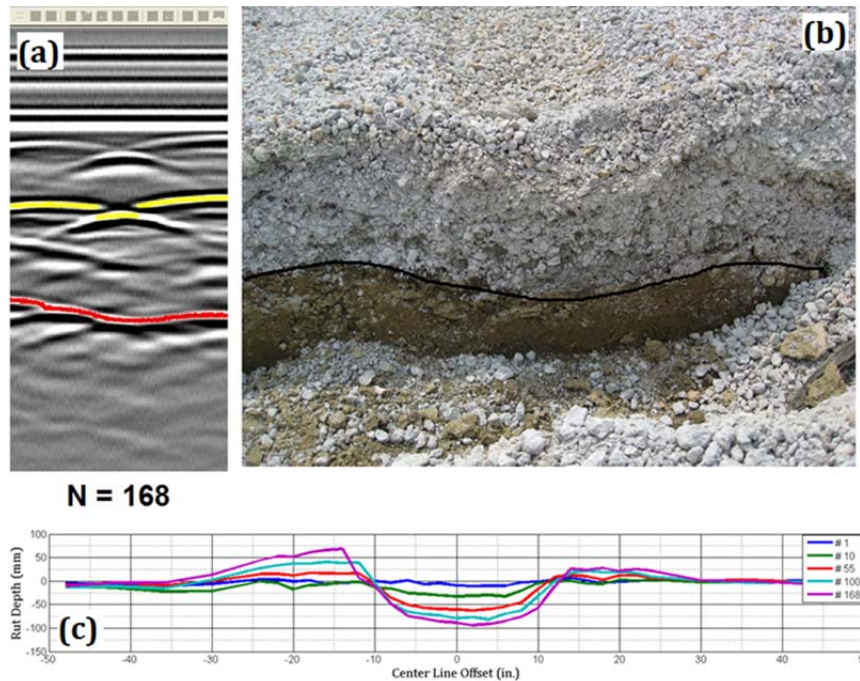
Figure 4.23. (a) GPR scan, (b) excavated trench, and (c) surface rut profile of the 8-in. (203-mm) thick crushed limestone section in Cell 4 (1 in. = 25.4 mm).

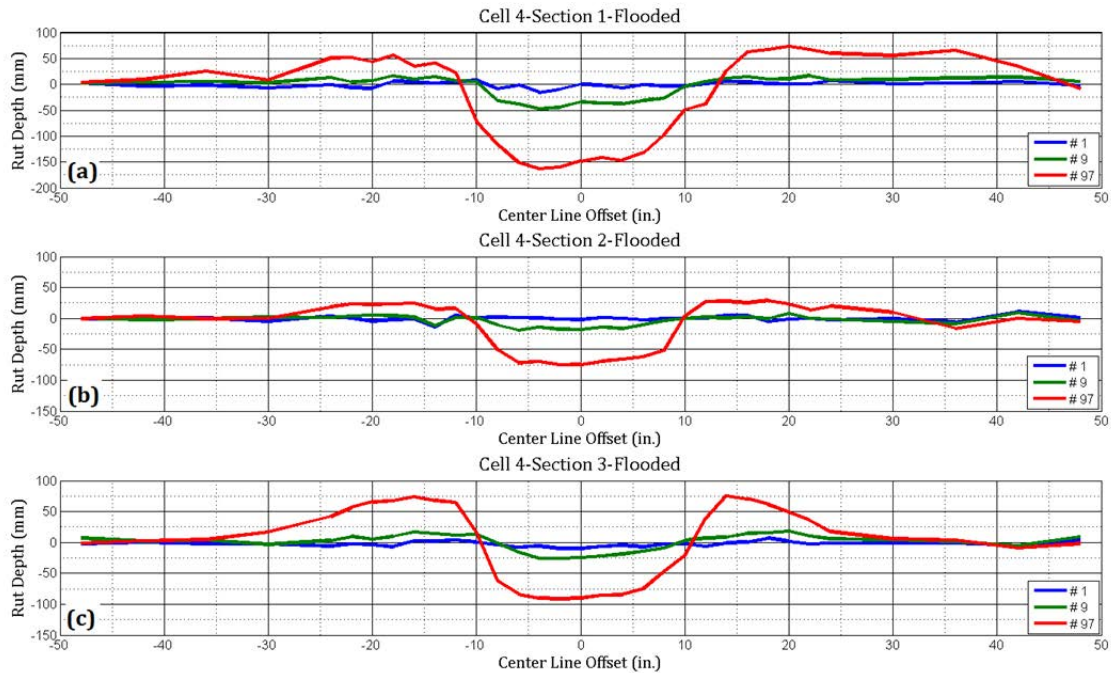
Figure 4.24. Rut developments in Cell 4 sections resulting from unidirectional ATLAS loading under flooded conditions. Sections 1, 2, and 3 correspond to aggregate layers of thicknesses 14, 12, and 8 in., respectively (1 in. = 25.4 mm).
