FIELD PERFORMANCE EVALUATIONS OF ILLINOIS AGGREGATES FOR SUBGRADE REPLACEMENT AND SUBBASE—PHASE II

Research Report FHWA-ICT-12-021

Illinois Center for Transportation
Project R27-81
Field Performance Evaluations of Illinois Aggregates for
Subgrade Replacement and Subbase-Phase II

April 2013

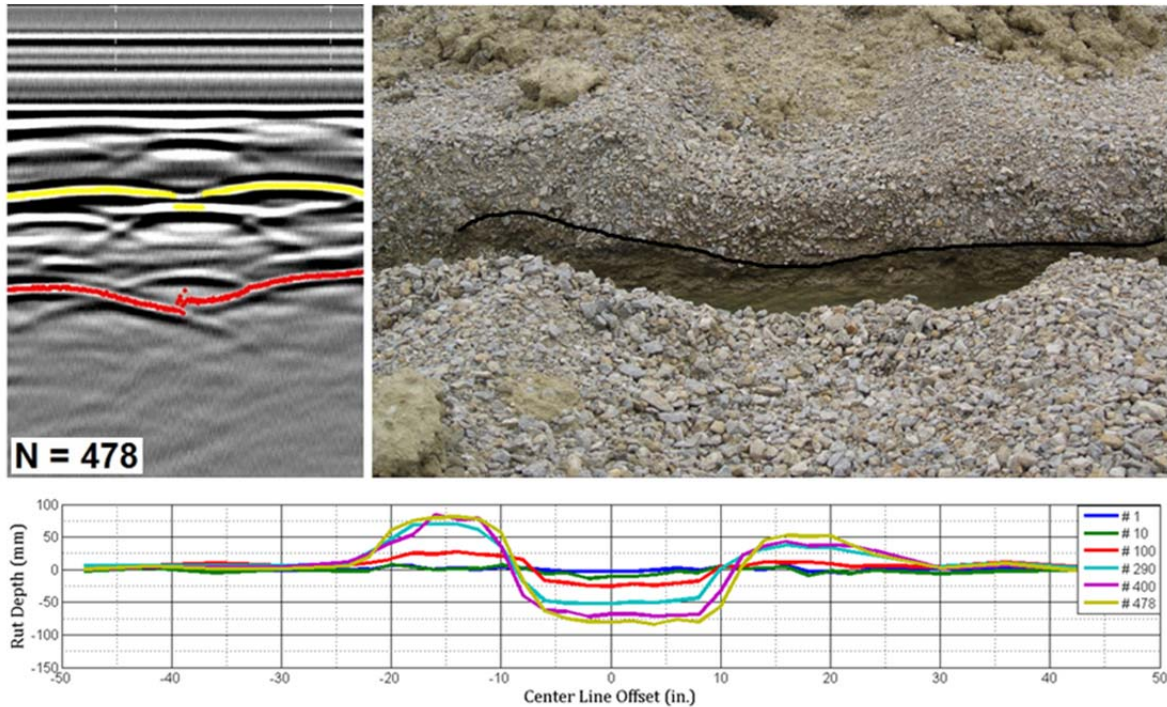
Figure 4.27. (a) GPR scan, (b) excavated trench, and (c) surface rut profile of the 6-in. (152-mm) thick crushed limestone section in Cell 5 (1 in. = 25.4 mm).

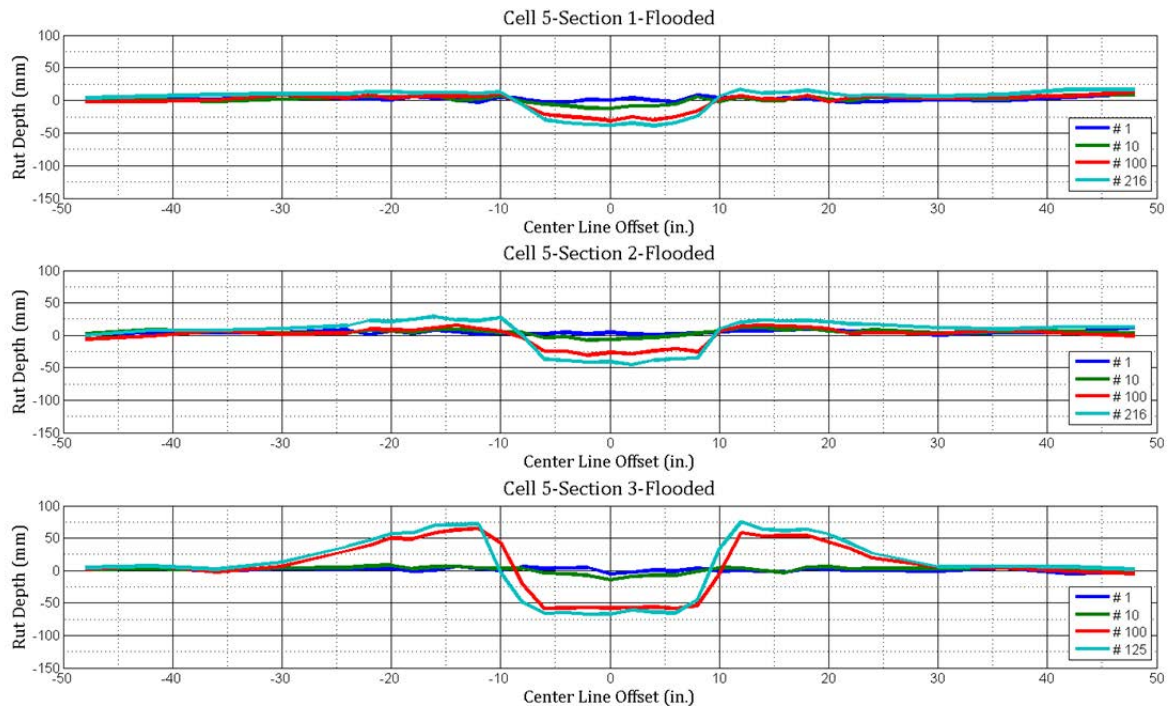
Figure 4.28. Rut developments in crushed limestone sections in Cell 5 resulting from unidirectional ATLAS loading under flooded conditions. Sections 1, 2, and 3 correspond to aggregate layers of thicknesses 10, 8, and 6 in., respectively (1 in. = 25.4 mm).

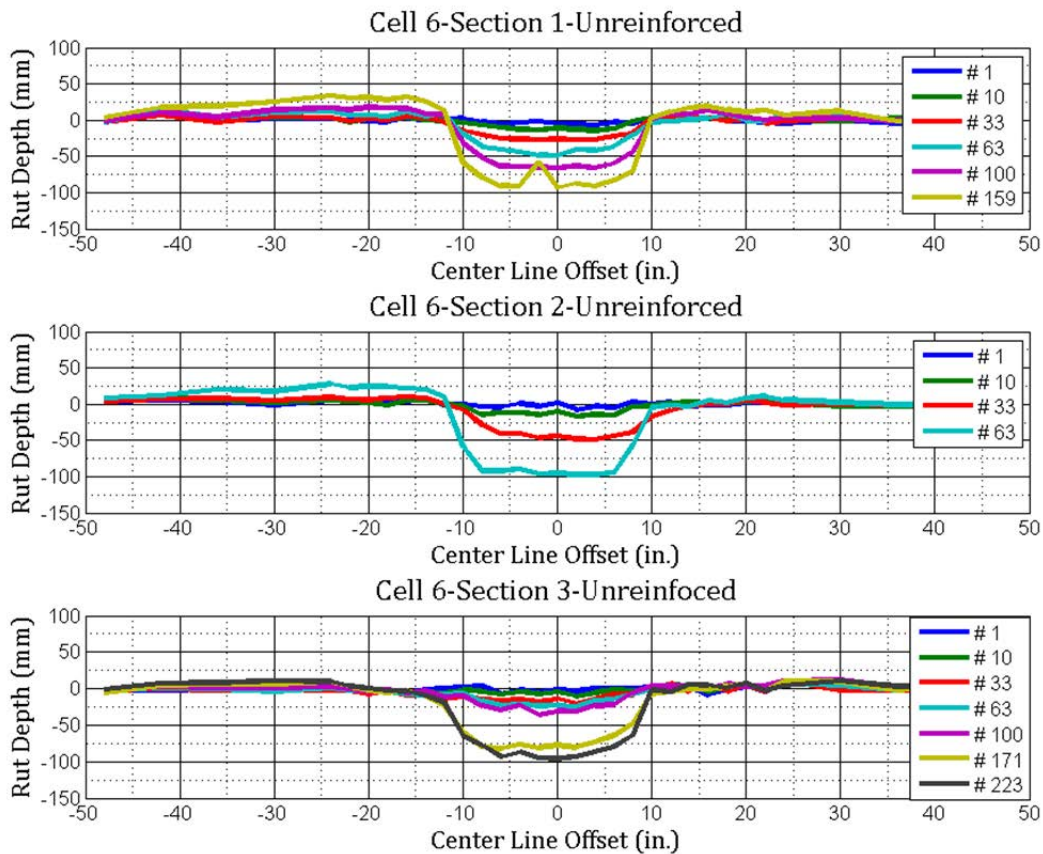
Figure 4.29. Rut developments in Cell 6 test sections resulting from unidirectional ATLAS loading under unreinforced (no geotextile) conditions. Sections 1, 2, and 3 correspond to rip rap gradation # 1, D3 aggregate-subgrade gradation # 1, and D6 rockfill for subgrade-primary crusher run, respectively (1 in. = 25.4 mm).

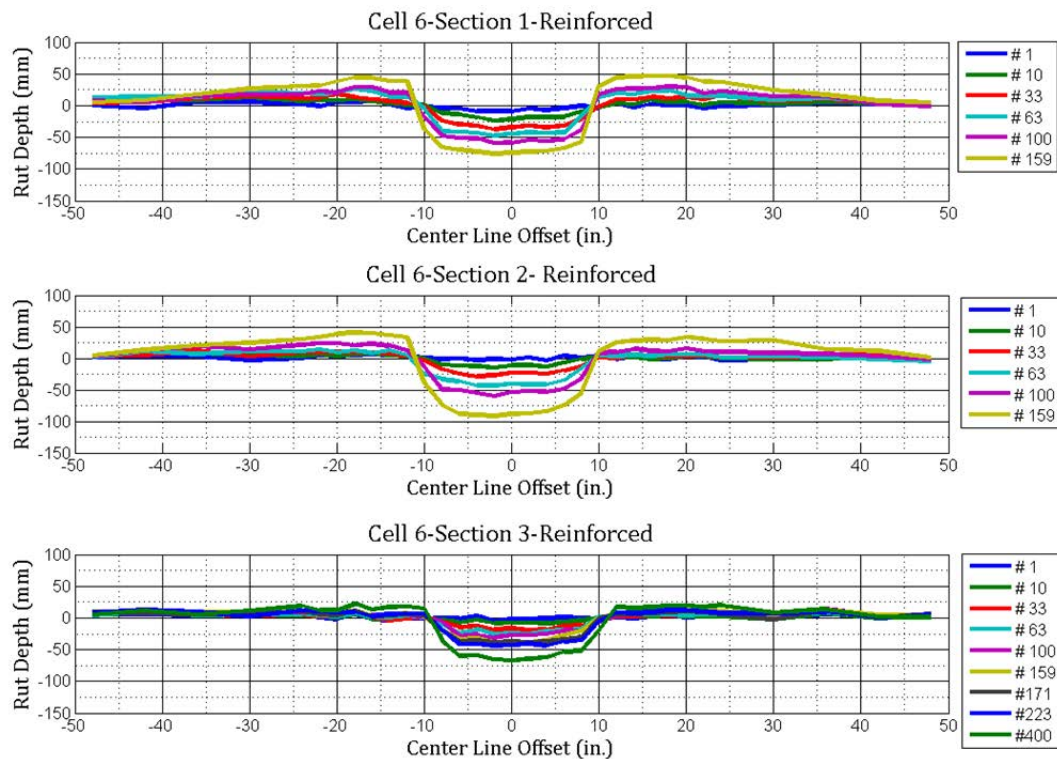
Figure 4.30. Rut developments in Cell 6 test sections resulting from unidirectional ATLAS loading under geotextile-reinforced conditions at the subgrade interface. Sections 1, 2, and 3 correspond to rip rap gradation # 1, D3 aggregate-subgrade gradation # 1, and D6 rockfill for subgrade-primary crusher run, respectively (1 in. = 25.4 mm).

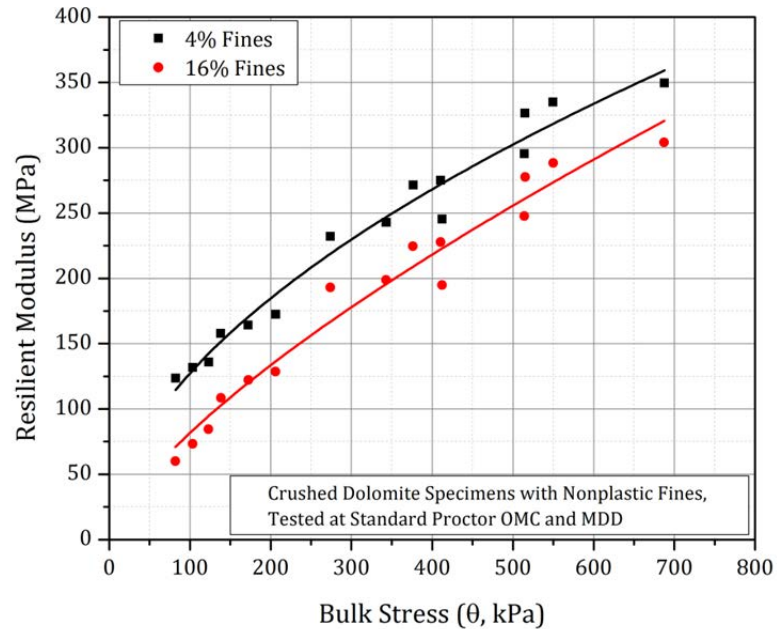
Figure 1 Resilient modulus values for crushed dolomite with nonplastic fines at W_{opt}

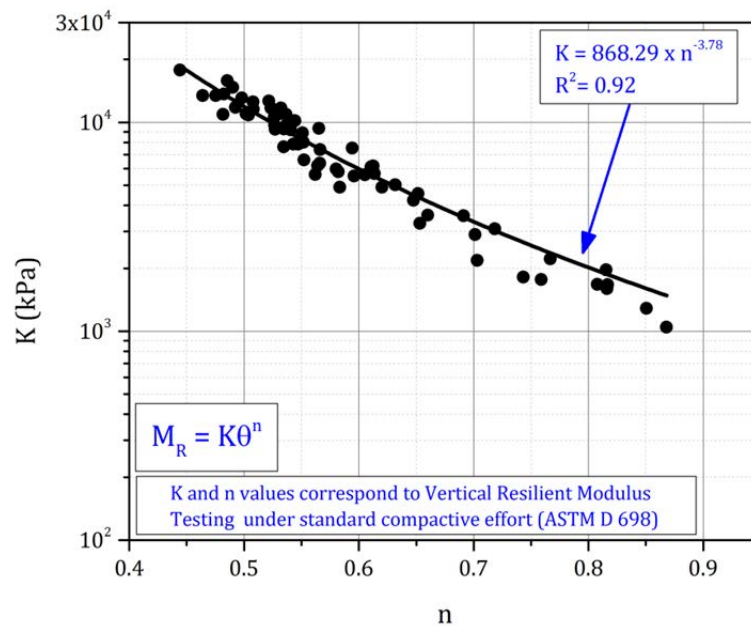
Figure 2 Relationships between K and n parameters of the K- θ model developed by the current study

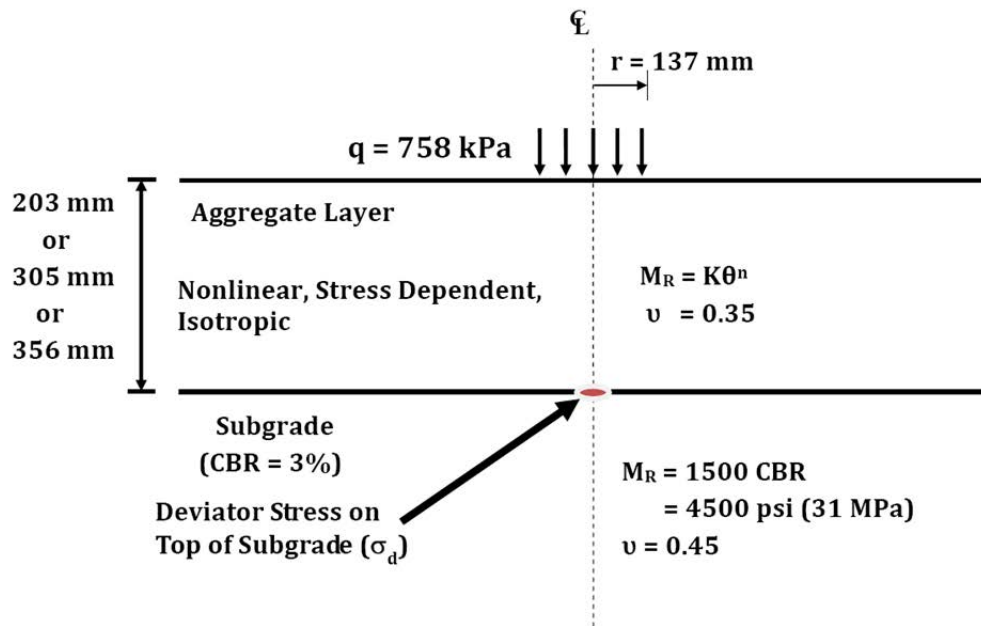
Figure 3 Schematic of a typical two-layer system analyzed using GT-PAVE

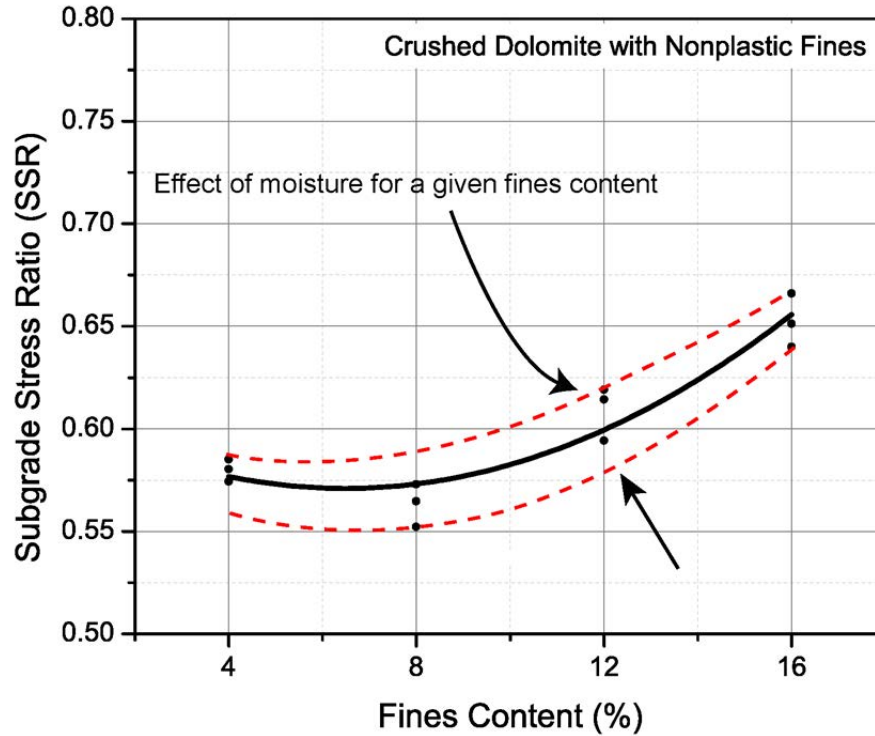
Figure 4 Subgrade Stress Ratios (SSRs) due to the 305-mm (12-in.) thick crushed dolomite layer with nonplastic fines

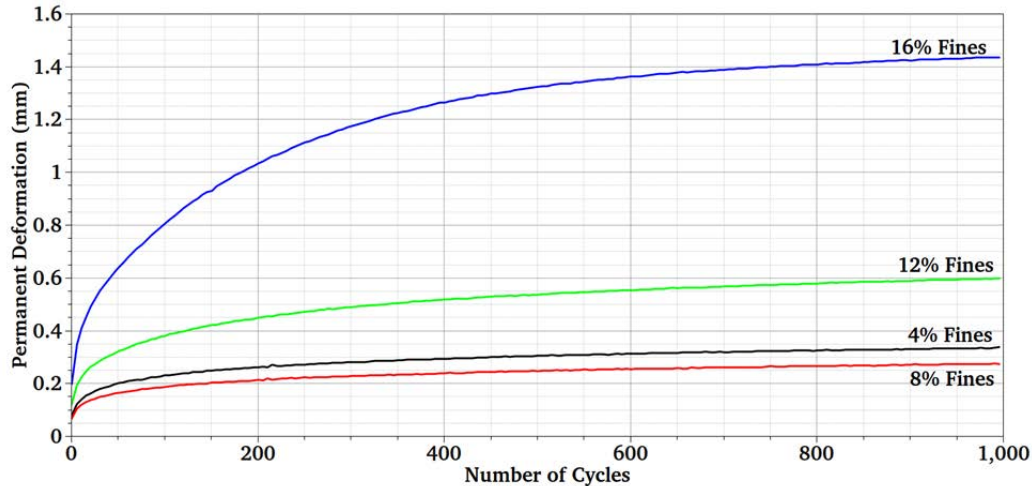
Figure 5 Permanent deformation trends for crushed dolomite with nonplastic fines at W_{opt}

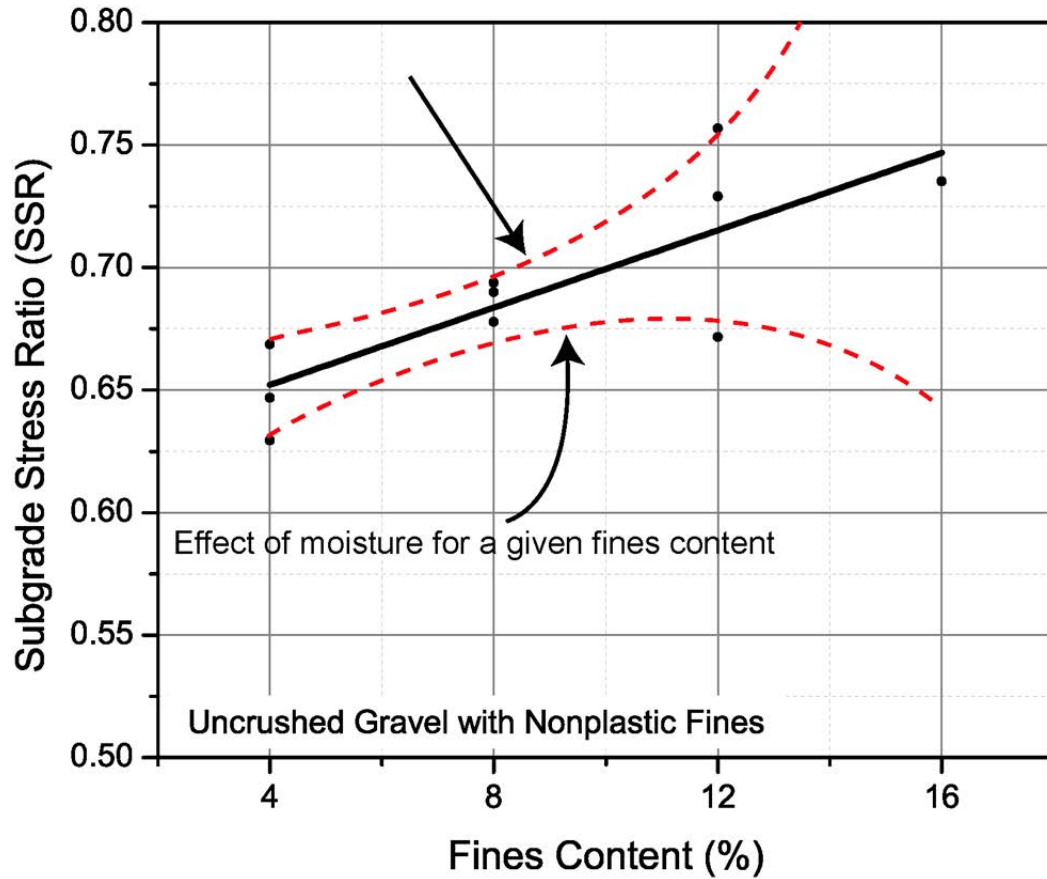
Figure 6 Subgrade Stress Ratios (SSRs) due to the 305-mm (12-in.) thick uncrushed gravel layer with nonplastic fines

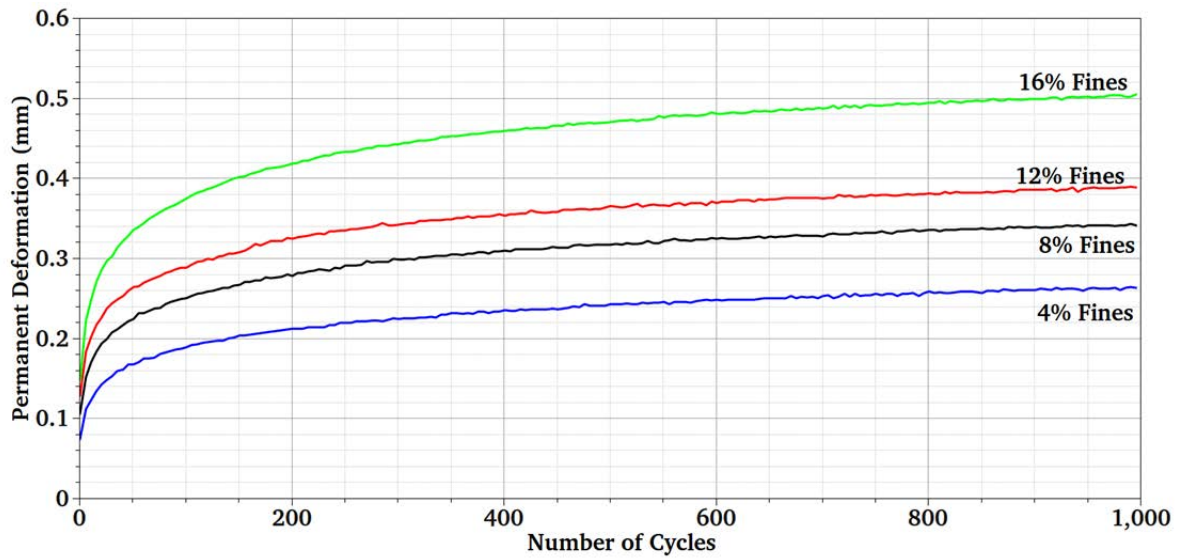
Figure 7 Permanent deformation trends for uncrushed gravel with nonplastic fines at 90% W_{opt}

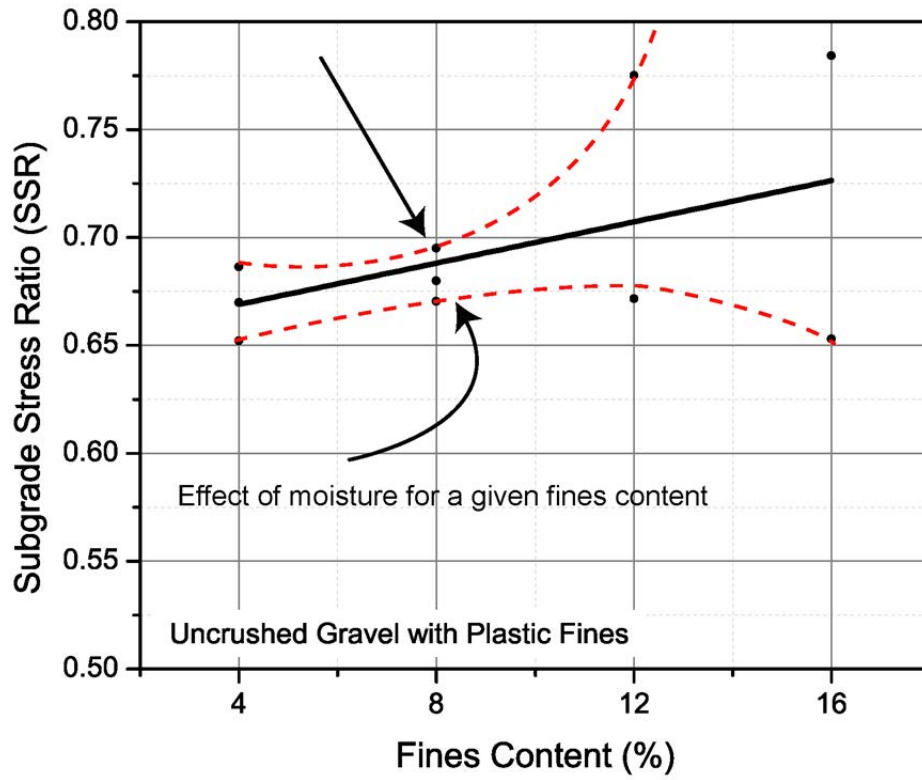
Figure 8 Subgrade Stress Ratios (SSRs) due to the 305-mm (12-in.) thick uncashed gravel layer with plastic fines

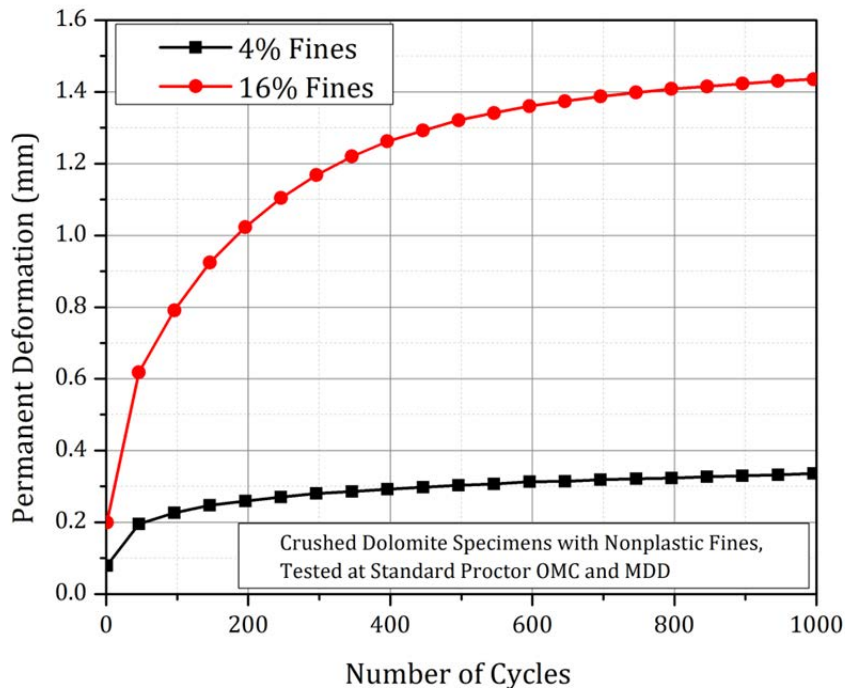
Figure 9 Permanent deformation behavior of crushed dolomite with nonplastic fines at W_{opt}

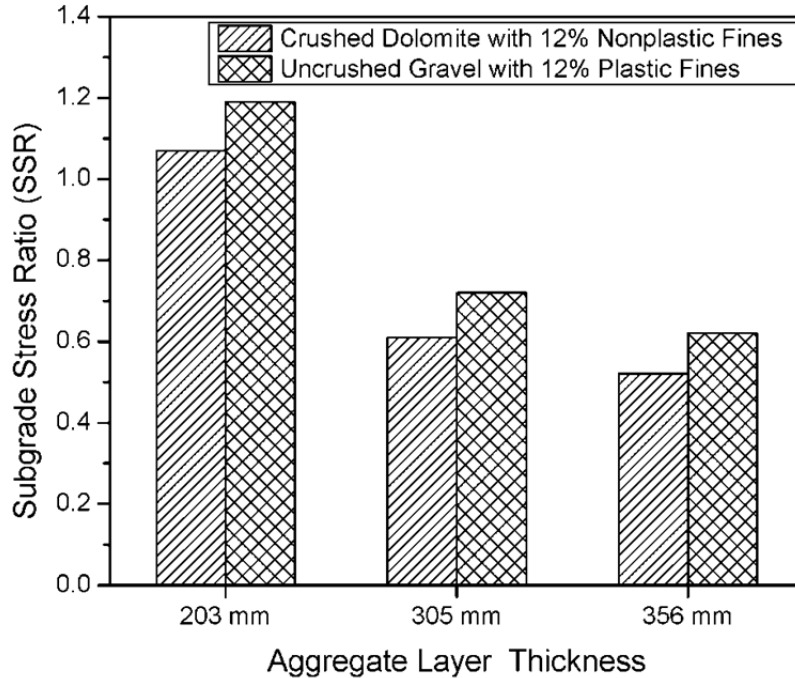
FIGURE 10 Subgrade Stress Ratios (SSRs) for crushed dolomite with 12% nonplastic fines compared to SSRs for uncrushed gravel with 12% plastic fines

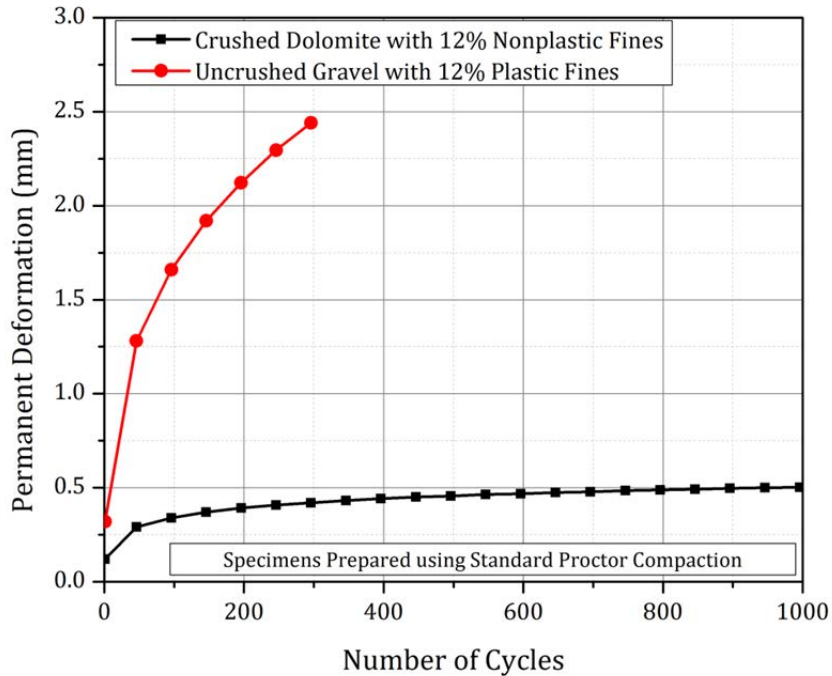
Figure 11 Permanent deformation trends of crushed dolomite with 12% nonplastic fines and uncrushed gravel with 12% plastic fines at W_{opt}

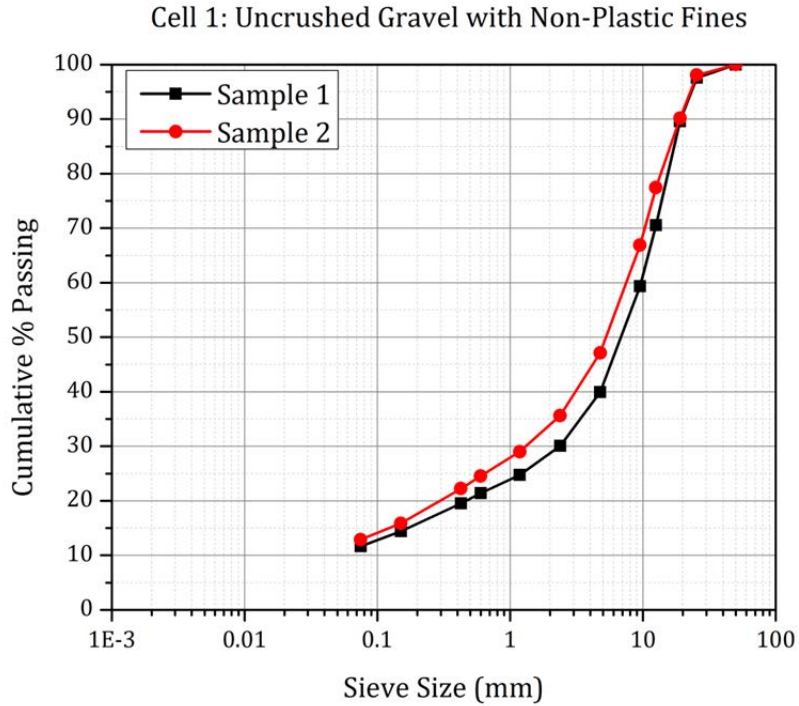
Figure B-1 Particle size distribution of the uncrushed gravel material with nonplastic fines used in Cell 1

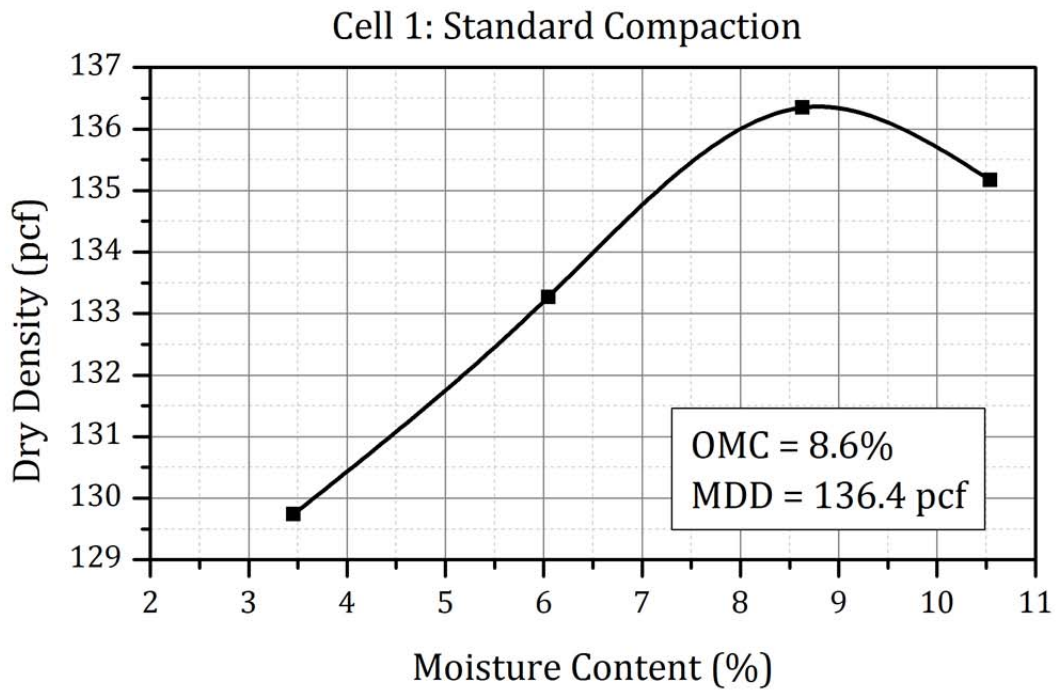
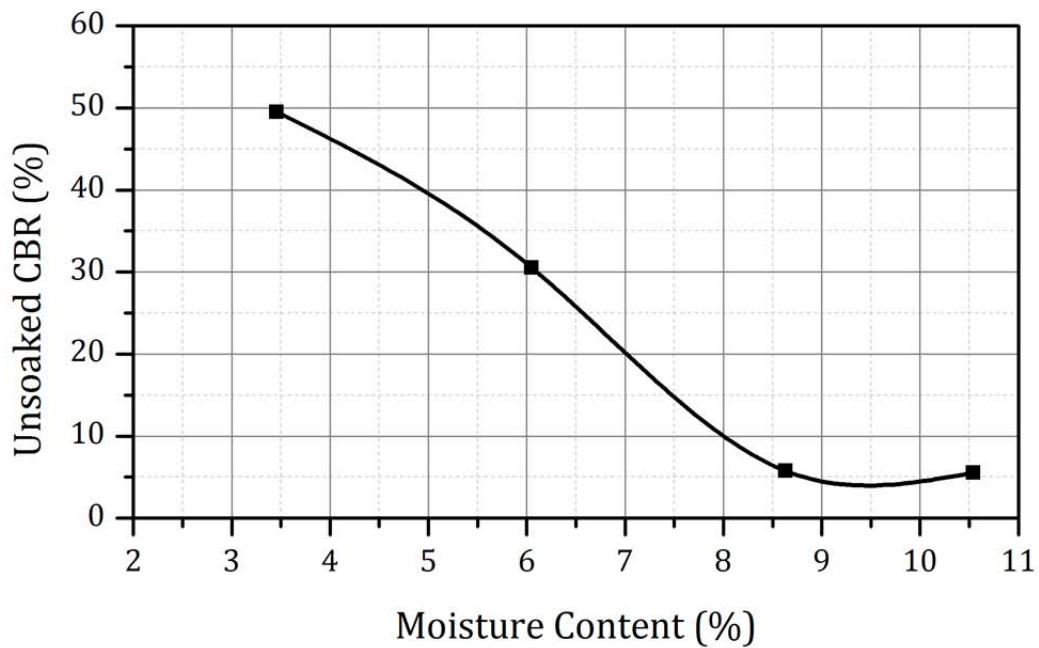
Figure B-5 Moisture-density and IBV characteristics for the uncrushed gravel material with high amounts of nonplastic fines (Cell 1) under standard compactive effort (IBV shown as "Unsoaked CBR" in the plot)

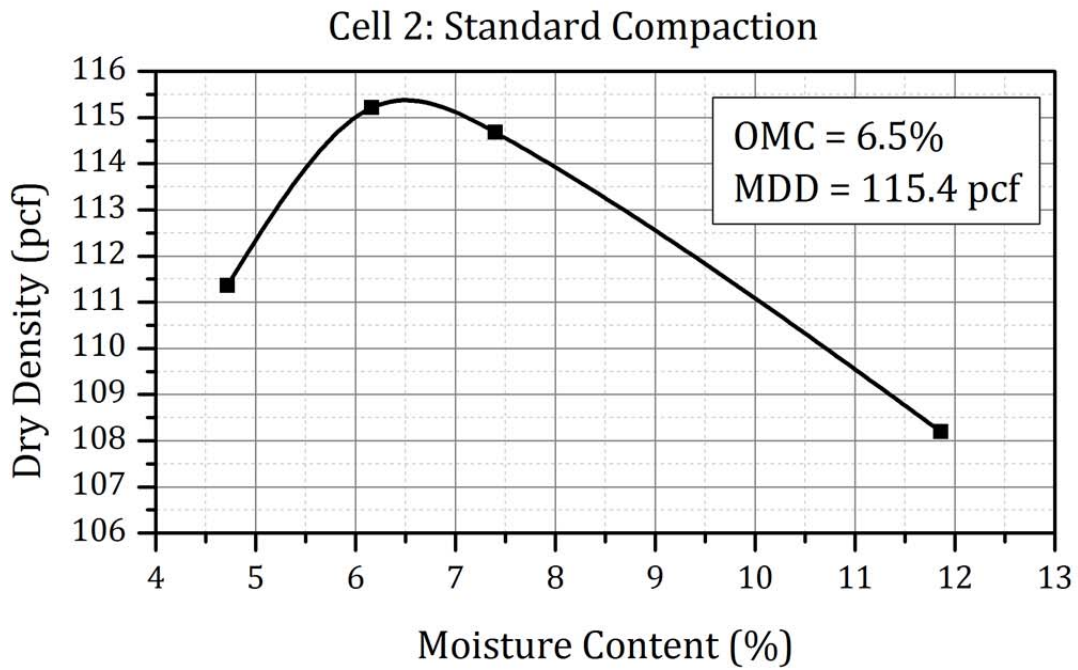
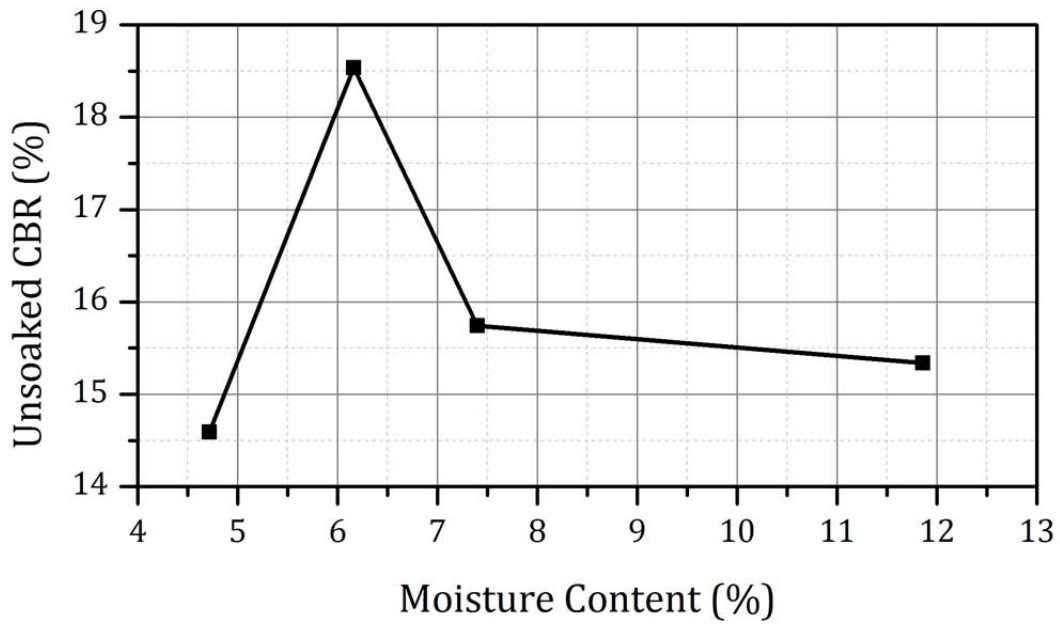
Figure B-6 Moisture-density and IBV characteristics for the crushed limestone material with low amounts of plastic fines (Cell 2) under standard compactive effort (IBV shown as “Unsoaked CBR” in the plot)

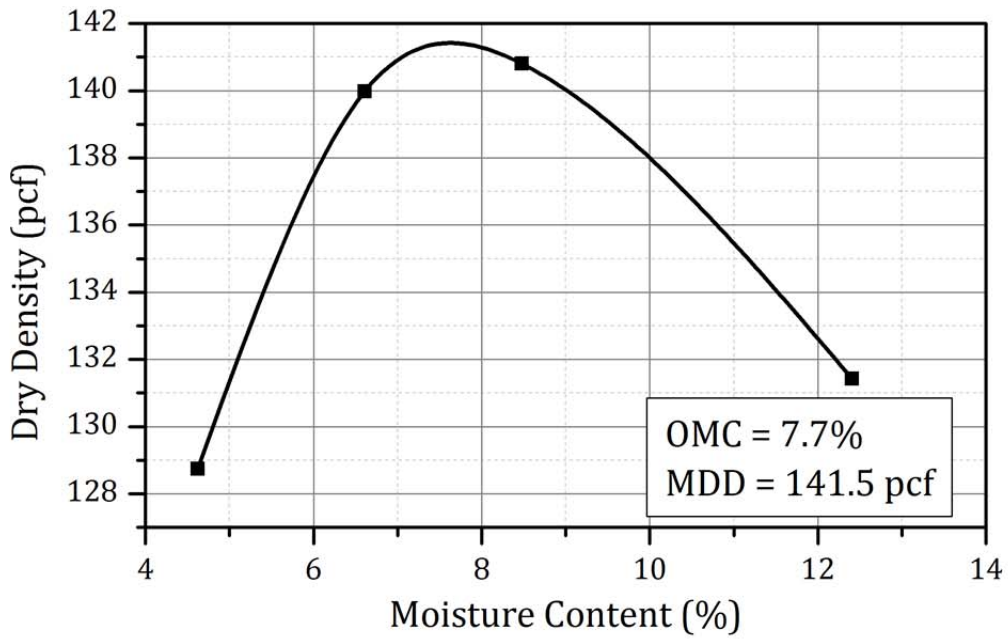
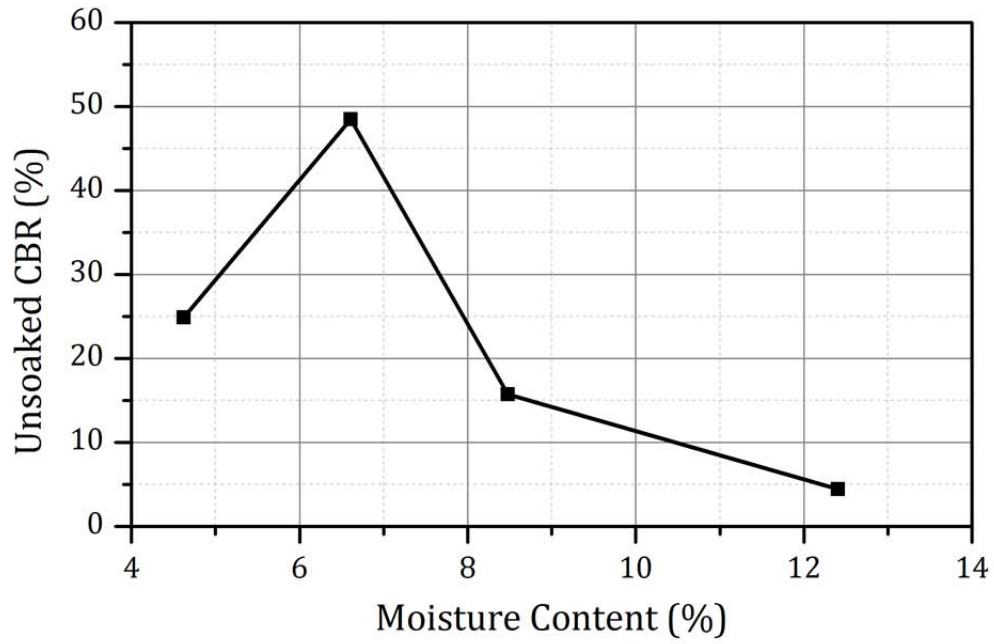
Figure B-7 Moisture-density and IBV characteristics for the crushed dolomite material with high amounts of nonplastic fines (Cell 3) under standard compactive effort (IBV shown as “Unsoaked CBR” in the plot)

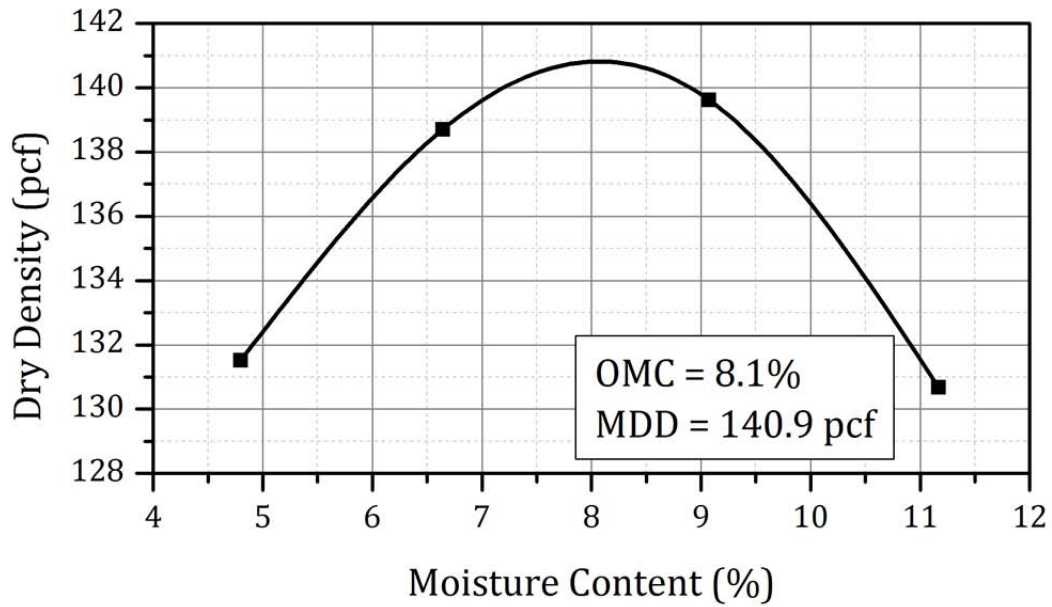
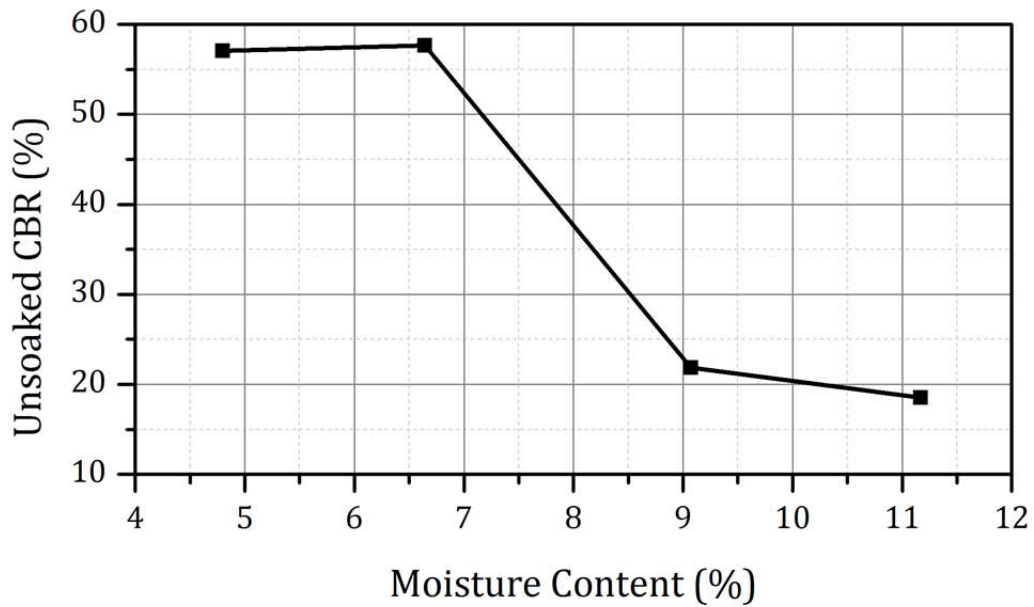
Figure B-8 Moisture-density and IBV characteristics for the crushed limestone material with high amounts of nonplastic fines (Cell 4) under standard compactive effort (IBV shown as “Unsoaked CBR” in the plot)

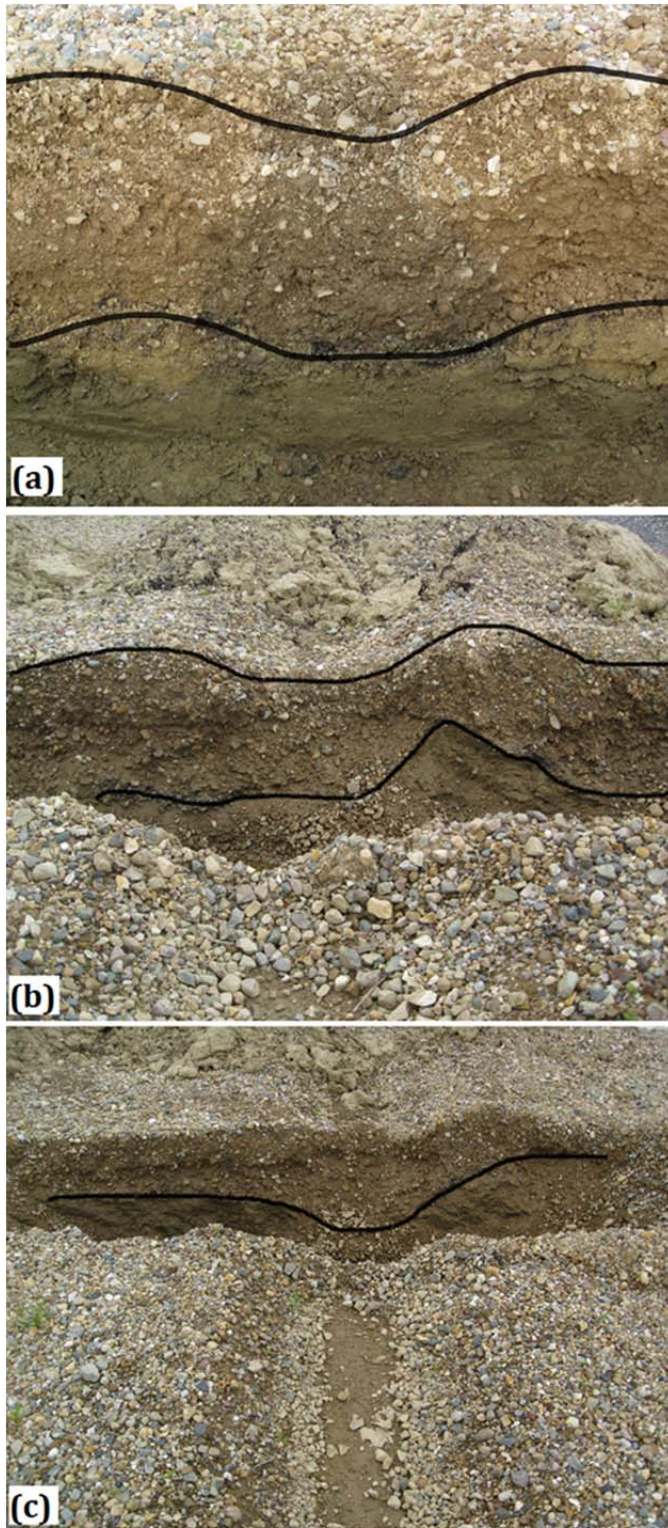
Figure C-1 Excavated trench photos showing surface and base-subgrade interface deformations in test sections (a) 1, (b) 2, and (c) 3 for Cell 1 due to loading under flooded conditions

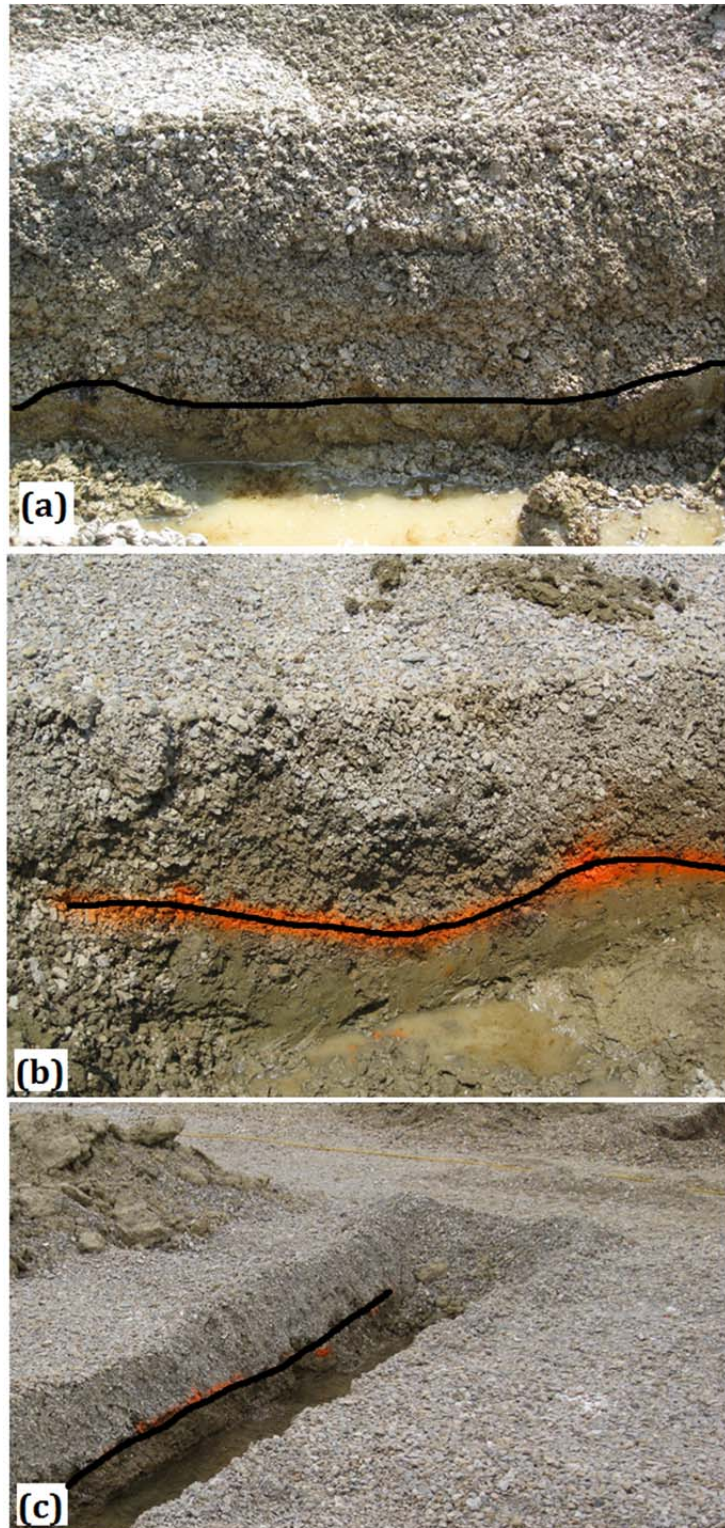
Figure C-2 Excavated trench photos showing surface and base-subgrade interface deformations in test sections (a) 1, (b) 2, and (c) 3 for Cell 2 due to loading under flooded conditions

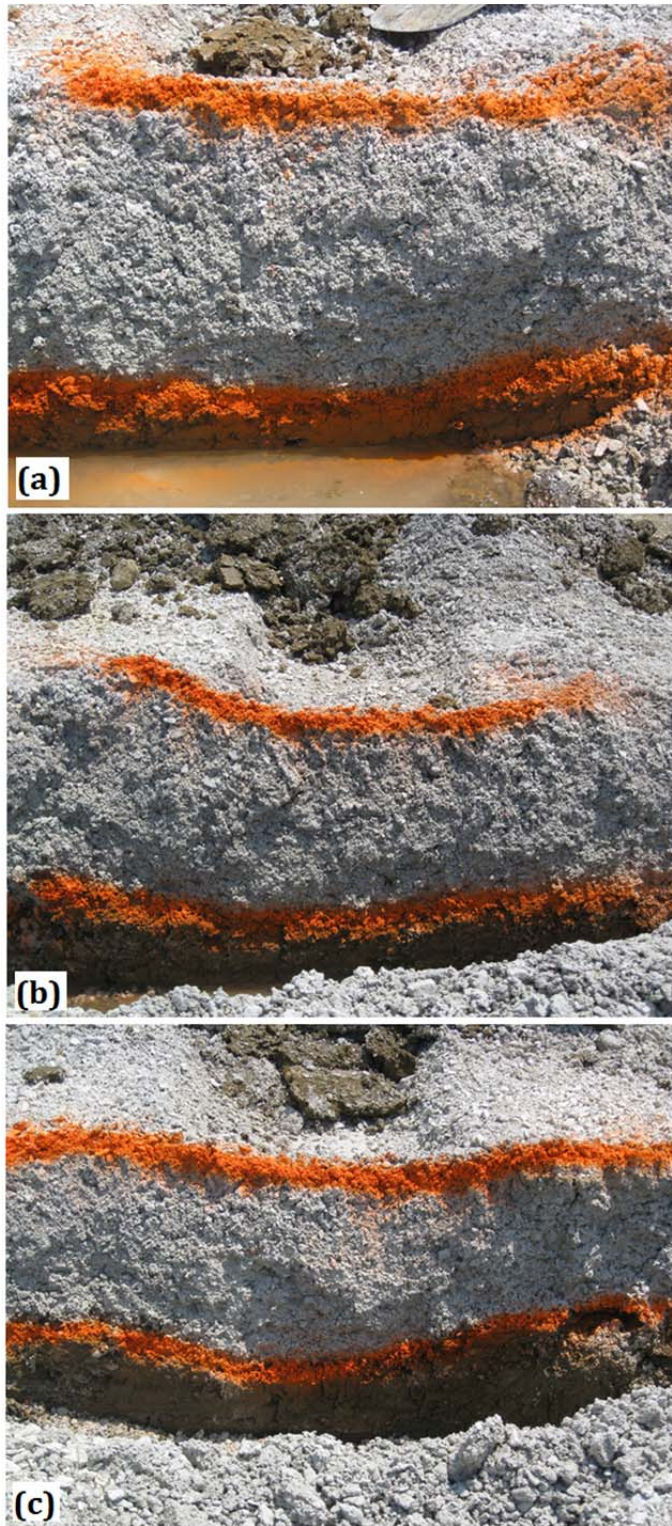
Figure C-3 Excavated trench photos showing surface and base-subgrade interface deformations in test sections (a) 1, (b) 2, and (c) 3 for Cell 3 due to loading under flooded conditions

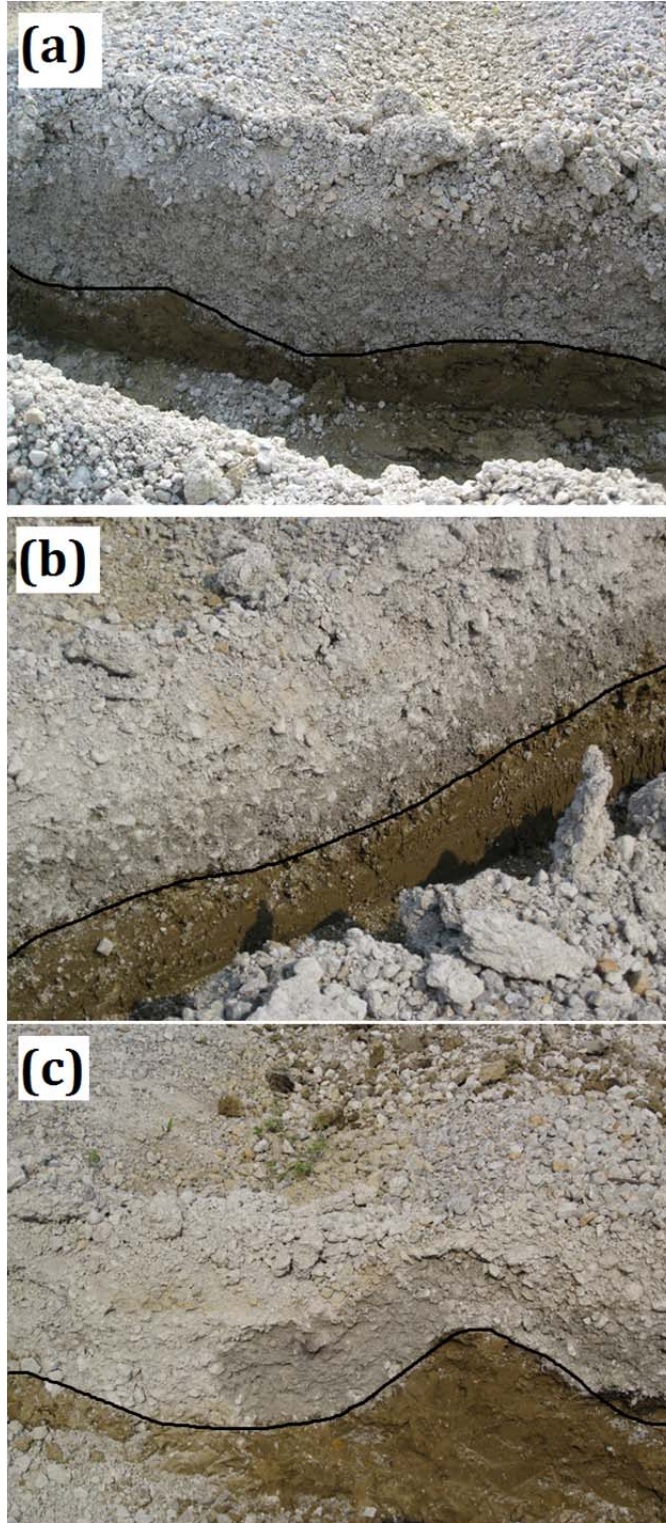
Figure C-4 Excavated trench photos showing surface and base-subgrade interface deformations in test sections (a) 1, (b) 2, and (c) 3 for Cell 4 due to loading under flooded conditions

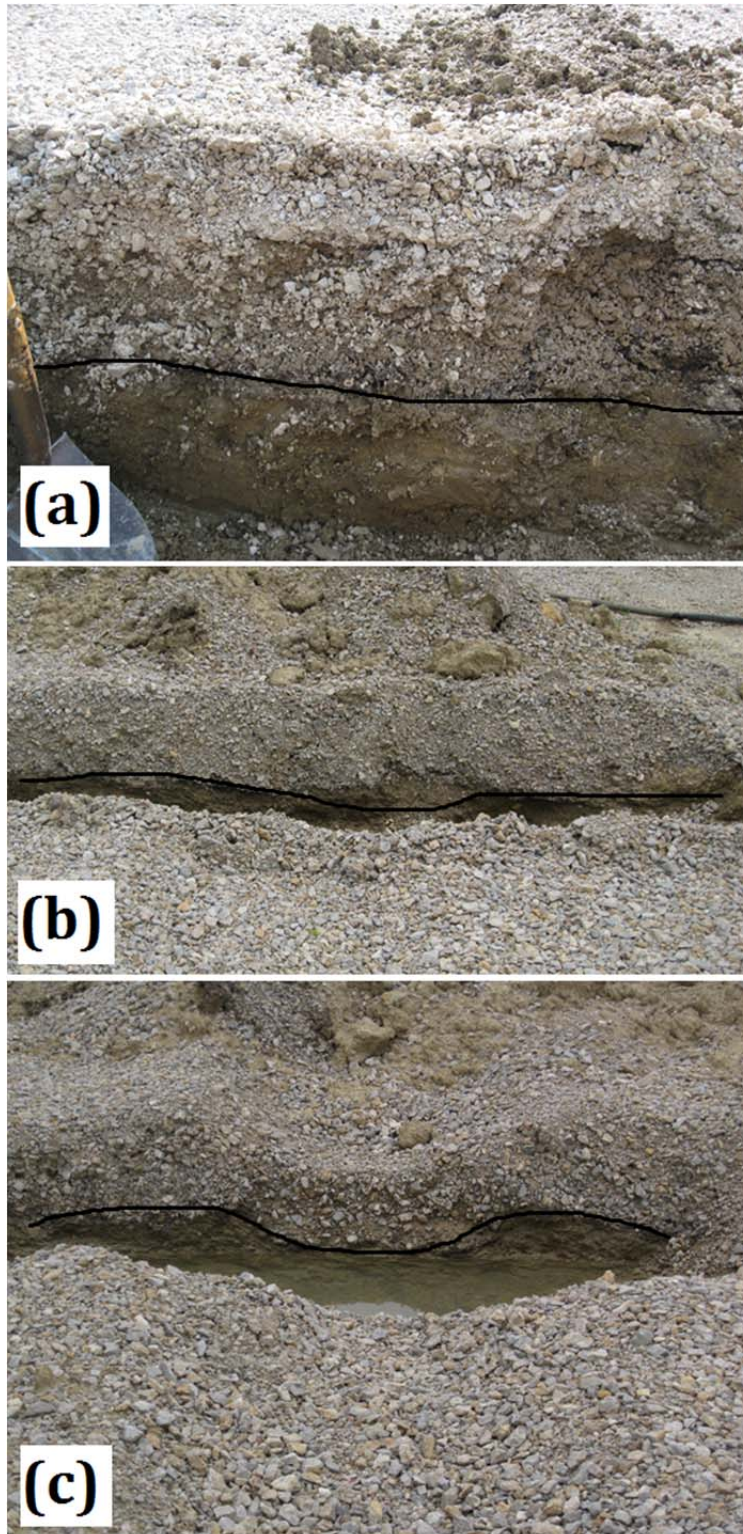
Figure C-5 Excavated trench photos showing surface and base-subgrade interface deformations in test sections (a) 1, (b) 2, and (c) 3 for Cell 2 due to loading under flooded conditions

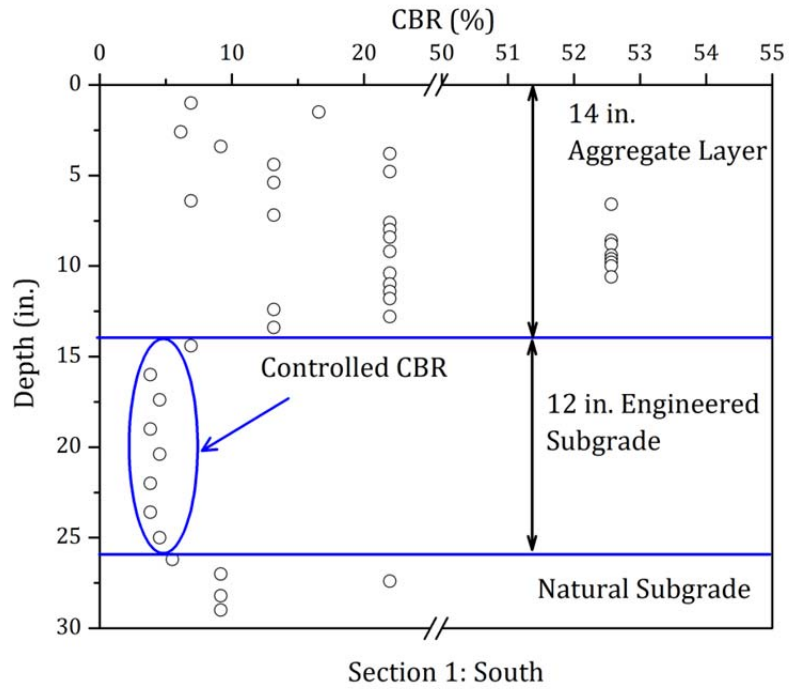
Figure D-1 IBV profile with depth along the South wheel path of Cell 3 Section 1 effort (IBV shown as “CBR” in the figure)
