FIELD PERFORMANCE EVALUATIONS OF ILLINOIS AGGREGATES FOR SUBGRADE REPLACEMENT AND SUBBASE—PHASE II

Research Report FHWA-ICT-12-021

Illinois Center for Transportation
Project R27-81
Field Performance Evaluations of Illinois Aggregates for
Subgrade Replacement and Subbase-Phase II

April 2013

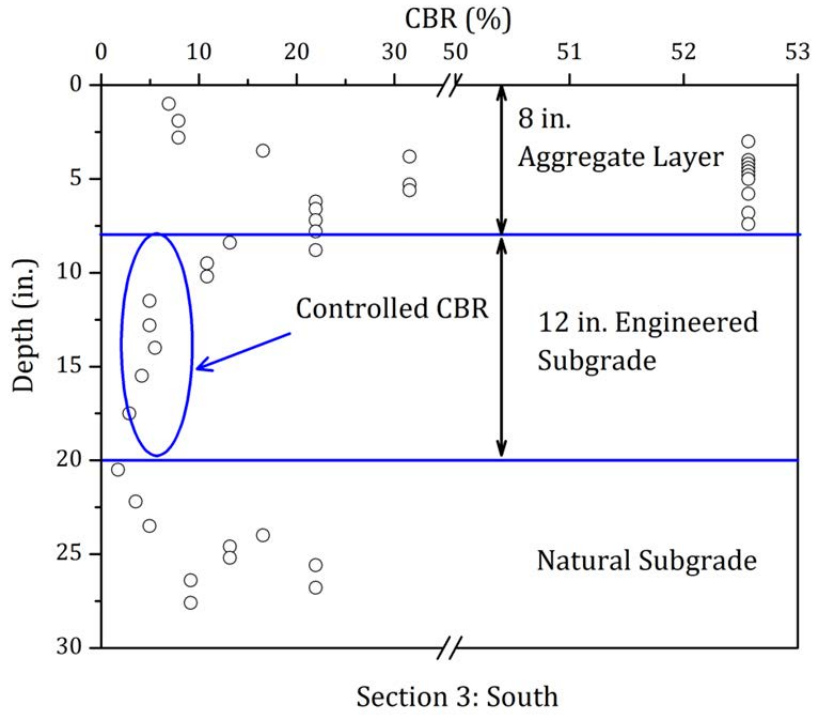
Figure D-5 IBV profile with depth along the South wheel path of Cell 3 Section 3 (IBV shown as “CBR” in the figure)
