**Final PUBLIC Report on Project**

**COMPLETION OF DEVELOPMENT OF ROBOTICS  
SYSTEMS FOR INSPECTING UNPIGGABLE  
TRANSMISSION PIPELINES**

**DTPH56-10-T-000008**

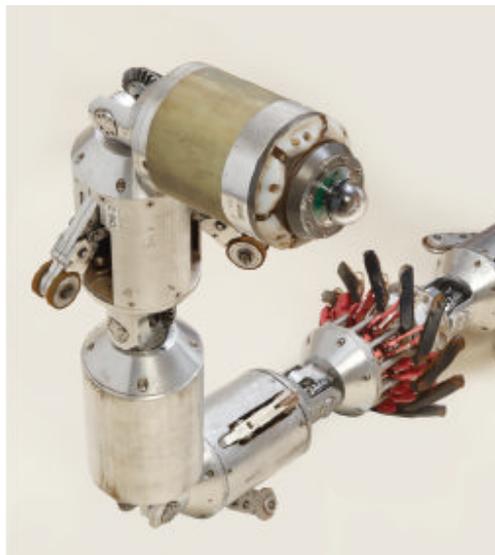
Explorer II (shown in Figure 1) is an un-tethered, modular, remotely controllable inspection robot for the visual and non-destructive in-line inspection of 6 inch and 8 inch natural gas transmission and distribution system pipelines. The Explorer II tool simultaneously records both RFEC sensor data and captures video. The inspection system relies on RFEC sensing technology to assess the wall thickness of a pipeline and a video imaging system for navigation. The Explorer II RFEC system consists of one (1) excitation coil and circumferentially distributed array of sensors.

**Figure 1: Explorer II robotic system for the inspection of 6” to 8”  
unpiggable natural gas pipelines.**

Table 1 shows the specification of Explorer II. Two (2) drive modules move the tool through a pipeline. Video modules at the front and rear of the tool provide video feedback to operators. Three (3) support modules support the sensor and battery modules and center the tool in the pipeline. One sensor module houses the excitation coil, while the other contains the RFEC sensors and associated electrical systems.

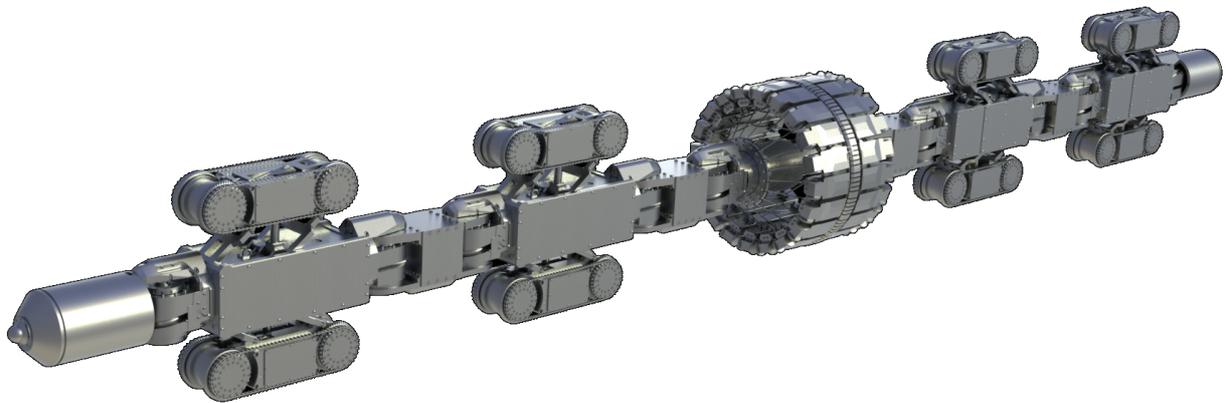
Explorer 20-26 (TIGRE) is an un-tethered, modular, remotely controllable inspection robot for the visual and non-destructive in-line inspection of 20 inch through 26 inch natural gas transmission and distribution system pipelines. The TIGRE tool simultaneously records both MFL sensor data and captures video. The inspection system relies on MFL sensing technology to assess the wall thickness of a pipeline and a video imaging system for navigation. The TIGRE MFL system consists of one module that carries the magnets and sensors as well as a system to shunt the magnets, something needed when the sensor module navigates through pipeline features.

**Figure 2: TIGRE robotic system for the inspection of 20” to 26”  
unpiggable natural gas pipelines.**

Four (4) drive modules move the tool through a pipeline. Video modules at the front and rear of the tool provide video feedback to operators. One sensor module houses the MFL sensor with its magnets, sensors, shunting system, driving system, and batteries.

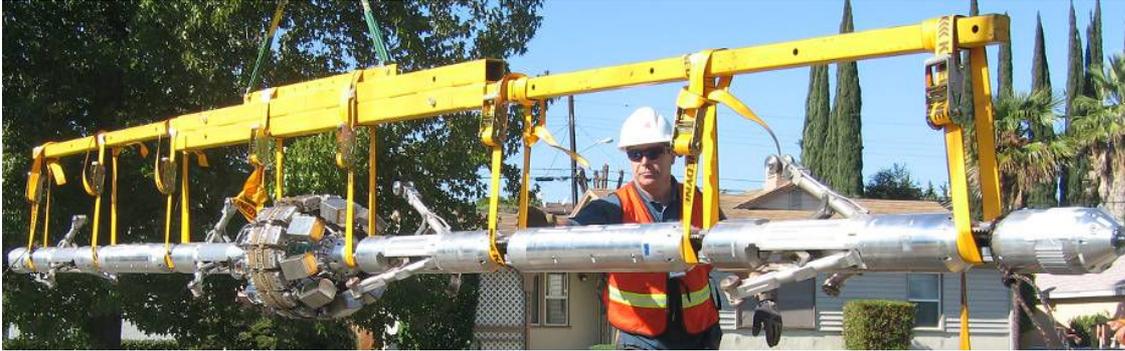
**Figure 3: Interim TIGRE tool lifted during testing**

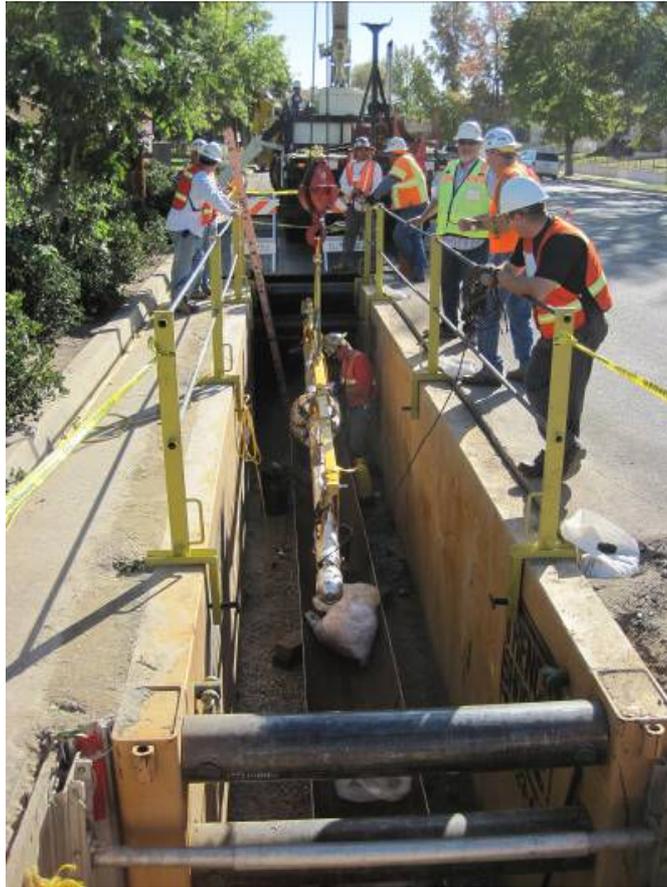
**Figure 4: Southern California 22” testing launch location. Tool can be seen being lowered into position**

The tool was run three times in the pipeline on three separate days of testing (see Figure 4). The first day was run without the sensor being deployed, while the second and third day data was collected (with 1,100ft of continuous data collected on day 3). Coupled with the data analysis that followed during the subsequent months, which identified certain regions of interest in the pipe, main objectives of the test were met from a system operations perspective.

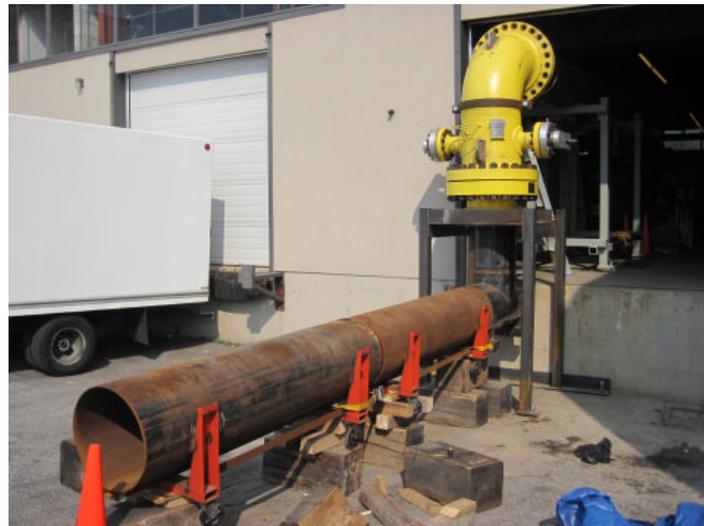
A full scale mockup of the pipe and hot tap were assembled at IE. The hot tap system was connected to this mockup, as seen in Figure . This was an important step for learning how to handle large (and heavy) pieces of equipment.

**Figure 6: Testing Explorer with hot tap system**

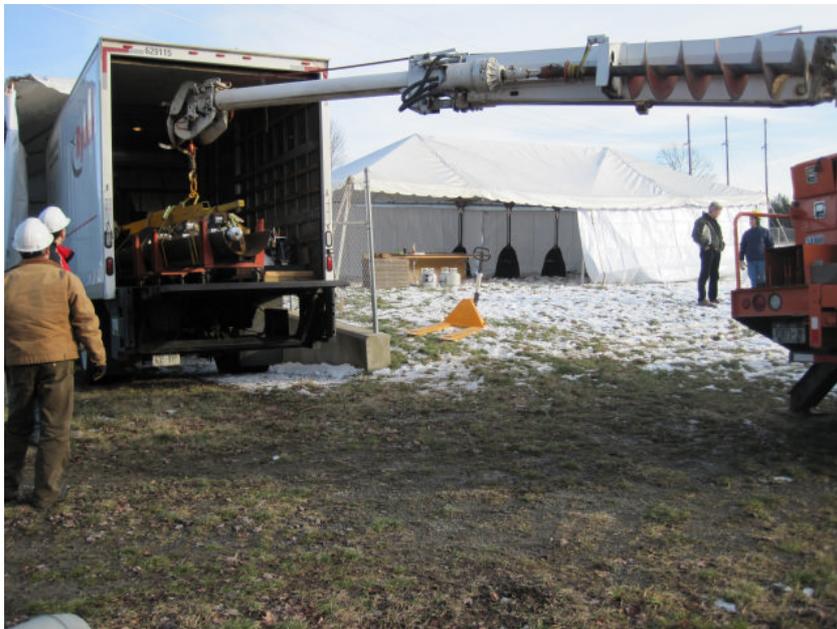
**Figure7: Handling final TIGRE onsite in preparation for deployment**

TIGRE was tested at the NYSEARCH test bed in Binghamton, NY, in late 2011 (see Figure 7). This underground pipe network, designed to mimic actual pipeline conditions, consists of several hundred feet of 20 inch diameter pipeline, a plug valve, back-to-back 45 degree bends, mitered bends, and open-end access. A large number of defects of various sizes and depths have been built onto the pipe surface. TIGRE's ability to negotiate this pipe network was tested. Prior to the demonstration, logistical operations, mobilization arrangements, and procedures were developed for the Binghamton demonstration. They were revised as needed and used in future deployments.

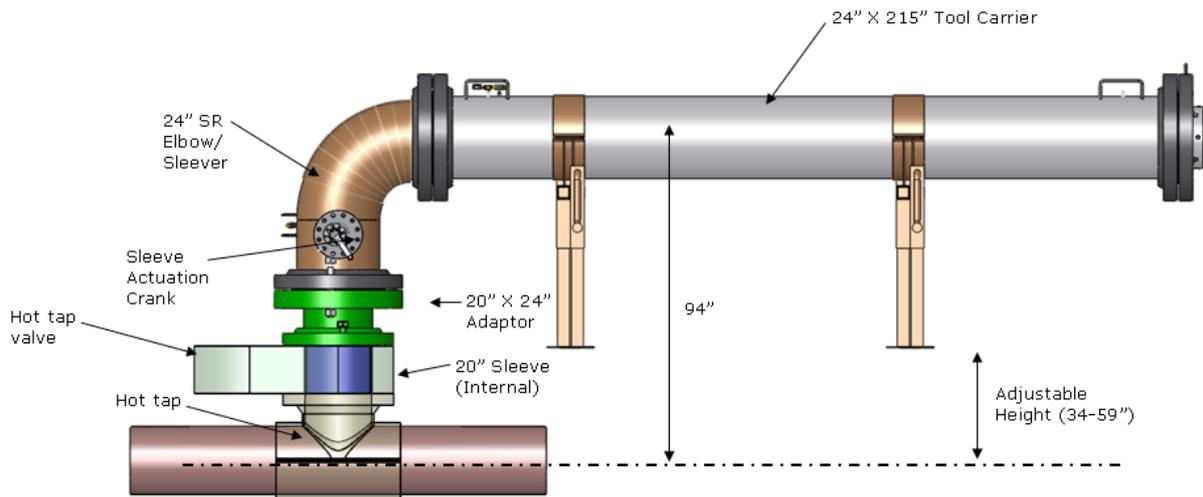
**Figure 8: TIGRE (20"-26") Launcher Concept**

A launch system was designed to allow for access to the pipe via the hot tap. The robot would be loaded into the launcher. After following a safety procedure, which is designed to eliminate any contact of natural gas and air, the valve is opened and the launcher is pressurized with natural gas from the pipeline. This launching system (shown in Figure 8) has the following features:

- A horizontal main tube from which the robot is launched. A majority of the weight is carried by special supports instead of being carried by the pipe.
- All pressurized components are designed to fit the full 20-26in sensor configuration according to the specification of the tool (750 [psi]).
- After the valve is opened, a protective sleeve (Figure 9) is placed over the valve sealing surfaces. This is designed to provide a good traction surface for the robot in the valve section and to protect the valve seats from any debris (ferrous and non-ferrous) that may inhibit the valve from closing.

A launcher system was designed and built for launching TIGRE into pipelines under live condition via hot tap access. Hot-tapping a pipe requires a fitting which is welded onto the pipe and a valve which sits on the fitting. With these two components in place, a specialized sealed cutter is used to make a hole in the side of the pipe. After this step is completed, the cutter is removed and the valve closed.

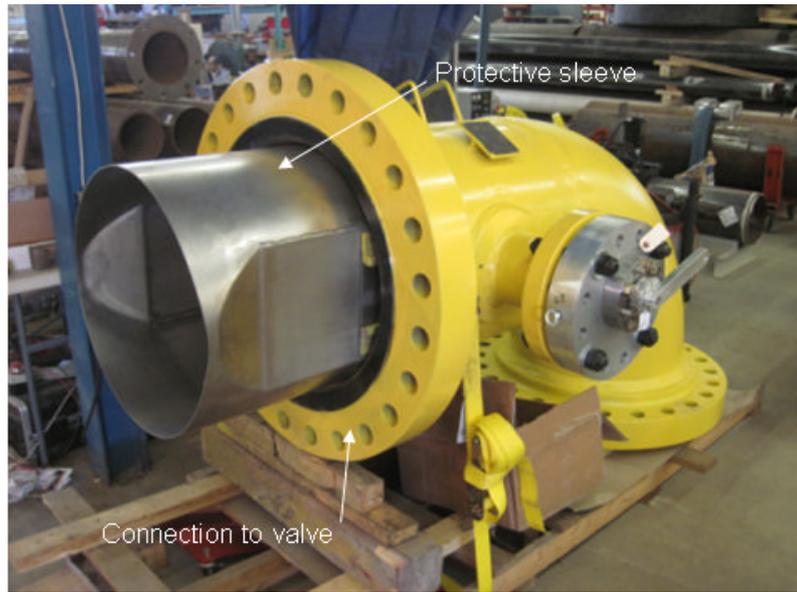
**Figure 9: Hot tap elbow designed to protect valve during deployment**

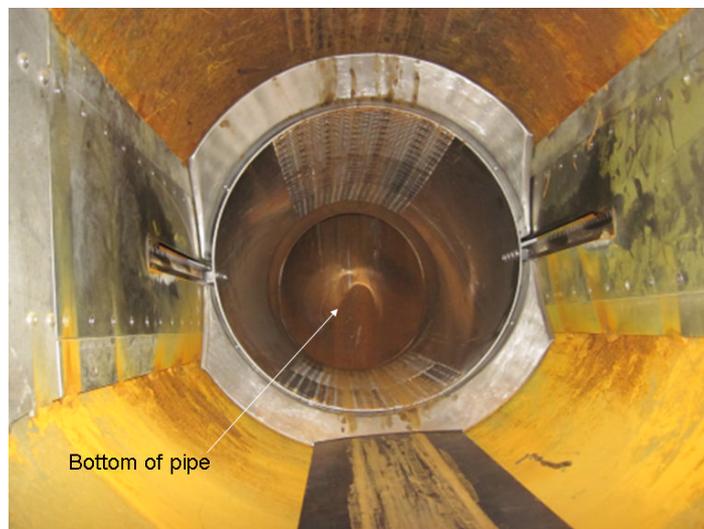
Figure 10 shows the view from the robot's camera looking down into the vertical section of the launch pipe. The tracks that the tool makes can be seen on the top and bottom of the picture. To aid in tool traction (top & bottom of the picture), low-profile grating has been added on the inside of the sleeve.

**Figure 10: View looking down the extended sleeve into the pipe**

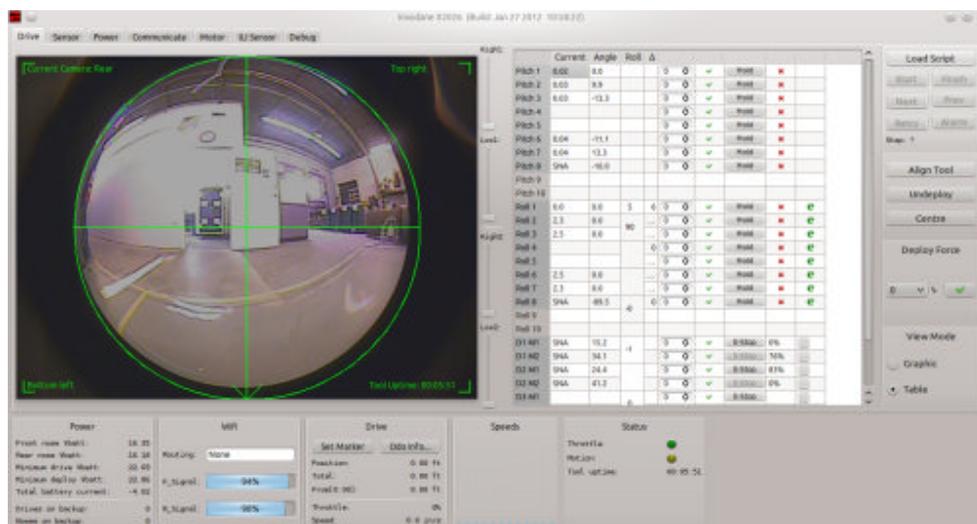
Figure 11: Graphical user interface showing driver view and controls

Shown in Figure 11, the driving tab has four main features:

- The video feed shown in the top left corner provides the operator with a visual feed of the pipe as the tool moves through.
- General tool diagnostic information is shown along the bottom such as wireless strength, antenna selection, and overall system parameters such as bus voltage and current.

- The middle right contains tool parameter control for manual movement of steer joints and driver modules
- The far right contains controls for automatic motion such as scripted maneuvers.

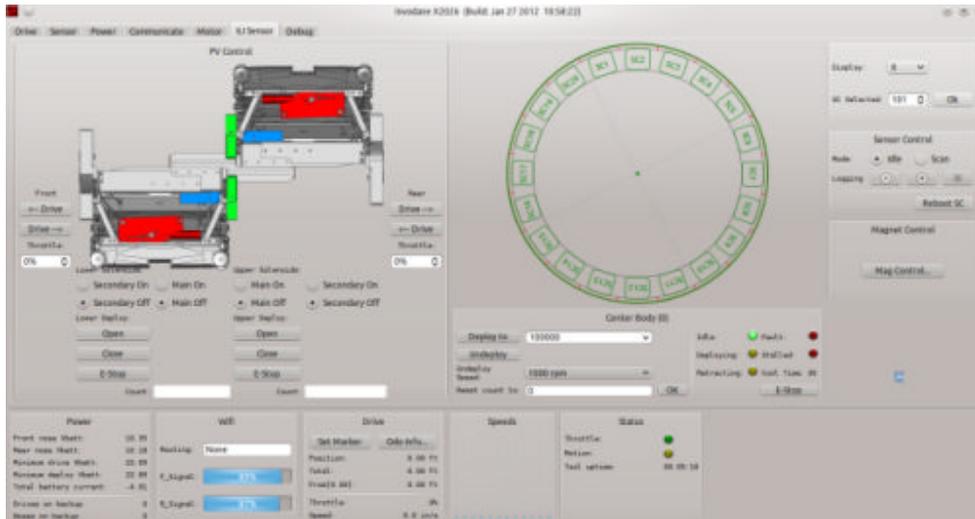
**Figure 12: Plug Valve Sensor GUI**

The driver view can be replaced by a view of the plug valve module (Figure 12) or general inspection sensor module, while the bottom status bar remains the same. However, two new views are available:

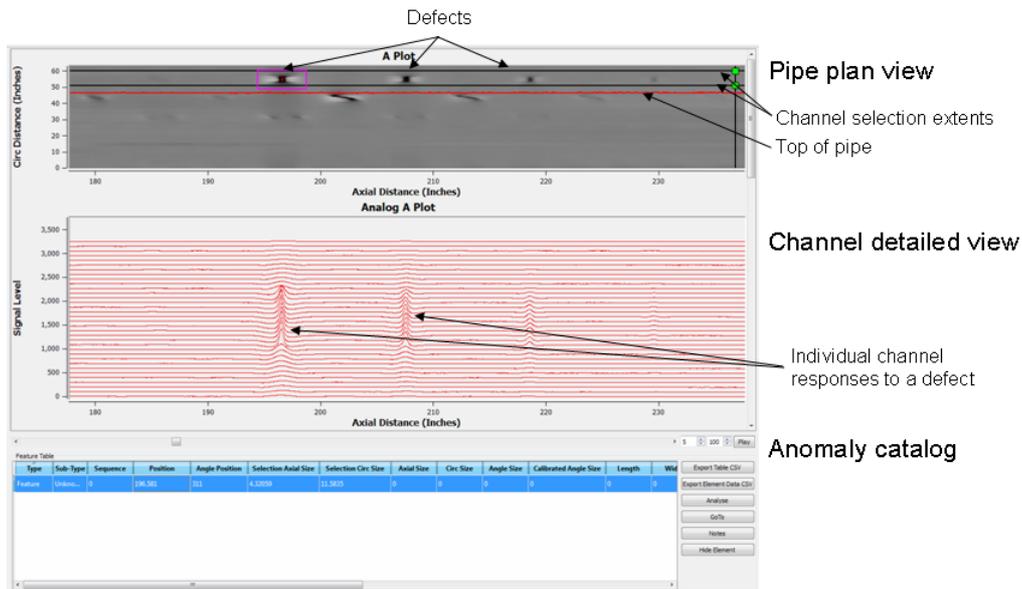
- The top view is the pipe section laid flat with the vertical axis as the circumference of the pipe and the horizontal axis as the axial distance, changes in the magnetic signal can be observed. Grey indicates a baseline value while white and black denote rise and fall of the signal (respectively). A magnetic signal occurs when the magnetic field changes within a local area in the pipe, usually due to wall thickness variation such as a weld, corrosion, or repair. The red line in the pipe plan view indicates the bottom of the pipe.

- The middle view displays the same signal in a line charts on a channel by channel basis (channel detailed view). The selection of these channels is controlled by varying the extents of the channel selection lines (black) in the top chart.

- The bottom view is the anomaly catalog view. When the analyst decides that a feature of interest is, the region is selected and tagged for future analysis and listed in this table.

**Figure 13: 13-ft segment of test pipe as visualized in data analysis software**

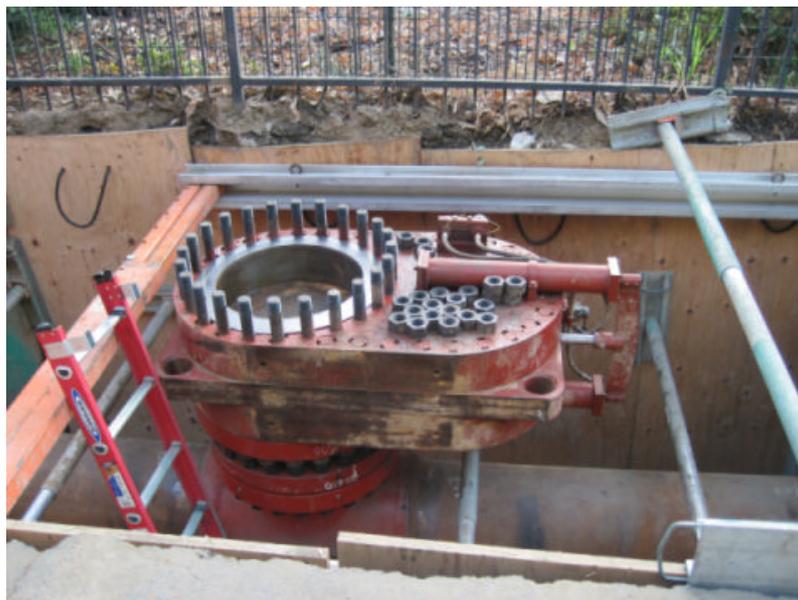
The hot tap fitting, on which the valve and launcher sit, was installed near to the casing (see Figure 14). The excavation was located approximately 15ft from a sharp 90deg bend. The bend was closer to the entry point than originally thought in the planning phase, but the operations team was able to smoothly adapt to this situation drawing on their knowledge from testing the system in the laboratory. The launch system was installed on to the hot tap as shown in Figure 15.

**Figure 1: Hot tap prepared prior to installation of TIGRE launcher**

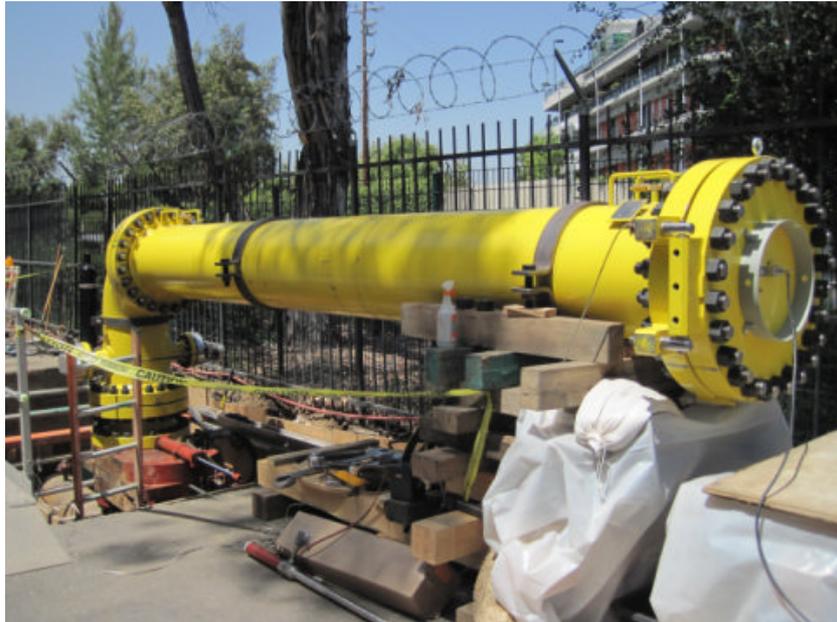
**Figure 2: Explorer launcher system installed and pressure tested**

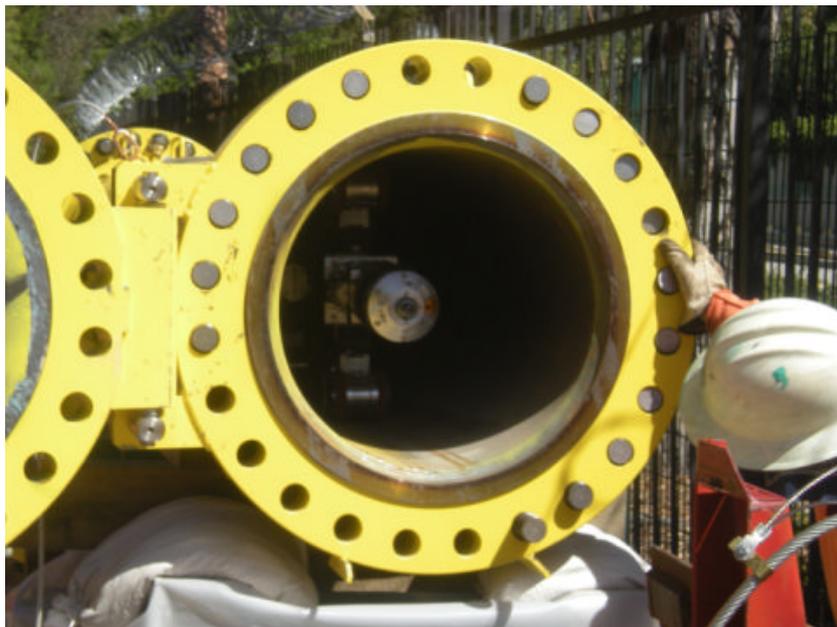
**Figure 16: Explorer driven into launch system**

After a final system check, the robot was inserted in the launcher (see Figure 16), the launch system was closed, purged and pressurized. Once in straight pipe the tool went on inspecting the pipe section of interest. The casing was inspected as planned going in and back

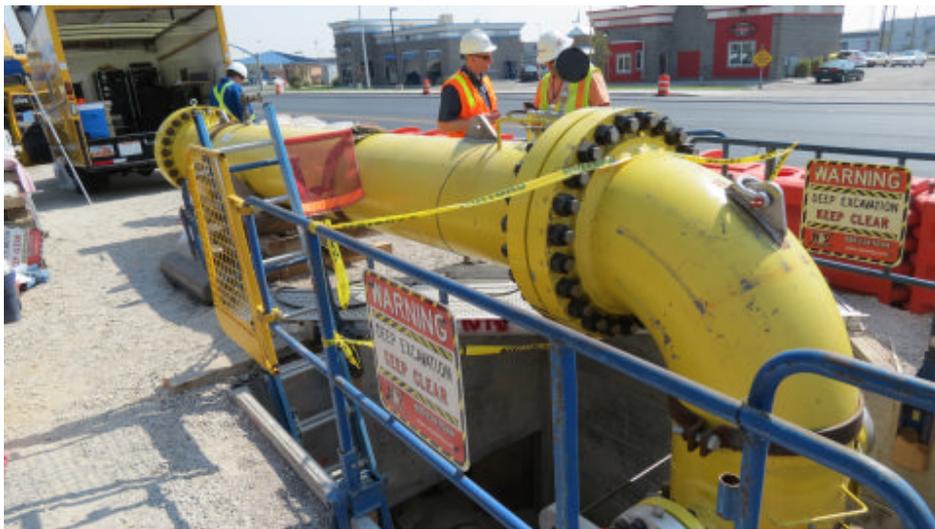
The hot tap fitting was installed and the pipeline tapped prior to the arrival of the Invodane crew on site. The crew assembled the launch system, as seen in Figure 17, without incident. With the tool passing all pre-run checklists, the crew inserted the tool into and

**Figure 17: Setup of hot tap system south of Salt Lake City, UT**

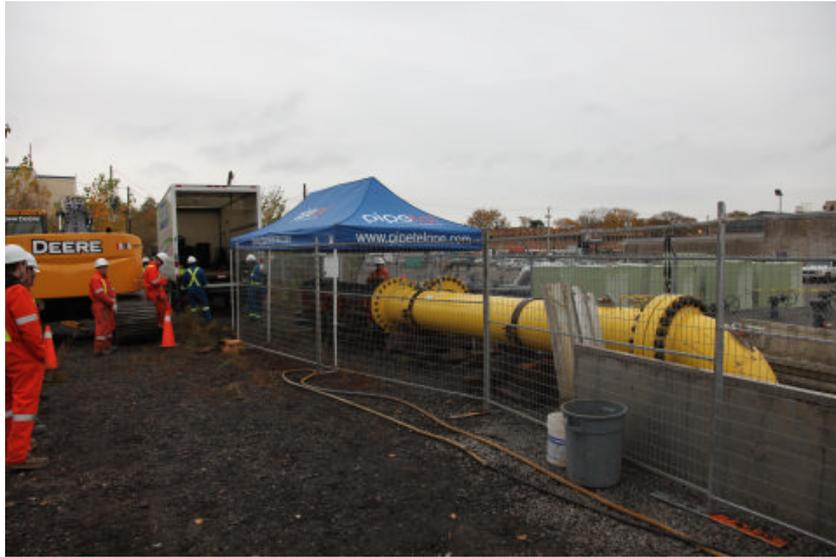
**Figure 19: Setup of hot tap system at Toronto, ON for Enbridge demo**
