Developing Guidelines for Use of Pedestrian Countdown Traffic Signals

Michigan Department of Transportation

**Ghassan Abu-Lebdeh
John R. Engle
Thomas L. Maleck**

January 2007

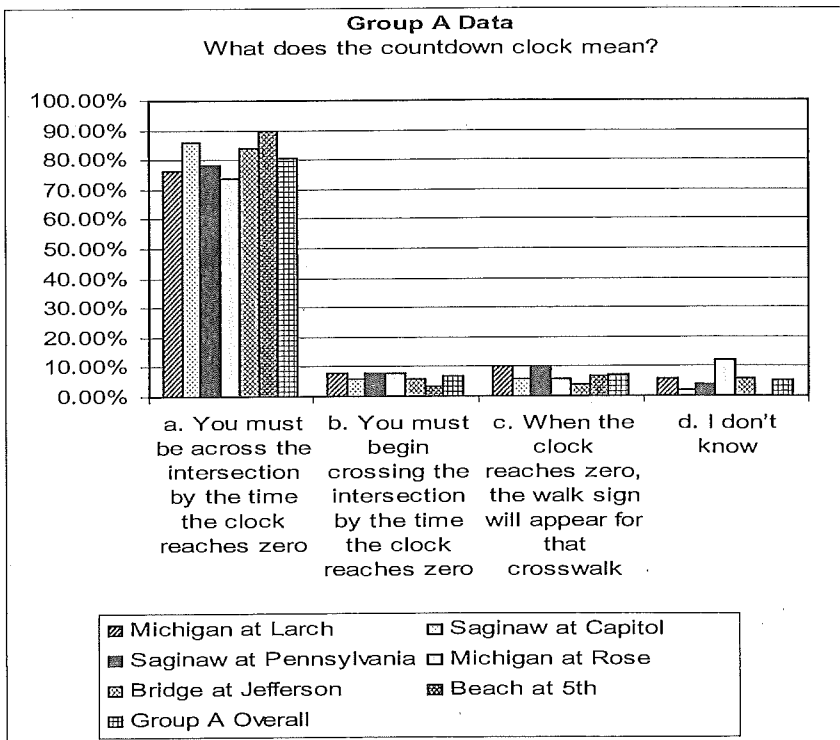
Figure 2 Understanding of countdown signal, group A

The same results for each of the three groups are shown in figures 2 through 4. Although there is variation between the groups, and among the individual intersections within each groups, the results are consistent in that majority of the surveyed pedestrians correctly understood the meaning of the countdown clock display. Given the diversity of the sites and the pedestrian population, there is little reason to believe these results would not hold for other locations.

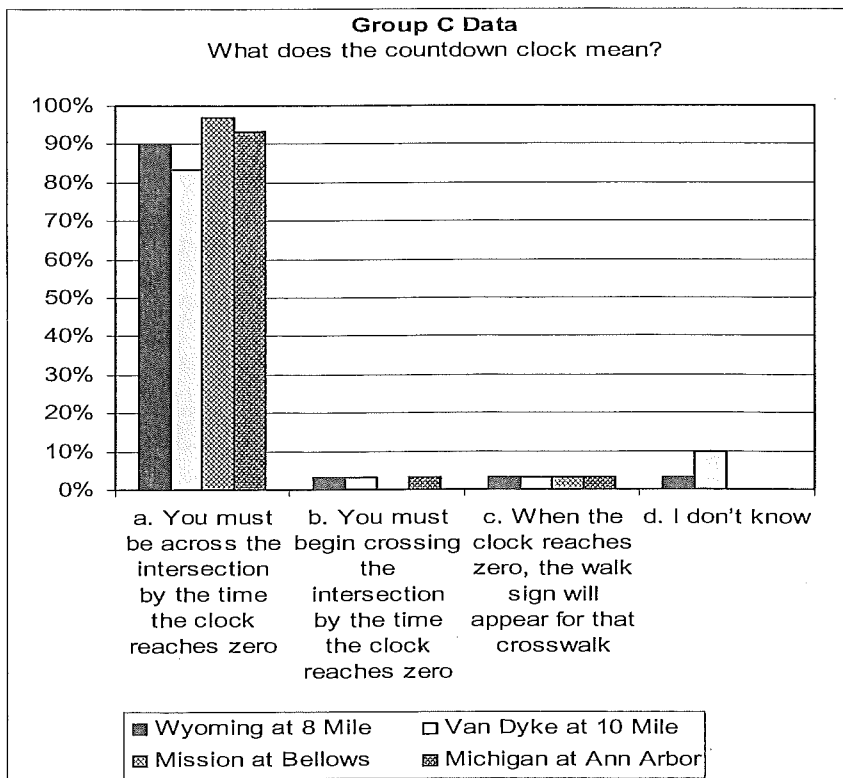
Figure 4 Figure 2 Understanding of countdown signal, group C
