Improved Traffic Control Measures to Prevent Incorrect Turns at Highway-Rail Grade Crossings

FDOT BDK85 Task Work Order #977-45

Final Report

USF Center for Urban Transportation Research

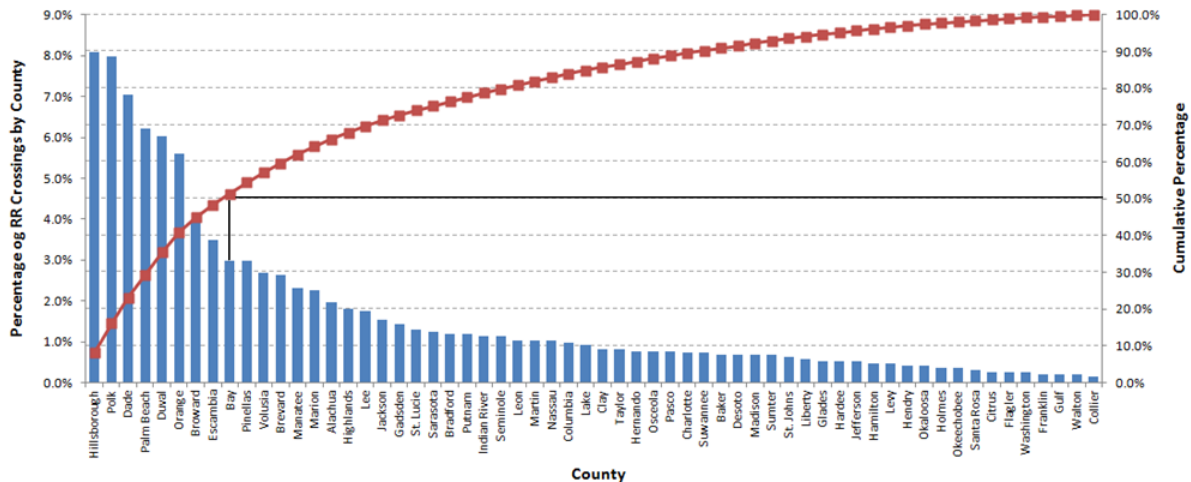
Figure 1-1: Railroad Crossings in Florida by County.

An initial assessment of the research scope was performed by the CUTR team by collecting GIS data on the number of railroad crossings by county, as shown in Figure 1-1. It was found that Hillsborough, Polk, Miami-Dade, Palm Beach, Duval, Orange, Broward, Escambia,

and Bay counties account for more than 50 percent of the railroad crossings in Florida. Areas covered by high-frequency commercial rail can also be observed (e.g., Hillsborough, Polk, and Orange counties). This assessment can help new railroad systems such as SunRail such that safety measures can be introduced in the early stages of its operation.

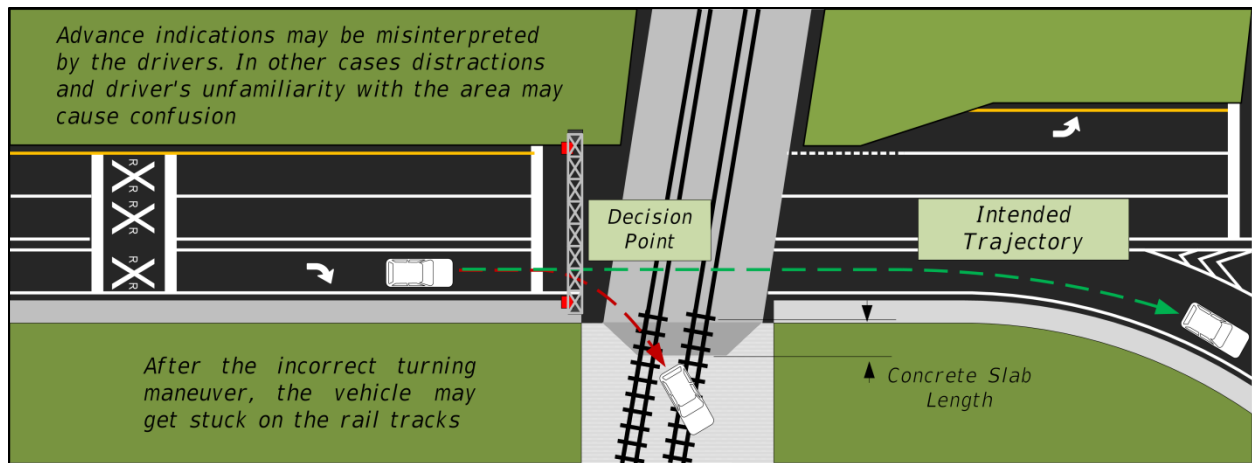
Figure 2-1: Sketch of Incorrect Turning Maneuver Near an Interstate Ramp.

Figure 2-1 presents an example of a scenario involving an incorrect turn onto railroad tracks near an on-ramp. Drivers unfamiliar with the area or who are distracted may enter the turning lane and make a wrong decision at the apparent turning point. Once the driver passes the shoulder and the lateral concrete slab, the vehicle will likely get stuck on the railroad tracks, leading to a hazardous situation.

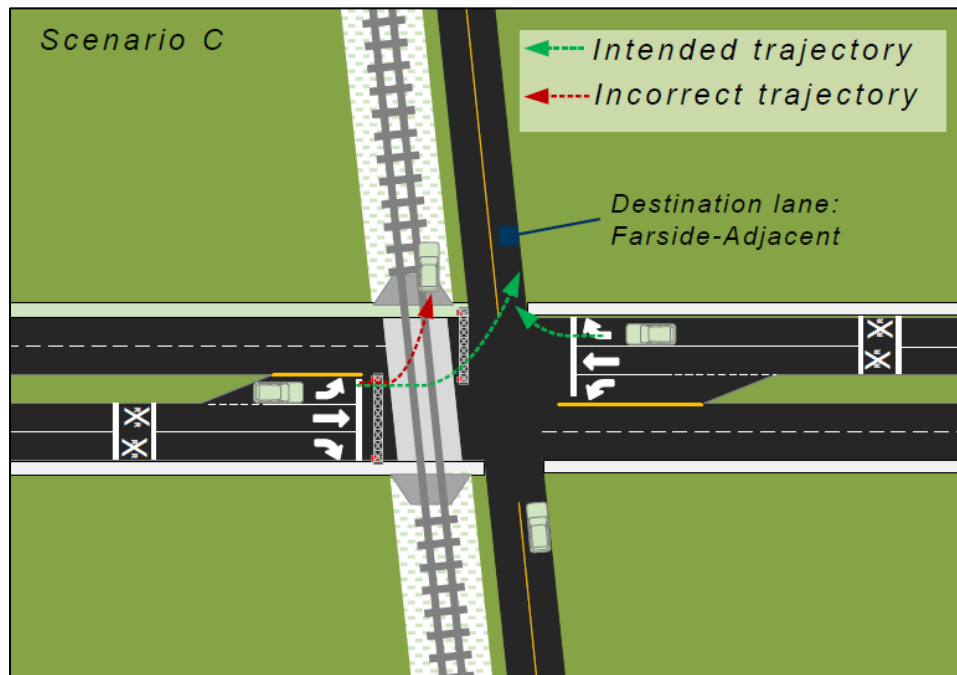
Figure 2-6: Scenario C, Turning onto Farside-Adjacent Lane.

Figure 2-6 presents scenario C, turning onto the farside-adjacent destination lane. It can be observed that such a lane is easily reached by the right turn movement. Left turns, depending on the geometry and median configuration, may present a chance to generate incorrect turns onto railroad tracks.

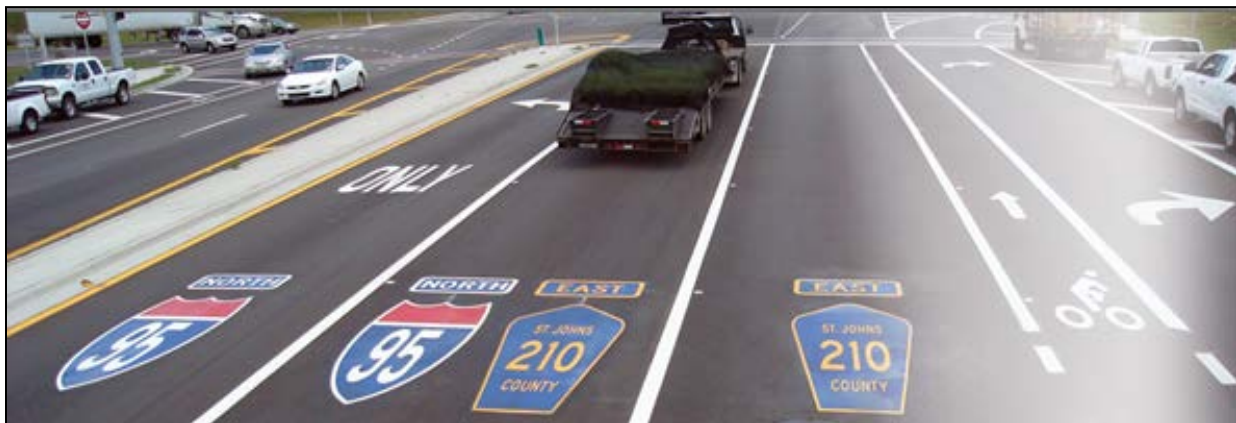
Figure 2-9: Pavement Markings in St Augustine, FL.

- Reduce pavement markings upstream of railroad crossing to avoid information overload.
- Add pavement markings before and after the railroad crossing to form a consistent pattern promoting path continuation.
- Add pavement markings with additional guidance, such as interstate signs (see Figure 2-9).

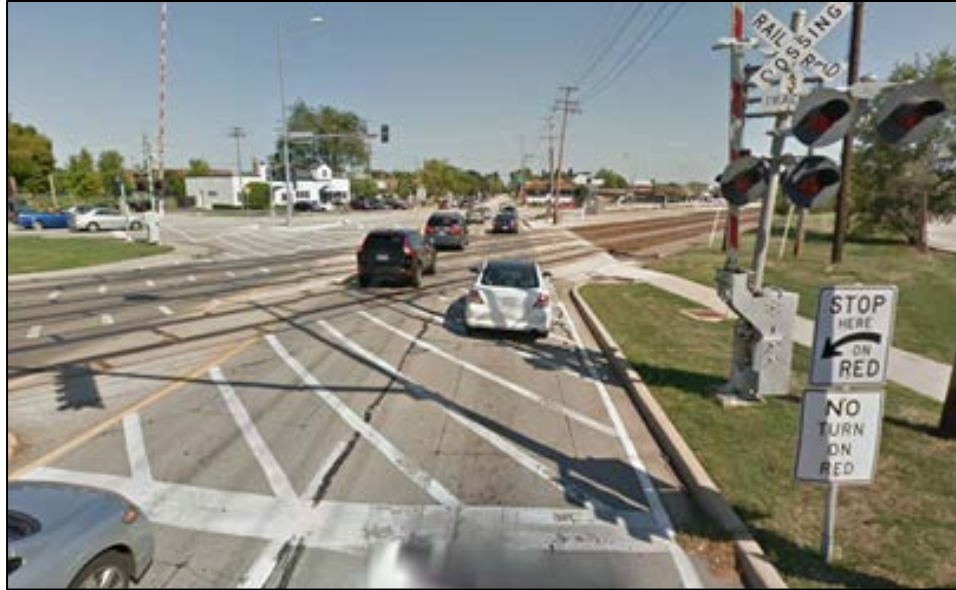
Figure 2-12: White Striping in Arlington, Illinois.

Pavement striping is very visible and promotes correct path continuation across the tracks. It is a low-cost option and requires minimal maintenance. The only maintenance cost associated with pavement stripes is the cost to repair damage incurred by normal fading, which is expected on the road surface. Figure 2-12 shows the white striping used in Illinois. Figure 2-13 shows the specifications for white striping at railroad crossings in Texas.

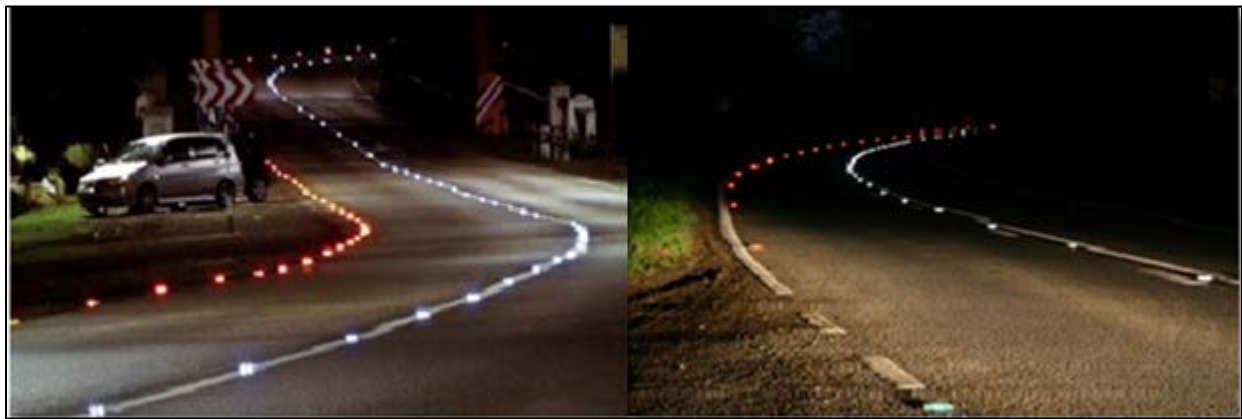
Figure 2-14: Examples of LED and Non-LED Raised Pavement Markings.

The use of delineation devices, such as reflectors and raised pavement markers, can also be used as an upstream countermeasure. Delineation devices include pavement markings, guideposts, and raised pavement markers used on and adjacent to the roadway to define vehicular travel paths. In terms of this project, drivers seemed to get confused by the curve when railroad tracks are not at a 90° angle. This can cause the driver to go off the road and onto the railroad tracks. Placing delineation devices upstream will encourage drivers to follow the designated path to prevent these incorrect turns. It will also improve the ability of drivers to follow the correct path by providing them with a visual of their travel path. Figure 2-14 shows how a delineation device can be used to promote the correct passageway to drivers and enhance operations in dark conditions. It provides drivers with a means to visualize what path needs to be taken across the railroad tracks.

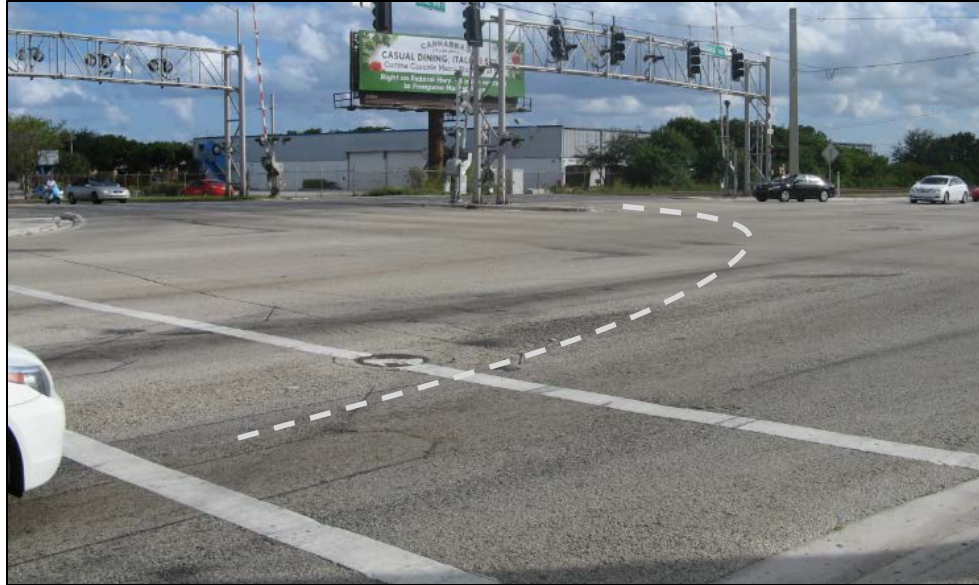
Delineation can be in the form of conventional retro-reflective studs. This can help drivers to maneuver at railroad crossings in the proximity of an intersection. Figure 2-15 shows an example of a potential application of delineation devices to guide drivers to the correct receiving lane after a left turn from the southbound of Dixie Highway to eastbound of Copans Road.

Figure 2-15: Example of Potential Application of Delineation Devices.

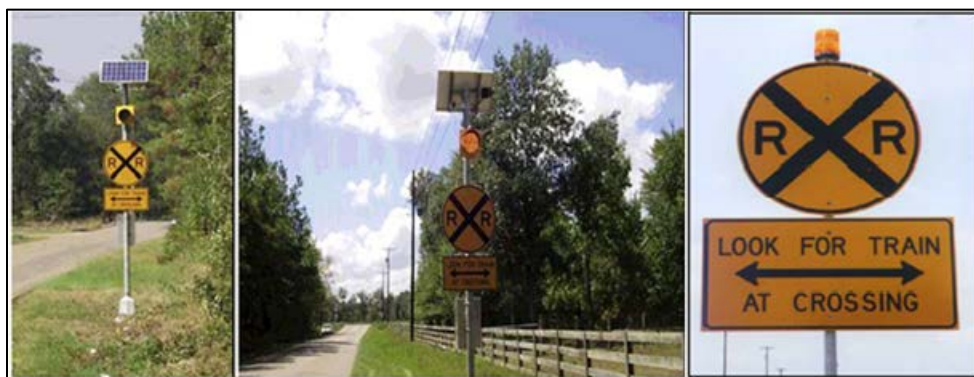
Figure 2-16: Vehicle-Activated Strobe Lights at Railroad Crossings.

Vehicle-activated strobe lights attract motorist attention by setting off a strobe light when a vehicle passes over detectors placed on the roadway, as shown in Figure 2-16. Studies conducted by the Texas Transportation Institute positioned a strobe light on top of a standard railroad advance warning sign and a vehicle detector approximately 8 seconds before the advance warning sign (Fambro and Noyce, 1997). The strobe light flashed 3–5 times to direct the driver's attention toward the advance warning sign and stopped flashing 2–3 seconds before the driver reached the sign to allow time to read the sign. Florida has a number of locations with beacons on advance warning signs. Most of these beacons are not activated by vehicles but, rather, by trains. It may be effective to make this countermeasure activated by vehicles, especially at night, to promote proper path continuation. Florida also has a number of beacon locations on R8-8 (“Do Not Stop on Tracks”) signs that are activated by vehicles.

The results of the Fambro and Noyce (1997) study concluded that a vehicle-activated strobe light device is an “effective traffic control device and can improve roadway safety at passive highway-rail grade crossings.” The device is most effective at reducing average speeds at night. When surveyed, drivers responded positively to an advance warning sign, and a favorable number were able to recall the exact wording imprinted on it. The vehicle-activated strobe signing system was concluded to increase driver awareness at the crossing and caused drivers to approach the crossing with caution (Fambro and Noyce, 1997). This device can serve a great purpose at both active and passive crossings to increase awareness during both daylight and night time hours.

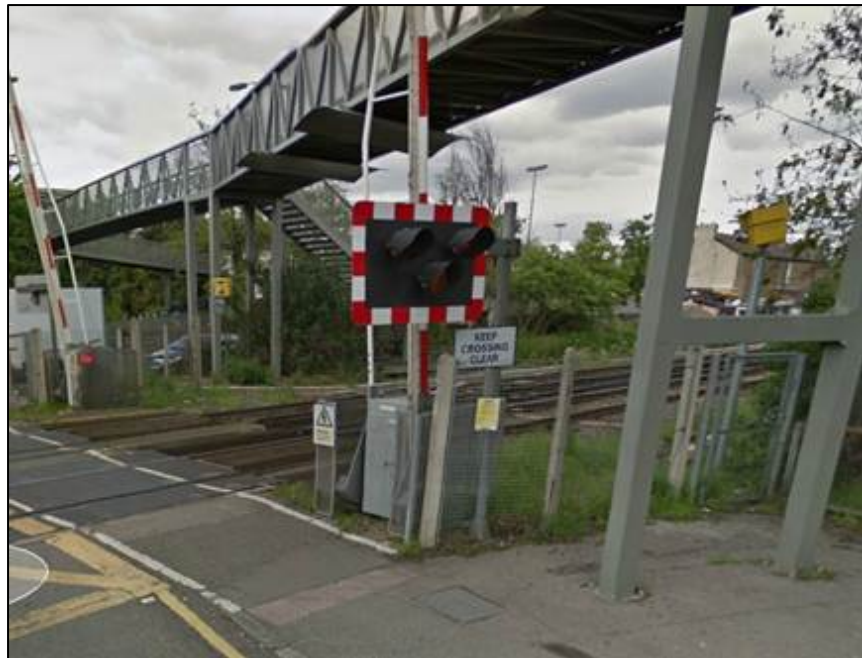
Figure 2-17: Flashing Strobe Lights in Europe.

The vehicle-activated strobe light is also similar to another device used in Europe called the flashing strobe light. They both work essentially the same way, but instead of a constant flashing beacon of light, this countermeasure flashes different colored lights, indicating the area to be dangerous. As shown in Figure 2-17, this design is implemented to caution road users that there are tracks ahead.

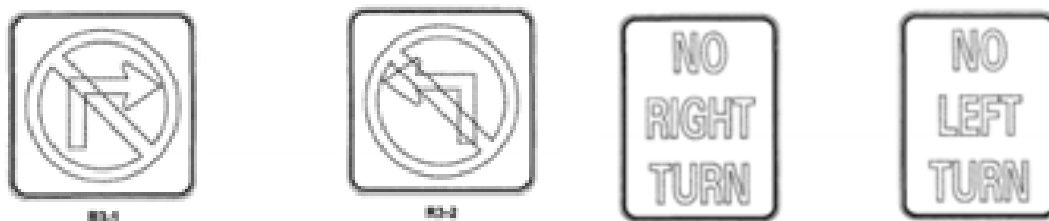
Figure 2-18: Active Internally-Illuminated Sign.

The use of active internally-illuminated signs for parallel traffic turning can also be implemented as a low-cost countermeasure. This device helps with illumination deficiencies at night. Placing an illuminated sign that clearly tells the driver not to turn is extremely beneficial. It indicates the correct path for the driver to take and provides some sort of light that will cause the driver to focus when approaching a critical zone. Figure 2-18 shows examples of sign design that could be used.

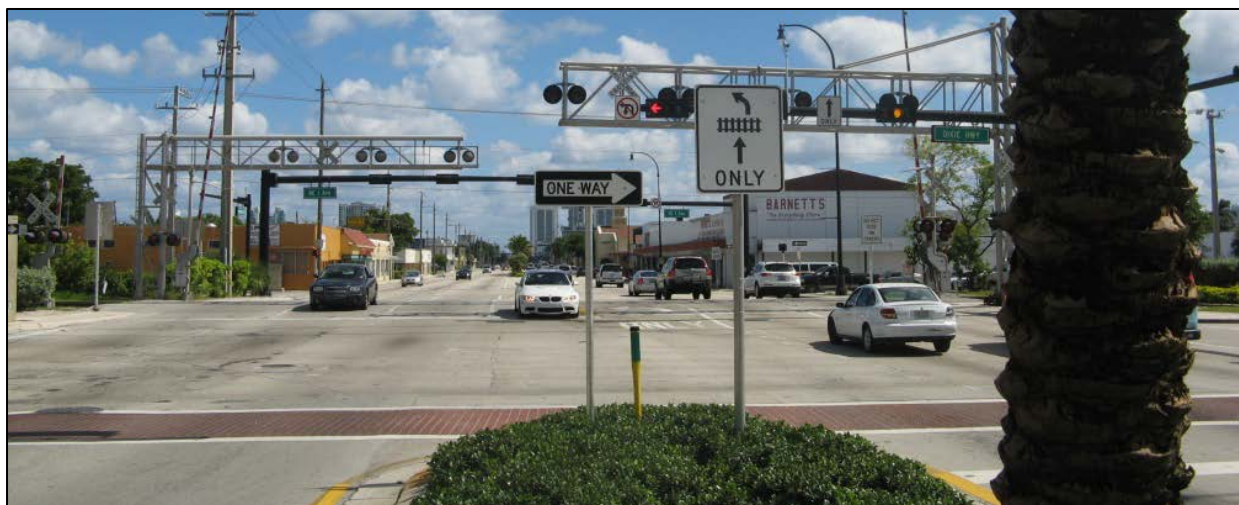
Advance direction signs, as shown in Figure 2-29, are currently being tested in the Hallandale Beach area on Dixie Boulevard. The dimensions of these 30×36-in. black & white reflective signs are shown in Figure 2-20. The signs consist of directional arrows that show the approaching driver where to turn and also warn them that there is a railroad track before the actual turn. The signs give advance indications and aim to prevent confusion so that the number of incorrect turns can be reduced on the highway-rail grade tracks.

Figure 2-19: Advance Warning Sign Used in Hallandale Beach, Florida.

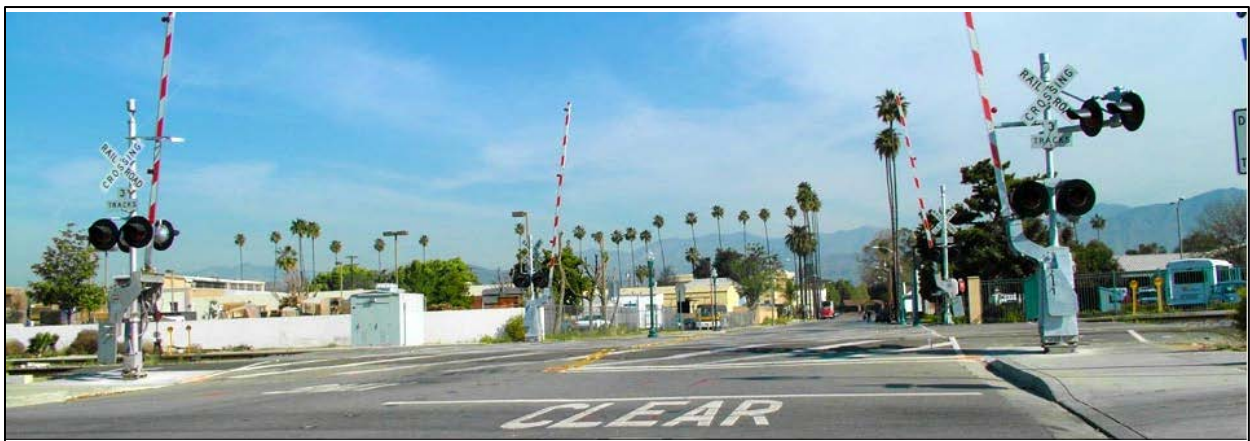
Four-quadrant gates consist of two exit gates used in combination with standard entrance gates, as seen in Figure 2-21. The additional gate arms, combined with standard entrance gates, restrict access to the track crossing area. When these gates are not in use, they lay dormant perpendicular to the railroad tracks. When active, the gates serve as another method to prevent drivers from incorrectly turning onto the tracks. The gates promote the use of the correct path by providing delineation to drivers and enhancing the conspicuity of the railroad tracks. As a countermeasure, instead of the gates laying perpendicular to the track when dormant, they can lay perpendicular across the track simulating a gate.

Figure 2-21: Example of Inactive Four-Quadrant Gates.

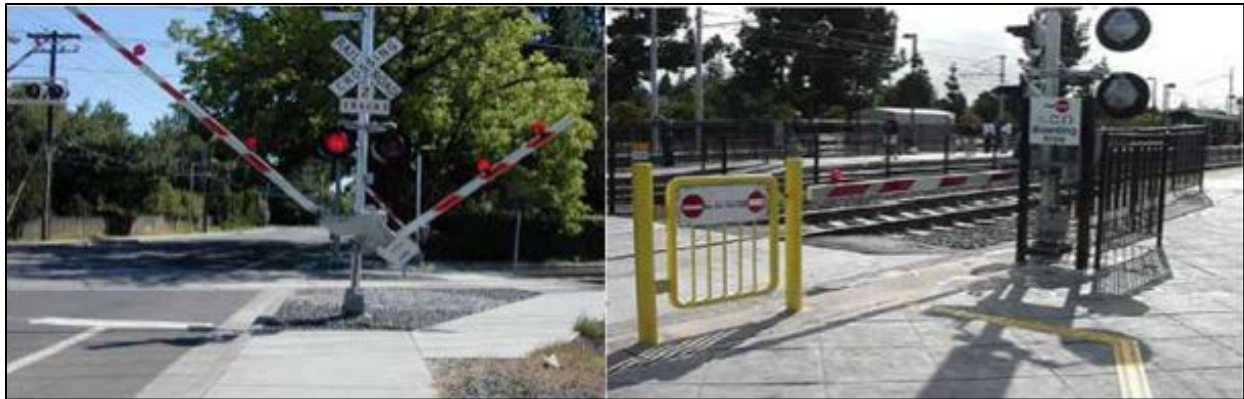
The use of sidewalk gates potentially can stop drivers from incorrectly turning onto the railroad tracks. These devices are used to warn pedestrians and also may result in drawing attention of drivers to the location of railroad crossings. This system can also be used in an alternate manner by placing the sidewalk gates perpendicular across the train tracks at the edge of the road to provide a delineation device for drivers. As a train approaches, the gated system can be activated so that the gates will open and allow the train to pass through without incident. This system promotes correct path continuation and delineation. It also brings driver attention to the fact that there are tracks ahead so that turning is discouraged (see Figure 2-22).

Figure 2-22: Sidewalk Gates in the U.S. (left) and Europe (right).

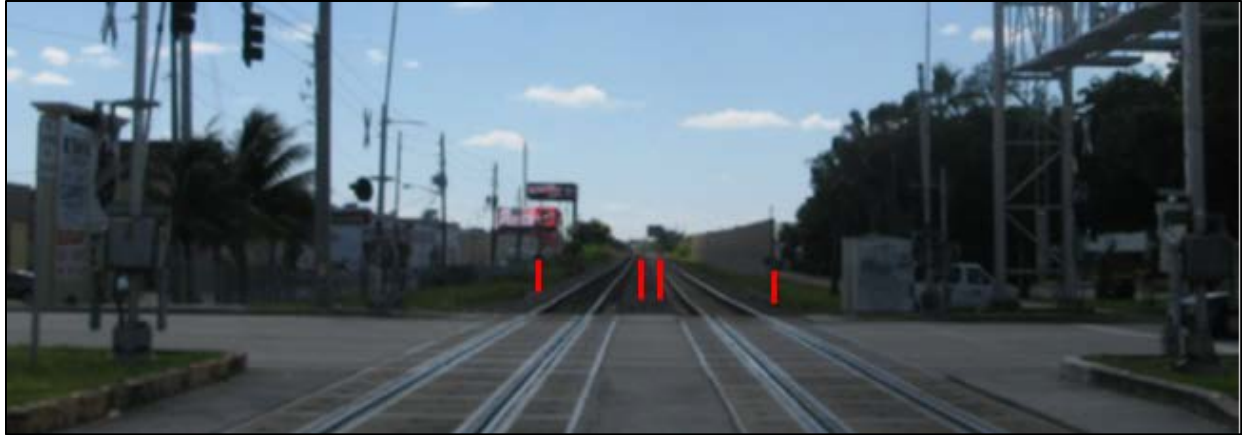
Median and side barriers are commonly used on roadways to effectively separate motorists traveling in opposing lanes, while also considering the safety of the occupants of errant vehicles (FHWA, 2013). The concept can also be applied to use bollards as side and median barriers to prevent drivers from making incorrect turns onto railroad tracks. Figure 2-23 shows one way that the bollards can be used to prevent drivers from incorrectly turning onto railroad tracks. With a system similar to this, roadway engineers can help promote the correct pathway to reduce driver confusion. Bollards are typically made of plastic to give way or break-away when struck by a vehicle.

Figure 2-23: Proposed Use of Side Barriers (Bollards).

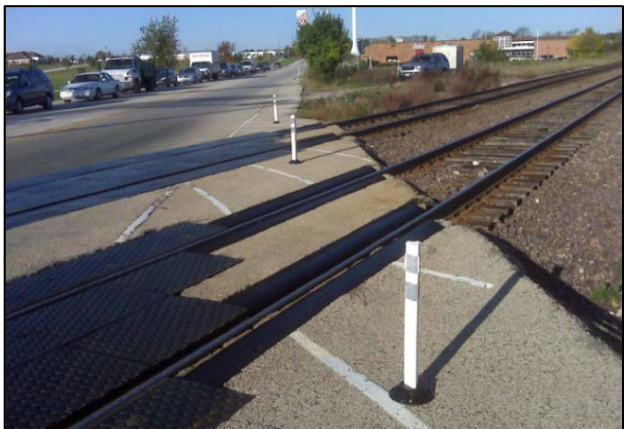
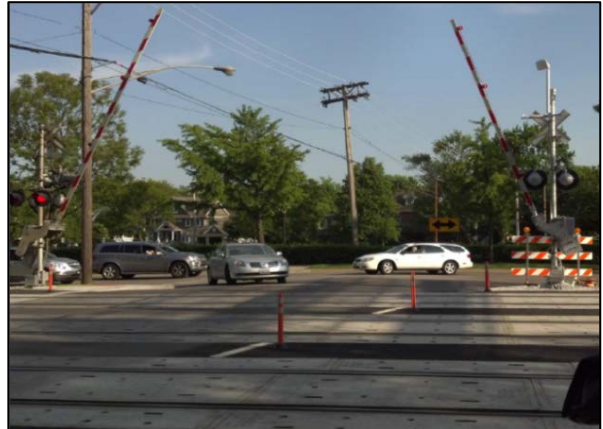
Another way this system can be configured is already being implemented in Illinois. In Figure 2-24, it can be seen that the bollards are used as a delineation device to promote the correct passageway and also gives an idea of what colors can be used when implementing this countermeasure. This figure was captured at two different locations in Illinois. The left shows a location at Three Oaks Drive of Union Pacific Railroad's tracks in Cary, McHenry County, Illinois; the right shows the location at the Monroe Street highway-rail crossing of the BNSF Railway's tracks in the Village of Hinsdale, DuPage County. On the left, white bollards with grey reflective striping were implemented; on the right red bollards with white reflective striping were implemented. In Florida, red bollards are being proposed. Both solutions were deemed acceptable for the scope of this project.

Figure 2-24: Median Barriers at Railroad Crossings in Illinois.

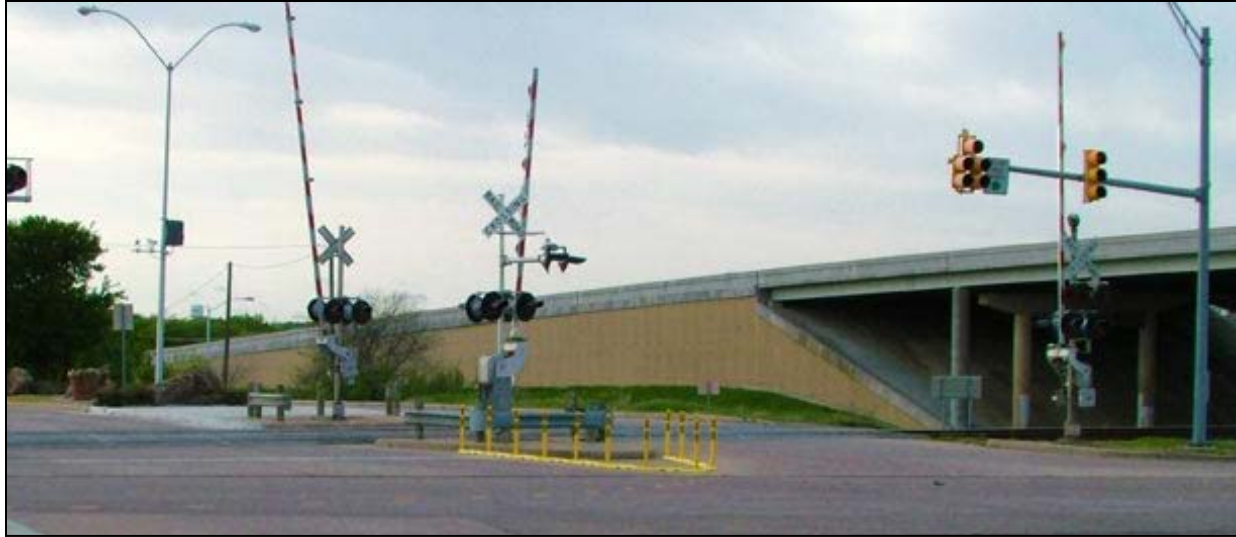
Figure 2-25 shows the use of a median barrier as a type of channelization device, warning drivers that they are approaching railroad tracks and that they should not turn at this point. Median barriers, along with quadrant gates, are an obvious indication to drivers that they should not turn at that moment. This device is used so drivers do not impact the warning device. An additional benefit from this is deterring drivers from turning onto the tracks.

Figure 2-25: Median Barriers at a Railroad Crossing.

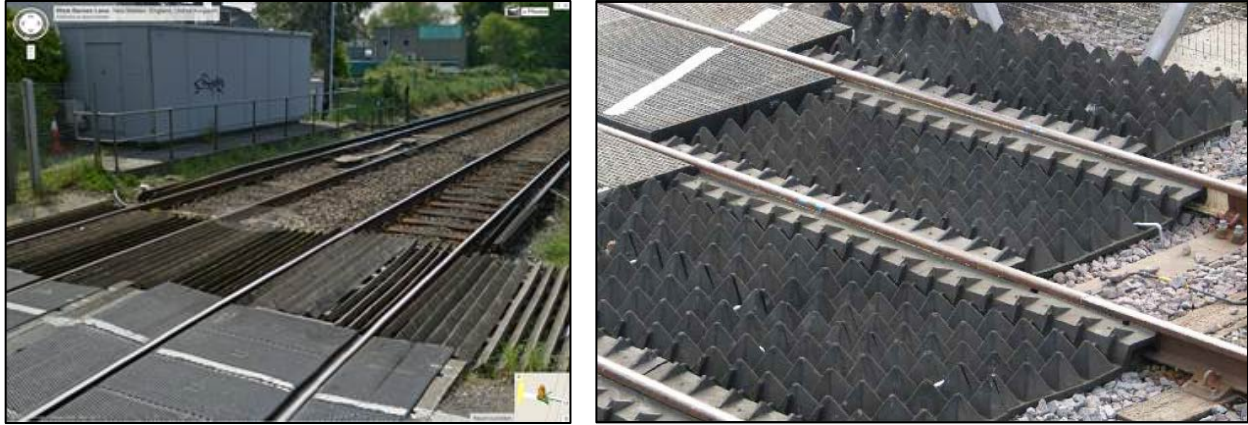
Figure 2-26: Cattle-Cum-Trespass Guards in Europe.

A delineation device called cattle-cum-trespass guards can be installed within the critical zone. These guards, shown in Figure 2-26, are placed adjacent to the road at level crossings in Europe. They are used to deter animals from straying and pedestrians from trespassing. They can also be used to inform drivers with visual and audible affects when they try to turn onto the tracks. This countermeasure produces a tactile vibration that is transmitted through the wheels into the car body and comes in two forms. Shown on the left of Figure 2-26 are the traditional guards that are placed at the railroad tracks, which are metal. On the right is shown a newly-developed design that incorporates reclaimed rubber. This method can be used to inform drivers of the correct driving passage along railroad tracks and can be installed on either side of the tracks so that drivers can be aware that they are not traveling along the right path.

For installation, these panels come with recycled plastic planks measuring 38mm × 80mm × 140mm and cadmium-plated, rust-resistant, self-tapping screws. The planks are inserted perpendicular and underneath the rail at each end of the panel. The panel is then screwed to the plank with the self-tapping screws. With the other half of the plank now sitting on the other side of the rail, the adjoining panel is attached to this with screws. The panels that are next to the previously-laid panels attach to the remaining half of the exposed plank so that it is perpendicular to the track (HoldFast Level Crossings Limited, 2009). This countermeasure could be incorporated by a transportation agency in cooperation with a railroad company because it requires extended right-of-way and coordination of train flagging for installation and maintenance.

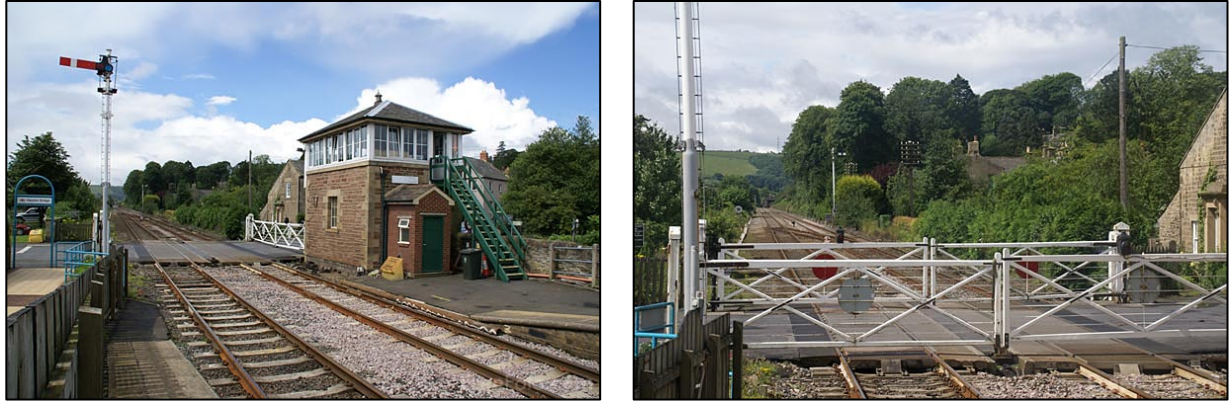
A gated railway level crossing design is primarily a British method and is used in Europe to stop people and animals from wandering onto the tracks when a train is approaching. This type of crossing is shown in Figure 2-28. As a train approaches, the gated system is activated by an operator who assures that the gates will block traffic while the train is passing. This method could be used in the U.S. to address the problem of people incorrectly turning onto the railroad tracks. It is feasible to make the gates train-activated where they are down when there is no train approaching and open to allow the train to pass through without incident.

Figure 2-28: Gated Railway Level Crossing in Europe.

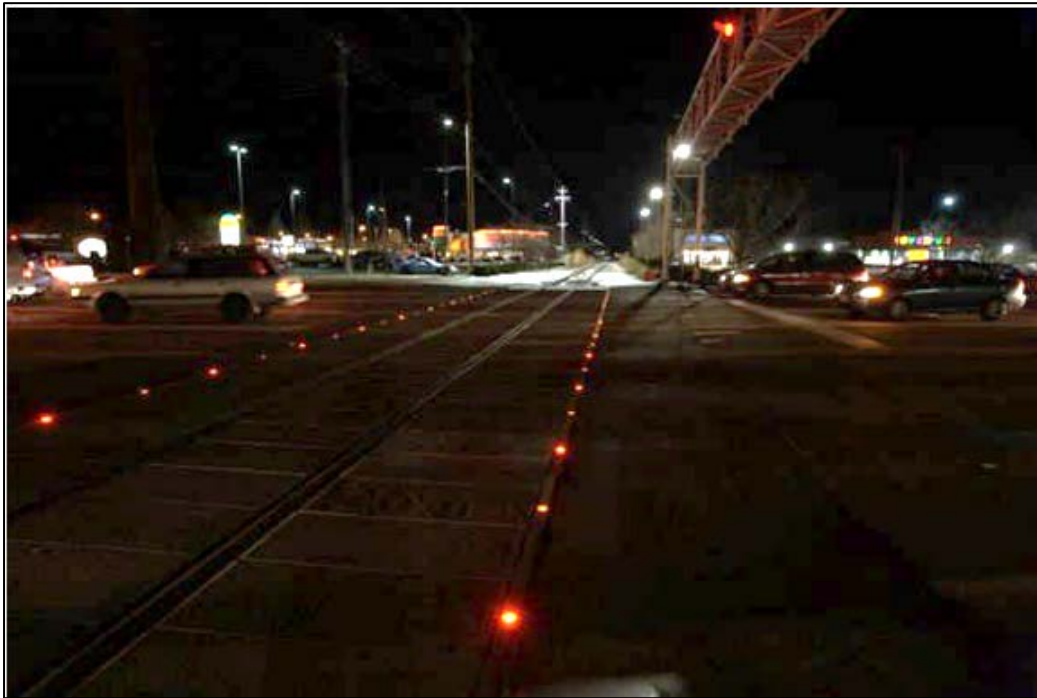
Figure 2-29: BODAN Level Crossing System at Night.

safety feature in which LED warning lights are molded into the edge of the beam, which runs parallel to the track on both sides of the crossing. These LED lights, as shown in Figure 2-29, alert approaching vehicles that there is a track ahead. This particular countermeasure promotes correct path continuation for safer conditions on the road. This crossing system without LED lights has been estimated to be significantly more expensive than the cost of other crossing systems, in some cases twice as much. There are some stipulations with this countermeasure, as it requires the railroad company to install and maintain the LED lights.

Unlike other level crossing systems, BODAN does not rely on railroad ties for attachment or support. Once installed, BODAN maintains a consistent level riding surface, even under heavy traffic volumes. The precast panels have an exposed aggregate surface that provides a highly skid-resistant surface, even in wet conditions. Custom precast BODAN panels incorporate highly-visible yellow surface aggregate and raised or recessed delineators, which enhance the visibility and safety of the crossing. The unique modular panel design allows for easy removal and reinstallation for track inspection and routine maintenance. BODAN components are available in a variety of shapes and sizes and may be custom-molded to match site geometry (Railway Technology, n.d.).

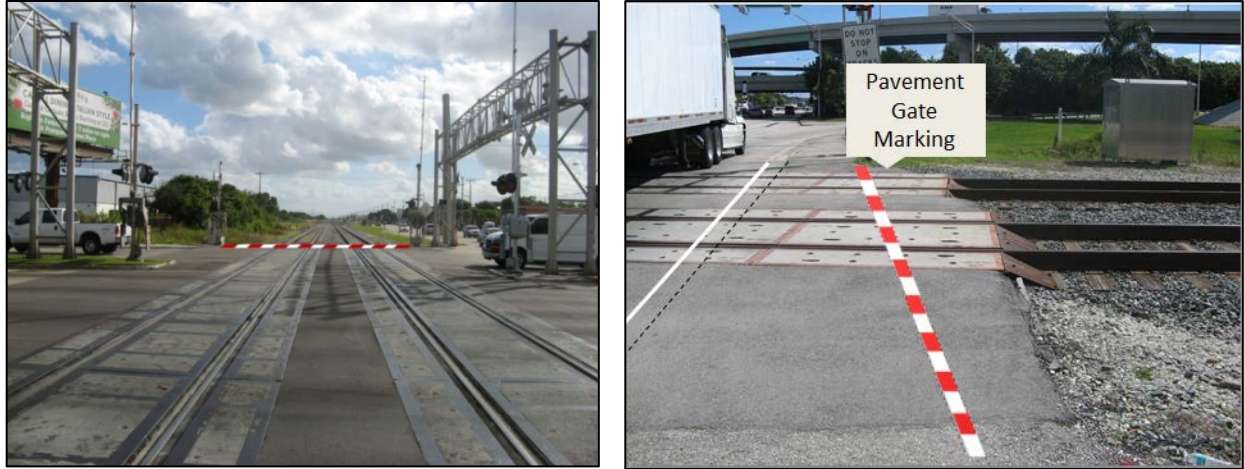
Figure 2-30: Proposed Pavement Gate Marking.

Pavement gate markings are a concept that was created by CUTR and require an experimentation request before it can be used. These markings incorporate the red and white reflective striping found on the railroad crossing gates and places it along the side of the road perpendicular to the railroad tracks. As shown in Figure 2-30, this low-cost countermeasure would be easy to implement and would require cooperation from transportation and railroad agencies to put this system into place. This measure would prevent incorrect turns similar to the side markings on a highway by providing separation between moving traffic and the railroad tracks. It also indicates that passing is prohibited and warns the driver from making an incorrect maneuver onto the railroad tracks. Another benefit is that the pavement gate markings can be used to alert users to conditions up ahead causing drivers to slow down and take precaution. A side gore striping (clear zone outside the edge of travel ways) in the vicinity of crossings, similar to the concept of pavement gate marking, is also proposed and illustrated in Figure 2-31.

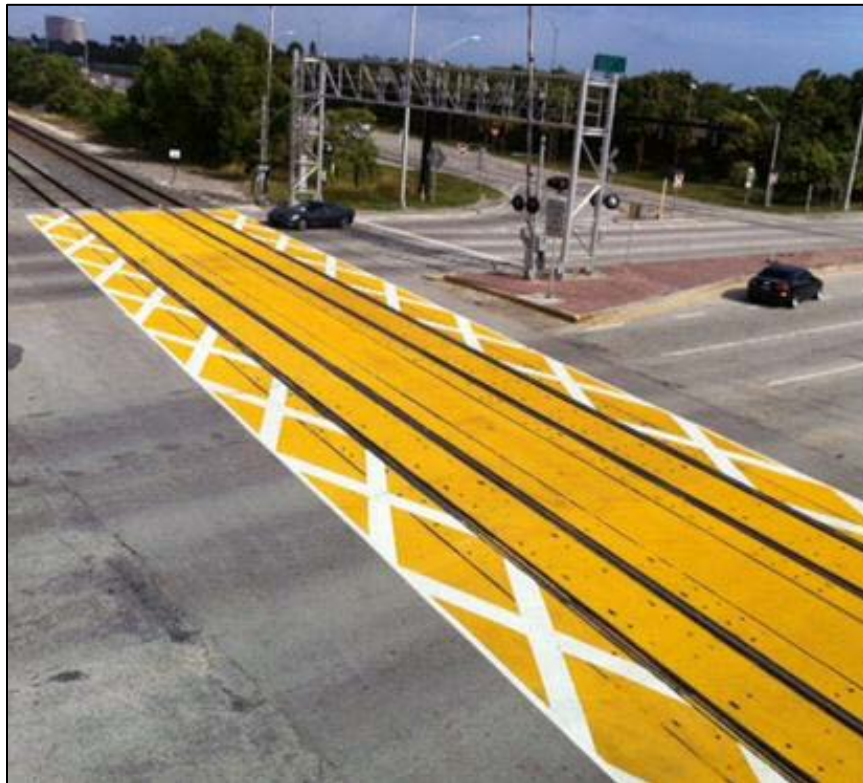
Figure 2-32: Dynamic Envelope Pavement Markings.

east side of the double tracks to the west side. The goal of this countermeasure is to reduce crashes by preventing drivers from stopping in the painted clear zone.

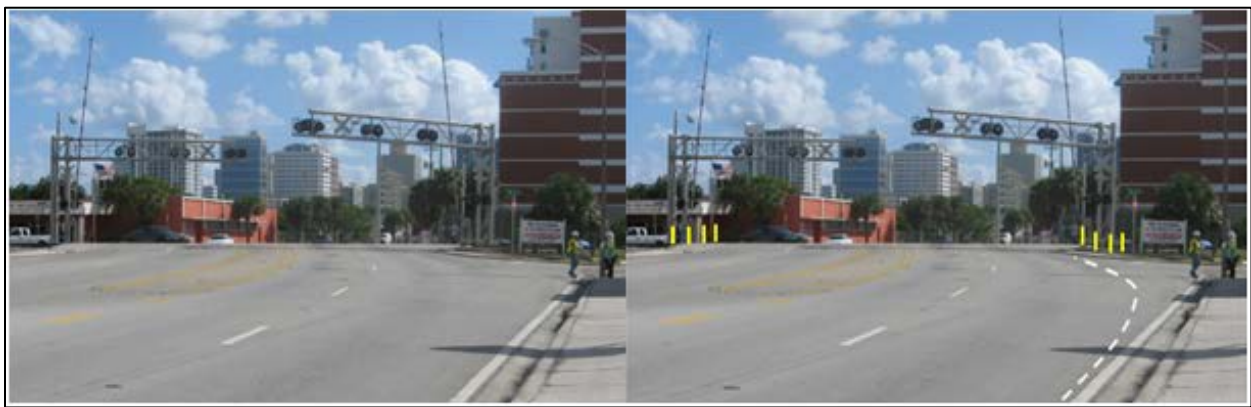
Figure 2-33: Example of Application of Treatments for a Site with a Curve to Prevent Incorrect Turns.

Based on the literature review and history of reported incidents of incorrect turns on railroad crossings, these crashes tend to occur at night. For this reason, the majority of the countermeasures listed in this section include increasing railroad crossing conspicuity through delineation and illumination. Several countermeasures can be applied to a single site to achieve the objective of minimizing the potential for incorrect left turns. For example, Figure 2-33 presents a site with a curve that is not delineated and may cause drivers to end up on the rail track or to crash into the gate. By providing illumination, delineation, and median/side barriers, the conspicuity of the crossing is increased. Another example is presented in Figure 2-34, where speed reduction, side barriers, and pavement striping can be used to enhance the railroad crossing, especially in dark conditions.

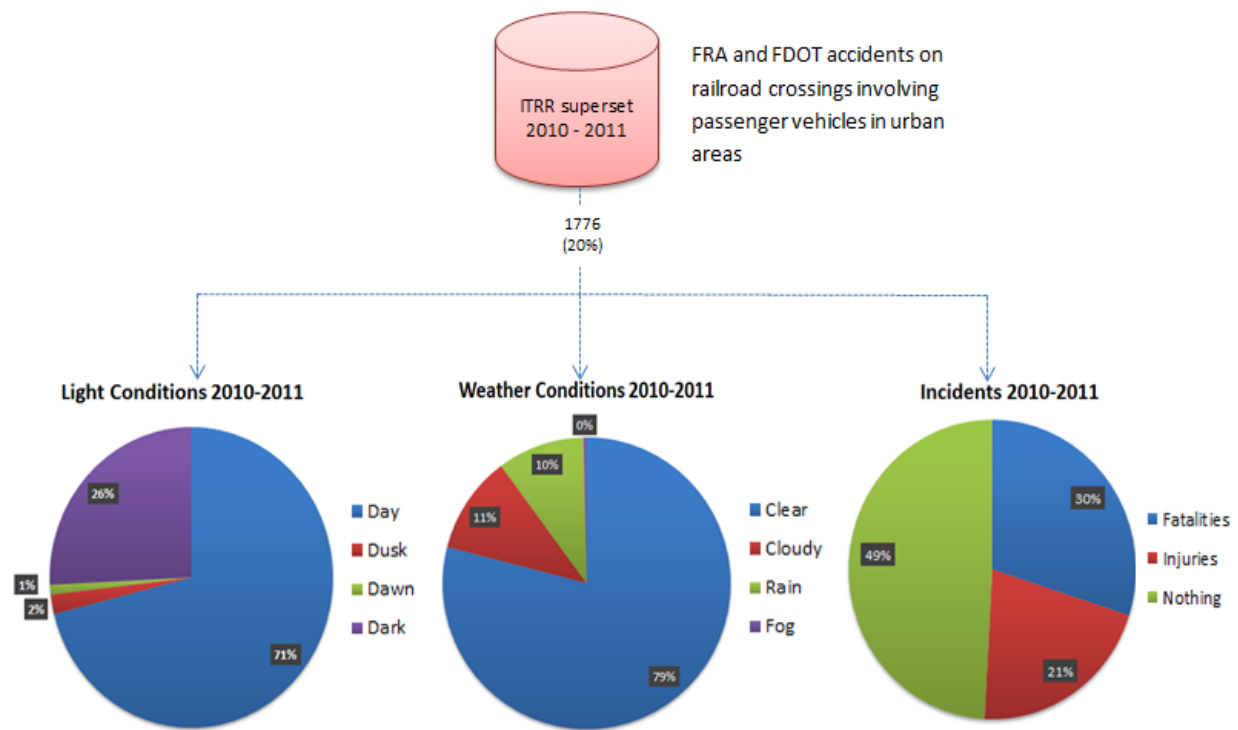
Figure 3-2: Correlation between Time of Day, Weather, and Occurring Incidents.

From the ITRR superset, the data were broken down based on injury levels, crash time of day, and weather conditions. Figure 3-2 presents the results of this categorization. It can be observed that 30 percent of the crashes in the ITRR superset included fatalities and 21 percent included injuries.

The distribution of the crashes based on time of day showed that 71 percent of incidents occurred during the day, 26 percent occurred at dark, and 3 percent occurred either at dusk or dawn. With respect to weather conditions, the ITRR superset in 79 percent of the cases occurred on a clear day.

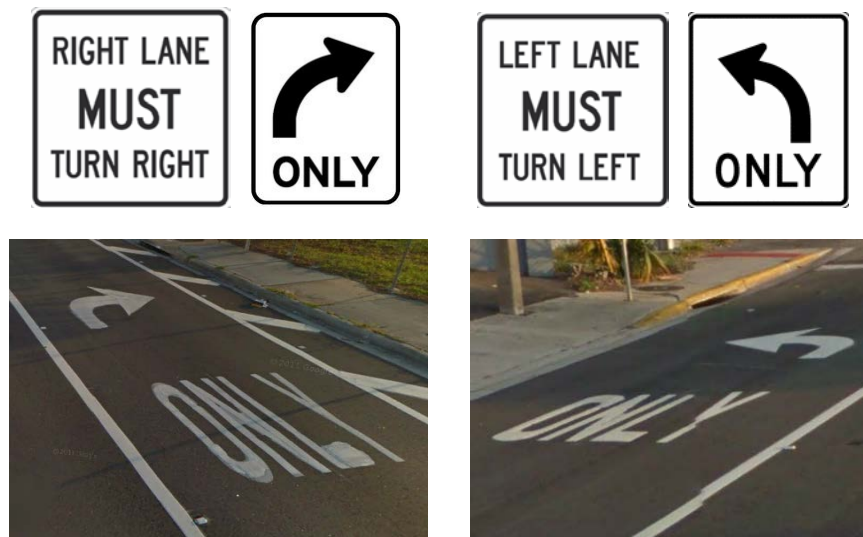
The most recognized regulatory signs and pavement marking that may confuse drivers are "Right Lane Must Turn Right" and "Left Lane Must Turn Left" and Right-Turn-Only and Left-Turn-Only pavement markings, as shown in Figure 3-4. The examples for these confusing signs and pavement markings at three different locations are shown in Figure 3-5, Figure 3-6, and Figure 3-7, respectively.

Figure 3-4: Confusing Signs and Pavement Markings near Railroad Crossings.

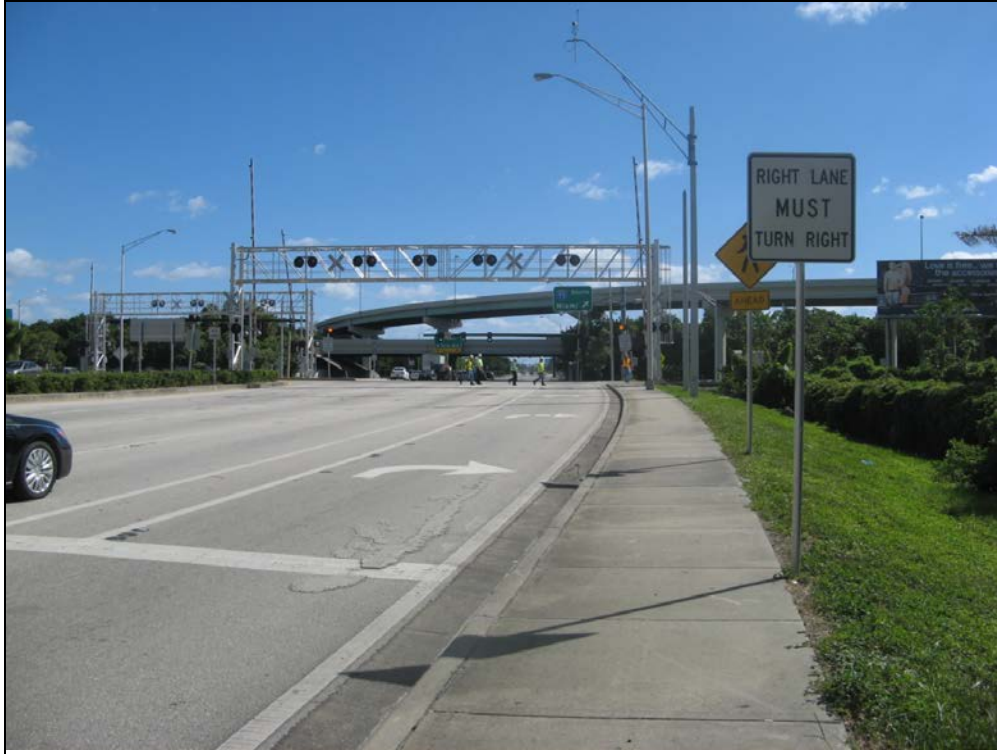
Figure 3-5: Confusing Right-Turn Sign and Pavement Marking on Commercial Blvd in Oakland Park, Florida.

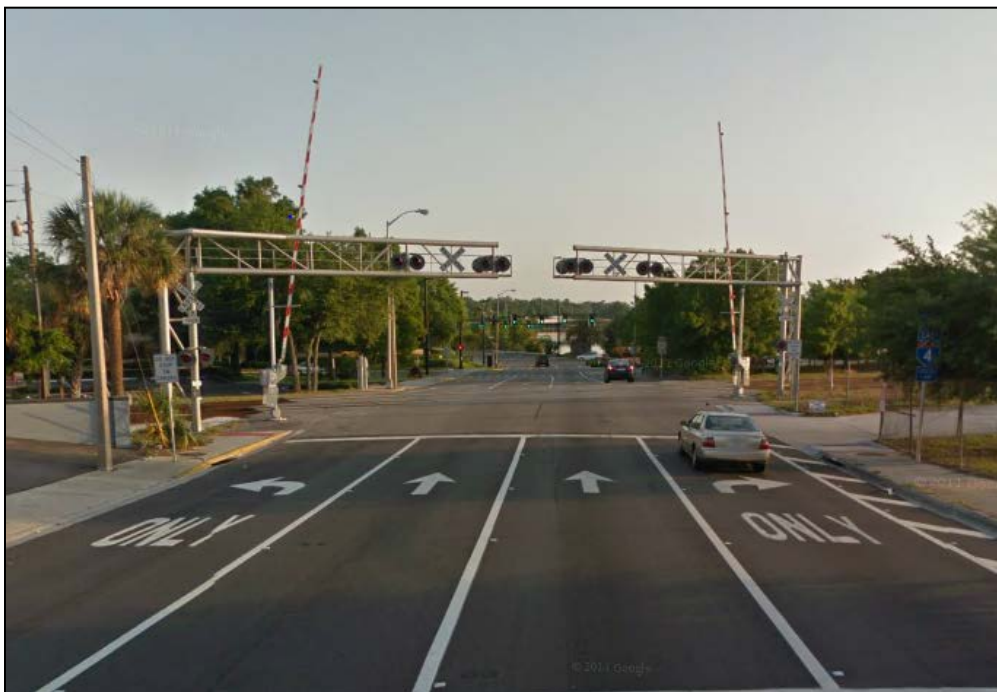
Figure 3-6: Confusing Left- and Right-Turn Pavement Markings on Magnolia Ave in Orlando, Florida.

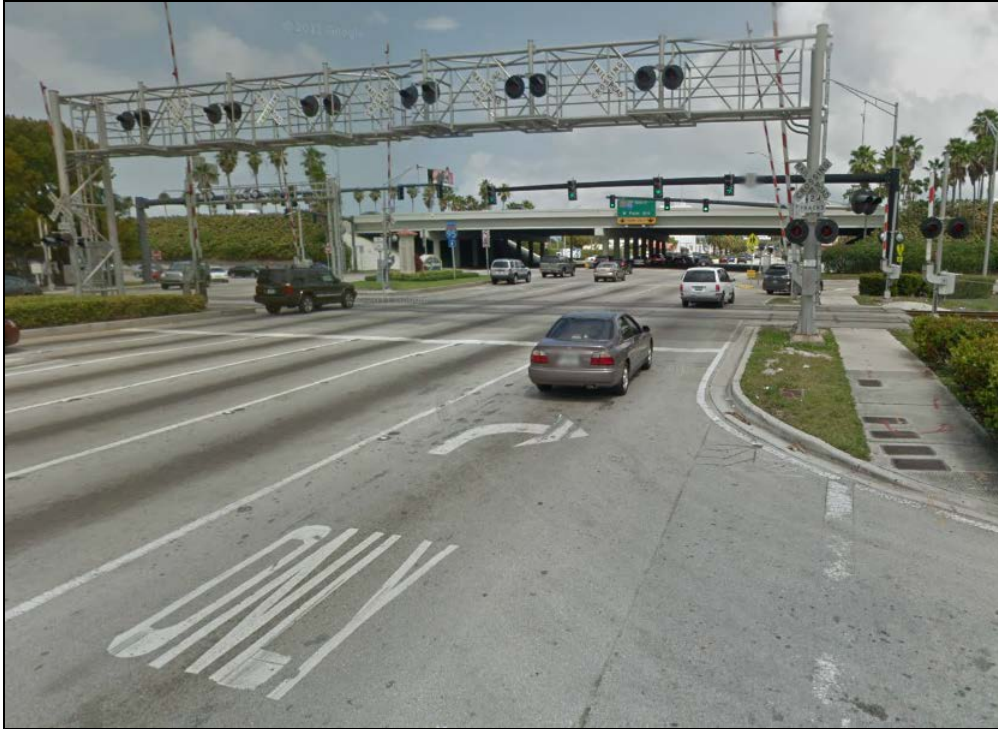
Figure 3-7: Confusing Right-Turn Pavement Marking on Hollywood Blvd in Hollywood, Florida.

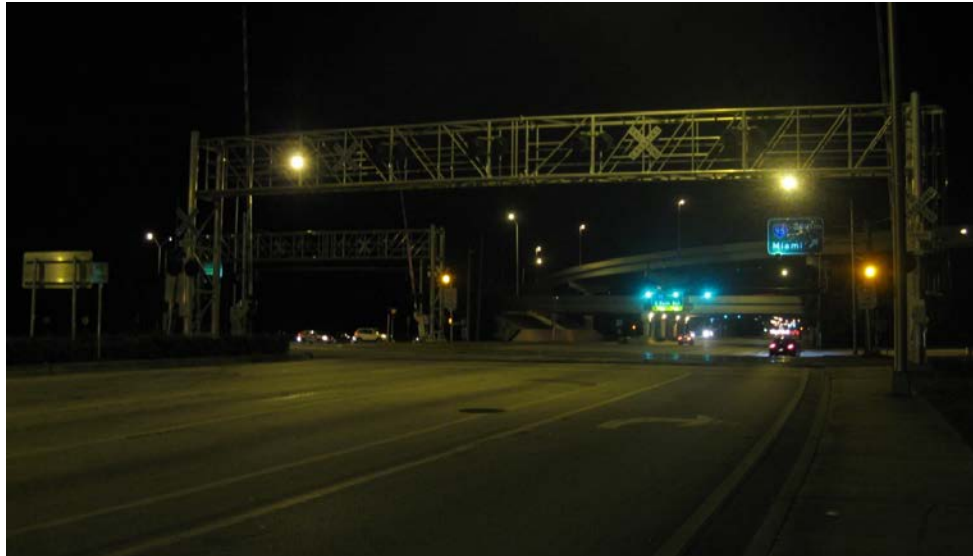
Figure 3-8: Darkness of Railroad Crossing on Commercial Blvd in Oakland Park, Florida near I-95.

Darkness and low visibility near or at railroad crossing may result from lack of street lighting, incompliance of street light illumination with an established standard, and/or adverse weather conditions such as foggy, smoky, and heavy rain situations. Darkness and low visibility can cause drivers to make incorrect turns because some drivers are unable to clearly recognize the railroad crossings, especially if they are not familiar with their surroundings. Drivers may mistake the railroad crossing as their destined nearby intersections, driveways or ramps, and make incorrect turns. Examples of two locations with darkness or low visibility are shown in Figure 3-8 and Figure 3-9, respectively.

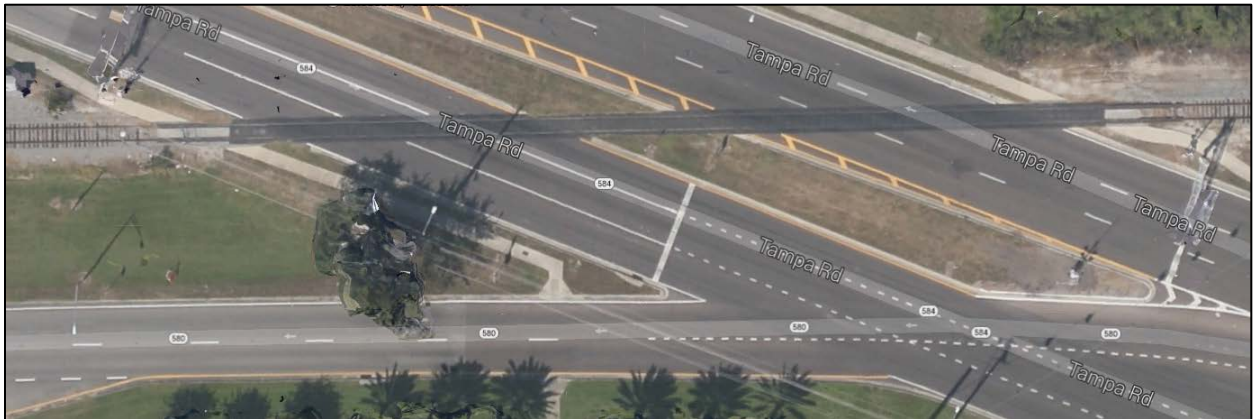
**Figure 3-11: Skewed Highway-Rail Crossing on Tampa Rd
Adjacent to State St in Oldsmar, Florida.**

When roadways and railroad crossings intersect at skewed angles, the intersections and crossings may experience many potential problems. For example, drivers may have more difficulty aligning their vehicles as they enter the cross-street to make a right or left turn. The larger intersection and railroad crossing areas may confuse drivers or cause them to deviate from the intended path. It becomes more confusing at dark or in low-visibility conditions. Faded longitudinal line pavement markings can also cause confusion for drivers. Three examples of skewed highway-rail grade crossings are shown in Figure 3-11, Figure 3-12, and Figure 3-13, respectively.
