Improved Traffic Control Measures to Prevent Incorrect Turns at Highway-Rail Grade Crossings

FDOT BDK85 Task Work Order #977-45

Final Report

USF Center for Urban Transportation Research

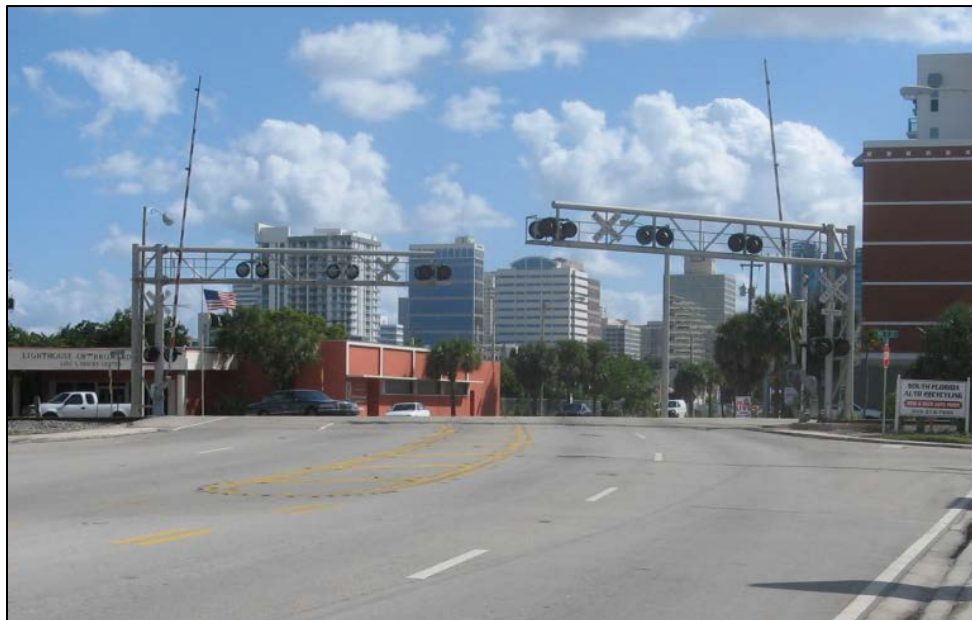
**Figure 3-12: Skewed Highway-Rail Crossing on N Andrews Ave
Adjacent to NW 7th St in Fort Lauderdale, Florida.**

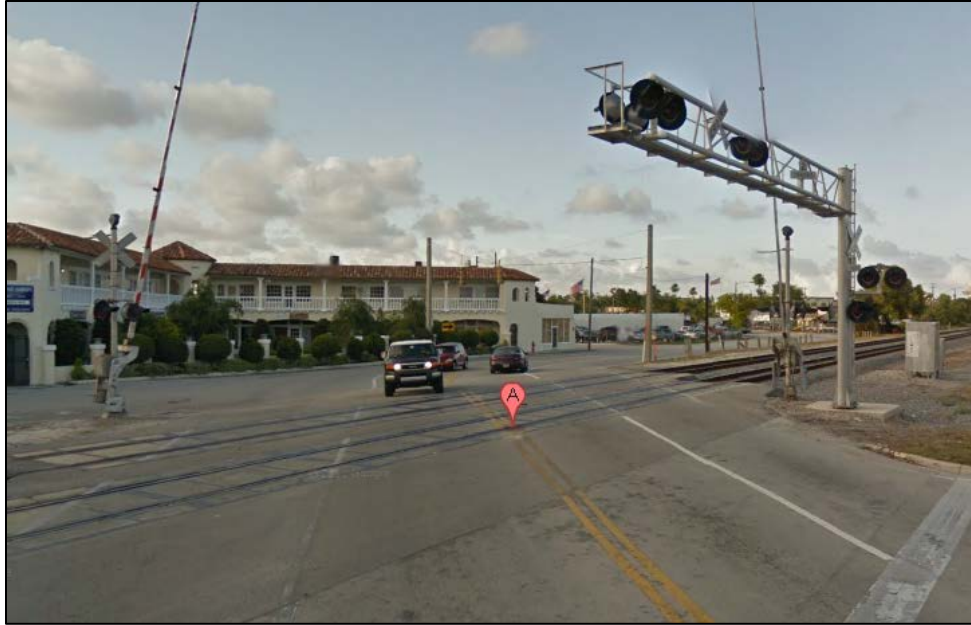
**Figure 3-13: Skewed Highway-Rail Crossing on NE 3rd Ave
Adjacent to Progresso Dr in Fort Lauderdale, Florida.**

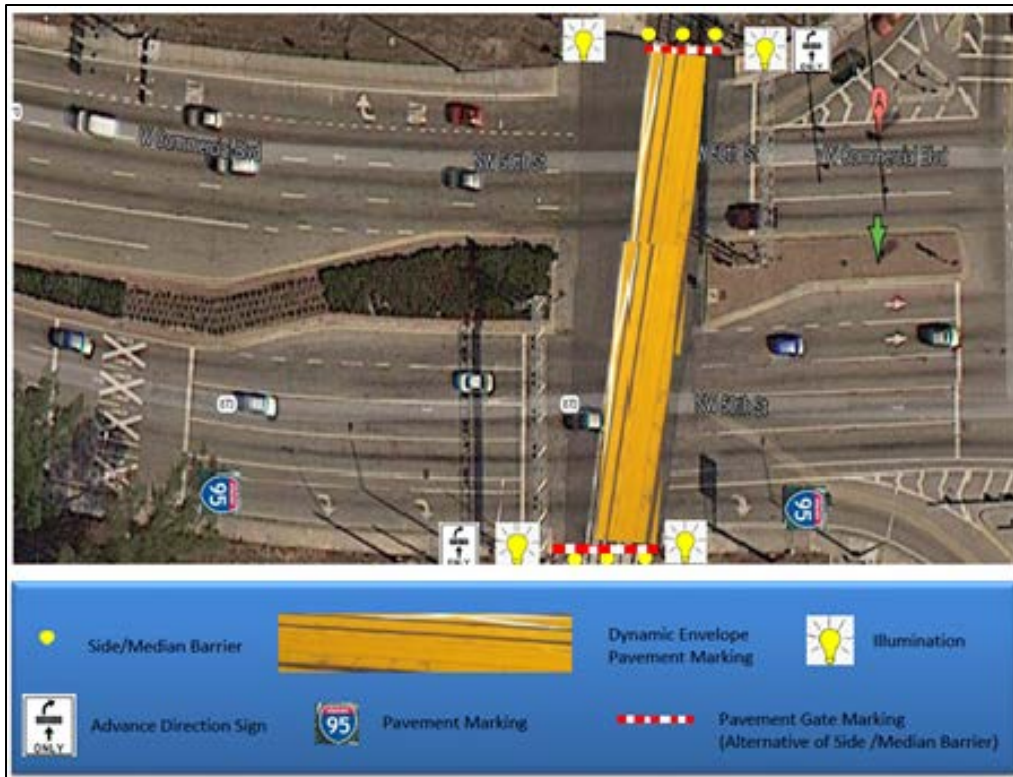
Figure 4-4: Possible Countermeasures for Site at Commercial Blvd.

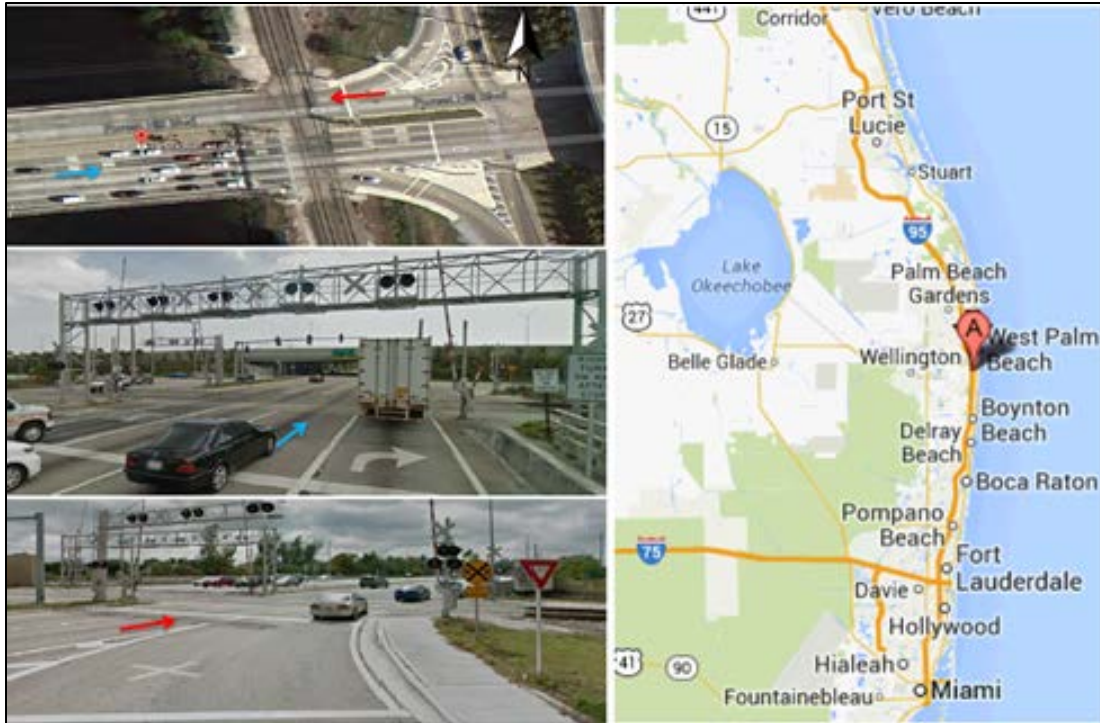
The aerial, street views, and map of the site at Forest Hills Blvd near I-95 at Lake Clarke Shore are shown in Figure 4-5. This site had several crashes occurred between the years 2010 and 2011. There were three crashes (two day, one night) and three stuck vehicle incidents (one day, two night) due to incorrect turns between May 2012 and January 2013. This issue seemed to occur evenly during daylight and night time hours at this site.

Figure 4-5: Aerial, Street Views, and Map of Site at Forest Hills Blvd.

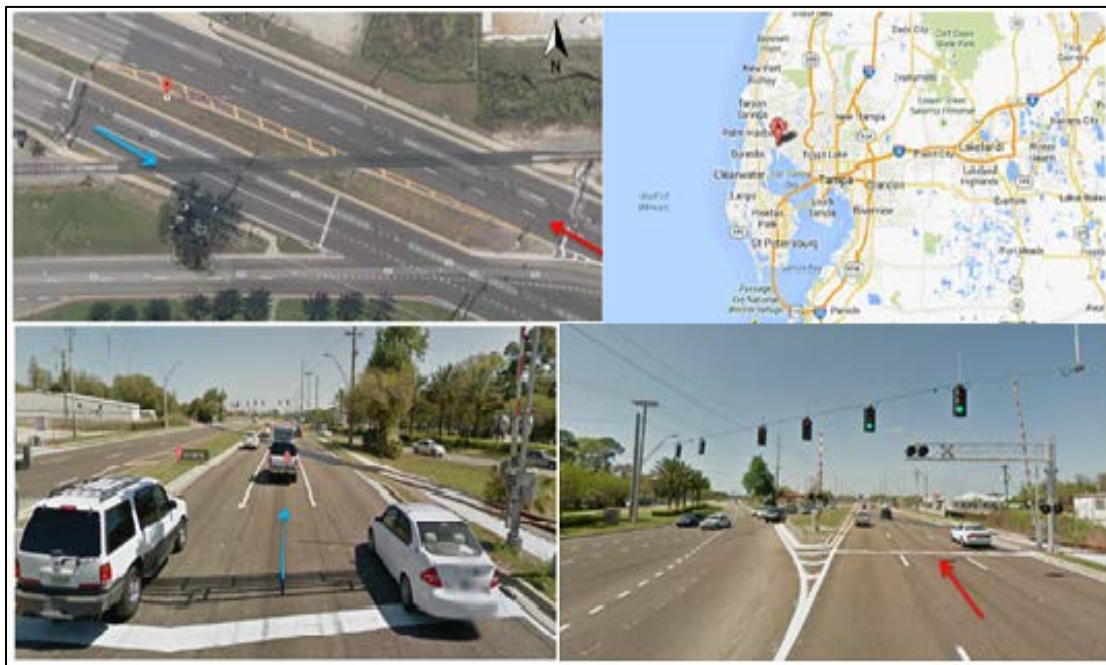
The aerial, street views, and map of the site at Tampa Rd and State St at Oldsmar are shown in Figure 4-7. This site had several crashes occurred between the years 2010 and 2011. Out of the 11 preliminary sites, this site had the most number of crashes. There were a total of five crashes (two day, three night). There was one stuck vehicle incident at night from May 2012 to January 2013. The current applicable treatments at this location include railroad crossing pavement markings, turning signs, and four-quadrant gates.

Figure 4-7: Aerial, Street Views, and Map of Site at Tampa Rd.

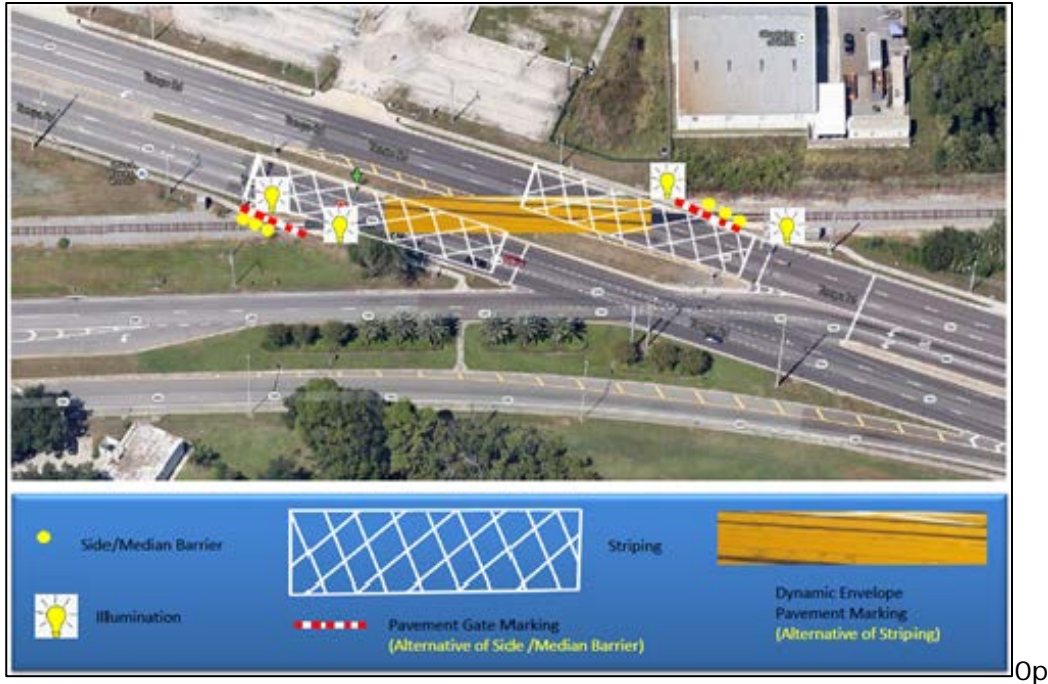
Most of the countermeasures were placed at the critical zone for this particular site due to the skewed angle of the railroad tracks on the road. These acute angles are clearly shown in Figure 4-8. The selected upstream and downstream treatment for this location is striping. Critical zone countermeasures include side and median barriers, illumination, striping or dynamic envelope pavement markings, and pavement gate markings.

Figure 4-8: Possible Countermeasures for Site at Tampa Rd.

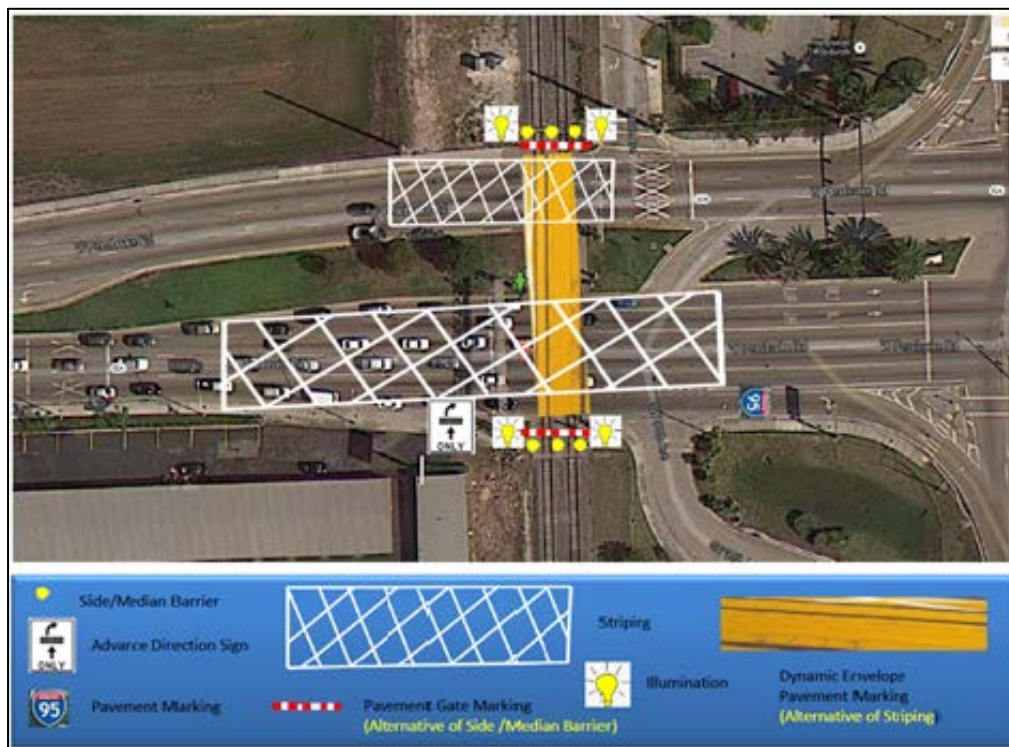
Figure 4-10: Possible Countermeasures for Site at Pembroke Rd.

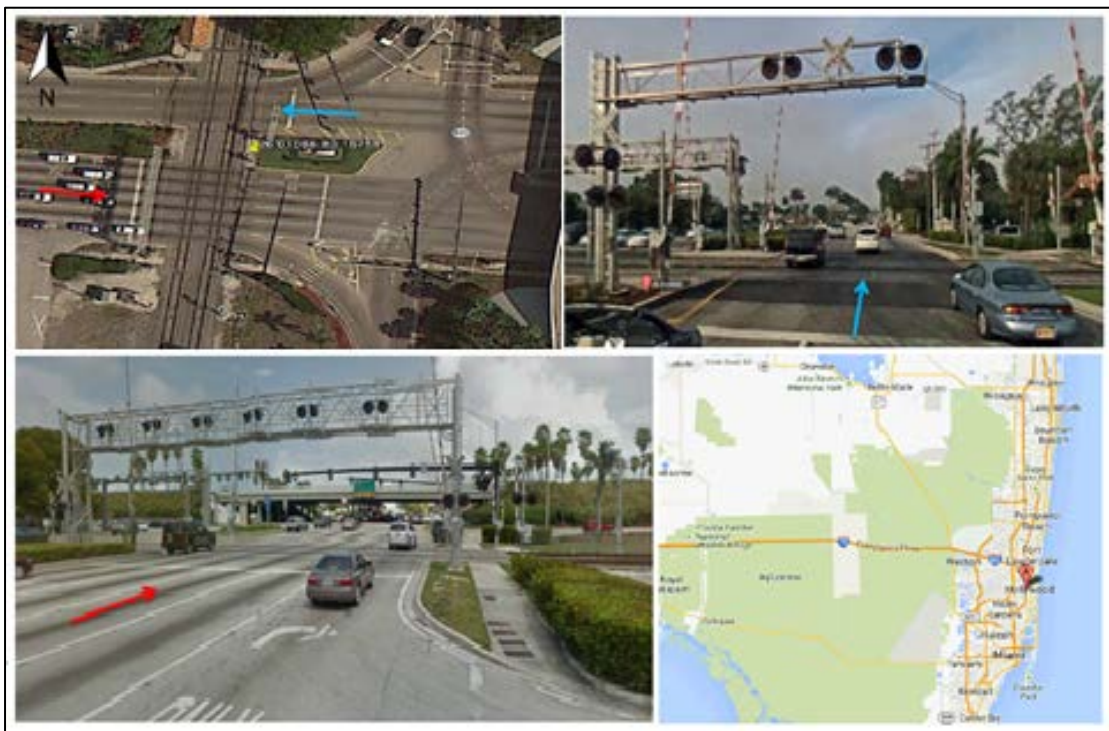
The aerial, street views, and map of the site at Hollywood Blvd near I-95 at Hollywood are shown in Figure 4-11. Similar to the other preliminary candidate site in Hollywood, there were a significant amount of train-vehicle crashes and stuck vehicle incidents due to incorrect turns at this location. The same problem seems to be recurring in both locations in Hollywood. At this site, there were six incidents related to drivers incorrectly turning onto the railroad tracks. There were three crashes (two day, one night) between 2010 and 2011. There were also three stuck vehicle incidents where drivers incorrectly turned onto the rail tracks all occurring at night.

Figure 4-11: Aerial, Street Views, and Map of Site at Hollywood Blvd.

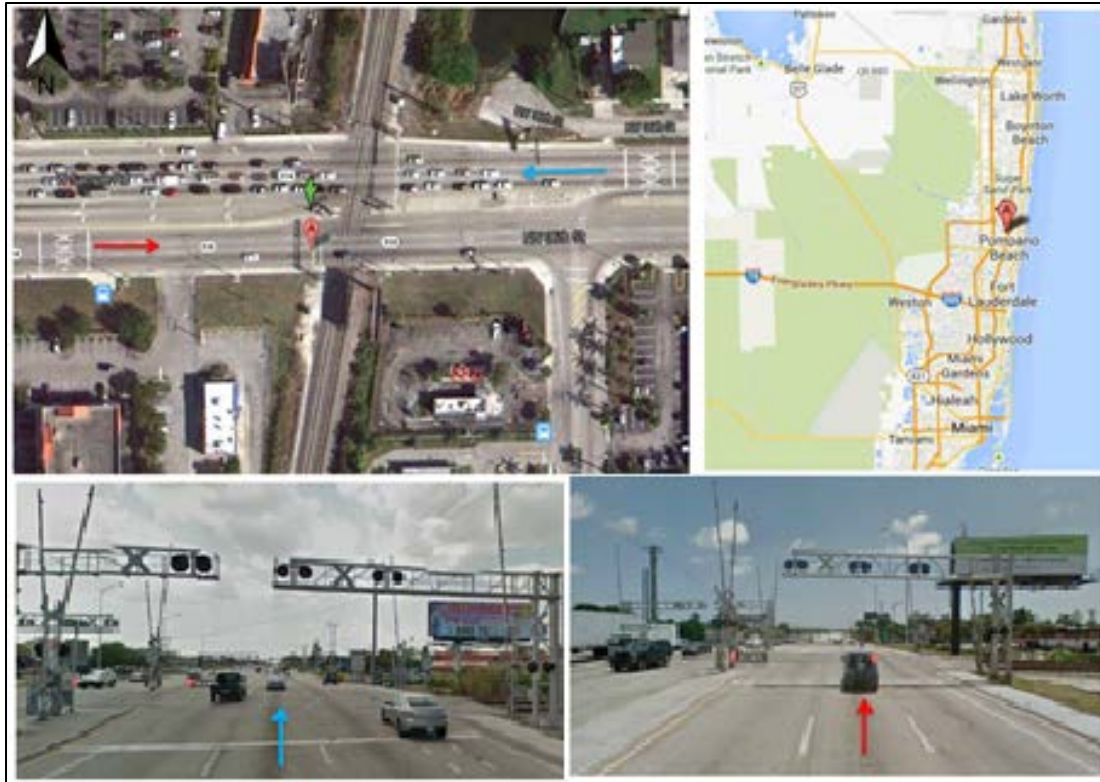
The aerial, street views, and map of the site at W. Sample Rd near I-95 at Pompano Beach are shown in Figure 4-13. This site had the most stuck vehicle incidents of any other site. From 2010 to 2011, there were three rail-vehicle crashes (two day, one night). From May 2012 to January 2013, there were four stuck vehicle incidents (one day, three night), all related to drivers incorrectly turning onto the tracks. There were more incorrect turns onto railroad tracks at night than those during the day for this site.

Figure 4-13: Aerial, Street Views, and Map of Site at Sample Rd.

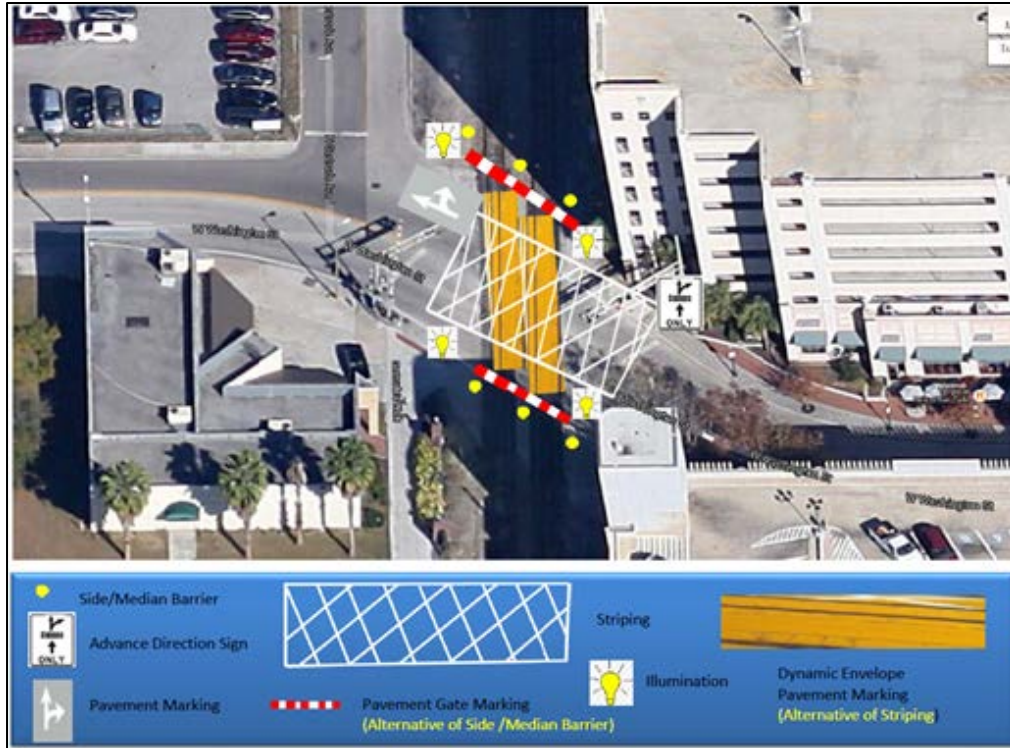
Upstream treatments for this intersection include striping and advance direction signage. The critical zone needs to be defined to bring awareness to this area. The critical zone treatments include side and median barriers, illumination, striping or dynamic envelope pavement markings, and pavement gate markings. Downstream suggested treatments consist of guide signs. The recommended treatments for this site are shown in Figure 4-16.

Figure 4-16: Possible Countermeasures for Site at Washington Ave.

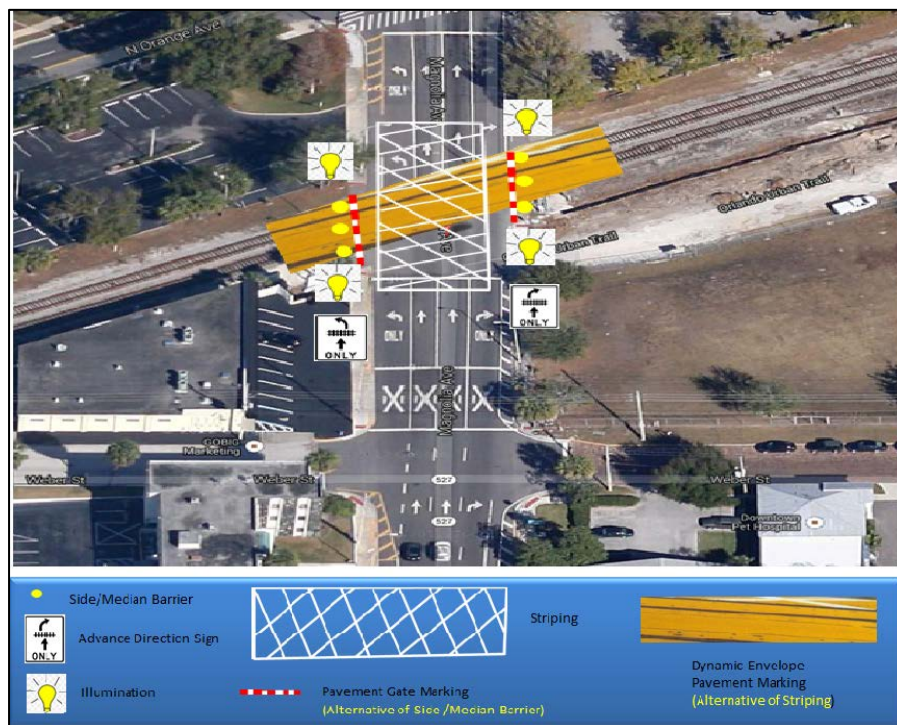
The countermeasure treatments proposed include striping and advance direction signs upstream of the railroad tracks. Side and median barriers, illumination, striping or dynamic envelope pavement markings, and pavement gate markings could be placed in the critical zone. The critical zone treatments were chosen due to the number of incidents that occur mainly at night. The downstream treatments consist of guide signs and striping. All of these countermeasures are shown in Figure 4-18.

Figure 4-18: Possible Countermeasures for Site at Magnolia Ave.

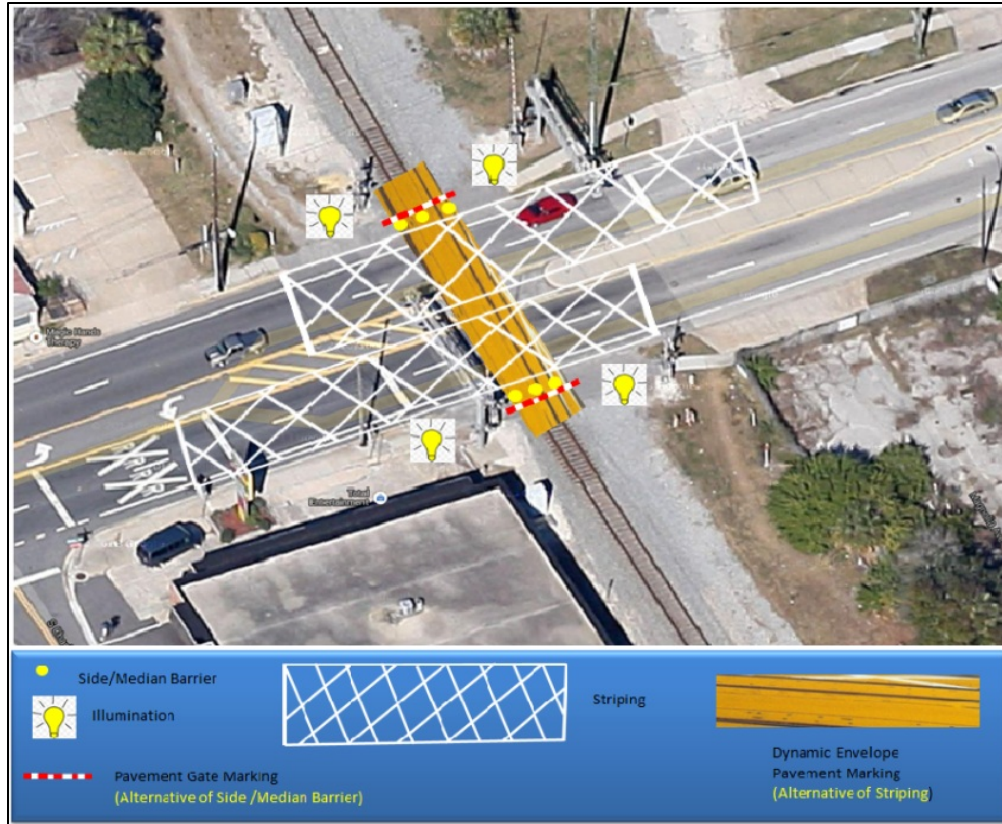
For this location, several countermeasure treatments are proposed to be placed upstream of the railroad tracks. These treatments include striping and advanced direction signs to warn the driver ahead of time before approaching the railroad crossing. The critical zone countermeasures include side and median barriers, illumination, striping or dynamic envelope pavement markings, and pavement gate markings. The incidents that occurred in this zone seem to happen mainly at night, which is why proper illumination, striping, and dynamic envelope pavement markings would be beneficial, as shown in Figure 4-20. The downstream treatments consist of guide signs and striping.

Figure 4-20: Possible Countermeasures for Site at International Speedway Blvd.

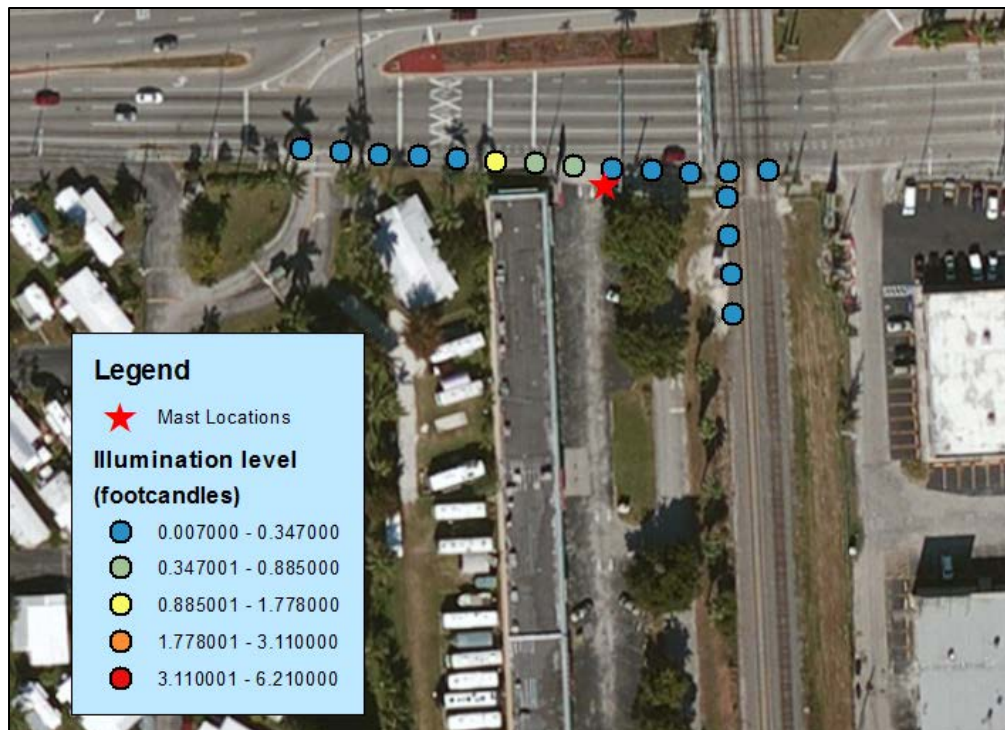
Figure 5-13: Illumination Levels for Pembroke Park Site (1).

In addition to the speed data, it was determined that lighting levels would help determine if the area needed more street lights at night to make the area visible to drivers. A spot measuring sensor was used to collect the lighting level at the five sites. Figure 5-13 through Figure 5-17 show the illumination levels close to the crossing. The illumination scale is in foot-candles.
