# Instrumentation of the US Grant Bridge for Monitoring of Fabrication, Erection, In-Service Behavior, and to Support Management, Maintenance, and Inspection

*Prepared by:*  
Arthur Helmicki and Victor Hunt  
University of Cincinnati

*Prepared for:*  
The Ohio Department of Transportation,  
Office of Statewide Planning & Research

*Final Report*

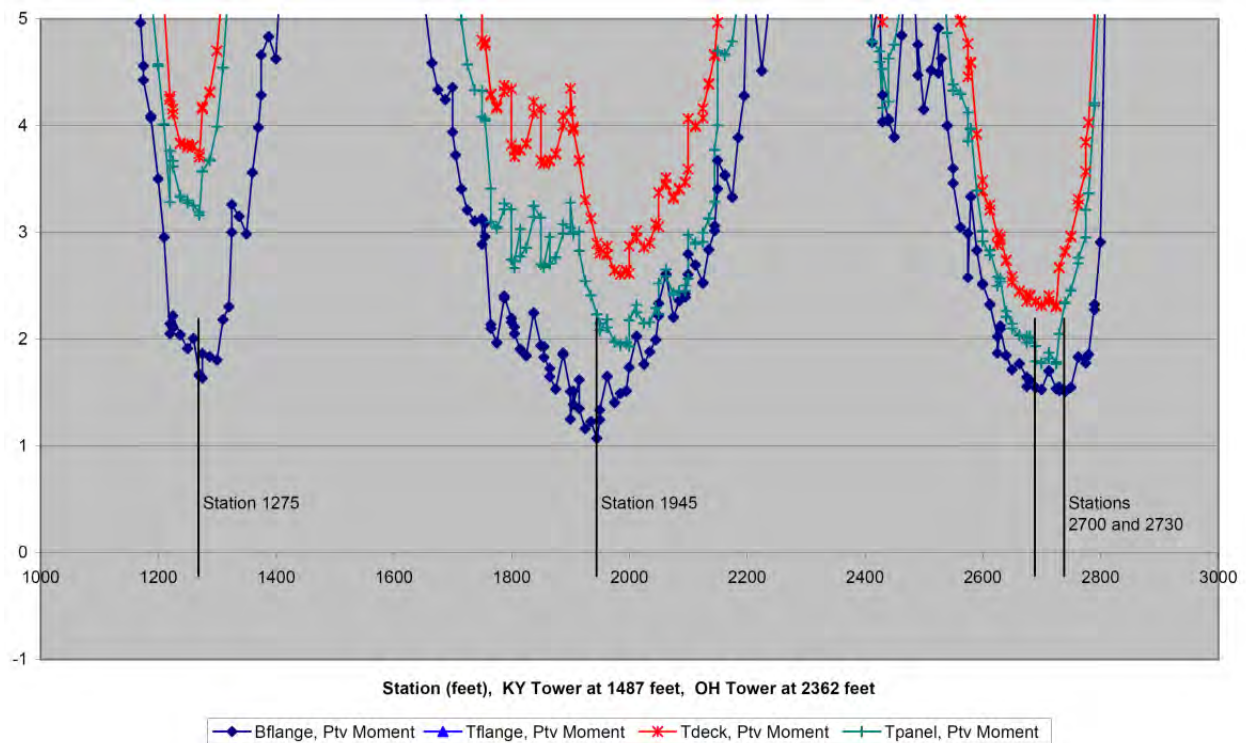
Figure 3.2: Allowable Stress Rating +M Live Load (Hunt, 2005)

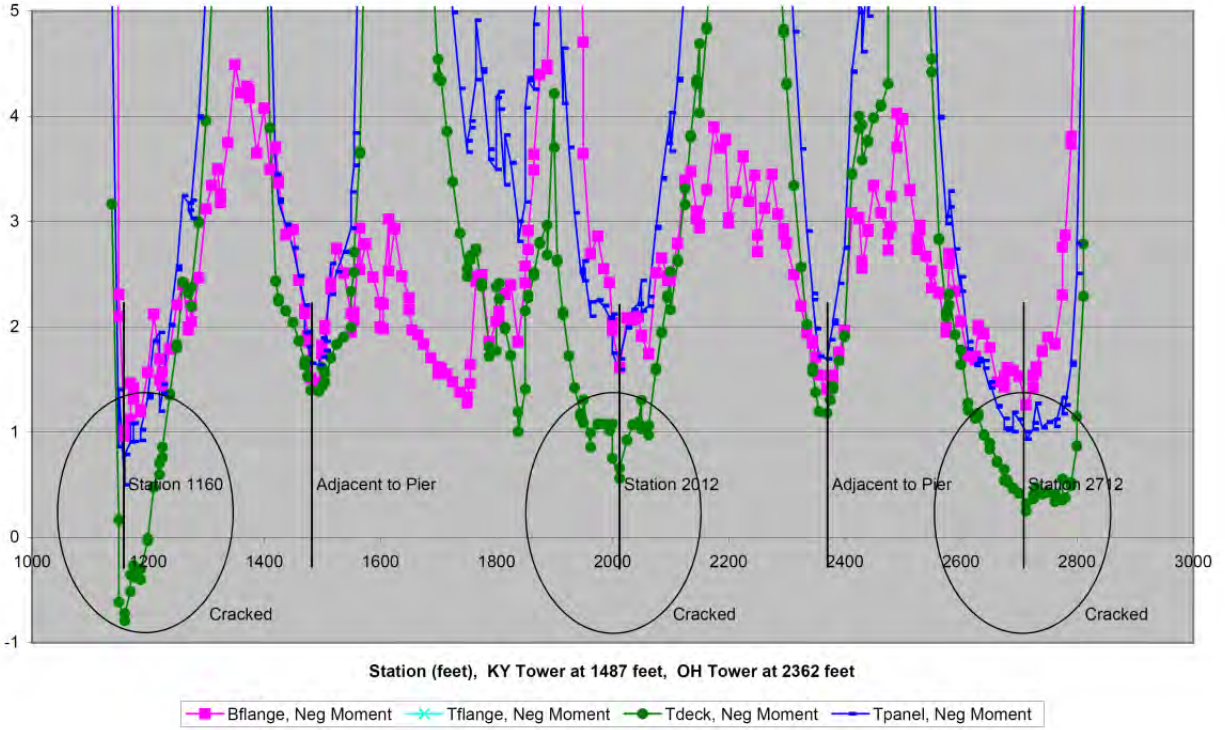
Figure 3.3: Allowable Stress Rating -M Live Load (Hunt, 2005)

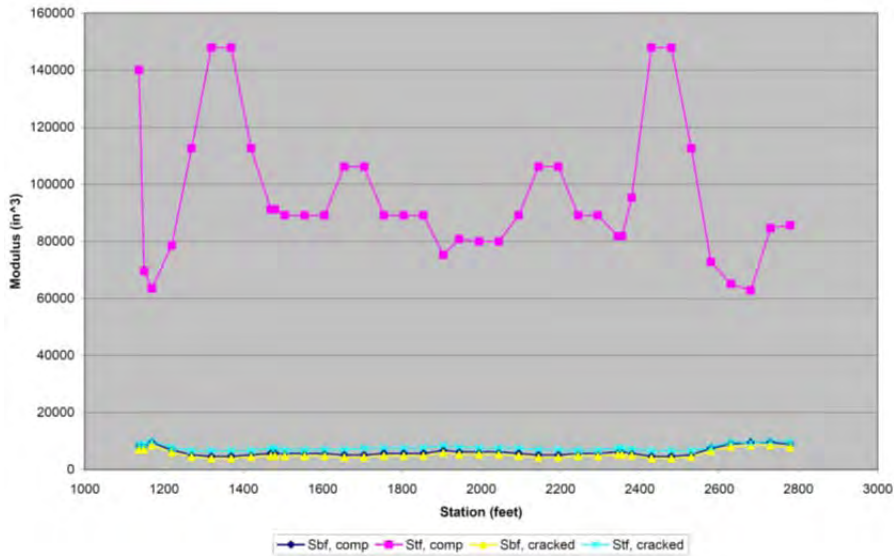
Figure 3.4: Section Modulus for a Cracked or Non-Composite Section (Hunt, 2005)

For a “cracked” or non-composite section, the sectional modulus for the top flange to resist bending, and the sectional area to resist axial force, were greatly reduced (Figures 3.4 and 3.5, respectively) [5, 2]. This dramatically increased the stress in a section for a given moment and axial load, and decreased the capacity to the girder alone. Further, the top flange extended to only one side of the girder’s web and failed the compactness test [10.48.1.1a, 1]; hence, the yield moment for the top flange was considered as the ultimate capacity in the case of negative moment.

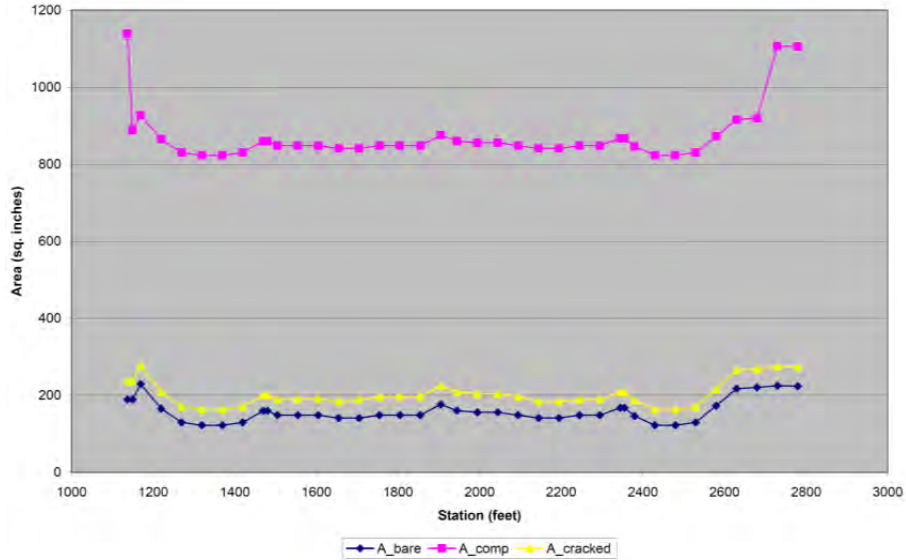
Figure 3.5: Section Area for a Cracked or Non-Composite Section (Hunt, 2005)

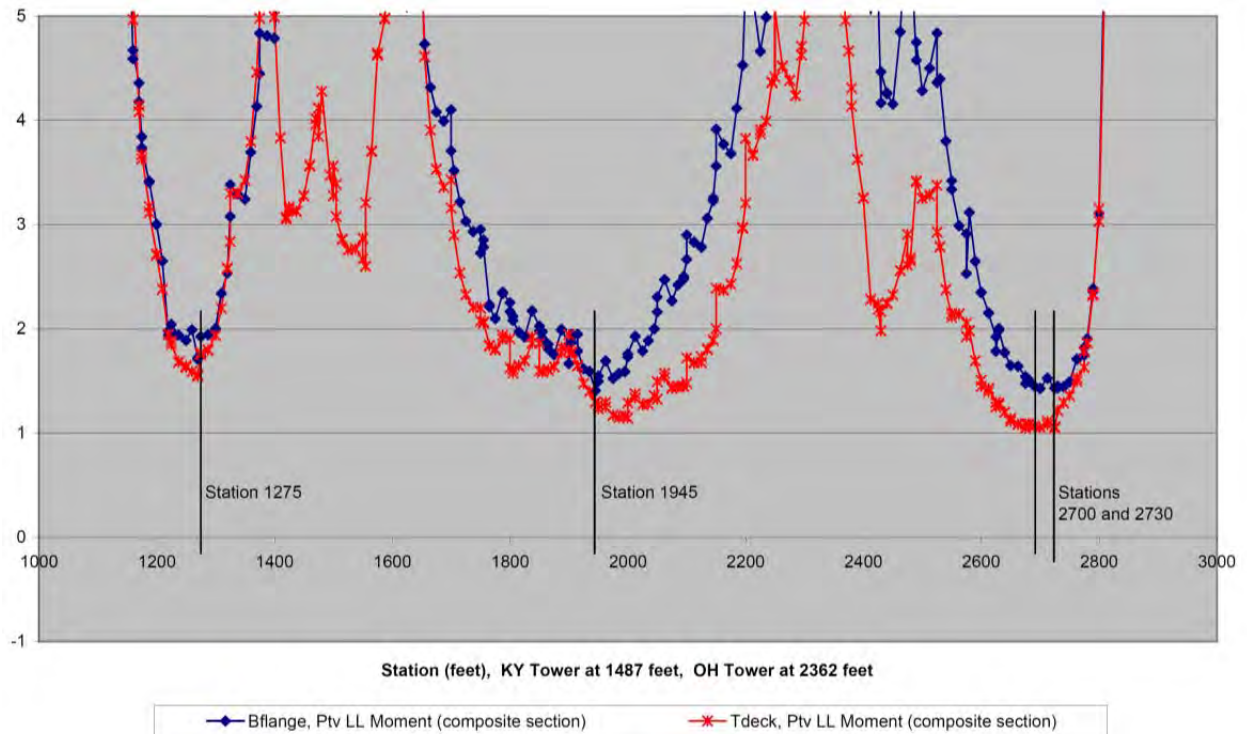
Figure 3.6: Load Factor Rating +M Live Load (Hunt, 2005)

Load factor rating of the exterior girder section identified three minima of concern in terms of positive moment (Figure 3.6) and five in terms of negative moment (Figure 3.7). Note that axial force was not considered in deriving the load factor rating. The section was assumed to act composite in positive moment and “cracked” or non-composite in negative moment. The derived results corresponded to each span and pier of the structure.

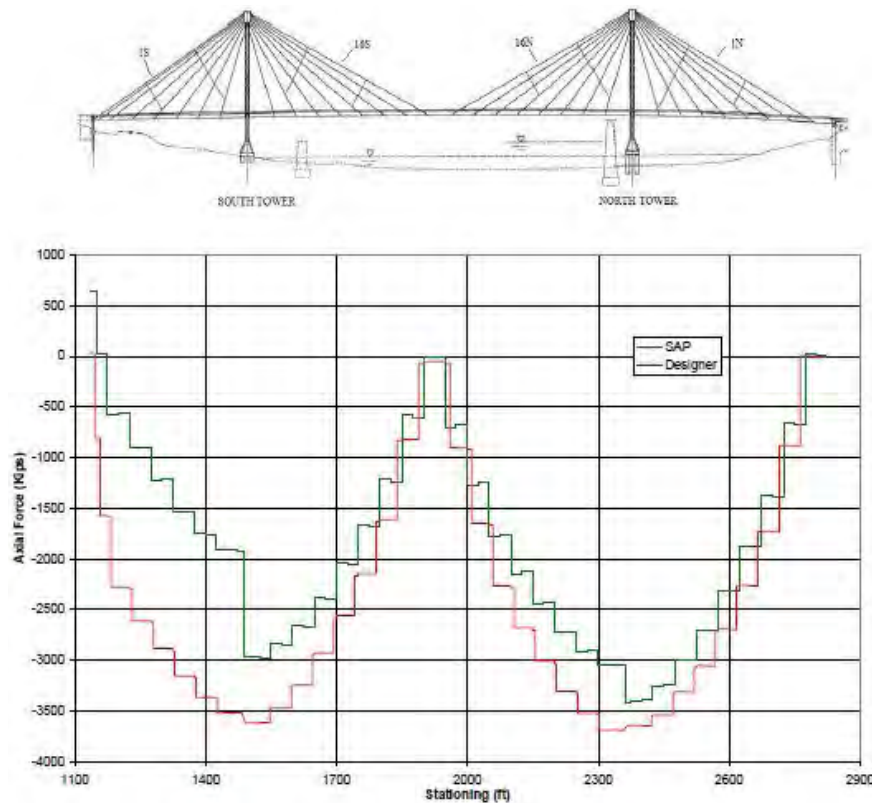
Figure 4.5 Axial Force Diagram for Longitudinal Girder

From the axial force diagram in Figure 4.5, it was observed that although the response from the conducted SAP2000 analysis followed the profile predicted by the designer, the numbers did not match. The difference in the results was higher on the Kentucky side (South Tower) as compared to the Ohio side (North Tower). The shear force diagram's profile of Figure 4.6 also showed some variations, especially at the forty-six Kentucky abutment, while for the bending moment response, variations occurred at the Kentucky abutment, near South and North towers, and near the closure segment in the middle of the bridge.

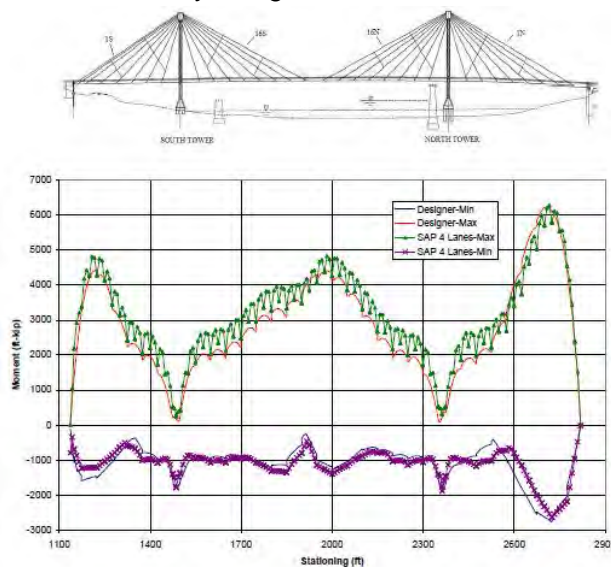
Figure 4.8 Bending moment envelope for Truck Load

Figures 4.8 and 4.9 show the moment response envelope for an edge girder for the truck load and lane responses, wherein the four lanes' load responses from the SAP2000 analysis were compared with the designer's responses. It was observed that slight discrepancies occurred at few locations, which were attributed to the modeling assumptions both by the designer and in the analysis. Also, an equivalent moving load analysis (Saini 2007) was developed to compute strain profile for the longitudinal girders at the end of bridge construction. The strain profiles acted as an indicator of available safety margins.

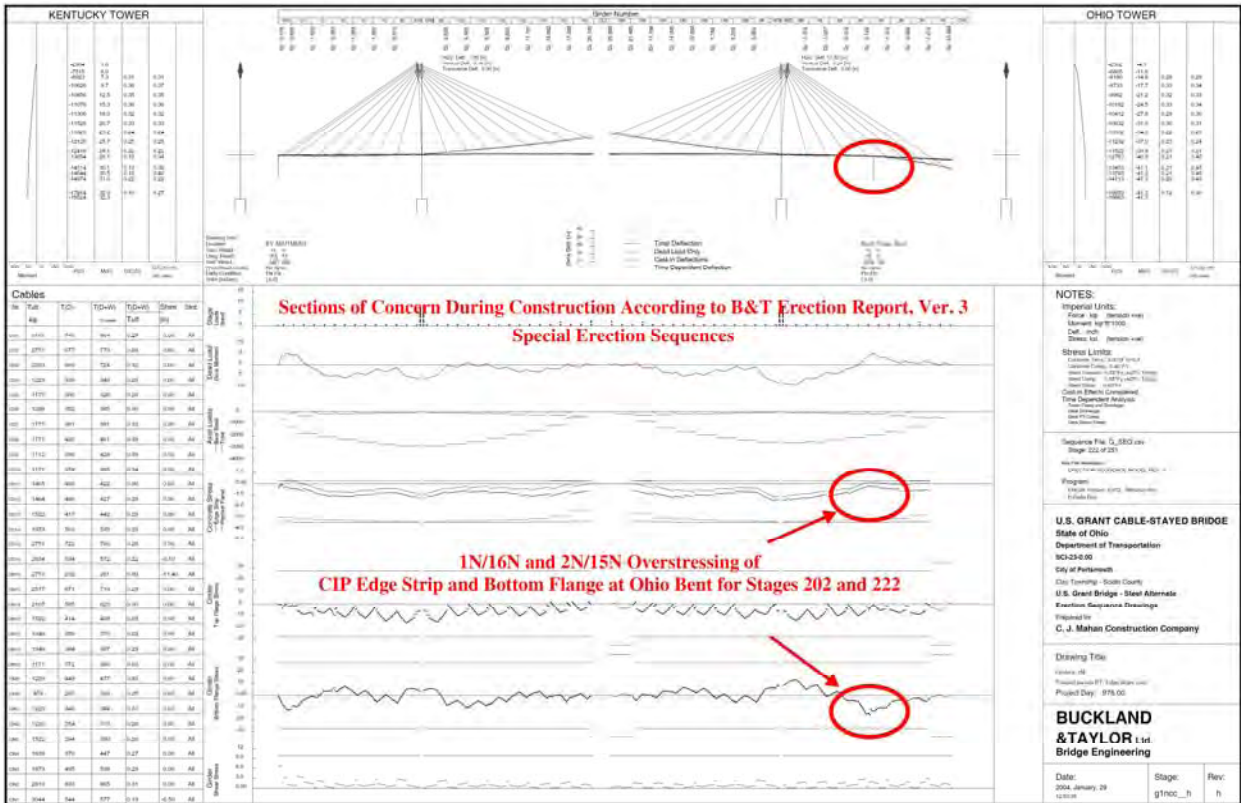
Figure 5.1: Overstress Concerns, Construction Stage 222 of 251, Segment 4N (B&T, 2004)

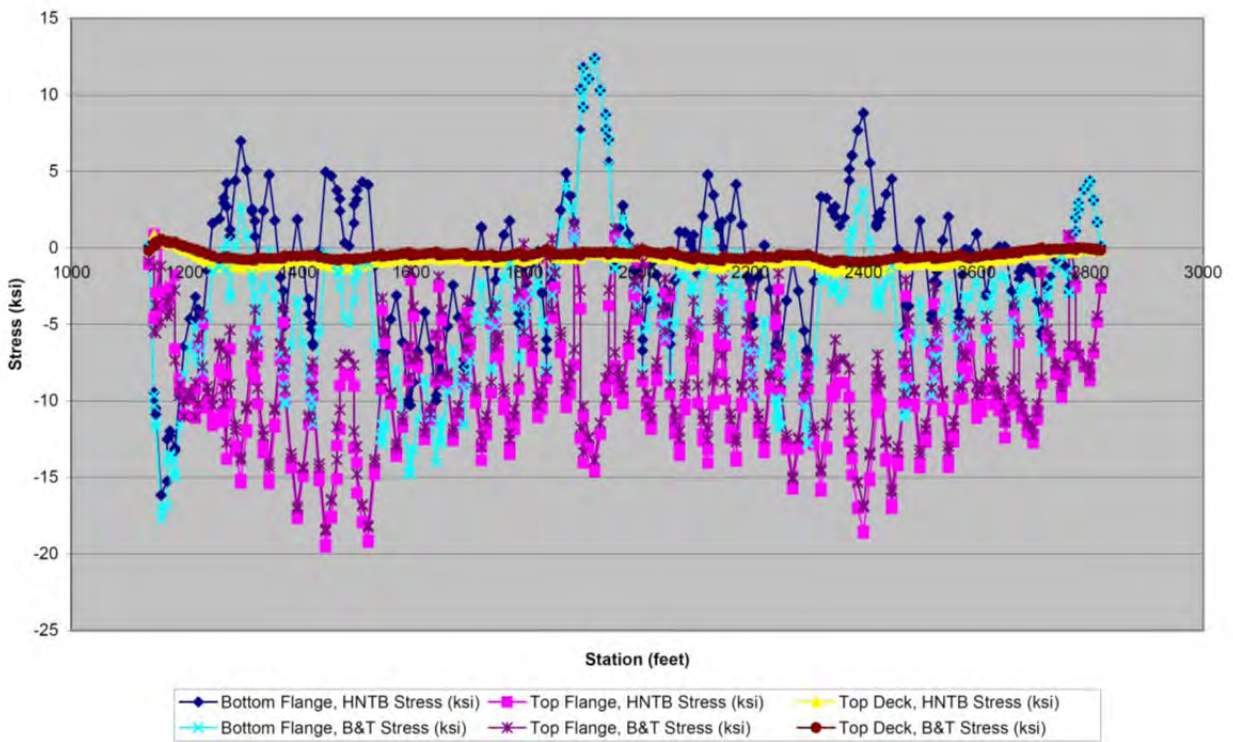
Figure 5.4: Deadload Stress using Two Values for Effective Width, USG (UCII, 2004)

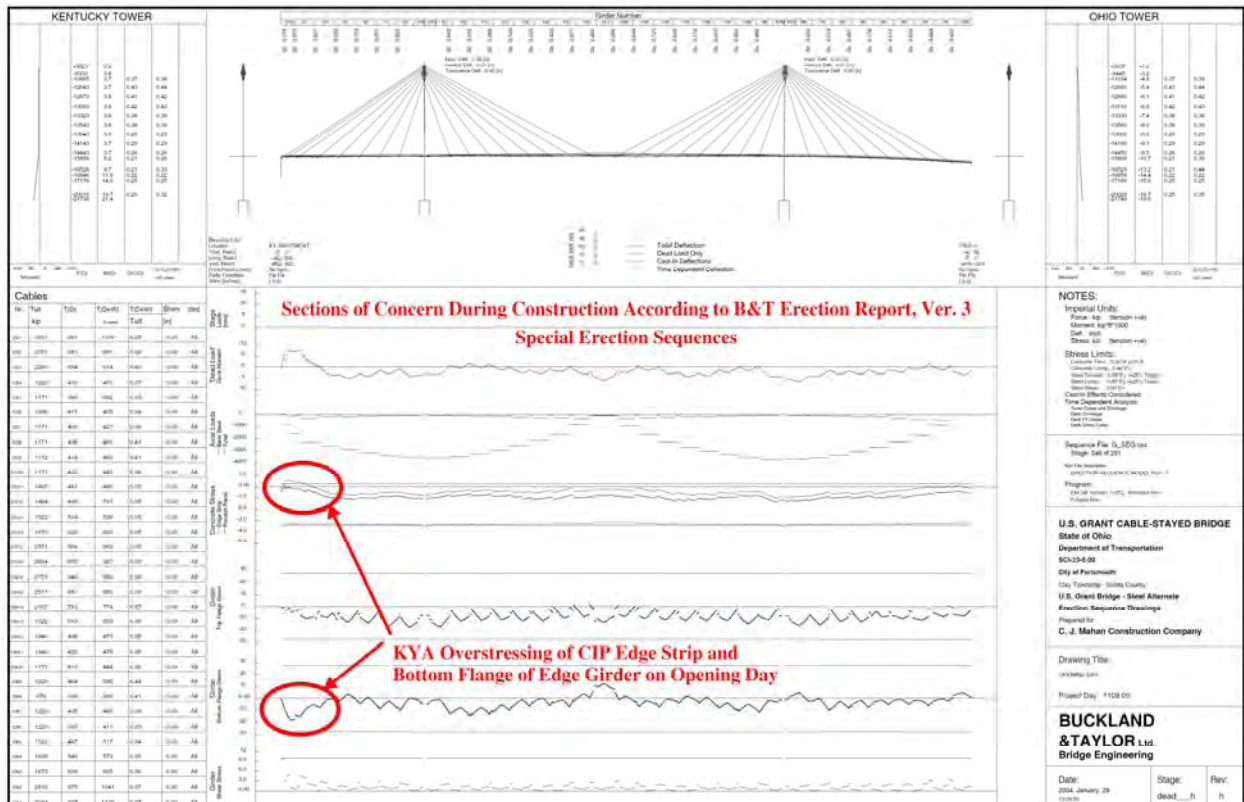
Figure 5.5: Overstress Concern from Pulldown, Segment 2S, USG (B&T, 2004)

One conclusion that was clear from any analysis of this structure was a concern regarding the ultimate effect and response due to the pulldowns at the Kentucky abutment (see Figure 5.5).

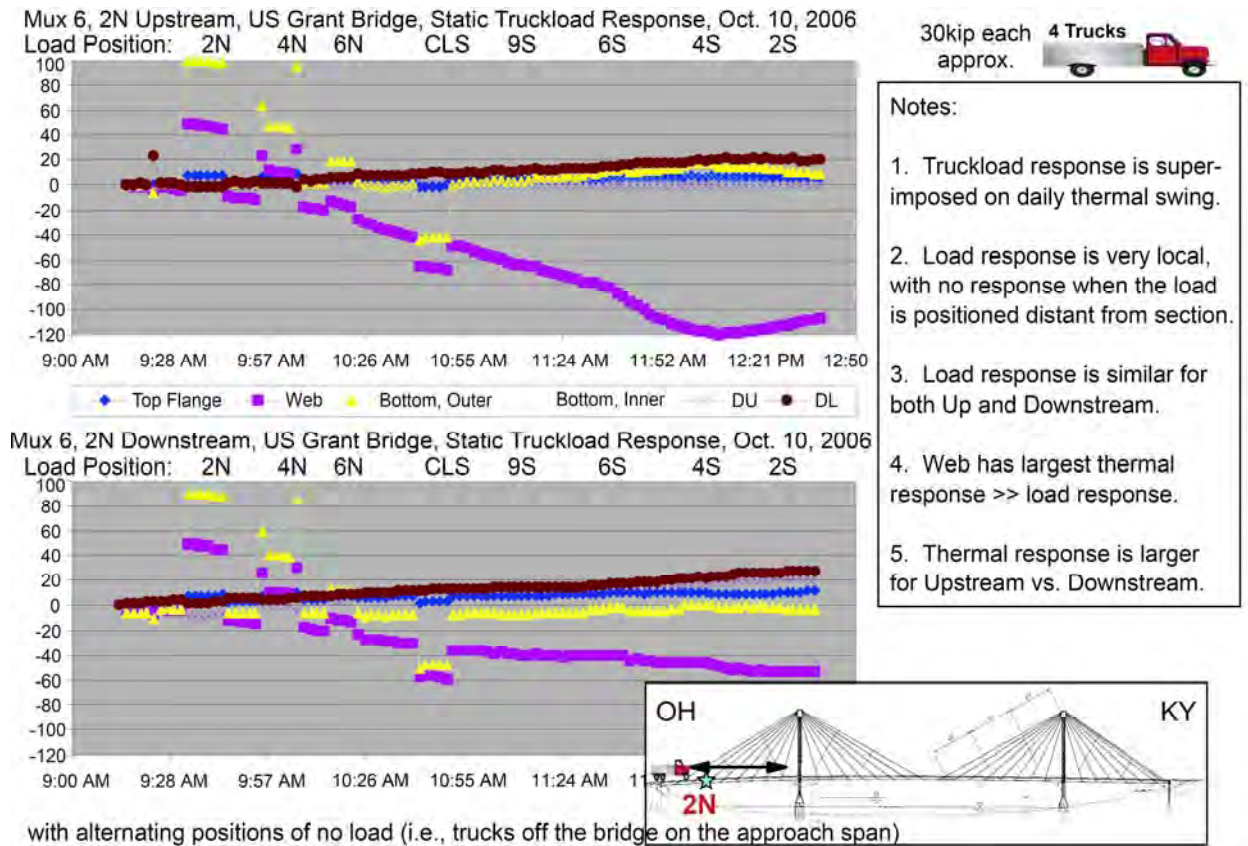
Figure 6.6: Static Truckload Results, Station 2N, USG, 2006 (UCII, 2007)

#### Example of Static Truckload Results: 2N, Upstream and Downstream

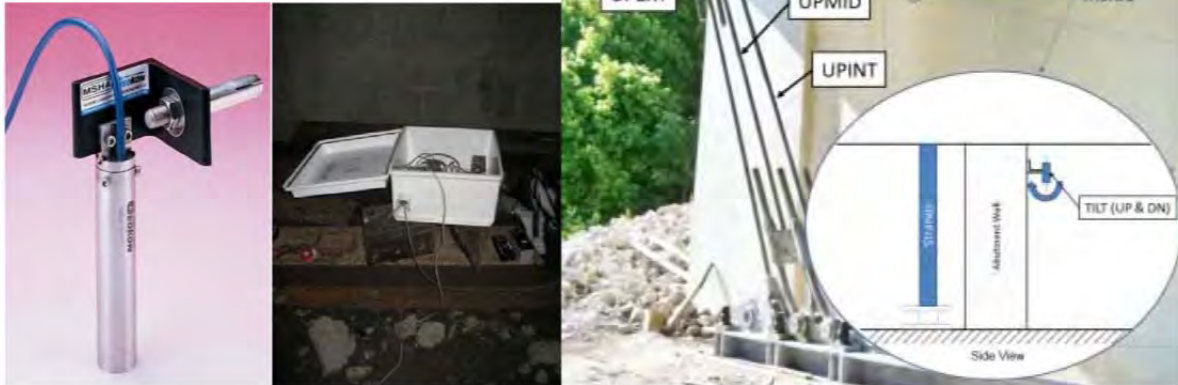
Figure 7.4: Tilt Meter on Abutment Wall, USG Bridge (UCII, 2012)

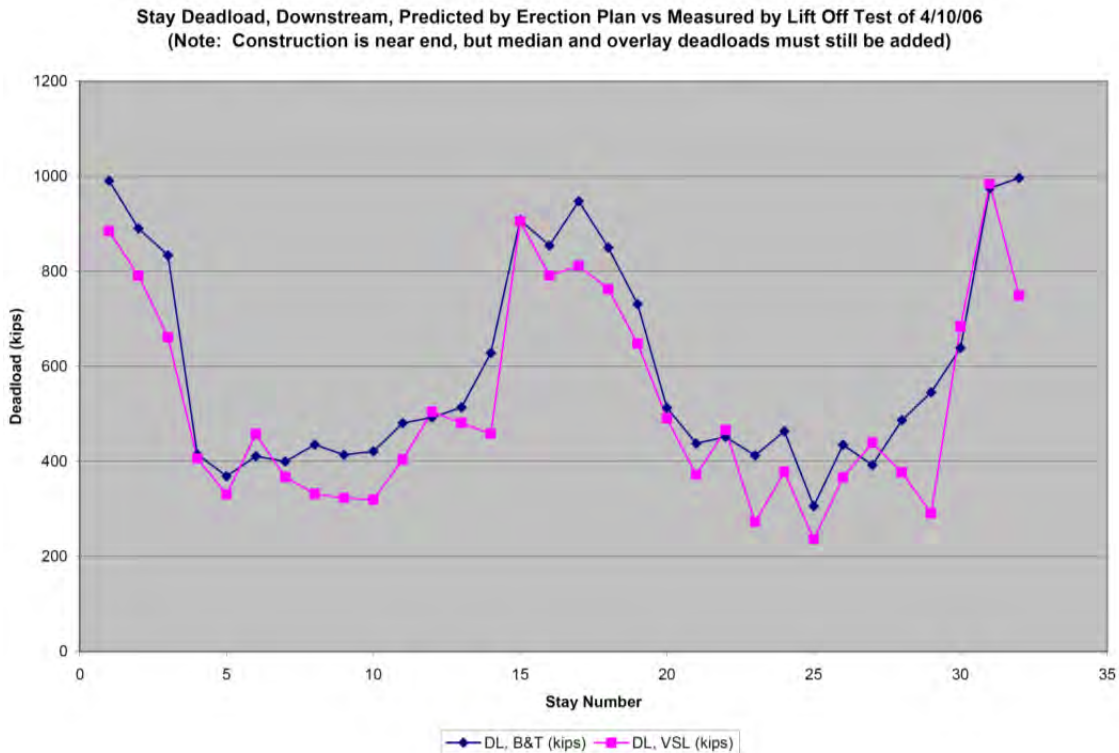
Figure 8.14: Differences between Erection Plan Estimates and Actual Test Results for Stay Deadload Force, US Grant Bridge (UCII, 2006)

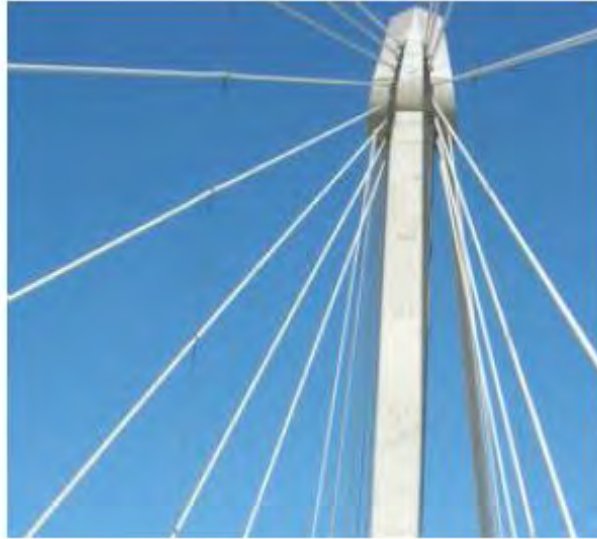
Figure 9.2: US Grant Stay Cable with Helical Surface Treatment and Cross-ties

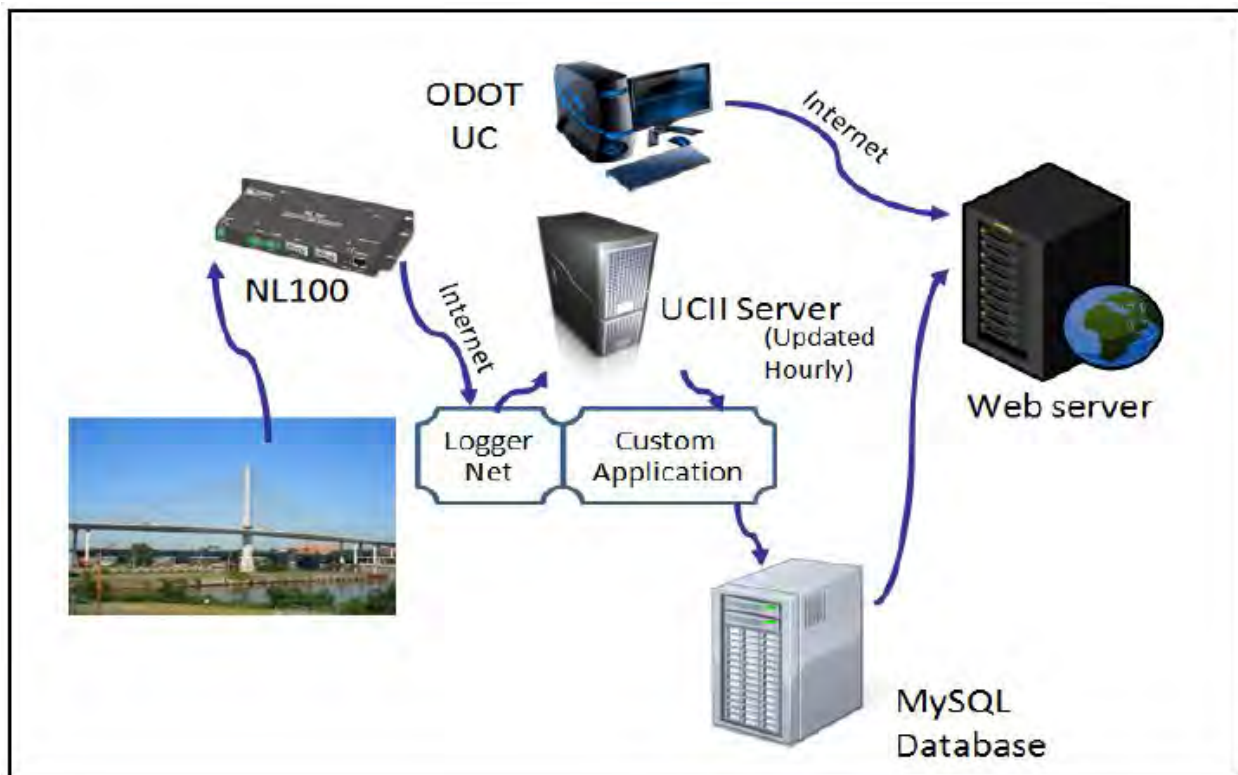
Figure 11.1: Complete Monitor System Diagram
