# **IN-PLACE VOIDS MONITORING OF HOT MIX ASPHALT PAVEMENTS: FOLLOW-UP**

**COLORADO DEPARTMENT OF TRANSPORTATION  
DTD APPLIED RESEARCH AND INNOVATION BRANCH**

1. Report No. CDOT-2013-19	2. Government Accession No.	3. Recipient's Catalog No.	
4. Title and Subtitle IN-PLACE VOIDS MONITORING OF HOT MIX ASPHALT PAVEMENTS: FOLLOW-UP		5. Report Date January 2014

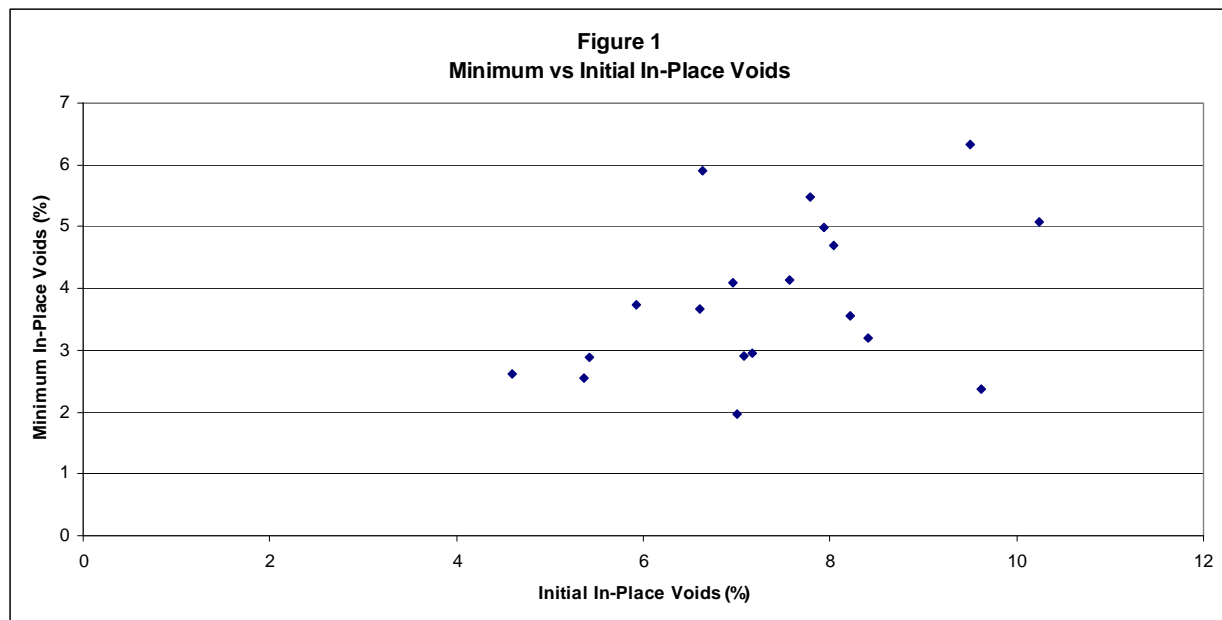
Figure 1 shows the relationship between the minimum and the initial in-place voids. The final minimum in-place voids are generally higher when the initial voids are high, but the correlation is not strong. Even if the initial in-place voids are high, roadways (especially those with heavy traffic) can experience a significant drop in voids. Since it is unreasonable to expect in-place voids to increase over time, the minimum in-place voids sometime during the monitoring period was selected as a variable for this graph as opposed to the latest value to avoid the few cases where the in-place voids went up in subsequent years. The increase in voids over time could be a reflection of the variability of the sampling methodology or the existence of an overlay unknown to the author.

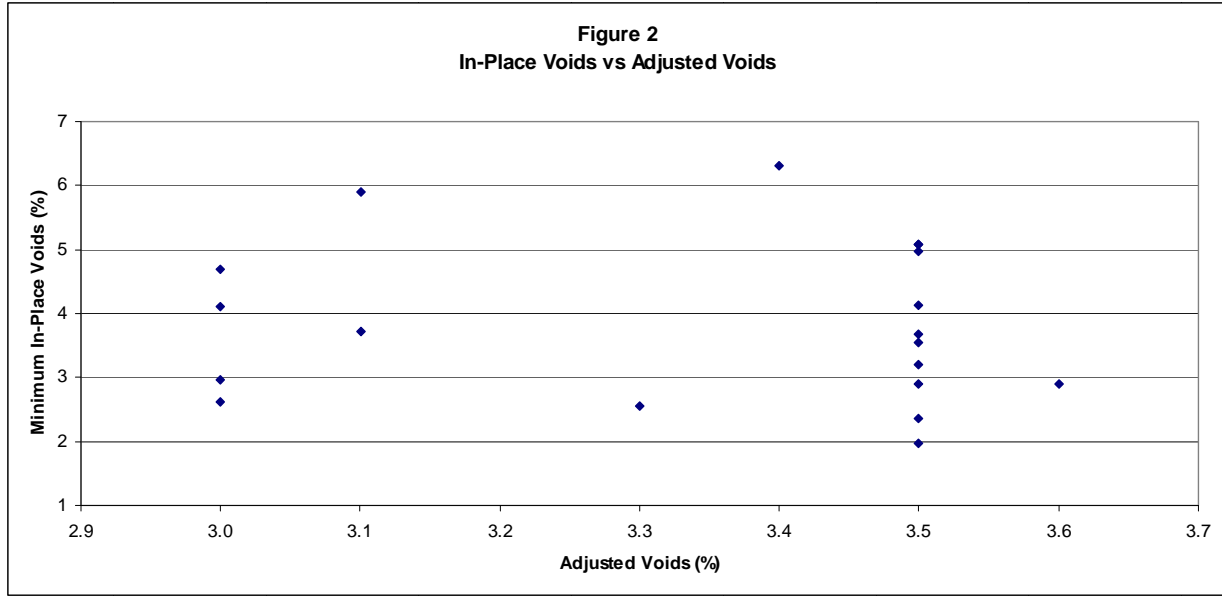
Figure 2 shows the relationship between in-place voids and adjusted voids. All but one of the projects were built with an adjusted voids of 3.0 to 3.1 percent or 3.4 to 3.6 percent. In either case, a broad range of in-place voids resulted. Within the range normally used, there does not seem to any correlation between in-place voids and adjusted voids.

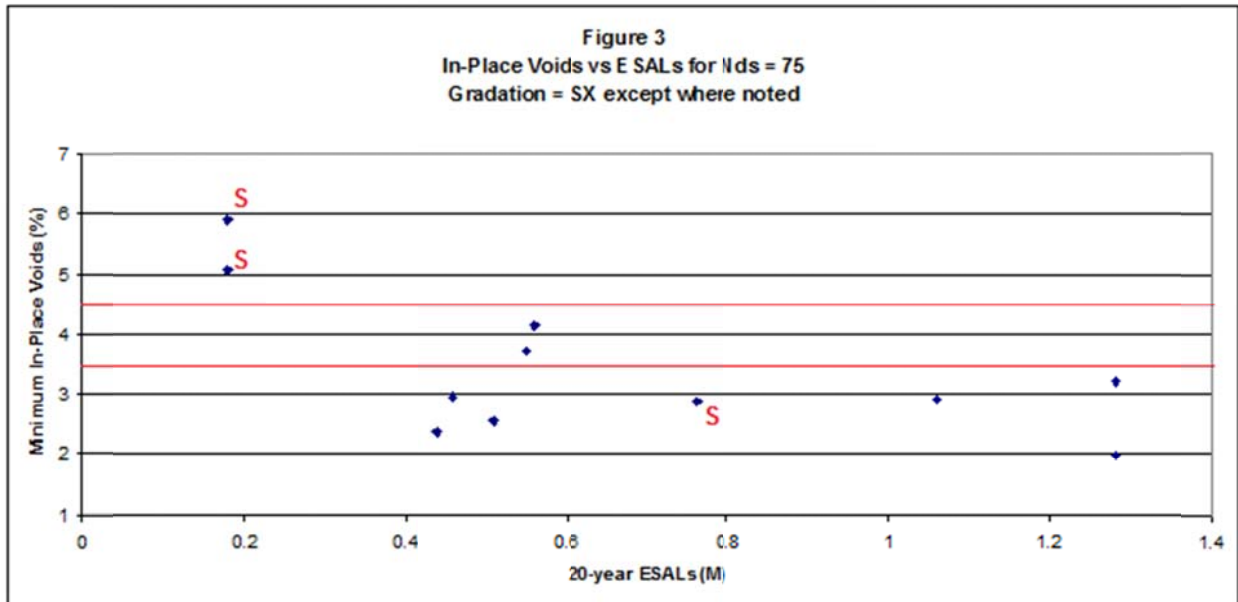
The following two graphs show the relationship between in-place voids and pavement loading. Figure 3 shows the data for projects that used a medium compaction effort ( $N_{ds} = 75$ ) for the mix design and Figure 4 shows the data for those projects that used a high compaction effort ( $N_{ds} = 100$ ) for the mix design. Gradation was also noted on these graphs to explore whether it is an issue in achieving appropriate in-place voids.

For the  $N_{ds}$ -75 projects, in-place voids generally go down with higher traffic loading. For the two pavements with the light traffic, the in-place voids remained above 5.5%. Because of the low traffic, this is probably not a problem, but the pavement could be subject to weathering and raveling. On the other extreme, the one pavement with high traffic loading had in-place voids go below 2% and because of the heavy traffic, may be subject to rutting, shoving, and bleeding. All but three of these  $N_{ds}$ -75 projects used a grading SX. Two of the three projects that used grading S had in-place voids that were too high, while the third had in-place voids that were too low. These 11 projects had average in-place voids of 3.4 %, which is slightly below the design range of 3.5% to 4.5%. Further only two of the 11 projects had in-place voids within the laboratory design range.

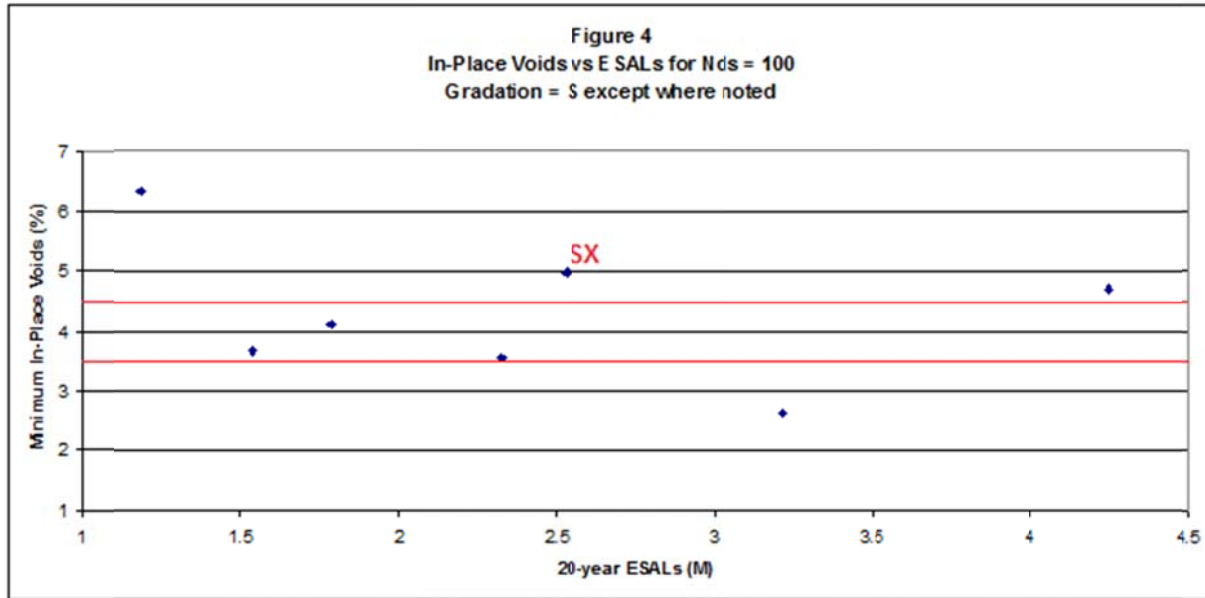
The graph of  $N_{ds}$ -100 projects does not seem to reveal any correlation between in-place voids and traffic loading (ESALs). Three of the projects had minimum in-place voids above the design range (3.5% to 4.5%), three of the projects were about right (in the design range), and one project had low in-place voids (2.6%). However, the average in-place voids of these seven projects was 4.3%, within the design range.

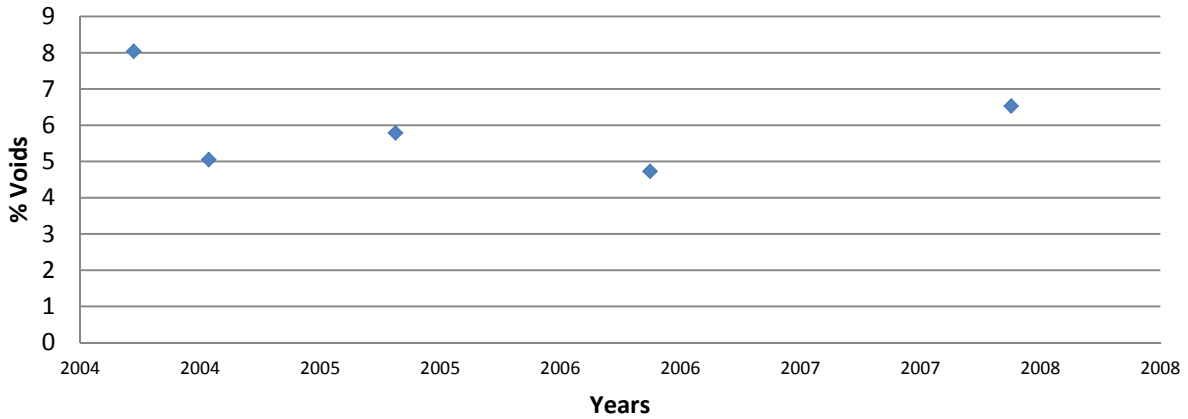
### 12287, US85-Santa Fe, Church to C-470

The in-place voids went down during the first year to around 5.0% due to substantial traffic loading (daily ESAL = 4.25M), but never got down below 4.5% (the maximum allowed for a mix design). This could be due to the voids in the overlay starting out high (8 %) combined with the aggressive compaction effort ( $N_{ds} = 100$ ) used in the design. In 2008 the in-place voids went up to 6.5% which is probably due to some undocumented overlay between 2006 and 2008. Due to this overlay, the rutting and cracking data are probably not relevant to the original overlay in 2003.

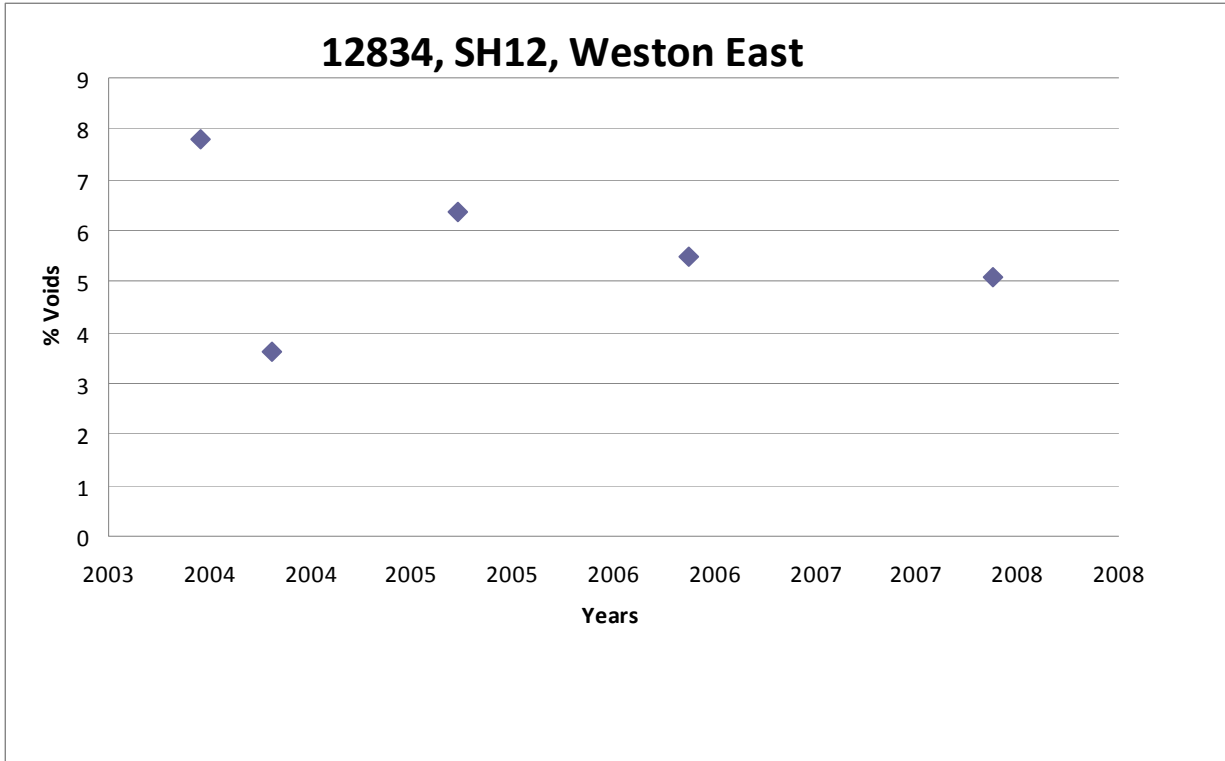
Aside from the 2004 data point, the in-place voids appear to go down over time in a uniform way. The fact that it took five years to reach final in-place voids is probably due to the low traffic loading.

Since there appears to be a problem with the 2004 data point, the 2008 data point was used as the “minimum in-place voids” for this project.

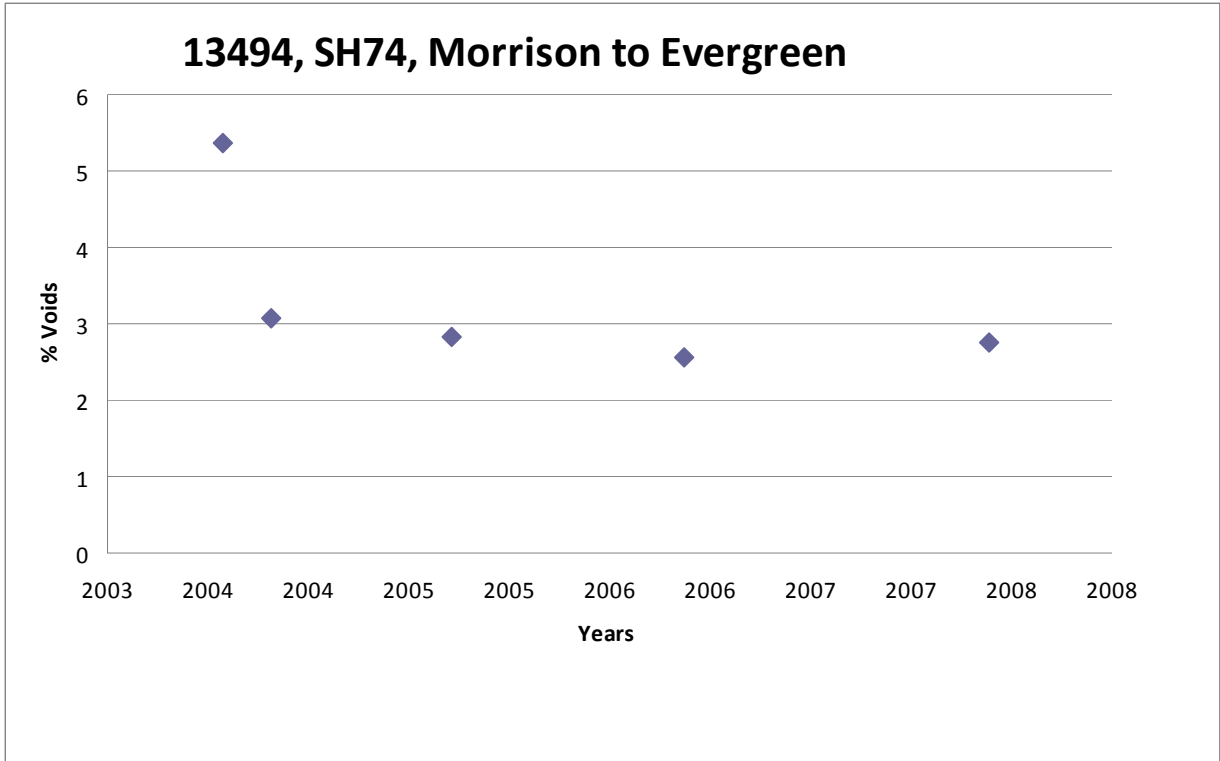
The pavement was constructed with in-place voids of 5.3% and pavement traffic loading after one year brought it down to just above 3% and on down to 2.6%.

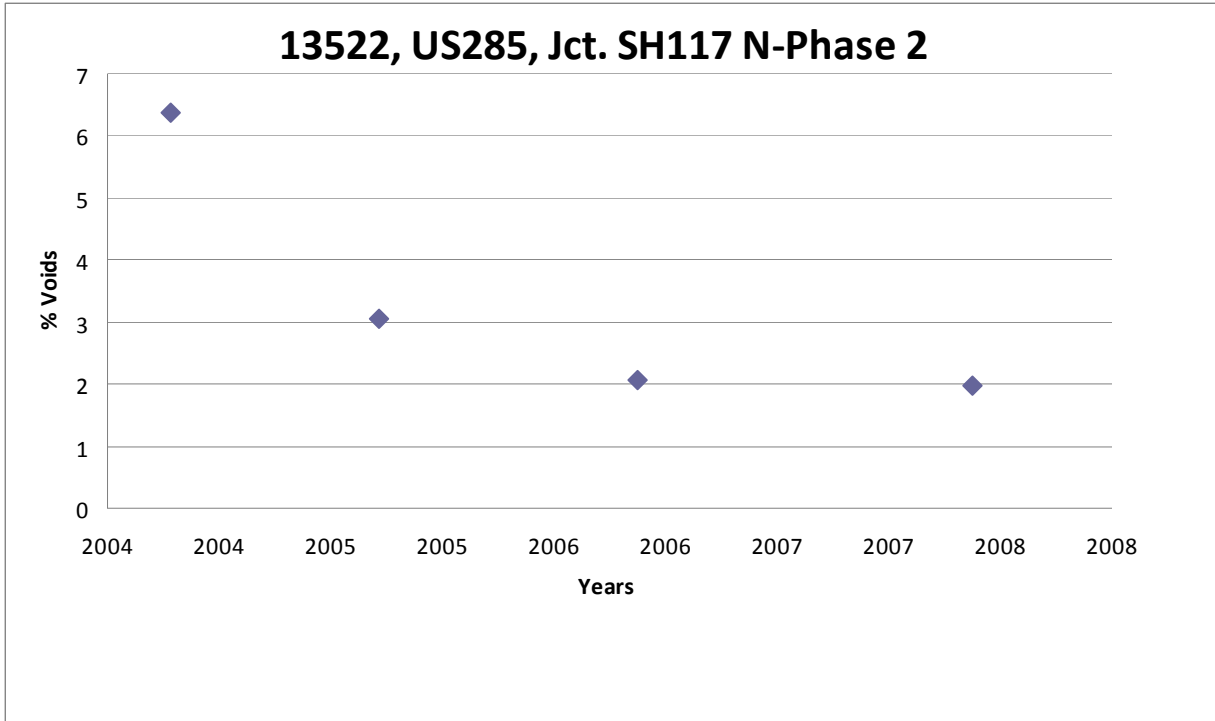
The in-place voids went down after the first year to around 3.0% due to traffic loading (daily ESAL = 1.28M). However, in-place voids went down further to 2.0% in 2006. But based on the modest rutting (0.13 in.), it appears that there is no rutting or shoving problem typically related to low voids.

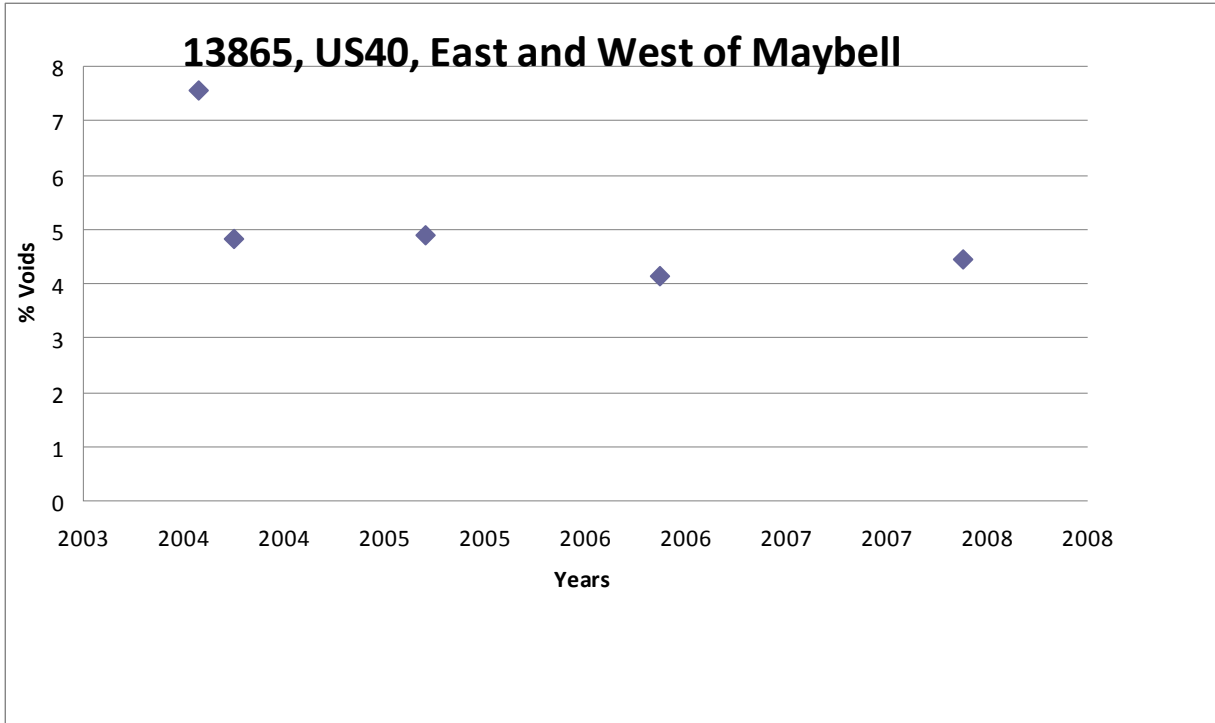
The pavement was constructed with in-place voids of 7.6% and dropped to just under 5.0% after a year of traffic. Long-term traffic compacted the pavement down to 4.4% in-place voids, the high end of the mix design requirement in the laboratory.

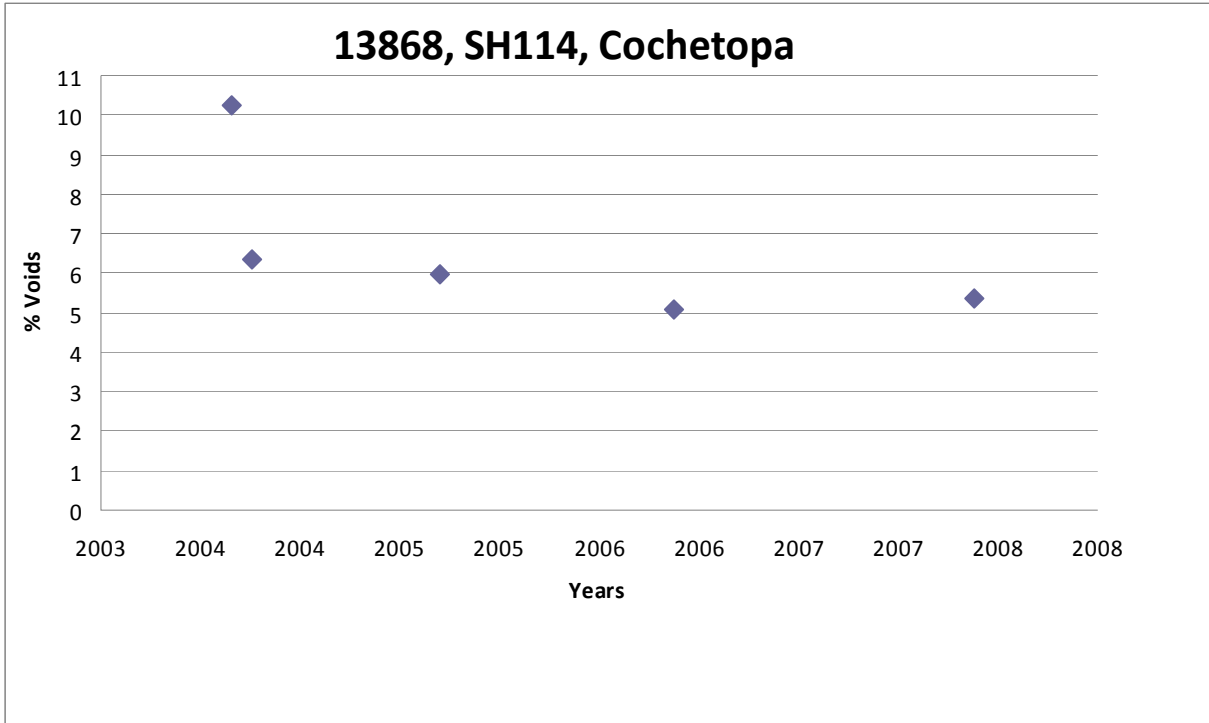
The pavement was constructed with in-place voids of 10.2% even though the AC content was increased to reduce the target in-place voids by 0.5%. The light traffic was able to compact the pavement to 6.0% in two years. Traffic compaction continued in later years but only resulted in in-place voids of about 5%. While rutting remains low after nine years, fatigue cracking appears to be becoming a problem. For this project, the flexibility for the Engineer to adjust the AC appears to be highly important. Maintaining the AC content corresponding to the higher design target voids would probably have resulted in early failure of the pavement.

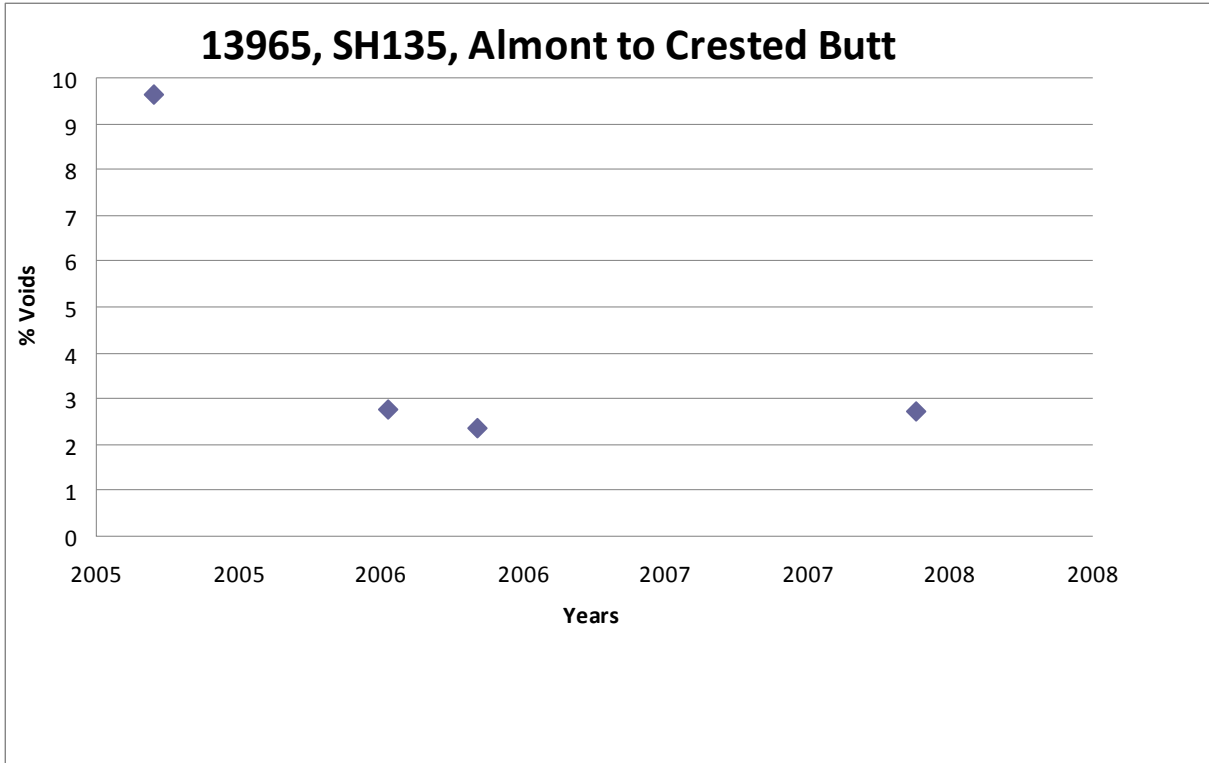
The in-place voids went down in the first year from 9.6% to around 3.0 % while the laboratory target value is 3.5%. It is not clear why the in-place voids over time went down to almost 2% with only light pavement loading. However, the condition did not seem to have an impact on pavement performance since the rutting was only 0.15 inches after nine years of service.

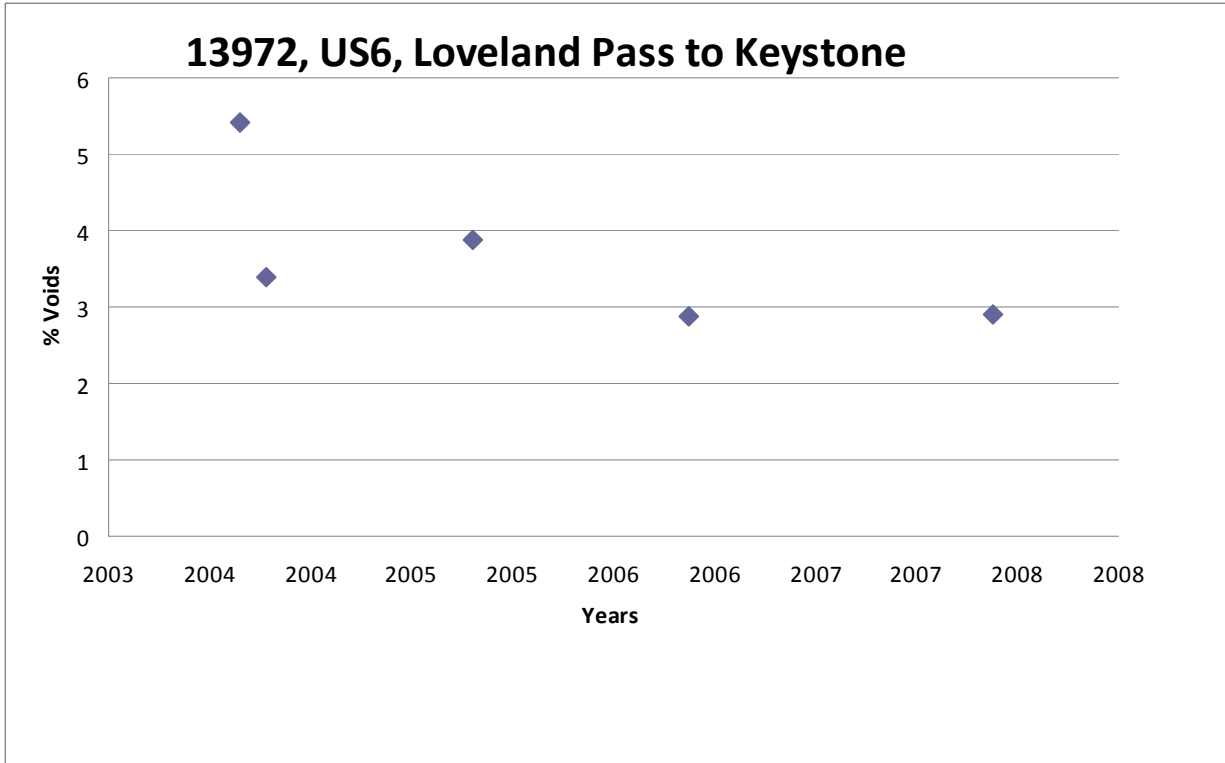
The pavement was constructed with in-place voids of 5.4% and pavement traffic loading over the years brought it down between 3 and 4%.

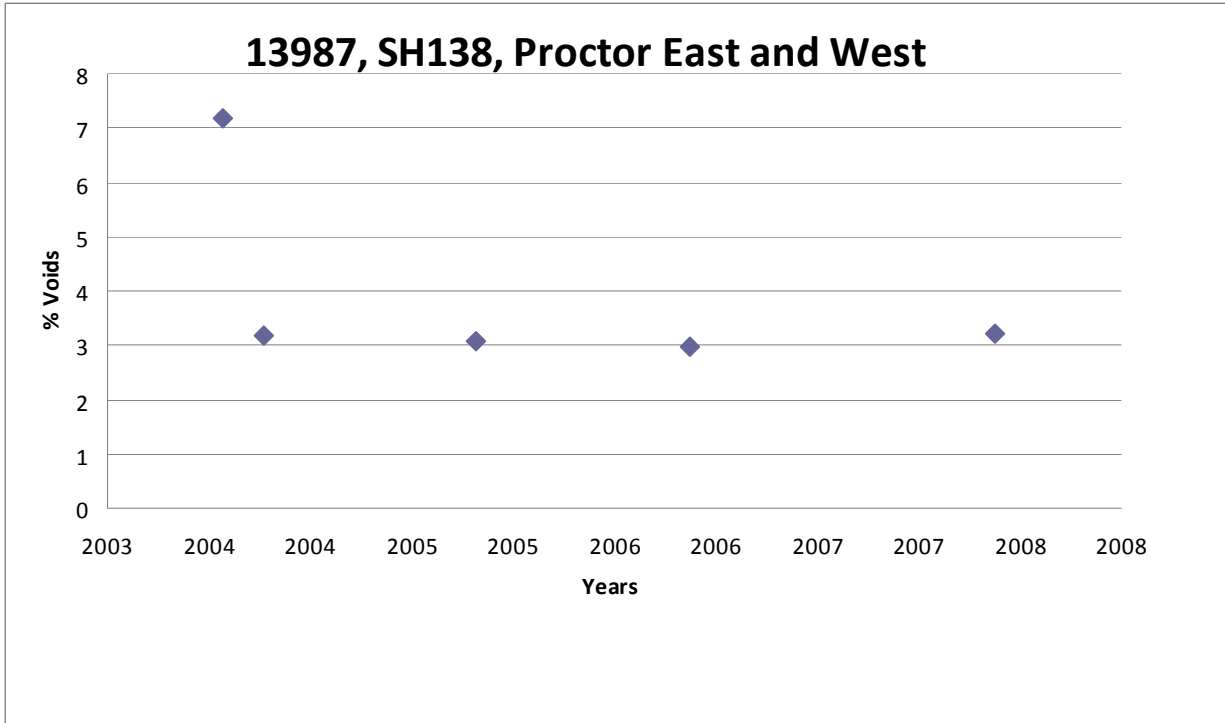
The in-place voids went down in the first year from 7.1% to close to the laboratory target value of 3.1% and remained stable. In this case, if the AC was not adjusted, the long-term in-place voids may have been closer to the ideal 4.0%

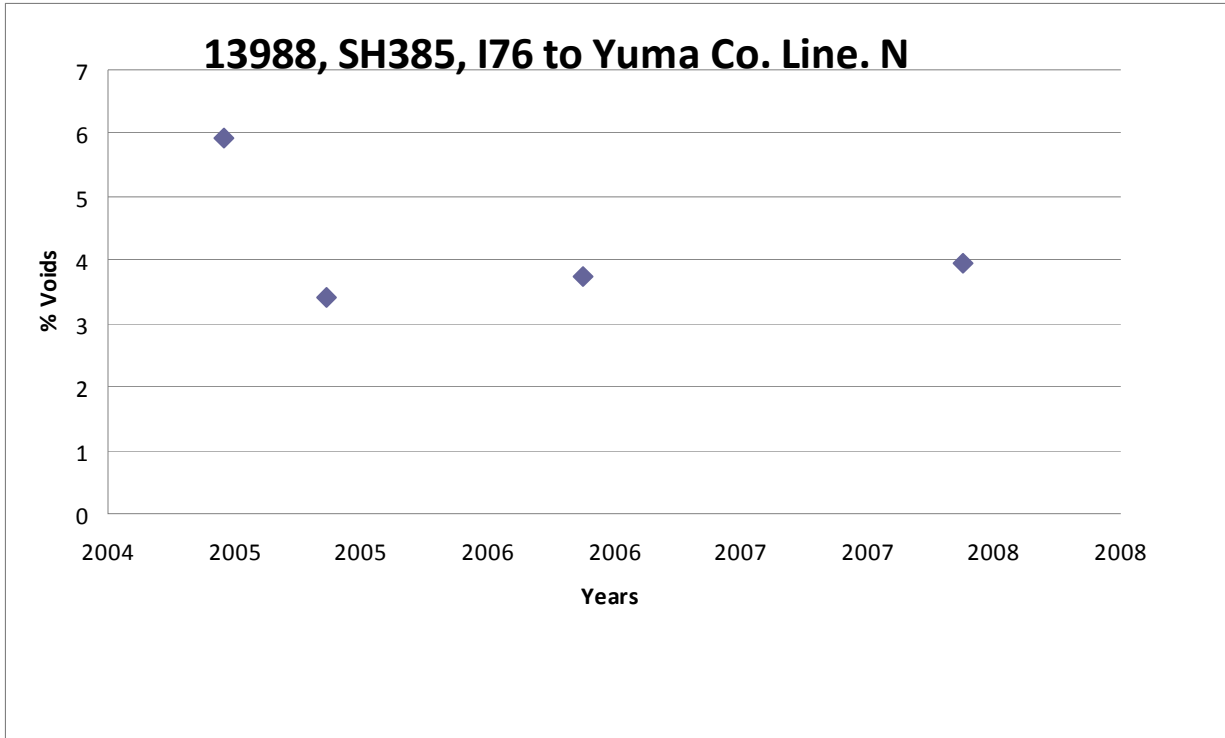
The in-place voids went down in the first year from 5.9% to within the laboratory design range of 3.5 to 4.5%. The pavement appears to have the ideal AC content.

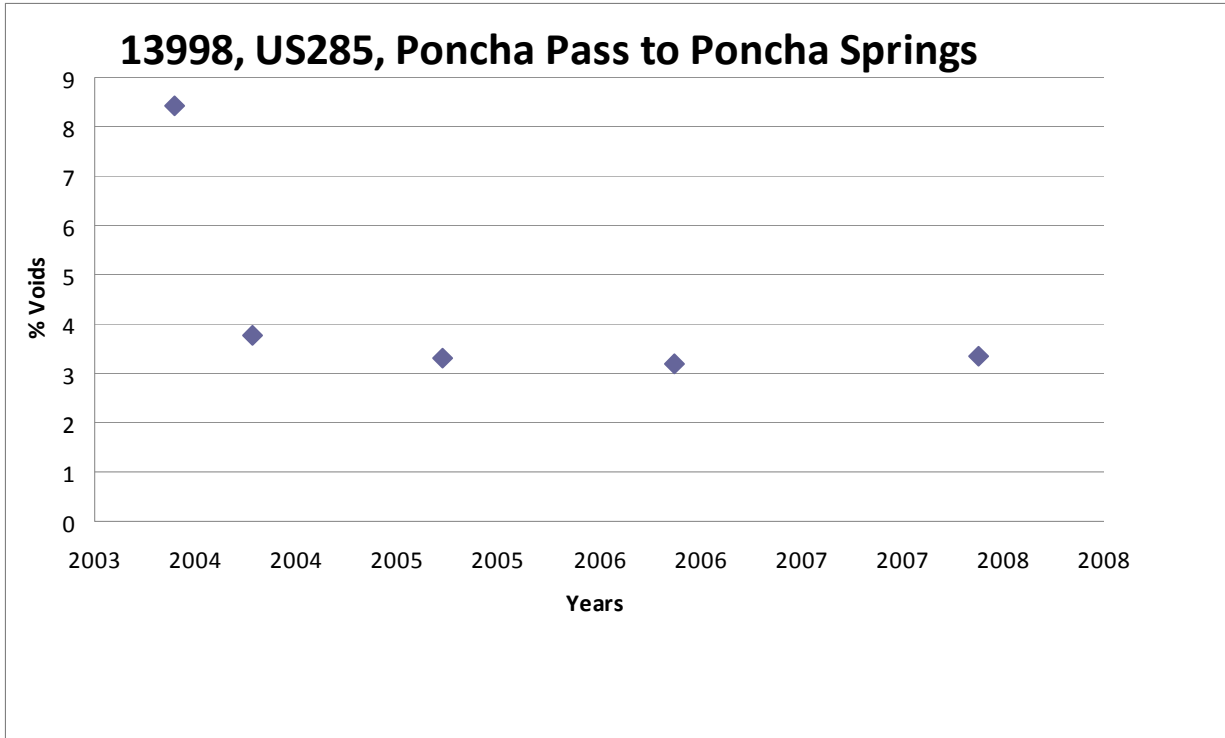
The in-place voids went down after to the first year to just below 4.0% and stayed above 3.0%. This is slightly below the design range (3.5% to 4.5%). But it should not be a problem and may be beneficial in the high-altitude environment.

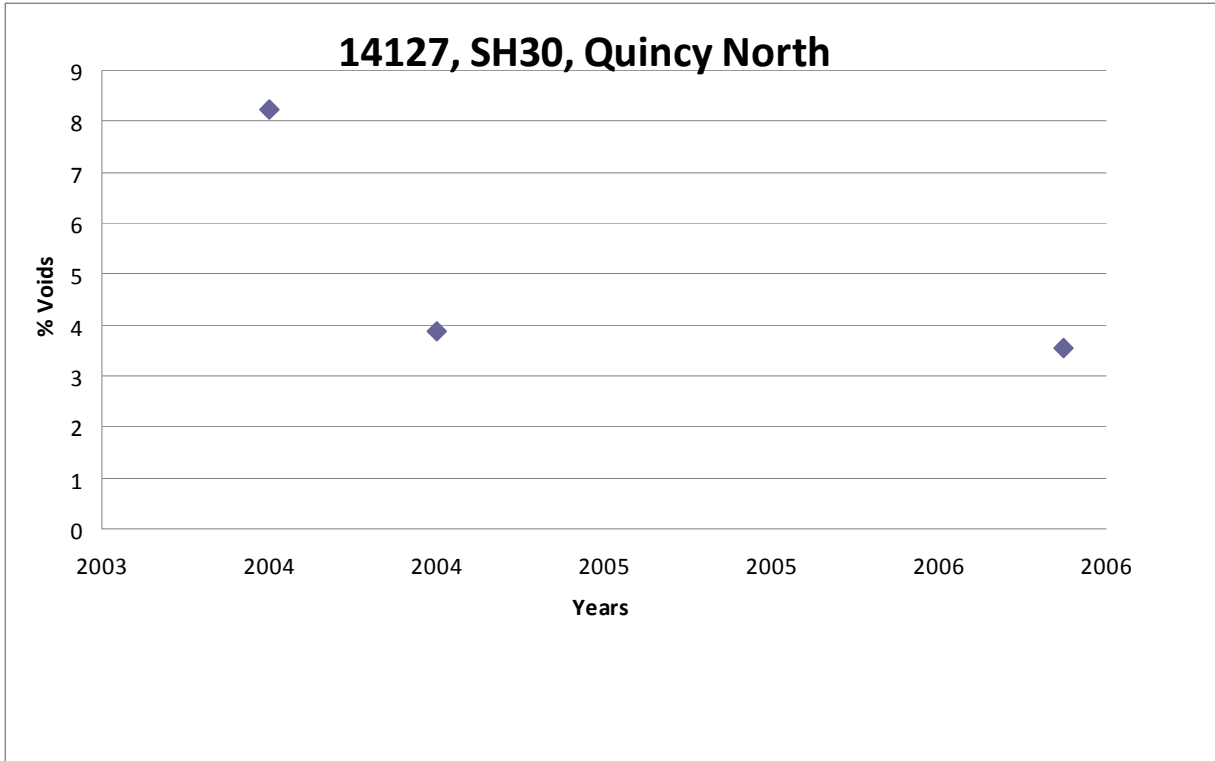
The pavement was constructed with in-place voids of 8.2% and dropped to below 4 % in one year. The AC content to reduce laboratory voids by 0.6% appears to have worked well, bringing the in-place voids within the design range (3.5% to 4.5%).

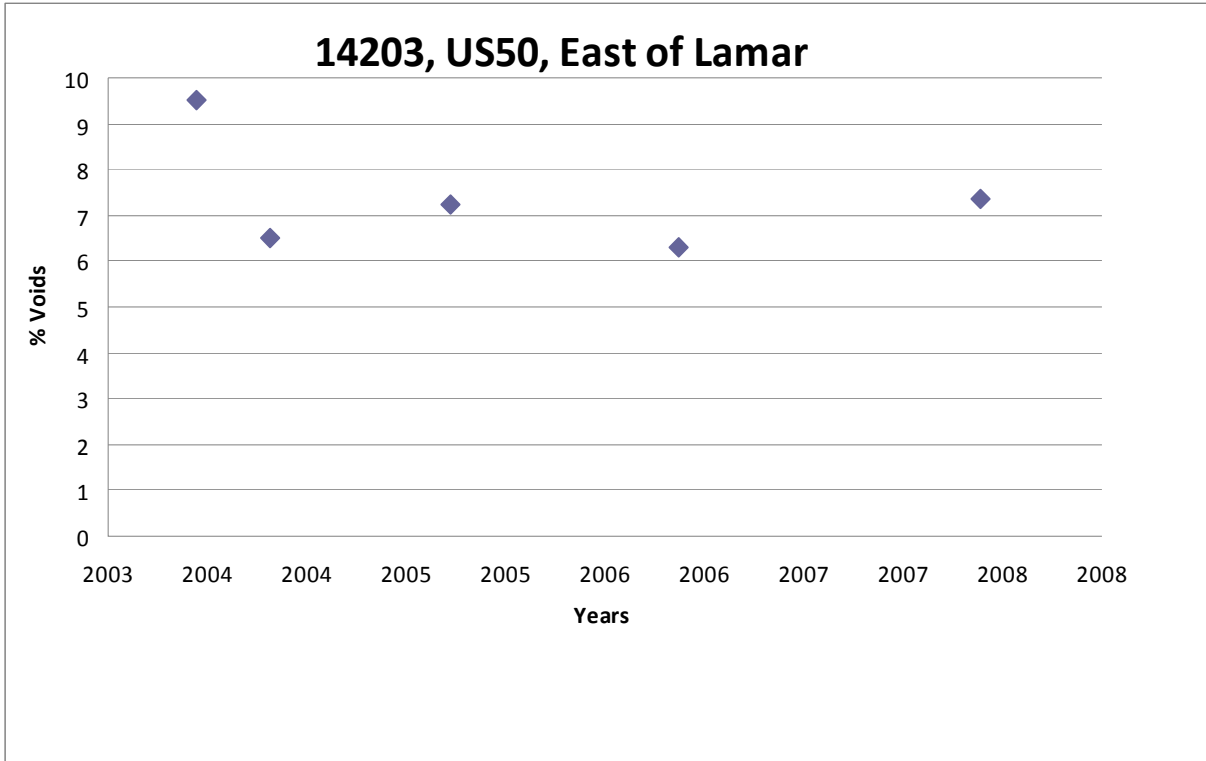
The pavement was constructed with in-place voids of 9.5% even though the AC content was increased to reduce the target in-place voids by 0.6%. The moderate pavement traffic was unable to reduce the in-place voids much below 6.0%. With a design based on a high compaction effort ( $N_{ds} = 100$ ) the moderate pavement loading (daily ESALs = 1.19) could not bring the in-place voids closer to the target value.

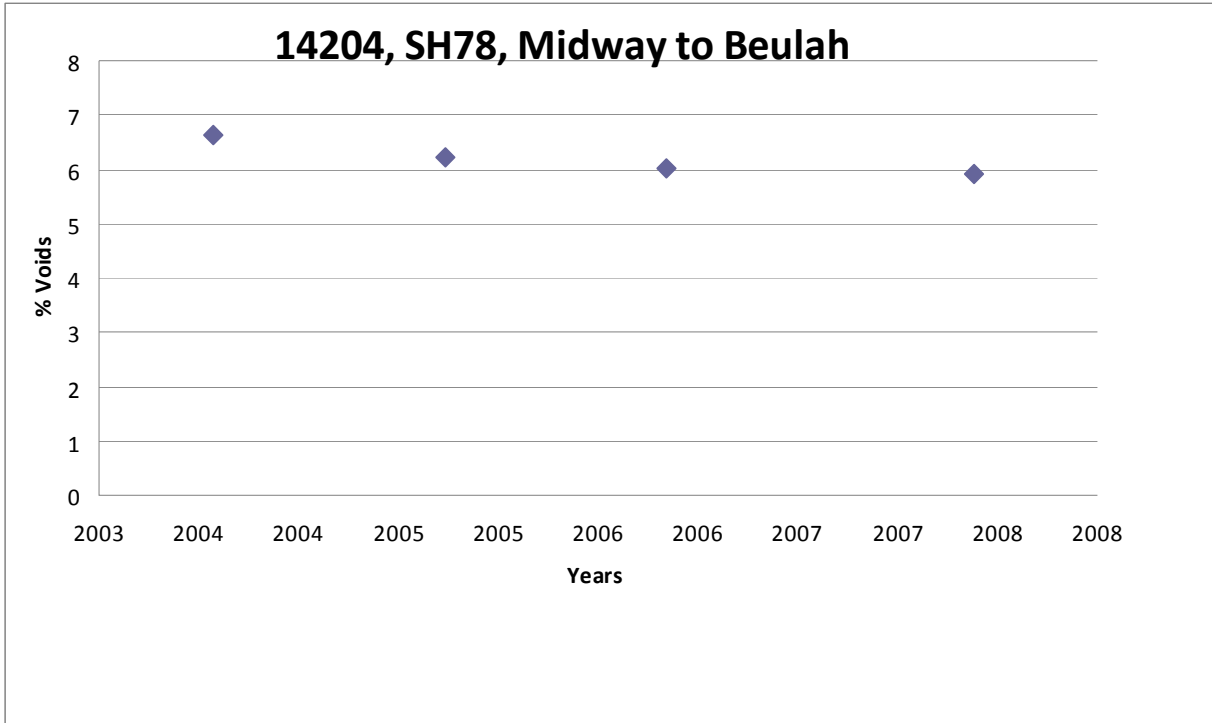
The pavement was constructed with in-place voids of 6.6% and the light traffic was unable to reduce the in-place voids much below 6.0%.

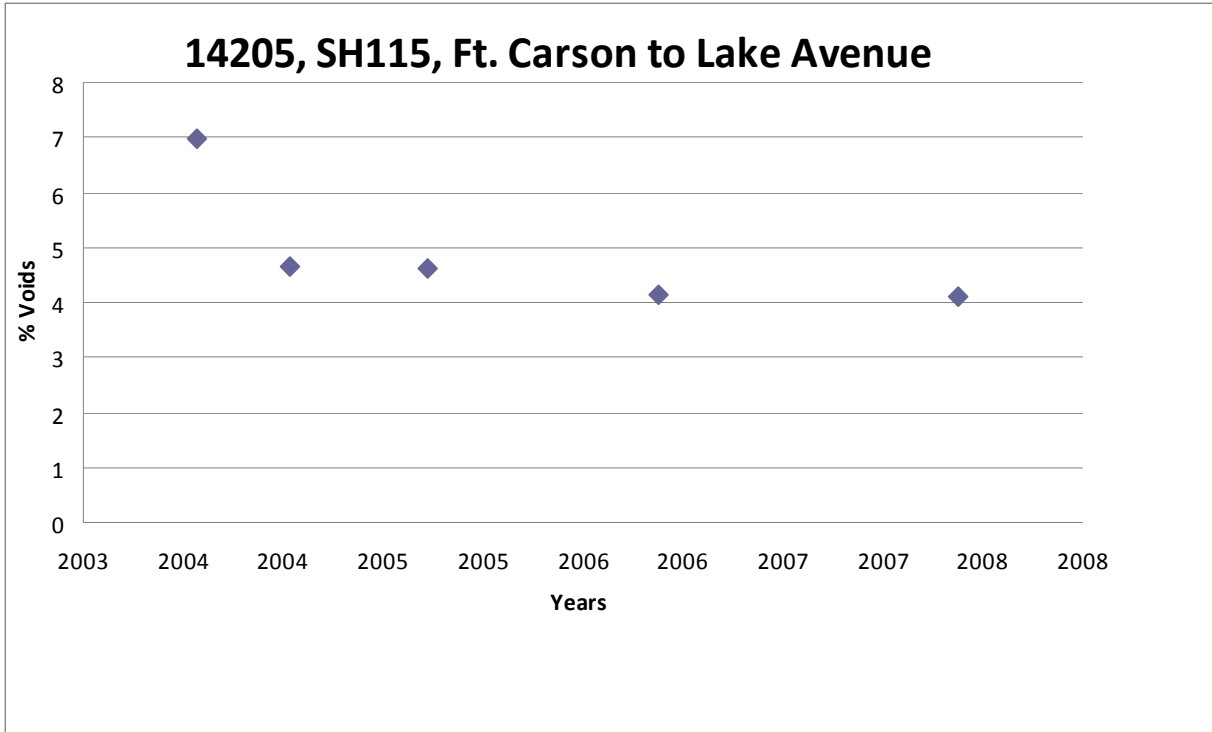
The pavement was constructed with in-place voids of 7.0% and pavement traffic loading and brought it down to 4.2% close to the center of the laboratory design range.

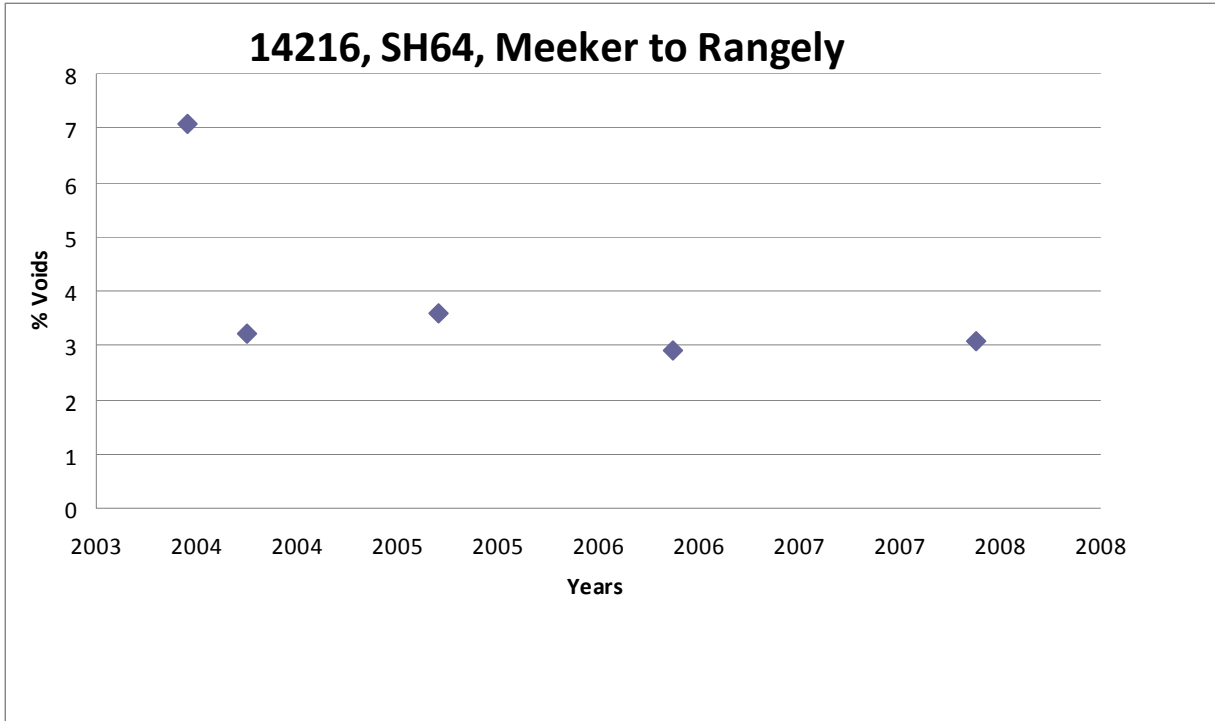
The in-place voids went down in the first year from 7.1% to around about 3.0%. Even though it is below the laboratory design range, the pavement appears to be performing well over the last 9 years with only 0.14 inches of rutting and low cracking.

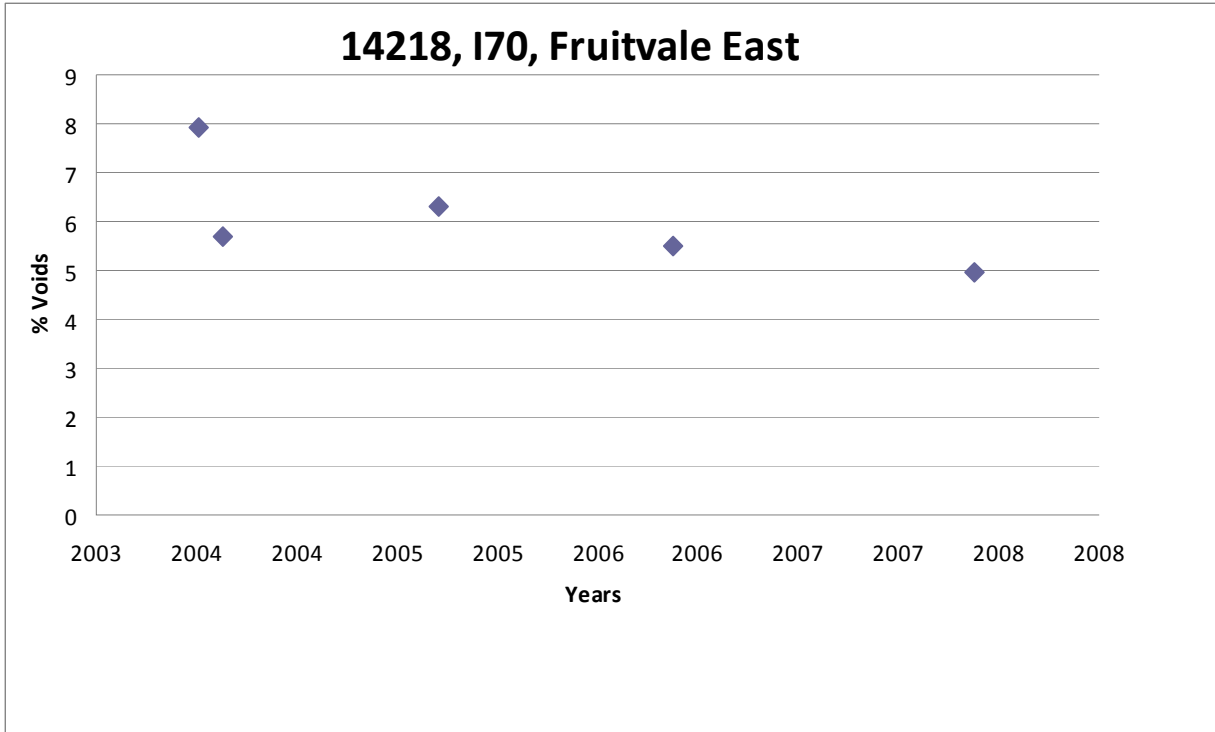
The pavement was placed at an in-place voids level of 7.9%. But fairly high traffic loading (ESALs = 2.53M) only brought it down to around 6% and it wasn't until 2008 that the in-place voids reach 5%. The inability of the pavement to meet the target voids of 4.0% may be due to the high compaction effort ( $N_{sd} = 100$ ) used in the design and that the AC content was not increased enough at construction time. A higher AC content may have reduced the fatigue cracking and possibly eliminated the need for a chip seal in 2011.

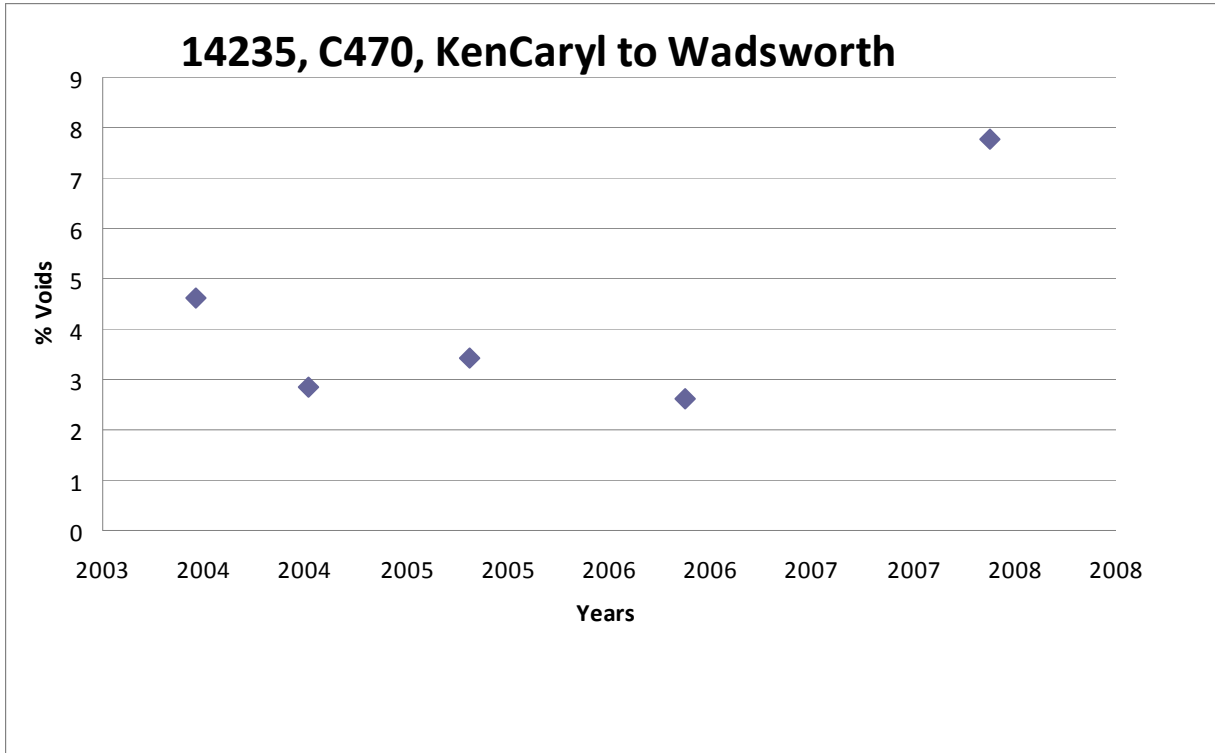
The in-place voids went down after the first year to around 3.0% due to substantial traffic loading (ESAL = 3.22M) reaching 2.6% in 2006. However, in 2008 the in-place voids went up to 7.8% which is probably due to some undocumented overlay between 2006 and 2008. Due to this overlay, the rutting and cracking data are probably not relevant to the original overlay in 2003.

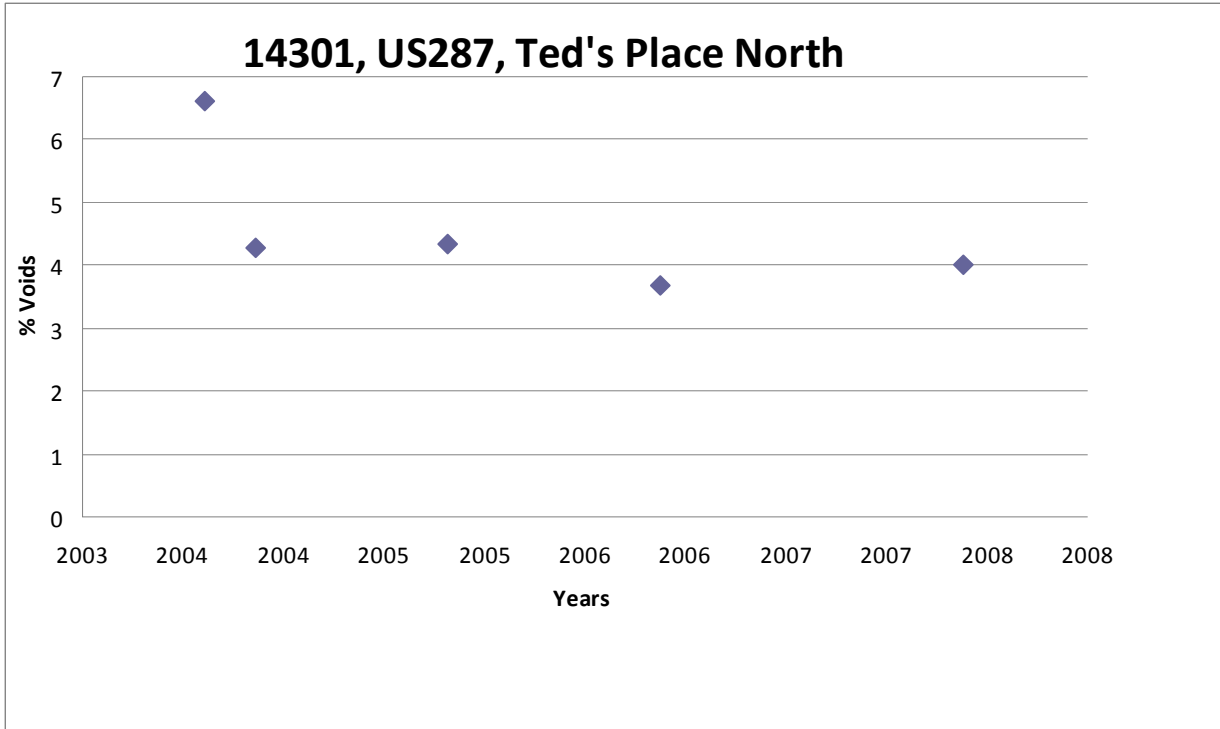
The in-place voids went down in the first year from 6.6% to around 4.0 % right in the center of the design range.
