Instrumentation and Monitoring of Precast Bridge Approach Tied to an Integral Abutment Bridge in Bremer County

**Final Report
April 2010**

IOWA STATE UNIVERSITY
Institute for Transportation

Sponsored by
Federal Highway Administration
Iowa Department of Transportation
(InTrans Project 08-335)

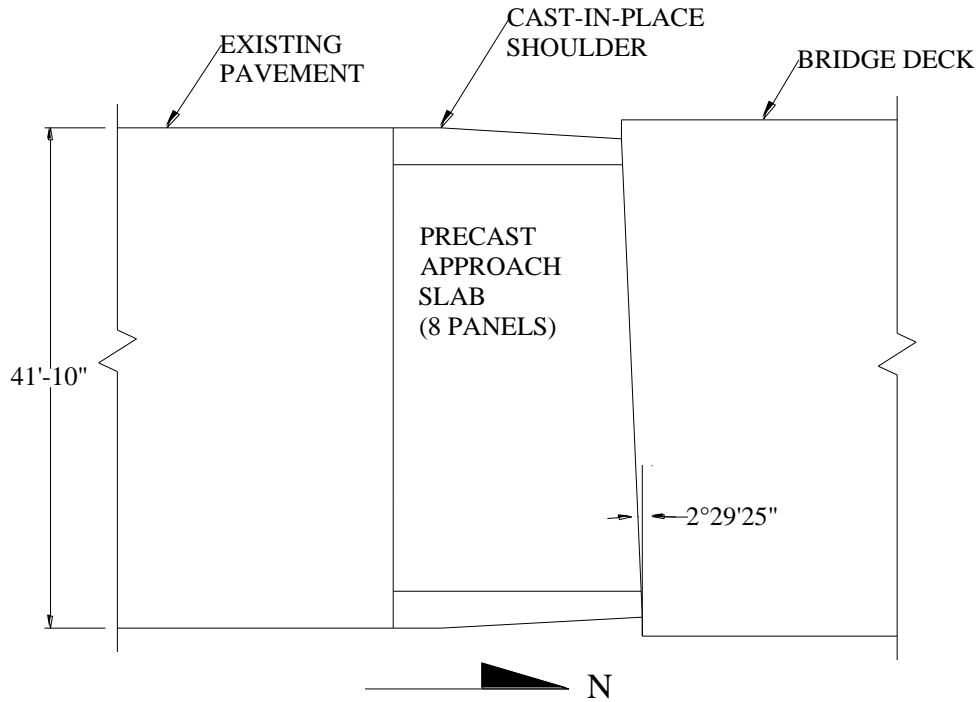
Figure 3.1. Plan view of precast approach slab with bridge and existing pavement (see Figure 3.2 for slab panel dimensions)

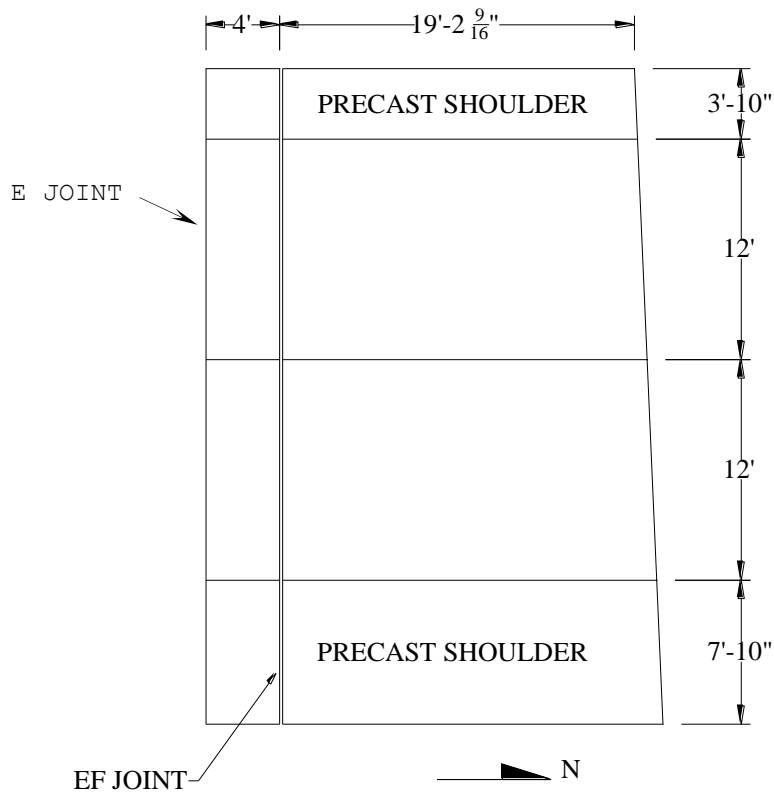
Figure 3.2. Plan view of precast approach slab

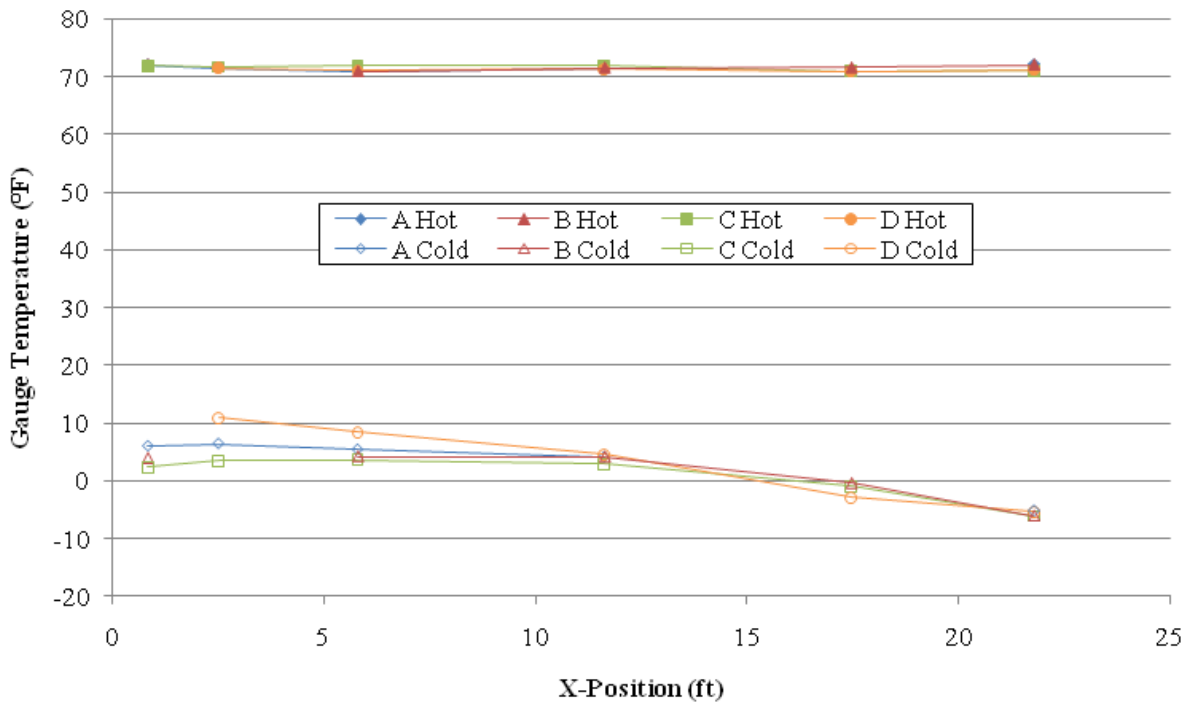
Figure 4.1. Temperature variation in approach slab (see Figure 3.5 for X-location)

A typical plot of temperature with respect to position of the gauges along the precast approach slab is shown in Figure 4.1. The hot temperature data occurred on July 21, 2009 at 12:00 p.m. (noon) and the cold temperature data occurred on January 5, 2010 at 12:00 p.m. (noon). Figure 4.1 shows that the temperatures across and along the slab were relatively uniform, varying somewhat more on cold days than hot days.

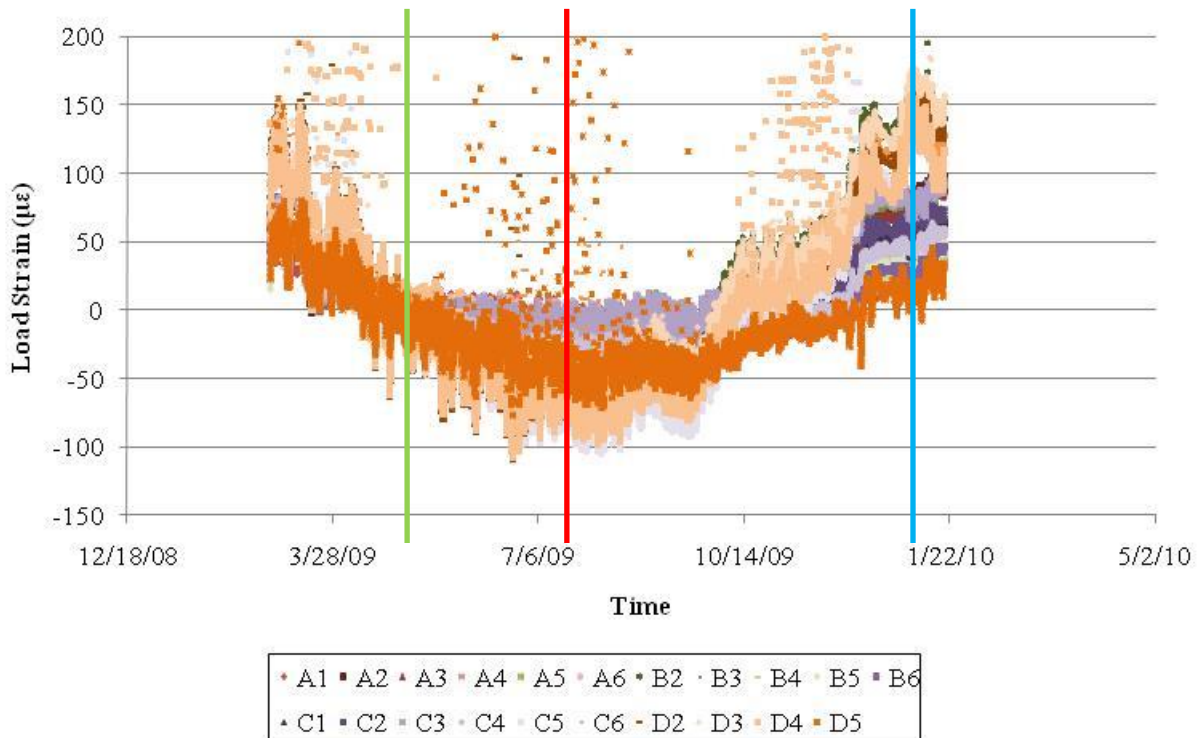
Figure 4.9. Load strain in approach slab over time (February 2009-February 2010, relative to “average” day)

The load strain time history, for all functioning gauges after February 25, 2009, is shown in Figure 4.9. In general, as the temperature decreases the load strain within the slab increases (i.e., the load strain moves toward tension in winter months and toward compression in summer months). The strain data shown in Figure 4.9 are relative to the “average” day listed in Table 4.2 (i.e., the data were zeroed on the “average” day). The three vertical lines represent the cold, hot and average days (see Table 4.2).

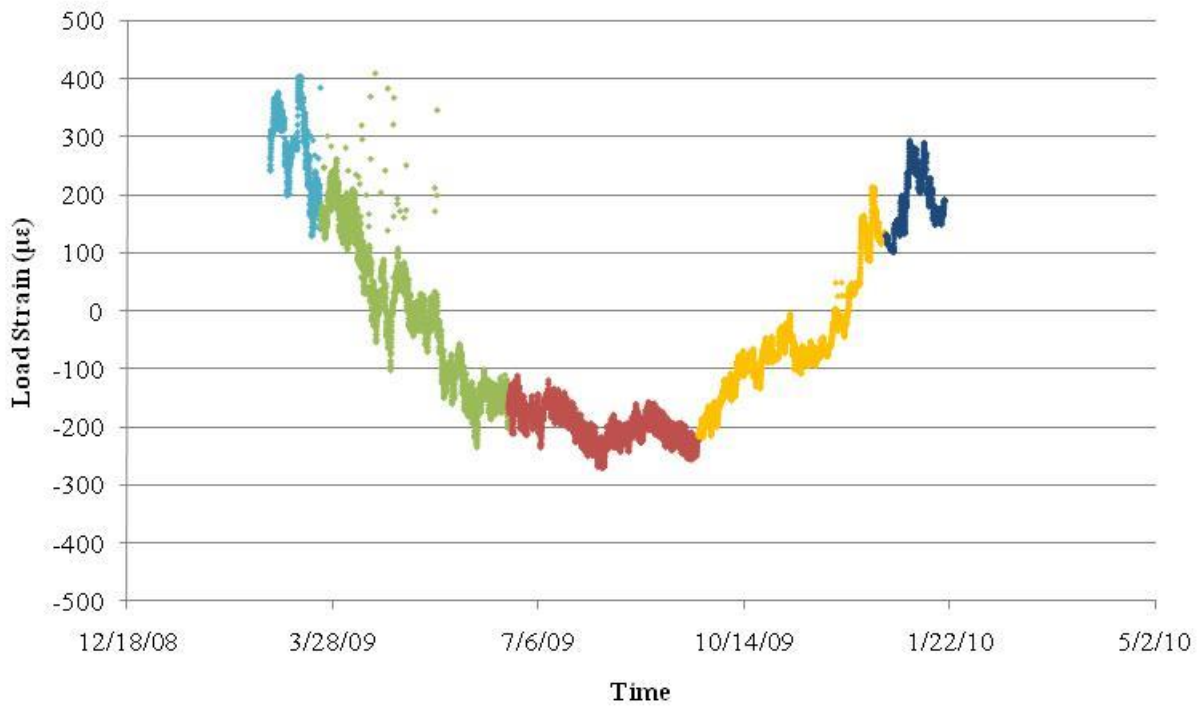
Figure 4.10. Load strain in approach slab over time for gauge D6

Data from strain gauges B1, D1 and D6 were not used in the calculation of load strain due to malfunctioning gauges or questionable data. There were no data from gauges B1 and D1. Gauge D6 gave data 2 to 3 times larger than other gauges as is shown in Figure 4.10.

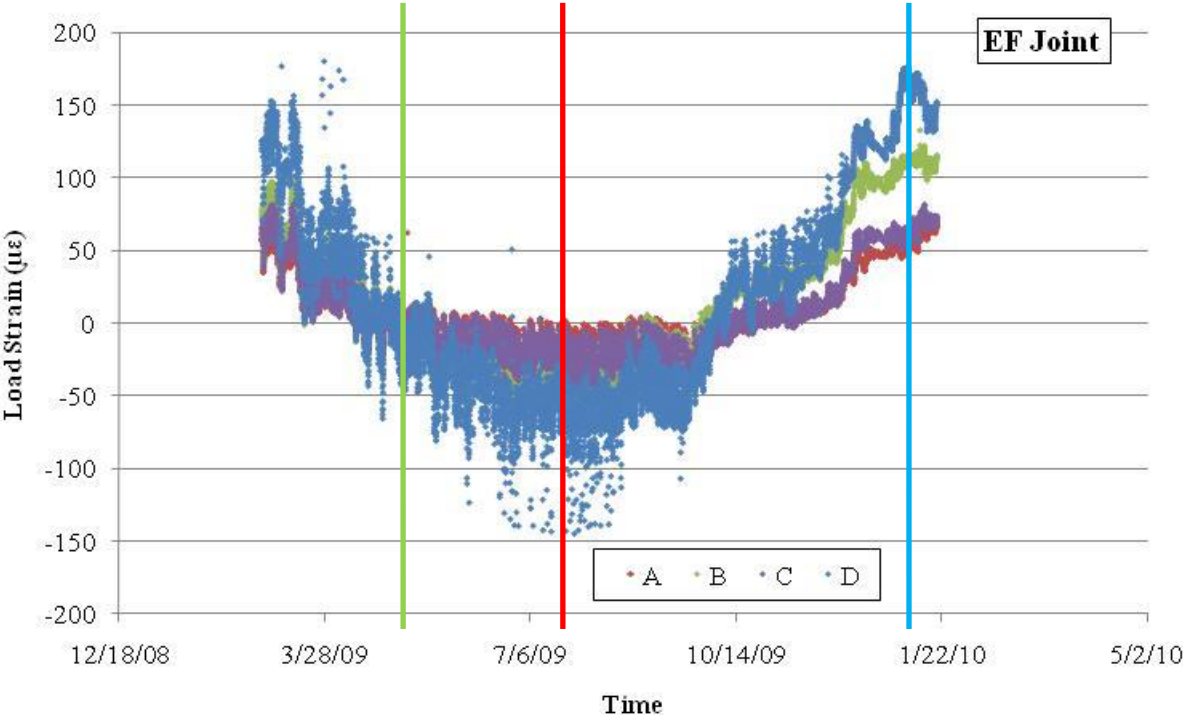
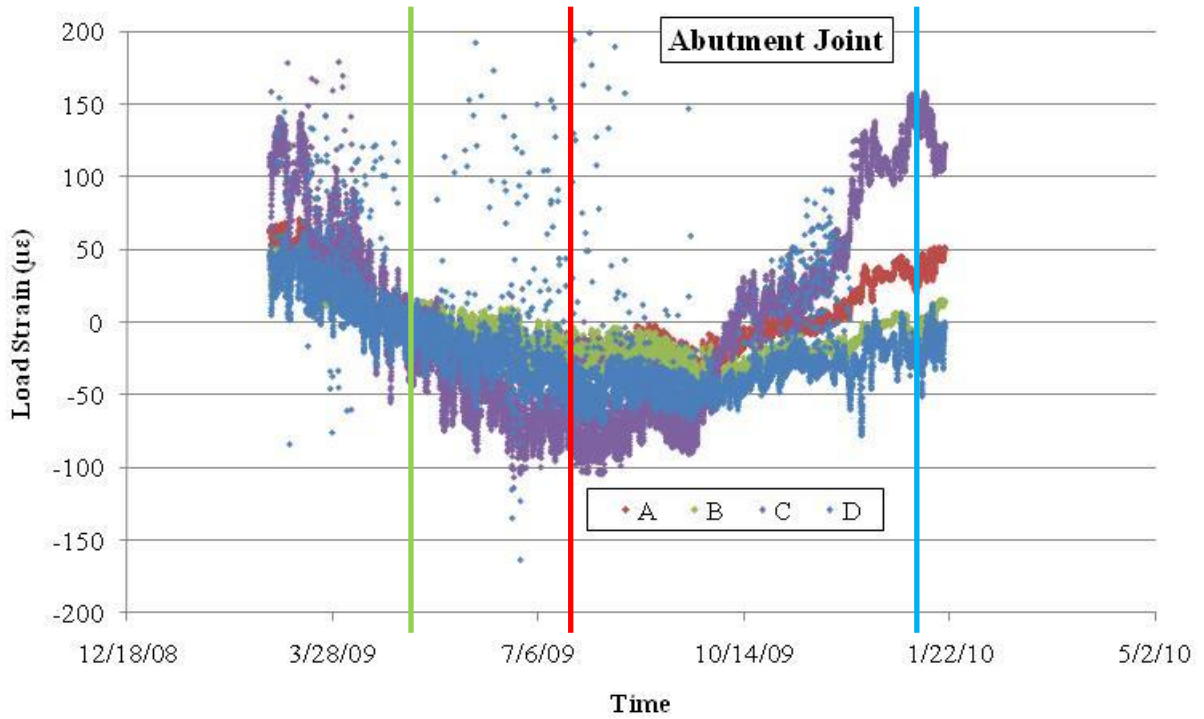
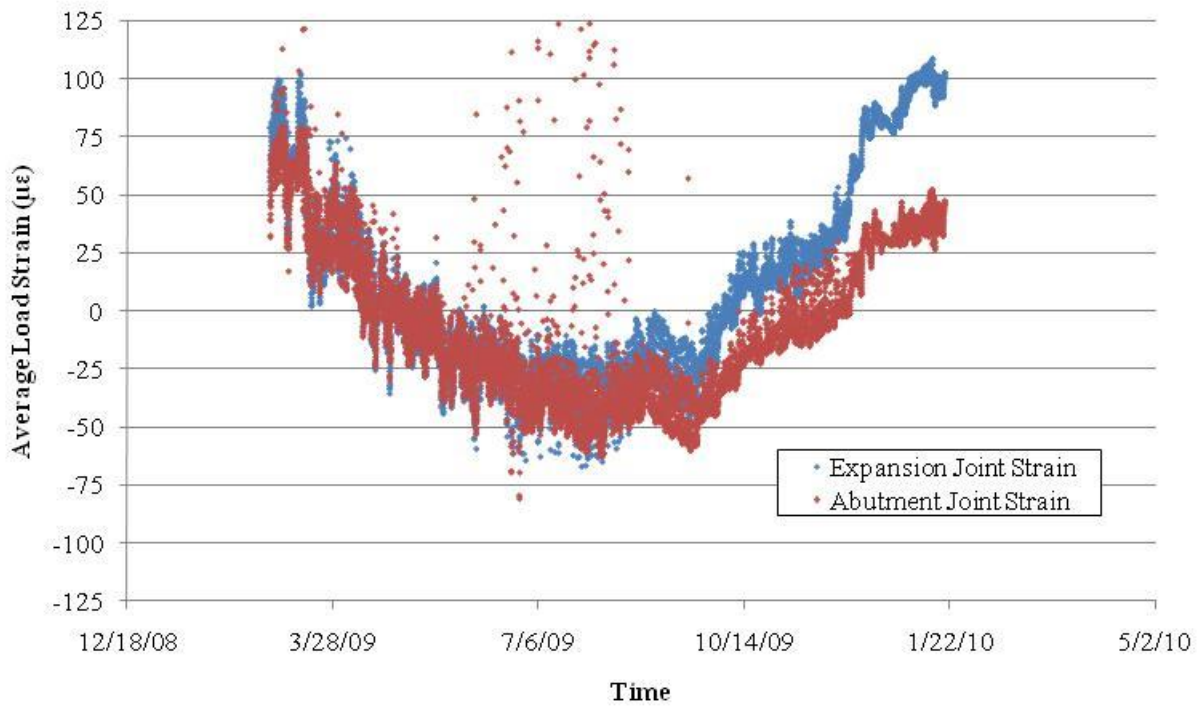
Figure 4.17. Load strain at EF joint

Figure 4.18. Load strain at abutment joint

Figure 4.19. Average load strain at EF joint and abutment joint

The load strains at the EF joint and abutment joint, from the A, B, C, and D lines in Figures 4.11 through 4.14, are shown in Figures 4.17 and 4.18, respectively. Figure 4.19 shows the average of the A, B, C, and D loads strains at the EF and abutment joints. The connection of the precast panels to the cast in place shoulders may have an impact on the strains in the precast panels.

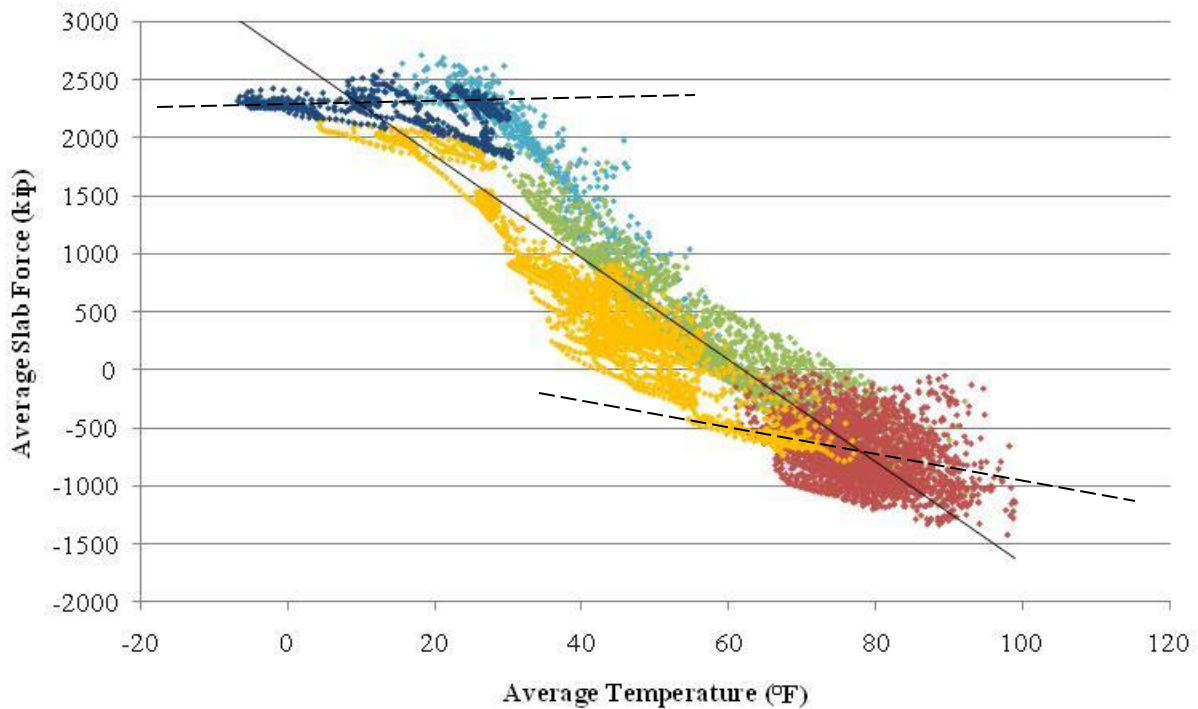
Figure 4.21. Average slab force with respect to average slab temperature

The average force from all gauges in the slab was plotted against average slab temperature and is shown in Figure 4.21. Figure 4.21 yields similar observations to those of Figure 4.20 with the same cyclical pattern found during the seasonal and short term changes. The slab forces tend toward compression in the summer and tension in the winter. The change in force in the slab ranged from 1166 kip (compression) in the summer to 2496 kip (tension) in the winter. The total

range of approximately 3662 kip relates to a 713 psi stress change in the slab from winter to summer.

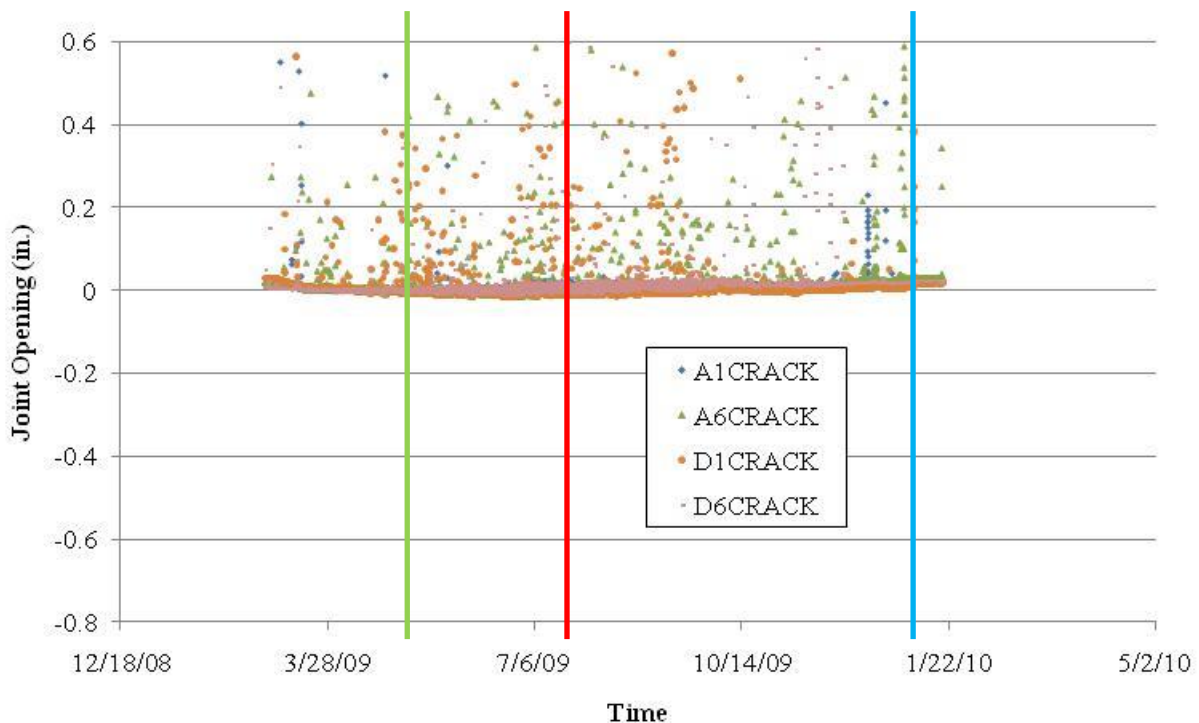
Figure 4.24. Precast approach slab opening at pavement and abutment joints

Figure 4.25. Precast approach slab opening at EF joint

The crackmeter located at the expansion joint between the east shoulder and east travel lane, C3CRACK, was damaged at some point after installation and the data obtained from this crackmeter were deemed to be unusable. The remaining crackmeters provided usable data during the duration of the project. Figure 4.24 shows the joint movement data across the abutment and pavement joints of the approach slab. Figure 4.25 shows the joint movement data across the EF joint of the approach slab. A positive movement indicates that the joint is opening. Figure 4.24 shows the crackmeters located along the abutment joint and pavement joint had movements of less than 0.02 in. Figure 4.25 shows the crackmeters located along EF joint indicate relatively larger movements ranging from 0.35 in. during winter months to 0.55 in. during summer months for a total range of 0.90 in.

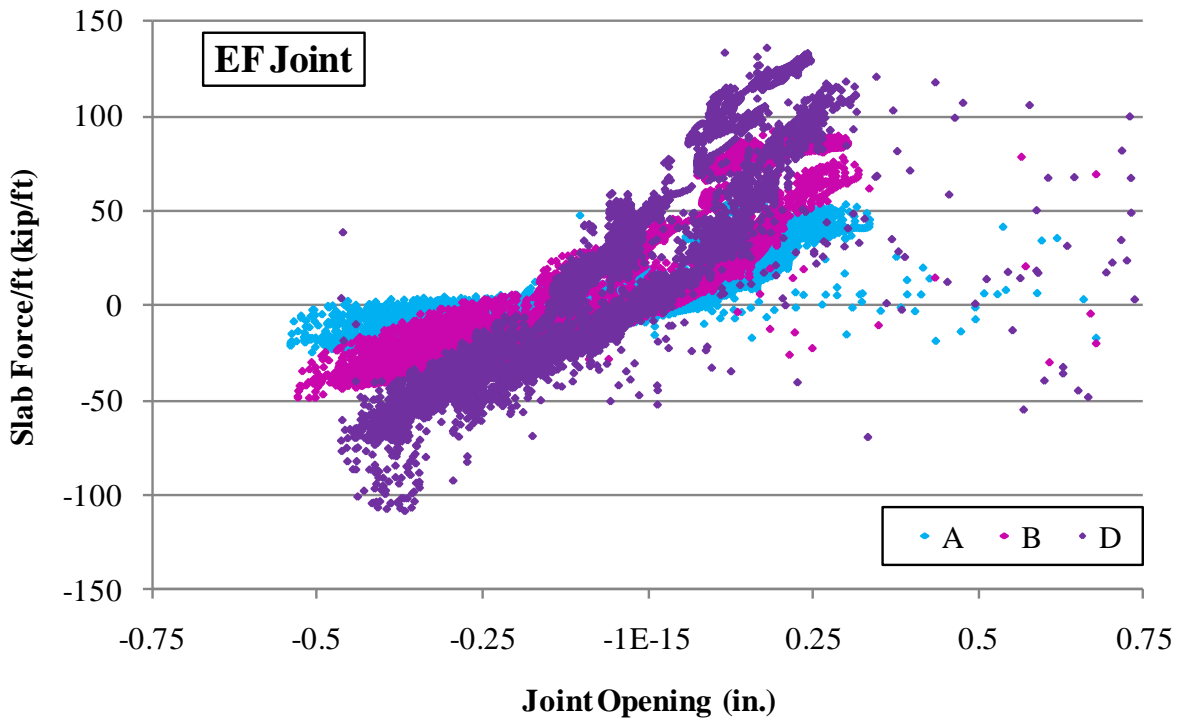
Figure 4.29. Expansion joint movements relative to average slab temperature

Slab force per foot of the approach slab versus joint opening for the EF joint is shown in Figure 4.29. The range of slab forces shown in Figure 4.29 is comparable to the force found in the approach slab of the Bigelow et al. (2008) study. Figure 4.29, similar to Figure 4.15, shows the force in the slab along line D of the slab behaves differently from the force in other areas of the slab. Apparently, the EF joint at line D is not functioning as well as elsewhere resulting in larger thermal forces, which may be affected by the connection of the cast in place shoulder to the bridge wing wall.
