## Evaluating the Need to Seal Thermal Cracks in Alaska's Asphalt Concrete Pavements

Date 04/30/2013

INE/AUTC 12.27

FHWA-AK-RD-12-20

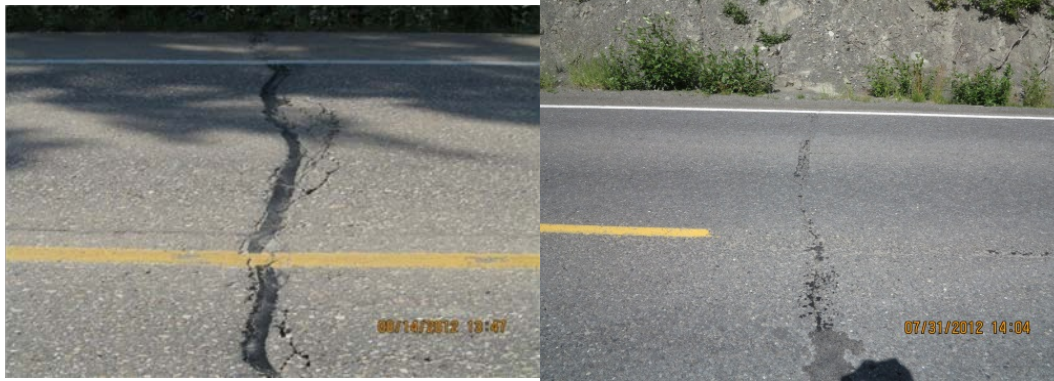
**Figure III.2 Major transverse thermal cracks with new sealant (left) and old sealant (right)**

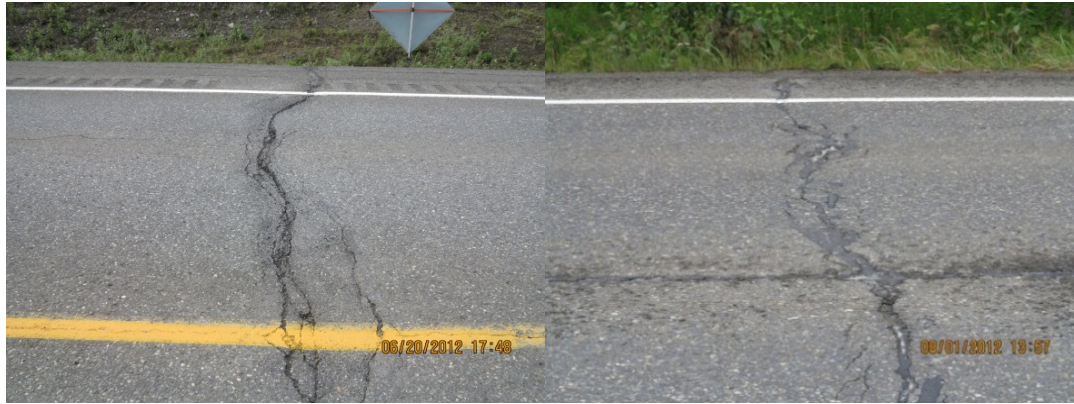
**Figure III.5 Examples of spalled zones along major transverse thermal cracks**

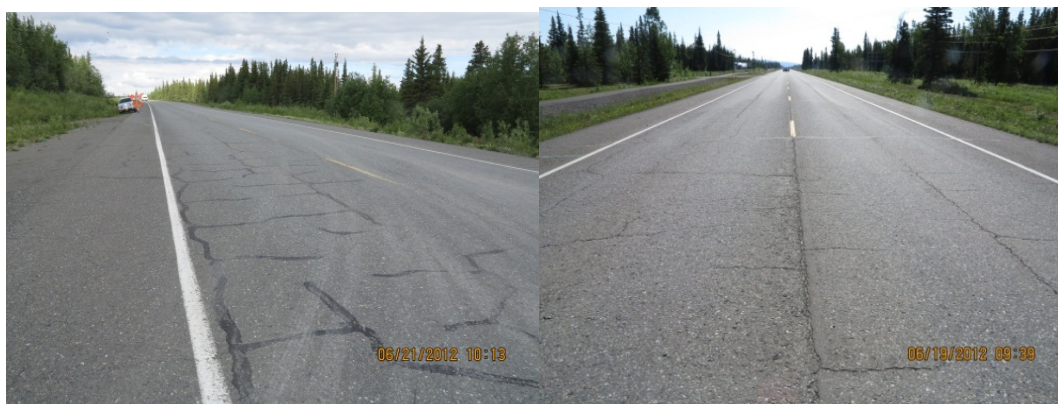
- **Slight** (Figures III.6 and III.7): Individual cracks are far apart, with little or no connectivity.
- **Moderate** (Figure III.8): An interconnected grid-type pattern has developed.
- **Severe** (Figure III.9): An interconnected grid-type pattern has developed with parallel grid elements usually closer than 10 feet. Cracks are also described as having an opening width of 1/8 inch or less, or more than 1/8 inch.

**Figure III.6 Lessor thermal cracking—slight (note sealing in left photo)**

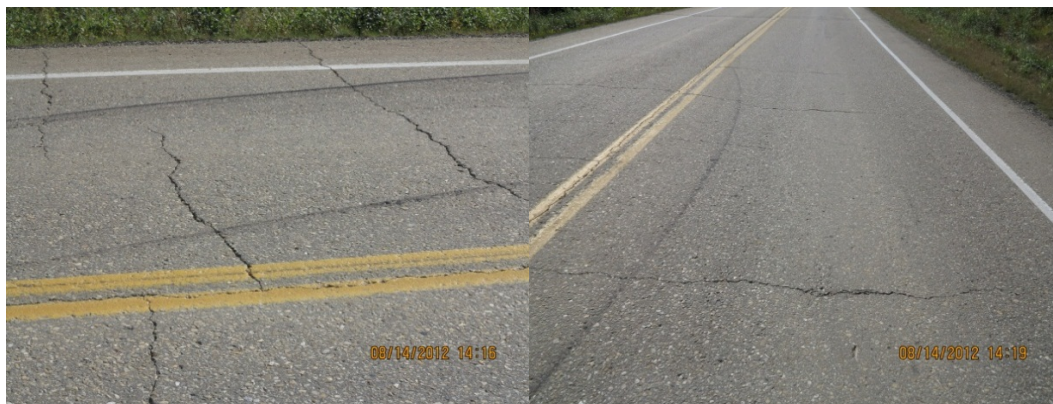
**Figure III.7 Lessor thermal cracking—slight w/ cracks wider than 1/8 inch**

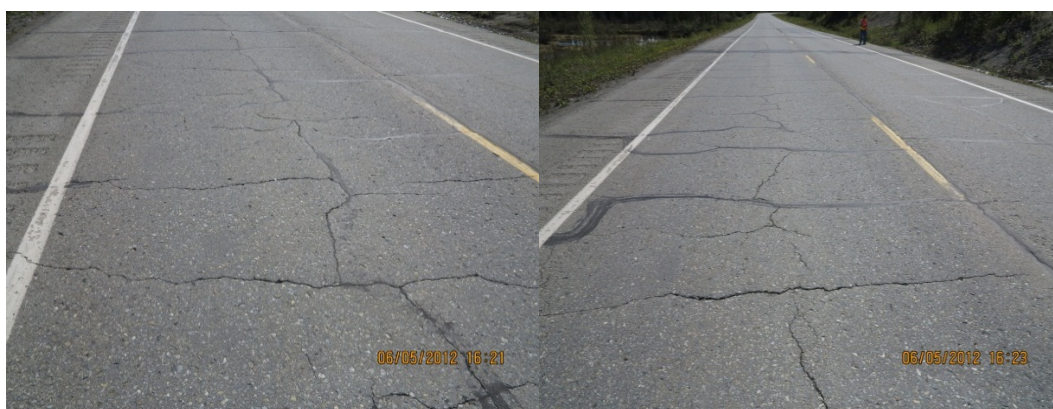
**Figure III.8 Lessor thermal cracks—moderate (note some very old sealant in left photo)**

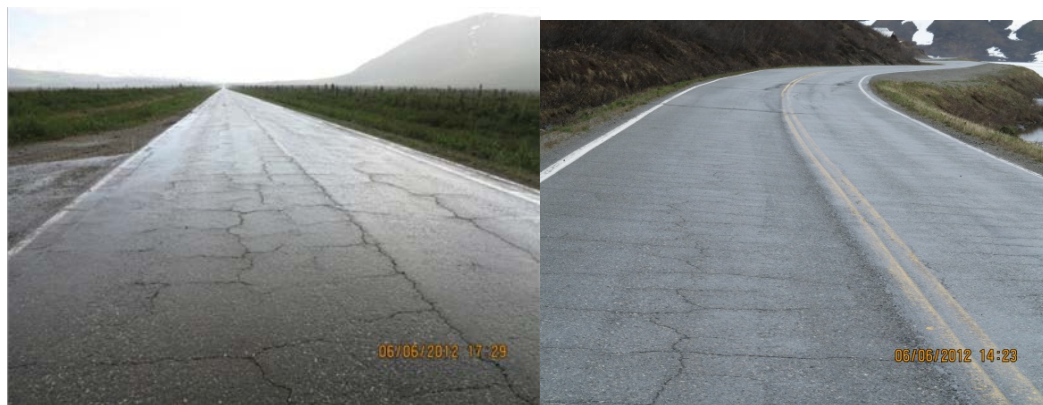
**Figure III.9 Lessor thermal cracks—severe (no sealant)**

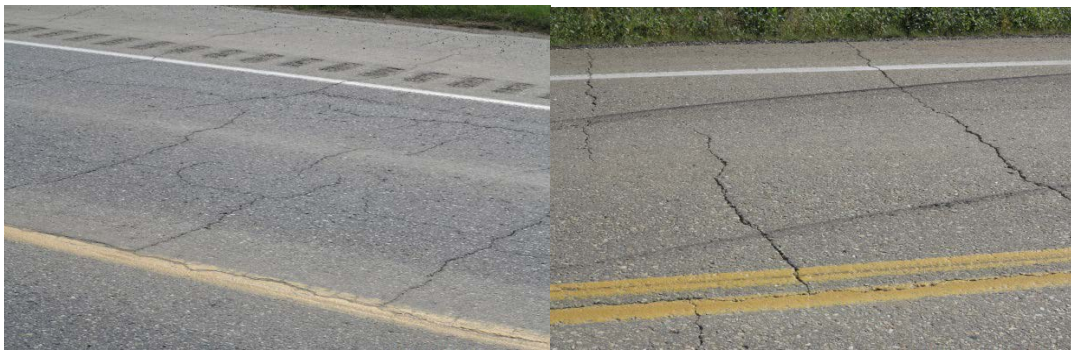
For lesser thermal cracking, visual observations identified *very few* instances where the condition of lesser thermal cracking was worse in wheel path areas than non-wheel path areas. The few examples where lesser thermal cracking showed more damage in the wheel paths were in areas where pavement delamination was occurring. These observations are well supported by substantial photographic evidence as in the following examples. Figure V.14 shows the typical appearance of nearly all lesser thermal cracks seen during fieldwork for this research. Note that there is essentially no difference in performance between wheel path and non-wheel path locations. Neither does pavement condition vary as a function of distance perpendicular to the edge of any individual crack.

**Figure V.14 Lesser thermal cracks showing same performance in wheel path and non-wheel path locations (extremely common appearance)**

Do not apply sealing materials to lessor thermal cracks.

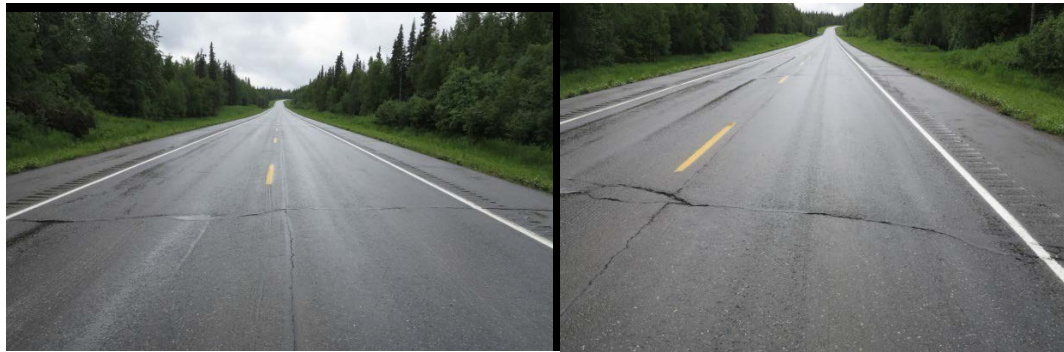
Relatively few observations support the theory that open pavement cracks always allow enough surface water infiltration to facilitate load-related pavement damage. The negative influence of water would have been evident if the most heavily trafficked areas of the pavement exhibited significantly more damage than the least trafficked areas.

**Figure V.15 Severe major transverse cracks with little influence on pavement performance beyond crack edges (very common)**

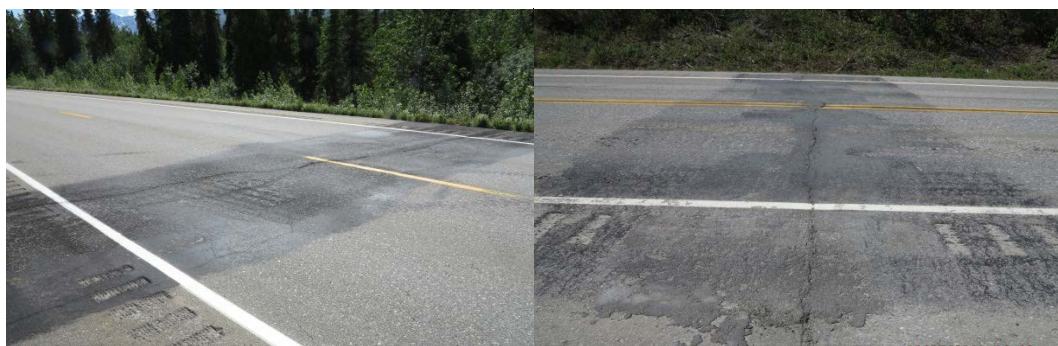
Except for the newest of these treatments, nearly every band had re-cracked to reveal the old thermal crack. Failure of the sealing function appeared to cause no problem however. These bands appeared to be performing a valuable function. Most of the banded transverse cracks, even those with old bands, still provided a permanent re-leveling of the area adjacent to the crack, and certainly less of a bump for the driving public than if there were no band. Figure V.16 shows two examples of maintenance banding in ADOT&PF’s Northern Region.

**Figure V.16 Examples of patch/seal band maintenance of major transverse thermal cracks**

Observations concerning the effectiveness of the bands provide more evidence that thermal cracks can be allowed to remain open without necessarily causing further pavement damage.

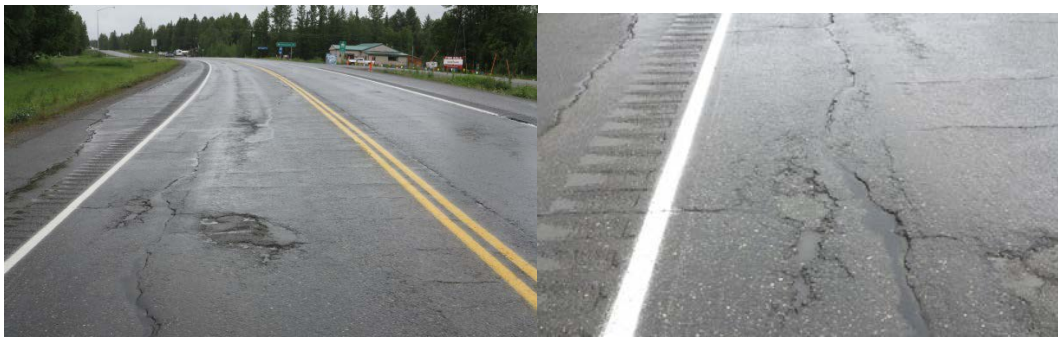
The problem of pavement delamination was observed at some of the research field sites. This problem was easy to identify where (1) much potholing and raveling were present, and (2) where another pavement layer could be found at the bottom of the potholes and heavily raveled areas. Figure V.17 shows typical negative results of a combination of pavement cracks and delaminating pavement.

**Figure V.17 Examples of pavement delamination damage accentuated at crack locations**

It was obvious that the delamination process greatly amplified the importance of all cracks in terms of other forms of surface damage. In fact, the delamination process seemed to be aggravated by *any* openings in the pavement surface that facilitated water getting to the interface between delaminating layers. Only in areas of delaminating pavement was pothole formation seen to be obviously associated with both types of thermal cracking. Delamination tended to increase the severity of spalling along major transverse cracks as well. It is fortunate that relatively few miles of Alaska's paved roads exhibit delamination.
