LUC-2-1682 Anthony Wayne Bridge

Main Cable Long Term Health Monitoring

January, 2014

Final Report

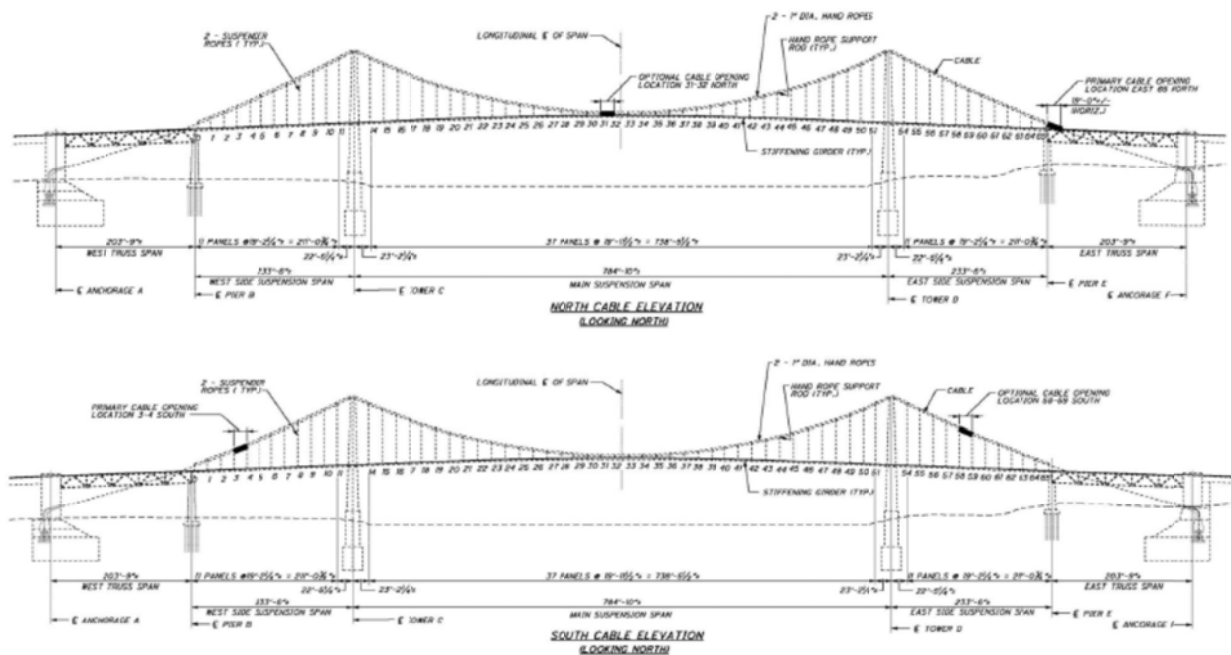
Figure 1: Elevation drawing of the north and south cables on the Anthony Wayne Bridge [2013 Cable Strength Evaluation Report]

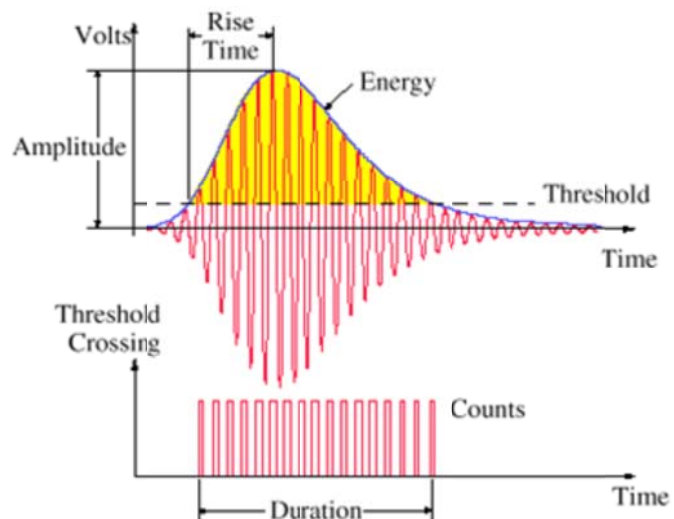
Figure 2 diagrams a sample waveform (or hit) and illustrates the associated parameters. The amplitude of the wave corresponds to the level of voltage produced by the sensor. When converted by the DAQ the amplitude is typically represented in decibels (dB). The threshold is set to the desired amplitude, and will not record any hits which do not meet this level. Rise time measures the time between the first crossing of the threshold and the peak of the wave. Duration is the time between the first and last crossing of the threshold for the same hit. The amount of energy in a signal is defined as the area encompassed by the signal envelope, and is shaded in yellow in figure 2. A count is the number of times a signal crosses the threshold. The characteristics of the signal are related to both the source and material through which the wave passes. Additional signal features, such as average frequency, can be determined using the signal processing software.

Figure 2: AE waveform features [Gostautas et al., 2012]

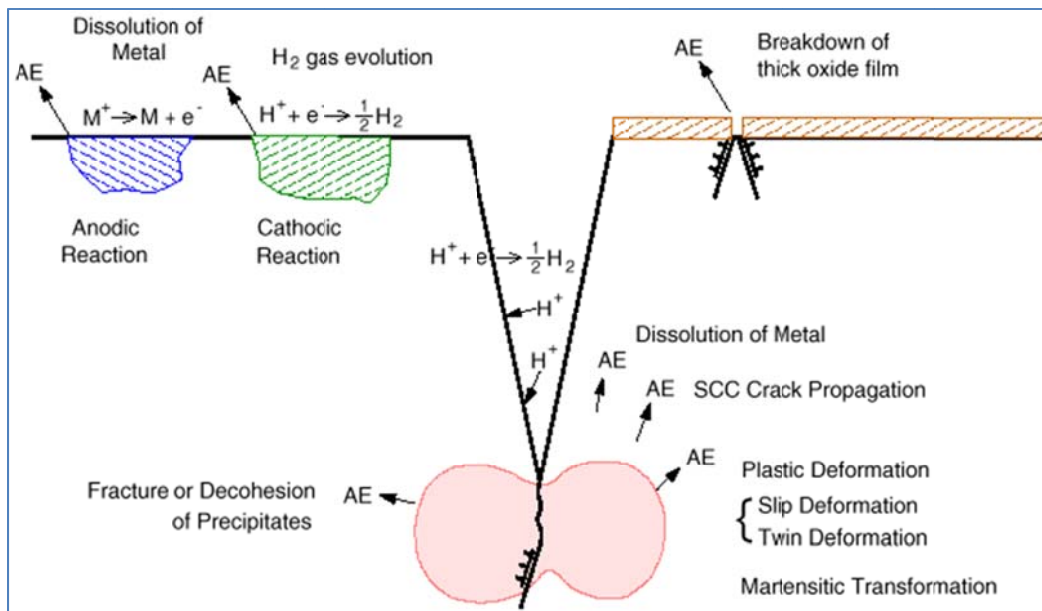
Figure 3: Schematic of A sources during corrosion, SCC and corrosion fatigue processes [Yuyama, 2002]

Corrosion begins when the surface of the metal comes in contact with some corrosive solution and is characterized by two major reactions. These reactions are the oxidation reaction and the reduction reaction, also known as the anodic reaction and cathodic reaction, respectively. During the oxidation reaction, at the anode, the molecules on the surface of the material are oxidized, losing an electron and releasing metal ions into the solution. This is called the dissolution of metal. Simultaneously, the electrons flow through the material to the cathode where they either react to neutralize positive ions, like hydrogen ions, or create negative ions [Roberge, 2006]. When the electrons react with the hydrogen ions this is called hydrogen evolution, as hydrogen gas is formed. Other common reactions at the surface of the cathode are the oxygen reduction reactions. These reactions may differ depending on the acidity of the solution. If the solution is acidic the oxygen tends to react with both hydrogen ions and electrons to yield water molecules. If the solution is more neutral or basic the oxygen will react with the water molecules and electrons to form negatively charged hydroxyl ions. Throughout the process the metal ions will react with the hydroxyl ions to produce various metal oxides which collect on the surface of the material. Depending on the metal, the oxide film may serve to protect the material beneath, such as for aluminum, or simply form and breakdown as the material continues to corrode, as happens in the case of steel. All of these processes are illustrated in figure 3.

In order to hunt for active corrosion it is important to understand the chemistry of corrosion and where the sources of AE originate. Acoustic emission is the elastic wave which propagates through a material as a result of the release of energy from a source event. In the case of corrosion, the source events can originate from the chemical reaction happening at the surface of the metal, or from mechanical processes which happen as a direct result of corrosion. These concepts are illustrated in figure 3, below.

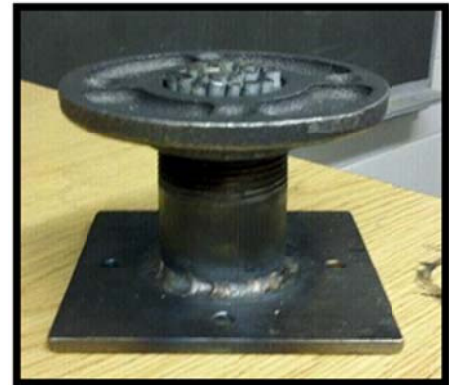
There were two critical requirements of the corrosion cell; functionality and mobility. The cell would have to work well in both the laboratory and the field testing stages. The key points of functionality included easy mounting of AE sensors for laboratory testing and effective contact between wires so that the propagation of acoustic waves could transfer efficiently to the sensors. The mobility requirement was simple; it must be easily mountable in a number of test settings, including to an AWB cable band. The resulting design included centering and welding of one half of a 1.5" pipe nipple onto a 4"x4"x1/4" steel plate. Compatible pipe flanges were used to provide additional versatility in mounting for various experiments. Straightened bridge wire was cut to lengths of 1.75" and were wedged together to fill the space of the corrosion cell. The last couple of wires are driven in with a hammer, which creates a compaction force and allows the AE from the wires to transfer to the surrounding wall of the pipe and to the bottom flange, where the sensors are mounted. During testing, corrosion was initiated through filling the cell with a corrosive solution of either tap water or a saline solution. Depending on the test, the cell could either be drained, leaving the wires simply wet, or left full to simulate wires submerged in solution. Due to the slight curve in the small wires, they are not as tightly packed as the parallel wire in a bridge cable. The percent of voids for the cell when filled with wires is about 32%, as opposed to roughly 20% in the case of a typical suspension bridge cable. The cell was tested with and without wires. A picture of the fabricated corrosion cell can be seen in figure 4.

Figure 4: Corrosion cell with wires

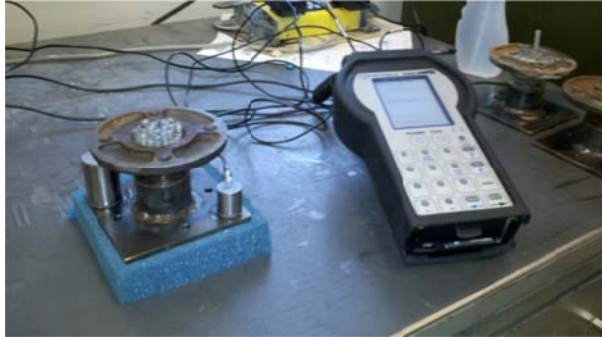
The laboratory corrosion cell testing explored a large variety of variables throughout over thirty experiments. Tests were designed to compare the AE during corrosion of galvanized and ungalvanized wire, the use of saline solution vs. tap water solution, corrosion of submerged wires vs. wet wires, and the length of the corrosion period. In addition, each of these experiments was recorded with both the R15 α high frequency sensor and the R.45 low frequency sensor, for comparison. The test set-up can be seen in figure 5, to the right. In general, since the true goal of this research was to apply findings to the Anthony Wayne Bridge, the results presented in this report will primarily compare data obtained by the R.45 sensor; which is the sensor used on the AW. The results of these tests are presented in this section.

Figure 5: Set-up for laboratory corrosion cell testing

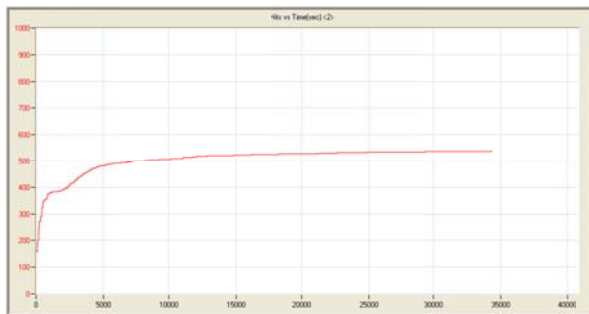
Figure 6: Hits vs. time for C3-NW-SS3-2

Figures 6 and 7 show the shapes of the hit vs. time curves for C3-NW-SS3-2 and C3-UG-SS3-2, respectively. Figure 8 provides the same graph for an experiment with galvanized wires, C2-G-SS3-2, for comparison.

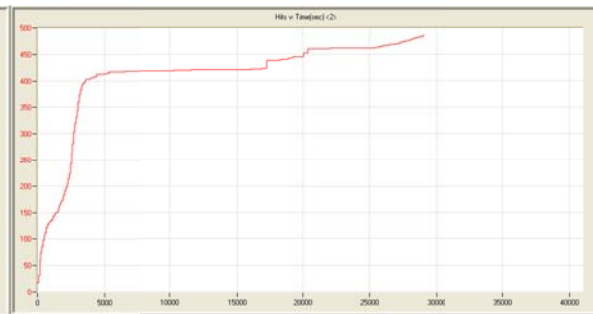
Figure 7: Hits vs. time for C3-UG-SS3-2

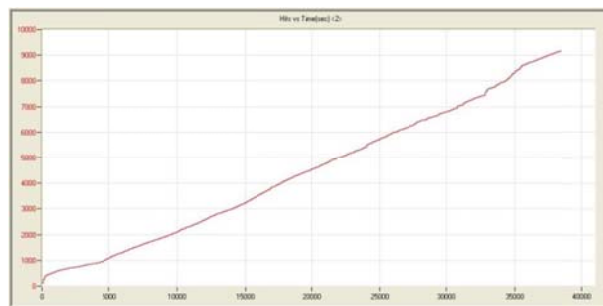
Figure 8: Hits vs. Time for C2-G-SS3-2

Another difference between the galvanized and ungalvanized experiments is the shape of their curves. The experiments with galvanized wires show a near constant curve with less variability at the beginning of the test. In contrast, the experiments with ungalvanized wires show a bi-linear curve including a steep portion during the first few thousand seconds of the test, followed by a plateau with a drastically reduced hit rate. The plateau generally remained at a constant hit rate until the completion of the test. While the exact reason for the bilinear curve is unknown, it is possible that it relates to the rate of diffusion of hydrogen ions and dissolved oxygen throughout the solution. This would justify a high initial rate, followed by a slower, stabilized period. However, this description can also be used to describe the shape of the hit vs. time curve during the corrosion of an empty cell with no wires. Despite the formation of obvious corrosion debris, there does not seem to have been a high additional participation of the ungalvanized wires in the data recorded by the AE sensors.

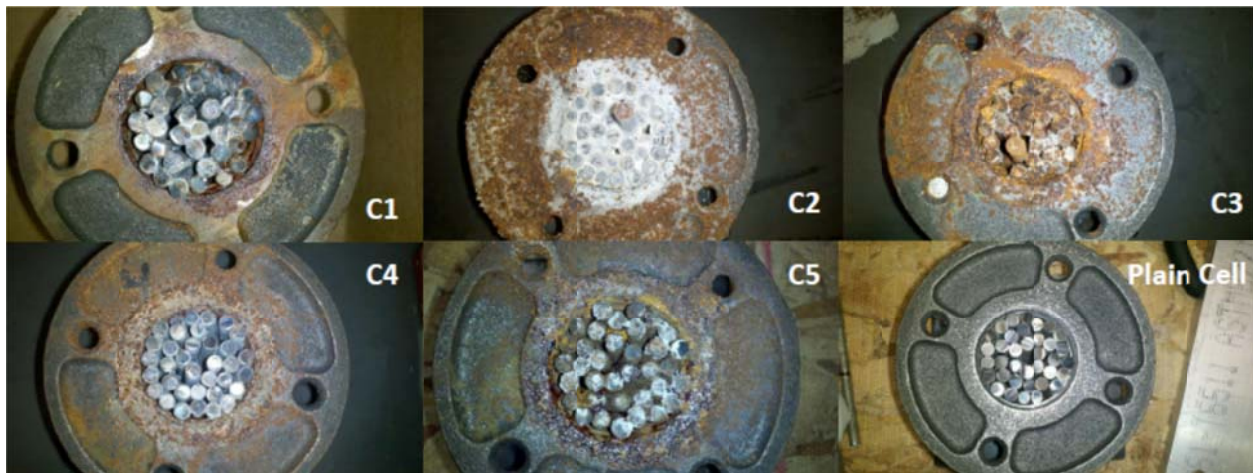
Figure 6: Visual of cumulative corrosion for each cell after completion of laboratory testing

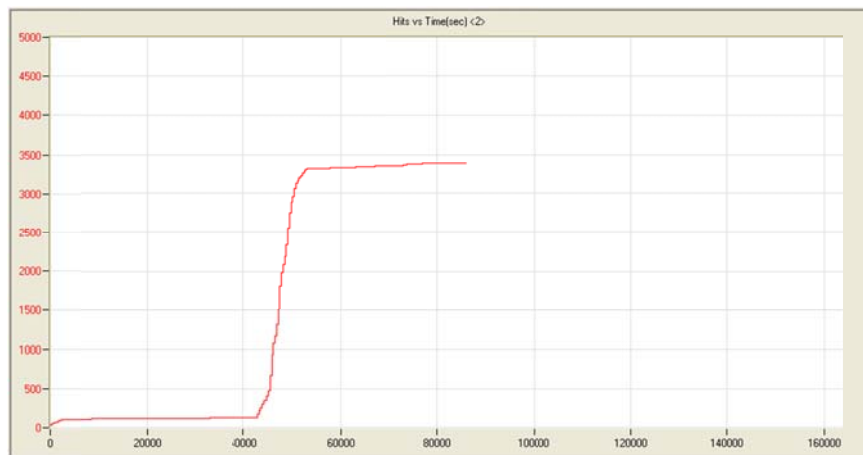
There was one test, however, that did not exhibit this behavior. The hits vs. time curve for test C3-UG-SS3-1 can be seen in figure 10. As can be seen from the graph, there is very little AE activity for the first 40,000 seconds of the test. At approximately 43,000 seconds the hit rate surges and reaches about 1300 hits per hour, for a period of nearly two and half hours until quickly returning to a rate that is close to zero. This test could indicate that corrosion of ungalvanized steel wire has some sort of cyclic tendency, although it was not apparent in any of the other equivalently long tests. It should also be noted that the increased hit rate actually included more hits on the high frequency sensor than the low frequency sensors, which is abnormal based on the other experiments. It seems the surge in AE may have been produced by a source which generates signals with a higher than normal average frequency. As mentioned previously, additional experiments with longer testing periods could provide clarification as to whether or not this test was some sort of anomaly or error.

Figure 7: Hits vs. time for C3-UG-SS3-1

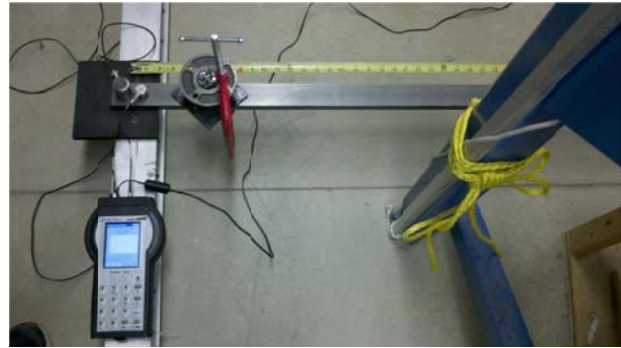
Figure 8: Set-up for mock cable band attenuation experiment

It is well known that the corrosion process produces very low level acoustic emission. It was understood going into this project that at best we would only be able to hear corrosion within a few feet of the sensor, which is mounted on a cable band. The objective of this experiment was to reasonably approximate the ability of sensors to record acoustic emission along anypoint near the cable band. To simulate this, a corrosion cell was clamped in place at 6" intervals along a 72"x1-3/4"x3/4" steel bar. The corrosion cell, C1, was filled with tap water a few hours prior and monitored in order to ensure a stabilized hit rate prior to starting the experiment. Once the experiment was started, the corrosion cell was moved 6" further away from the sensor at time intervals of approximately 30 minutes. Time marks can be seen in figures 12 and 13 which indicate when the data collection was paused for moving the cell. The figure on the left shows amplitude vs. time while the figure on the right shows the cumulative hit vs. time curve. If there were attenuation, the left graph would show a gradual reduction in peak amplitudes while the right figure would show a changing hit rate. Both of the graphs indicate that there is no attenuation seen during this experiment. This test shows that if a corrosion source has near direct contact with the cable band, then it is probable that it can be detected by the acoustic emission sensor given a proper threshold.

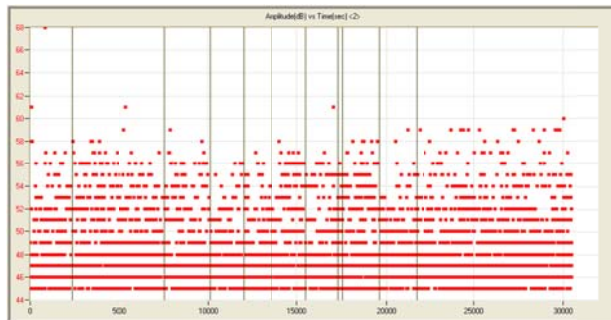
Figure 102: Mock cable band attenuation experiment Amplitude vs. time graph

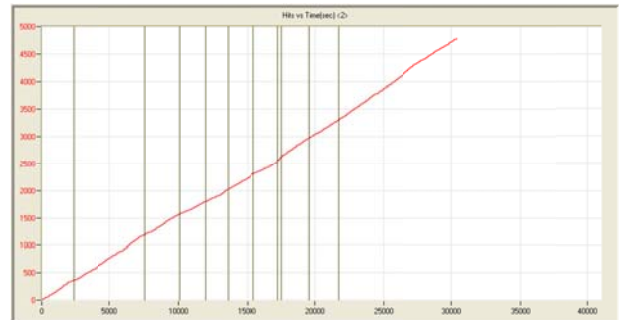
Figure 93: Mock cable band attenuation experiment Hit rate vs. Time graph

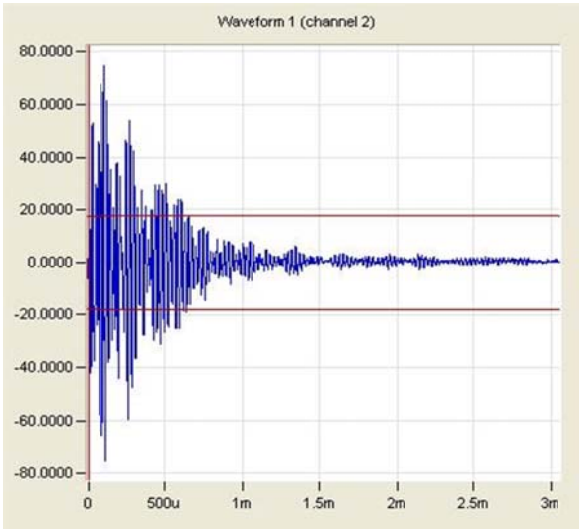
Figure 11: Waveform of a typical corrosion source

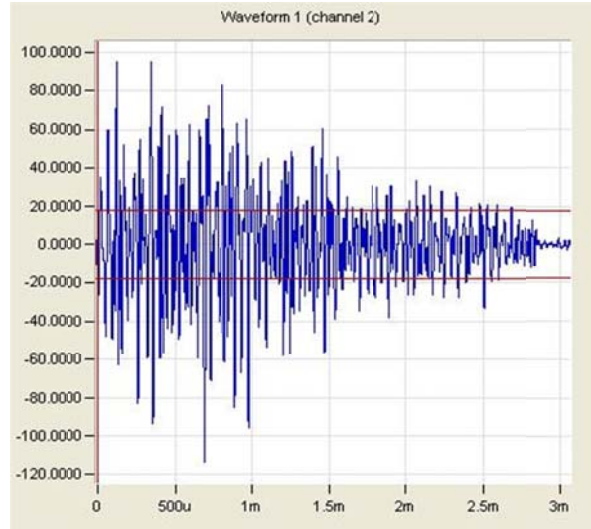
Figure 12: Waveform from a typical frictional source

slowly displaced by small amounts, rubbing against the surrounding wires. The waveform presented in figure 15 is highly representative of the typical friction signal from that test. Given the waveforms, one could begin to separate corrosion signals from friction signals. Unfortunately, due to limited space during data acquisition, the acoustic monitoring system on the AWB is limited to only records select waveforms.

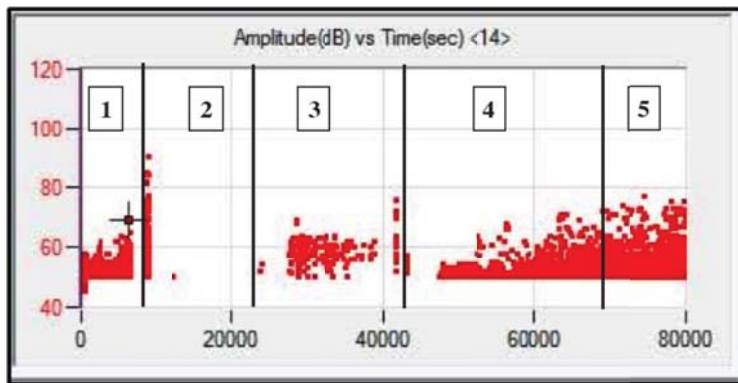
Figure 13: Amplitude vs. Time for channel 14 on the north cable of AW [Gostautas et al., 2012]

Figure 16 shows the Amplitude vs. Time of hits recorded by channel 14 during the shutdown. The graph is broken up into 5 periods. The first period shows normal traffic loading on the bridge. The second period is the time just after the bridge closure, and is relatively quiet. Period three is characterized by an increase in wind loading on the bridge, potentially causing frictional noise. Period four included reduced wind gusts and the beginning of increased relative humidity. Period 5 consisted of a rain event and increasing relative humidity. The data from various channels from both the north and south cable was replayed utilizing the corrosion characteristics filter to analyze the 3rd, 4th and 5th periods during the shutdown. The resulting percent passing the filter during each period, for each channel, is presented in table 3.

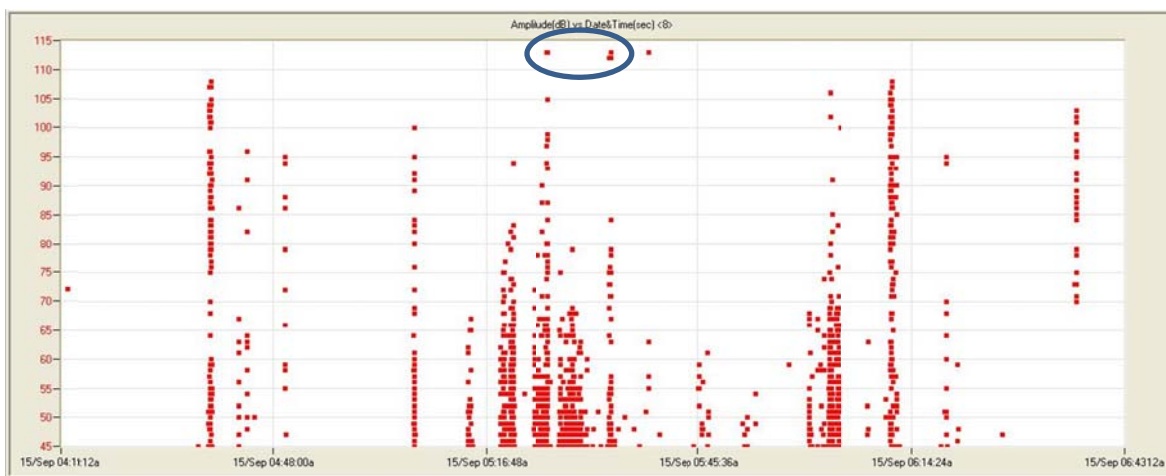
This data does however represents the typical noise level of channel 8 between 4:30 AM and 6:30 AM on Sunday morning. Based on the abundant amount of corrosion AE generated in some of the tests, given the right conditions, it would definitely be possible to detect corrosion at that level and consistency.

Figure 14: Amplitude vs. Date&Time graph from field test experiment

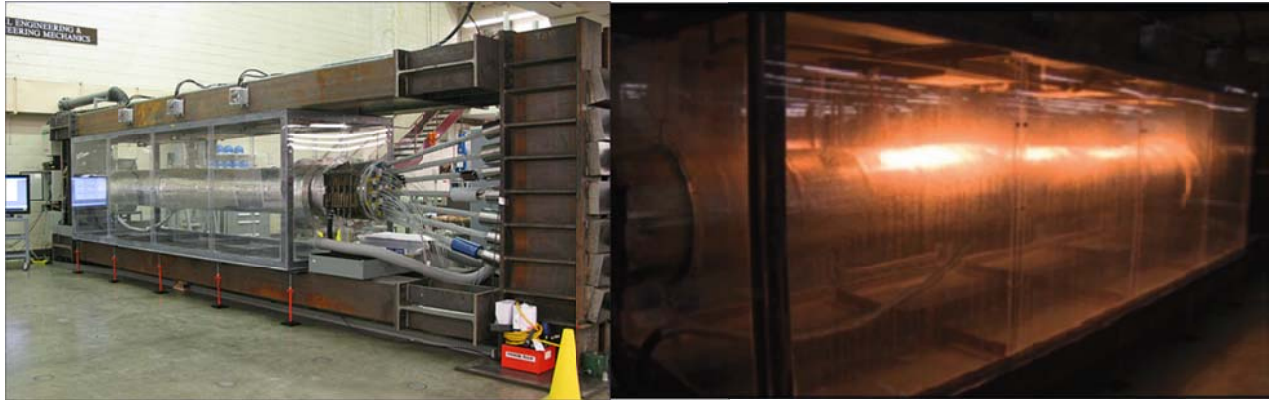
hexagonally shaped strands. The majority of the strands were cut to a length of 20 ft, which approximates the distance between two cable bands. However 7 strands were cut to 35 ft and were tensioned to approximate a load slightly higher than typical service load conditions. The load in the cable was carried by a large reaction frame which surrounds the specimen. The compacted diameter of this cable was 20 inches [Sloane et al., 2012]. Figure 18, left, shows an angled view of the cable mock-up.

Figure 15: Mock-up cable specimen and environmental corrosion chamber; Left: angled view of specimen [Khazem, Serzan & Betti, 2012] & Right: heating phase of cyclic environmental conditions [Sloane et al., 2012]

In addition, an environmental simulation chamber was constructed around the cable. This allowed the cable specimen to be exposed to variable weathering through cyclic combinations of rain, heat, air conditioning and ambient conditions. Heating was provided by heat lamps which were installed at the top of the chamber and air condition and ventilation units were used to level temperature and fluctuate relative humidity. Moisture was introduced via perforated PVC pipes which ran along the top of the chamber and simulated rain. An aluminum foil tape was used as a wrapping system to prevent direct contact between the cable and the environmental conditions [Sloane et al., 2012].

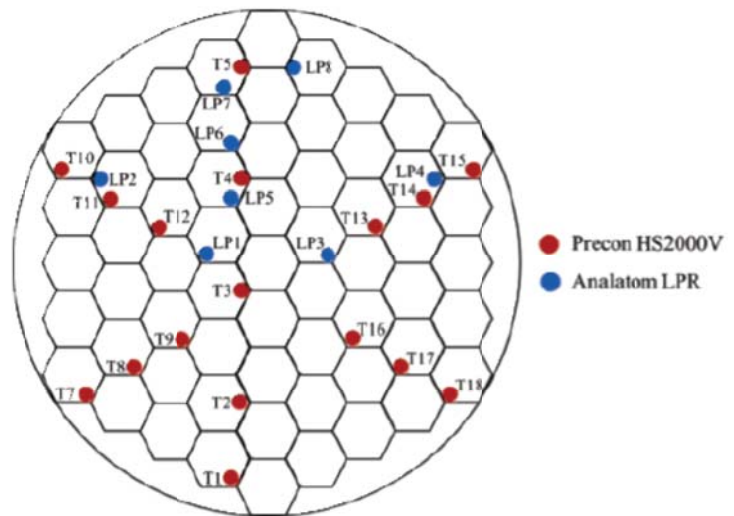
The arrangement of the sensors within the laboratory cable can be seen in figure 19, to the right. Included in this diagram are the locations of the embedded HS2000V (17) and LPR (8) sensors throughout the cable cross-section. Sensors are placed along three diagonals of the cable area, separated by 60°. The HS2000V sensors are denoted with a “T” while the LPR sensors are denoted with “LP”. [Sloane et al., 2012] desired to distribute LPR sensors throughout the bottom of the cable, but laboratory construction operations prevented this.

Figure 16: Sensor arrangement in cable cross-section [Sloane et al., 2012]

Each sensor was protected from crushing by small stainless steel tubes which were inserted before and after the sensor within the bundle. The small tubes were 1 inch long and covered with a heat shrinking, moisture resistant coating. The sensors were hard-wired and connected to the Sensor Highway II data acquisition system. The cable was then closed, compacted, and resealed for testing.

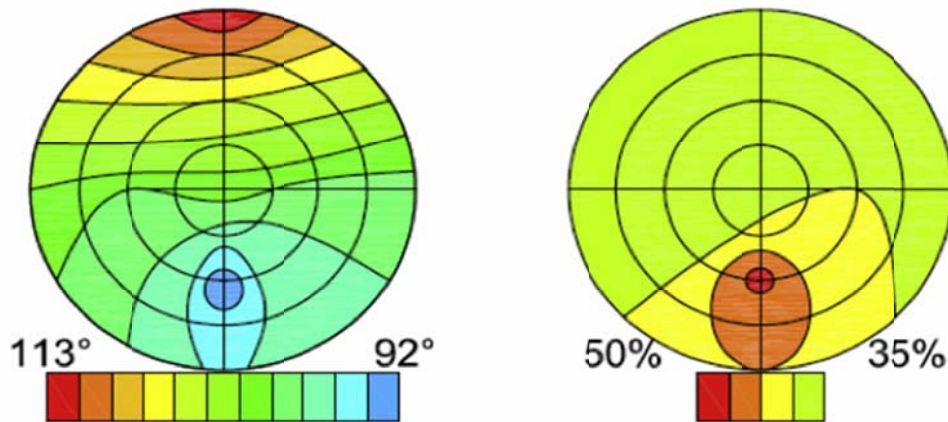
The field testing was performed in 2011 by installing sensors at one location on the Manhattan Bridge in New York City. The system has been used to record data throughout a number of periods covering multiple days. Figure 20 shows the distributions of temperature (a) and relative humidity (b) throughout the cable cross-section on August 1st, 2011. The embedded sensors proved to be functional and accurate based on the external conditions at the times of data collection, and seem to confirm parameter trends and relationships as seen in the laboratory. The location of minimum temperature corresponds to that of maximum relative humidity experienced that day, verifying the inverse relationship between the two parameters, as expected.

Figure 17: Environmental variable distribution as recorded from the Manhattan Bridge on August 1, 2011
(a) temperature (b) humidity [Sloane et al., 2012]

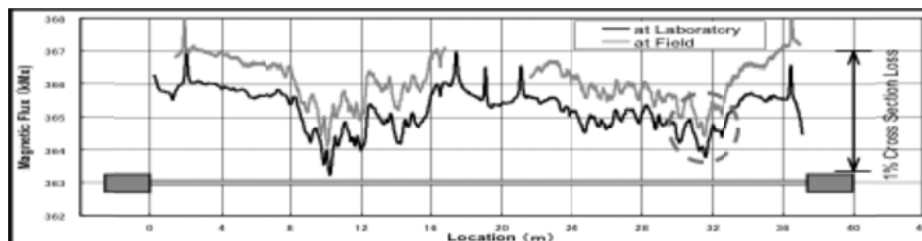
A number of laboratory and field tests were performed to verify the performance level of MMFM. The tests with relevance to the AW include inspections on suspender ropes and the main cable. Figure 21 shows good agreement between field and laboratory testing of suspension bridge suspender ropes. The region encompassed by the dashed circle in figure 21 represents an area where there was no deterioration outwardly visibly. Upon further investigation, significant corrosion was found on the interior of the strand. The ability to detect deterioration without external indications is one of the major advantages of this technology.

Figure 18: Scan measurement chart for suspension bridge suspender rope [Sugahara et al., 2013]

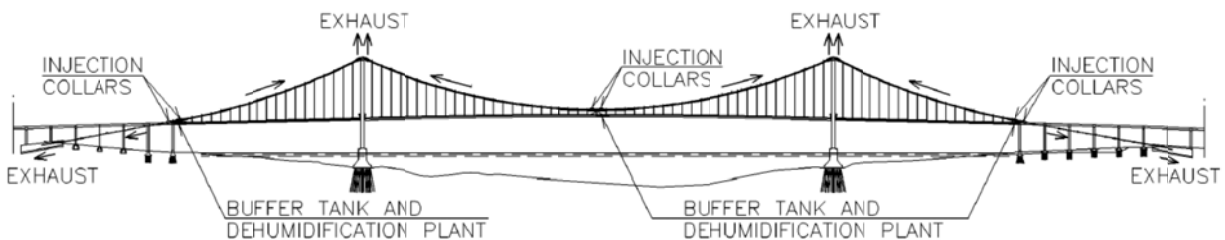
The main components of a dehumidification system include: the dehumidification plant, injection points and exhaust points. The dehumidification plant manufactures dry air which is blown into the cables at the specific injection points. Exhaust points are used to maintain the proper flow and overpressure inside the sealed cable system. The overpressure prevents infiltration of water at minor imperfections along the exterior of the cable sealing system. A layout is designed for each bridge with the goal of optimizing the locations of the dehumidification plants, injection collars and exhaust points. An example layout for the Little Belt Bridge is shown in figure 22.

Figure 19: Dehumidification system layout for Little Belt Bridge, Denmark. [Bloomstine & Sorenson 2006]

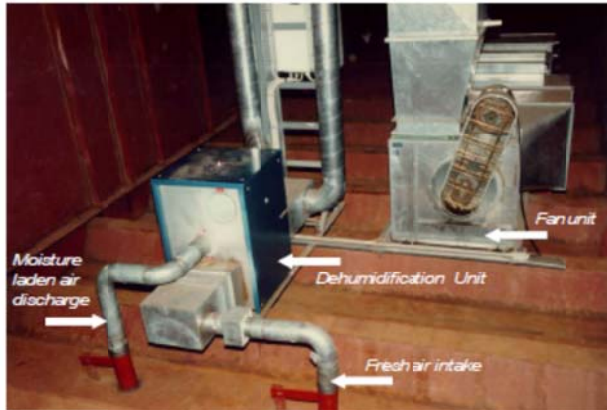
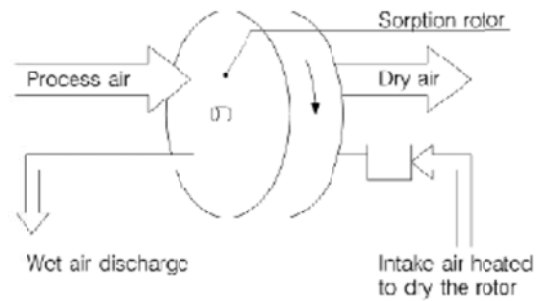
The dehumidification plant includes the following components: dehumidification unit, a fan, an electrical board, filters and ducting. A complete dehumidification plant can be seen in figure 23. The actual process for drying the air is called active sorption, and is also illustrated in figure 23. A sorbent, or desiccant, is known as a hygroscopic material. An example of a sorbent would be the silica gel packets that can be seen packaged with electronics and carry a warning label which reads "do not eat". These materials can absorb water or return water to the air given the proper environmental conditions and are the key to the dehumidification system. Inside the dehumidification unit is a sorption rotor, or wheel, which is coated with a sorbent. The wheel continuously and slowly rotates through two sides of the rotor chamber. On one side process air is drawn through the rotor, dehumidified, and sent along to the cables. On the opposite side heated air is sent through to rotor and absorbs water from the sorbent material, drying it out. The hot, wet air is then discharged from the system. One optional addition to the plant is a buffer tank. The buffer tank mixes the dried air with some of the ambient air to provide a mixture at the preferred relative humidity. This strategy will reduce the amount of energy consumed through running the dehumidification unit.

Figure 20: Typical dehumidification plant (left) and diagram of active sorption rotor (right). [Bloomstine 2011]

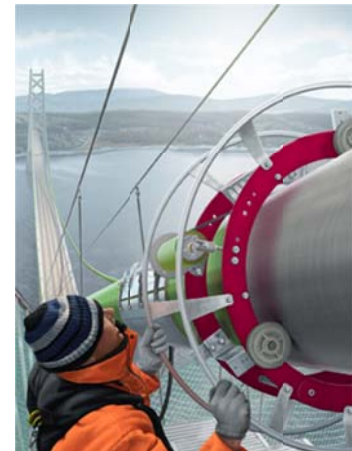
Figure 21: Cableguard™ wrapping application. [dsbrown.com]

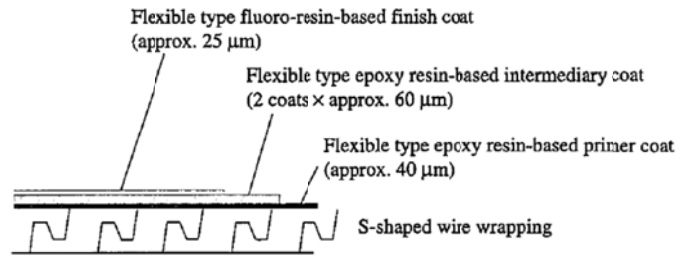
dehumidification systems. The product is a specially designed wrapping wire with an S shape which is wrapped such that it forms a continuous link along the cable. The linked wire restricts the displacement of the wrapping wire and provides a better surface for painting. The extra rigidity helps to prevent cracks in the paint allowing the exterior of the protection surface to last longer. The S-shaped wire creates higher water sealing and air tightness than the traditional round wire wrapping. The product is typically paired with a specialized, 4 layer, flexible paint system which provides additional protection against cracking and weathering compared to traditional paint. This reduces the maintenance and decreases the frequency of re-painting the cables. Figure 25 shows the cross-section of the S-wire and paint corrosion protection system.

Figure 22: S-shaped wrapping wire and flexible paint corrosion protection systems. [Eguchi et al. 1999]
