FINAL REPORT

**Comparative Testing of Radiographic Testing, Ultrasonic Testing and Phased Array  
Advanced Ultrasonic Testing Non Destructive Testing Techniques  
in Accordance with the AWS D1.5 Bridge Welding Code**

**BDK84-977-26**

February, 2014

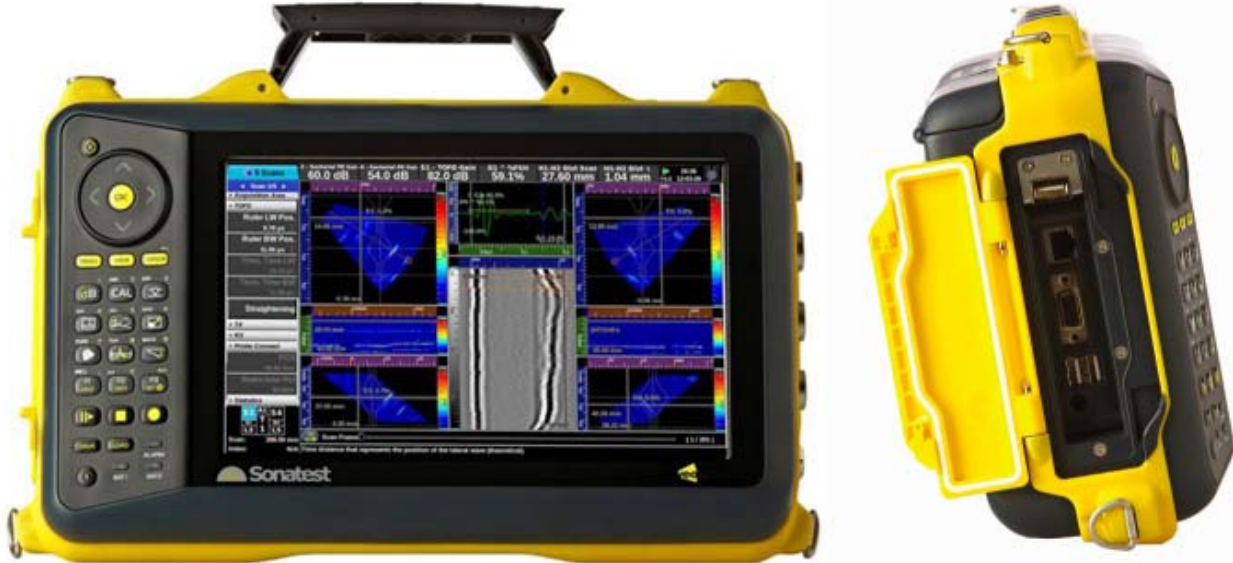
Figure 2-1 Sonatest Veo™ Phased Array Instrument

#### **PHASED ARRAY INSTRUMENT (SONAAP VEO 16/128 BNC)**

BNC connector, USB memory stick, user guide manual and CD, 2 lithium ion batteries, protective screen, mains cable power cord, AC adaptor, Veo™ strap, certificate of conformance and calibration certificate.

Type 1 DAAH, linear pulse-echo array, 2.25 MHz, 20 elements, 1.2 mm pitch.

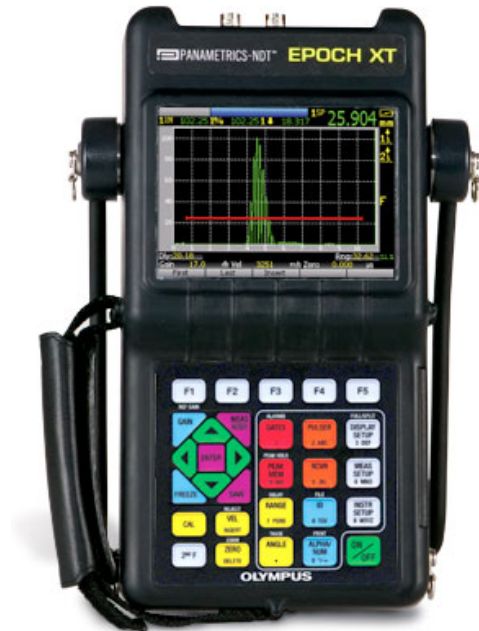
The Olympus EPOCH XT Ultrasonic Flaw Detector is designed for inspection flexibility and for use in extreme environments. It combines a multitude of enhanced flaw detection and measurement features, including Dynamic DAC/TVG (Distance Amplitude Correction/ Time Varied Gain), On-board DGS/AVG and AWS D1.1 & D1.5 criteria.

Figure 2-2 Olympus Panametrics EPOCH XT™
