EVALUATION OF ENERGY ABSORBERS FOR USE IN A ROADSIDE/MEDIAN BARRIER

MwRSF Research Report No. TRP-03-280-14

February 6, 2014

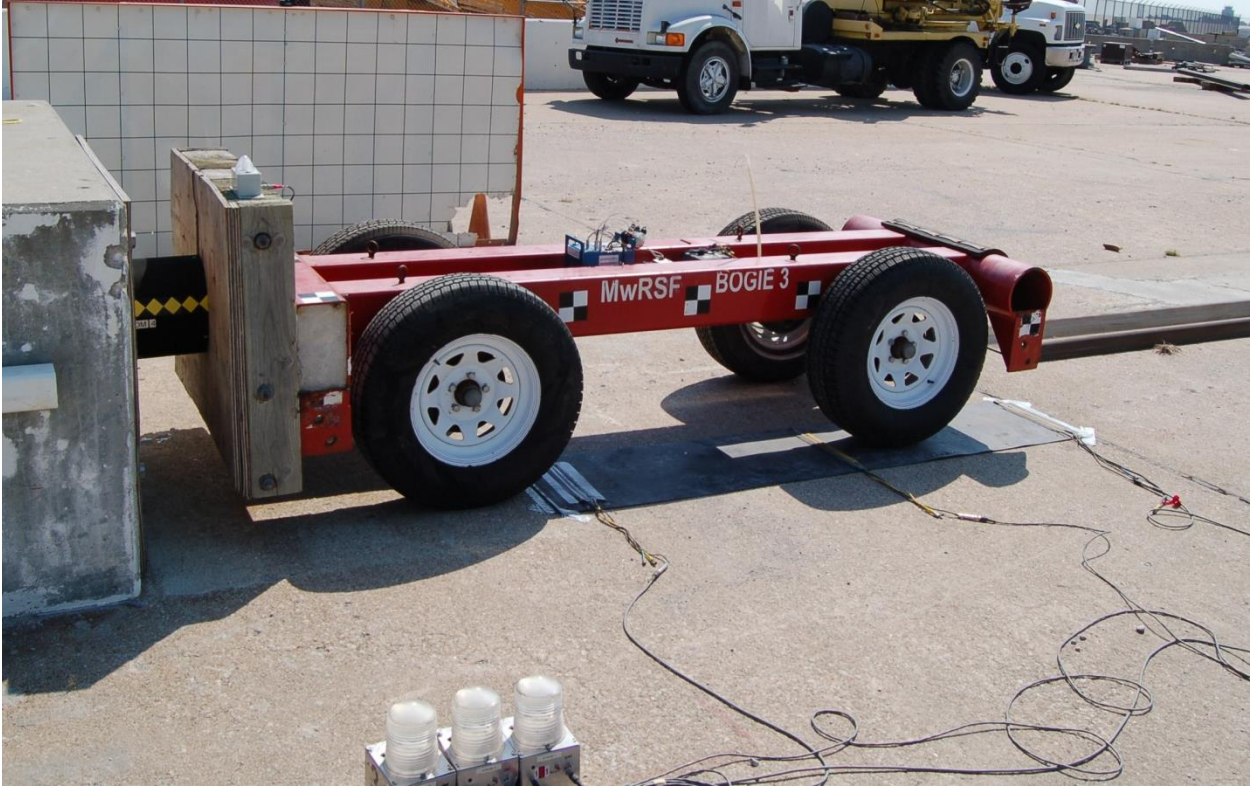
Figure 1. Rigid-Frame Bogie on Guidance Track, Test Nos. EPDM-1 through EPDM-12

A steel corrugated-beam guardrail was used to guide the tires of the bogie vehicle for test nos. EPDM-1 through EPDM-12 and test no. HSF14-5, as shown in Figures 1 and 3. A steel-pipe guidance track was used to guide the bogie vehicle for test nos. HSF14-1 through HSF14-4, SFHC-1, and SFHT-1, as shown in Figures 2 and 4.

Two rigid-frame bogies were used to impact the elastomeric components and simple barrier systems. A variable-height, detachable impact head was used during the dynamic component testing. The fabricated bogie head was constructed of six 6-in. (152-mm) wide x 8-in. (203-mm) deep x 34-in. (864-mm) long timbers covered with plywood. In test no. HSF14-5, an additional 6-in. (152-mm) x 8-in. (203-mm) timber beam was attached horizontally to the impact head. The impact head was bolted to the bogie vehicle, thus creating a large impact face. The bogie weights, including the mountable impact head and accelerometers, are shown in Table 1. The bogie vehicles used in each of the tests are shown in Figures 1 through 4.

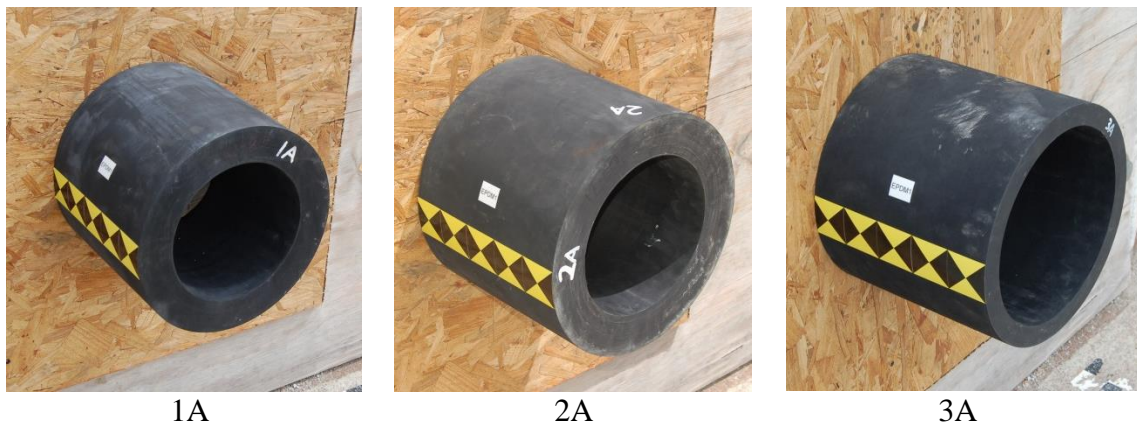
Figure 5. EPDM Rubber Cylinders 1A, 2A, and 3A

nos. EPDM-3 through EPDM-12 were conducted on an 80 durometer, 1-in. (25-mm) thick cylinder with repeated impact events. The cylinders are shown in Figure 5. The target impact conditions were a speed of 5 mph (8 km/h) and an angle of 0 degrees, axially compressing the cylinders. The cylinders were impacted 22 in. (559 mm) above the groundline, such that the applied force was approximately aligned with the center of gravity (c.g.) height of the bogie. The test matrix and test setup are shown in Figures 6 through 9.

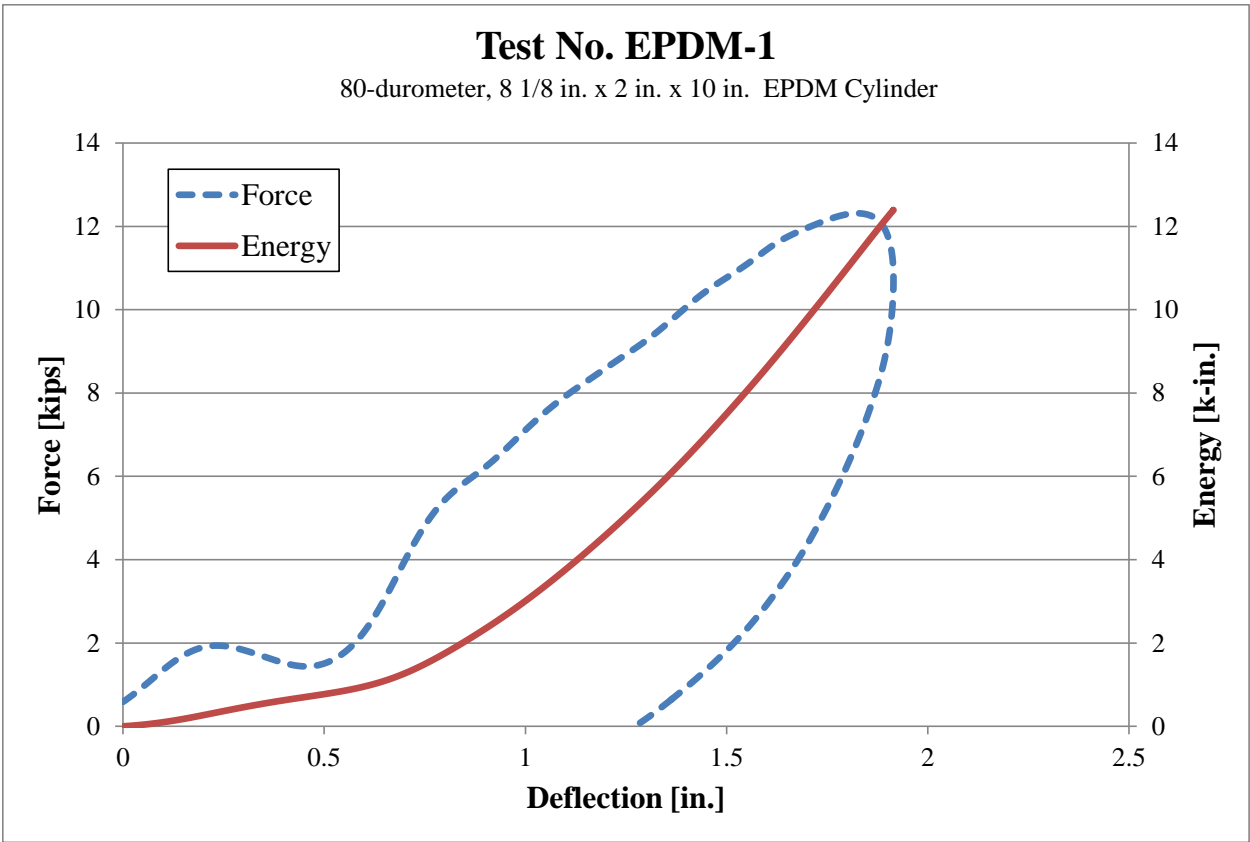
Figure 14. Force vs. Deflection and Energy vs. Deflection, Test No. EPDM-1

The 1,686-lb (765-kg) bogie impacted the 2-in. (51-mm) thick, 80-durometer EPDM cylinder at a speed of 4.3 mph (6.9 km/h) and at an angle of 0 degrees. The cylinder compressed 1.9 in. (48 mm) in 0.040 sec. Upon post-test examination, the cylinder was not damaged and had no permanent set.

Force vs. deflection and energy vs. deflection curves created from the DTS accelerometer data are shown in Figure 14. The peak force of 12.3 k (54.7 kN) occurred at 1.8 in. (46 mm) deflection. The total energy was 12.4 k-in. (1.4 kJ). Sequential photographs are shown in Figure 15.

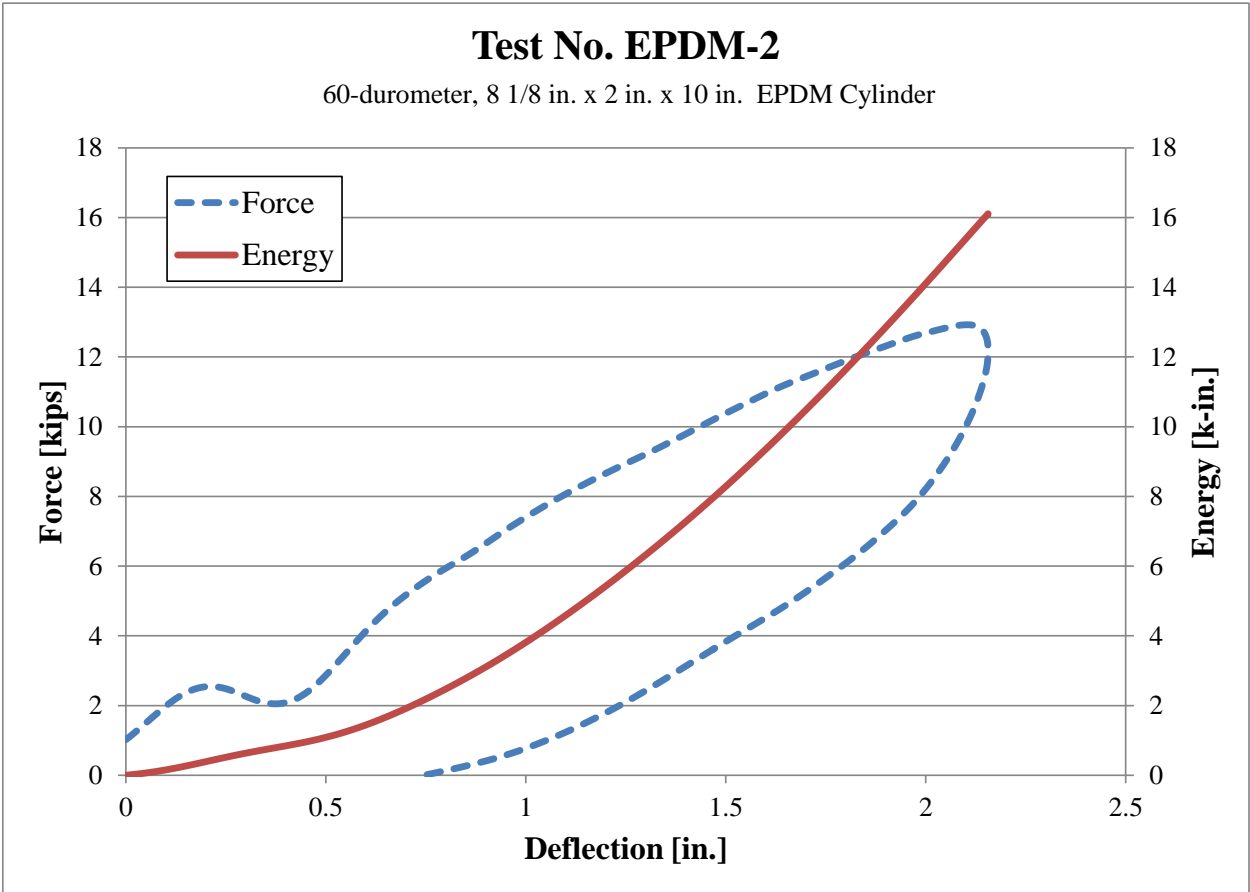
Figure 16. Force vs. Deflection and Energy vs. Deflection, Test No. EPDM-2

The 1,686-lb (765-kg) bogie impacted the 2-in. (51-mm) thick, 60-durometer EPDM cylinder at a speed of 4.9 mph (7.8 km/h) and at an angle of 0 degrees. The cylinder compressed 2.2 in. (56 mm) in 0.041 sec. Upon post-test examination, the cylinder was not damaged and had no permanent set.

Force vs. deflection and energy vs. deflection curves created from the DTS accelerometer data are shown in Figure 16. The peak force of 12.9 k (57.5 kN) occurred at 2.1 in. (53 mm) deflection. The total energy was 16.1 k-in. (1.8 kJ). Sequential photographs are shown in Figure 17.

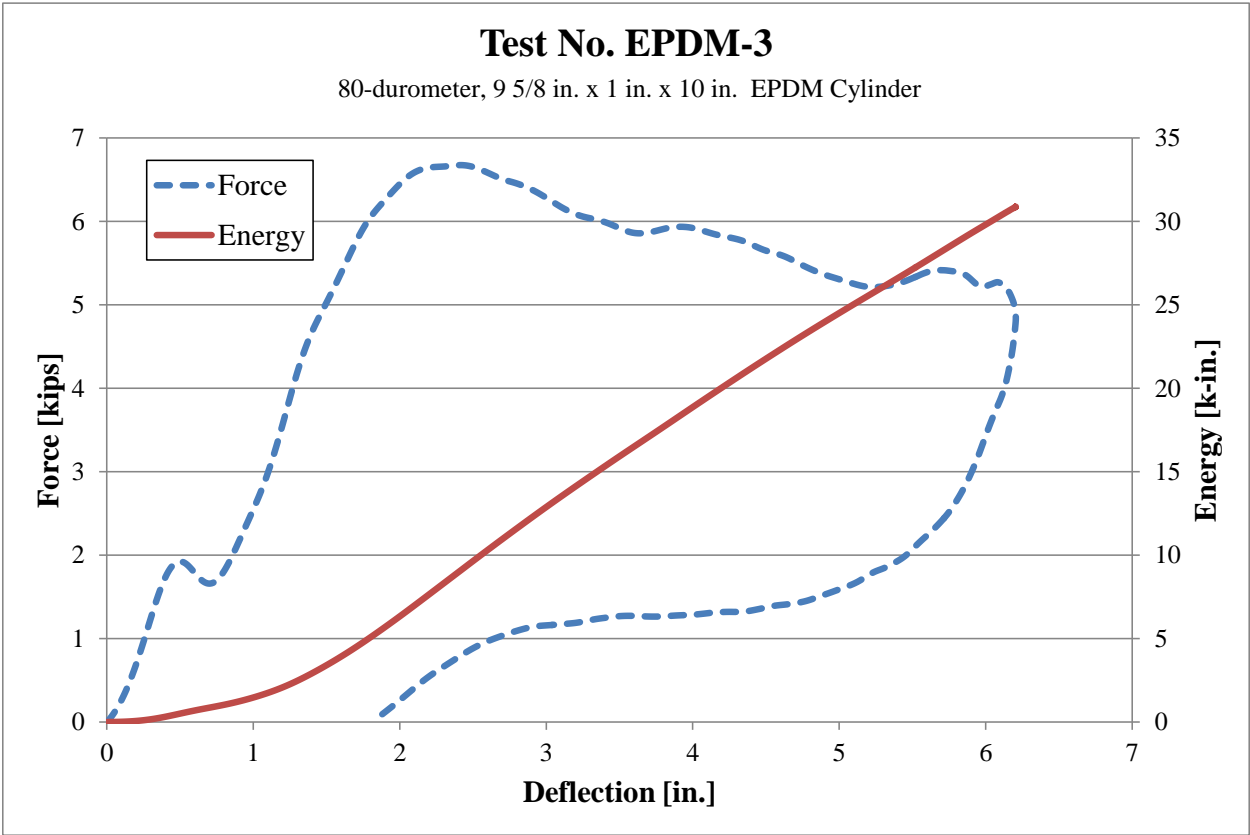
Figure 18. Force vs. Deflection and Energy vs. Deflection, Test No. EPDM-3

The 1,686-lb (765-kg) bogie impacted the 1-in. (25-mm) thick, 80-durometer EPDM cylinder at a speed of 6.8 mph (10.9 km/h) and at an angle of 0 degrees. The cylinder compressed 6.2 in. (157 mm) in 0.101 sec. Upon post-test examination, the cylinder was not damaged and had no permanent set.

Force vs. deflection and energy vs. deflection curves created from the DTS accelerometer data are shown in Figure 18. The peak force of 6.7 k (29.8 kN) occurred at 2.4 in. (61 mm) of deflection. The total energy was 30.9 k-in. (3.5 kJ). Sequential photographs are shown in Figure 19.

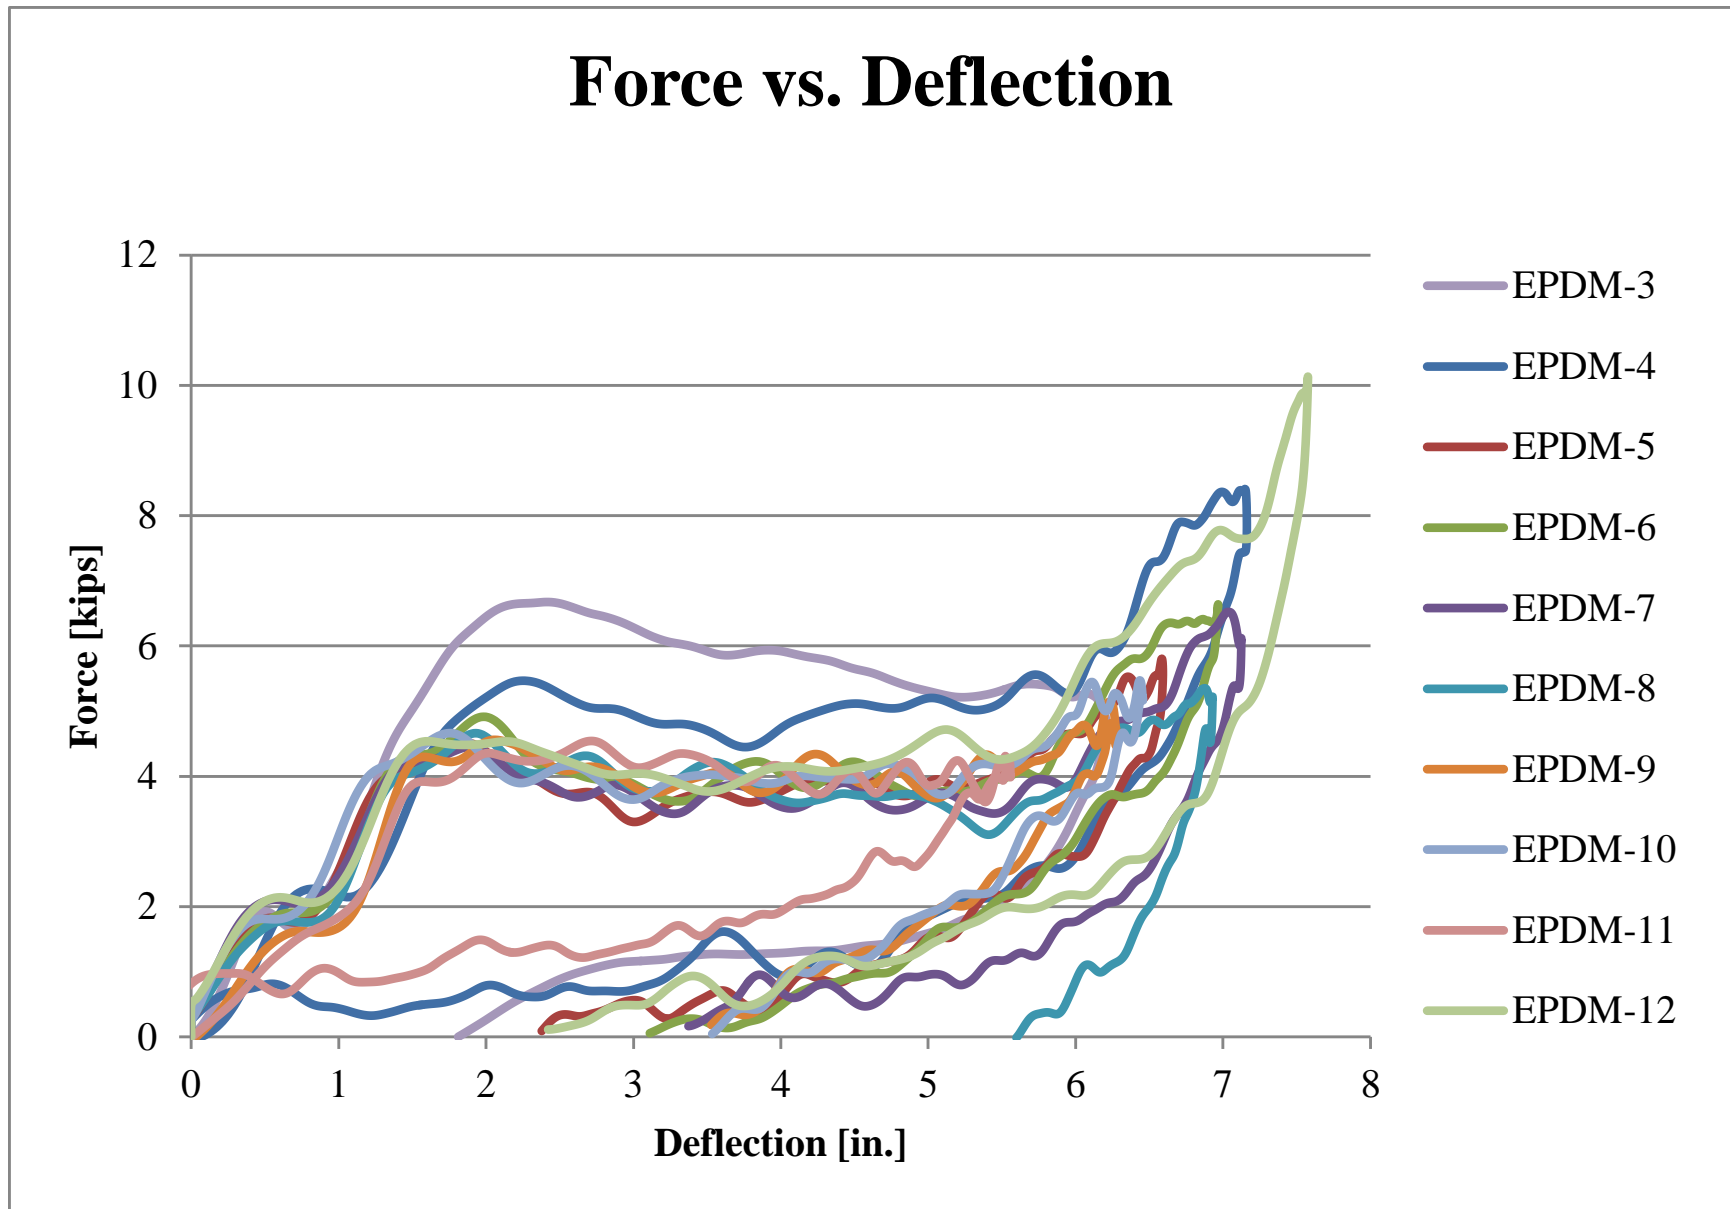
Figure 20. Force vs. Deflection of 9% x 1x10 in. (244x25x254 mm) Cylinders, Test Nos. EPDM-3 through EPDM-12

The 1,689-lb (766-kg) bogie impacted the 1-in. (25-mm) thick, 80-durometer EPDM cylinder at approximately 5 mph (8 km/h) and at an angle of 0 degrees for 9 consecutive tests. With the addition of EPDM-3, a total of 10 component tests were conducted on this cylinder. Upon post-test examination, the cylinder was not damaged and had no permanent set.

Plots showing the energy vs. velocity and peak force vs. deflection for the 10 tests are shown in Figures 22 through 23, respectively. While the surface temperature of the rubber was taken for each test, there was not a specific trend that could be discerned due to temperature; since, there was not an extreme variation in temperature. The rubber surface temperature, bogie velocity, maximum deflection, peak force, and total energy for test nos. EPDM-3 through EPDM-12 are shown in Table 5.

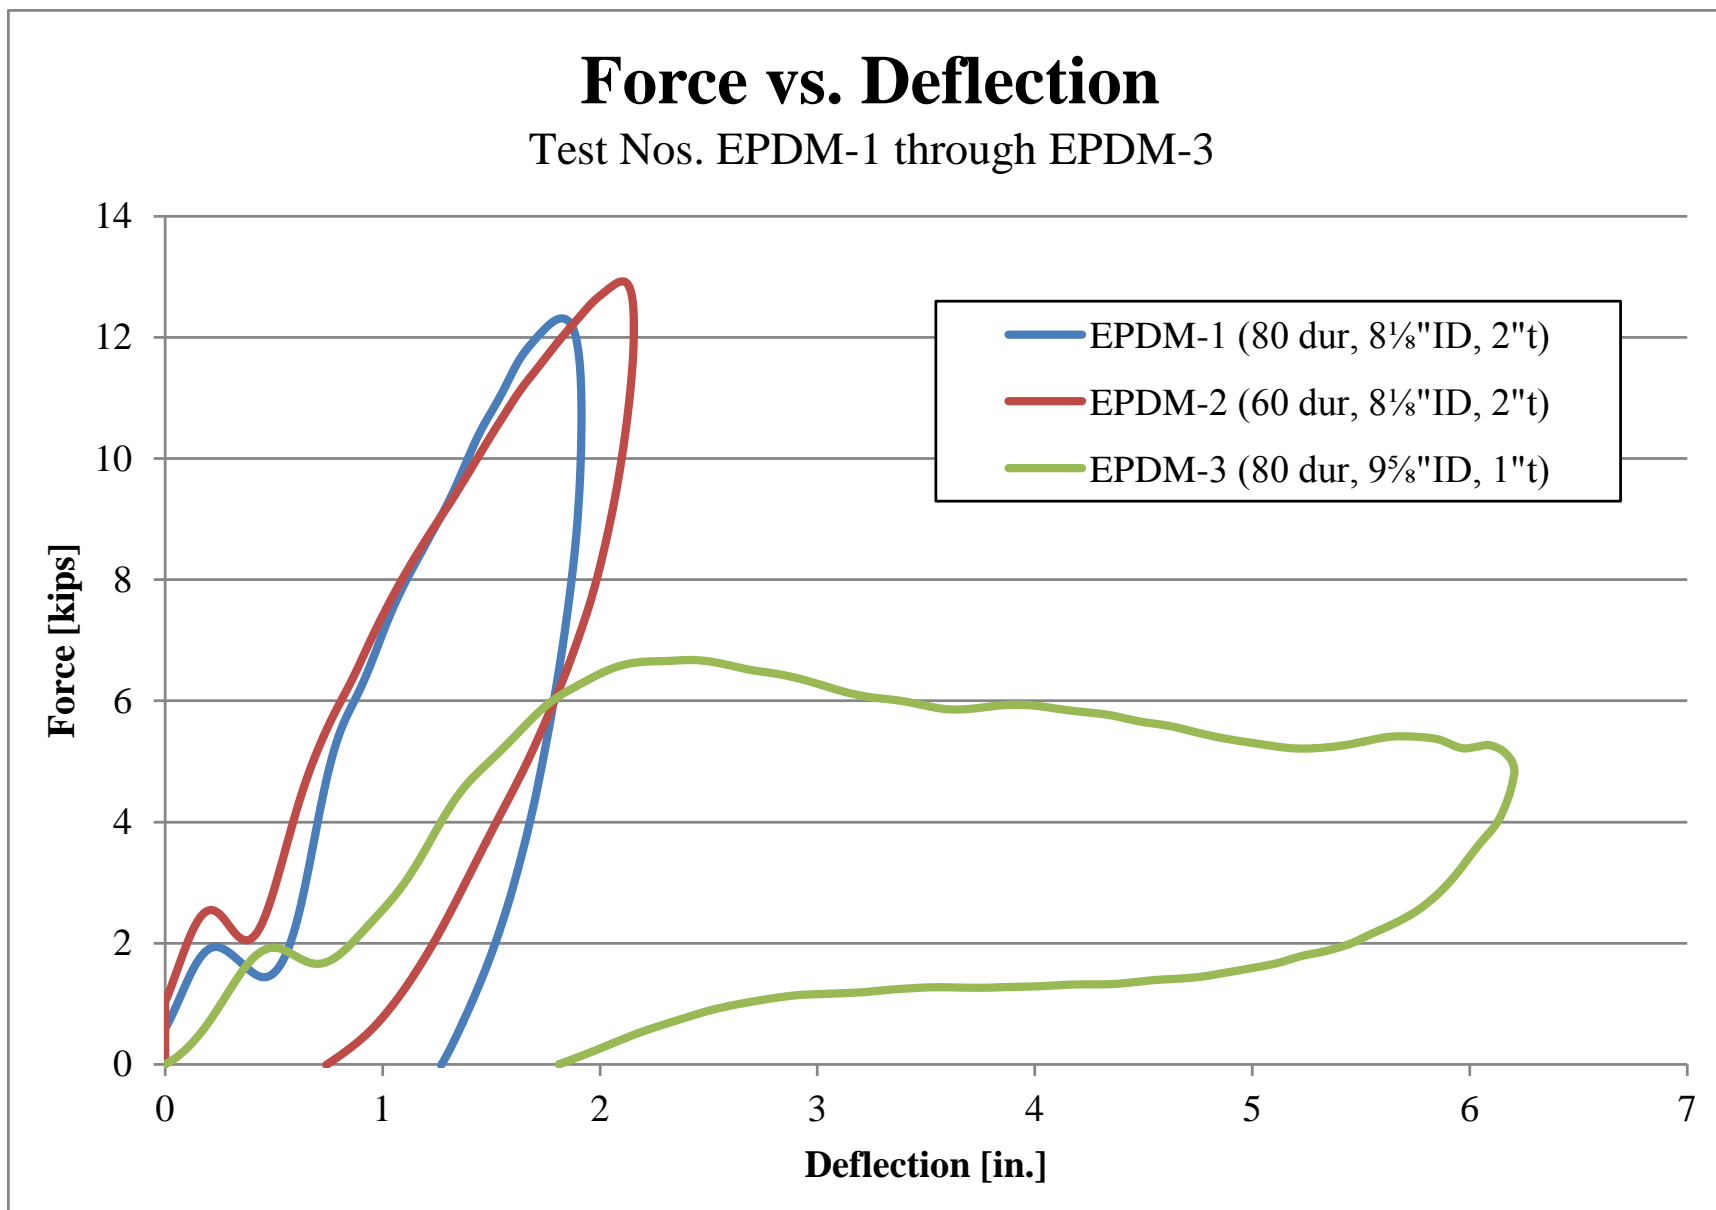
Figure 24. Force vs. Deflection of EPDM Cylinders, Test Nos. EPDM-1 through EPDM-3

Force vs. deflection and energy vs. deflection were compared for the three different cylinder types, as shown in Figures 24 and 25, respectively. Only a slight difference was observed between the 60 and 80 durometer rubber cylinders (test nos. EPDM-1 and EPDM-2). The 1-in. (25-mm) thick cylinder (test no. EPDM-3) had one-half of the peak force, 2.5 times the total energy, and deflected 3 times as much as the 2-in. (51-mm) thick cylinder (test no. EPDM-1). However, the velocity of test no. EPDM-3 was also approximately 1.5 times greater than test no. EPDM-1. At

Only a slight difference was observed between the 60 and 80 durometer rubber cylinders (test nos. EPDM-1 and EPDM-2). The 1-in. (25-mm) thick cylinder (test no. EPDM-3) had one-half of the peak force, 2.5 times the total energy, and deflected 3 times as much as the 2-in. (51-mm) thick cylinder (test no. EPDM-1). However, the velocity of test no. EPDM-3 was also 1.5 times greater than test no. EPDM-1. Test nos. EPDM-4 through EPDM-12 did not show much

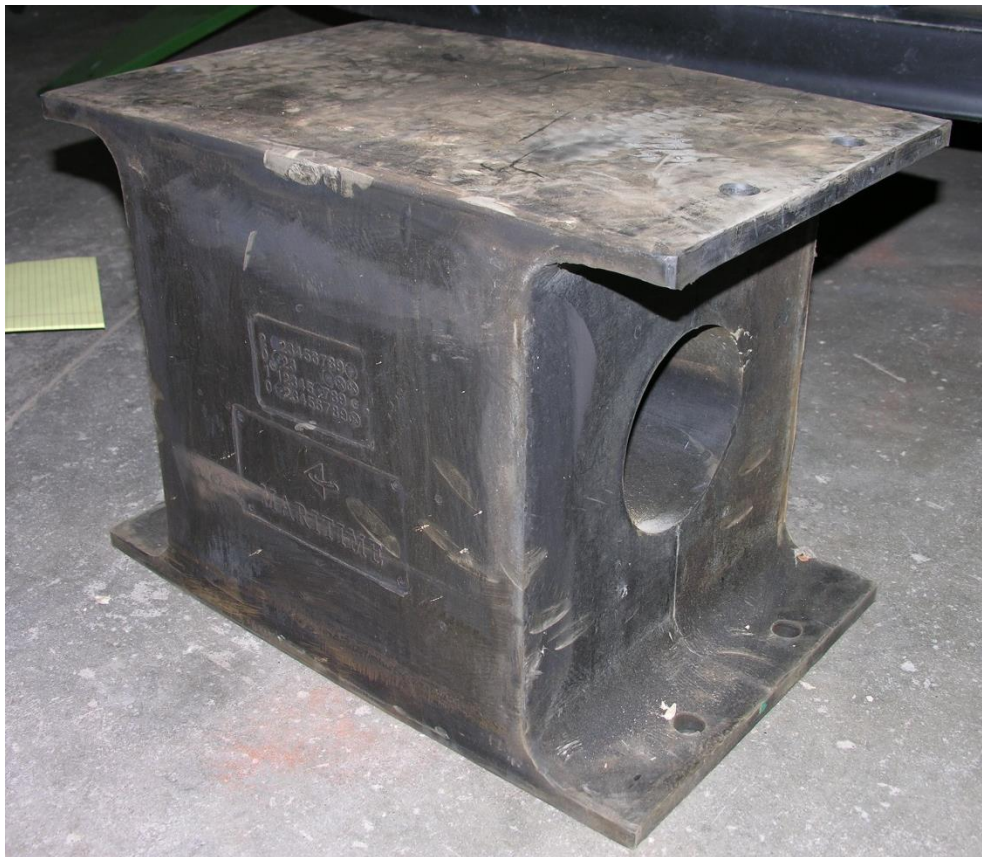
Figure 26. Maritime International, Inc. HSF-14 Marine Shear Fender

Another design concept included energy-absorbing posts in conjunction with a continuous top rail. Maritime International, Inc. from Broussard, LA donated two HSF-14 marine shear fenders for evaluation in an energy-absorbing barrier. An example of a HSF-14 marine shear fender is shown in Figure 26.

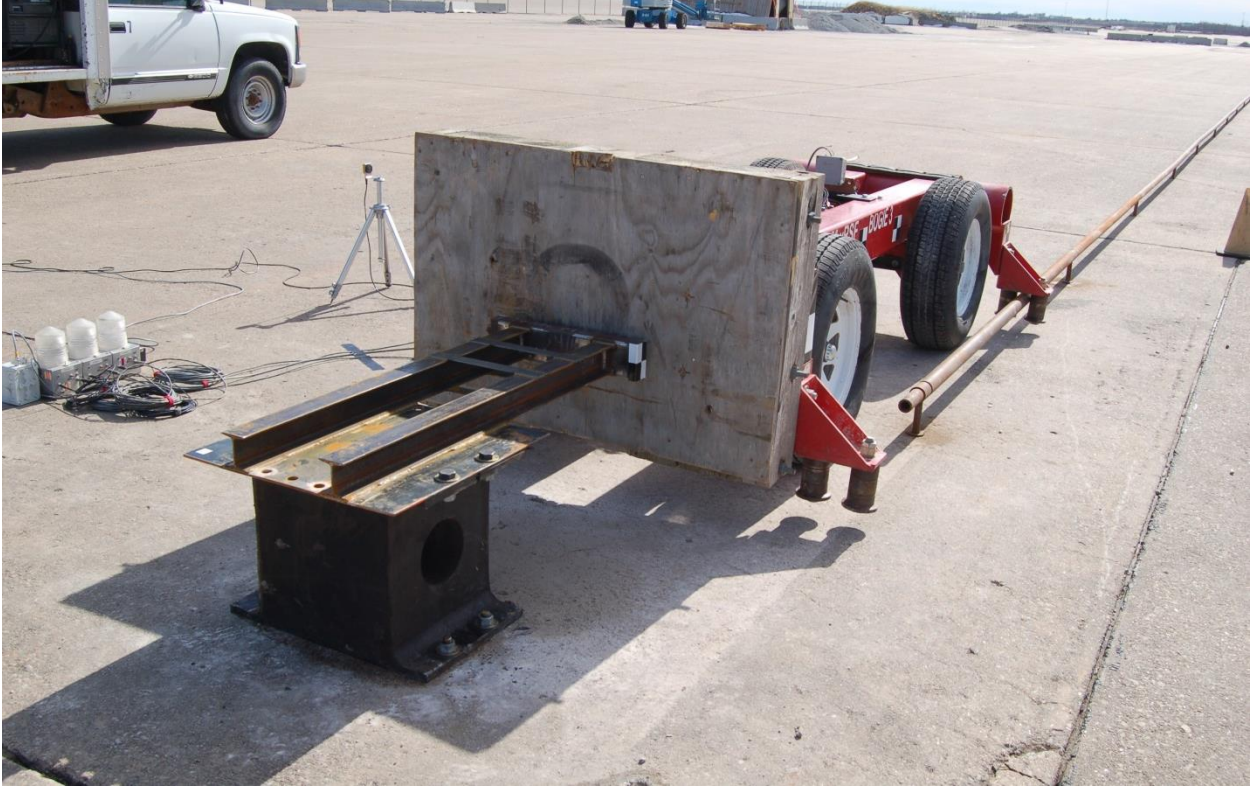
Figure 37. Bogie Setup, Test No. HSF14-1

The target impact speeds included 5 mph (8 km/h) for test nos. HSF14-1 and HSF14-2, 10 mph (16 km/h) for test nos. HSF14-3 and HSF14-5, and 15 mph (24 km/h) for test no. HSF14-4. An 1,818-lb (825-kg) bogie was used for test nos. HSF14-1 through HSF14-4, and a 4,946-lb (2,243-kg) bogie was used for test no. HSF14-5. The impact height was 17¾ in. (451 mm) above the ground line. A steel-frame structure was bolted to the top of the shear fender. The bottom of the shear fender was attached to the ground with threaded rods that were epoxied into a concrete tarmac. The test matrix and test setup are shown in Figures 27 through 36. Test setup photographs are shown in Figures 37 through 39.

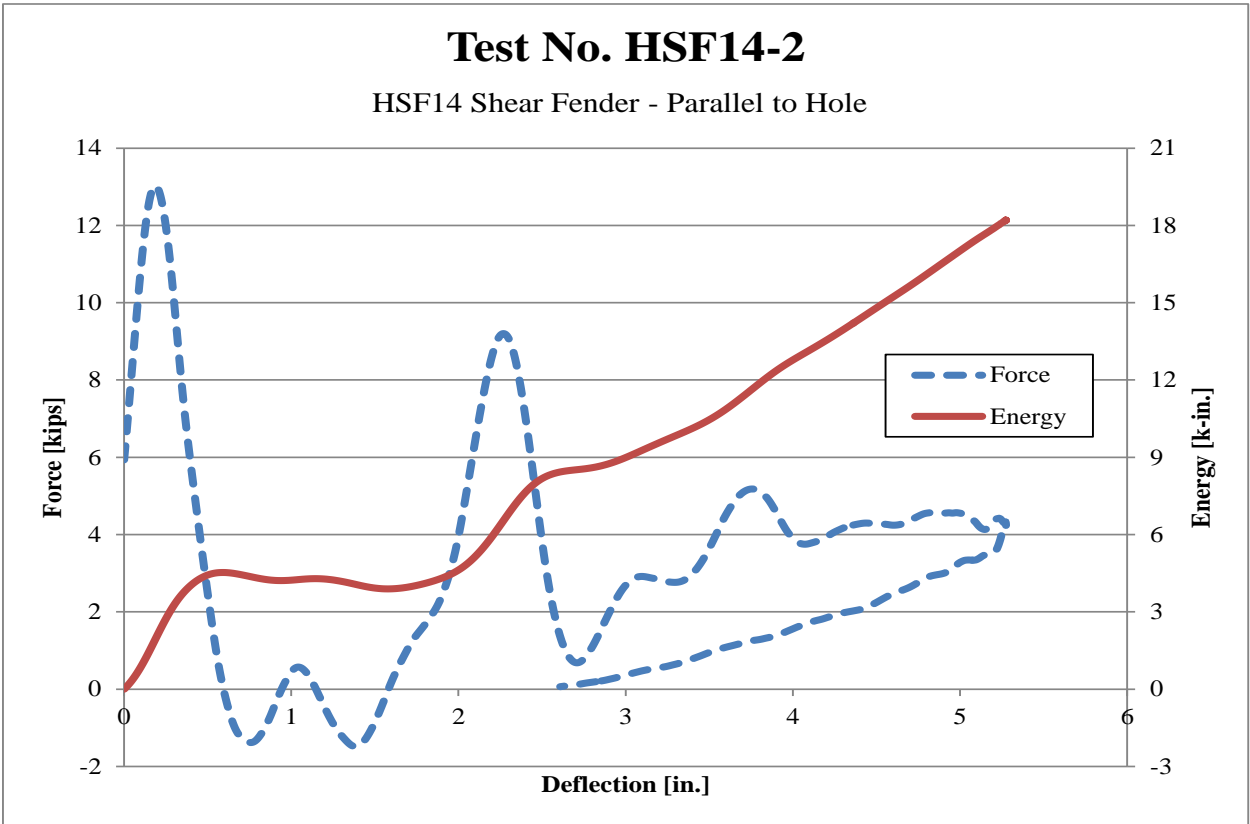
Figure 42. Force vs. Deflection and Energy vs. Deflection, Test No. HSF14-2

The 1,818-lb (825-kg) bogie impacted a new HSF14 shear fender longitudinally (parallel to the hole) at 5.0 mph (8.0 km/h). The shear fender deflected in shear to a maximum of 5.3 in. (135 mm) at 0.110 sec after impact. Upon post-test examination, the shear fender was not damaged and had no permanent set.

Force vs. deflection and energy vs. deflection curves created from the DTS accelerometer data are shown in Figure 42. Initially, inertial effects resulted in a high peak force over the first 0.5 in. (13 mm) of deflection. The force then returned to 0 kips for the next 1 in. (25 mm) of deflection due to the rebounding nature of rubber. From 1.5 in. to 5.3 in. (38 mm to 135 mm), the average force was approximately 4 kips (17.8 kN). At the maximum deflection of 5.3 in. (135 mm), the shear fender had absorbed 18.2 k-in. (2.1 kJ) of energy. Sequential photographs are shown in Figure 43.

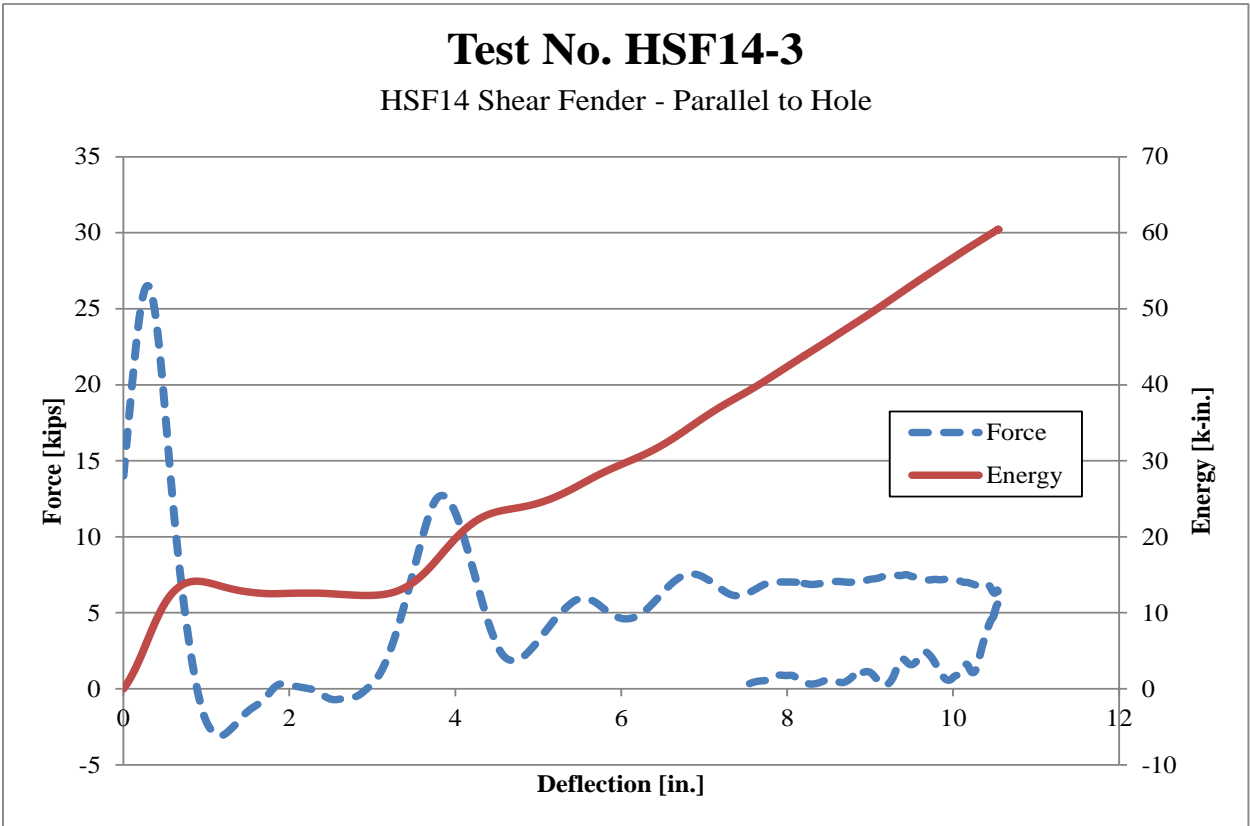
Figure 44. Force vs. Deflection and Energy vs. Deflection, Test No. HSF14-3

The 1,818-lb (825-kg) bogie impacted the HSF14 shear fender, which was used in HSF14-2, longitudinally (parallel to the hole) at 9.1 mph (14.6 km/h). The shear fender deflected in shear and reached a maximum deflection of 10.5 in. (267 mm) at 0.124 sec after impact. Upon post-test examination, the shear fender was not damaged and had no permanent set.

Force vs. deflection and energy vs. deflection curves created from the DTS accelerometer data are shown in Figure 44. Initially, inertial effects resulted in a high peak force over the first 1 in. (25 mm) of deflection. The force then returned to 0 kips for the next 2 in. (51 mm) of deflection due to the rebounding nature of rubber. From 3 in. to 10.5 in. (76 mm to 267 mm), the average force was approximately 6.5 kips (28.9 kN). At a maximum deflection of 10.5 in. (267 mm), the shear fender had absorbed 60.5 k-in. (6.8 kJ) of energy. Sequential photographs are shown in Figure 45.

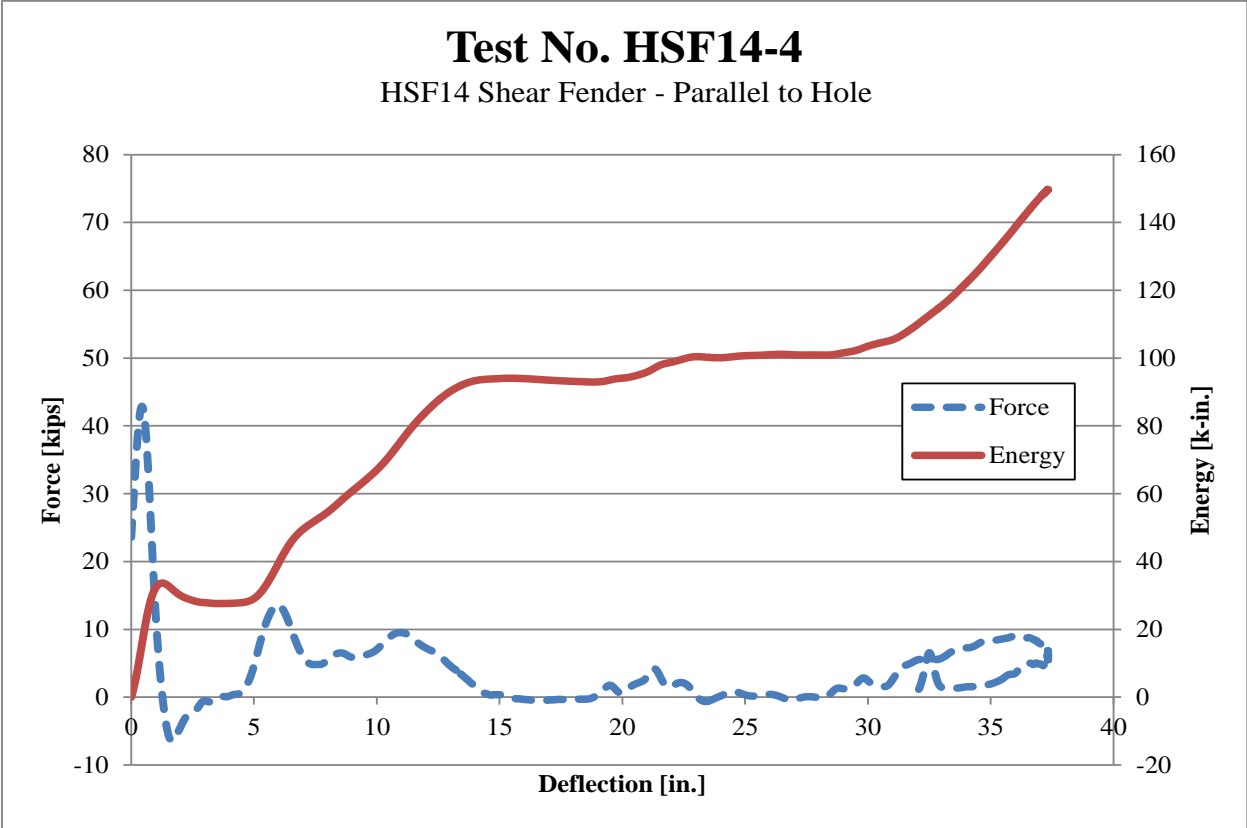
Figure 46. Force vs. Deflection and Energy vs. Deflection, Test No. HSF14-4

The 1,818-lb (825-kg) bogie impacted the HSF14 shear fender, which was used in test no. HSF14-3, longitudinally (parallel to the hole) at 14.3 mph (23.0 km/h). The maximum longitudinal displacement of the bogie was 37.3 in. (947 mm) at 0.274 sec after impact. However, the steel impact structure rotated and caught on top of the bogie head, and the maximum deflection of the shear fender was approximately 13 in. (330 mm), as determined from high-speed video. The shear fender was subjected to shear, torsional, and tensile loading. Upon post-test examination, the shear fender was not damaged and had no permanent set.

Force vs. deflection and energy vs. deflection curves created from the DTS accelerometer data are shown in Figure 46. Initially, inertial effects resulted in a high peak force over the first 1 in. (25 mm) of deflection. The force then returned to 0 kips for the next 3 in. (76 mm) of deflection due to the rebounding nature of rubber. From 4 in. to 13 in. (102 mm to 330 mm), the average force was approximately 7.0 kips (31.1 kN). At the shear fender's maximum deflection of 13 in. (330 mm), the shear fender had absorbed 90.2 k-in. (10.2 kJ) of energy. The steel impact structure slide up the face of the bogie head between 15 in. and 28 in. (381 mm to 711 mm) of deflection and the shear fender was mostly unloaded, so the force was approximately zero. From 28 in. to 37.3 in. (711 mm to 947 mm), the impact head contacted the face of the shear fender, and the average force was approximately 6.2 kips (27.6 kN). At the bogie's maximum deflection of 37.3 in. (947 mm), the shear fender had absorbed 149.7 k-in. (16.9 kJ) of energy. Sequential photographs are shown in Figure 43.

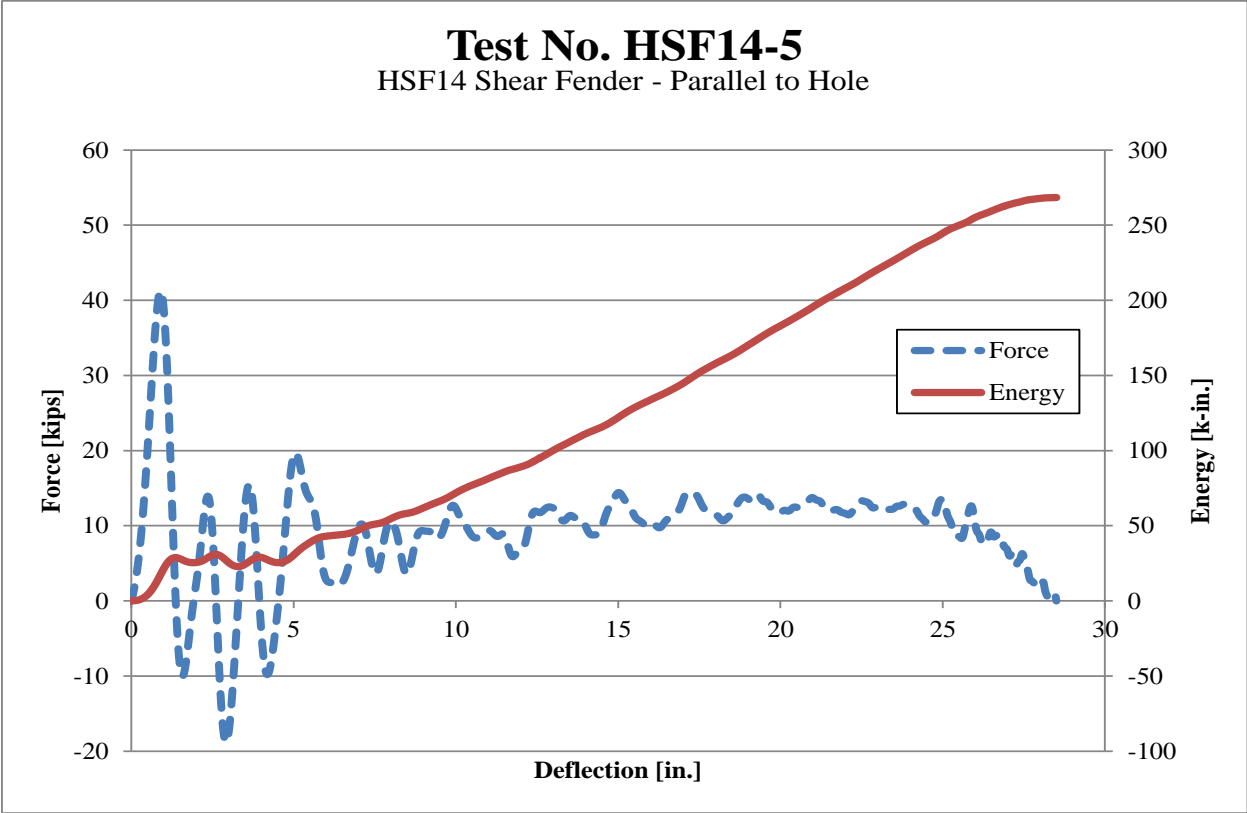
Figure 48. Force vs. Deflection and Energy vs. Deflection, Test No. HSF14-5

Upon post-test examination, slight permanent set was found. The impact-side height from the ground to the bottom of the impact plate was compressed $2\frac{1}{4}$ in. (57 mm), while the non-impact-side height was compressed $1\frac{5}{8}$ in. (41 mm) with the bogie resting on top of the shear fender. Upon removal of the bogie, the front of the shear fender was $\frac{1}{2}$ in. (13 mm) shorter and the back of the shear fender was $\frac{1}{8}$ in. (3 mm) taller. The shear fender later fully restored.

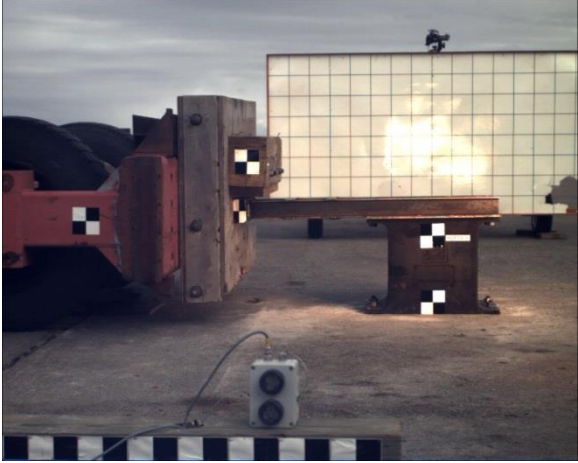
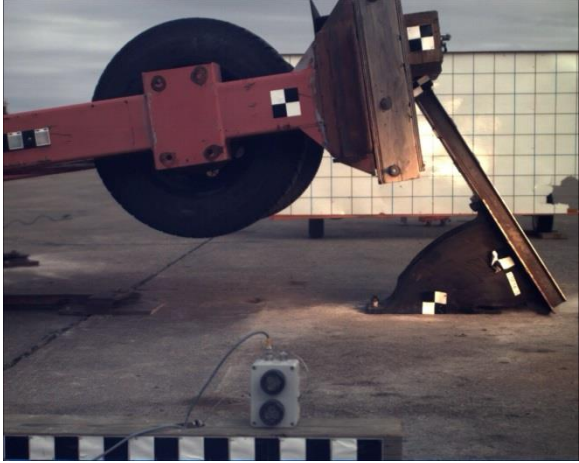
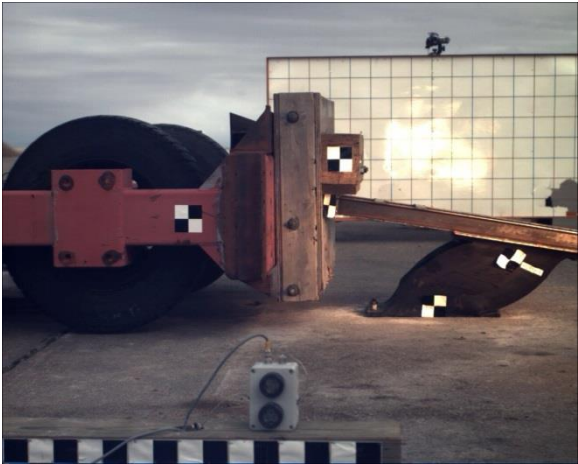
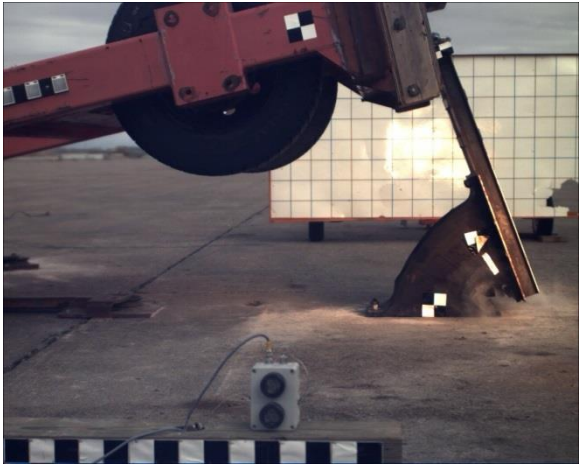
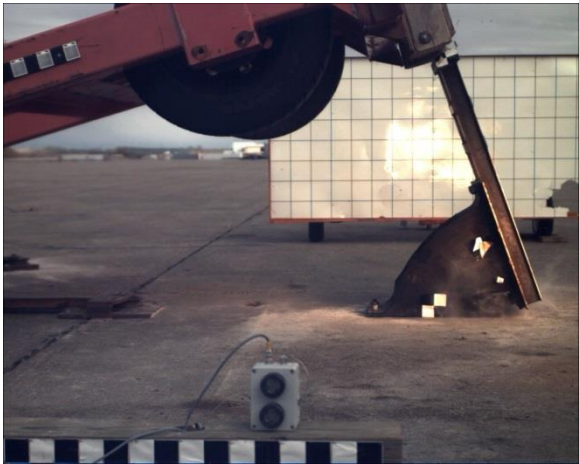
Figure 49. Time-Sequential Photographs, Test No. HSF14-5

The 4,946-lb (2,243-kg) bogie impacted the HSF14 shear fender, which was used in test no. HSF14-4, longitudinally (parallel to the hole) at 11.9 mph (19.2 km/h). The maximum longitudinal displacement of the bogie was 28.5 in. (724 mm) at 0.236 sec after impact. The shear fender deflected approximately 20 in. (508 mm), as measured from digital video. Force vs. deflection and energy vs. deflection curves created from the DTS accelerometer data are shown in Figure 48. Initially, inertial effects resulted in a high peak force over the first 1 in. (25 mm) of deflection. The force then oscillated around zero over for the next 4 in. (102 mm) of deflection due to the rebounding nature of rubber. From 5 in. to 28.5 in. (127 mm to 724 mm), the average force was approximately 9.5 kips (42.3 kN). After approximately 20 in. (508 mm) of deflection, the steel impact structure slid up the face of the bogie, and the front of the bogie became airborne. Subsequently, the front of the bogie landed on top of the shear fender and steel-frame structure. At a maximum deflection of 28.5 in. (724 mm), the shear fender had absorbed 268.4 k-in. (30.3 kJ) of energy. Sequential photographs are shown in Figure 49. Post-impact photographs immediately after the test and after removal of the bogie are shown in Figure 50.

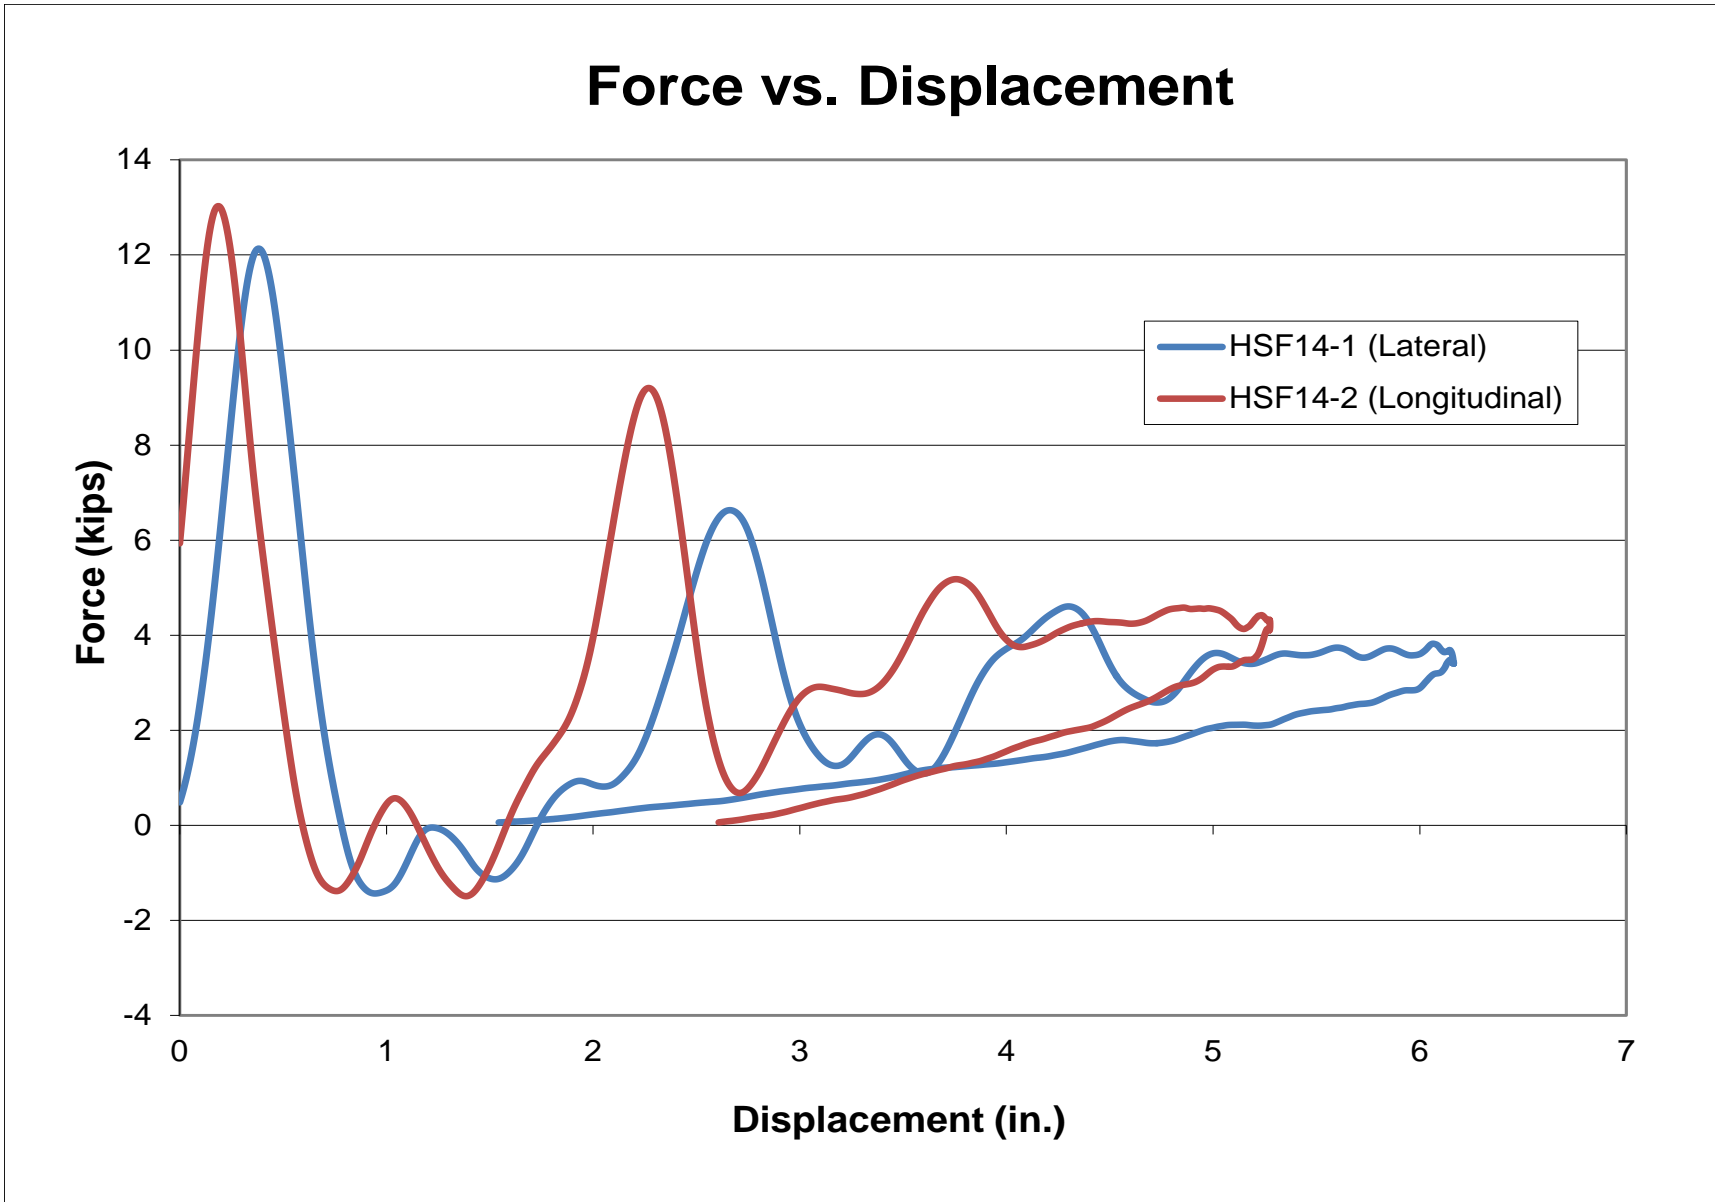
Figure 51. Force vs. Deflection, Test nos. HSF14-1 and HSF14-2

Inertial effects at the beginning of each impact were observed during all five bogie tests. As illustrated in Figures 51 and 53, the recorded data from each of the tests showed a large force spike over the first 2 in. (51 mm) of deflection. These force spikes were all different in magnitude but extended over approximately the same duration.
