EVALUATION OF ENERGY ABSORBERS FOR USE IN A ROADSIDE/MEDIAN BARRIER

MwRSF Research Report No. TRP-03-280-14

February 6, 2014

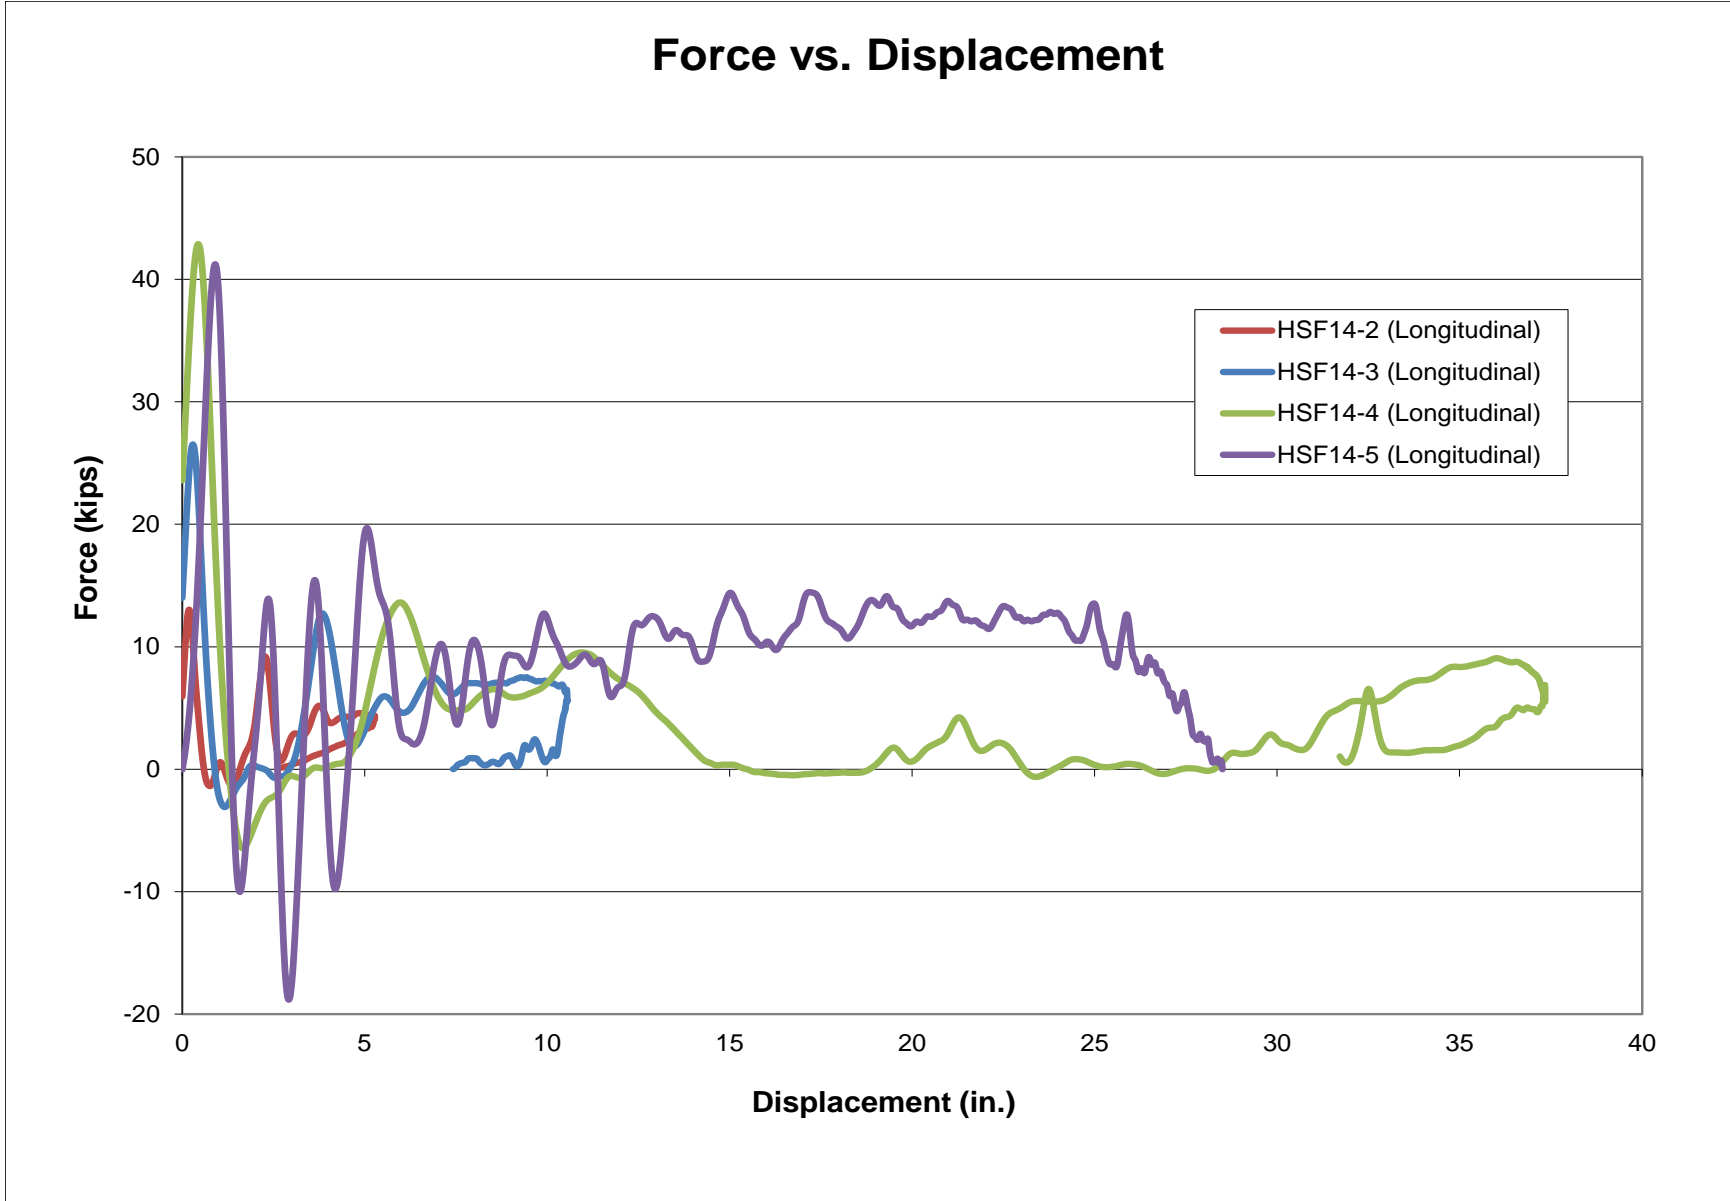
Figure 53. Force vs. Deflection, Test nos. HSF14-2 through HSF14-5

Inertial effects at the beginning of each impact were observed during all five bogie tests. As illustrated in Figures 51 and 53, the recorded data from each of the tests showed a large force spike over the first 2 in. (51 mm) of deflection. These force spikes were all different in magnitude but extended over approximately the same duration.

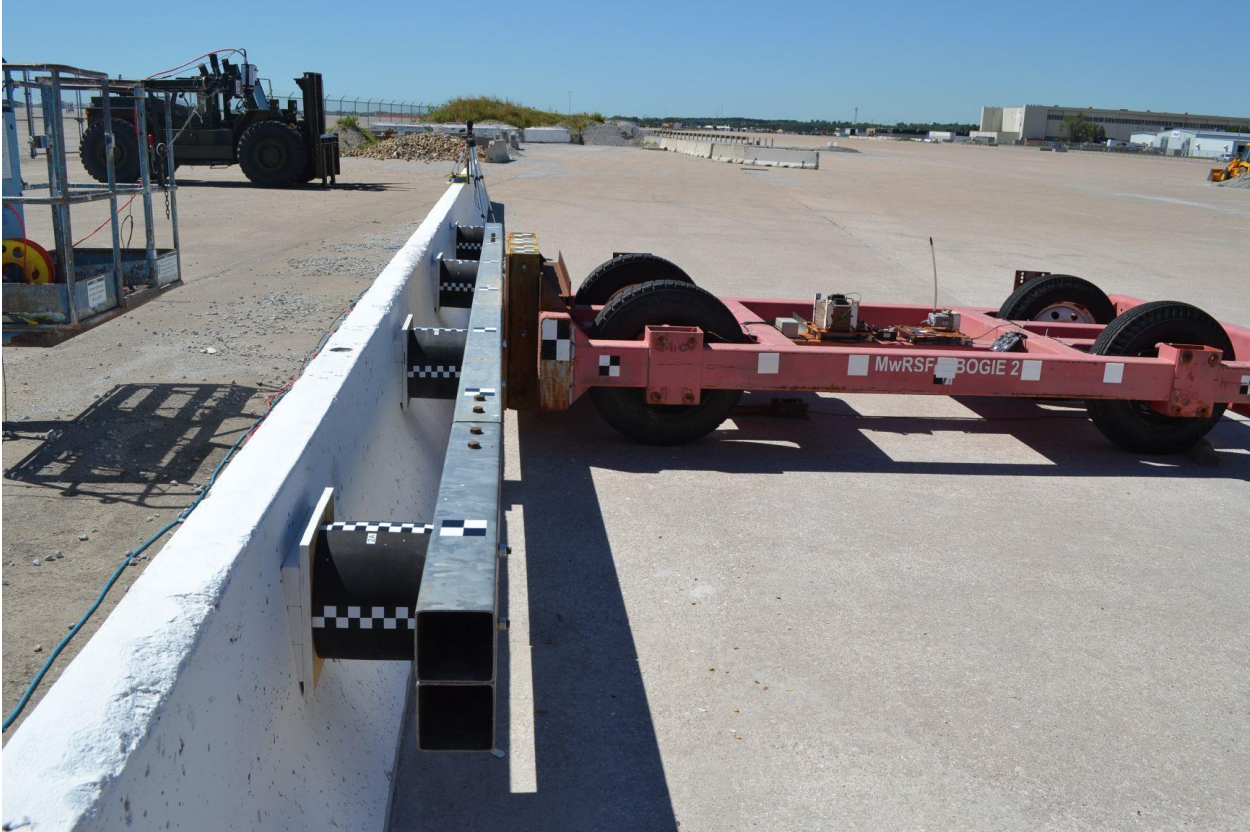
Figure 63. Bogie Test Setup, Test No. SFHC-1

A bogie test was conducted on a 27-ft (8.2-m) long prototype rubber-cylinder retrofit barrier system. The bogie impacted the system at a 90-degree angle with the target impact location at the midspan between the middle two rubber cylinders. The target impact speed was 18 mph (29.0 km/h). The impact height was 21½ in. (546 mm) above the ground line. Four 2-in. (51-mm) thick x 10-in. (254-mm) long rubber cylinders were spaced at 96 in. (2,438 mm) along a 32-in. (813-mm) tall New Jersey-shaped concrete barrier. Two ASTM A500 Grade B 6-in. x 6-in. x 3/16 in. thick (152-mm x 152-mm x 5-mm) steel tubes were placed on the front face of the cylinders. The tube hardware was selected from existing on-site remnants from prior research and development studies. The splice could not develop the full bending strength of the tube sections. However, it was deemed adequate for the concept evaluation test. The test matrix and test setup are shown in Figures 55 through 62. Testing setup photographs are shown in Figure 63.

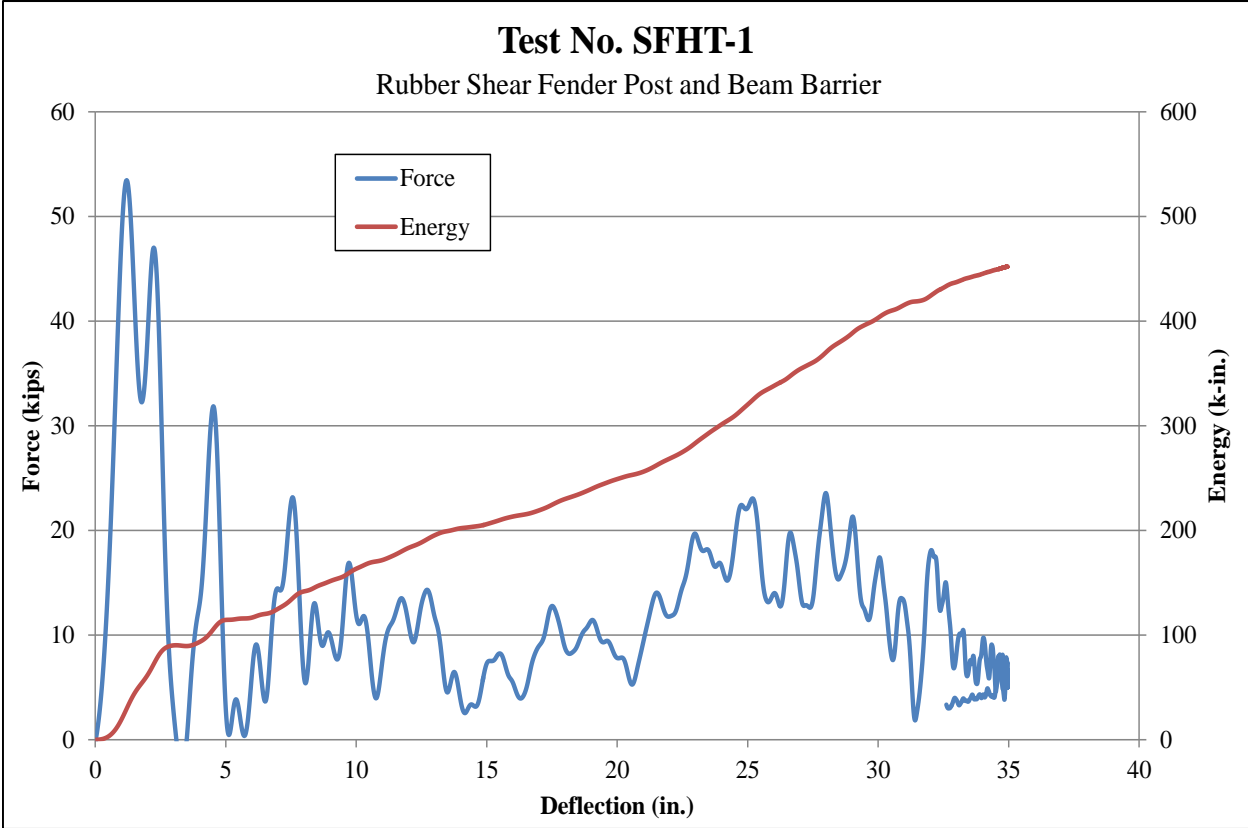
Figure 81. Force vs. Deflection and Energy vs. Deflection, Test No. SFHT-1

The 4,871-lb (2,209-kg) bogie impacted the prototype shear fender post and beam system at 15.2 mph (24.5 km/h). The timber rail displaced a maximum of 35 in. (889 mm). The timber rail rotated backward and completely fractured near the bogie's maximum displacement of 35 in. (889 mm). Each shear fender, as labeled from left to right of the barrier (nos. 1-4), rotated and deflected differently during the impact event. Shear fender no. 1 rotated for almost the entire impact to a maximum lateral deflection of 13.5 in. (343 mm). Shear fender no. 2 deflected 8 in. (203 mm) in shear and then began rotating until a maximum lateral deflection of 21.8 in. (554 mm). Shear fender no. 3 deflected 7.1 in. (180 mm) in shear and then began rotating until a maximum lateral deflection of 23 in. (584 mm). Shear fender no. 4 deflected 3.4 in. (86 mm) in shear and then began rotating until a maximum lateral deflection of 16.3 in. (414 mm).

The bogie's kinetic energy was absorbed by the barrier primarily through the deflection of the rubber shear fenders and bending and fracture of the timber rail. Shear fender no. 1 rotated during almost the entire impact. Shear fender nos. 2, 3, and 4 deflected in almost pure shear for 8 in. (203 mm), 7.1 in. (180 mm), and 3.4 in. (86 mm), respectively.

Force vs. deflection and energy vs. deflection curves created from the SLICE 6DX accelerometer data are shown in Figure 81. Initially, inertial effects resulted in an initial maximum jump in the force to 53.5 kips (238 kN). At a maximum deflection of 35 in. (889 mm), the shear fender system absorbed 452.2 k-in. (51.1 kJ) of energy. Sequential and post-impact photographs are shown in Figures 82 and 86.

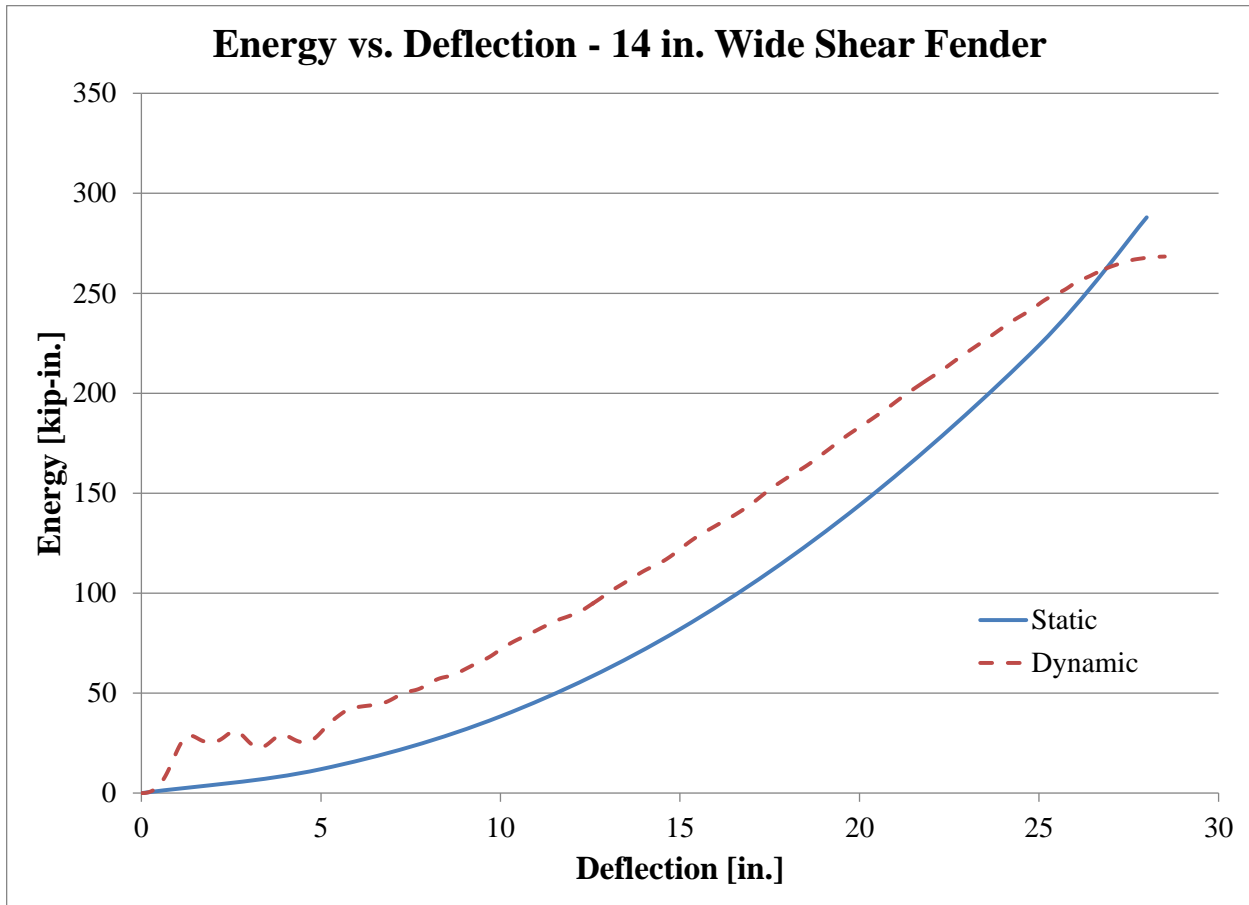
Figure 87. Static and Dynamic Energy vs. Deflection – 14-in. (356-mm) Wide Shear Fender

From test no. HSF14-5, the dynamic component test had an energy vs. deflection curve that followed the same trend as the static curve, except that it was about 30 k-in. (3.4 kJ) higher due to inertia, as shown in Figure 87. When a shear fender bends and rotates rather than deflecting in pure shear, less energy is absorbed, which is evident in Figure 87. It should be noted that the energy from the dynamic test does not increase as quickly as the static test after 20 in. (508 mm) of deflection. Considering that the dynamic energy dissipation was greater than the static energy dissipation and a rotating shear fender absorbs less energy than when deforming in shear, the energy absorbed by each shear fender during the dynamic test would be approximately the same as the static energy.

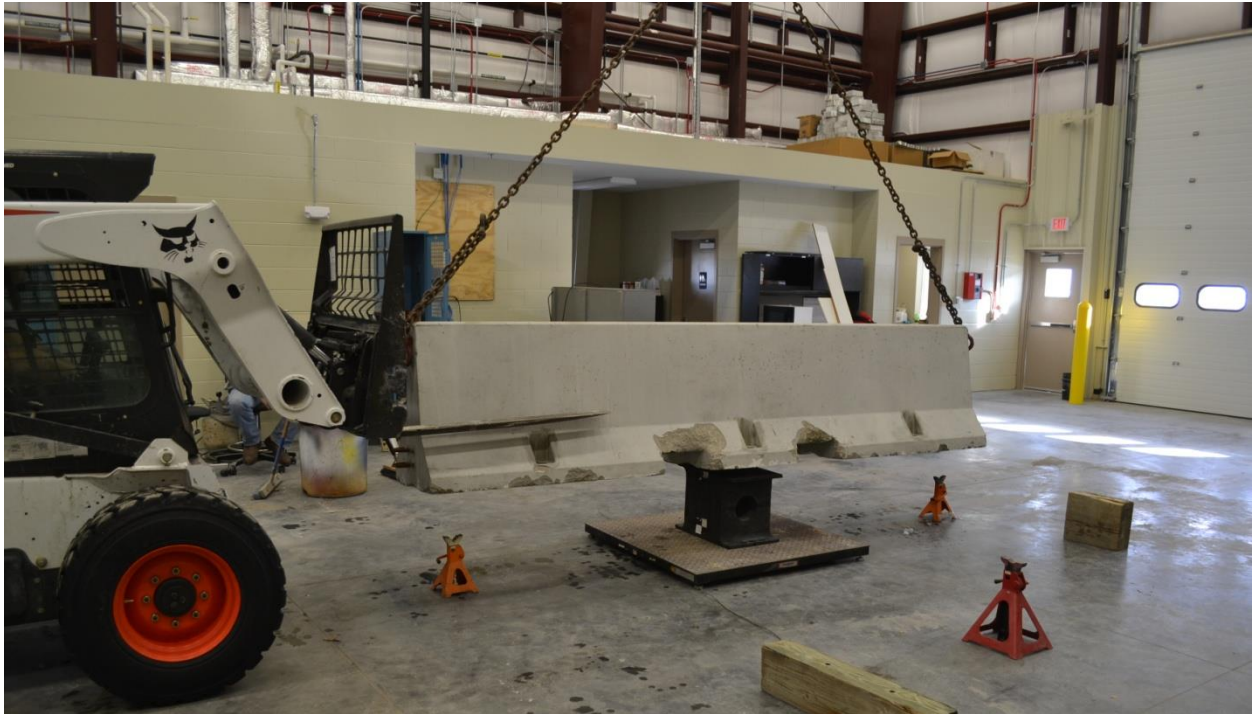
Figure 91. Testing Apparatus, Test Nos. SFHS-1 through SFHS-3

shear fender. The shear fender was loaded incrementally and deflections were measured at each known load. The test setup is shown in Figure 91.

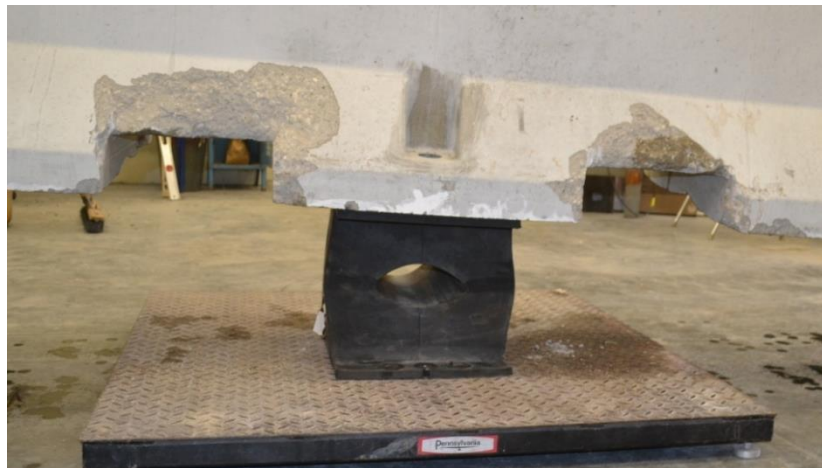
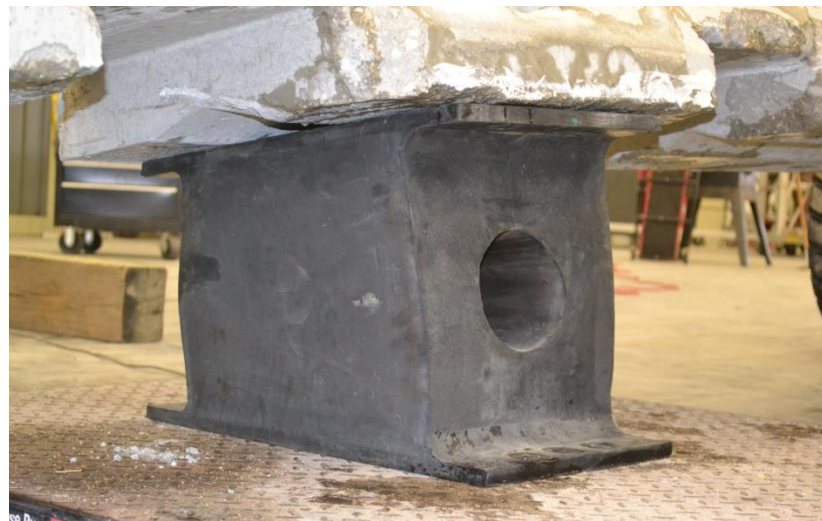
Figure 92. Example of System Instabilities, Test Nos. SFHS-1 through SFHS-3

The shear fender was loaded as uniformly as possible. However, the barrier began to lean and/or twist at higher loads and temperatures, which caused the system to be unstable, as shown in Figure 92. Therefore, the barrier was supported laterally when needed so that deflections could be measured at each load.

The system appeared to be more unstable when the shear fender was warmer. For the subfreezing temperature measurement, the shear fender was relatively stiff, and instability was not seen until loads of 4,000 to 4,500 lb (1,814 to 2,041 kg). At room temperature, instability was seen at loads of 3,000 to 3,500 lb (1,361 to 1,588 kg). For the hot temperature measurement, instability was seen at loads as low as 500 lb (227 kg). This observation may be attributed to non-uniform or unsymmetrical loading on the shear fender as well as a decrease in the modulus of rubber at warmer temperatures. Nonetheless, the shear fender showed similar load versus deflection curves over all temperature ranges, as shown in Figure 93. Vertical deflections at each point were averaged to obtain an average shear fender deflection.

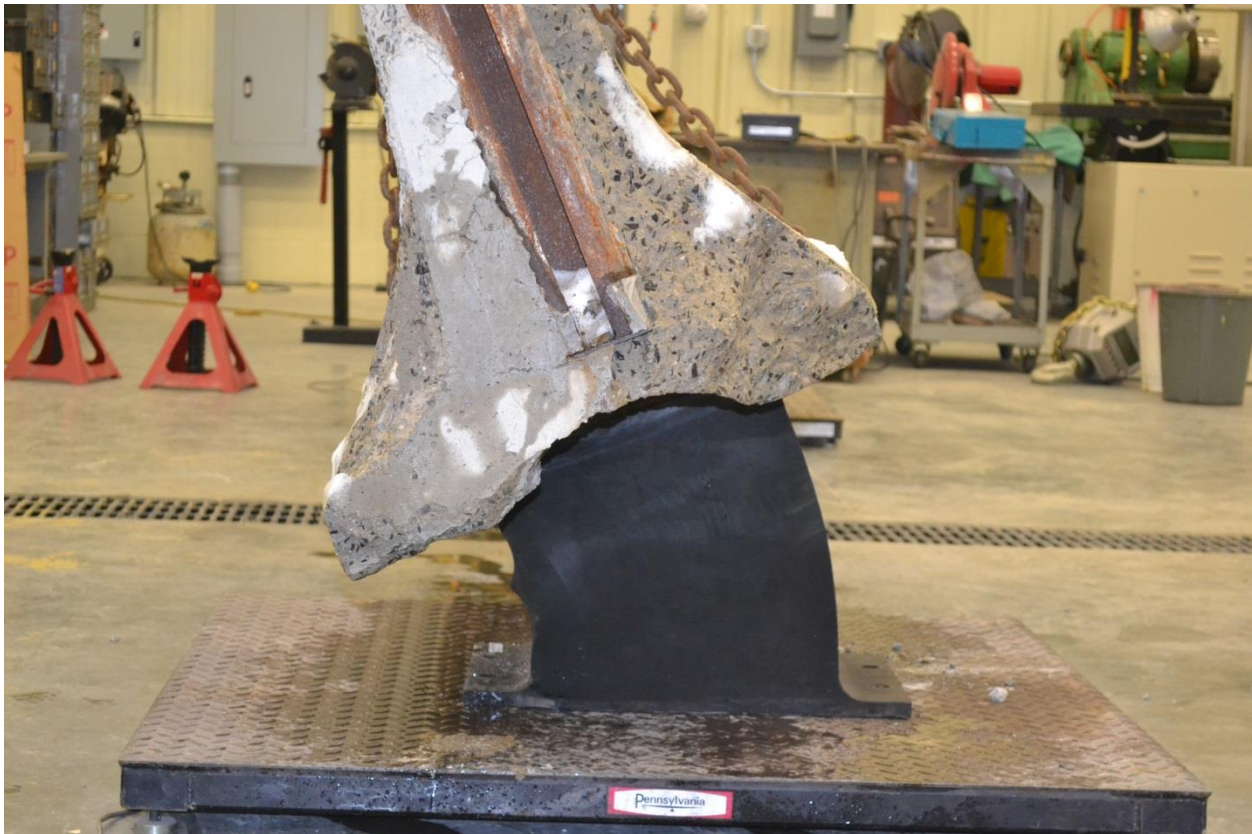
Figure 95. System Instabilities, Test No. SFHS-4

When the total applied load on top of the shear fenders was 2,977 lb (1,350 kg), the system was stable. However, when the total applied load reached 3,760 lb (1,706 kg), the barrier began leaning toward one side, as shown in Figure 95. Additional load was not applied and deflection measurements were not taken.

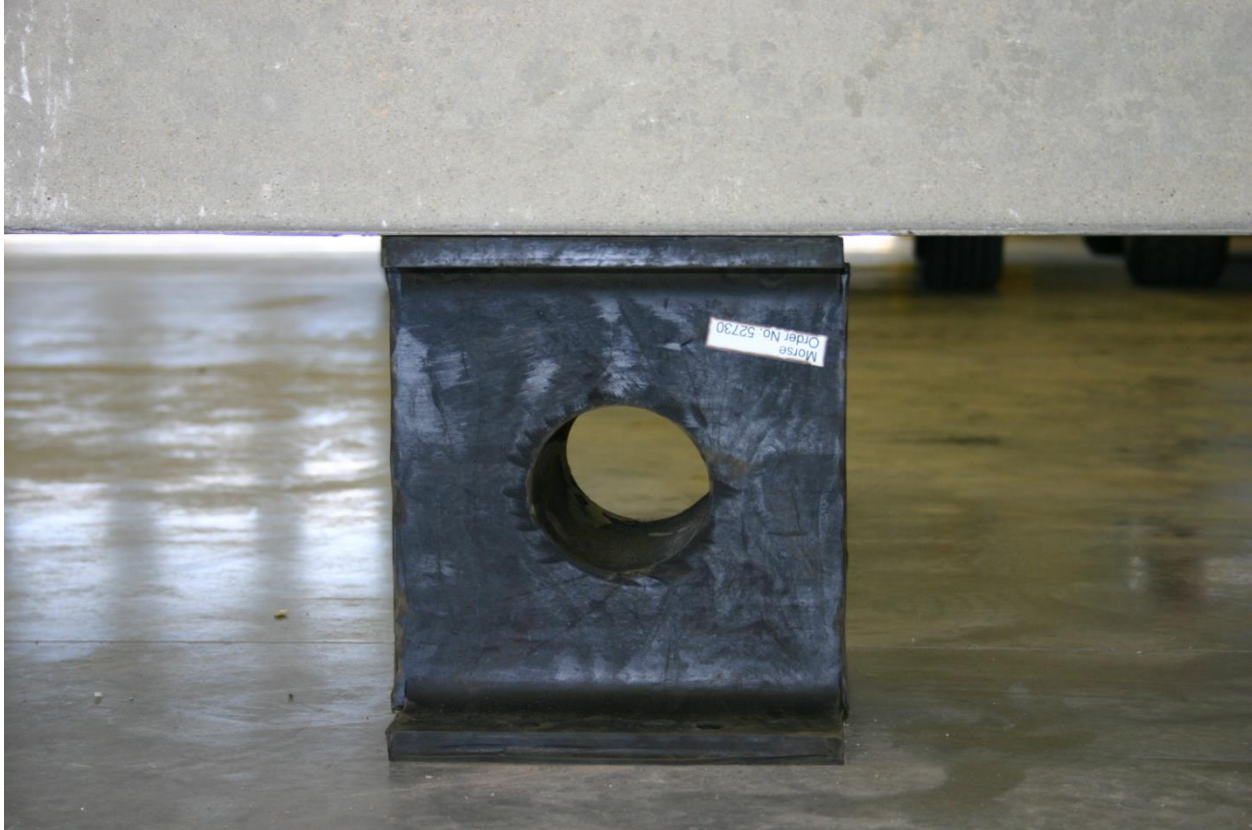
Figure 97. System Deflection at 7,000-lb (3,175-kg) Load, Test No. SFHS-7

did not present any instabilities. Load and average deflection measurements up to 4,994 lb (2,265 kg) are shown in Table 17. The deflection of one of the shear fender at the 7,000 lb (3,175-kg) load is shown in Figure 97.

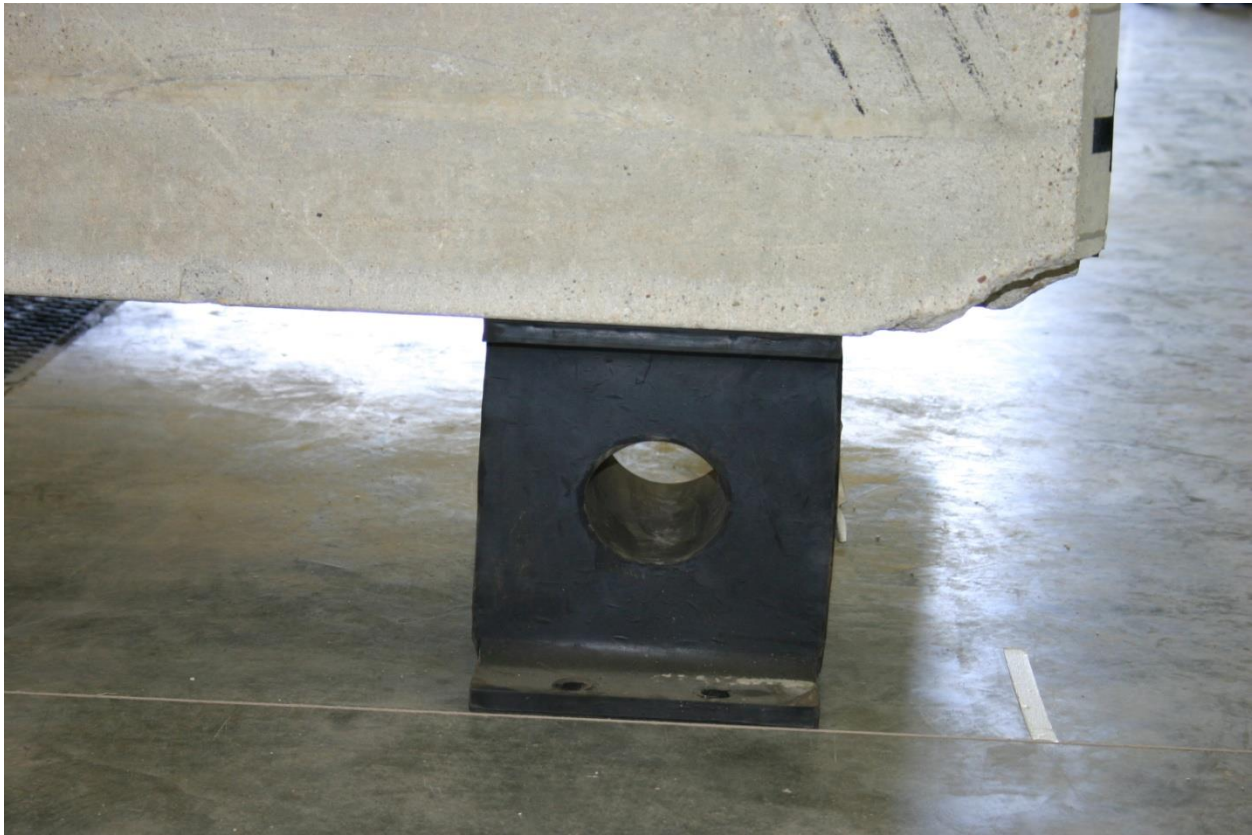
Figure 101. System Deflection at 4,994-lb (2,265-kg) Load, Test No. SFHS-10

In test no. SFHS-10, an 18-in. (457-mm) wide x 12-in. (305-mm) high x 16-ft (4.9-m) long rectangular concrete beam was lowered incrementally onto three 10-in. (254-mm) wide shear fenders spaced at 7 ft (2.1 m) on center, as shown in Figure 100. An additional 18-in. (457-mm) wide x 12-in. (305-mm) high x 16-ft (4.9-m) long concrete beam was lowered incrementally on top of the other concrete beam. The system became unstable at approximately a 6,500-lb (2,948-kg) load. Load and average deflection measurements up to 4,994 lb (2,265 kg) are shown in Table 19. The deflection of one of the shear fenders at the 4,994-lb (2,265-kg) load is shown in Figure 101.

Total Applied Load lb (kg)	Average Deflection in. (mm)
3,490 (1,583)	0.37 (9)
3,970 (1,801)	0.44 (11)
4,494 (2,038)	0.47 (12)
4,994 (2,265)	0.53 (13)
