UNIVERSAL BREAKAWAY STEEL POST FOR OTHER APPLICATIONS

MIDWEST ROADSIDE SAFETY FACILITY

MwRSF Research Report No. TRP-03-288-14

April 1, 2014

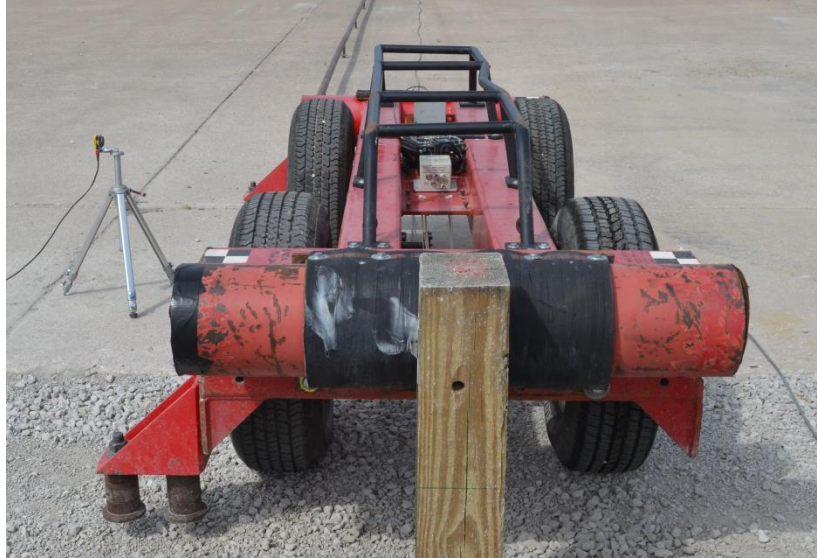
Figure 2. Rigid Frame Bogie and Guidance Track

A rigid-frame bogie was used to impact the posts. A variable-height, detachable impact head was used in the testing. The bogie head was constructed of 8-in. (203-mm) diameter, 1/2-in. (13-mm) thick standard steel pipe, with 3/4-in. (19-mm) neoprene belting wrapped around the pipe to prevent local damage to the post from the impact. The impact head was bolted to the bogie vehicle, creating a rigid frame with an impact height of 24⁷/₈ in. (632 mm). The bogie with the impact head is shown in Figure 2. The weight of the bogie with the addition of the mountable impact head and accelerometers was 1,875 lb (850 kg).

A pickup truck with a reverse cable tow system was used to propel the bogie to a target impact speed of 20 mph (32 km/h). When the bogie approached the end of the guidance system, it was released from the tow cable, allowing it to be free rolling when it impacted the post. A remote braking system was installed on the bogie allowing it to be brought safely to rest after the test.

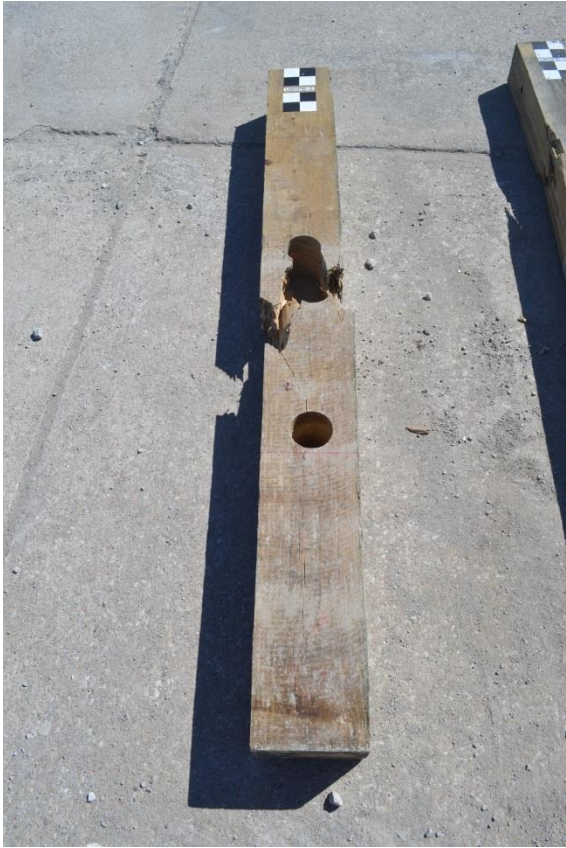
Figure 16. Time-Sequential and Post-Impact Photographs, Test No. UBSPB-2

During test no. UBSPB-2, the bogie impacted the CRT wood post, which created strong-axis bending at a speed of 21.2 mph (34.1 km/h). Initially, the post began to rotate backward. However, by 13 ms, the post began to fracture. The top of the post continued to rotate backward until the bogie lost contact with it and overrode it. Upon post-test examination, the post fractured through the hole at ground level.

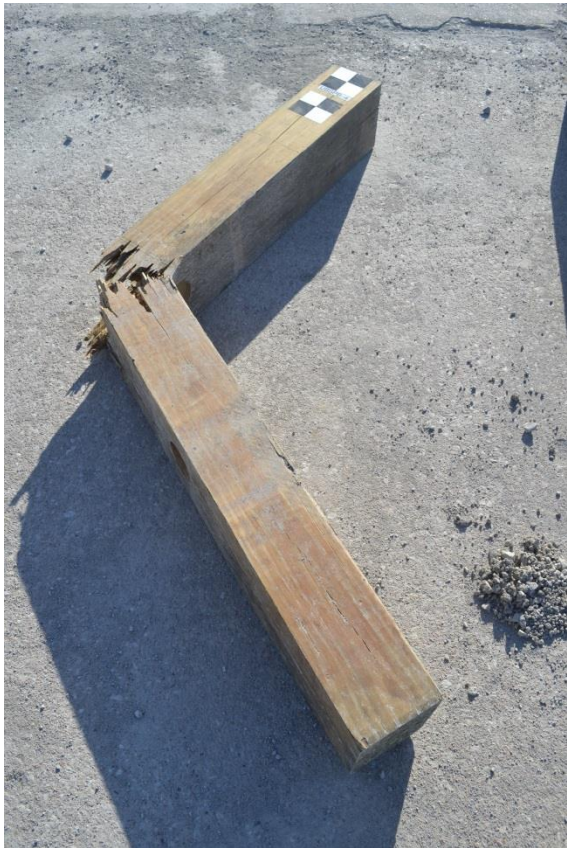
Figure 22. Time-Sequential and Post-Impact Photographs, Test No. UBSPB-4

During test no. UBSPB-4, the bogie impacted the CRT wood post, which created weak-axis bending at a speed of 20.9 mph (33.6 km/h). Initially, the post began to rotate backward. However, by 13 ms, the post began to fracture. The top of the post continued to rotate backward until the bogie lost contact with it at 54 ms. Upon post-test examination, the post fractured on the front face through the hole at ground level, but it did not fracture completely through the post and remained attached on the backside.

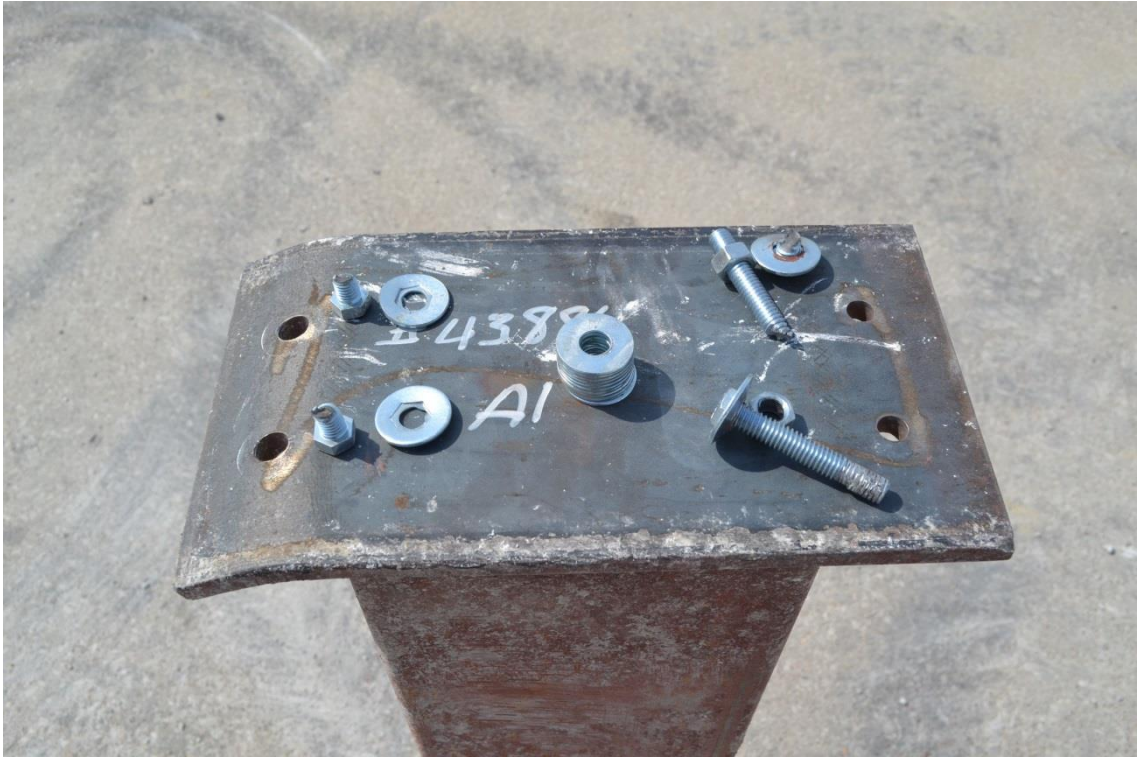
Figure 26. Bolts and Lower Base Plate, Test No. UBSPB-5

Damage to the UBSP is shown in Figure 26. Upon post-test examination, it was found that three of the four bolts had fractured in tension. The remaining bolt, which was located on the impact-side, was stripped of its threads as the nut slid off. The non-impact side of the bottom post plate was bent downward. The upper section and lower tube section did not experience noticeable deformation.

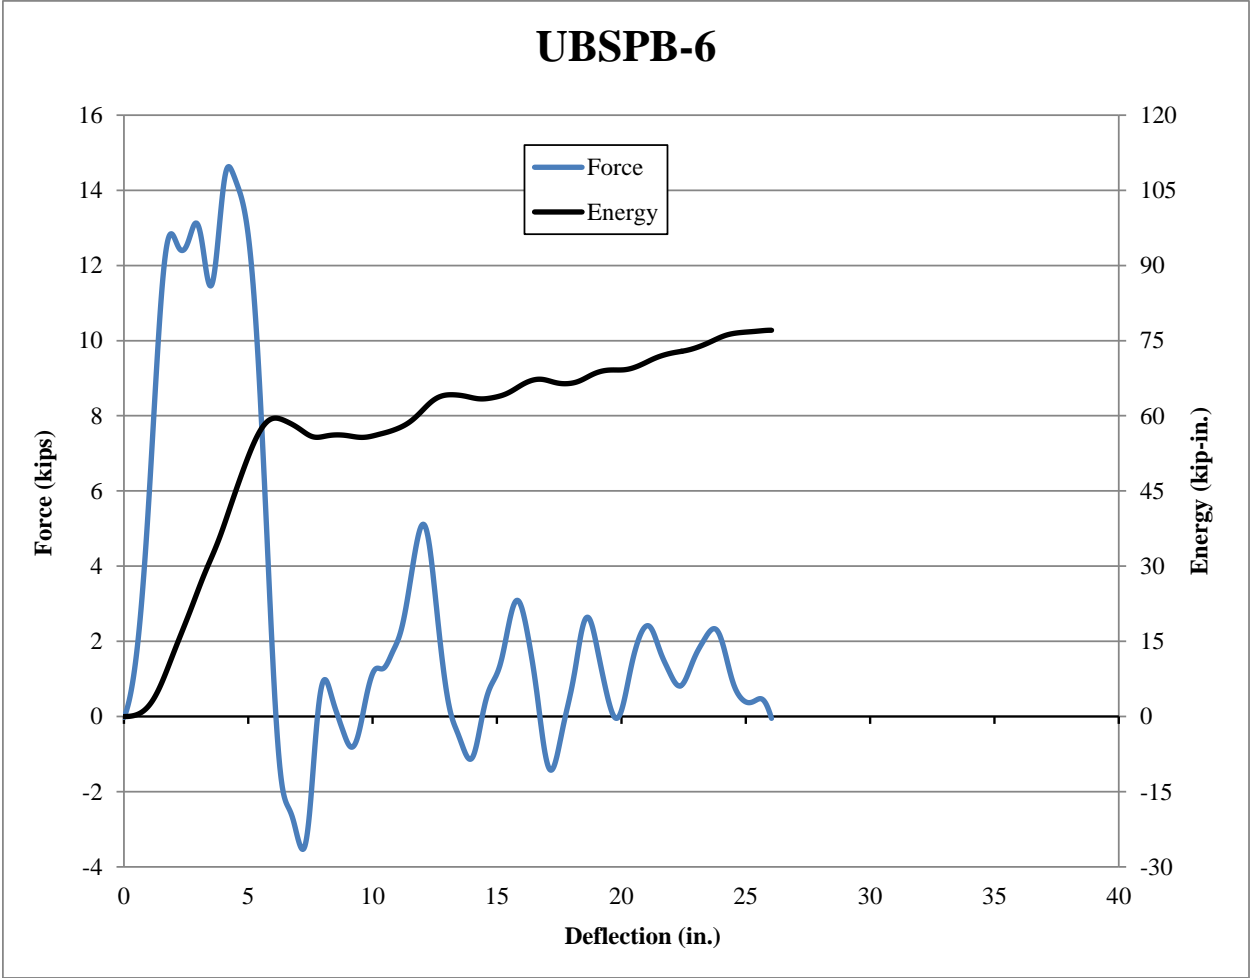
Figure 27. Force vs. Deflection and Energy vs. Deflection, Test No. UBSPB-6

Force vs. deflection and energy vs. deflection curves created from the SLICE accelerometer data are shown in Figure 27. A pre-test photograph is shown in Figure 28. Time-sequential and post-impact photographs are shown in Figure 29. The post reached a peak force of 14.6 kips (64.9 kN) at 4.2 in. (107 mm) of deflection. When the top of the post broke away, the resistive force rapidly decreased. At the maximum deflection of 26.0 in. (660 mm), the post absorbed 77.1 kip-in. (8.7 kJ) of energy.

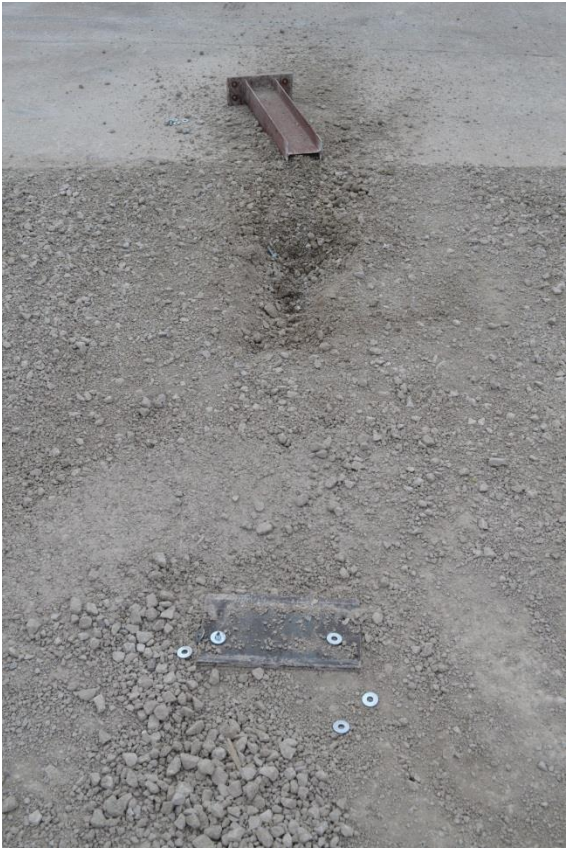
Figure 33. Time-Sequential and Post-Impact Photographs, Test No. UBSPB-7

Fractured bolts are shown in Figure 33. Upon post-test examination, all four bolts had fractured in tension, and the top of the post was bent slightly. The top post plate did not experience noticeable deformation. The lower section of the post was undamaged and displaced very little in the soil. The previous research with the UBSP in the three beam bullnose had noted similar behavior in the full-scale testing [9]. At that time, the researchers noted that if the lower section was undamaged and had displaced less than ½ in. (13 mm), then the bottom section could be reset without removing the post by tamping around the base. In order to further investigate this recommendation, test no. UBSPB-8 was conducted with the same base as UBSPB-7 after re-compacting the soil around the post.

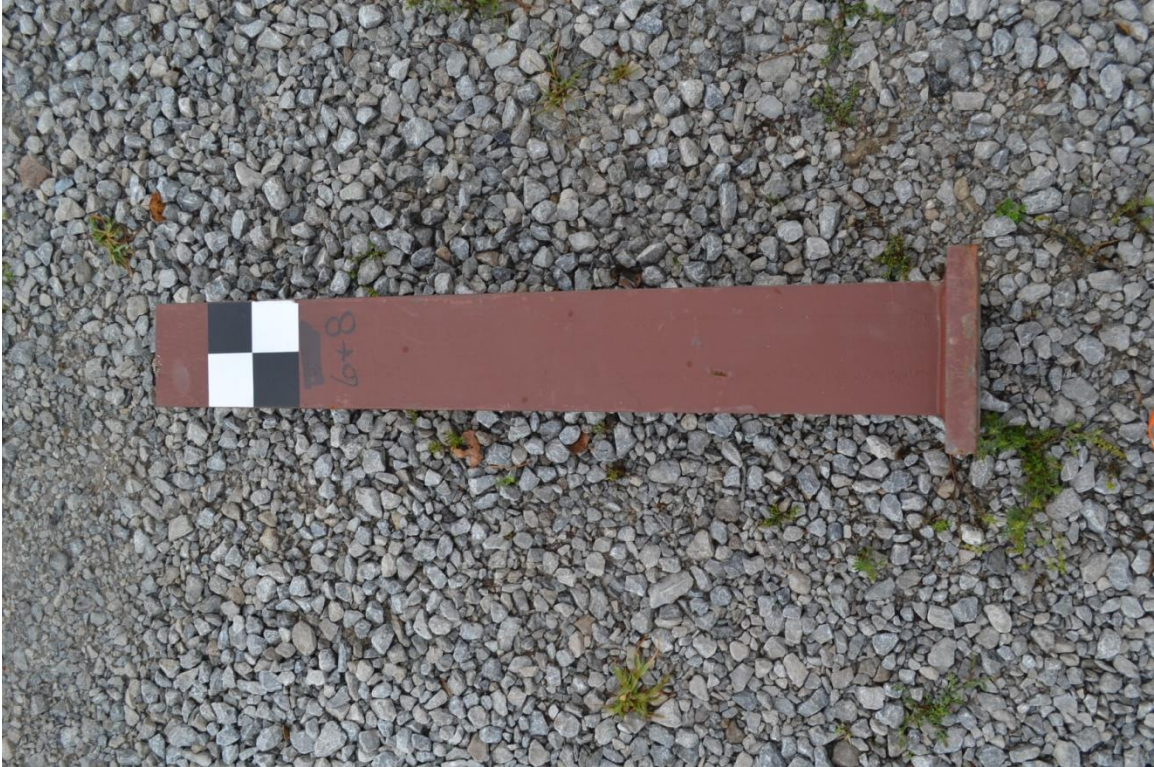
Figure 38. Top Section, Test No. UBSPB-8

Damage to the UBSP is shown in Figures 37 and 38. Upon post-test examination, it was found that all four bolts had fractured in tension. The top of the post and bottom of the post did not experience noticeable deformation.

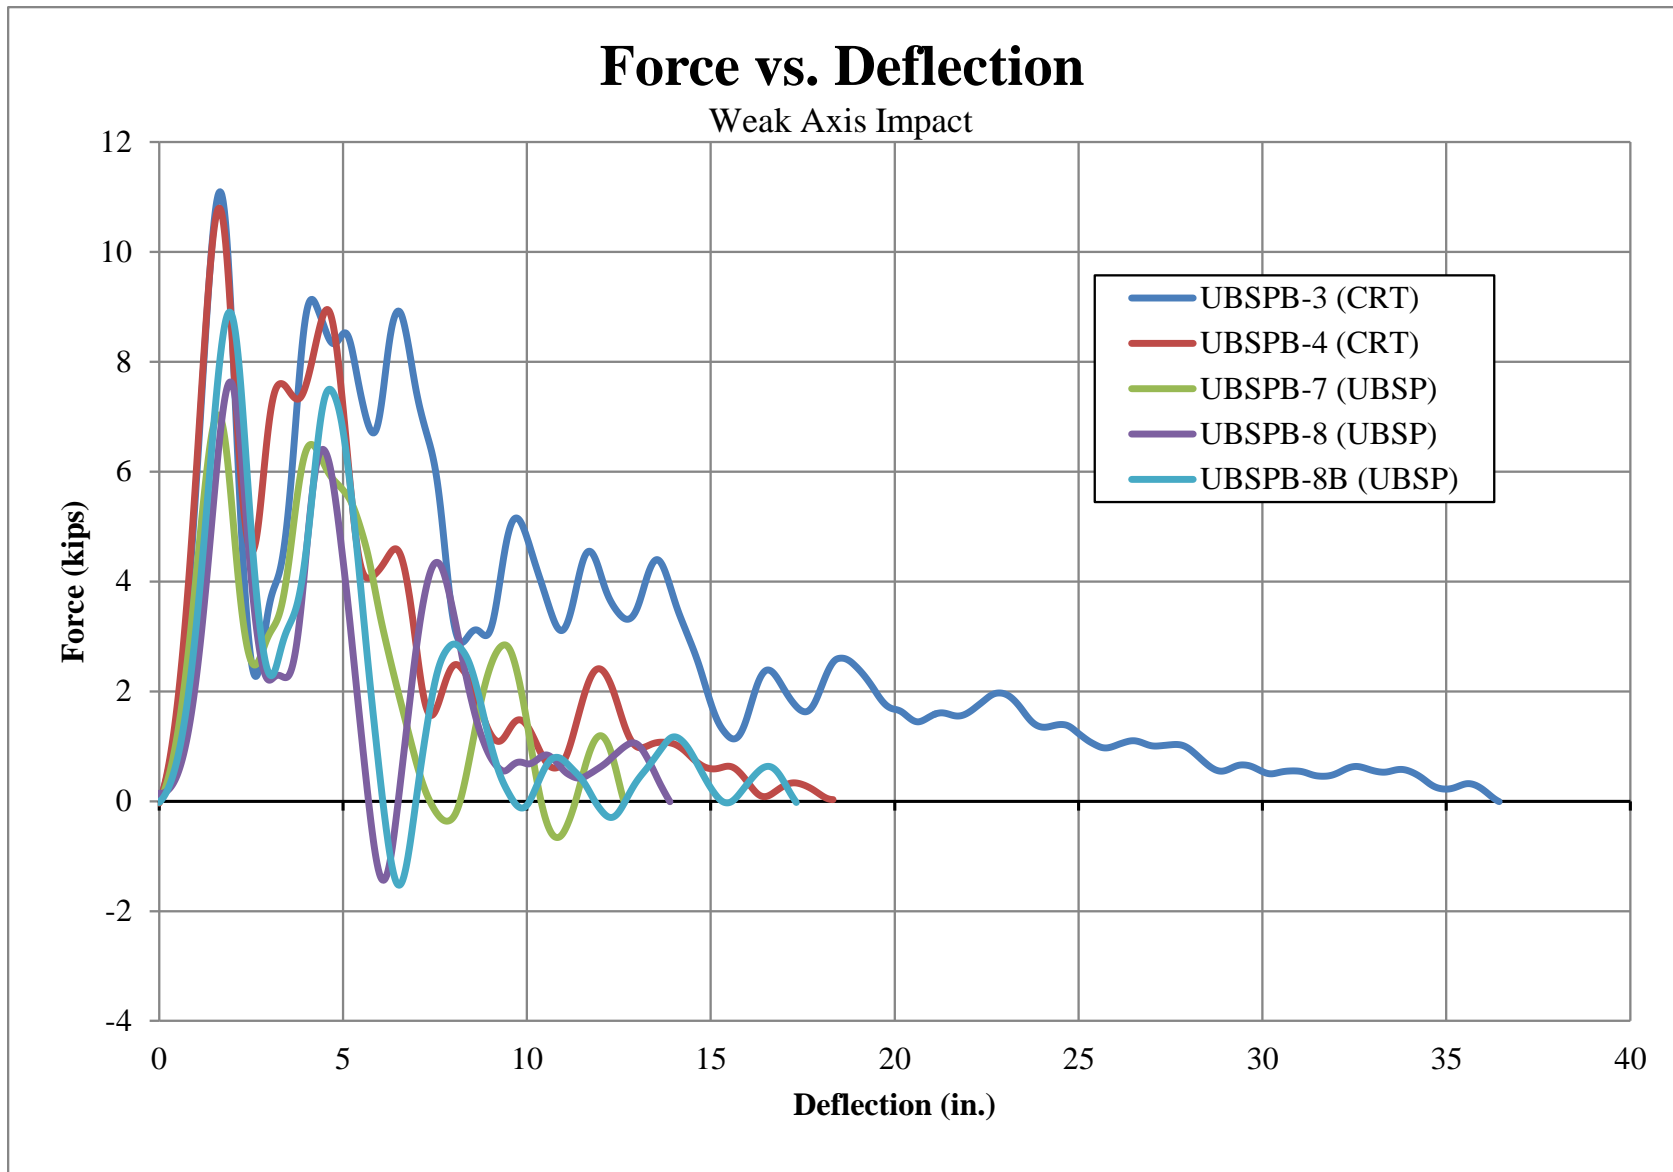
Figure 44. Force vs. Deflection Comparison Plot, Weak-Axis Tests

Test nos. UBSPB-3, UBSPB-4, UBSPB-7, UBSPB-8, and UBSPB-8B were conducted with the bogie impacting along the weak axis of the posts. Test results are summarized in Table 3 and shown graphically in Figure 44 and Figure 45. The forces developed in the weak axis by the UBSPs and CRT posts displayed more variation than was observed in the strong-axis testing. Peak forces for the UBSPs were 28.2 percent lower on average as compared to the CRT post.

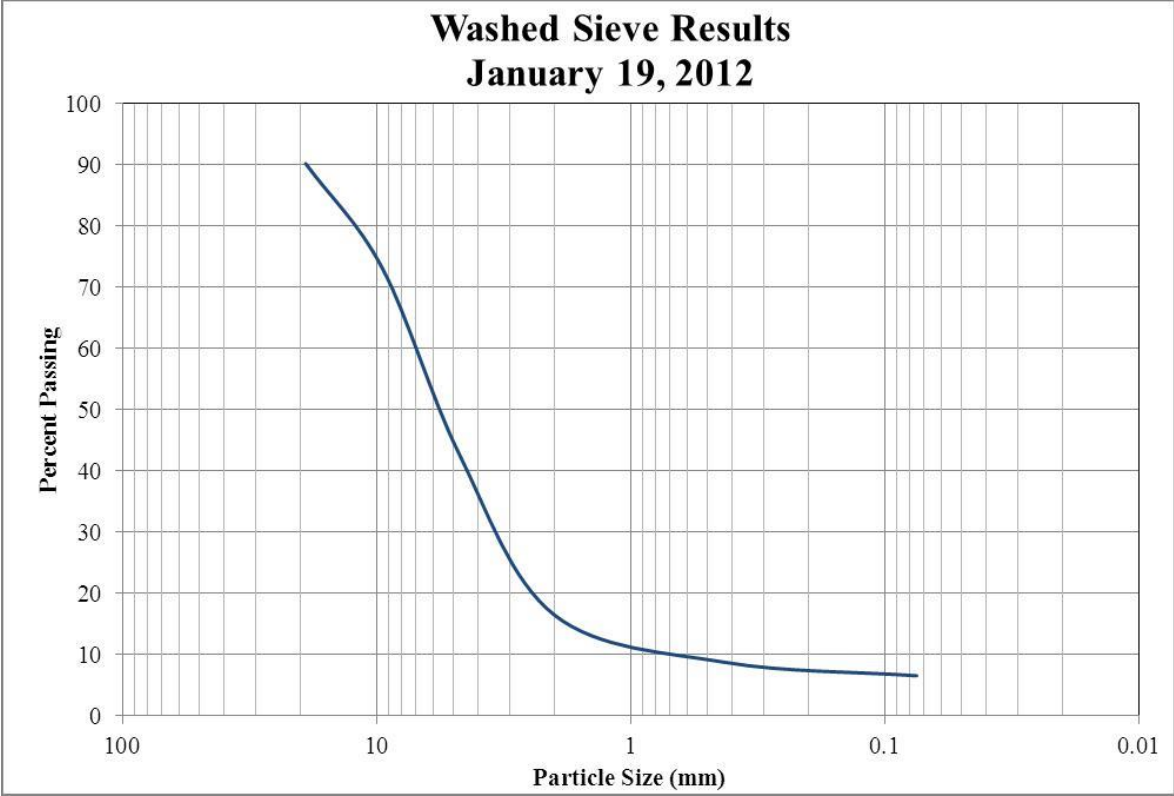
Figure B-1. Soil Gradation for Test Nos. UBSPB-1 through UBSPB-8B

A compacted, coarse, crushed limestone material, as recommended by MASH, was utilized for all tests [10]. Soil specifications are shown in Appendix B. MASH adheres to the general philosophy that testing longitudinal barriers in stiff soil results in higher impact and barrier loads, increased occupant risk values, and increased propensity for rail rupture, pocketing, and snag. Therefore, MASH has established a minimum post-soil resistance force standard to ensure systems are installed in strong, stiff soil. Thus, using heavily compacted soils was justified by MASH. Therefore, all tests utilized heavily compacted soil.
