Technical Report 06-01

*Field Testing of a Low-Cost Retrofit Filter Berm to Treat
Stormwater Runoff Contaminants*

FINAL REPORT ON FIELD VERIFICATION TESTING OF THE MAINE DEPARTMENT OF TRANSPORTATION FILTER BERM SWALE

**FINAL REPORT ON FIELD VERIFICATION TESTING OF THE MEDOT FILTER
BERM SWALE
BY THE UNIVERSITY OF NEW HAMPSHIRE STORMWATER CENTER**

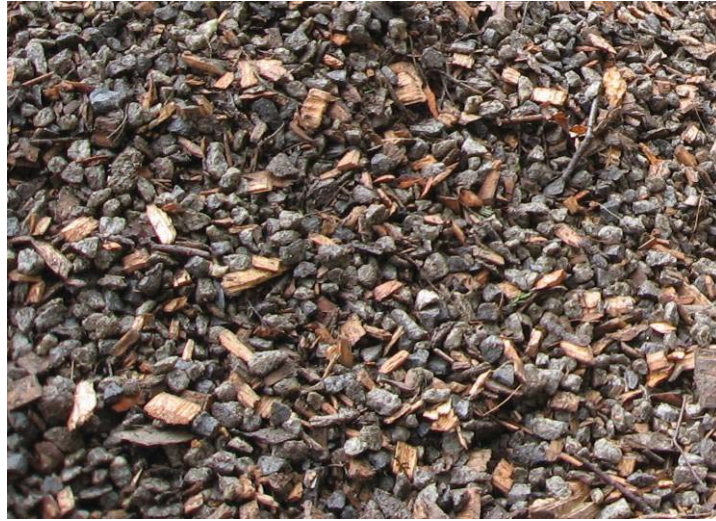
Figure 3: Inner Filter Core Comprised of 50% Wood Chips and 50% ½” Angular Stone

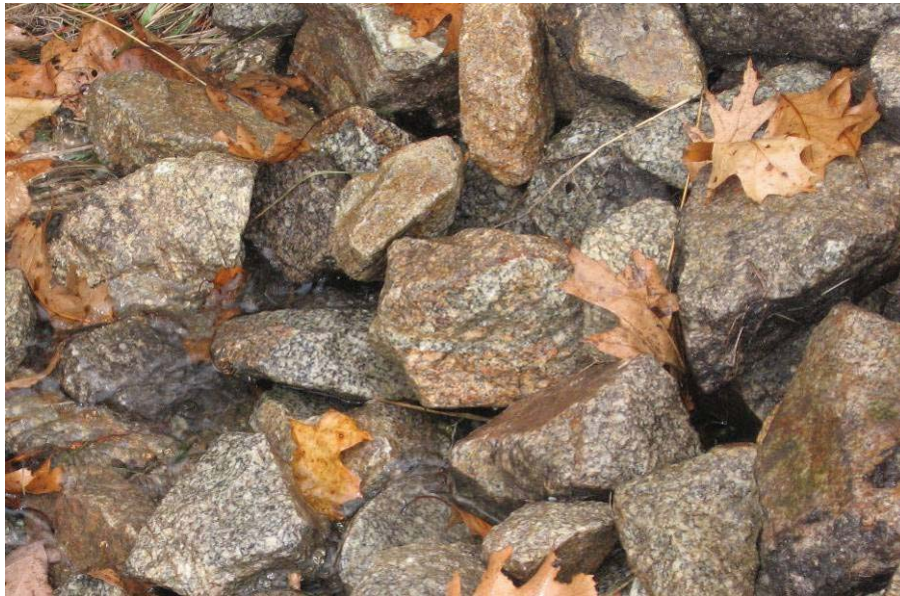
Figure 4: Outer Layer 6-8” Diameter Stone Casing for Filter Berm

The swale filter berm failed after a 100 year flow event. The swale conveyed a 6.8 cfs peak flow. The 8 inch stone outer casing washed off the downward side of the swale exposing the smaller stone filter core which then eroded rapidly. Prior to this failure, it had largely been concluded that the filter berm was not working effectively primarily due to high maintenance sensitivity. The poor performance was immediately noticeable in the fall season from quickly accumulating leaves that resulted in clogging of the berm and subsequent over-topping. This is evident in Figure 5. Regular removal of leaves and debris was a standard maintenance routine. This could

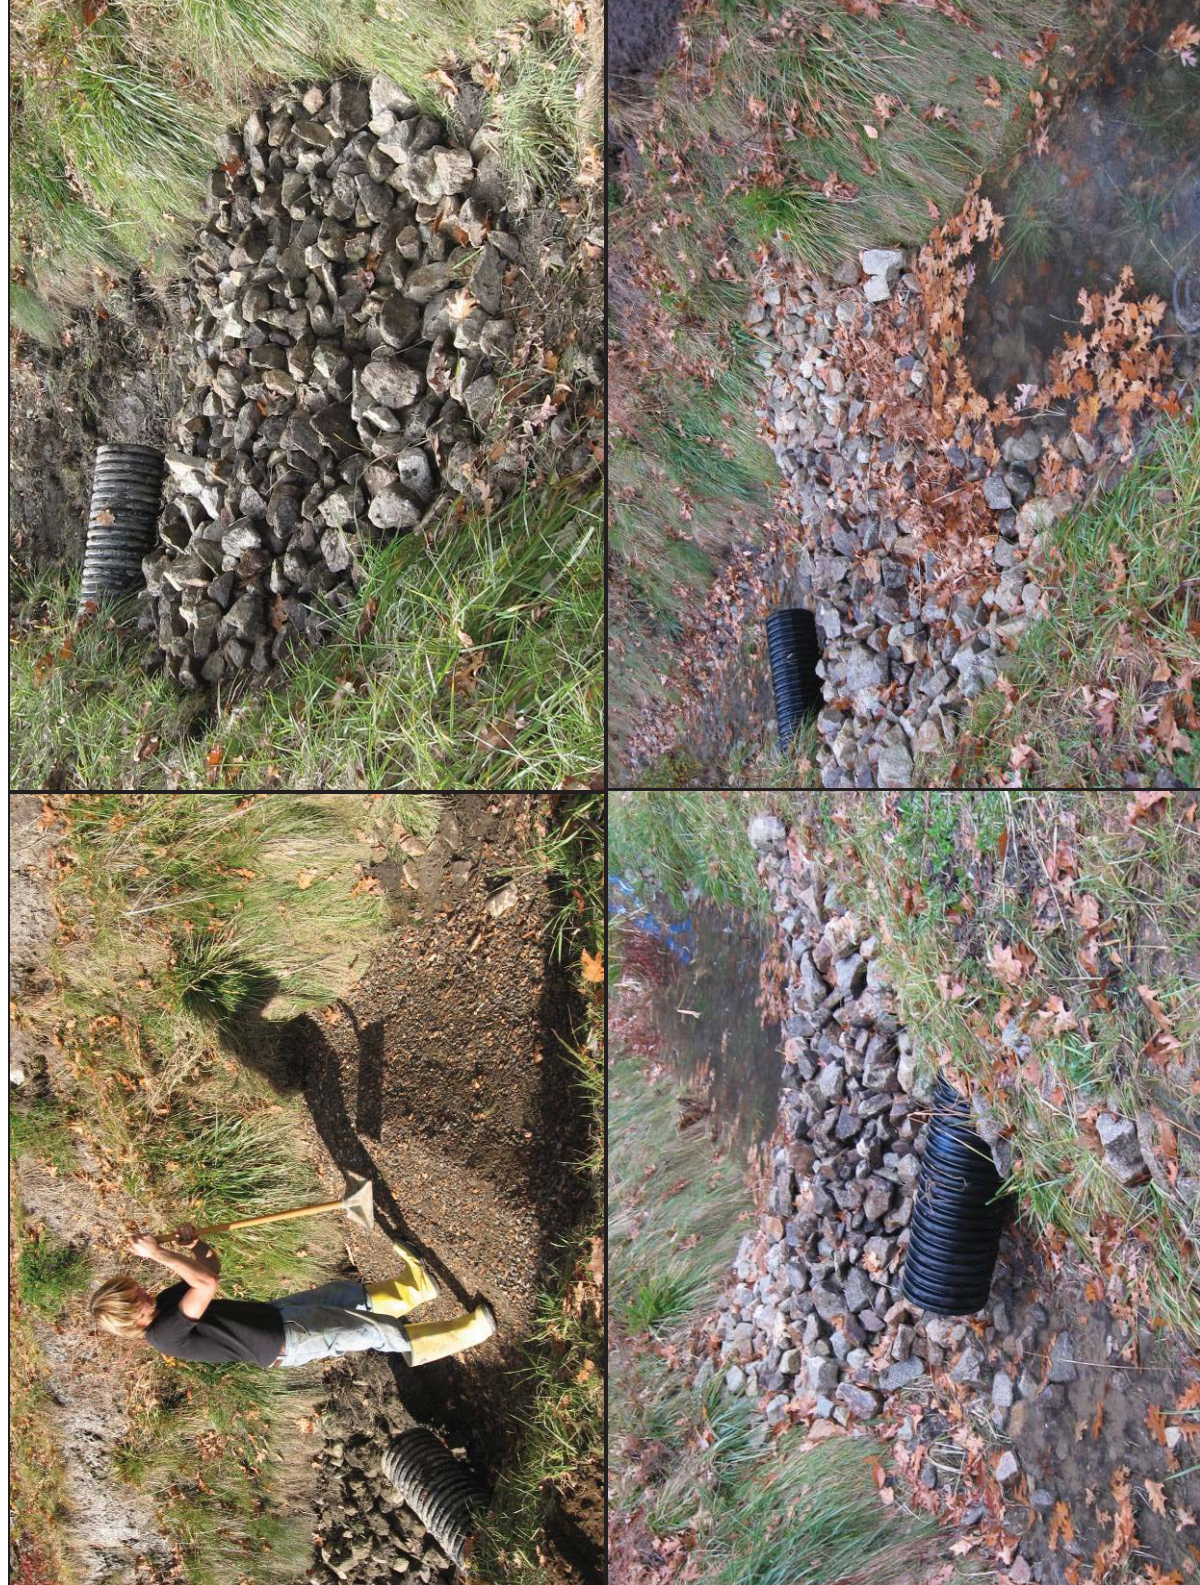
Figure 5: Filter Berm Installation at UNHSC (Top left to right clockwise; Filter core placement; Looking downstream after installation; Looking downstream during rain event; (Culvert is not part of berm structure and is located downstream of installation)

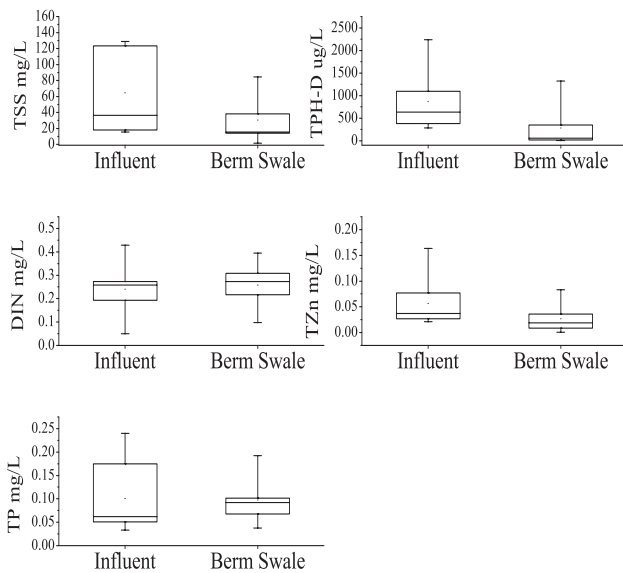
Figure 8: Effluent EMC box and whisker plot comparisons for the range of contaminants. (Box reflects the 25th and 75th percentile, the line reflects the median and the whiskers reflect minimum and maximum)

Performance statistics and EMC values are presented for each storm for the 5 contaminants in Table 3, Table 4, Table 5, Table 6, Table 7. These events are heavily biased to cold weather months as the system failed early June 2007. Figure 8 presents the distribution of influent and effluent EMCs. Use of removal efficiencies in this setting is appropriate as the systems are all receiving the same stormwater from the same watershed. TSS performance was below that observed for a vegetated swale with no berm at 50% and 60% removal efficiency respectively filter berm and the vegetated swale. The same was true for TZn, at 50% and 88% removal efficiency respectively. For TPH-D the swale appears to be slightly better at 81% and 67% respectively. For DIN no improvement in performance was observed at -12% RE. TP is observed to be 8% versus the -95% observed for the vegetated swale. This is a small data set (n=6-10) and it should be noted that 4 of the TSS events were eliminated during data set quality assurance procedures. It appears that the filter berm is not enhancing water quality for TSS and TZn when compared with a vegetated swale with slight improvements observed for TP and TPH-D.

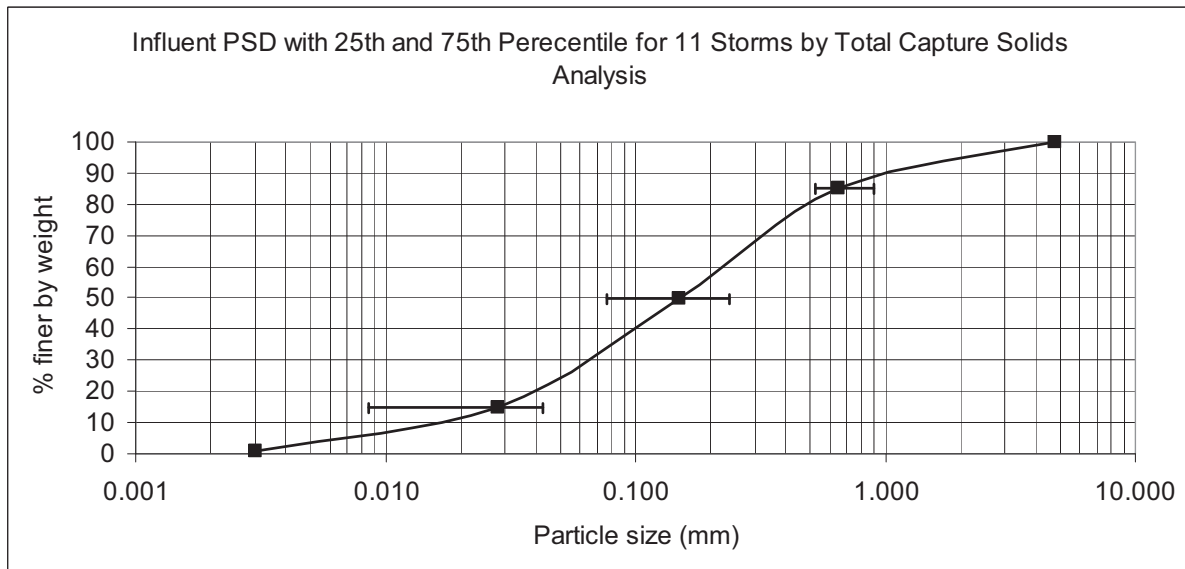
Figure 10: Total solids particle size distributions by wet-sieving and hydrometer analyses for influent (n= 11 storms, 25th and 75th percentile)
