CONSTRUCTION OF NEW PROFILER CERTIFICATION TRACKS

Report 5-9047-01-1

Project Title: Improvement to TxDOT Certification Program of Inertial Profilers

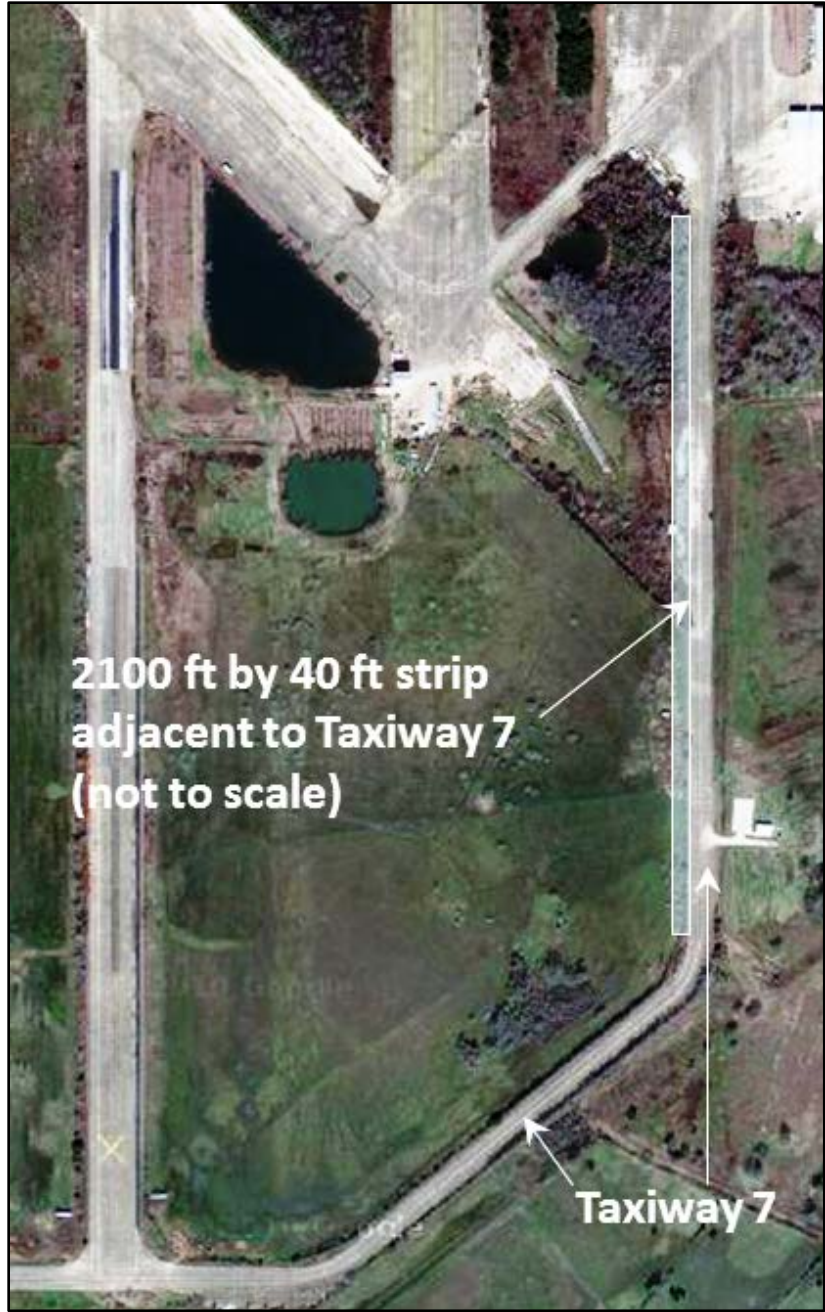
Figure 3. Approved Site along Taxiway 7 for Construction of New Test Tracks.

One other alternative that researchers considered was locating the new test tracks along Taxiway 7 of the Riverside Campus. Figure 3 shows this alternate location. To accommodate the proposed construction of new test tracks in this implementation project, the existing fence line at the site needs to be moved about 15 ft west of its current location, which will encroach into the existing pasture that Vet Med Research uses, and will thus require their approval. However, preliminary discussions with Vet Med Research suggested that they can accommodate this change. The alternate location along Taxiway 7 also provides existing concrete pavements that test vehicles can use as a lead-in and a lead-out to get up to speed and to decelerate. It is also near the existing test track along runway 35C. However, this location does not provide space for future growth, and the clay soil at the site will likely require chemical stabilization and a thicker pavement. Nevertheless, among the alternative locations considered within the Riverside Campus, Taxiway 7 provided the least conflict with existing users. Consequently, TTI proposed this site as the location to build new test tracks for inertial profiler certifications. The TTI Facilities Coordinator presented this proposal in a meeting of the Texas A&M Council on the Built Environment (CBE). The Council subsequently submitted its recommendation for the President of the University to approve use of the land space adjacent to Taxiway 7 to build new test tracks for inertial profiler certifications. Figure 4 shows the approval document signed by the Texas A&M University President. Having procured land on which to build new test tracks, the researchers proceeded with developing plans for construction of these tracks.

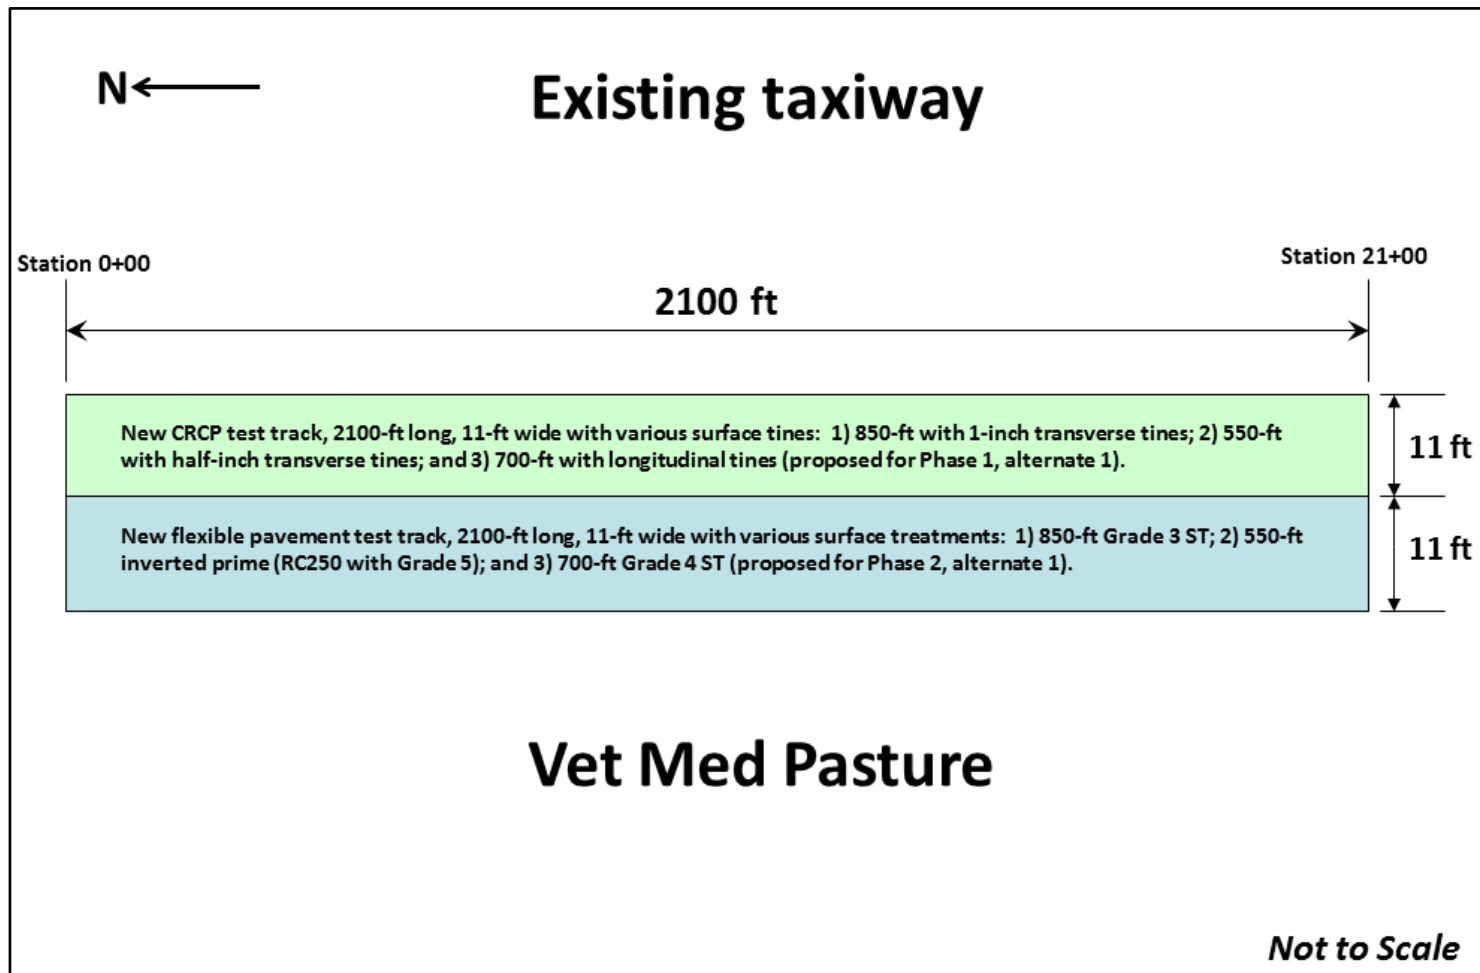
Figure 5. Plan View of Proposed New Test Tracks.

In addition to the construction of test tracks in Phase I and Phase 2, researchers included an alternate third phase covering placement of access ramps to the test tracks. Contractors were also asked to submit bids for this Phase 3 work according to the plans and specifications given in this chapter.

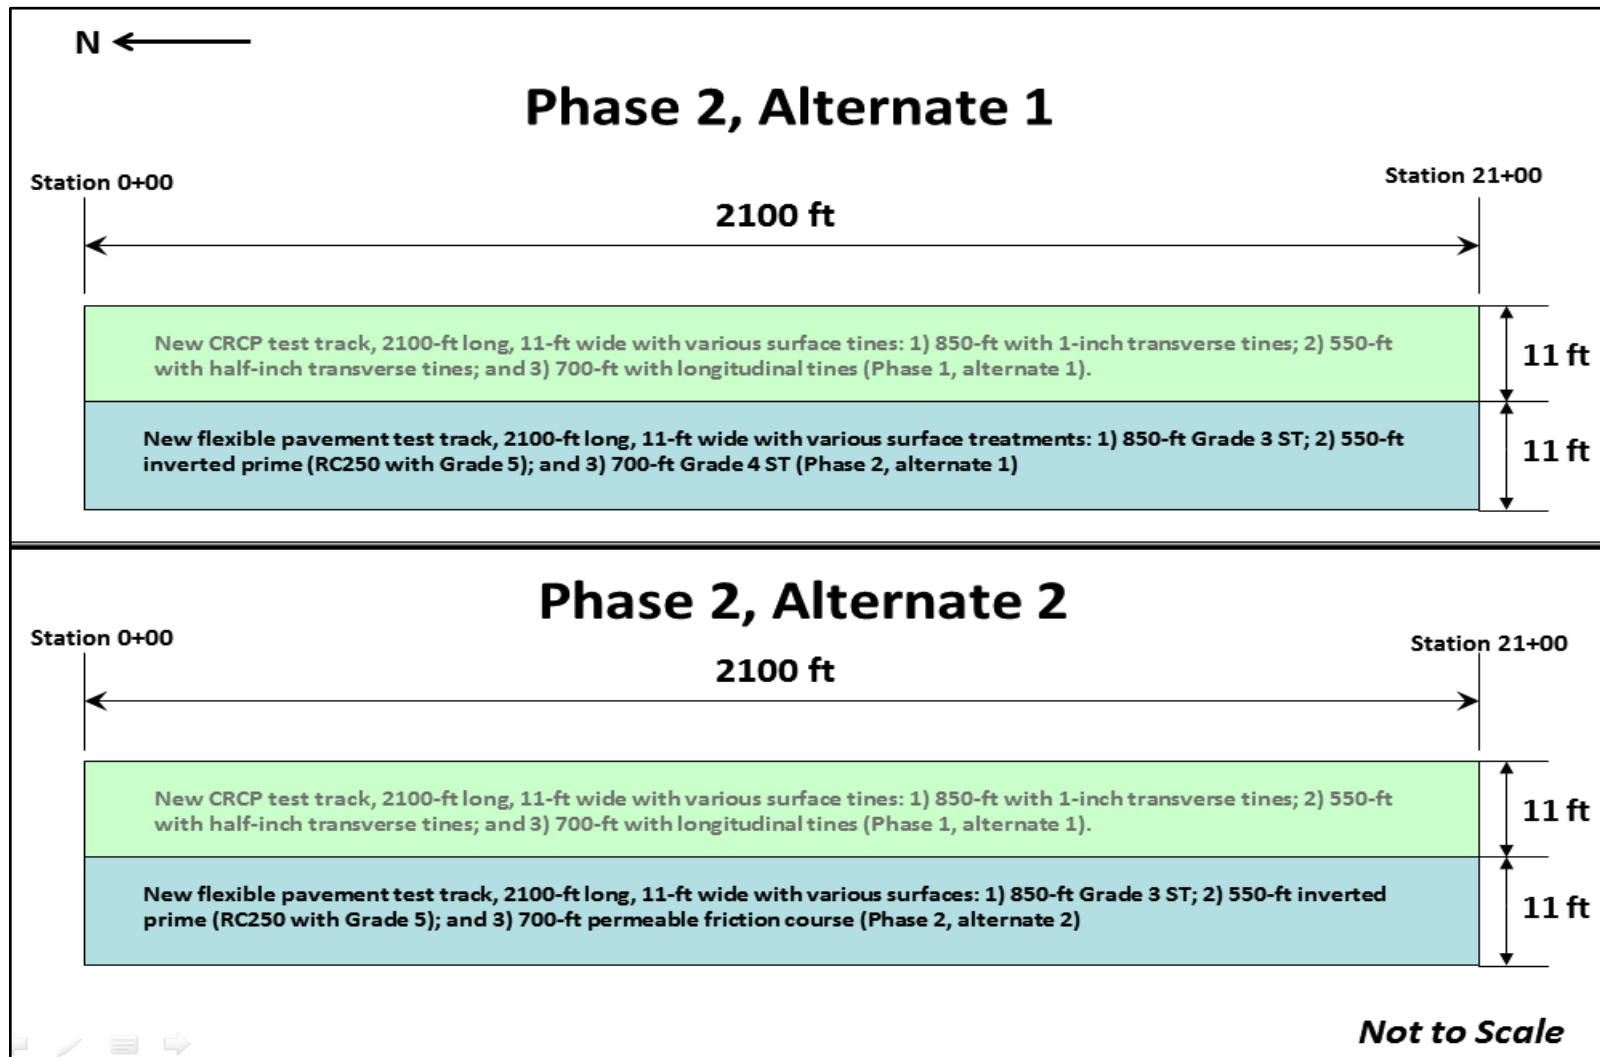
Figure 9. Plan View of Two Alternates for Construction of Flexible Pavement Test Track in Phase 2.

The second alternate, with a PFC section, will be considered only if a 2100-ft CRCP test track is built in Phase 1 (alternate 1). If a 2000-ft CRCP test track is built (Phase 1, alternate 2), the flexible pavement test track will be constructed using alternate 1 in Phase 2 (see Figure 10). The following additional notes are provided to supplement the plans and specifications given in Figures 9 to 15 in connection with the Phase 2 construction of the flexible pavement test track.

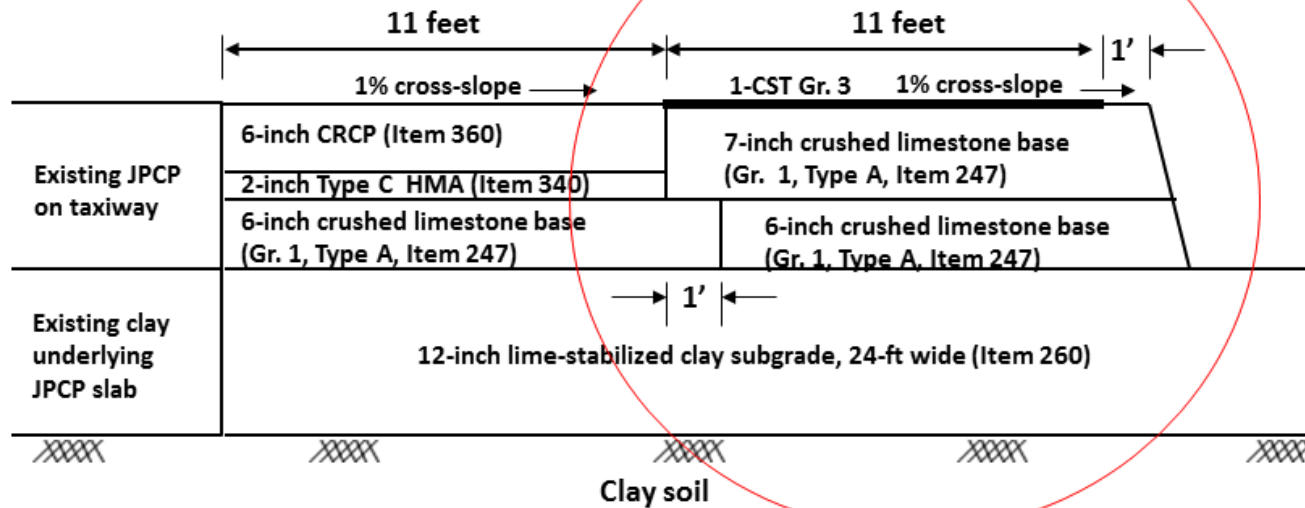
PAVEMENT CROSS-SECTIONS: 00+00 to 08+50

Notes on Placement of Grade 3 Surface Treatment:

Surface Treatment: AC-20-5TR at 0.4 gal/yd² with Grade 3 aggregate PB or PL at 95 yd²/yd³.
 Material specification Items 300 & 302.
 Construction specification Item 316.

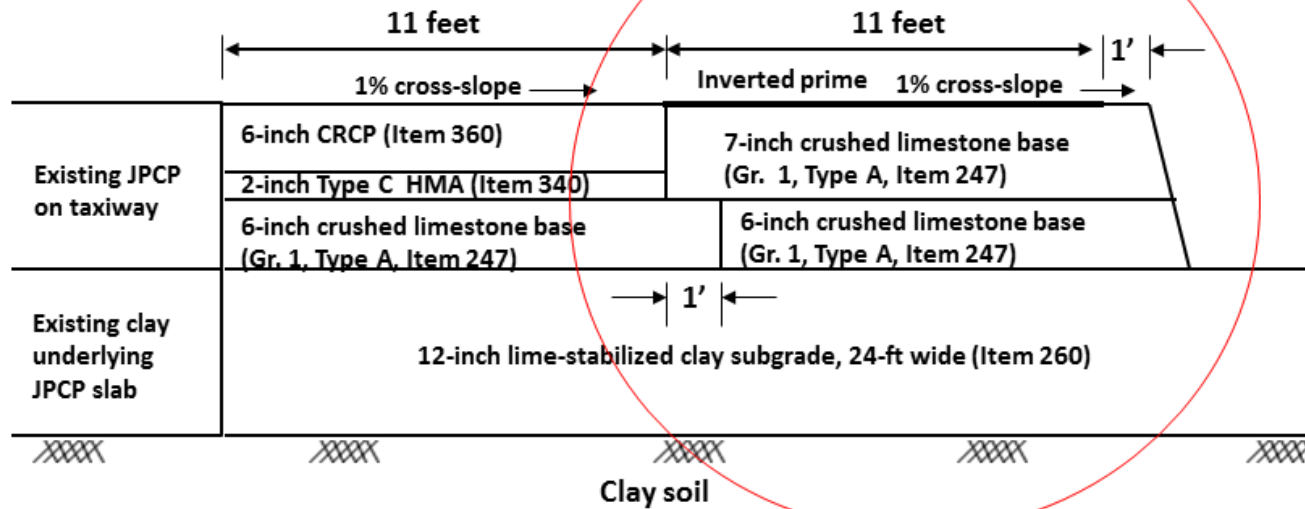
PAVEMENT CROSS-SECTIONS: 08+50 to 14+00

Notes on Placement of Inverted Prime:

Inverted prime: RC 250 at 0.20 gal/yd² with Type PB or PL Grade 5 aggregate at 140 yd²/yd³.

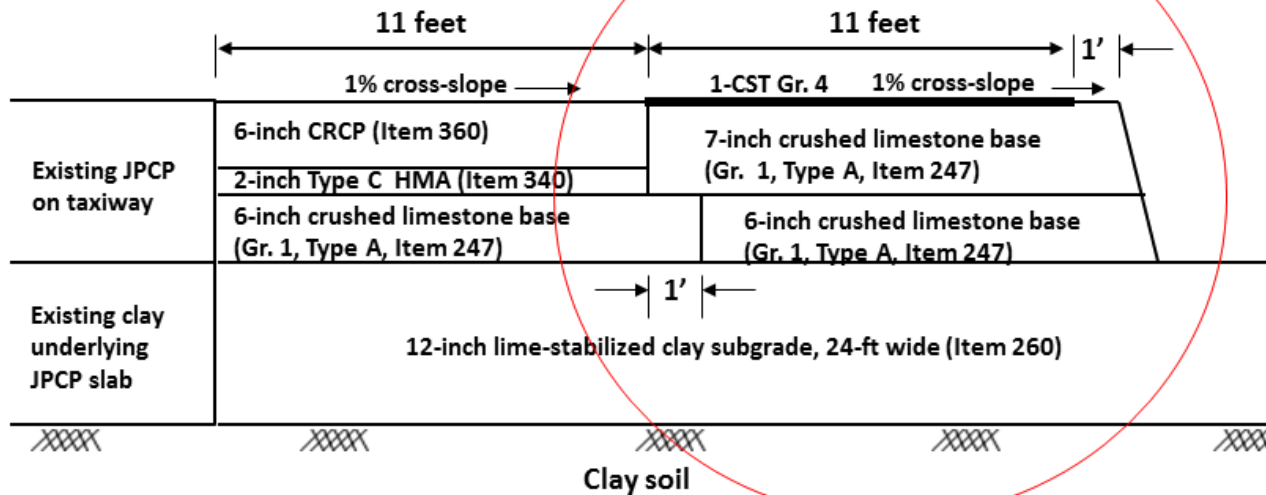
PAVEMENT CROSS-SECTIONS: 14+00 to 21+00

Notes on Placement of Grade 4 Surface Treatment:

Surface Treatment: AC-20-5TR at 0.4 gal/yd² with Grade 4 aggregate PB or PL at 125 yd²/yd³.
 Material specification Items 300 & 302.
 Construction specification Item 316.

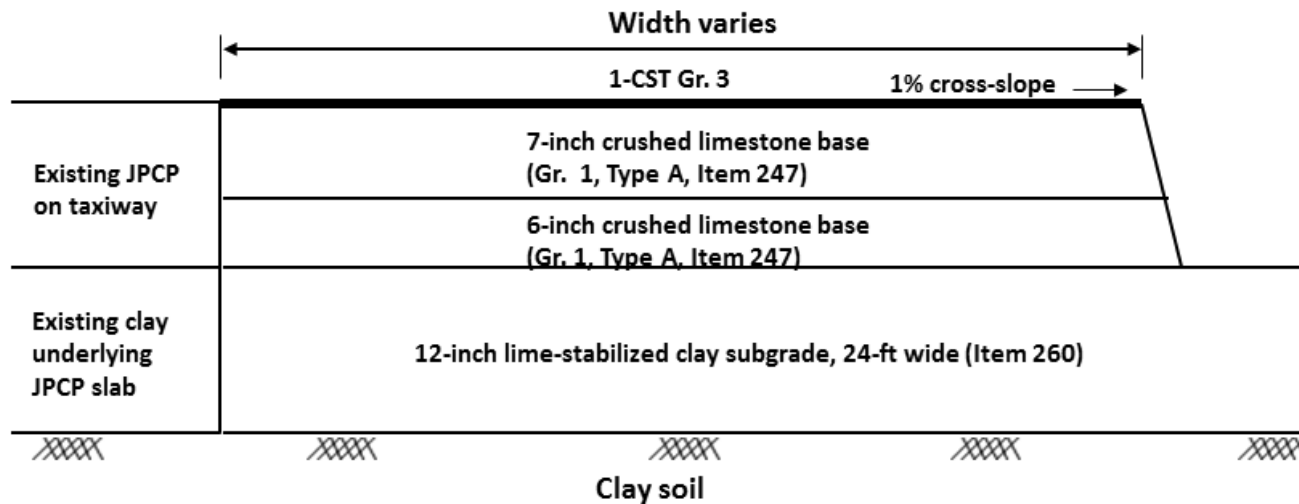
NORTH ACCESS RAMP TYPICAL CROSS-SECTION

Notes on Placement of Grade 3 Surface Treatment at North Access Ramp:

Surface Treatment: AC-20-5TR at 0.4 gal/yd² with Grade 3 aggregate PB or PL at 95 yd²/yd³.

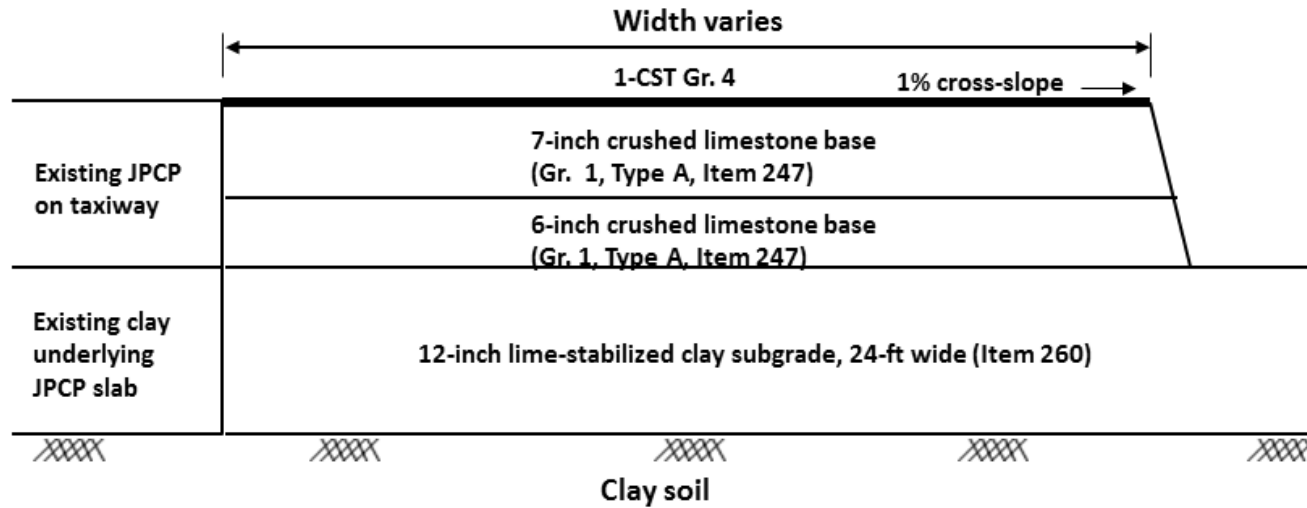
SOUTH ACCESS RAMP TYPICAL CROSS-SECTION (ALT. 1)

Notes on Placement of Grade 4 Surface Treatment at South Access Ramp (alt. 1):
 Surface Treatment: AC-20-5TR at 0.4 gal/yd² with Grade 4 aggregate PB or PL at 125 yd²/yd³.
 Material specification Items 300 & 302.
 Construction specification Item 316.

Primed crushed limestone base surface: MC-30 applied at a rate of 0.12 gal/yd².
 Material specification Item 300.
 Construction specification Item 310.

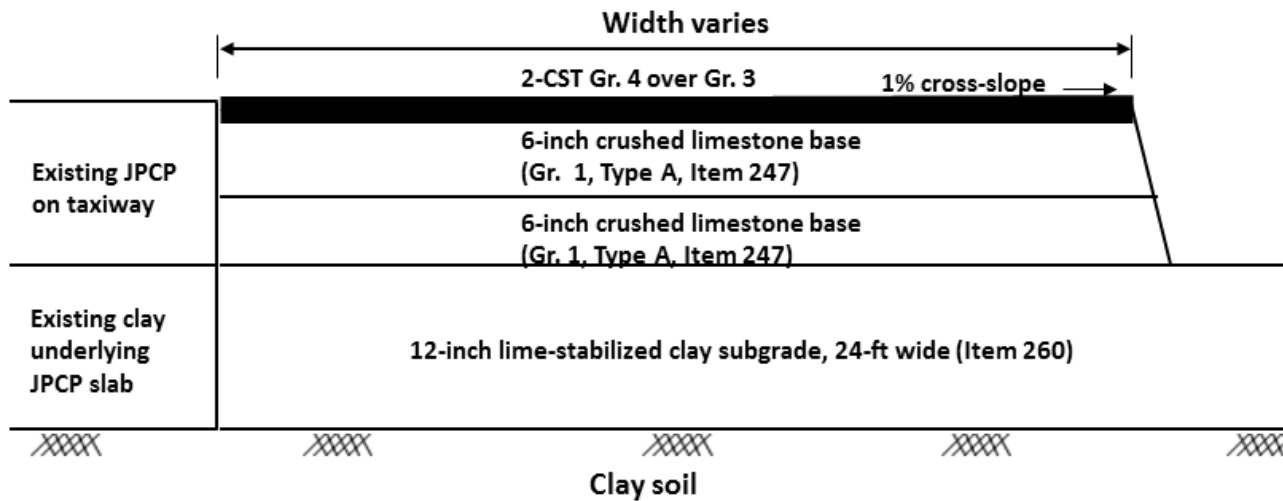
SOUTH ACCESS RAMP TYPICAL CROSS-SECTION (ALT. 2)

Notes on Placement of 2-CST Gr. 4 over Gr. 3 Surface Treatment at South Access Ramp (alt. 2):

2-CST: AC-20-5TR at 0.4 gal/yd² with Grade 4 aggregate PB or PL at 125 yd²/yd³ and AC-20-5TR at 0.4 gal/yd² with Grade 3 aggregate PB or PL at 95 yd²/yd³.

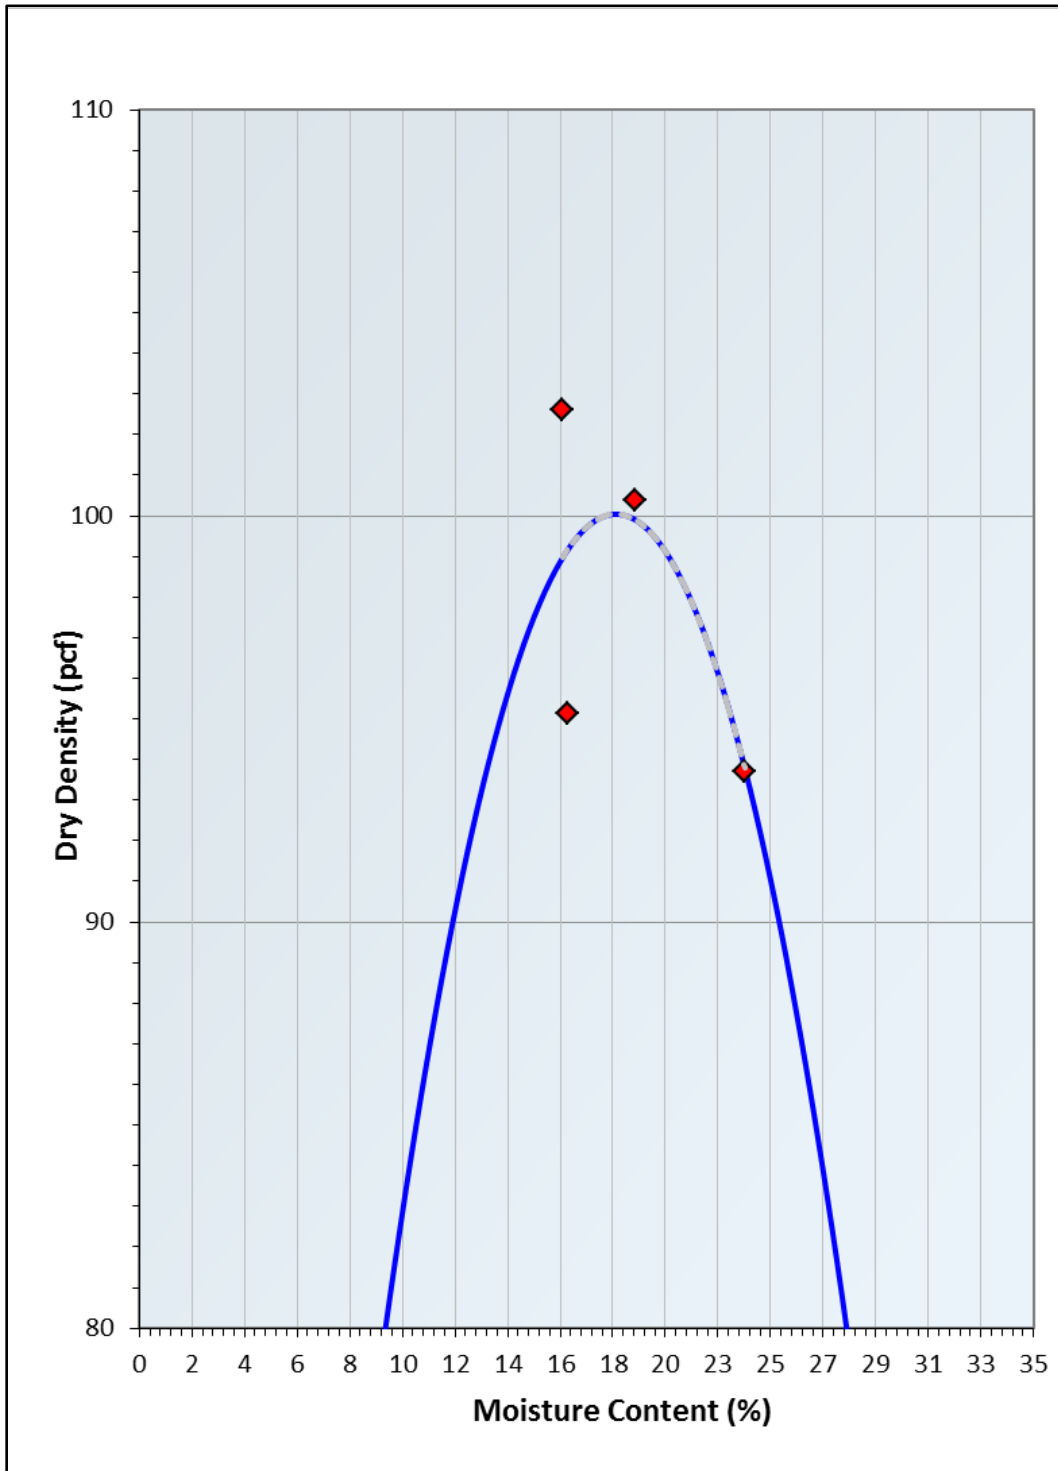
different locations to determine the moisture-density curves shown in Figure 28 and Figure 29. The corresponding maximum densities were then used to check the level of compaction achieved at different stations along the job site. Table 6 summarizes the results from these density tests. As shown, the contractor met the density required in the plans.

Figure 28. Moisture-Density Curve for Soil-Lime Mixture Sampled at Station 2+00.

Figure 29. Moisture-Density Curve for Soil-Lime Mixture Sampled at Station 12+00.

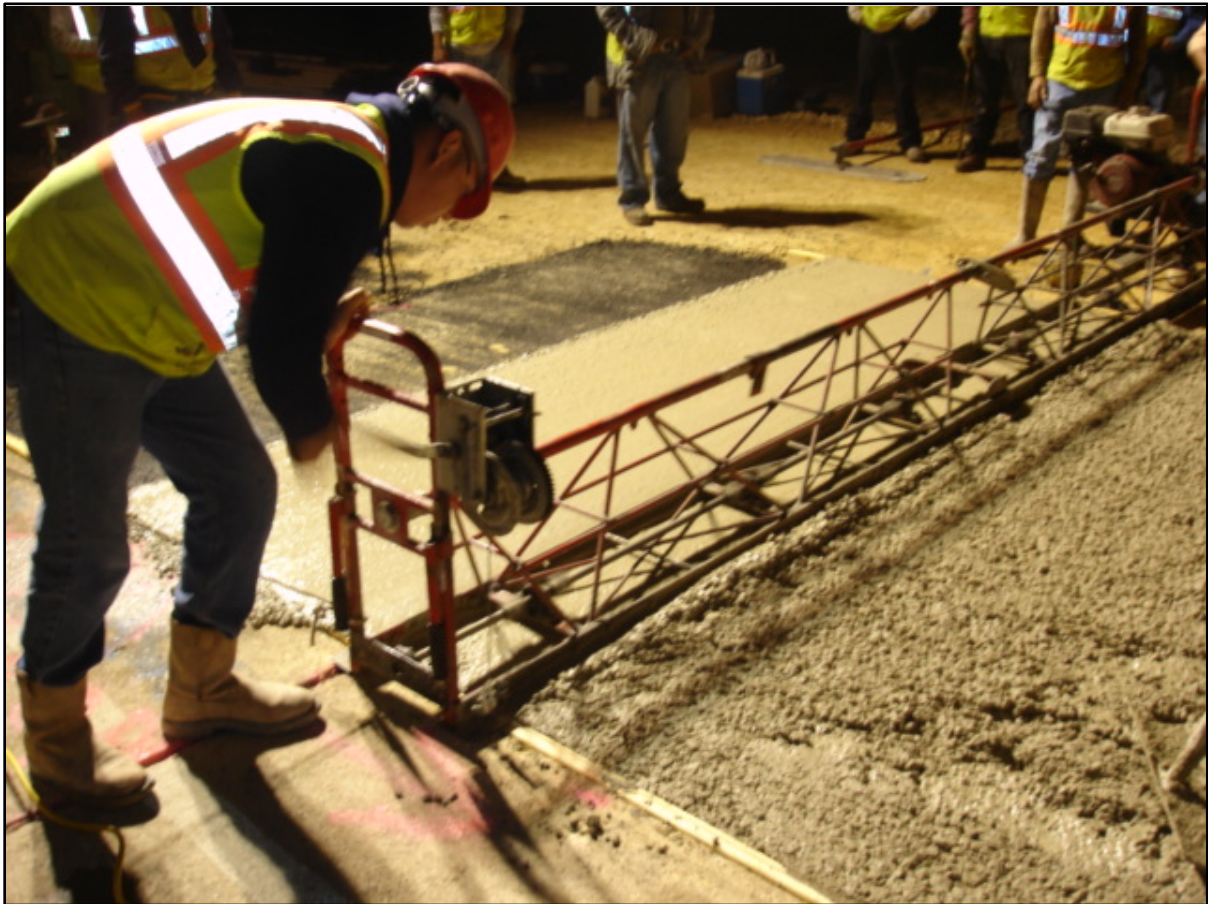
The contractor scheduled placement of the concrete for the CRCP test track on November 9, 2012. He had his crew and equipment on the job site at midnight that day. TTI technicians were also at the site to monitor the work. The contractor initially sprayed the concrete forms with a releasing agent to facilitate removal of the forms after the concrete was placed. Figure 37 shows the contractor placing his vibrating screed on the form when the concrete pour began. This picture was taken at the south end of the track where the contractor started pouring concrete.

Figure 37. Vibrating Screed Used to Place the Concrete Mix.

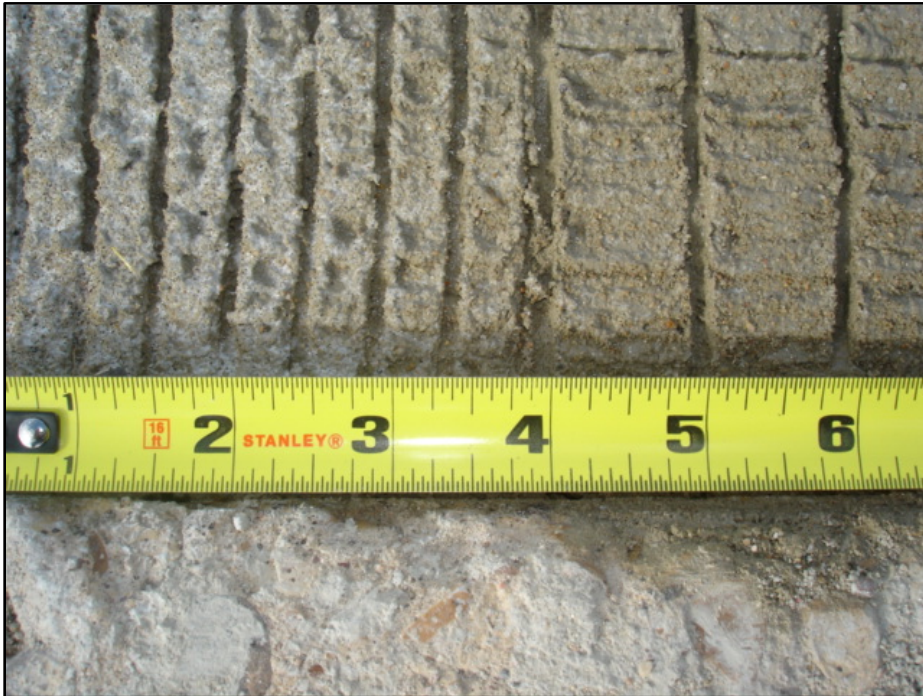
Figure 40 shows a close-up view of the change from the longitudinally tined section to the half-inch transversely tined section. This photograph was taken at station 14+00. Figure 41 shows the change from the half-inch to the one-inch transversely tined section at station 8+50. The contractor placed 1-inch tines as illustrated in Figure 42. As may be observed in the figure, it was already morning when this picture was taken. The entire process of placing the CRCP—from the time the concrete pour began to the time the concrete was completely tined—took about 12 hours. The contractor imprinted 09-11-12 (dd-mm-yy) as the date of concrete placement at the northwest corner of the CRCP test track.

Figure 40. Change from Longitudinal Tines to 1/2-inch Transverse Tines.

Figure 41. Change from 1/2-inch to 1-inch Transverse Tines.

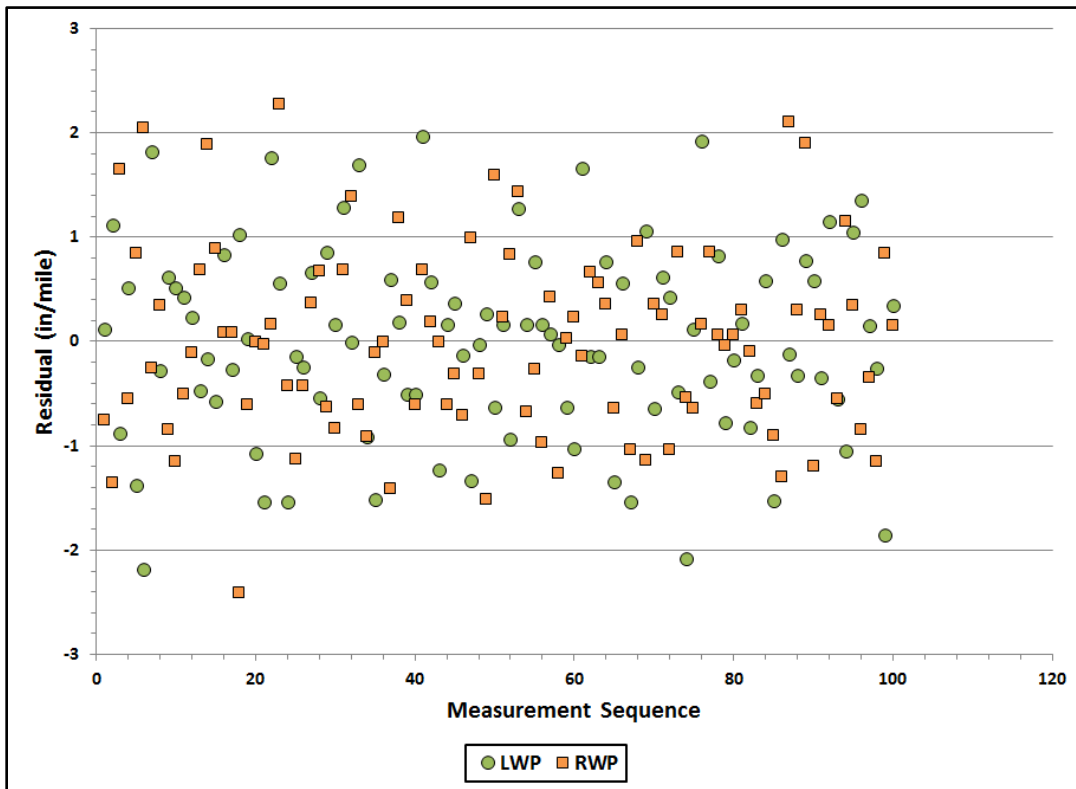
Figure 60. Results of Residual Analysis on 1-inch Transversely Tined Section IRIs.
