Maine Department of Transportation Transportation Research Division

Technical Report 97-20 Subsurface Drainage for Rehabilitation of PCC Pavement – Rt. 202 Gray – New Gloucester

Final Report, December 2003

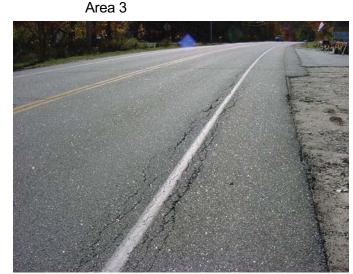
Photo 1. Area 3 PCC Related Edge Cracking

The length of PCC related edge cracking in Area 3 has increased dramatically from a total length of 5.3 m (17 ft) in 2001 to 28 m (92 ft) in 2002, an increase of 428% (Photo 1).

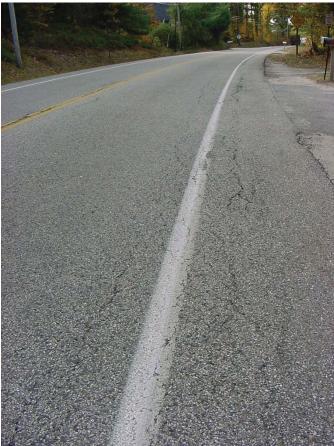
Photo 2. Area 4 PCC Related Edge Cracking

Area 4 PCC edge cracking increased 72% from a length of 12.2 m (40 ft) to 21 m (69 ft) in 2002 (Photo 2).

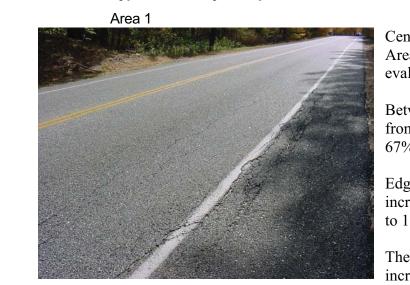
Photo 4. Area 1 Cracking

Edge of pavement or shoulder cracking has increased 333% from a total length of 26.1 m (86 ft) to 113 m (371 ft) (Photo 4).

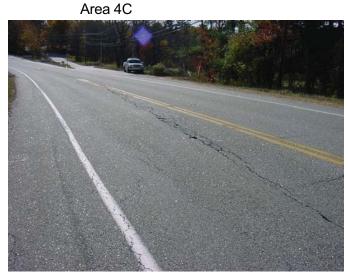
Photo 6. Area 4C PCC Edge Reflective Crack

Area 4C has 19.7 m (65 ft) of PCC running under the roadway. All of it is skewed across the lane due to realignment of the road as can be seen in Photo 6. The original composite road is where the truck is parked and you can see where the PCC pavement edge crack lines up with the edge of the original road. Although Area 4C has PCC under the roadway it is not included in the Composite Roadway Group because the PCC offset is great enough that the experimental drainage would have no influence on this section of road.

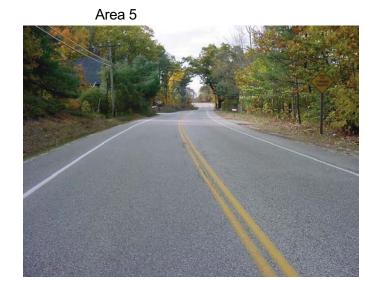
Photo 7. Area 5 (Left Lane)

Area 5 has a slight increase in centerline separation from 103.1 to 107 meters (338 to 351 feet). Forty seven meters of this cracking is greater than 25 mm (1 in) in width (Photo 7).

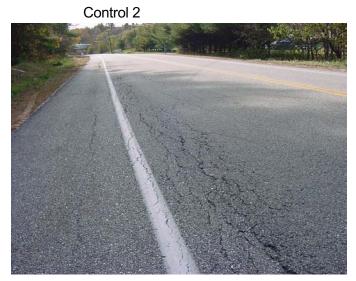
Photo 8. Control 2 Cracking

Load cracking has increased 22% from a total area of 189.9 m^2 to 231 m^2 (2044 ft² to 2486 ft²) (Photo 8)
