Technical Report 98-3
*Potential Benefits of Adding Emulsion to
Full Depth Reclamation Material*

Final Report - September 2004

Potential Benefits of Adding Emulsion to Full Depth Reclamation Material

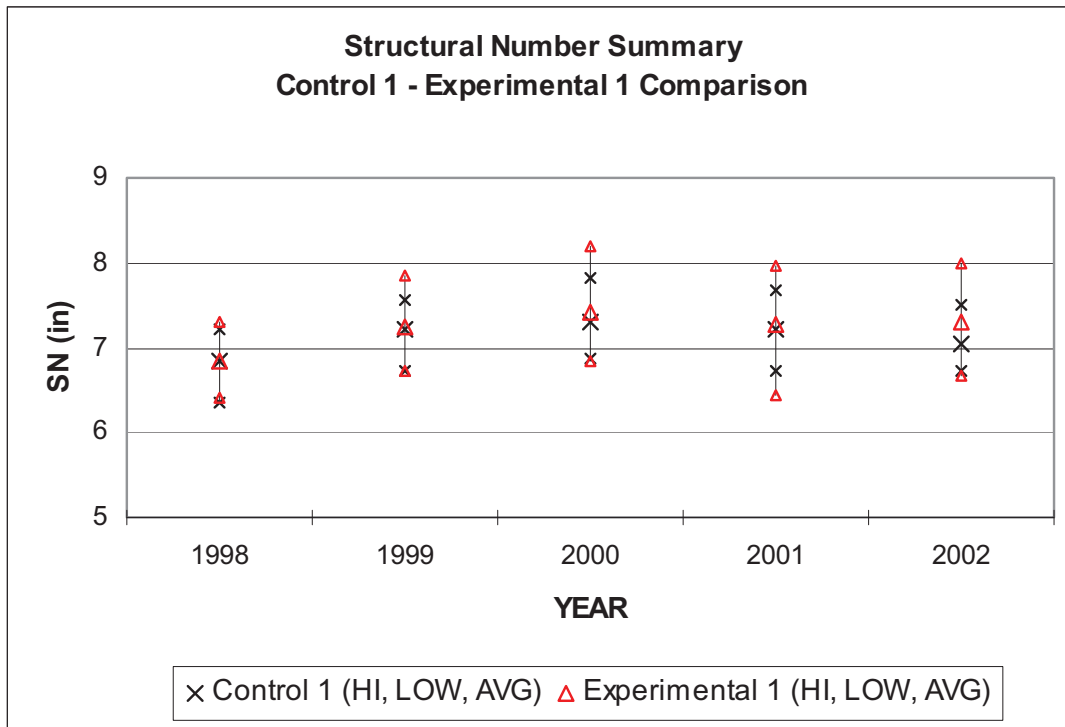
Figure 2 contains a graphical display of the high, low and average Structural Number for Experimental 1 and Control 1 sections from 1998 to 2002. Control 1 Structural Numbers peaked in year 2000 and has decreased since then. Experimental 1 Structural Numbers also peaked in 2000 then decreased and stabilized at 7.28 and 7.30 for 2001 and 2002 respectively. As mentioned in the Fourth Interim Report, Experimental 1 Structural Numbers decreased at a greater rate than Control 1 section during year 2001 tests. In 2002, Control 1 section continues to decline whereas Experimental 1 section increased slightly.

Figure 2. Control 1 and Experimental 1 Structural Number Comparison

COV results are displayed in Table 4. Control 1, Experimental 1 and Control 2 sections have a Fair classification. Experimental 2 section is classified as Poor. Although the mean deflection is lower than the Control 2 section, the standard deviation is high resulting in a non-uniform pavement. This is further supported by the range of Structural Number data in Figures 2 and 3. Experimental 2 has a greater range of data than Experimental 1 section.

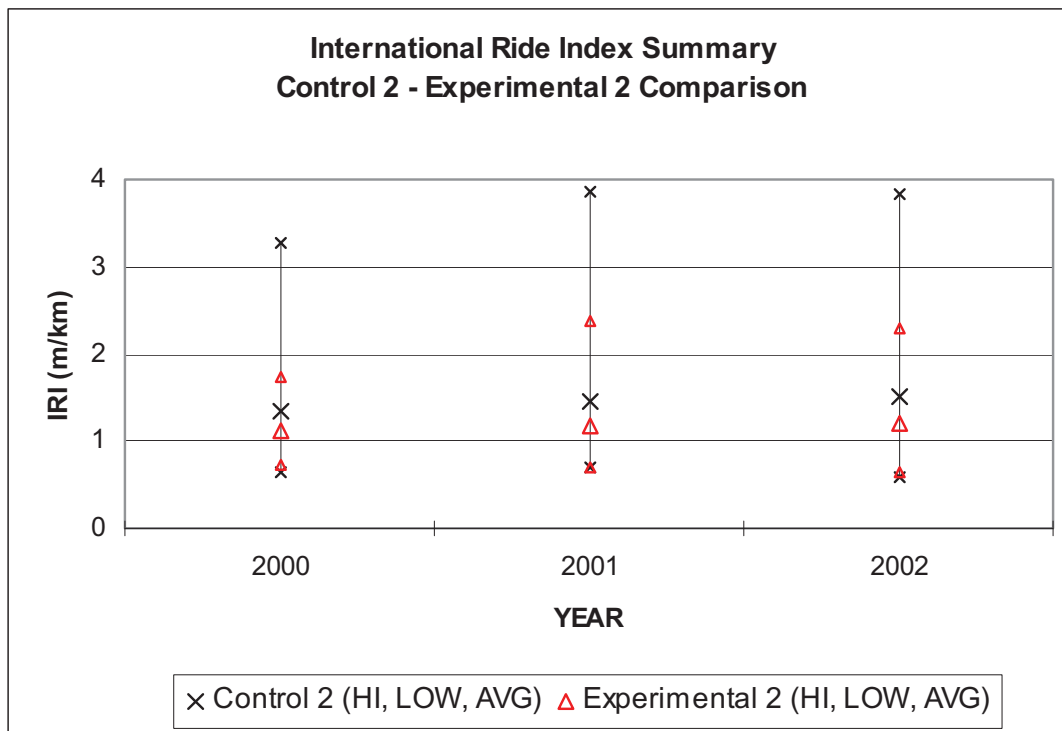
Figure 5 contains a graphical display comparing Control 2 and Experimental 2 hi, low, and average IRI readings. Experimental 2 section has a smoother ride than Control 2 section and a narrow range of IRI values.

Figure 5. Control 2 and Experimental 2 International Ride Index Comparison

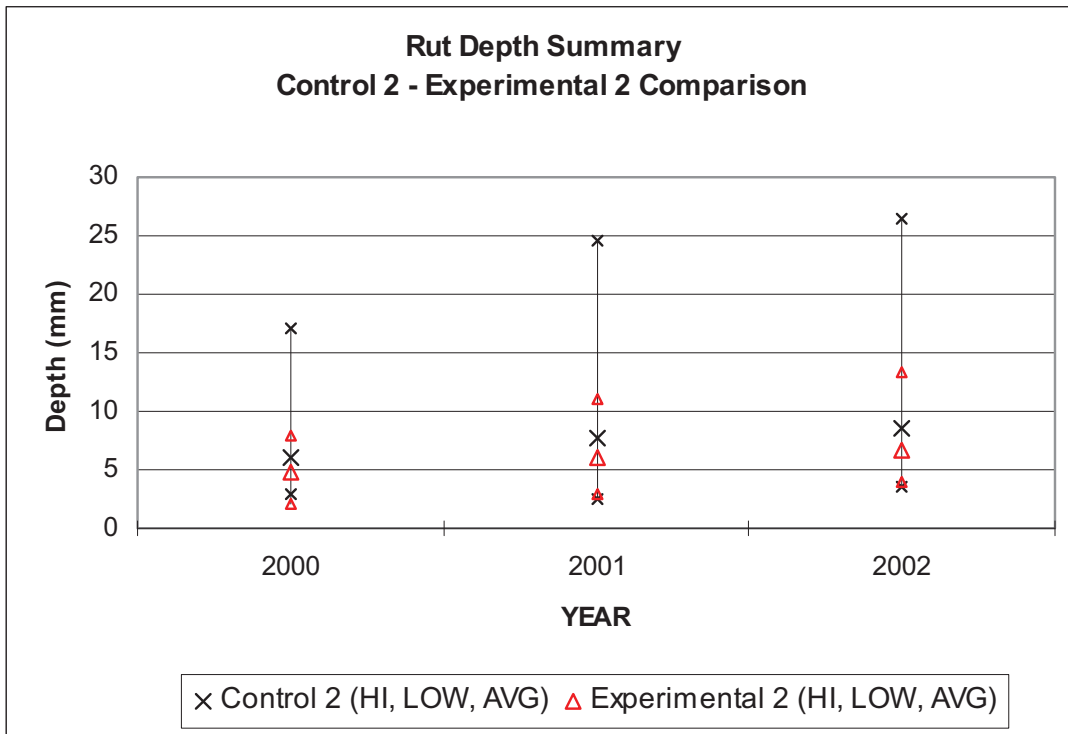
Rutting is greater and the spread of data is greater in this portion of the project. Figure 7 contains mean, hi, and low rut depth values. The Experimental 2 section has less severe rutting and the range of data is smaller than the Control 2 section. Control 2 section has a butt joint at station 3+093 where paving ended and started the next day. The mix is visually dissimilar north of the joint and bituminous tests, summarized later in the report, confirm the difference. Severity of rutting is greater north of this joint where paving continued the next day indicating a possible pavement failure and increasing the range of rut data.

Figure 7. Control 2 and Experimental 2 Rut Depth Comparison

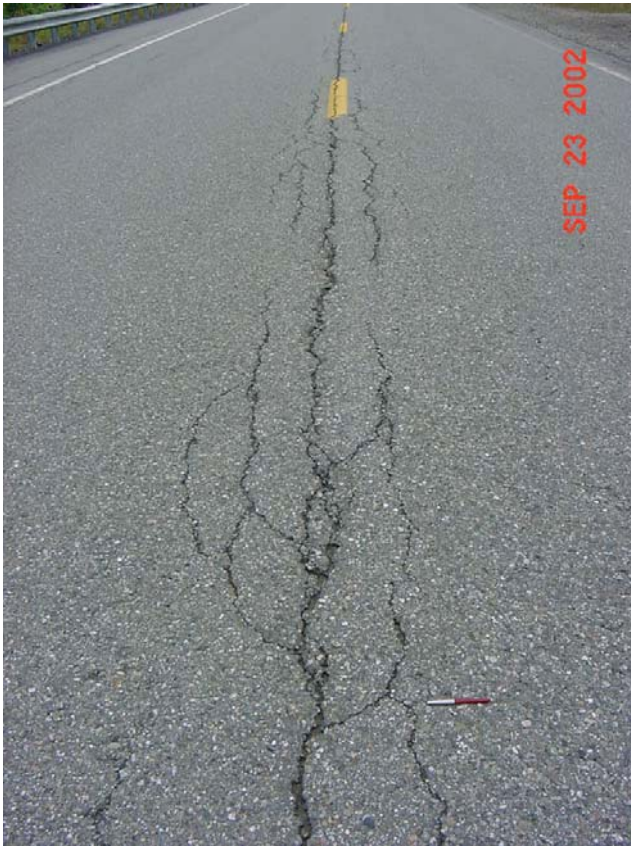
Control 1 section continues to have the majority of centerline joint cracking (Photo 1) and Experimental 2 section has the least amount. Centerline joint separation is not as severe in Experimental 1 section as compared to Control 1 section. Joint separation is also less severe in Experimental 2 section as compared to Control 2 section.

Photo 1. Control 1 Centerline Separation

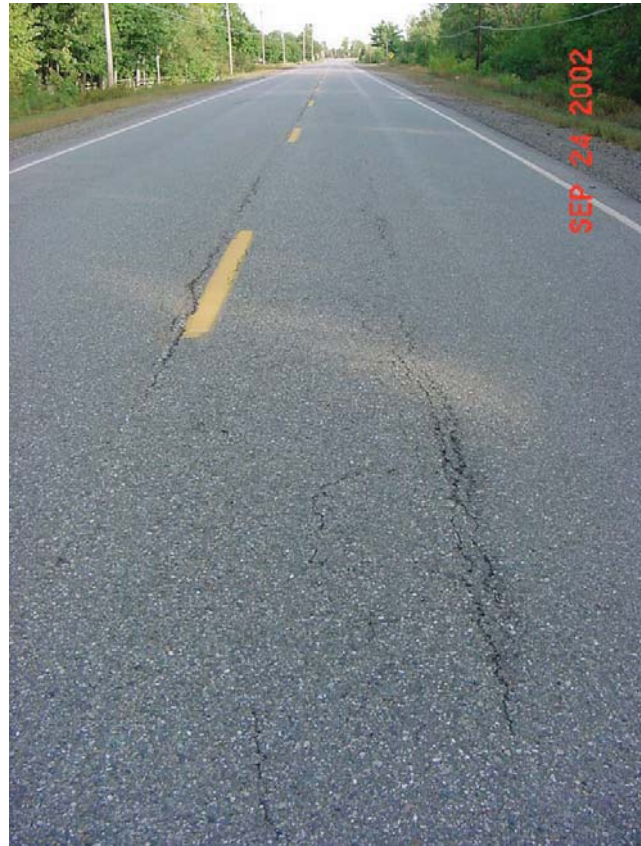
Load cracking is a key indicator of roadway performance. All sections experienced an increase in initial and moderate load cracking with no severe load cracking. Both Experimental sections have less initial and moderate cracking than their respective Control sections. Control 1 has the greatest amount of initial load cracking at 286.7 m (940.6 ft), an increase of 76 %. Moderate cracking in this section increased from 20.8 to 106.9 m (68.2 to 350.7 ft) an increase of 414 %. Experimental 1 section has the second highest amount of initial load cracking at 240.2 m (788.1 ft), an increase of 212 %, and the least amount of moderate load cracking at 7.1 m (23.3 ft) (Photo 2). Control 2 section has the second lowest amount of initial load cracking at 214.9 m (705.1 ft), an increase of 48 % and the lowest increase of all sections. Moderate load cracking in this section increased 26 % from 45.0 to 56.9 m (147.6 to 186.7 ft) (Photo 3). Experimental 2 section has the lesser amount of initial cracking at 194.0 m (636.5 ft), an increase of 79 %, and the second lowest amount of moderate cracking at 50.4 m (165.3 ft) (Photo 4), an increase of 288 %.

Photo 2. Experimental 1 Centerline & Load Cracking

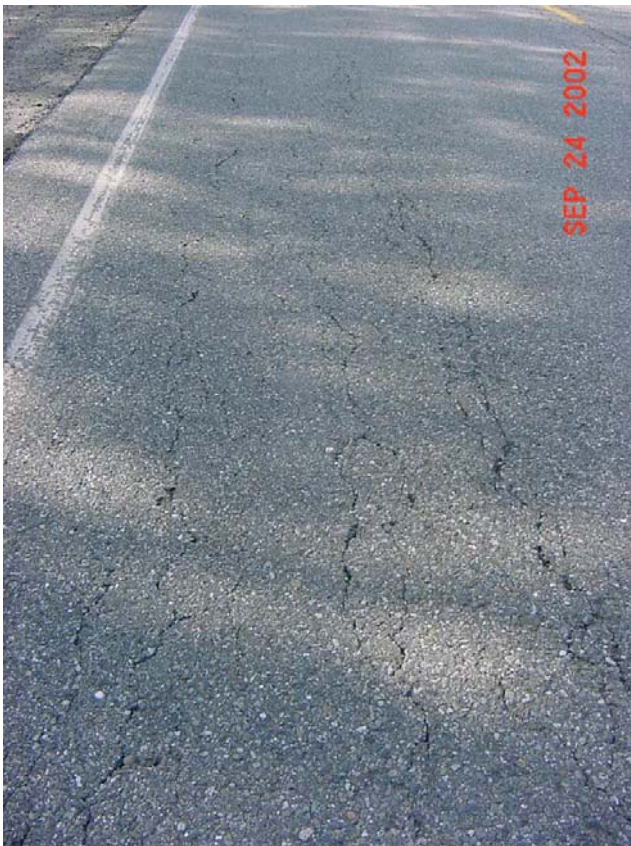
The majority of load cracking in Control 2 section is located beyond the butt joint at station 3+093. When the control and experimental sections were surfaced in 1997, the first day of paving ended at station 3+093 and the second day completed the experimental area. Beyond the butt joint at station 3+093 it appears that the surface mix is coarse with less asphalt. A review of the aggregate and asphalt content reports for this area is included in Table 13 and confirms the coarse aggregate observation. Reference number 43367 was sampled on August 20, 1997 and had sieve analysis tests only. Reference number 43368 had sieve and asphalt content tests and was sampled on August 21, 1997. It's possible that the bituminous mix change may be contributing to the additional cracking in this area of Control 2 section.

Photo 3. Control 2 Moderate Load Cracking
