Design, Construction, and Field Testing of an Ultra-High Performance Concrete Pi-Girder Bridge

Final Report
January 2011

Sponsored by
Iowa Highway Research Board
(IHRB Project TR-574)
Iowa Department of Transportation
(InTrans Project 07-295)

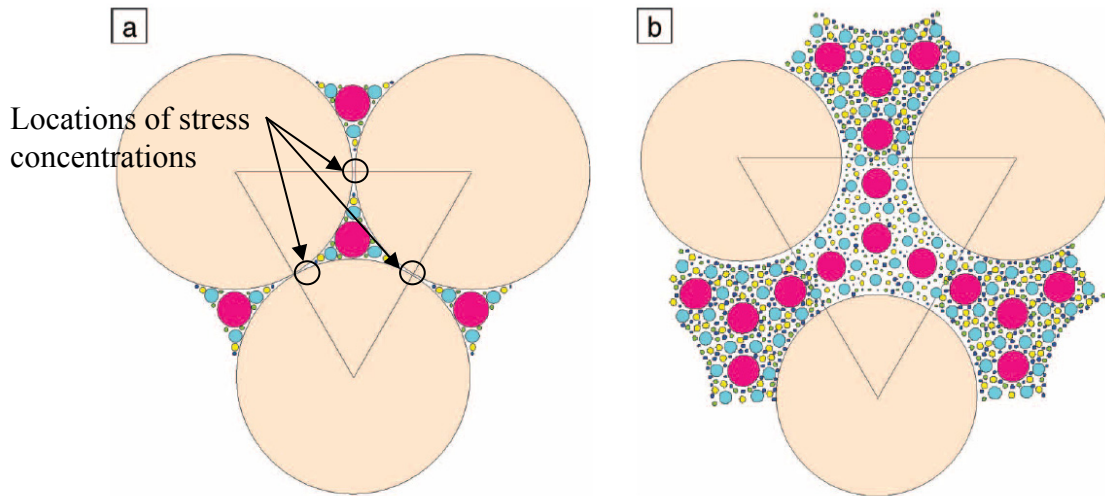
Figure 1.1-Packing Diagrams a) Appollonian Packing b) Spacing Packing-(Vernet 2004)

The material selections for UHPC are based on an optimization of particles to ensure maximum density, mechanical homogeneity, and “spacing packing” of the mix. Optimization of the granular mixture can be achieved through the use of packing models. Larrard and Sedran (1994), found that the Solid Suspension Model (SSM) proved a valuable tool in optimizing high packing densities for cementitious materials. Mechanical homogeneity was improved through the removal of coarse aggregates and improved mechanical properties of the paste. Mechanical homogeneity is desirable as it allows for a more uniform stress distribution, therefore reducing stress concentrations on individual particles. To ensure spacing packing, as opposed to apollonian packing, a wide distribution of particle sizes is selected such that each particle is surrounded by more than one layer of the next smallest particle size, see Figure 1.1 (Vernet 2004). Spacing packing creates a more dispersed and uniform transmission of stress by eliminating the stress concentrations at the particle interfaces (Vernet 2004). Richard and Cheyrezy (1995), found that maintaining a minimum ratio between the mean diameters of two consecutive granular class sizes of thirteen, (i.e. the diameter of sand particles should be thirteen times larger than the diameter of cement particles), provides the desired spacing packing. The combination of maximizing density, ensuring mechanical homogeneity, and spacing packing allows UHPC to sustain large compressive stresses, often in the range of 28 ksi (193 MPa).

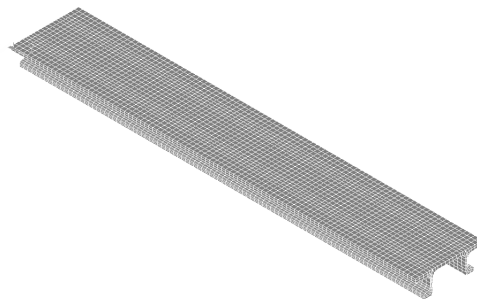
Figure 1.3-Single Girder Finite Element Model

A 3-D finite element model (FEM) used for the analytical study of the second generation section was created with the commercial software, ANSYS. The model was generated by using the ANSYS parametric design language (APDL). APDL was utilized to minimize the required inputs and to expedite the generation of the model when changing one or more key geometric variables, or the mesh size of the model. The model was limited to elastic analysis since no cracking of the UHPC was to be allowed for service level loads (Keierleber, et al. 2008). Thus, all stresses and strains predicted by the model were checked to be within the elastic range of the UHPC. Figure 1.3 illustrates the single girder model geometry and the elastic material properties used for the UHPC are given in Table 1.1.

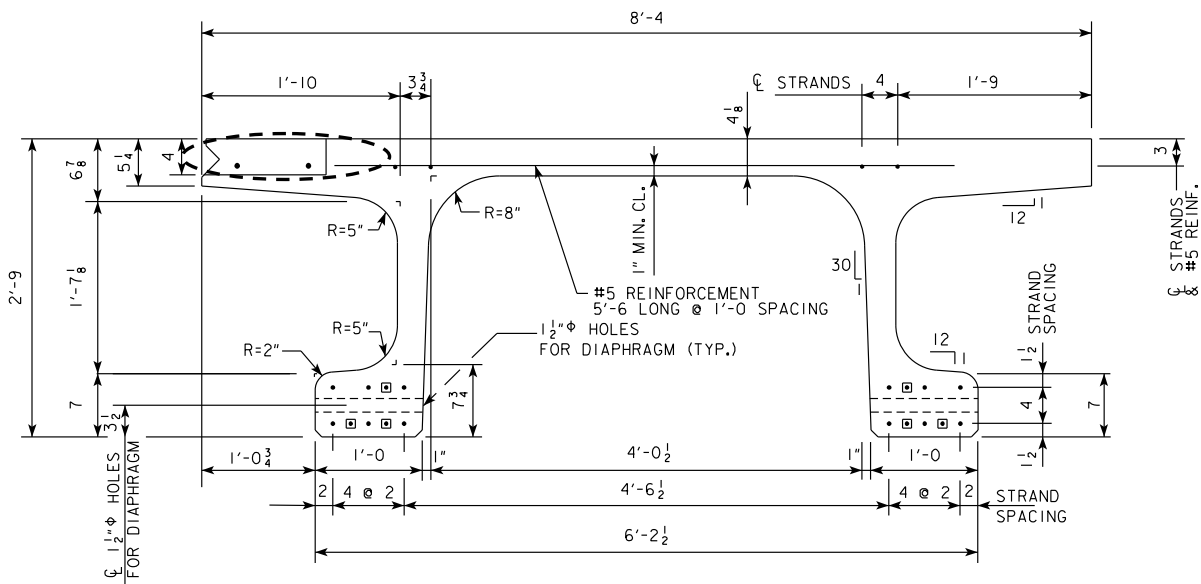
Figure 1.4-Second Generation Pi-Section-(Keierleber, et al. 2008)

The results of the analytical study were used by the Iowa DOT bridge office along with collaboration among the BEC, LaFarge, and FHWA to establish a second generation pi-section. Figure 1.4 shows the second generation pi-section.

Longitudinal reinforcement details for the pi-girders are shown in Figure 1.4. Twenty-two 0.6 in diameter, low-relaxation prestressing strands provided the flexural reinforcement. Eighteen strands were placed in the bottom of the bulbs, nine in each bulb, and tensioned to a total force of 766 kips (3407 kN). The four strands located in the deck were prestressed to a total initial force of 170 kips (756 kN). Along with Figure 1.4, Figure 2.12 and Figure 2.13 display the layout of the longitudinal prestressing strands.

Transverse flexural reinforcement consisted of mild #5 (15.9 mm) bars placed in the bottom of the deck at 1 ft. on center as shown in Figure 1.4. The transverse flexural strength of the UHPC deck alone was estimated to be sufficient to avoid cracking, but the #5 bars (15.9 mm) were added to provide reinforcing to the section if the UHPC in the deck were to experience inelastic deformation.

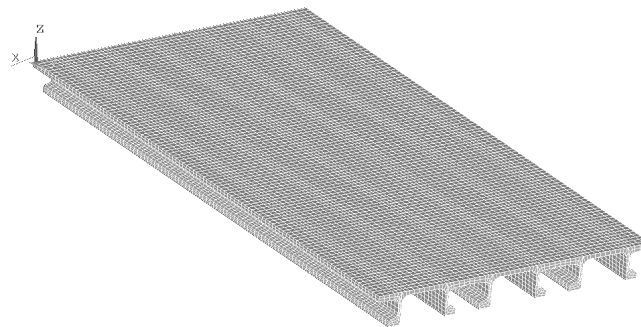
**Figure 2.1-Centerspan Finite Element Model**

To analyze the UHPC pi-girder span a finite element model of the three-girder centerspan was generated. The model was created by combining three individual girders to create a model composed of over 25,000 solid elements. The model's span length, prestressing force, support conditions, connections between individual girders, number of diaphragms, the spacing of diaphragms, and mesh size were adjusted to provide estimates of stresses and strains acceptable for the bridge. The finite element model of the centerspan is shown in Figure 2.1.

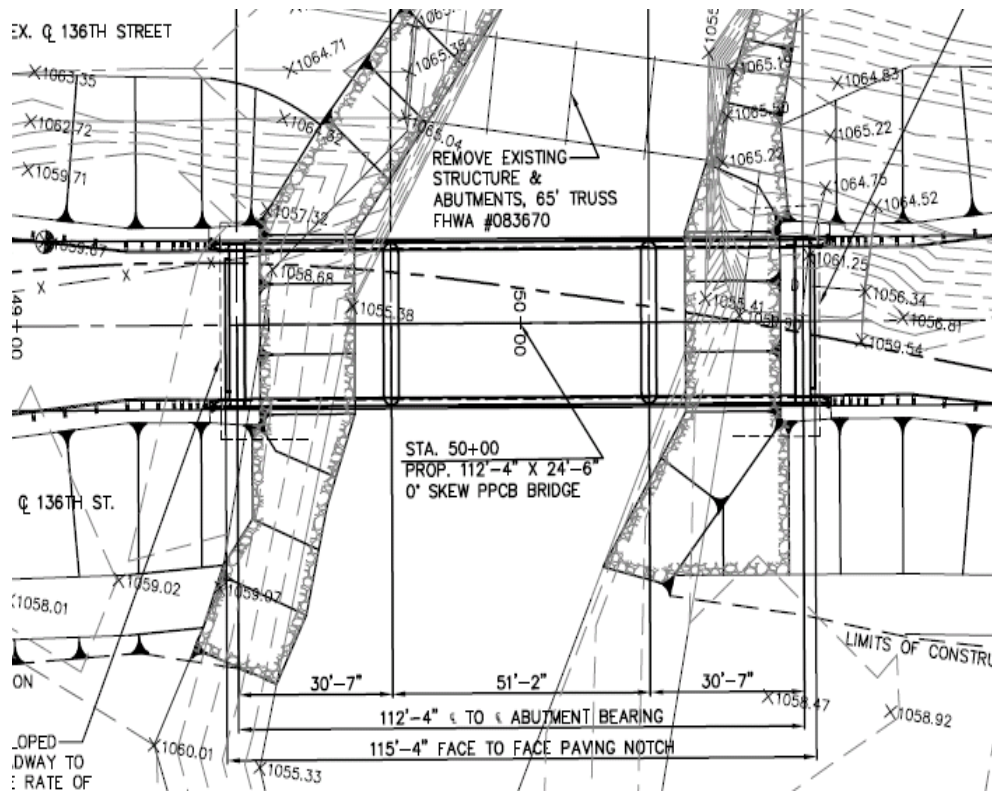
Figure 2.4-Situation Plan of Buchanan County Pi Girder Bridge-(Keierleber, et al. 2008)

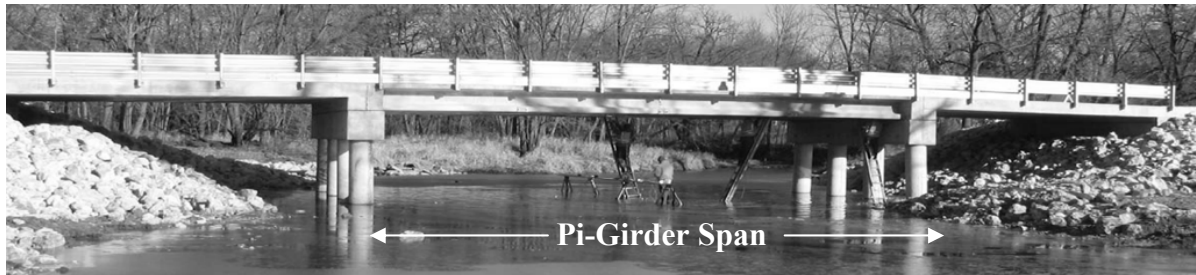
Figure 2.5-Elevation Photograph of Pi-Girder Bridge

The subject bridge is located on a low volume road in Buchanan Co., Iowa, as shown in Figure 2.2, Figure 2.3, and Figure 2.4. The bridge is 25 ft (7.62 m) in width, 115 ft 4 in. (35.15 m) in length, and consists of three spans. An elevation photograph of the bridge can be seen in Figure 2.5. The center span of the bridge consists of three UHPC pi-girders each with a span length of 50 ft-0 in. (15.24 m). A cross section view of the center span is presented in Figure 2.6. The end spans are 18 in. (45.72 cm) thick, normal strength reinforced concrete slabs with spans of 31 ft.-8 in. (9.65 m). An elevation view of the end spans is shown in Figure 2.7. An asphalt wearing surface was placed on the bridge in Spring of 2009.

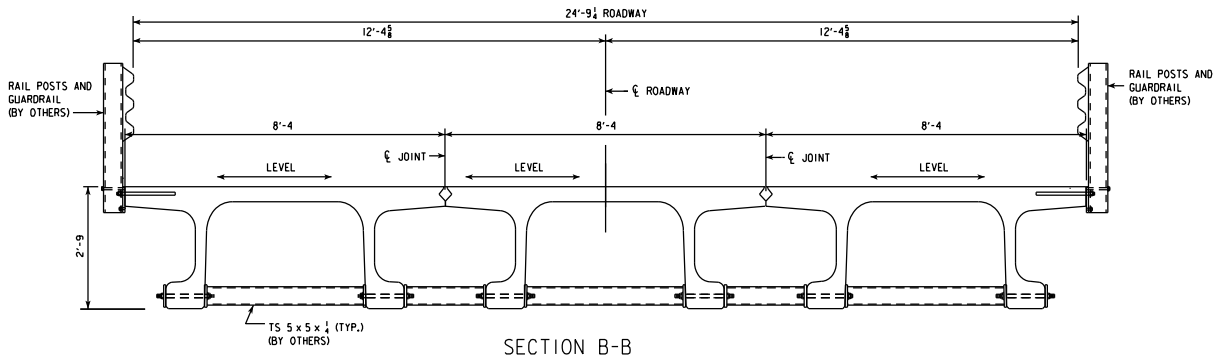
Figure 2.6-Cross-Section of Center Span-(Keierleber, et al. 2008)

For the pi-girder span, steel tube diaphragms were placed at quarterspan and midspan. Although these diaphragms were primarily installed to improve the lateral live load distribution (Keierleber, et al. 2008), previous tests results on the first generation section suggested that these diaphragms would significantly increase the ultimate strength of the section (Graybeal 2009a). The steel diaphragms are shown in Figure 2.6, Figure 2.8, and

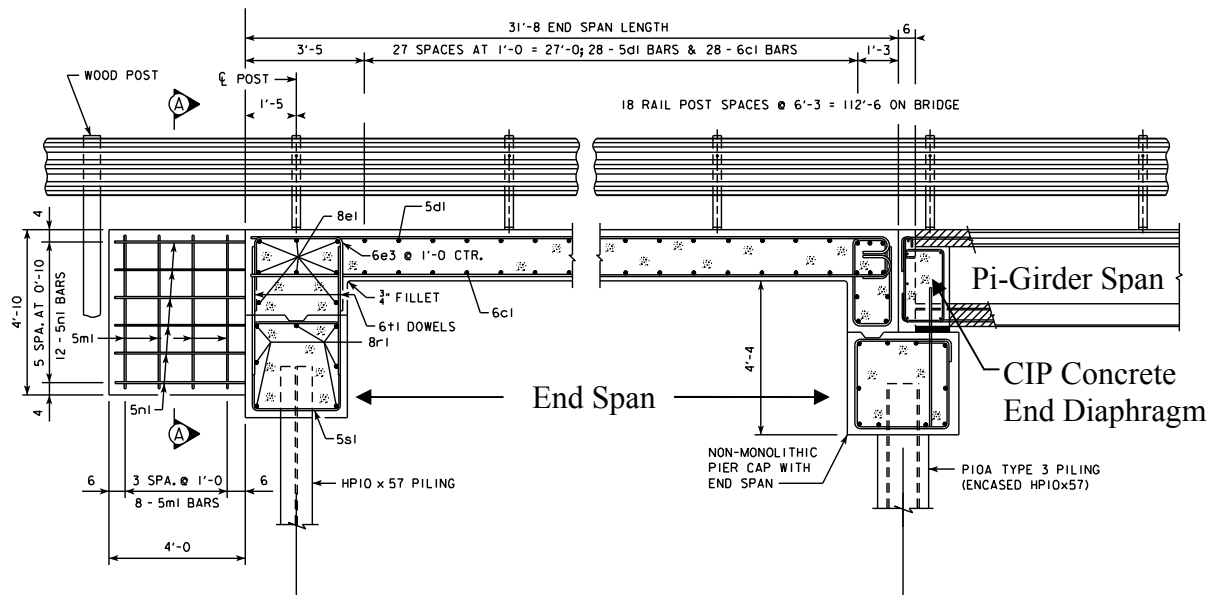
Figure 2.7-Elevation View of End Spans and Pier-(Keierleber, et al. 2008)

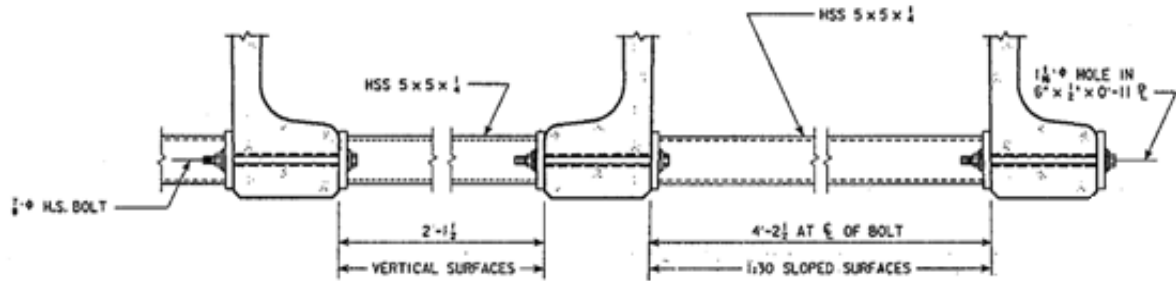
Figure 2.8-Construction Details of HSS Diaphragms

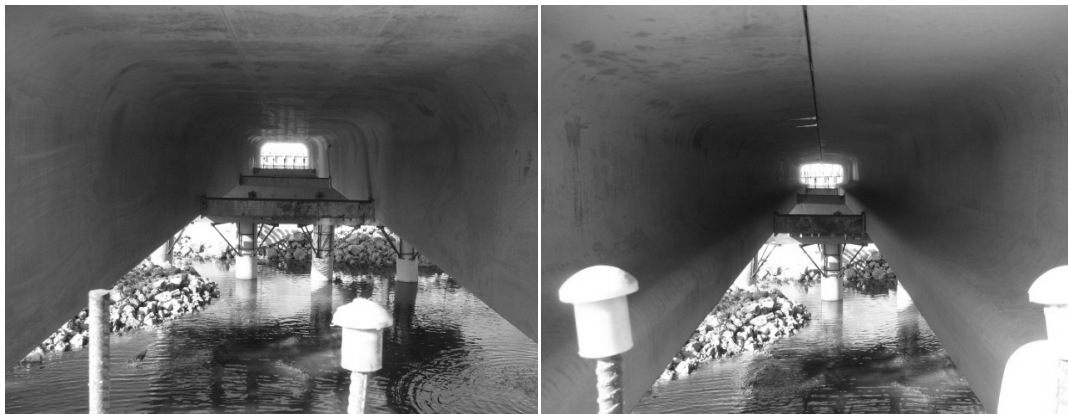
a. Diaphragm in a girder

b. Diaphragm between adjacent girders

Figure 2.9-Steel Tube Diaphragm Placement Photographs

Figure 2.9. The girder ends were seated on neoprene bearing pads and were encased in cast-in-place concrete diaphragms as shown in Figure 2.7.

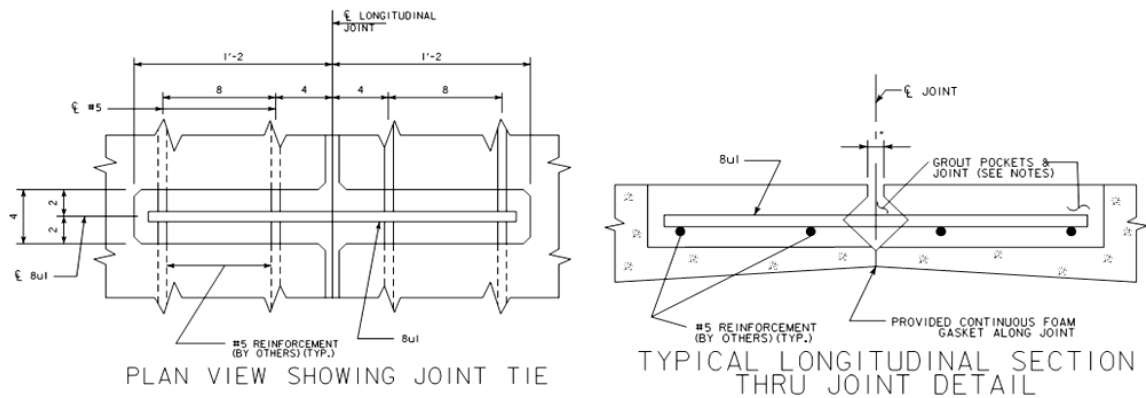
Figure 2.10-Pi-Girder Longitudinal Joint Connection Detail

A cast-in-place shear key was used to connect adjacent girders at the deck level. In addition, #8 bars (25 mm diameter bars) were placed in grout pockets on the top of the deck every 18 in. (45.7 cm.). The location of the grout pockets is shown in Figure 1.4 with a dashed oval, while Figure 2.10 and Figure 2.11 provide the construction details and pictures for the connection.

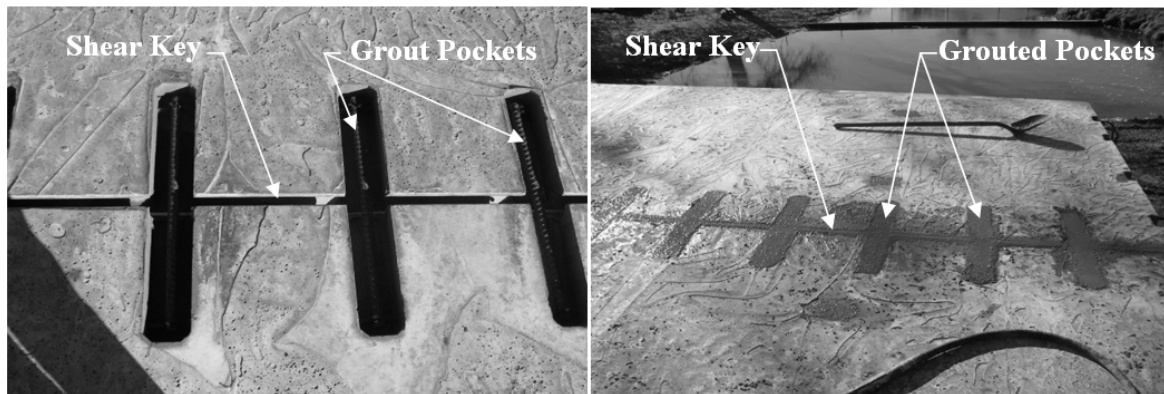
Figure 2.11-Longitudinal Joint Connection Photographs

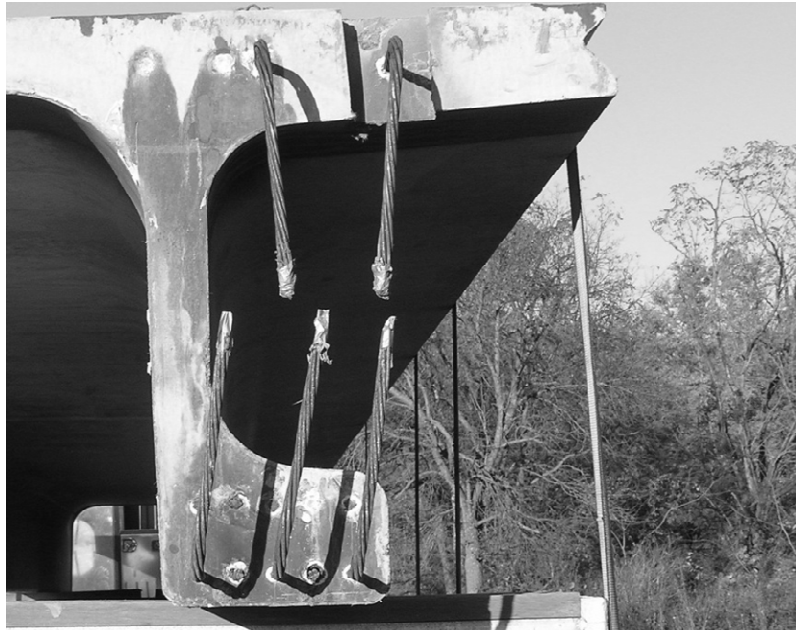
Figure 2.12-Pi-Girder Longitudinal Prestressing

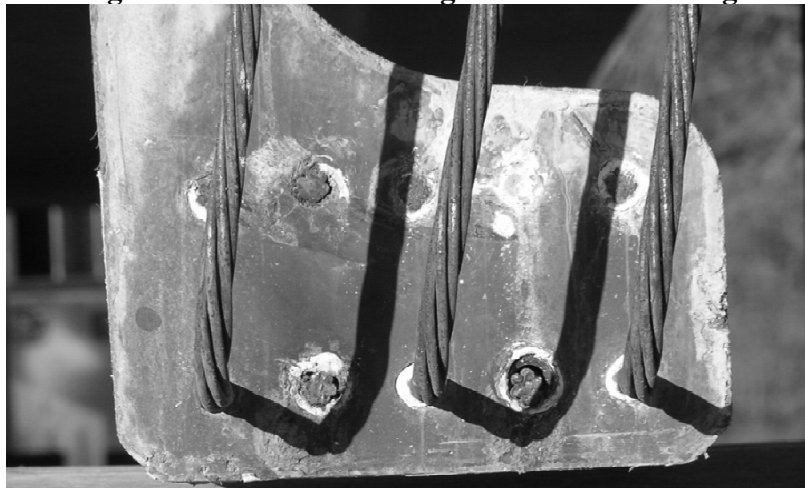
Figure 2.13-Bottom Bulb Longitudinal Prestressing

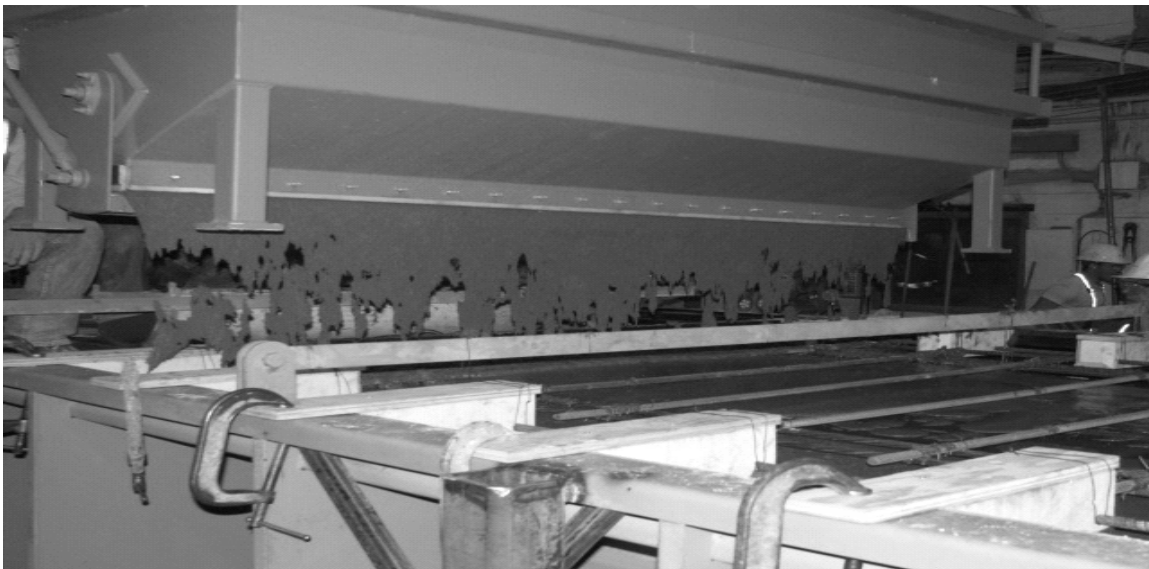
Figure 3.1 Placement of UHPC Material into Forms

The fluid UHPC material was placed into the forms with a crane-mounted hopper as shown in Figure 3.1. Following placement into the forms, the top surface was immediately covered with plastic and then steam cured using thermal blankets for 48 hours at 195° F as shown in Figure 3.2. Initial set to break forms was achieved in 25-30 hours from placement, and strands were released at 40 hours after placement.

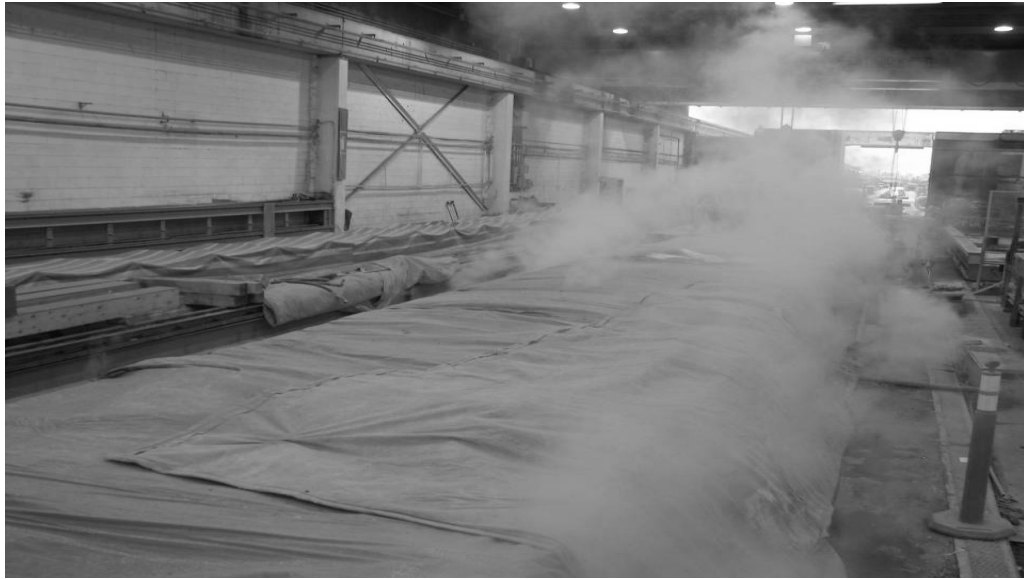
Figure 3.2 Steam Curing of Pi-Girder

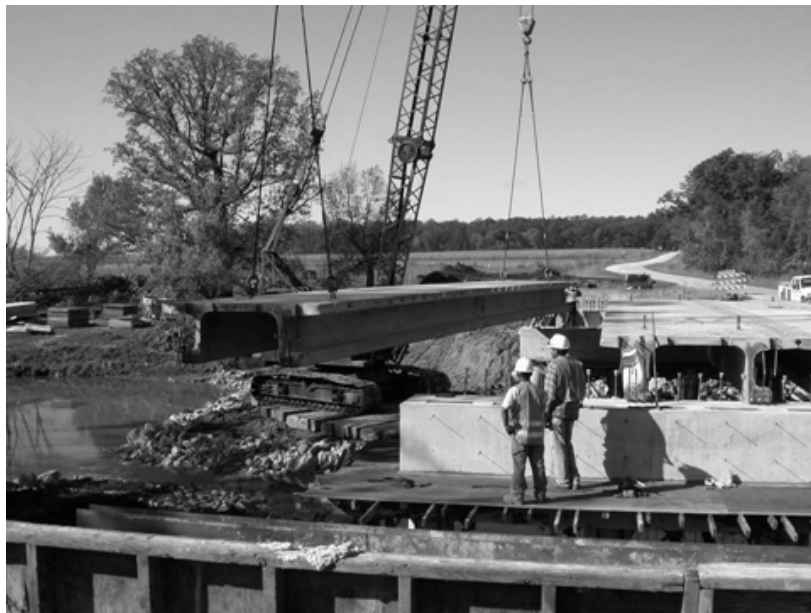
Figure 3.3 Erection of Pi-Girders

The pi-girders were the first component of the bridge superstructure to be erected. Upon arrival to the construction site, the pi-girders were lifted into place using two cranes, each on opposing sides of the span as shown in Figure 3.3. Once positioned on the pier caps, the pi-girders were connected to one another at their top flanges by placing dowels in each grout pocket and then filling the pockets and shear keys with a non-shrink grout as shown in Figure 3.4.

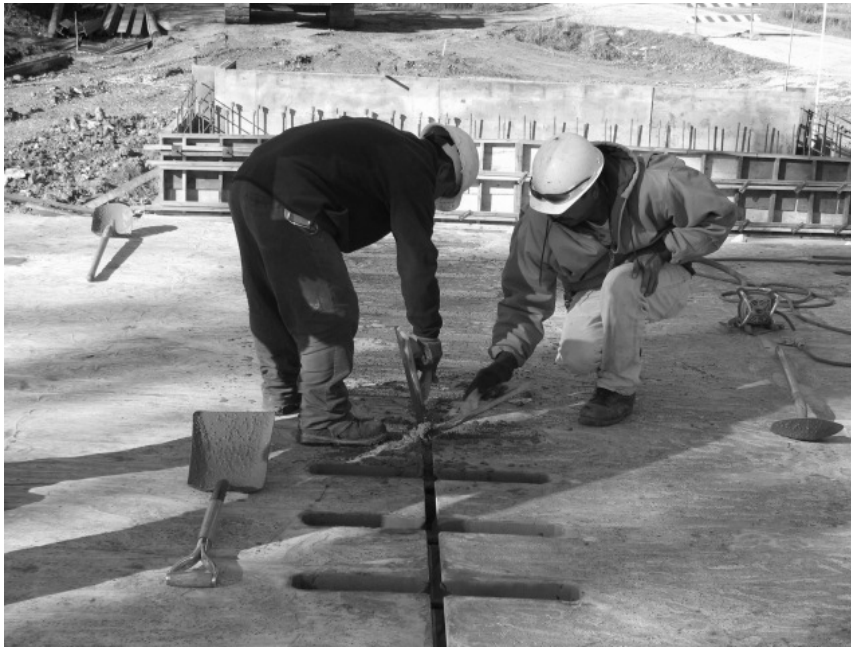
Figure 3.4 Connecting the Flanges of the Pi-Girders

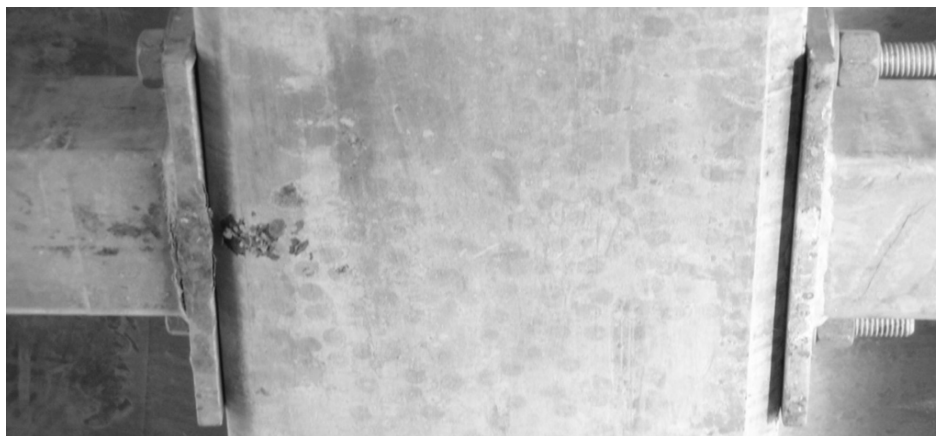
Figure 3.5 Damage to End Plates of Steel Diaphragm Members

Finally, the steel tube diaphragms for the pi-girders were installed and bolted into place. In several instances, the steel tubes fit poorly. To fit the diaphragm members in place the end plates were cut and the members rammed into place causing minor damage to the end plates (see Figure 3.5) and significant strain in the webs of the pi-girders as will be discussed subsequently.

During installation of the diaphragms, it was observed that some of the HSS members needed to be modified to fit between the webs. Modifications included lubrication of the members as well as shaving off portions of the base plates. Even with adjustments to the members, the diaphragm installation was sometimes difficult. The installation process often resulted in members being forced into place. Possible explanations for the tight fit of diaphragm members include shrinkage of the section, deformation of the webs under prestressing and self-weight, and inadequate length tolerances of the HSS members.

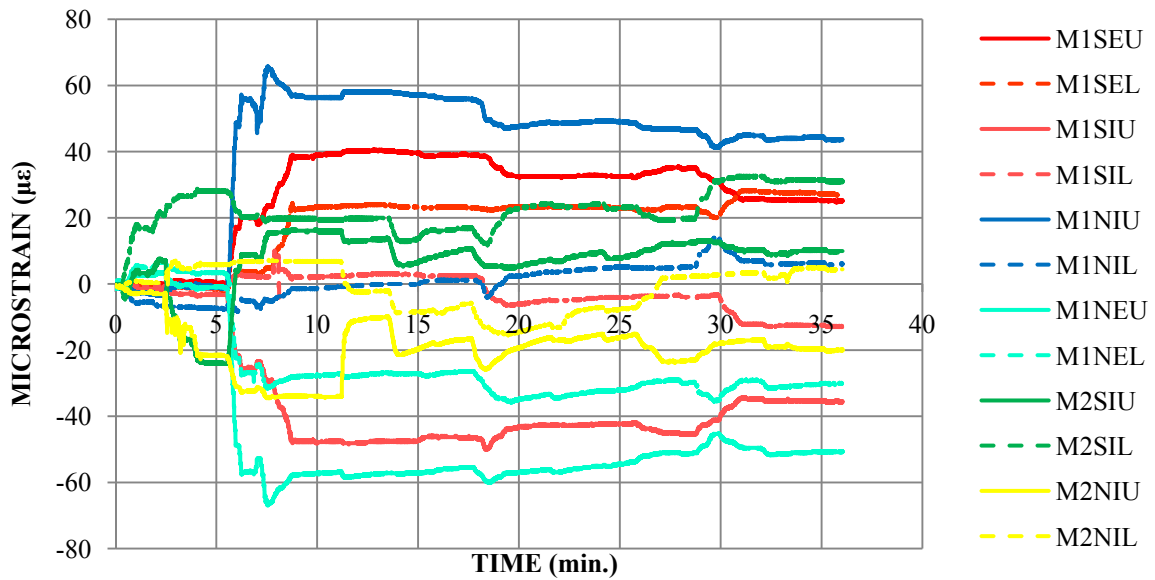
Figure 3.8-Construction Vertical Web Strain Measured at Midspan

The construction strains measured in the vertical transducers at midspan ranged from -65 to +65 $\mu\epsilon$. After all of the diaphragm members had been installed, the maximum residual tensile strain in the webs was roughly 45 $\mu\epsilon$ recorded at M1NIU. Forty-five $\mu\epsilon$ is significant as the maximum live load strain measured in the webs during live load testing, as will be discussed subsequently, was 45 $\mu\epsilon$. Figure 3.8 displays the measured construction strains at midspan. Note that abrupt changes in strain correspond to the tightening of nuts on various diaphragm members.

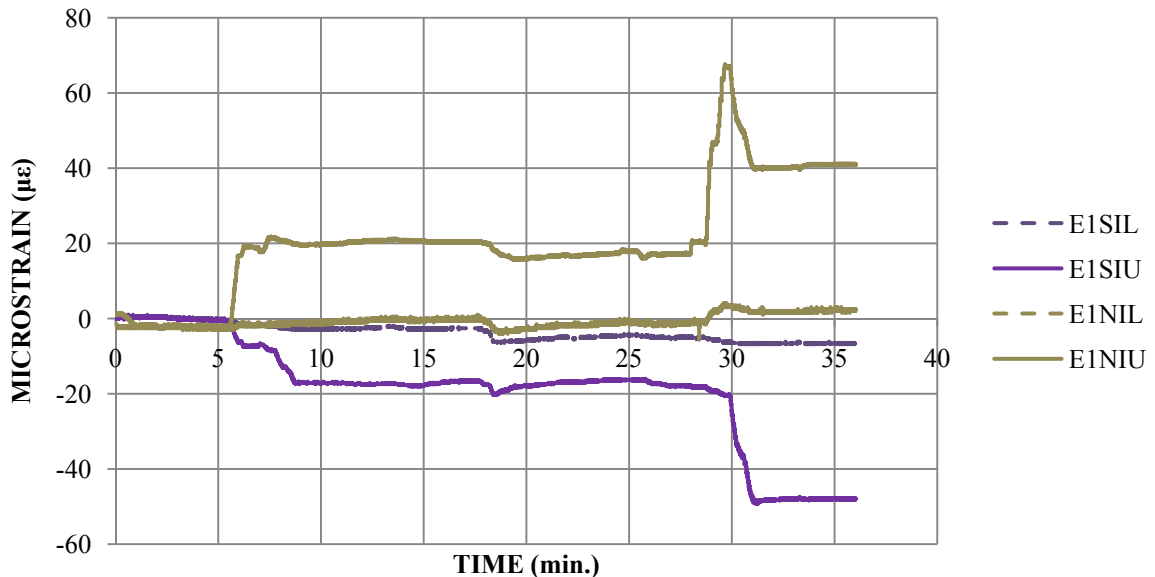
Figure 3.9-Construction Vertical Web Strain Measured at 3/8 Span

The construction strains measured by the transducers at three-eighths span ranged from -50 to +65 $\mu\epsilon$. After all of the diaphragm members had been installed, the maximum residual tensile strain in the webs was roughly 40 $\mu\epsilon$ recorded at E1NIU. Figure 3.9 displays the construction strains measured at the three-eighths span as the diaphragm members were installed.

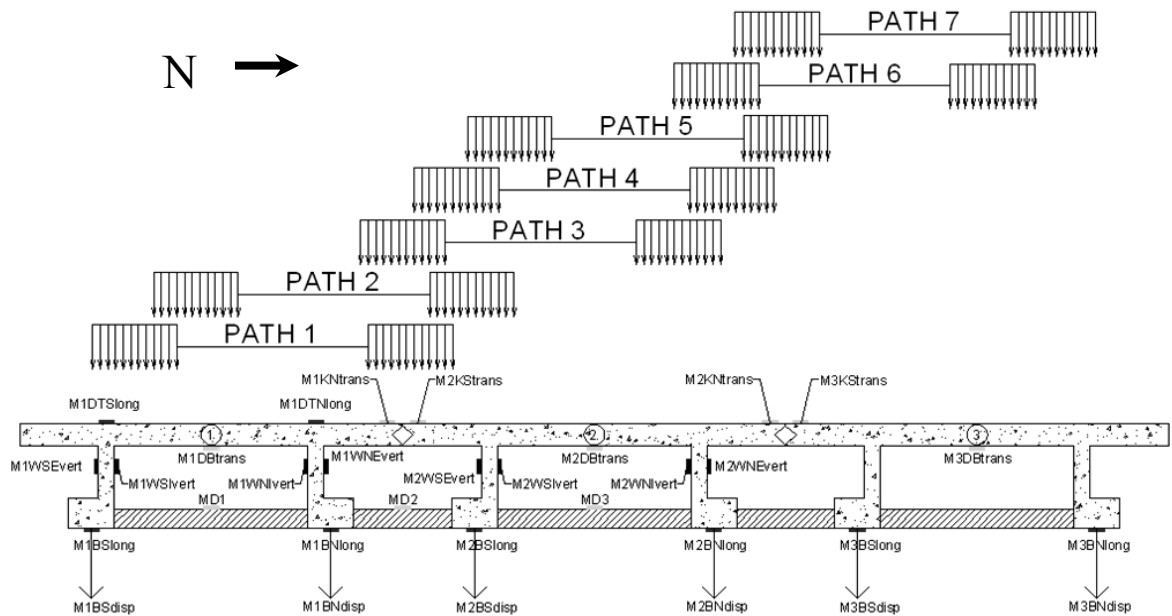
Figure 5.1-Schematic Layout of 2008 Transducers and Loading Paths at Midspan

the naming key can be seen in Figure 5.1 and Table 5.1 respectively. The quarterspan instrumentation consisted of three strain transducers located on bottom of the three southernmost bulbs oriented longitudinally. The instrumentation near the eastern pier consisted of three longitudinal strain transducers, two of which were located on the bottom of the southernmost bulbs oriented longitudinally with the remaining transducer located on the top of the deck over the northern bulb on girder 1 also oriented longitudinally.

The seven transverse load paths shown in Figure 5.1 were used for the static load test conducted 2008. In total, 28 passes were made during the test, 14 with the midspan diaphragm bolts tight and 14 with the midspan diaphragm bolts loose. The initial 14 passes were to quantify the bridge behavior under normal service conditions. These initial passes could then be compared to the passes made with the diaphragm bolts loose to examine the effect of the HSS diaphragm members on the bridge.

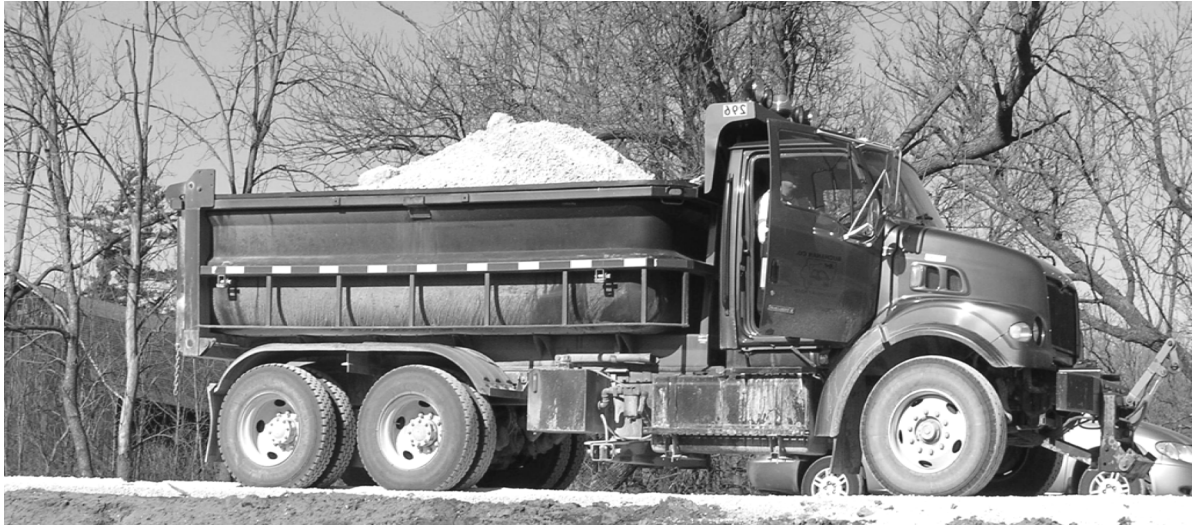
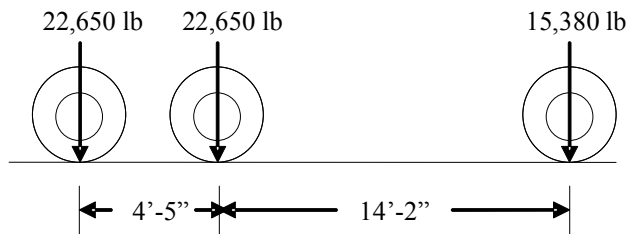
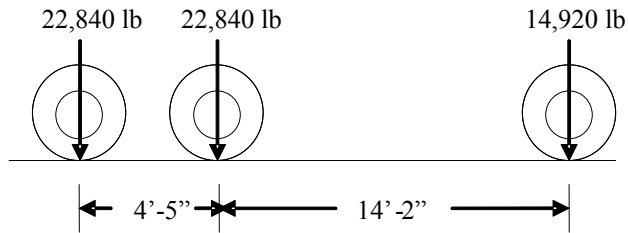
a. 2008 & 2009 Test Truck

b. 2008 load values

c. 2009 load values

Figure 5.3-Test Truck Configuration and Loading

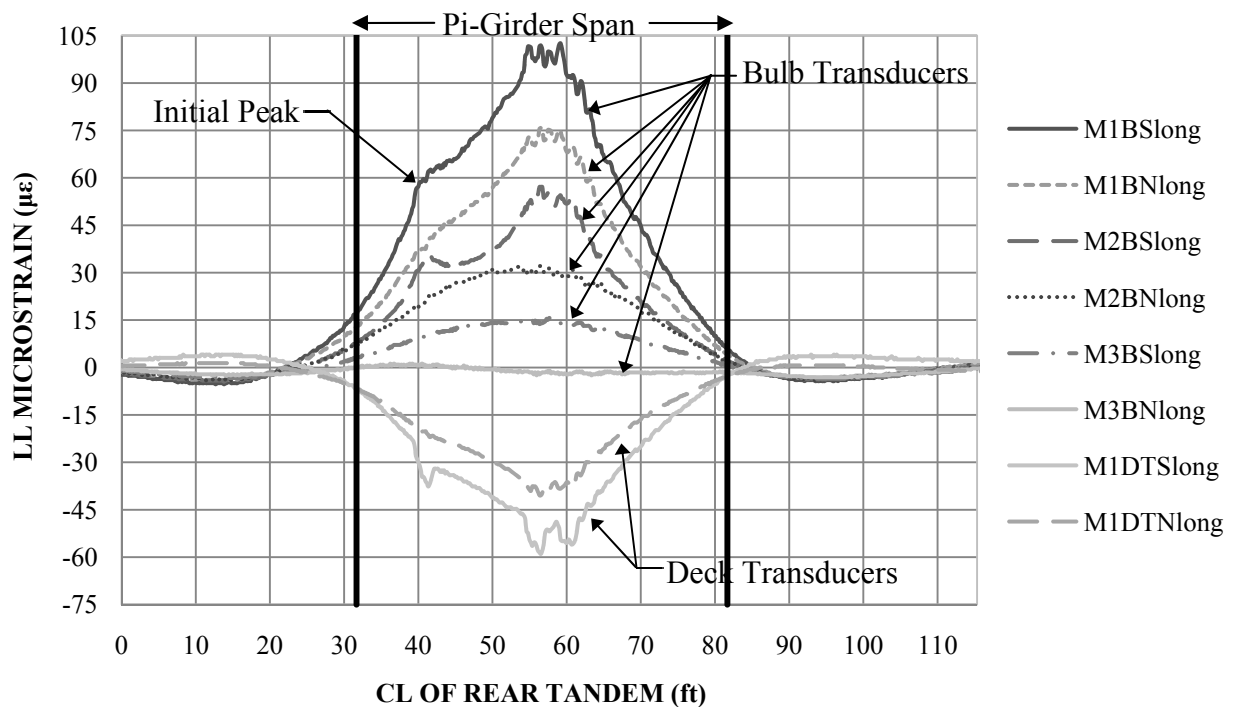
Figure 5.4-Representative Sample of LL Longitudinal Strain at Midspan along Path 1

A trend present in a majority of the longitudinal strain data was the presence of an initial spike in the strain caused by the front axle passing directly over the transducers. The spike occurs in Figure 5.4 when the centerline of the rear tandem axle is roughly 40 ft beyond the beginning of the bridge.

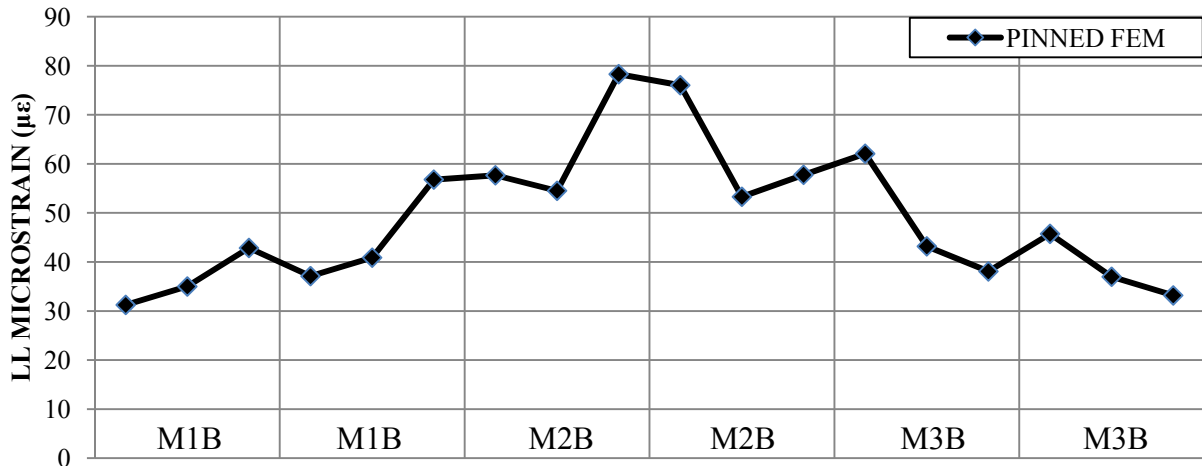
Figure 5.6-Localized LL Longitudinal Strain Variation between Nodes at Midspan

The strain predicted by the FEM at midspan varies greatly depending on which node on the bottom of bulb is being considered. The possible nodes for consideration are shown in Figure 5.5. Variations of up to 25 $\mu\epsilon$ were observed between the three nodes on the bottom of the bulbs at midspan. Figure 5.6 displays the strain variation between nodes along the centerline of the bridge for path 4. Strain transducer placement in the field was not always along the centerline of the bulb due to limitations on ladder placement and individual worker capabilities. Therefore, to account for deviations of transducer location from the bulb centerline, the maximum strain reading of the three nodes located on the bottom of the bulbs will be reported in this section as the FEM prediction.

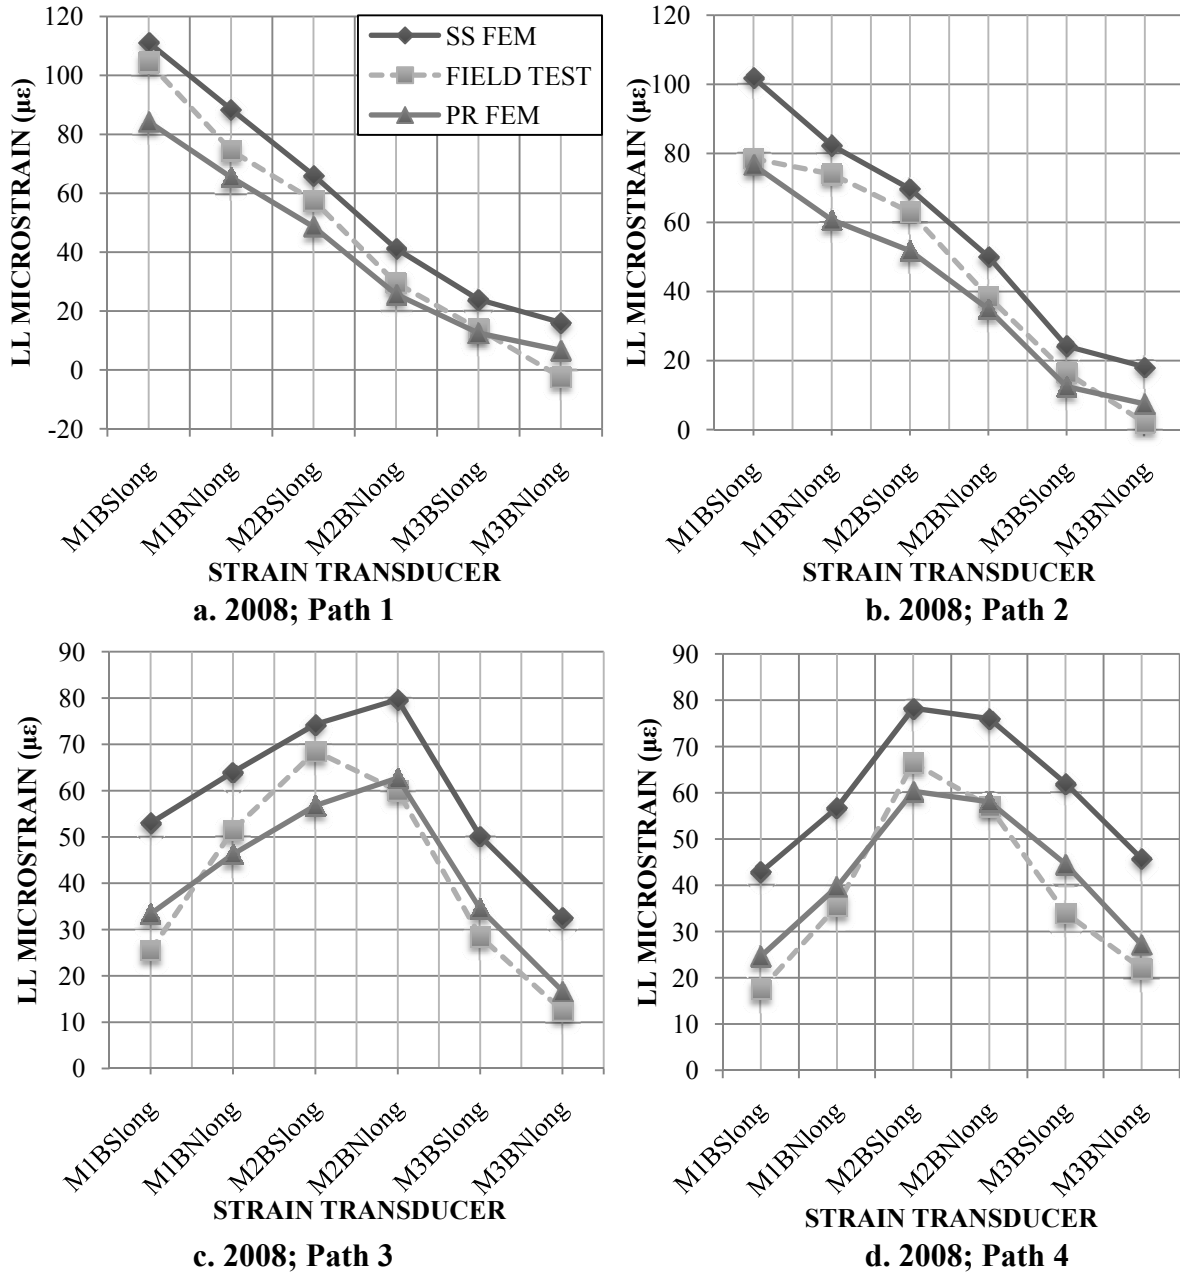
Figure 5.7-FEM LL Longitudinal Bulb Strain at Midspan Paths 1-4

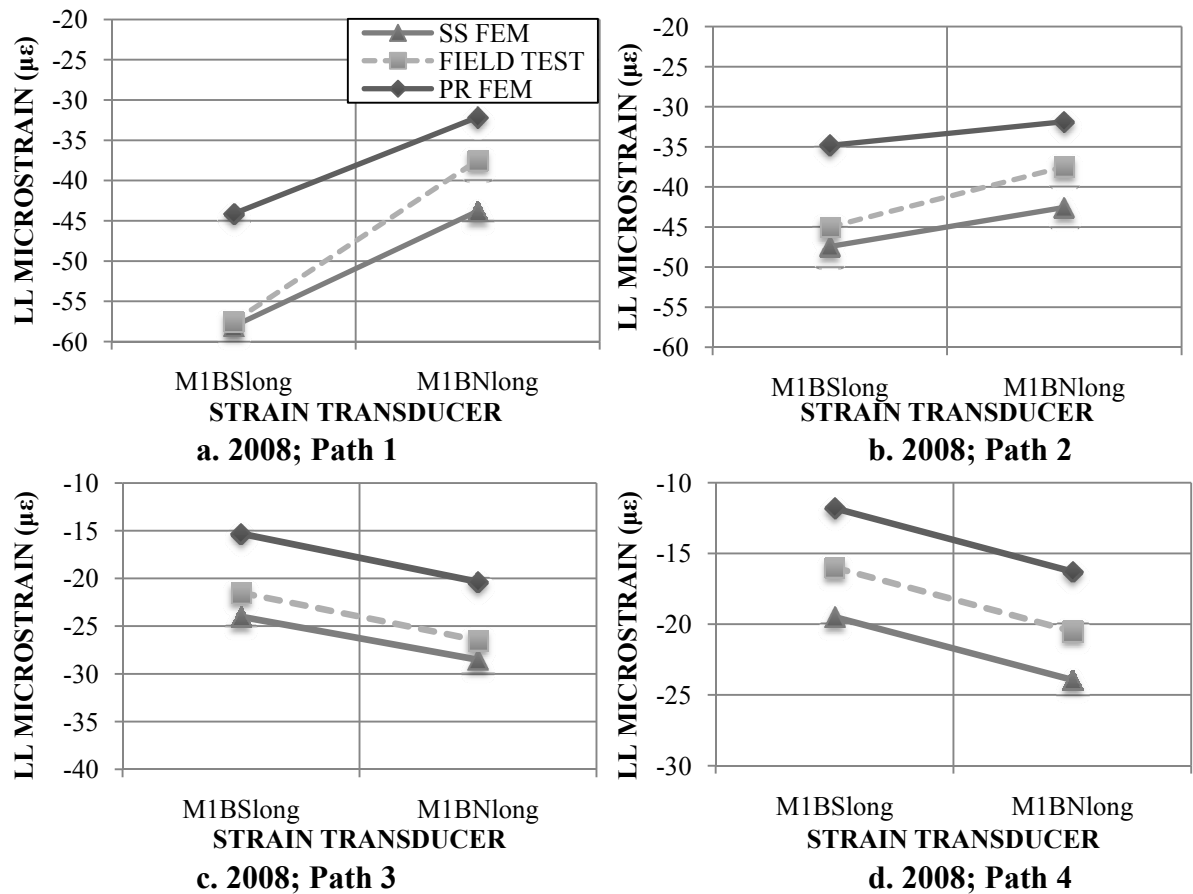
Figure 5.8-FEM LL Longitudinal Deck Strain at Midspan Paths 1-4

The longitudinal deck strains at midspan were also predicted with the FEM. Since only two transducers were orientated longitudinally on the top of the deck, only two data points were available for comparison. The strains were predicted using both a simply supported and partially restrained end condition. The predictions for load paths 1 through 4 are shown in Figure 5.8a-d. Paths 5-7 are not shown due to their similarity to paths 1-3.

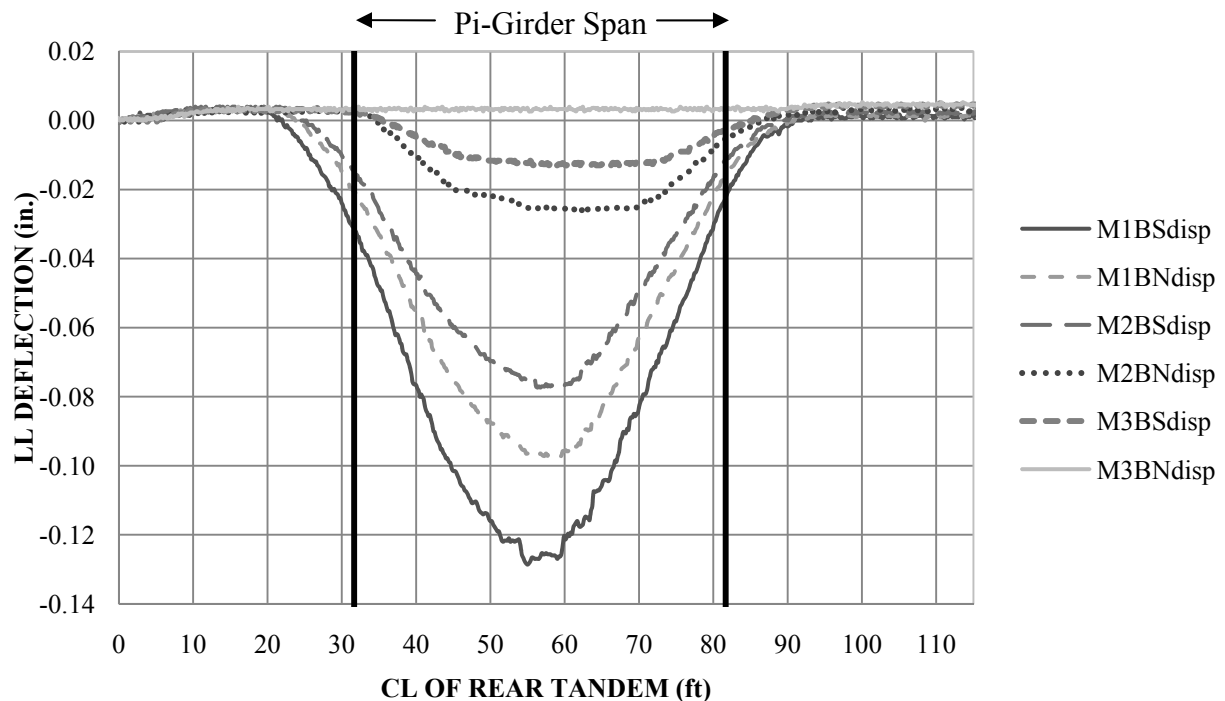
Figure 5.9-Representative Sample of LL Deflection at Midspan along Path 1

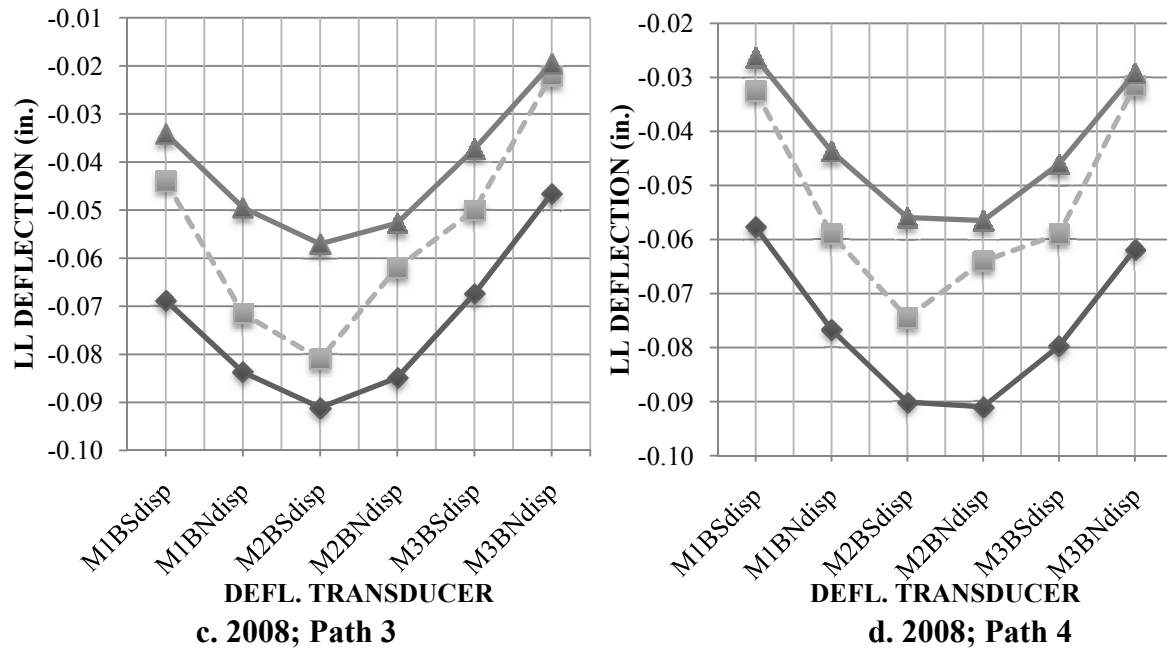
Figure 5.11-FEM LL Deflection at Midspan Paths 1-4

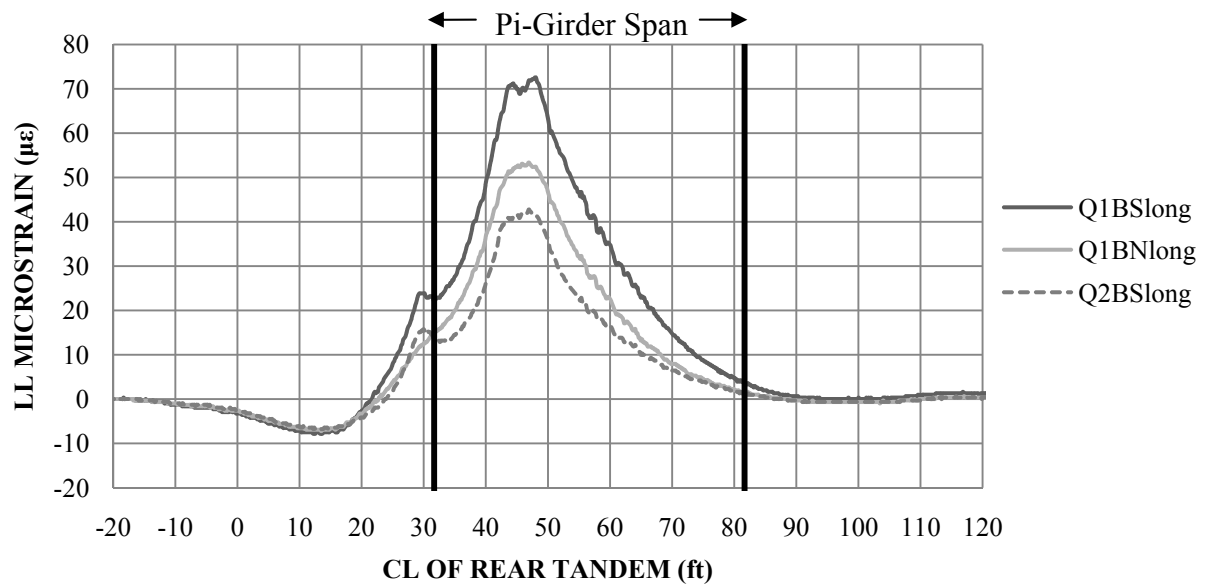
Figure 5.12-Representative Sample of LL Longitudinal Strain at Quarterspan along Path 1
