Design, Construction, and Field Testing of an Ultra-High Performance Concrete Pi-Girder Bridge

Final Report
January 2011

Sponsored by
Iowa Highway Research Board
(IHRB Project TR-574)
Iowa Department of Transportation
(InTrans Project 07-295)

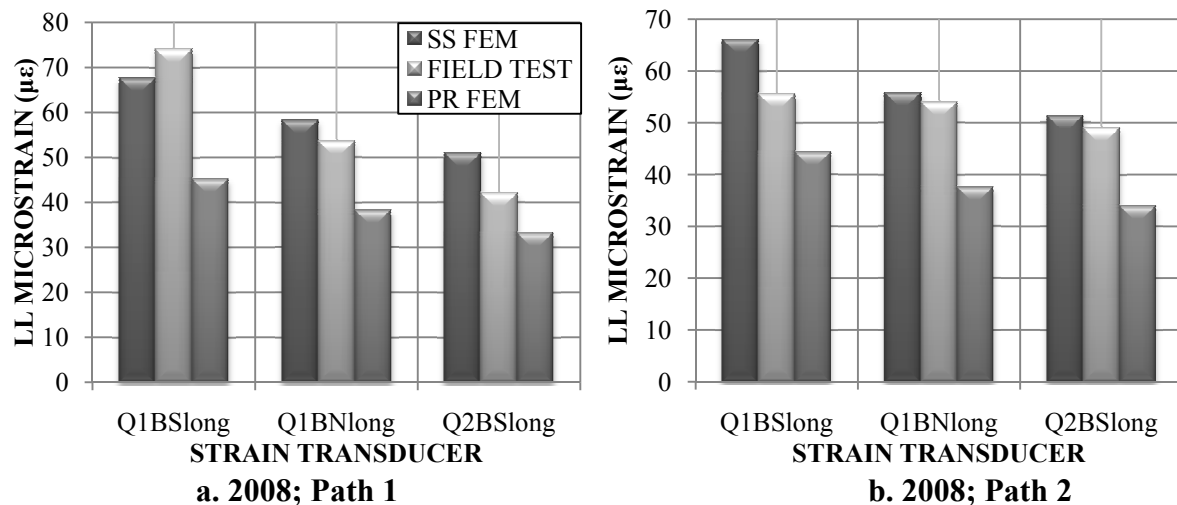
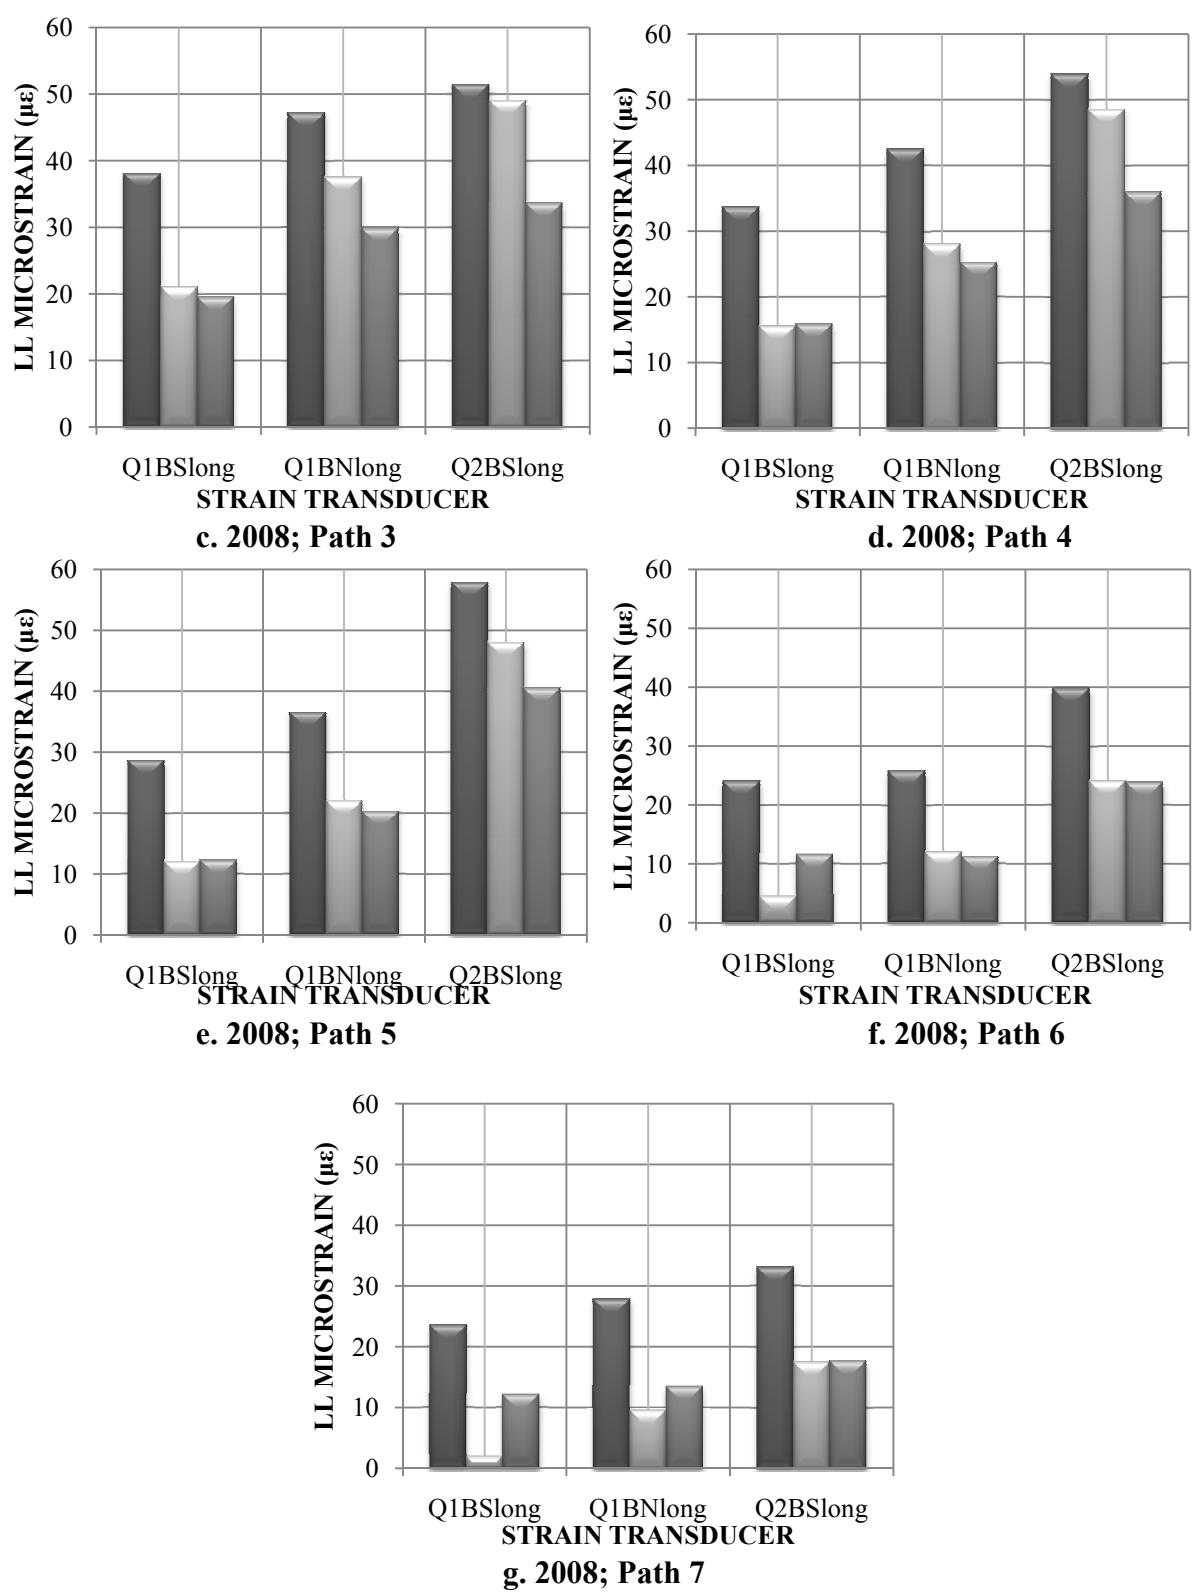
Figure 5.13-FEM LL Longitudinal Bulb Strain at Quarterspan Paths 1-7

The FEM predictions for a pinned end condition for the quarterspan bulb strain were very similar to the field test strains. 10 µε, recorded along path 7, was the largest difference between the FEM predictions and the field test results when the field test results were not bounded by the predictions. When examining data from paths 5 through 7 there is a pronounced decrease in the strains measured from the field test relative to the FEM predictions. This effect is likely due to the model distributing the loads more effectively than was observed in the field. Ignoring paths 4 through 7 and only considering paths 1 through 3 when the majority of the wheel loads were on girders 1 and 2, the FEM was able to bound all of the field test results. The predictions for load paths 1 through 7 are shown in Figure 5.13a-g.

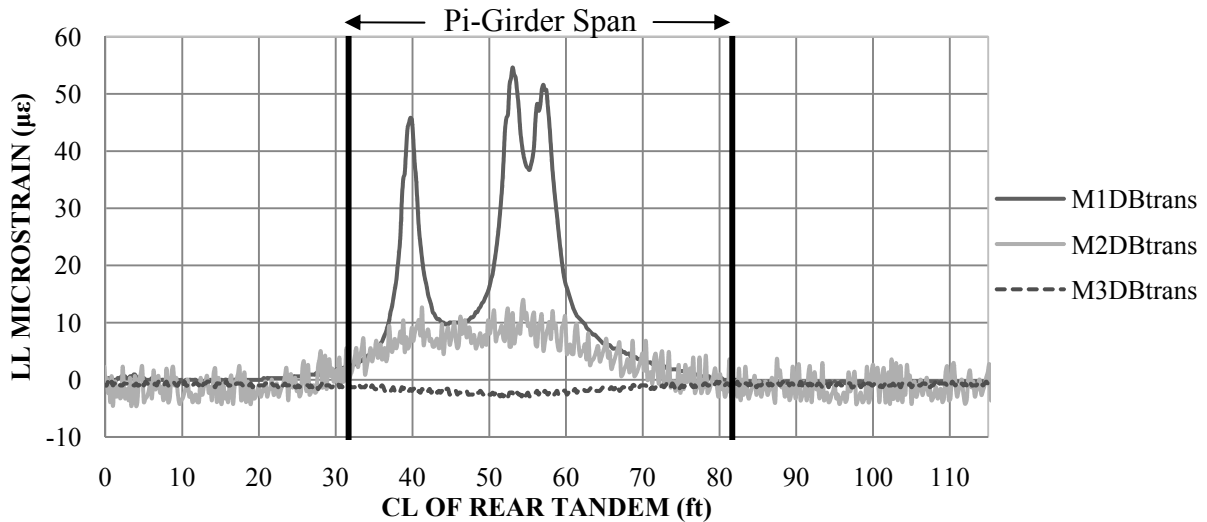
Figure 5.14-Representative Sample of LL Transverse Bottom Deck Strain along Path 2

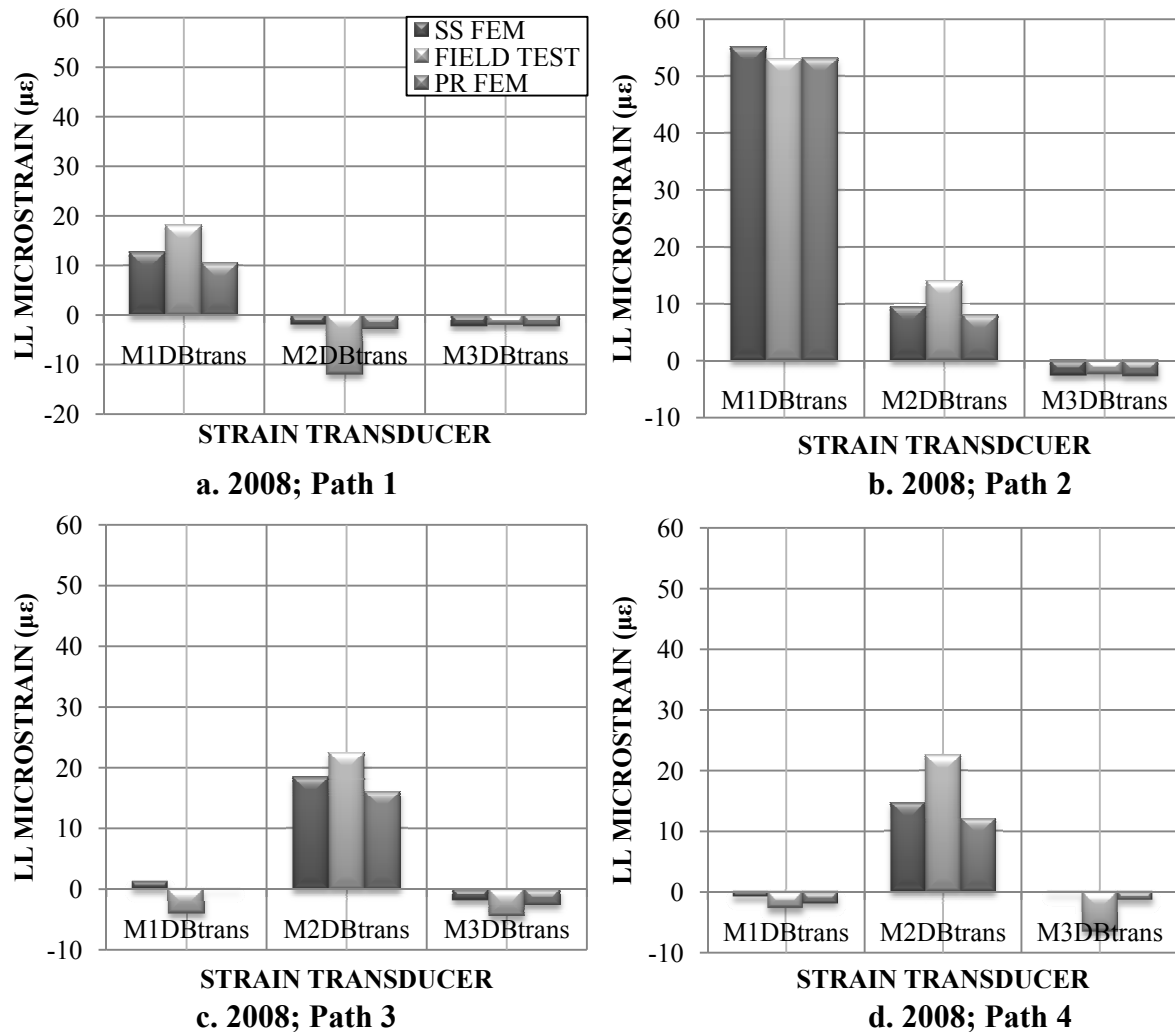
Figure 5.15-FEM LL Transverse Bottom Deck Strain at Midspan Paths 1-4

results varied from the FEM predictions by approximately $5 \mu\epsilon$. At worst, the measured field test strain lay outside of the bounded predictions by $12 \mu\epsilon$ at M2DBtrans along path 5. Figure 5.15a-d shows the predictions from the FEM when compared to the field test data. Paths 5, 6 and 7 are not shown because of their similarities to the data in paths 1, 2, and 3.

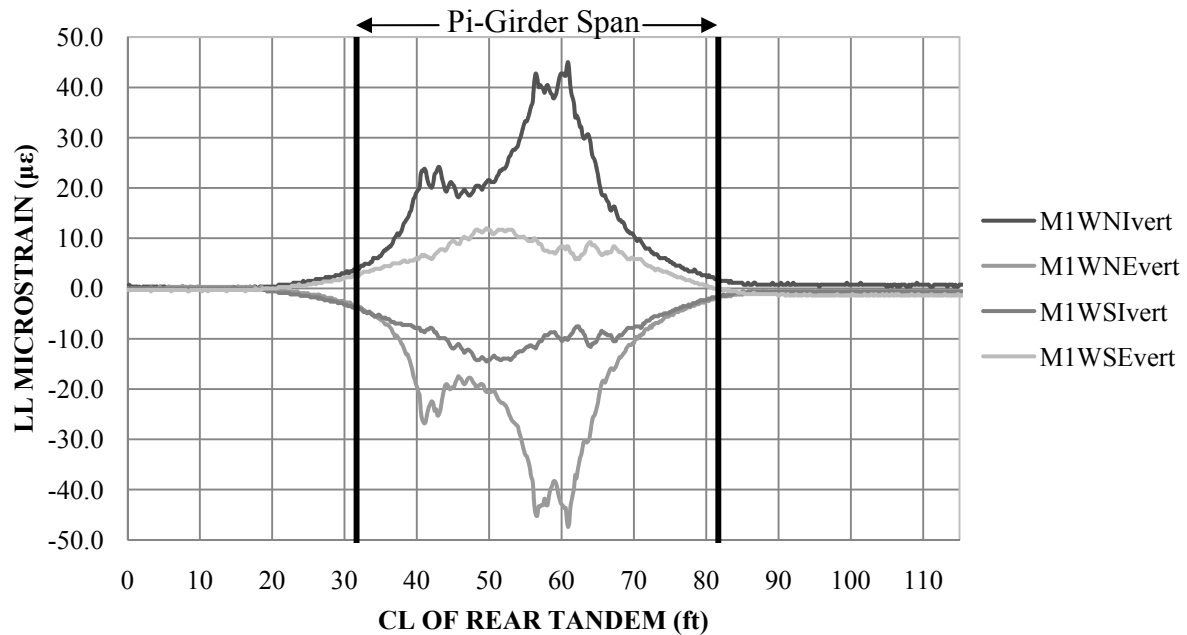
Figure 5.16-Representative Sample of LL Vertical Web Strain along Path 3

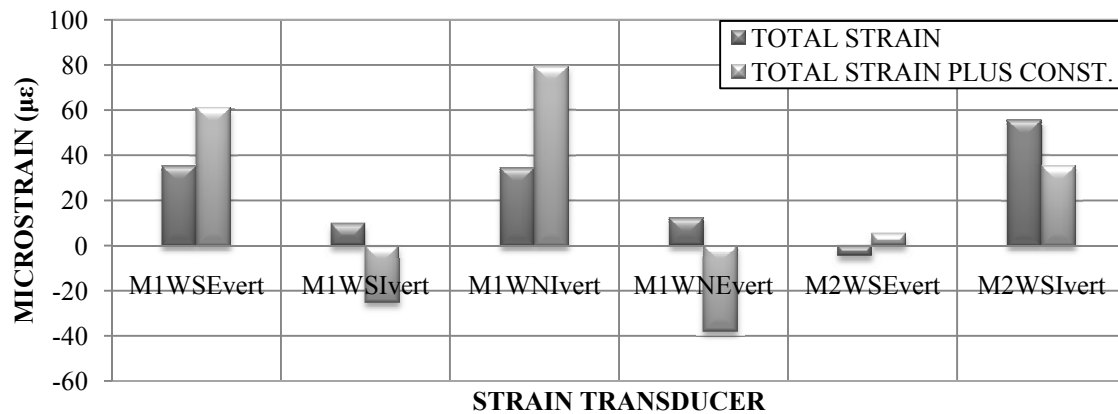
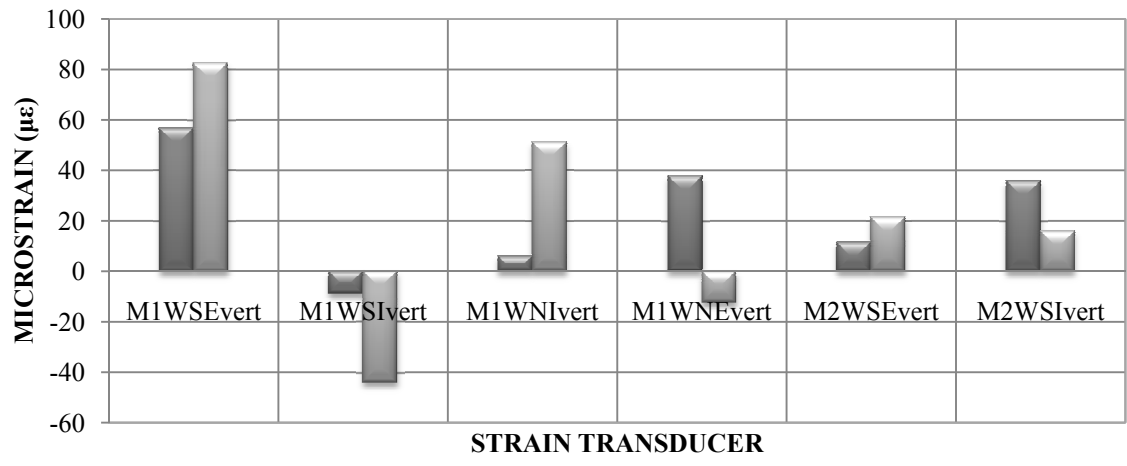
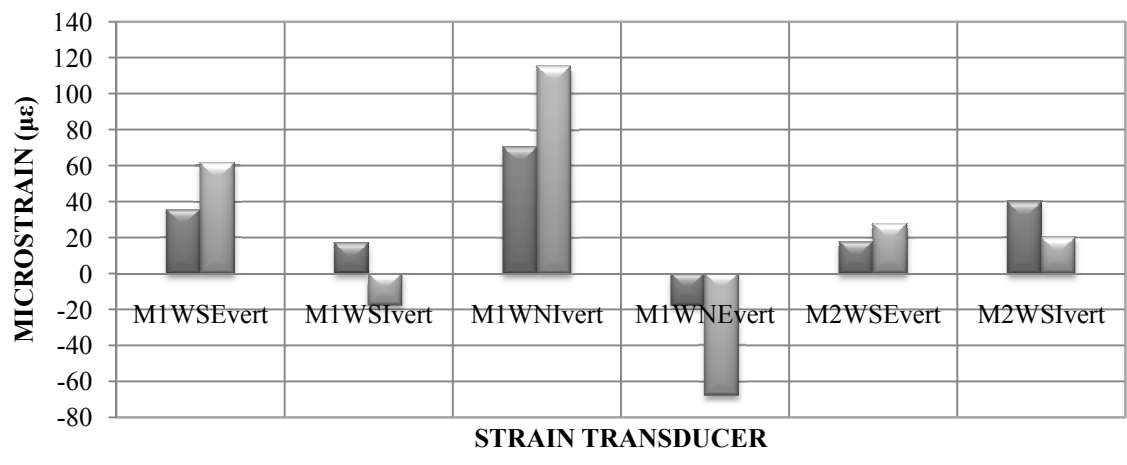
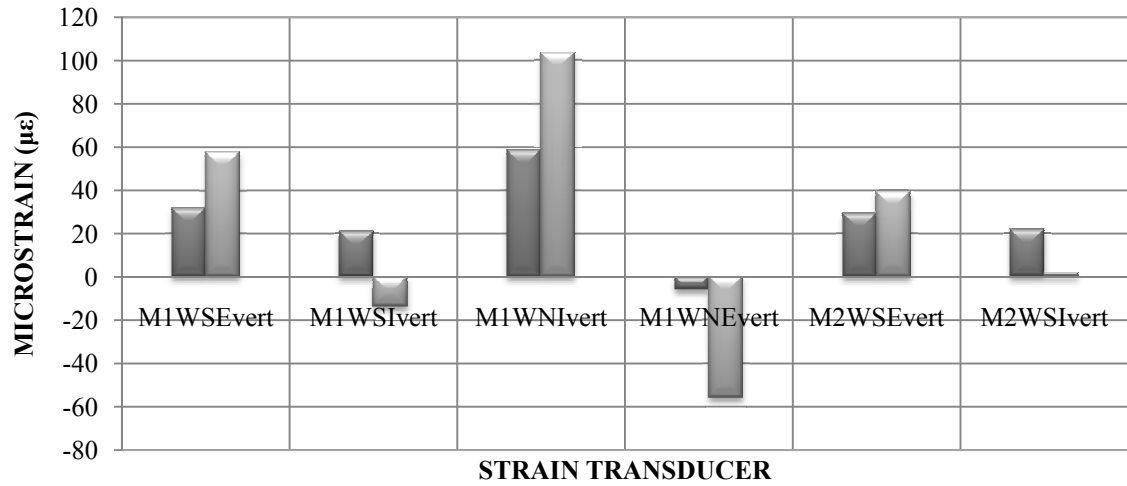
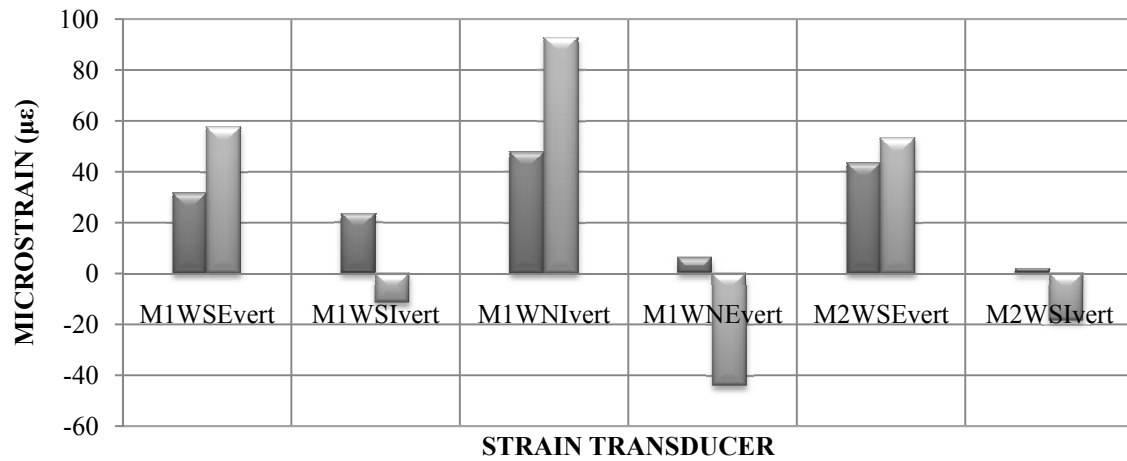
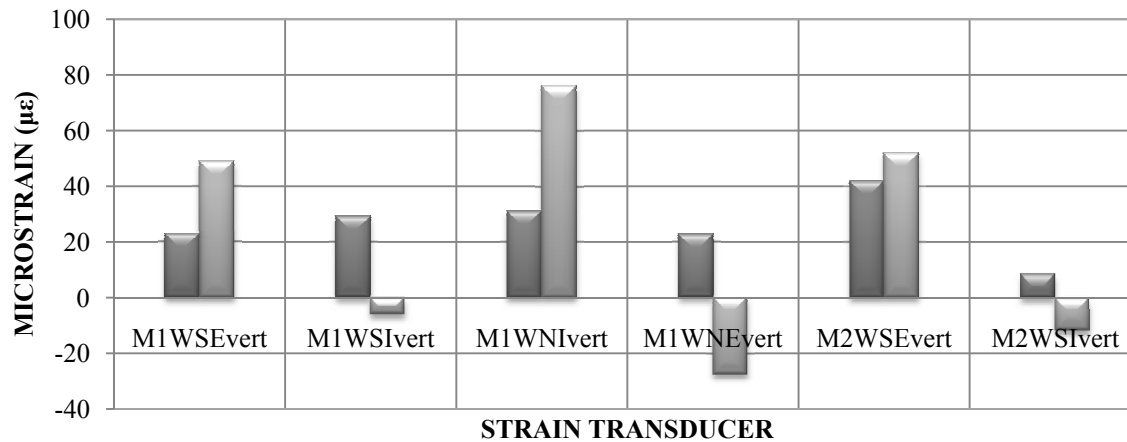
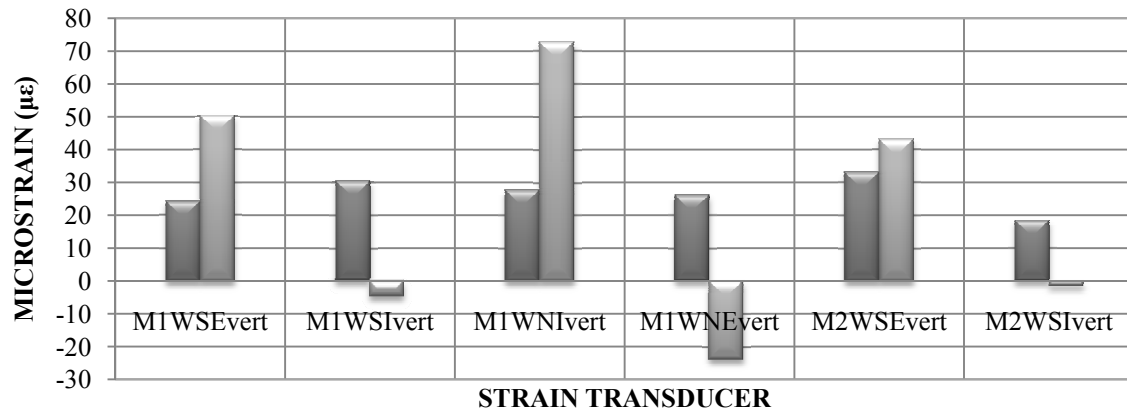
Figure 5.17-Estimated Total Vertical Web Strain (includes residual construction strain) at Midspan

Total vertical web strains were also calculated using dead load strains predicted by the FEM, live load strains from static load tests, and the measured residual construction strains (see section 3). The maximum estimated total strain, including residual construction strain, was 115 µε observed along path 3 at M1WNIvert. 115 µε is 23% less than the predicted cracking strain of UHPC. Therefore, longitudinal cracking of the webs is unlikely under service level loads. Figure 5.17a-g displays the estimated total strains including residual construction strains for paths 1-7.

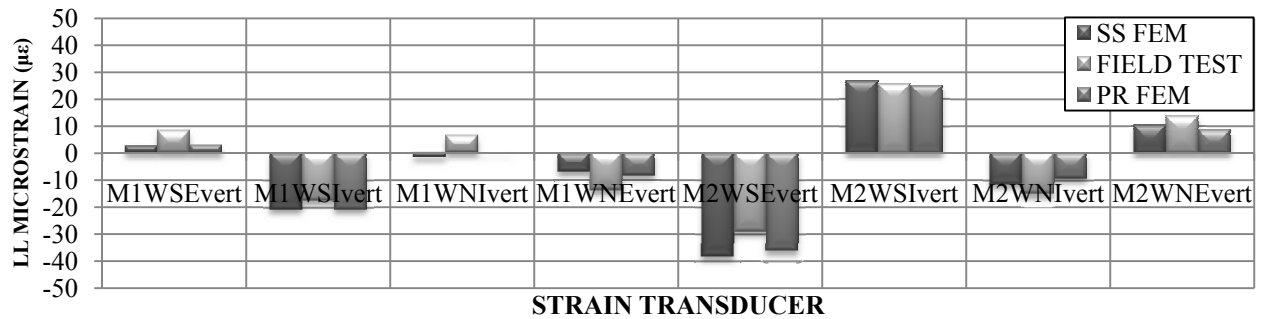
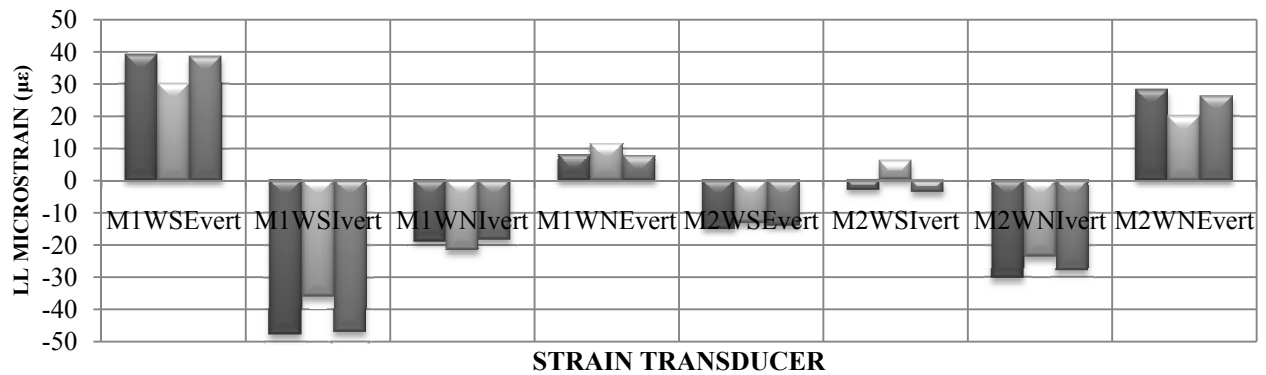
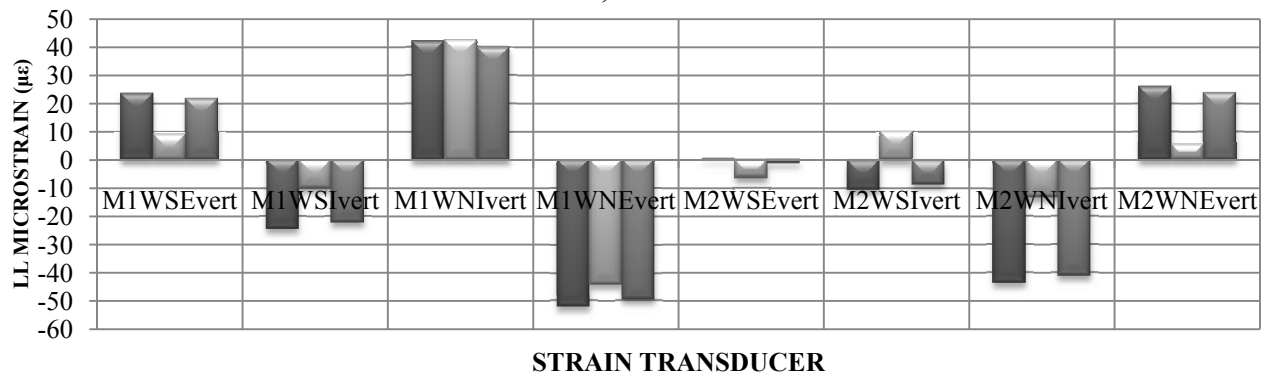
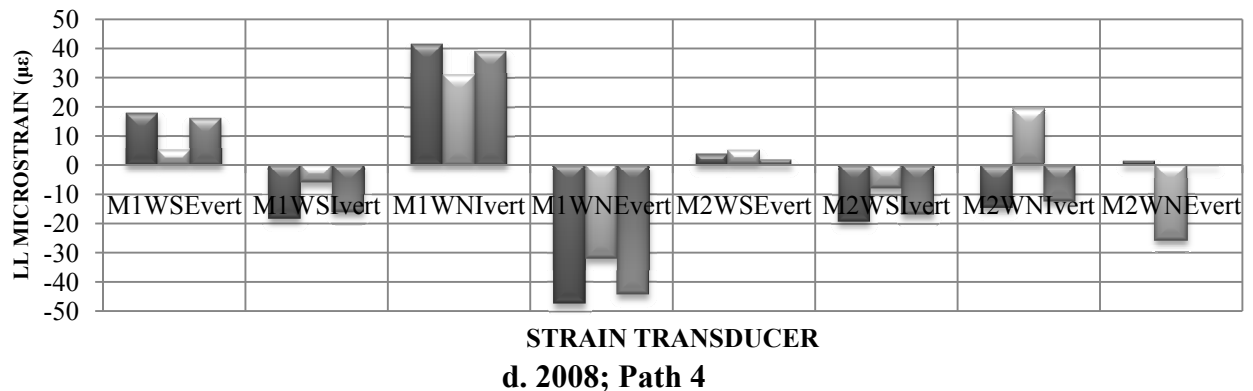
Figure 5.18-FEM LL Vertical Web Strain at Midspan Paths 1-4

Figure 5.18a-d shows the FEM predictions for path 1 through 4. Paths 5-7 are not shown but are very similar to trends for paths 1-3. Since the shear forces between girders strongly affect the web strain, the modeling of the connection between girders in the FEM is a likely source of the discrepancies. As previously discussed, adapting the model to incorporate elastic springs at the shear keys might better reflect the behavior observed in the field.

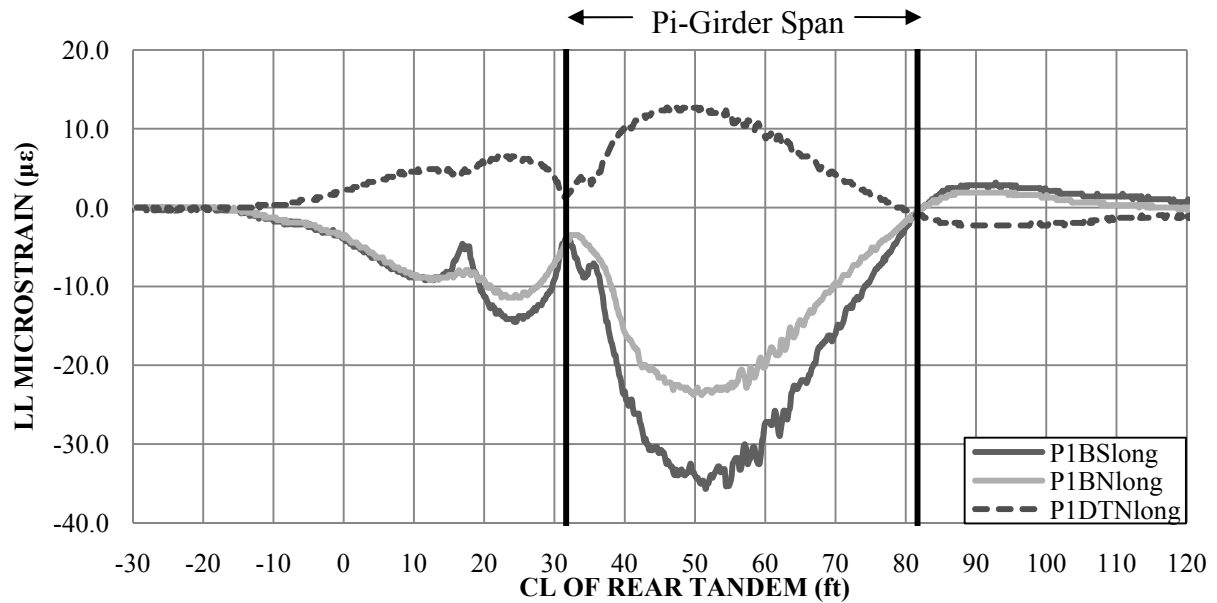
Figure 5.19-Representative Sample of LL Longitudinal Strain near the East Pier along Path 1

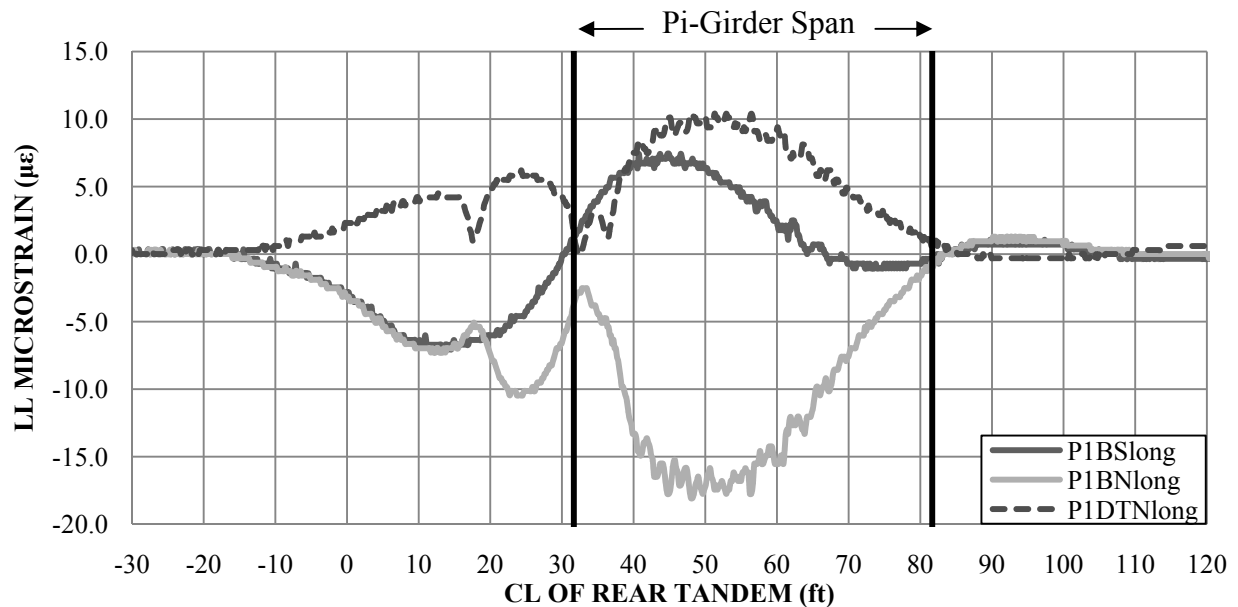
Figure 5.20-Representative Sample of Reversal of LL Longitudinal Strain near the East Pier along Path 3

As the truck travelled along path 3 transducer P1BSlong began to record tensile strains at roughly 30 ft. The strain data for path 3 are provided in Figure 5.20. In addition, this strain reversal occurred on paths 4 through 7 as well, eventually including transducer P1BNlong. It should be noted that these strains are small often with a magnitude of 10 µε or less. While interesting and somewhat counterintuitive, this strain reversal was predicted by the FEM.

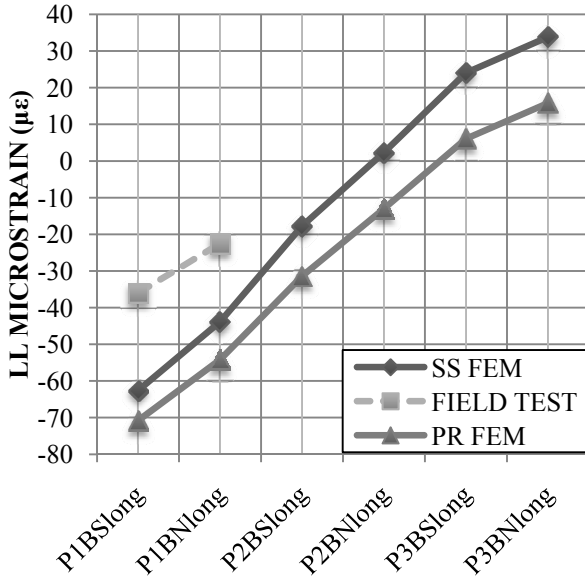
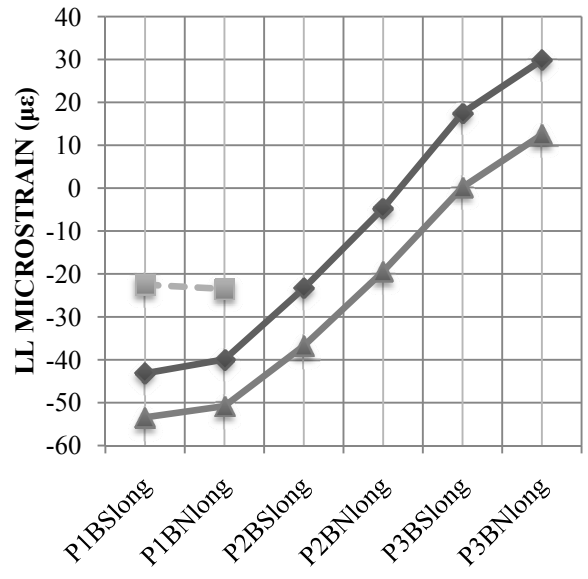
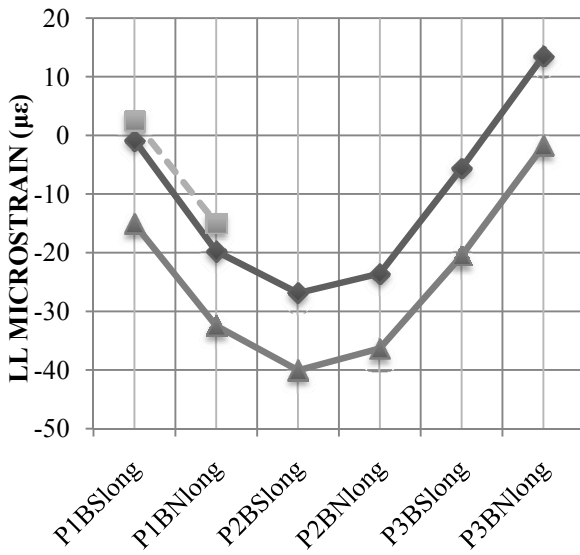
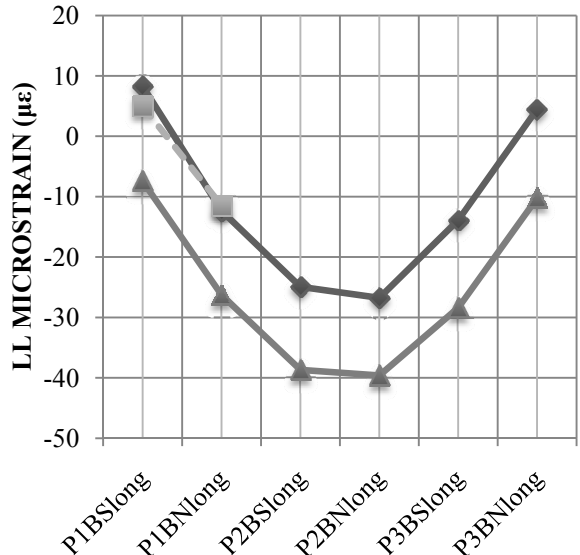
Figure 5.21-FEM LL Longitudinal Strain near the East Pier Paths 1-7

The FEM tended to under predict the live load strains for paths 1, 2, 6, and 7 while the strains for paths 3, 4, and 5 tend to be very similar to the FEM simply supported condition results. It was observed that the FEM did predict a reversal of readings similar to the LL strains measured during testing. From a review of the displacement readings at midspan it was observed that when the truck was along path 7 and the centerline of the rear tandem was at midspan the displacement of M1BSdisp was upward which would cause a reversal of strains

at the support. The reversal of displacement readings at midspan corroborate the reversal of strains shown near the eastern pier. Figure 5.21a-g provide the field test results along with the FEM predictions for both a simply supported and partially restrained condition.

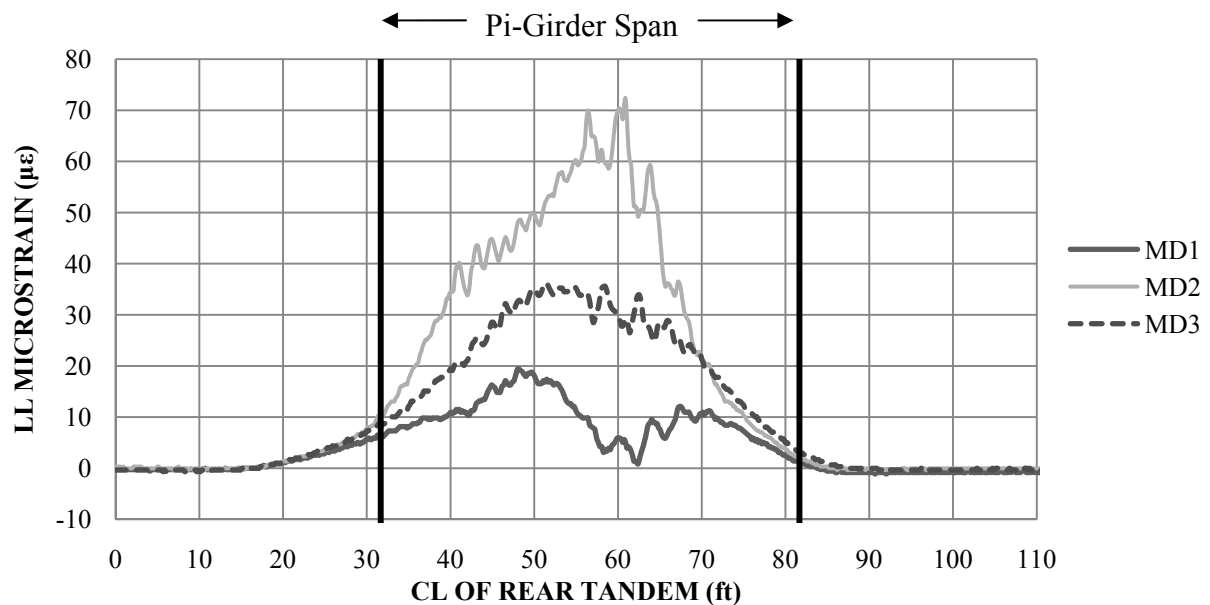
Figure 5.22- Representative Sample of LL Axial Diaphragm Strain at Midspan along Path 3

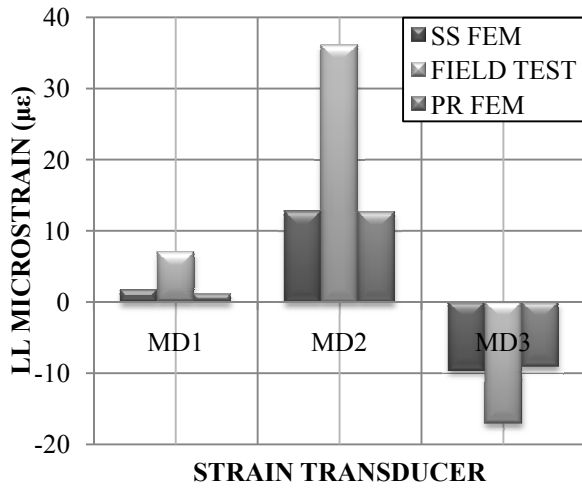
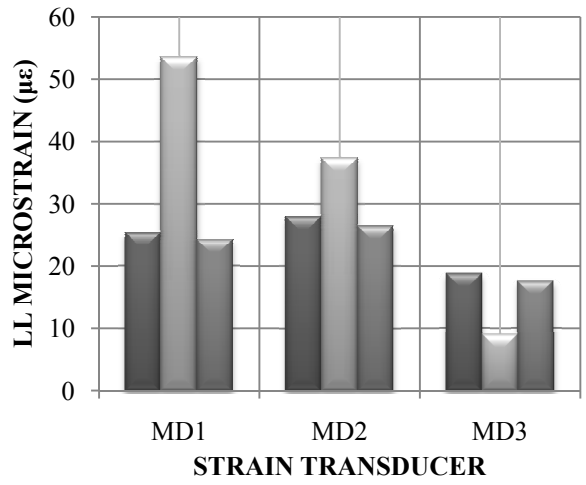
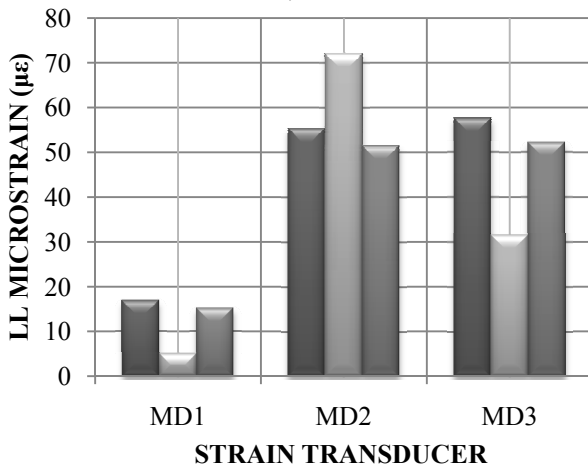
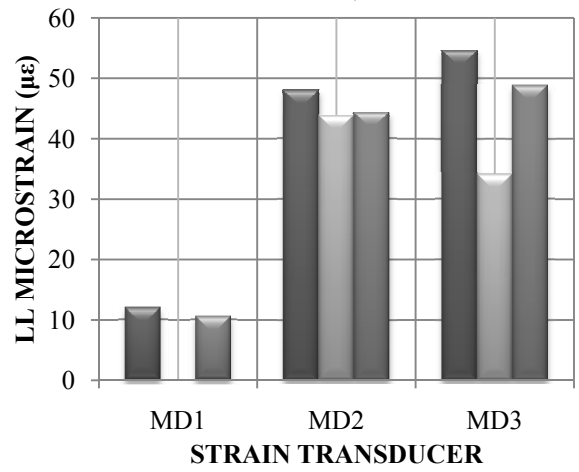
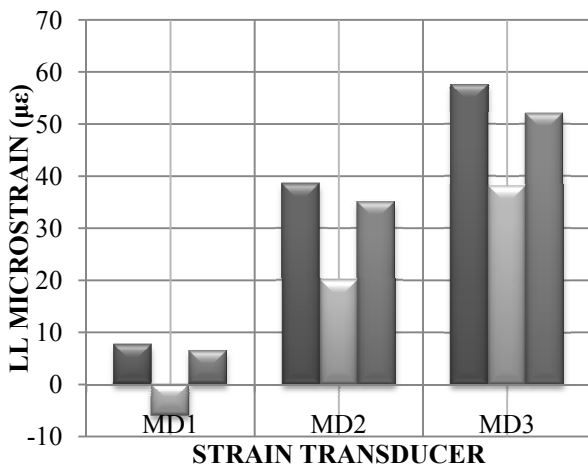
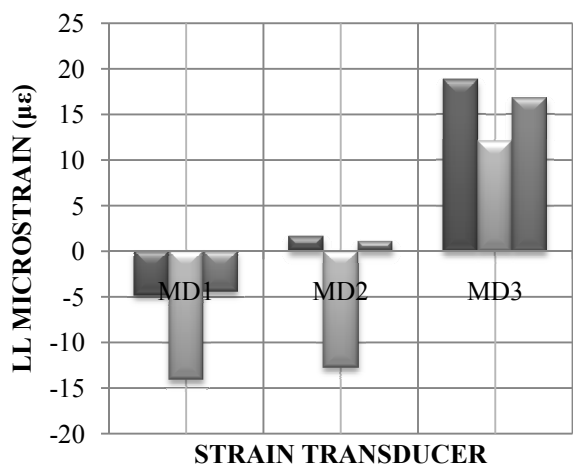
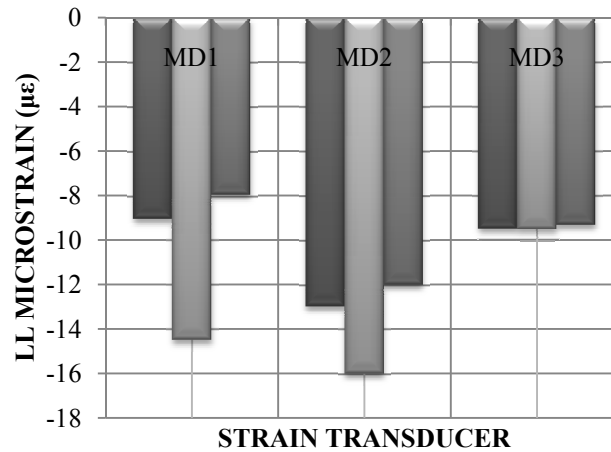
Figure 5.23-FEM LL Axial Diaphragm Strain at Midspan Paths 1-7

The FEM was able to replicate the trends seen in the field data for the axial diaphragm strains. At worst, the model varies by roughly 30 $\mu\epsilon$ from the field results along path 2. A likely explanation for the deviation of analytical results from field measurements could be the imperfect fit of diaphragm members between webs, as discussed in Section 3.

Figure 5.23a-g show the FEM predictions for path 1 through 7.

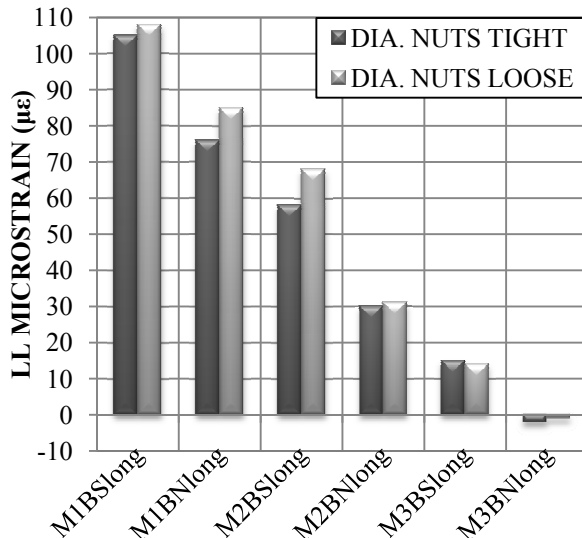
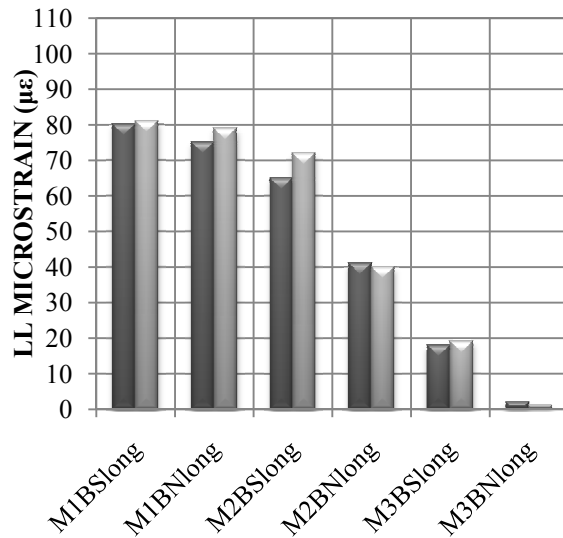
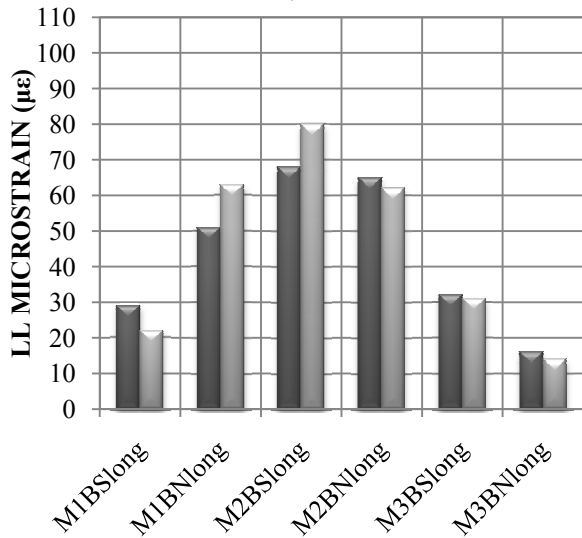
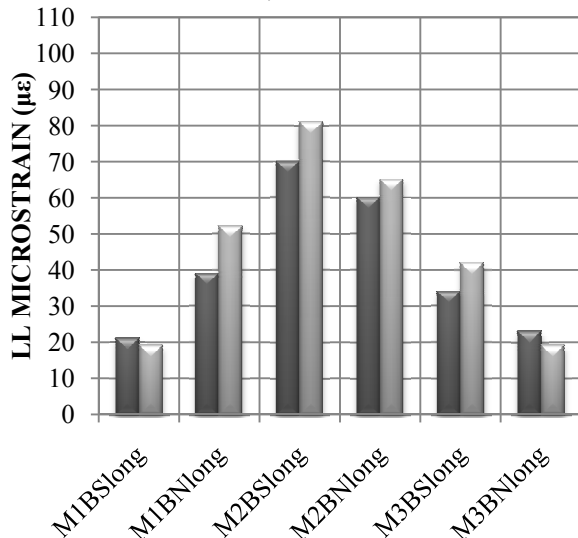
Figure 5.24-Longitudinal LL Bulb Strain at Midspan with Midspan Diaphragm Loosened

When the diaphragm was partially inactive the bulbs located nearest to the load experienced higher strains without the diaphragm, but farther away from the load the strains without the diaphragm are similar if not less than the strains recorded when the diaphragm was present. This increase in strain can be attributed to a partial reduction in the lateral live load distribution factors, discussed in Section 6.4. The overall average increase in strain was 4 µε. The strains recorded for paths 1 through 4 with the diaphragm nuts tight and loose are shown in Figure 5.24a-d.

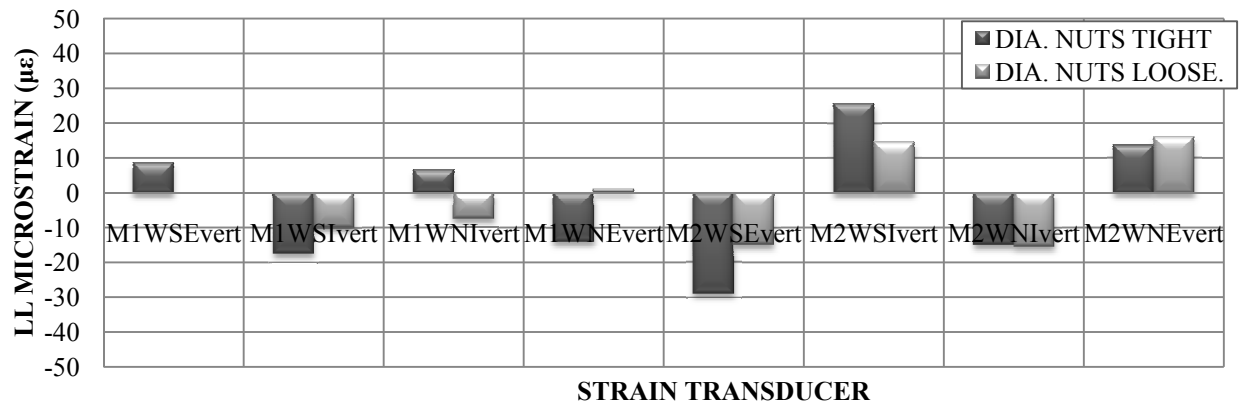
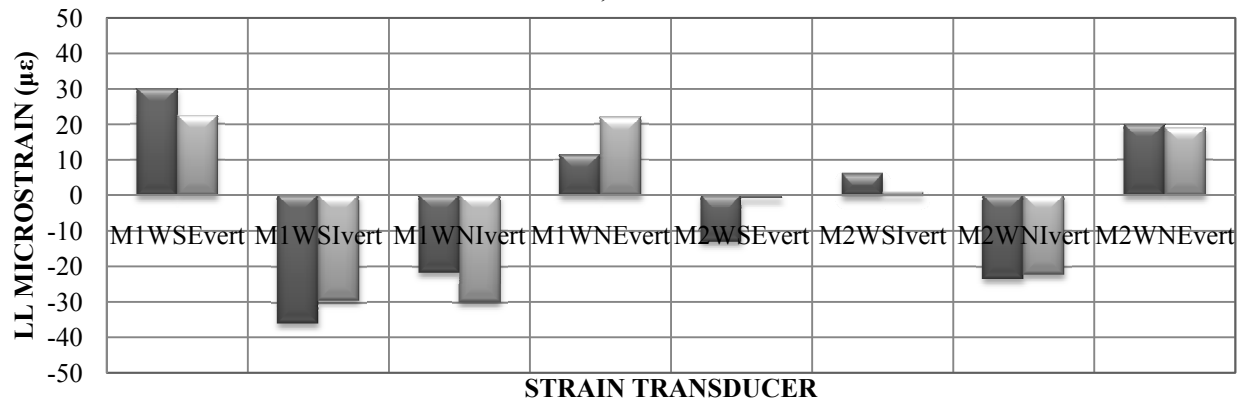
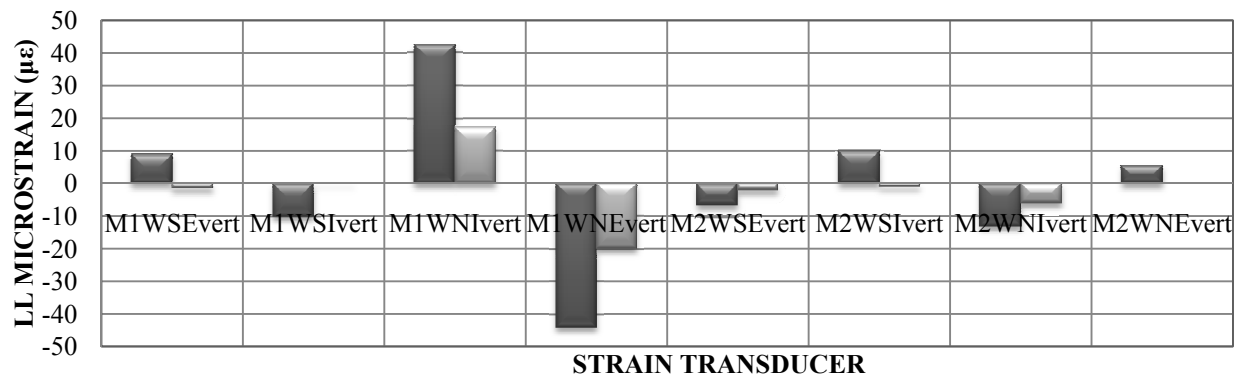
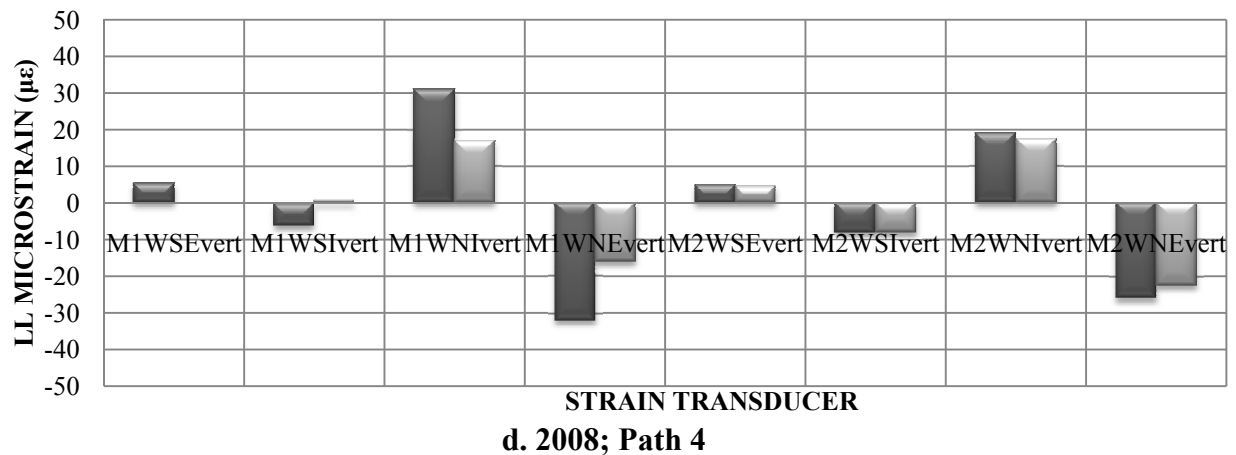
Figure 5.25-FEM LL Vertical Web Strain Paths 1-4 with Midspan Diaphragm Loosened

Figure 5.25 5.25a-d displays the finite element prediction for paths 1 through 4 for web strains with the diaphragm nuts tight and loose. Similar to the field tests, the FEM predicted that the majority of the web strains would be larger when the diaphragm is present. The similarity of the FEM results to the field test results provides confidence that the vertical strains in the web will not be decreased due to the presence of the diaphragm.

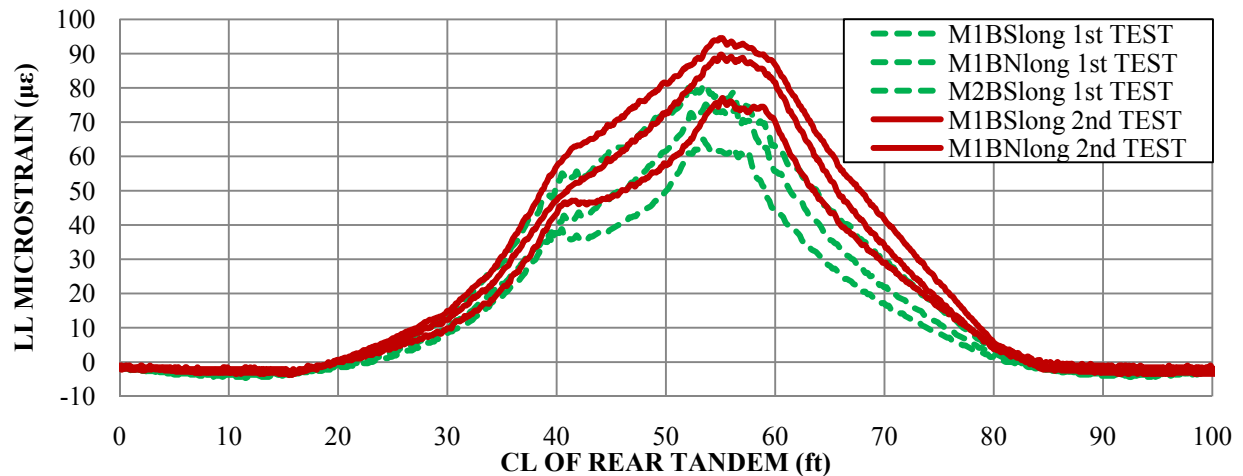
Figure 5.26-Comparison of 2008 & 2009 LL Longitudinal Strain at Midspan along Path 2

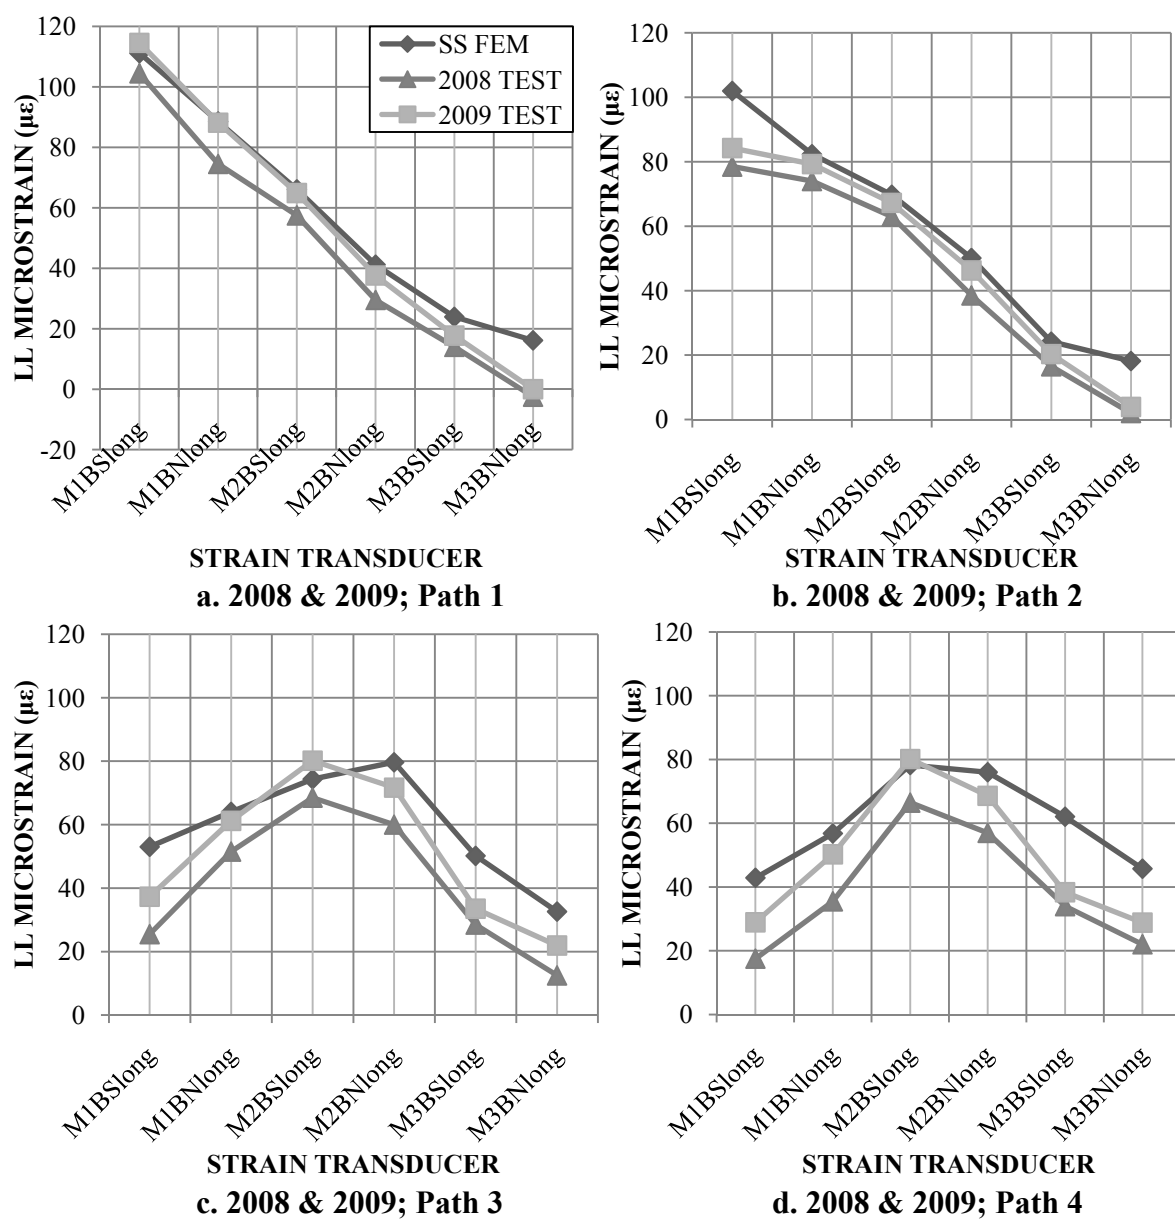
Figure 5.27-Comparison of 2008 & 2009 LL Longitudinal Strain to FEM at Midspan

Due to loss of continuity between the end span and pi-girder span, the simply supported boundary condition finite element model should predict quite well the measured stains for the second test. Figure 5.27a-d provides comparisons between the first and second rounds of tests to the FEM predictions for a simply supported boundary condition for paths 1-4.
