Design, Construction, and Field Testing of an Ultra-High Performance Concrete Pi-Girder Bridge

Final Report
January 2011

Sponsored by
Iowa Highway Research Board
(IHRB Project TR-574)
Iowa Department of Transportation
(InTrans Project 07-295)

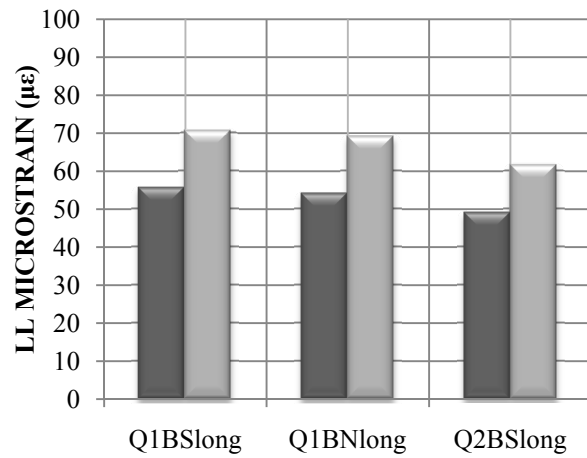
a. 2008 & 2009; Path 1

b. 2008 & 2009; Path 2

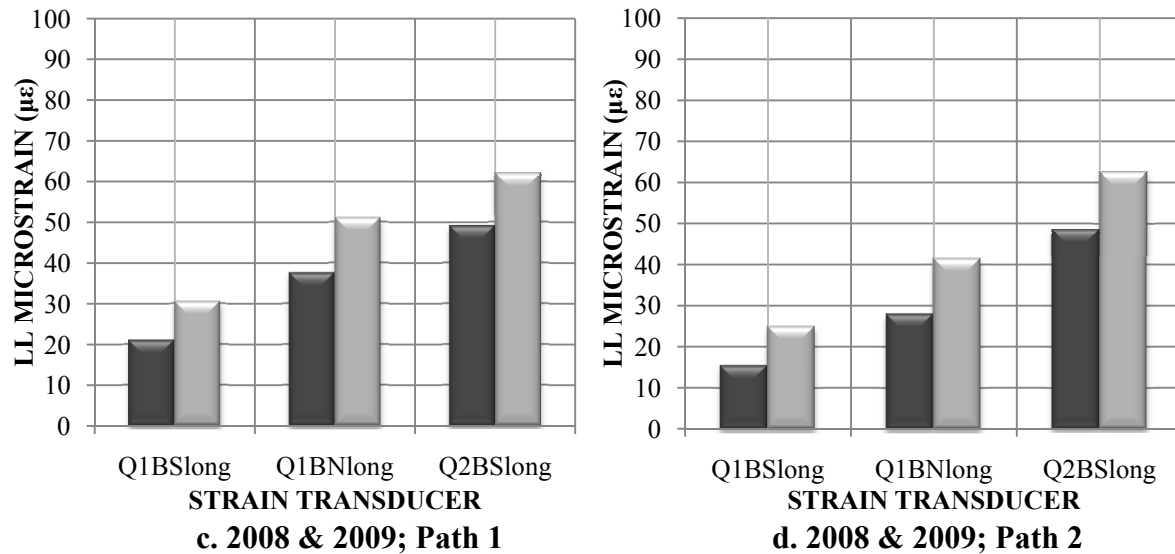
Figure 5.28-Comparison of 2008 & 2009 LL Longitudinal Strain at Quarterspan

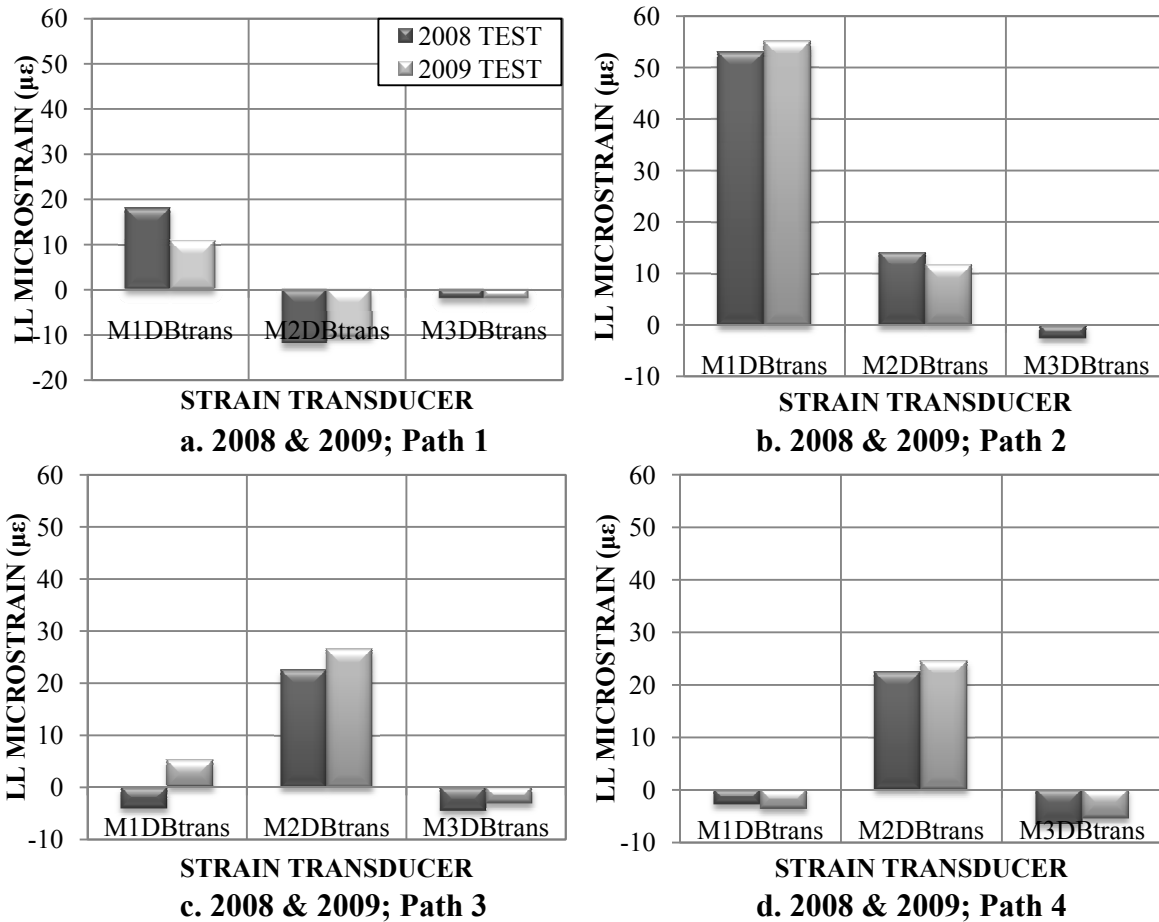
Figure 5.29-Comparison of 2008 & 2009 LL Transverse Deck Strains at Midspan

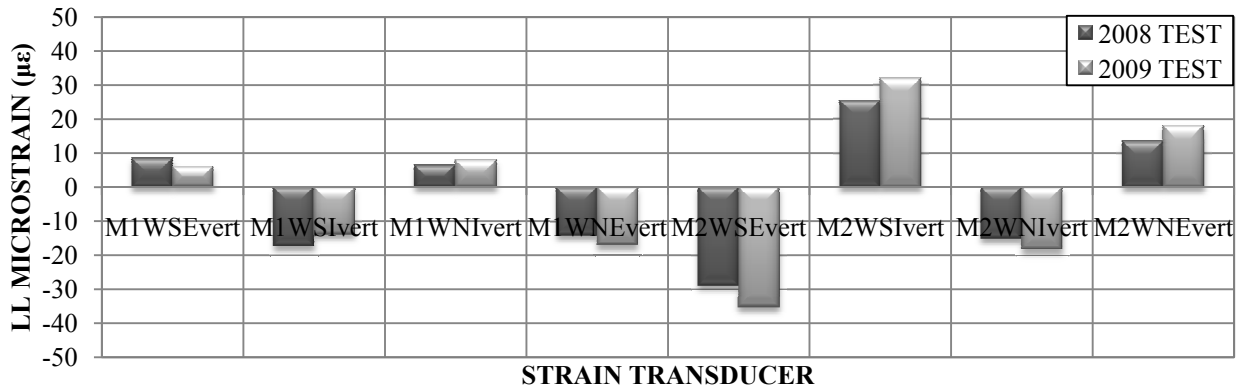
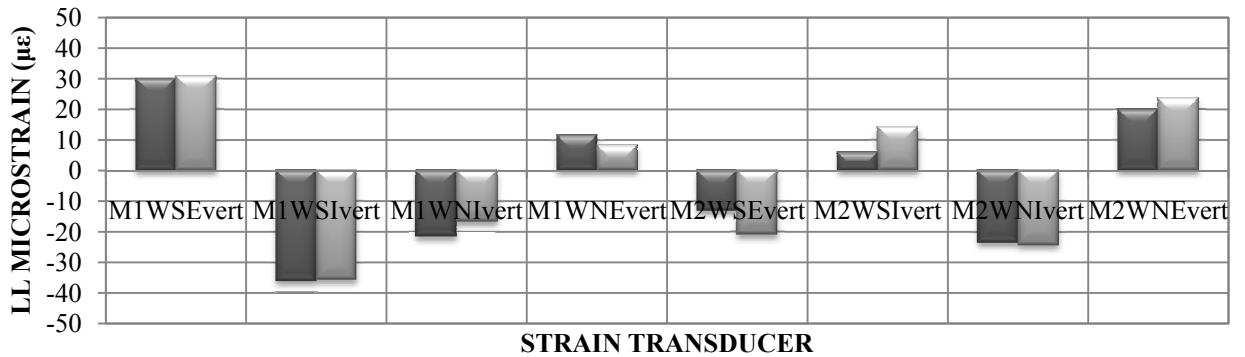
a. 2008 & 2009; Path 1

b. 2008 & 2009; Path 2

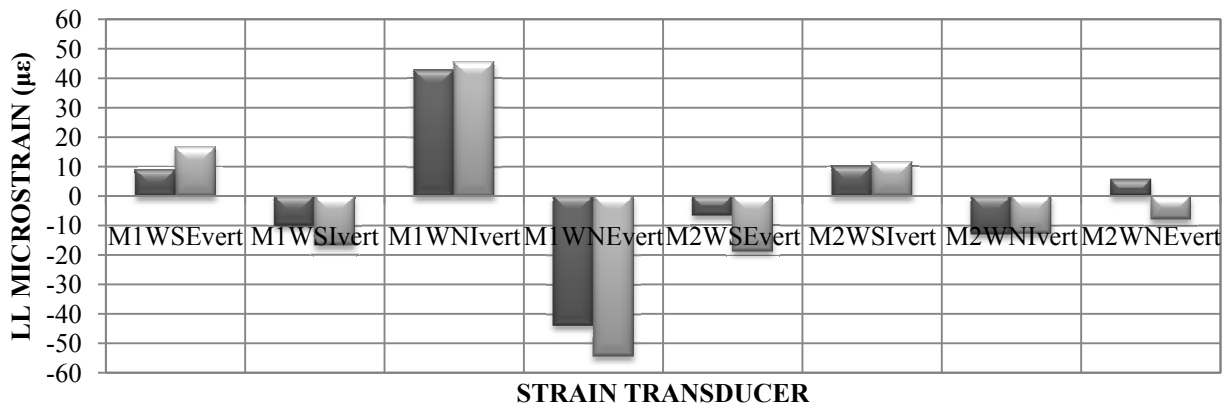
c. 2008 & 2009; Path 3

Figure 5.30-Comparison of 2008 & 2009 LL Vertical Web Strain at Midspan

The results of the second static load field test displayed an average decrease of $3 \mu\epsilon$ in the strains recorded by the vertical transducers located on the webs. Similar to the transverse deck strain, the decrease in continuity did not have a pronounced effect on the vertical web strains. However, some transducers did record increases of $10 \mu\epsilon$ or more. The largest increase of $12 \mu\epsilon$ was recorded at M1WNInvert along path 4. Small localized variations in strain could be due to deviations of the test truck from path centerlines, or slight differences in gage locations between tests. Table 5.14 provides the measured maximum tensile values for the first and second round of tests. The initial strains predicted by the FEM coupled with the measured live load strains and residual construction strains predict a total strain of $120 \mu\epsilon$, roughly $30 \mu\epsilon$ below cracking. Therefore cracking of the webs in the vertical direction is unlikely under service level loads. Figure 5.30d provides a graphical representation of the maximum strains measured at midspan for paths 1-4, paths 5-7 are not shown due to their similarity to paths 1-3.

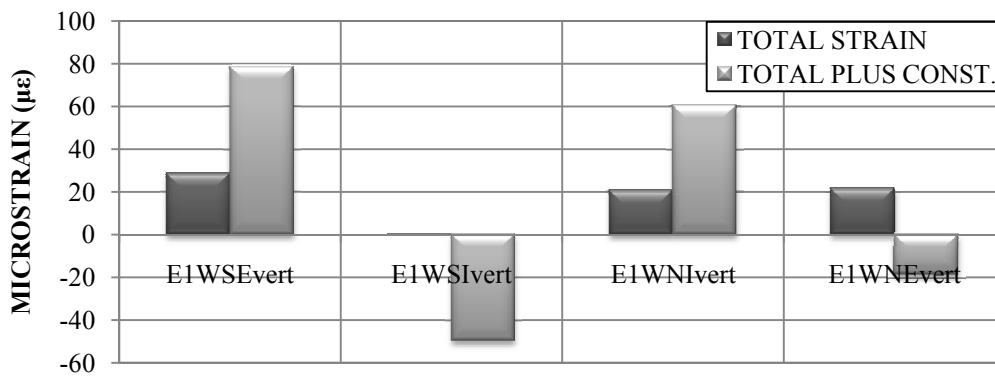
a. 2009; Path 1

Figure 5.31-Estimated Total Vertical Web Strain (includes residual construction strain) at 3/8 Span

Including residual construction strains the maximum estimated total strain was $100 \mu\epsilon$ observed along path 2 at E1WSEIvert. $100 \mu\epsilon$ is roughly 35% less than the predicted cracking strain of UHPC therefore cracking of the bulbs is unlikely under service level loads. Figure 5.31a-g displays the estimated total strains for paths 1-7.

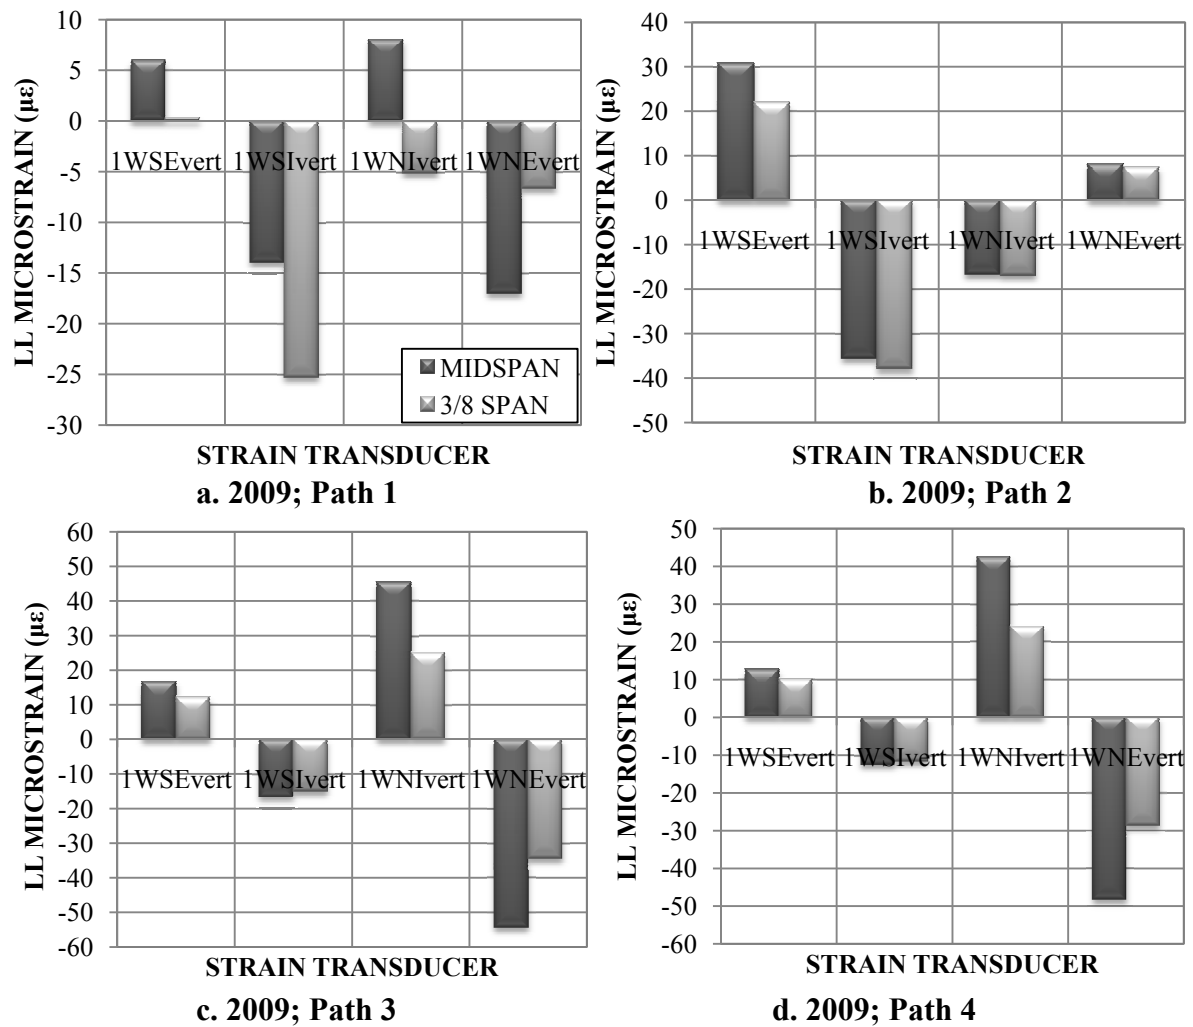
Figure 5.32-Comparison of 2009 Midspan and 3/8 Span Live Load Vertical Web Strain

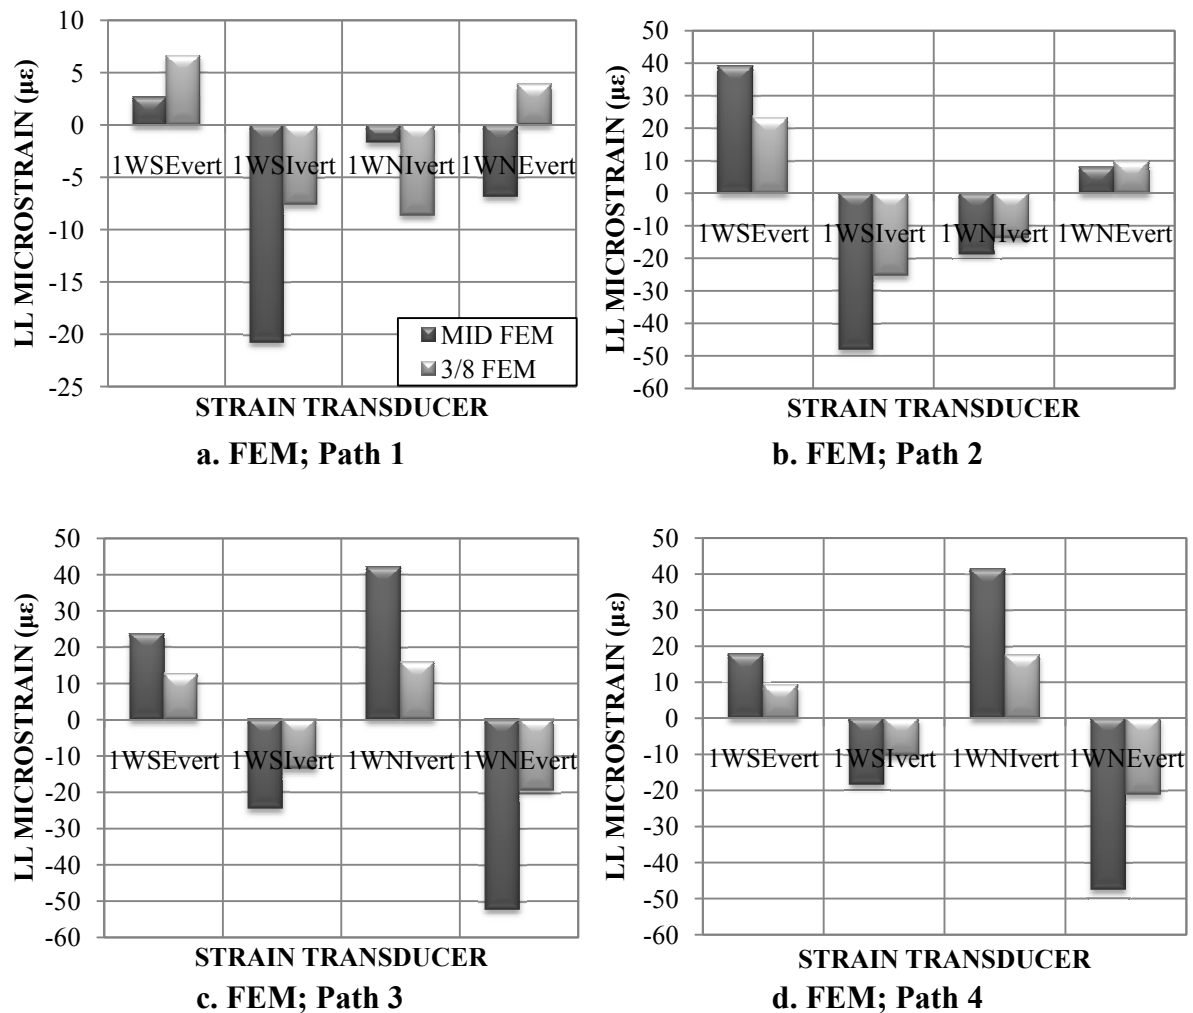
Figure 5.33-Comparison of FEM Midspan and 3/8 Span Live Load Vertical Web Strain

The FEM predicted lower strains for the majority of the web strains at three-eighths span when compared to midspan. The finite element comparisons are provided in Figure 5.33a-d.

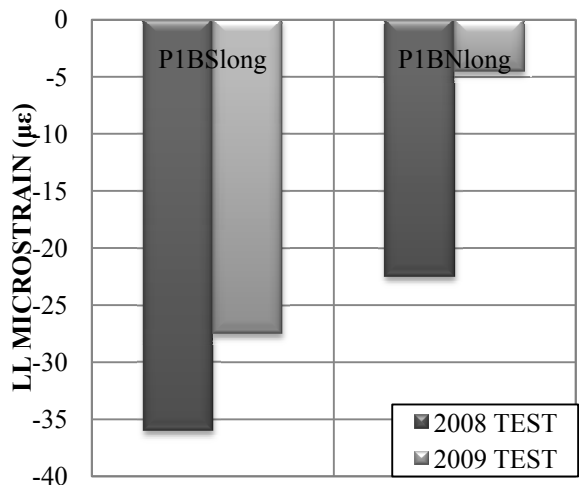
STRAIN TRANSDUCER
a. 2008 & 2009; Path 1

Figure 5.34-Comparison of 2008 & 2009 LL Longitudinal Strain near the Eastern Pier

The results of the 2009 static load field test showed that the strains measured near the eastern pier on the bottom of the bulbs tended more towards tension than those from the first test. This corroborates that a loss of continuity at the pier has occurred. Figure 5.34 provides a graphical representation of the maximum strains measured near the pier for paths 1-7. From Figure 5.34 a-f every 2009 reading is larger (i.e. less negative) than the corresponding reading from 2008. Figure 5.20 a-g shows that the strains predicted by the FEM were always larger (more positive) for a simply supported condition when compared to a partially restrained condition. Therefore, the transition from 2008 to 2009 readings provides evidence that the bridge is transitioning from a partially restrained condition to a simply supported condition as designed.

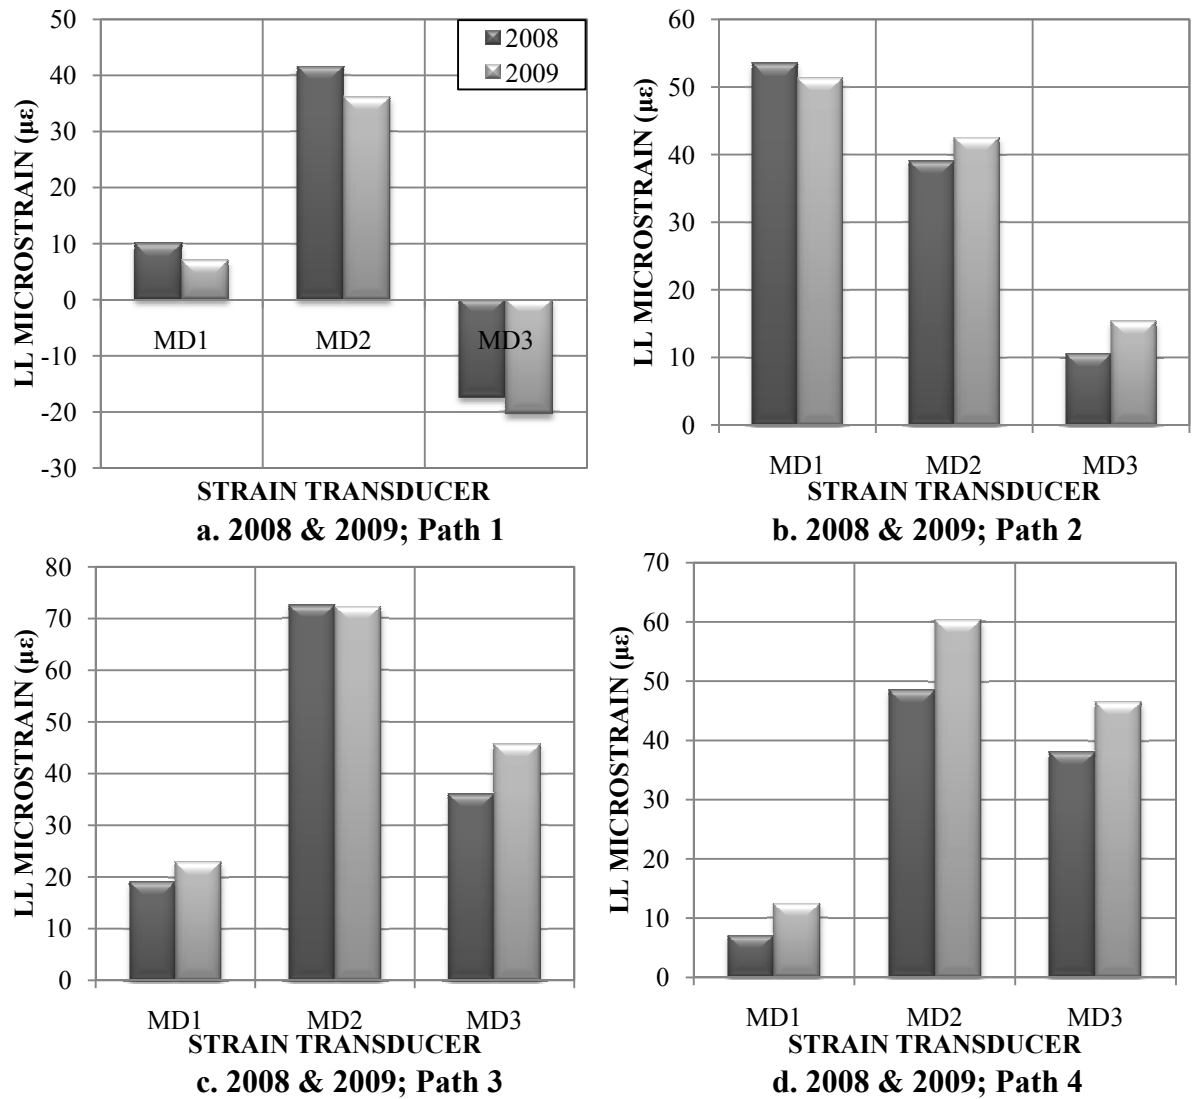
Figure 5.35-Comparison of 2008 to 2009 LL Axial Diaphragm Strain at Midspan

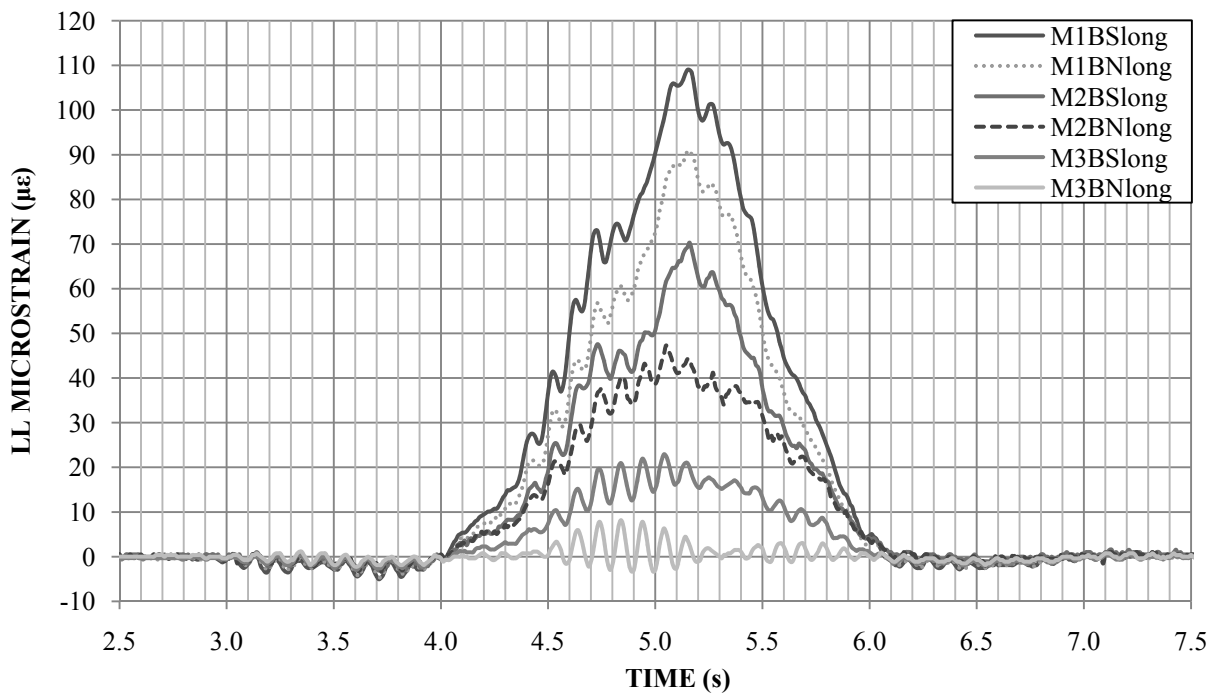
Figure 5.36-Representative Sample of Dynamic LL Longitudinal Strain at Midspan along Path 2

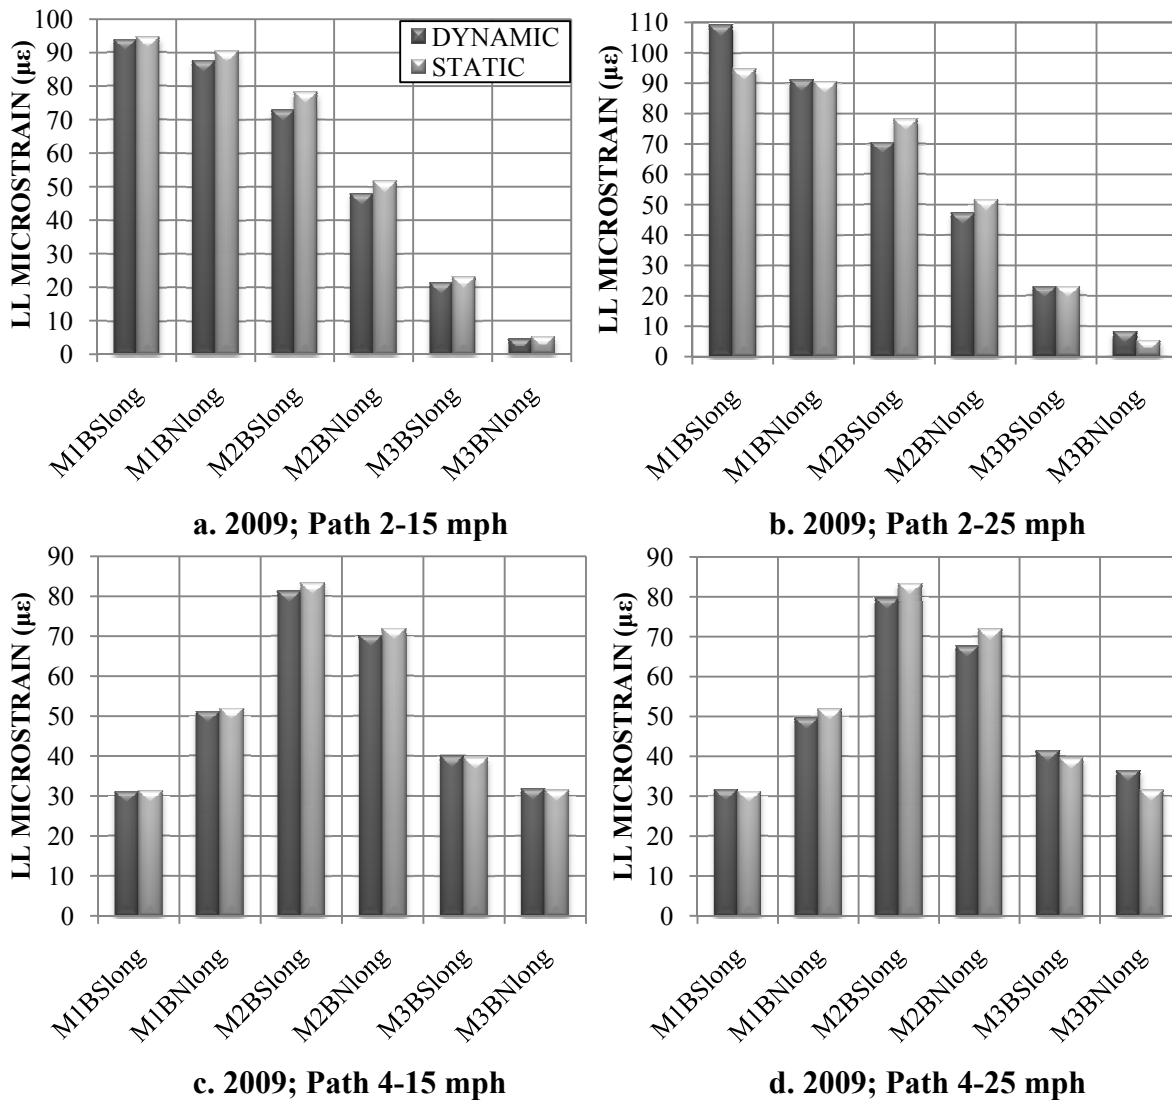
Figure 5.37-Comparison of LL Longitudinal Bulb Strain for Static and Dynamic Loading
