# Performance Oriented Guidance for Mississippi Chip Seals-Volume II

## Final Report

## FHWA/MS-DOT-RD-13-211-Volume II

December 31, 2013

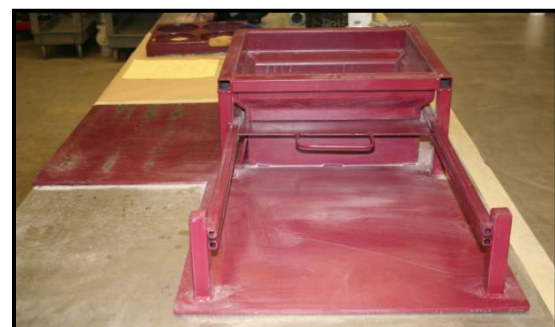
The *Spreader Base* consists of multiple parts, compartments, and platforms (Figure 4.2). It is a funnel-shaped assembly which contains the *Specimen Box* during aggregate spreading (only when circular specimens are fabricated). The front of the spreader base serves as a platform where the *Specimen Box* is placed before and after aggregate spreading. The platform allows for smooth motion of the *Specimen Box* in and out of the assembly without disturbing LTP specimens. The platform connects to a quadrangle compartment located under the funnel assembly where aggregate is dropped. The funnel assembly and spreader sheet are positioned 90 mm from the bottom platform, directly above the quadrangle compartment where the *Specimen Box* is introduced. Rails enable lateral movement of the *Aggregate Spreader Sheet* through which aggregate is spread into the specimen box.

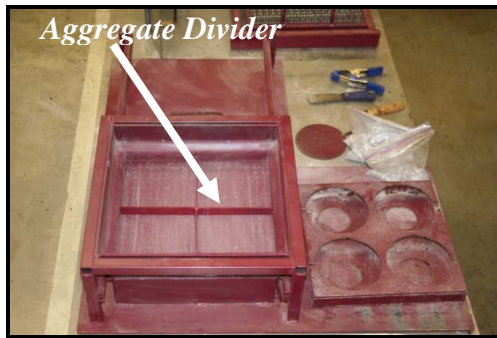
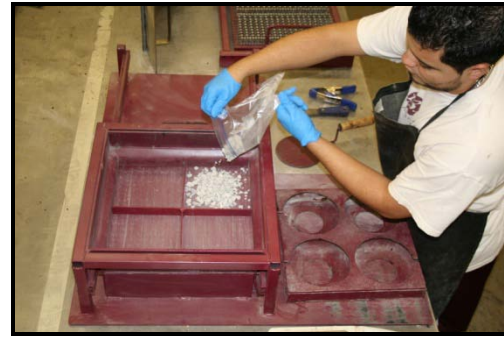
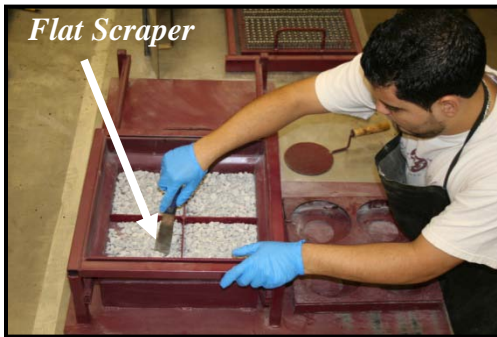
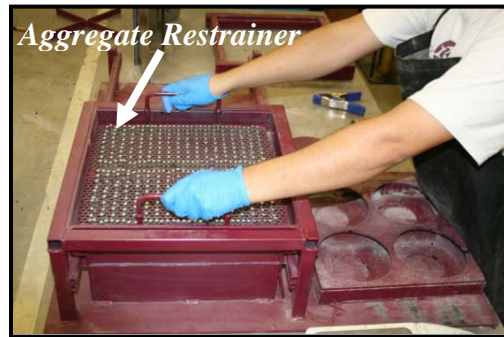
**Figure 4.9. Preliminary Aggregate Arrangement**

Preliminary steps consist of placing the *Aggregate Divider* on the *Aggregate Spreader Sheet* (Figure 4.9a), placing and spreading aggregate onto the sheet (Figure 4.9b and 4.9c), and placing the *Aggregate Restrainer* in place (Figure 4.9d). Aggregate is pre-batched in plastic bags equivalent to the desired application rate and equivalent to one-fourth the area of the *Spreader Sheet*. One aggregate batch is dropped and spread within each quarter area using a flat scraper to facilitate uniformity and single layer application. The *Aggregate Divider* is then removed, and the *Aggregate Restrainer* is set in place.

a) Placement of Aggregate Divider

b) Aggregate Drop in Funnel Assembly

c) Even Spread with Flat Scraper

d) Placement of Aggregate Restrainer

Slab specimens are fabricated in a similar manner to core specimens which are described in Section 4.5.2. However, some modifications to the core fabrication procedure were necessary. After preliminary aggregate arrangement (Figures 4.9a to 4.9c) but before placement of the *Aggregate Restrainer* (Figure 4.9d), small gaps left from the *Aggregate Divider* are closed by additional, minor spreading of the aggregate batches to form one continuous aggregate layer.

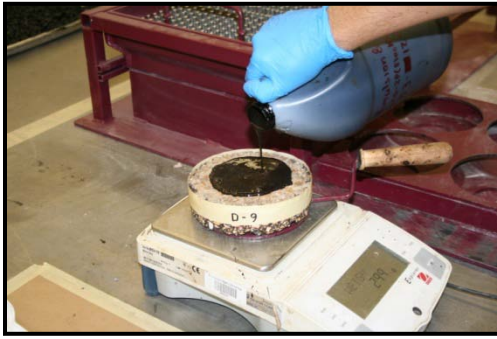
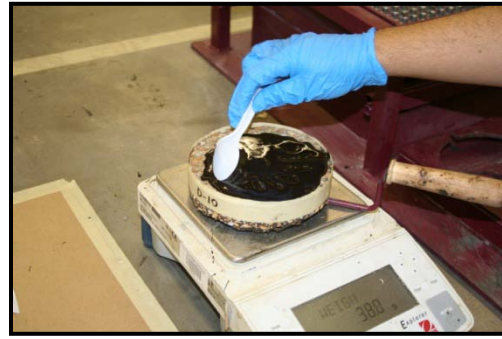
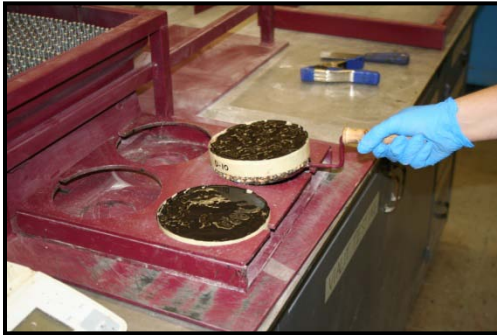
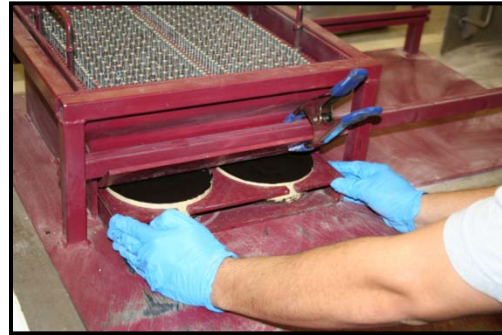
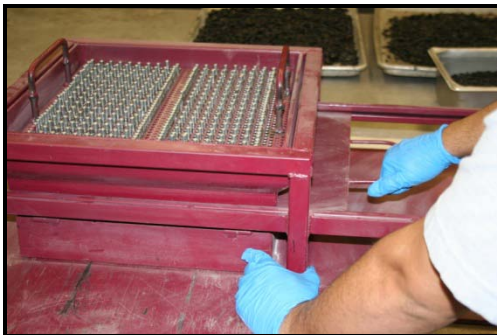
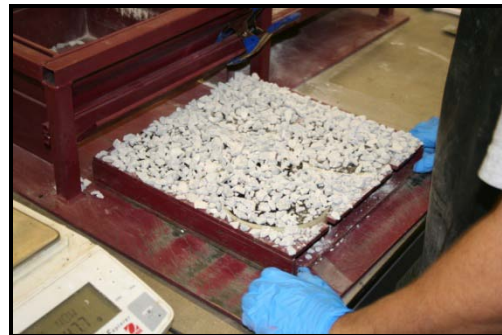
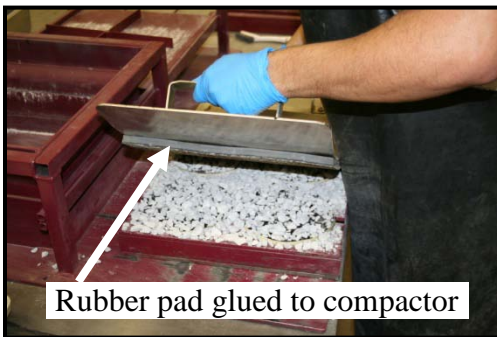
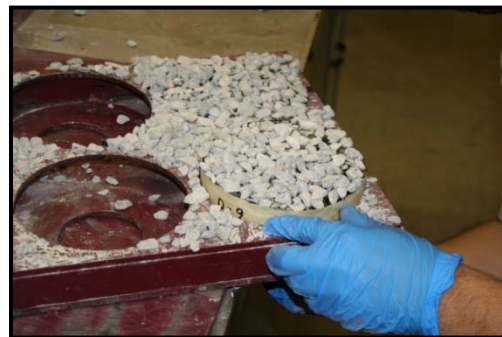
**Figure 4.10. Specimen Fabrication Procedure - Cores**

Prior to emulsion application, all specimens are taped around the sides to prevent emulsion runoff and assist with even emulsion distribution. Emulsion was heated to 60 C in an oven and gently agitated to produce uniform consistency (further details are provided in the State Study 211 Volume I report). The emulsion is applied by placing each individual specimen on a scale and evenly spreading a fixed mass of emulsion corresponding to a desired application rate over the surface with a plastic spoon as shown in Figures 4.10a and 4.10b. The *Specimen Panhandle* is then used to move each specimen from the scale and place it inside the *Specimen Box*. Once all four specimens are introduced in the *Specimen Box* (Figure 4.10c), the box is slid into the bottom compartment of the *Spreader Base* (Figure 4.10d).

The aggregate is spread onto the specimens by pulling the *Aggregate Spreader Sheet* laterally until all aggregate is dropped onto the specimen box (Figure 4.10e). The spreader sheet is pulled completely across the funnel in approximately one second. Afterwards the *Specimen Box* is pulled out of the funnel compartment prior to seating (Figure 4.10f).

Aggregate seating is performed on the surface of the *Specimen Box* so that all specimens are seated simultaneously (Figure 4.10g). The surface is seated in three passes first; then, the specimen box is rotated 90 degrees and the surface is seated again in three passes. The sweep test compactor (shown in the top right corner of Figure 4.1) is used during this procedure. In order to modestly represent in-situ rubber tire compaction, a 380 mm by 380 mm by 13 mm thick rubber pad was affixed to the face of the compactor. The rubber padding was changed periodically as needed during fabrication of specimens in this report. Initial seating attempts placed the rubber pad between the specimens and the compactor, but gluing the pad to the compactor was preferred and was used to produce useable specimens.

Removal of LTP specimens from the *Specimen Box* is performed by pushing the *Specimen Box* slightly off the *Spreader Base*, pushing up from the bottom of each specimen individually, and then carefully removing each specimen off the base (Figure 4.10h). The fully fabricated slab being removed in Figure 4.10h is ready for embedment, conditioning, or testing as desired.

-- The rubber pad used in E-7 is identical to that glued to the sweep test compactor (Figure 4.10g).

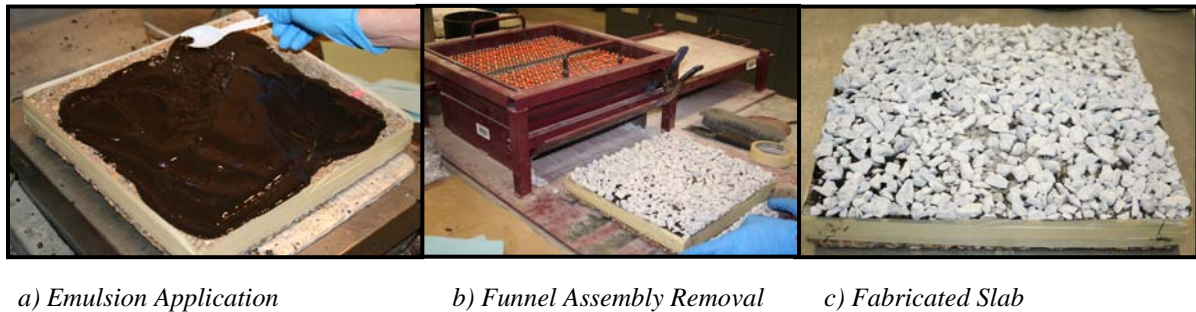
**Figure 4.11. Specimen Fabrication Procedure - Slabs**

Figure 4.11 demonstrates slab specimen fabrication. Emulsion application for slabs is identical to that of cores. Once emulsion is applied, the slab is inserted into the funnel assembly without the use of the *Specimen Box*. After aggregates are spread and the slab is removed from the funnel assembly, the surface is seated in the same manner as for core specimens. Once fabricated, slabs went through embedment and conditioning prior to having test specimens cored from the slabs. Generally speaking, two circular test specimens were cored from each slab.

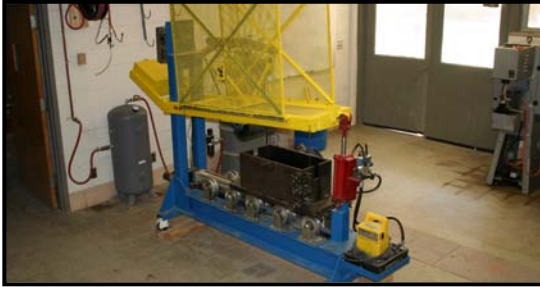
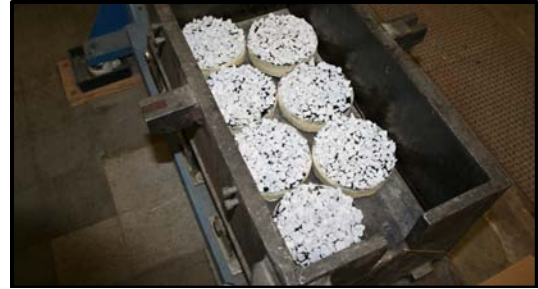
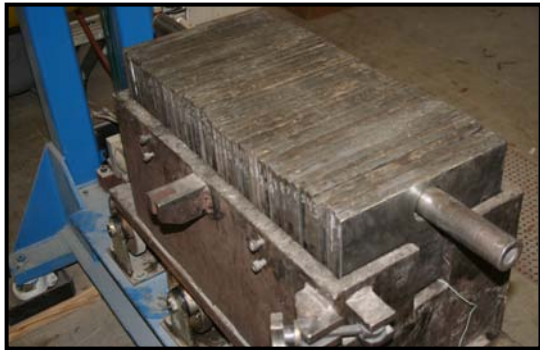
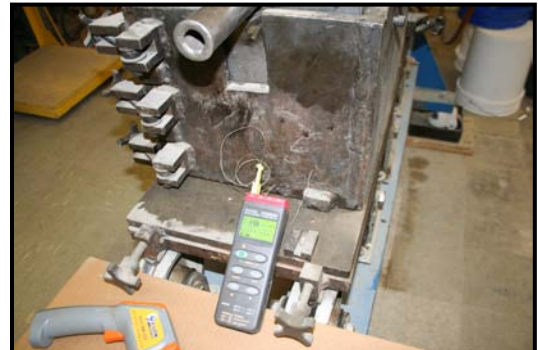
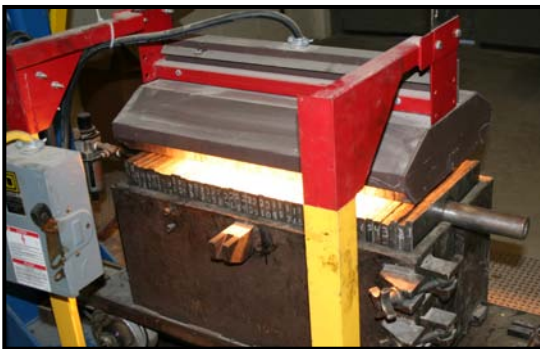
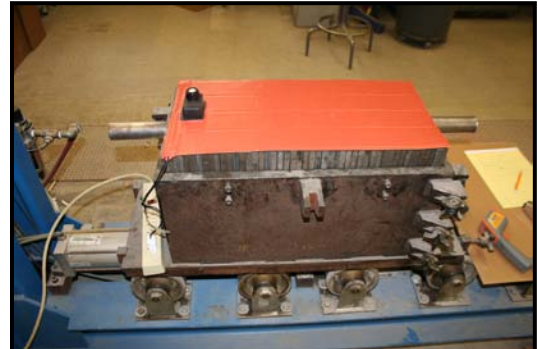
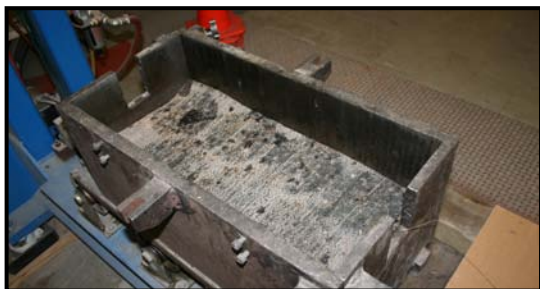
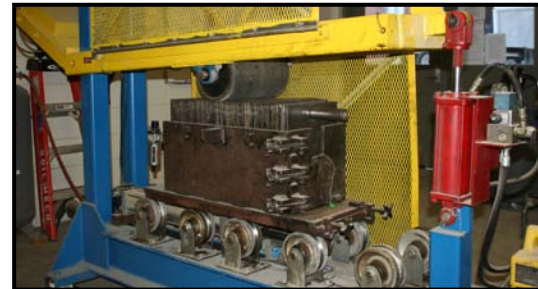
**Figure 4.12. Embedment Using the Linear Asphalt Compactor**

The Linear Asphalt Compactor, or LAC, (Doyle and Howard 2011) was a key embedment component. Figure 4.12 provides photographs of the LAC in various stages of the embedment processes described in Table 4.2. Under normal operation, the LAC has 47 steel plates with thicknesses of 12.7 to 14 mm that are placed side by side to produce kneading compactive effort. For this project, 46 plates were used. The plate removed is normally driven into the specimen mold to tighten the plates; there was concern this might damage specimens on one end prior to beginning embedment. The LAC mold's inside length and width are 62.4 and 29.3 cm, and each LAC plate weighs on the order of 6.7 kg (total mass on the order of 308 kg), producing a static pressure of approximately  $0.17 \text{ kg/cm}^2$ .

Figure 4.13 is a measured temperature versus time curve within the LAC cavity when under the Figure 4.12f heating element that was measured using a thermocouple inserted through the side of the steel mold by drilling a small hole (see Figure 4.12d). The Figure 4.13 curve began with the system at room temperature (as would occur for E-4) and

-- The rubber silicone heating element (Figure 4.12f) is a commercially available product (McMaster Carr Product Number 35765K509) which emits 1,440 Watts. The unit was set to 100 C to maintain 30 to 35 C within the LAC specimen cavity.

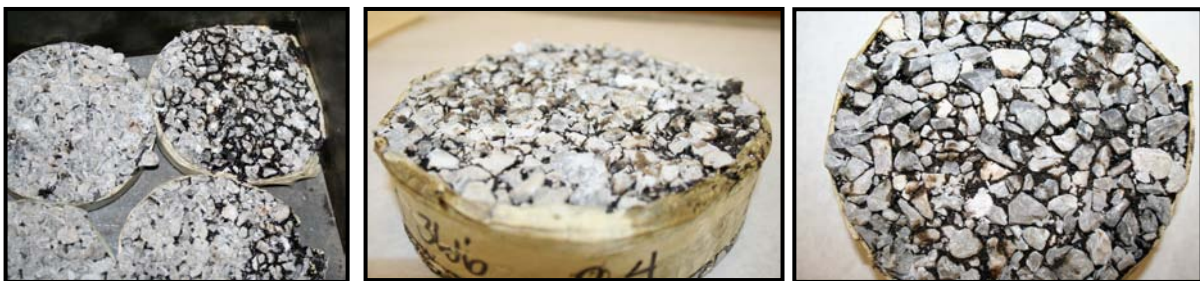
**Figure 4.14. Example Photographs of Specimens Damaged During LAC Embedment**

Several specimens were damaged during embedment in that the pavement cores or gyratory specimens distorted during roller passes (Figure 4.14 provides a few example photographs). Embedment protocol E-5 broke chip seal aggregates, but otherwise there were no protocols that damaged the chip seal itself. Specimens that were damaged were easily identified visually, so the decision was made to continue with testing and discard damaged specimens as opposed to developing a support fixture that could be inserted into the Figure 4.12b LAC carriage to provide lateral support to cores (i.e. focus efforts on proof of concept rather than creating specimen fixture). Note that slab specimens were fully supported and were not damaged during LAC embedment. Some attempts to limit damage to cores or gyratory specimens included placing fine sand between cores and using small wood fixtures to provide some lateral support. In addition, spacers were used to regulate specimen height to some extent, but incorporating better height control into a support fixture should also improve specimen survivability during embedment.

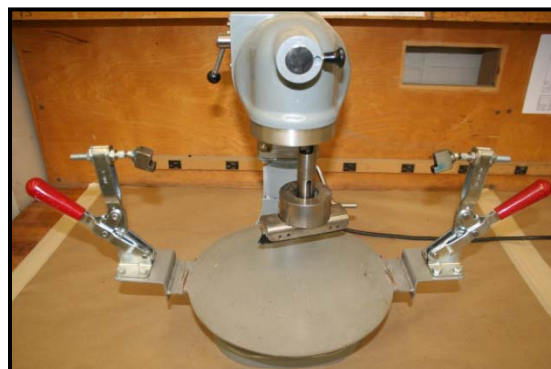
**Figure 4.16. Hobart N50 Mixer with Mounting Base in Place**

All testing was performed using the Hobart N50 planetary mixer which is discussed in detail in the State Study 211 Volume I report. The LTP abrasion test was conducted at mixer speed number 1. Figure 4.16 shows the Hobart N50 mixer with the sweep test mounting base and the Figure 4.15a brush head in place.

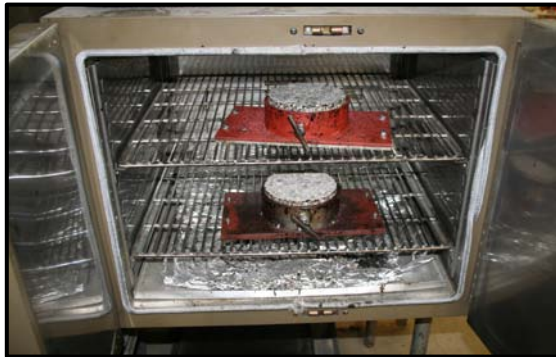
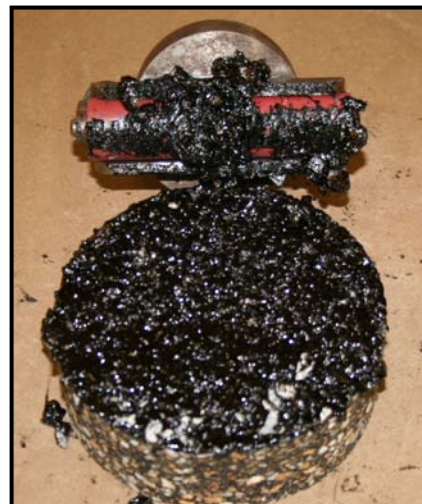
In phase 1, specimens were pre-heated from room temperature 1 hr in an oven set at the test temperature absent the *Adapter Base*. After pre-heating, specimens were carefully secured in the room temperature *Adapter Base* in less than 30 seconds. Aluminum spacers of different thicknesses were placed on the bottom, inside of the steel ring to adjust the specimen height so that the chip seal application was at least 10 mm above the *Adapter Base* (Figure 4.18c is an example).

base to be taken directly from the oven to the mixer for testing and minimization of heat loss. The time from opening the oven doors to commencing abrasive forces (T1) from the LTP test (Figure 4.18c) was generally 50 seconds or less (a 60 second or less tolerance is reasonable and was achieved for almost all cases in this project). T1 was the beginning of the LTP test. The final pre-heating configuration for phases 2 and 3 was 2.5 hours while pre-positioned in the *Adapter Base* (Figure 4.18a).

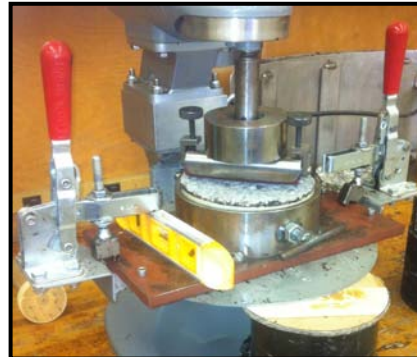
b) Overall LTP Test View

During phase 1 efforts, a few LTP approaches were investigated. In all cases, abrasive forces were applied to a specimen using either the D7000 or D3910 abrasion heads. Figure 4.18b shows the overall LTP setup where a specimen has been secured in the Figure 4.17 *Adapter Base* that is sitting on the Figure 4.16 mixer mounting base. The specimen is secure, level, and has 10 mm or more of clearance above the *Adapter Base*. Thereafter the mixer is turned on to speed number 1 and abrasive forces are applied through the abrasion heads that are free-floating, capable of vertical movement, and are rotating on top of the specimen's surface to dislodge aggregates.

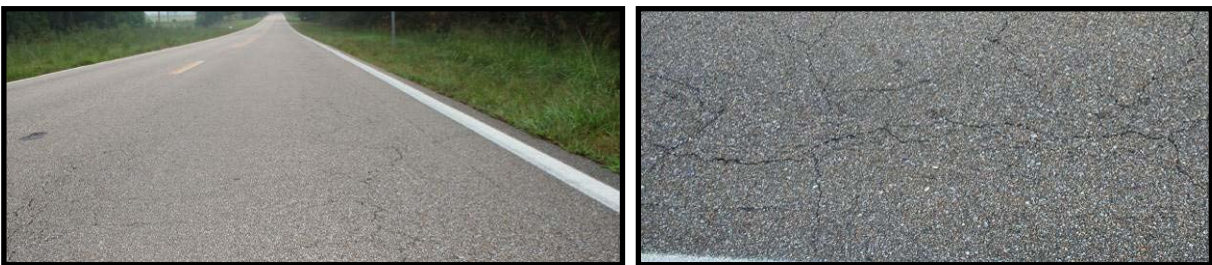
**Figure 5.1. Hwy 44 Section 1 Pre-Sealing Survey (09/19/2011)**

Several cracks ≈ 1 m long. Some wheel path fatigue cracking and numerous cracks ≈1 to 3 mm wide. Pavement appeared somewhat degraded as cores had to be handled carefully.

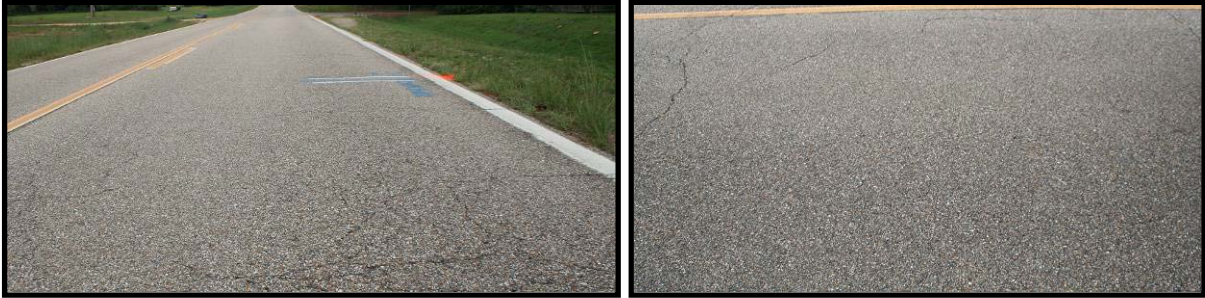
**Figure 5.2. Hwy 44 Section 2 Pre-Sealing Survey (09/19/2011)**

Several cracks  $\approx$  1 m long. Some wheel path fatigue cracking and numerous cracks  $\approx$  1 to 3 mm wide. Similar condition to Section 1.

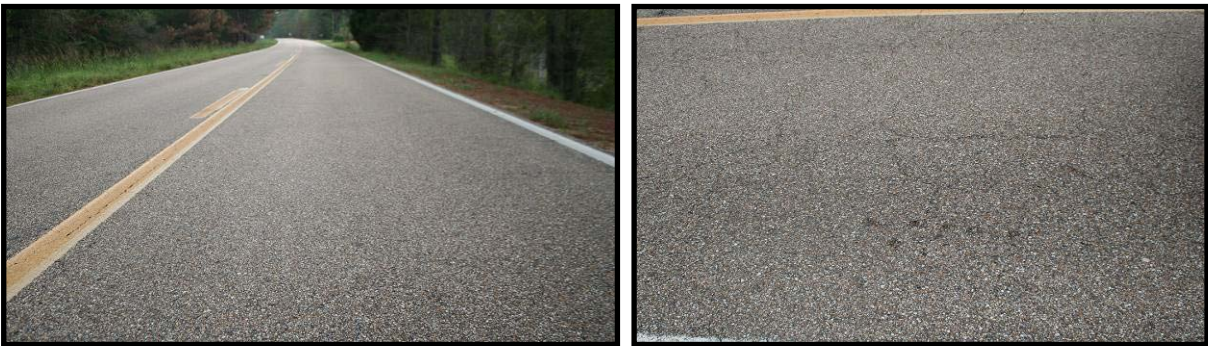
**Figure 5.3. Hwy 44 Section 3 Pre-Sealing Survey (09/19/2011)**

Some cracks, but not as many as sections 1 or 2. Most cracks were evenly spaced and did not cover full pavement width. Typical cracks were 1 to 3 mm wide.

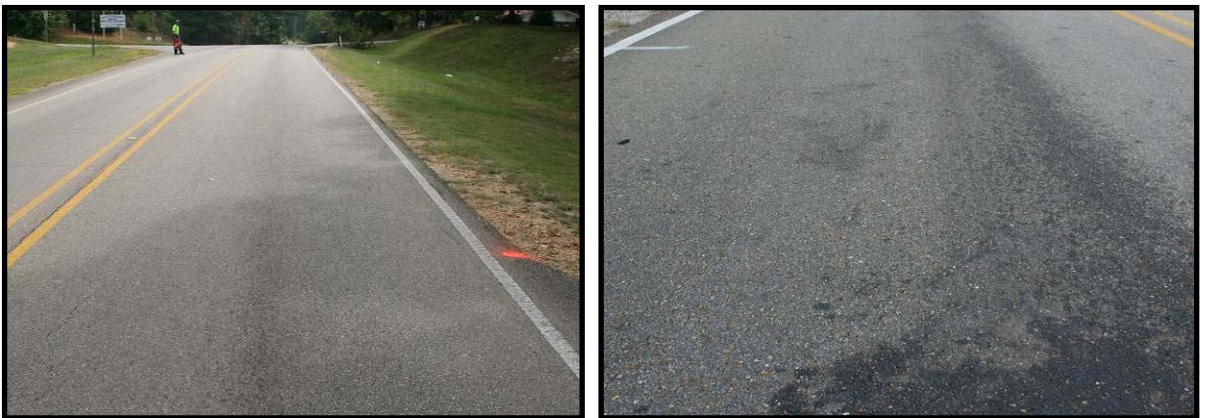
**Figure 5.4. Hwy 366 Section 1 Pre-Sealing Survey (09/10/2010)**

Oil and grease droppings were present in some areas, as well as a small amount of polished aggregate. Cracking was minor.

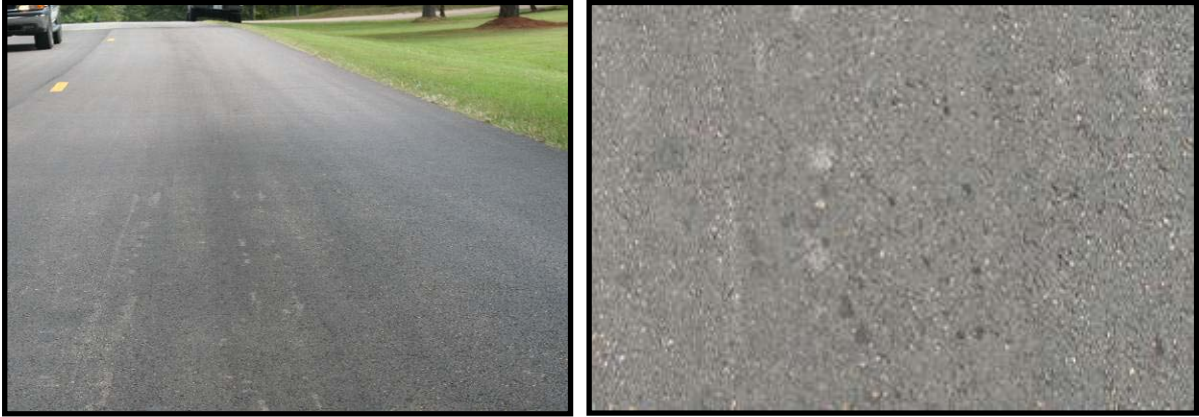
**Figure 5.5. Hwy 366 Section 2 Pre-Sealing Survey (09/10/2010)**

Surface was in good condition. No cracks were observed in the section.

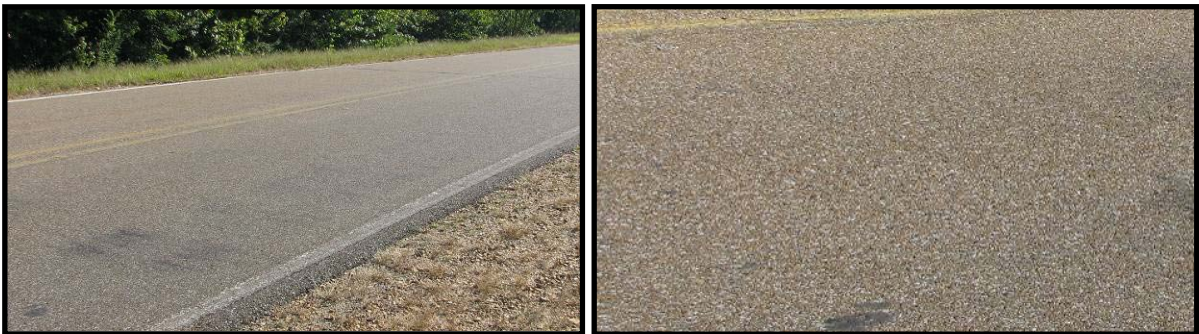
Surface was in fair condition, with exception of large transverse cracks that were avoided when selecting section boundaries. Otherwise the section had some cracks, but was not highly cracked.

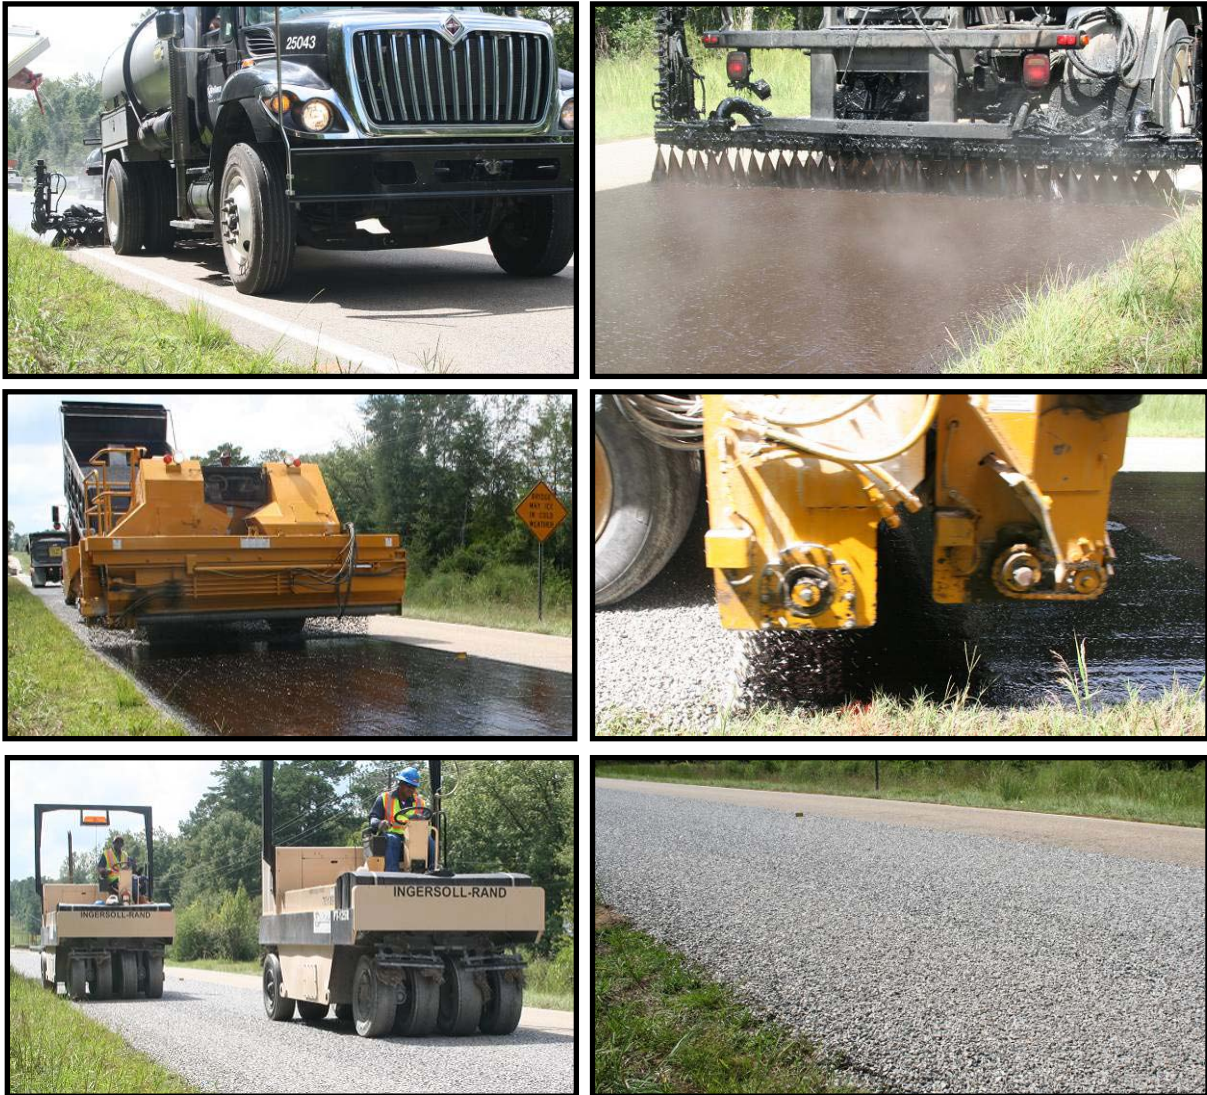
**Figure 5.7. Hwy 44 Chip Seal Application (09/20/2011)**

The Hwy 44 chip seal was placed by TL Wallace Construction, Inc. out of Columbia, MS. At 8 AM on the west end of the project, the relative humidity was 95% and the air temperature was 26 °C. Sealing commenced later in the morning and the three test sections were sealed in the afternoon. Figure 5.7 provides example photographs of the Hwy 44 sealing process.

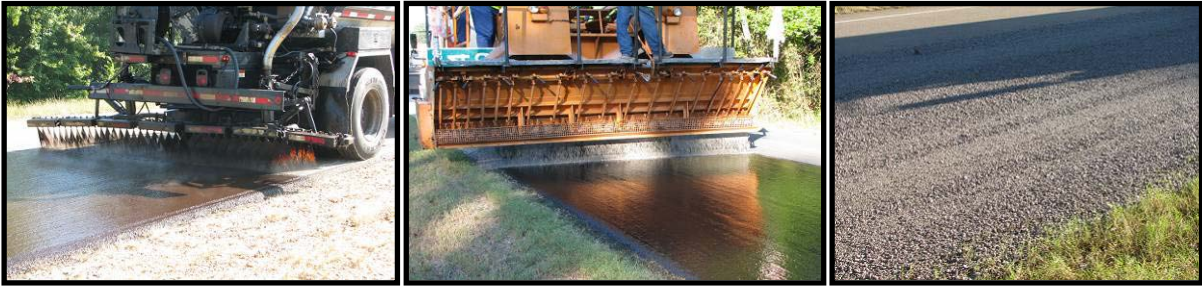
**Figure 5.8. Hwy 366 Chip Seal Application (09/14/2010)**

The seal was placed with MDOT forces, so no bid or specification information was obtained for this project. Figure 5.8 provides example photographs of the Hwy 366 sealing process. The pavement edge was scraped with a John Deere 570 B motor grader, and the pavement surface was swept with a Waldon Sweepmaster 250 prior to emulsion application. Once swept with a Rosco Maximizer asphalt distributor, aggregates (stockpiled on site) were placed with a Rosco Flaherty SPR-H chip spreader. Aggregates were seated into the emulsion with two rollers with empty water tanks that had five pneumatic tires on the front and six pneumatic tires on the back: BROS PS 2500 and Ferguson SP-1115. Three passes were made with each roller. The BROS roller had a maximum tire pressure rating of 860 kPa (125 psi), and the standard weight of the roller is 3,380 kg (7,450 lb), which is approximately

307 kg (675 lb) per tire. The Ferguson roller is similar except the tire pressure rating was 275 kPa (40 psi). The chip seal was swept on September 14, 2010 and again on September 16, 2010 to complete the process.

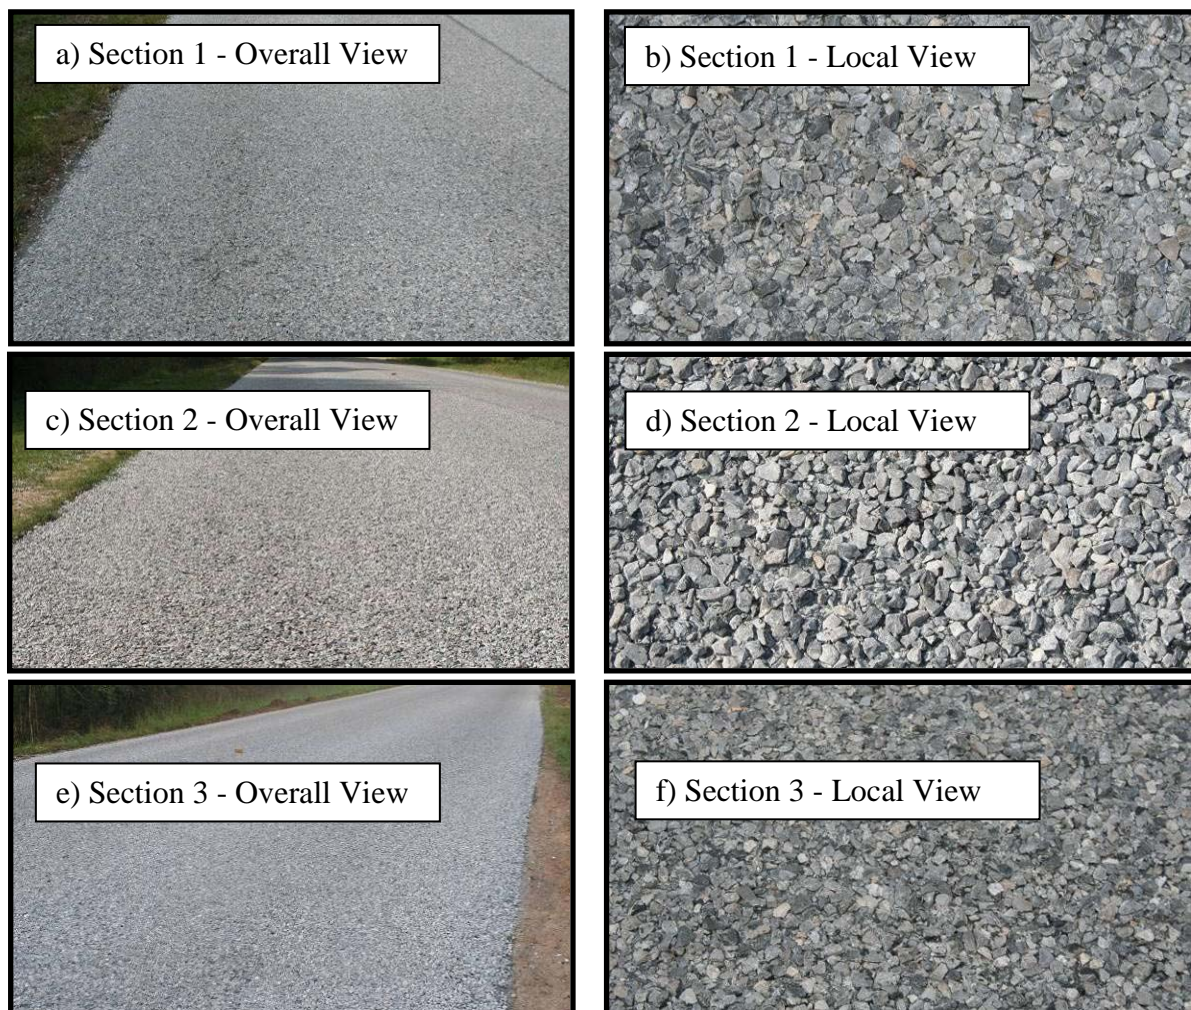
Figure 5.9. Hwy 44 Post-Sealing (09/26/2011)

The seal was in good condition just after placement (Figure 5.9). Aggregate coverage was generally very good. Section 3 had a few areas that were not covered as well as other sections, but these areas were reasonably covered. The seal within a few centimeters of the centerline was not as well covered as the rest of the pavement. Neither Hwy 44 or Hwy 366 sealed the pavement's centerline prior to applying the chip seal. Wood and Olson (2011) state this practice can avoid excessive asphalt absorption at the joint. The centerline joint appeared to be the best in section 2, a little worse in section 1, and the worst in section 3.

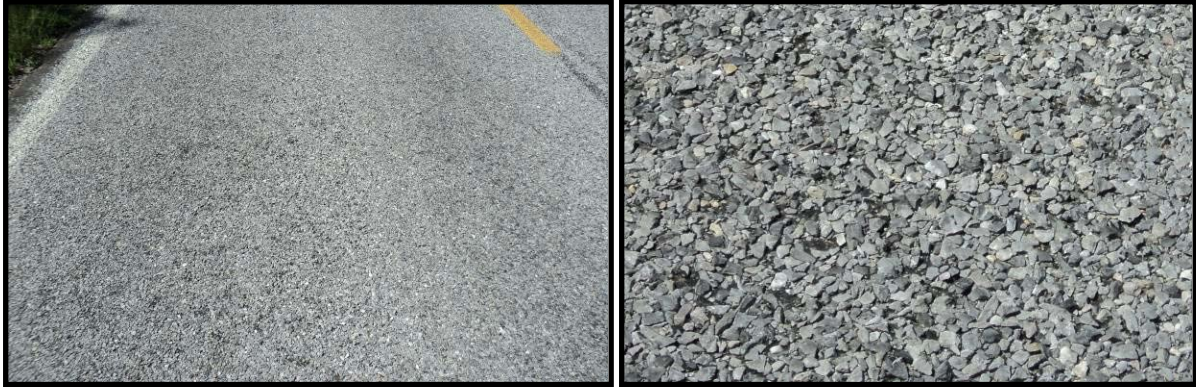
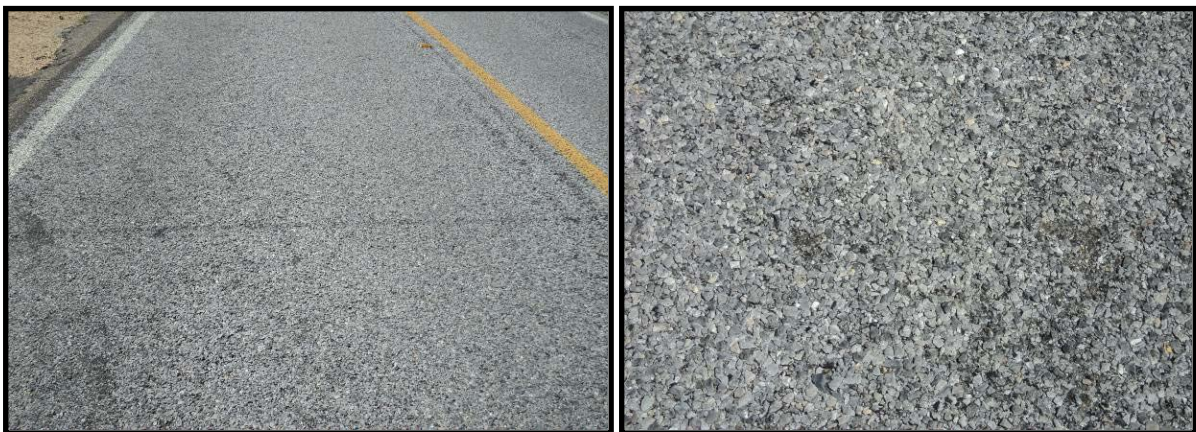
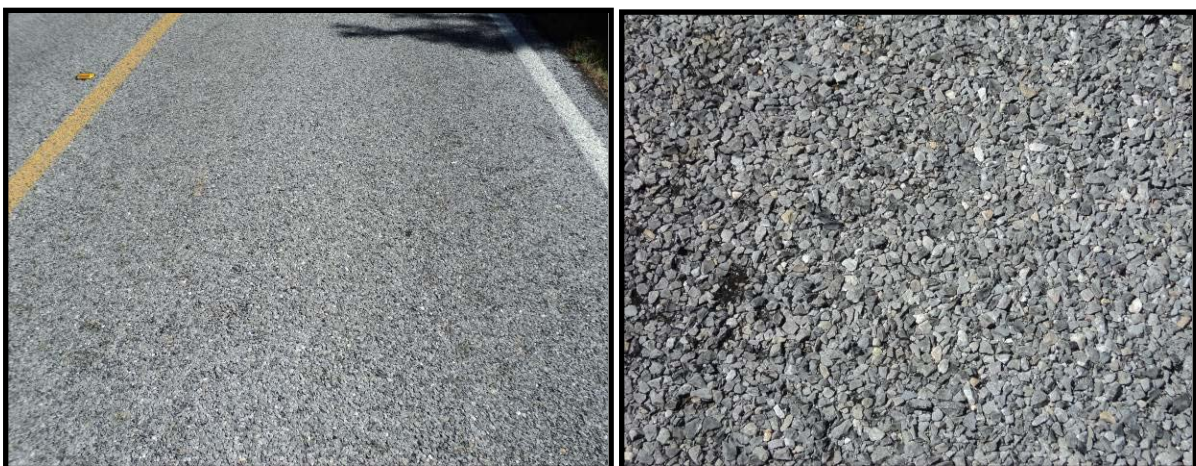
The Hwy 44 intermediate survey occurred 356 days after chip seal placement. The seal was evaluated by MDOT's acting District Maintenance Engineer who reported the seal to be in very good shape with no raveling or bleeding and good aggregate retention (Figures 5.10 to 5.12). Approximately two years after placement (729 days), the seal's condition was evaluated again (Figures 5.13 to 5.15). The seal was in reasonable to decent shape.

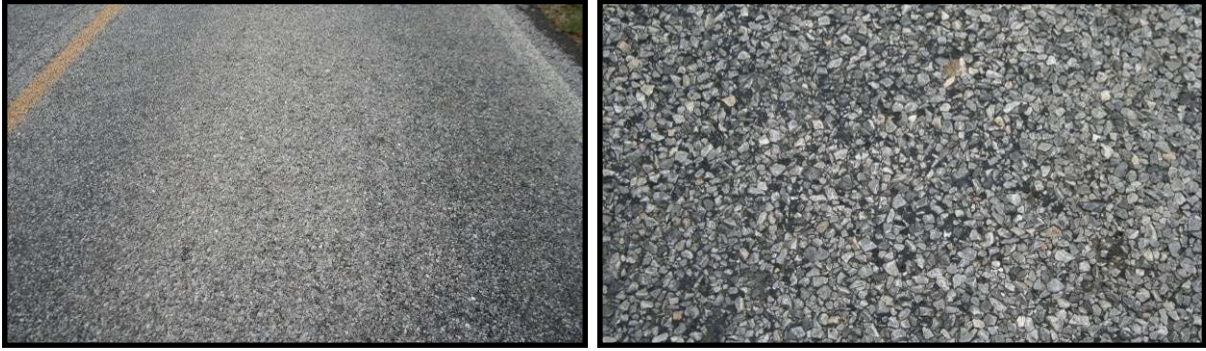
**Figure 5.13. Hwy 44 Section 1 Two Year Survey (09/18/2013)**

There were signs of lack of texture/full embedment in wheel paths, but no meaningful bleeding/flushing. Centerline was in better shape than Section 2. There was some wheel path rutting.

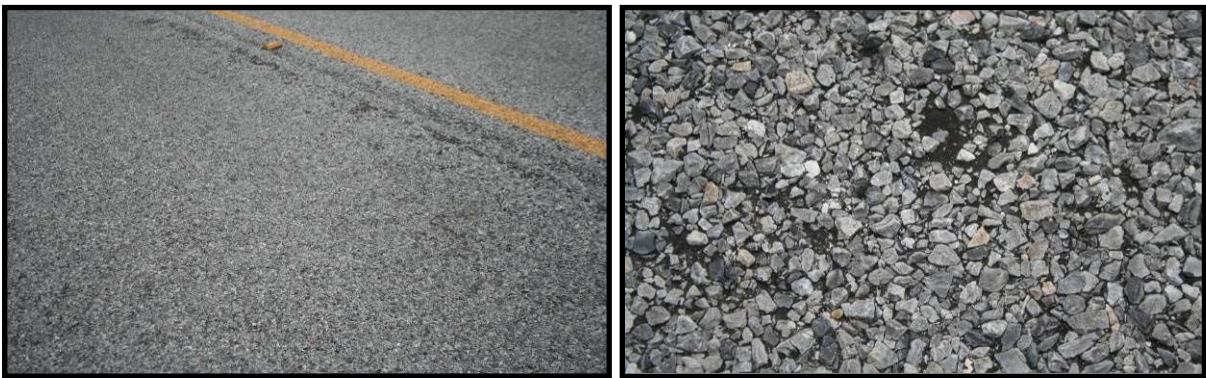
**Figure 5.14. Hwy 44 Section 2 Two Year Survey (09/18/2013)**

Centerline had some noticeable problem areas. Aggregate loss and bleeding were a little worse visually than Section 3, but otherwise the same general observations were made. Seal was in decent shape.

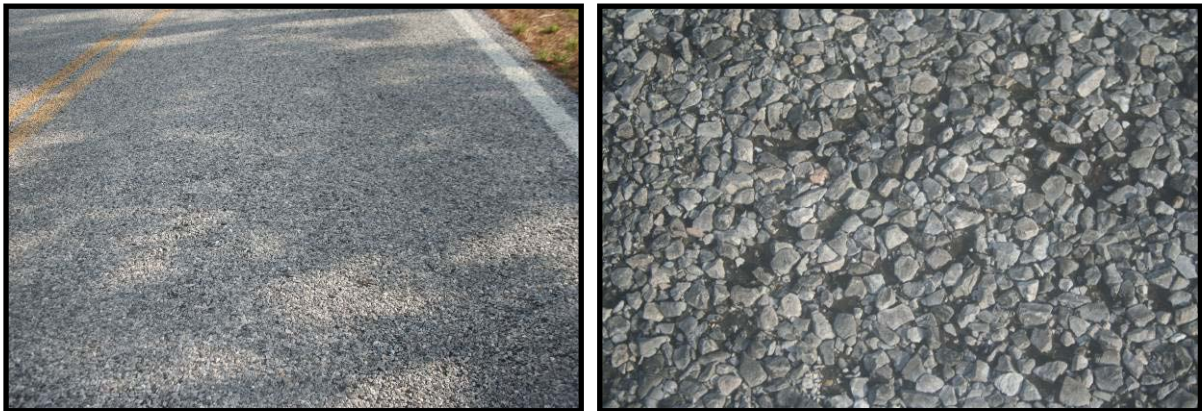
There were noticeable areas where binder was visible; i.e. aggregate loss. Some areas were as large as 2.5 cm diameter. There were no signs of bleeding and overall the condition was about the same as Section 1 even though aggregate loss seemed a little worse than Section 1. Seal was in reasonable shape.

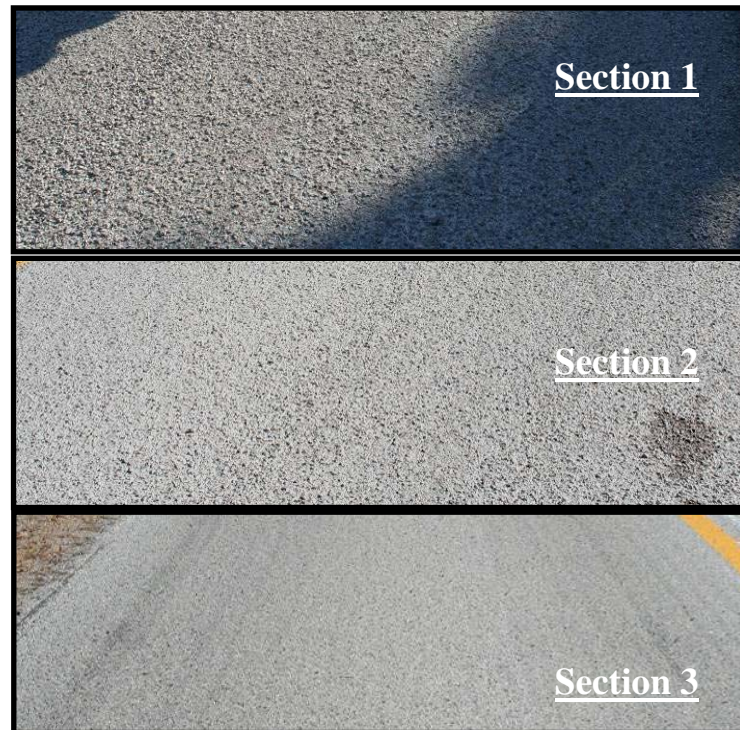
Figure 5.16. Hwy 366 Post-Sealing Survey (09/24/2010)

The Hwy 366 seal was in good condition just after placement (Figure 5.16). Two-hundred and eighty-six days later the seal was in reasonable shape (Figures 5.17 to 5.19). No major failures were observed in the test sections. The pavement was plowed for snow three times in the winter of 2010. Approximately two years after placement (736 days), the seal's condition was evaluated again (Figures 5.20 to 5.22). The seal had degraded, but was still in reasonable shape and functional. The winter of 2011 was mild and no snowfall occurred, so there was no additional snow plow activity between the intermediate and two year surveys.

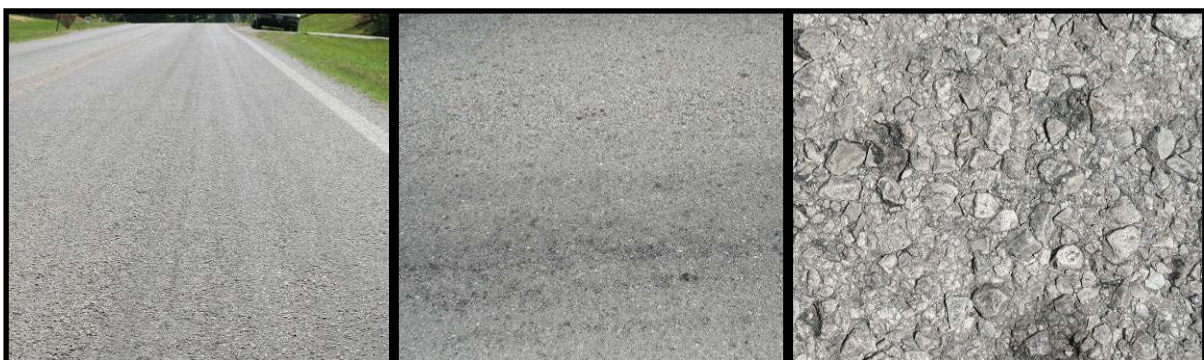
Slight aggregate loss, some popouts, and a little more aggregate loss in the wheel path. Some underlying cracks were beginning to be visible, but overall no major distresses were observed.

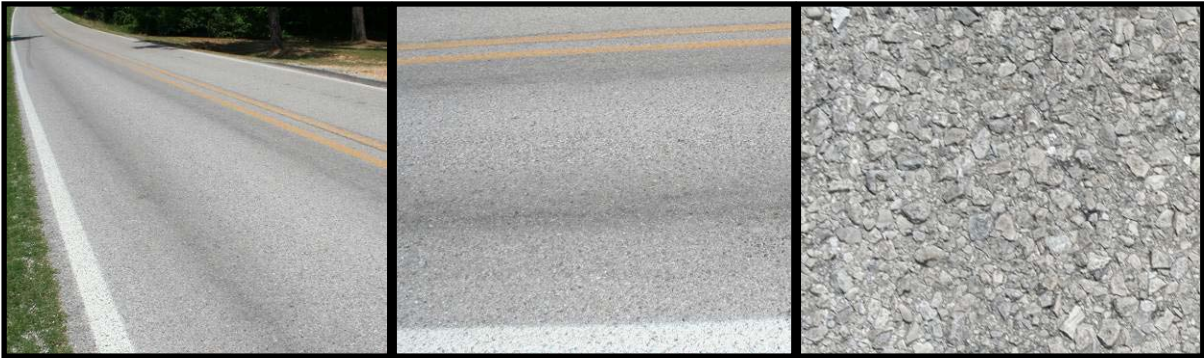
Wheel path appeared slightly more polished than lane center. Very few popouts were observed; dark areas were from oil drippings and not bleeding/flushing. Aggregate loss was insignificant, and a few small cracks were beginning to be visible. Slightly better condition than Section 1.

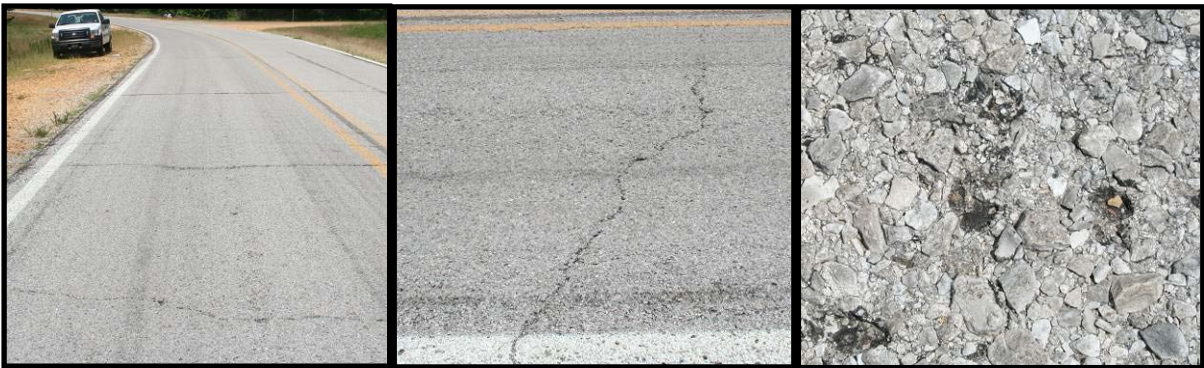
Several popouts and large cracks were easily visible. The large cracks are likely due to highly cemented base for bridge approach. Very little wheel path polishing was observed.

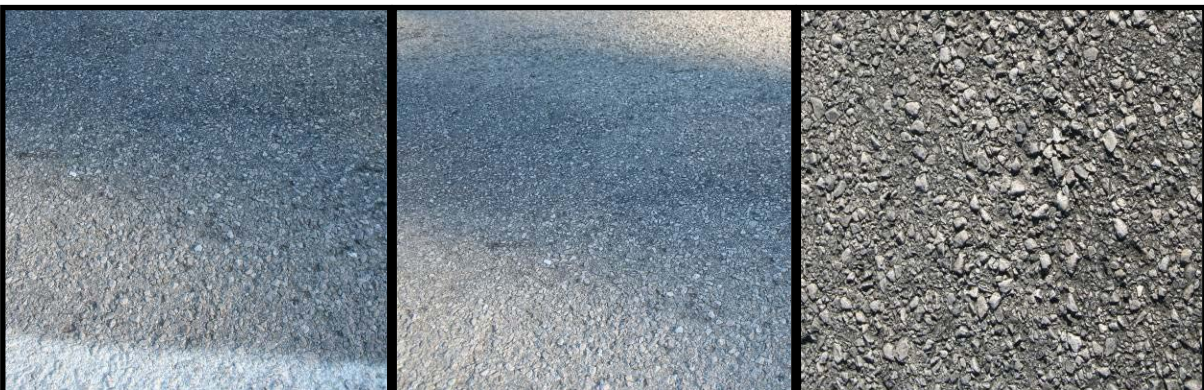
Some aggregate loss and popouts; greater loss in wheel paths. Some cracks visible that were present pre-sealing. No major distresses; overall in good shape for two years old.

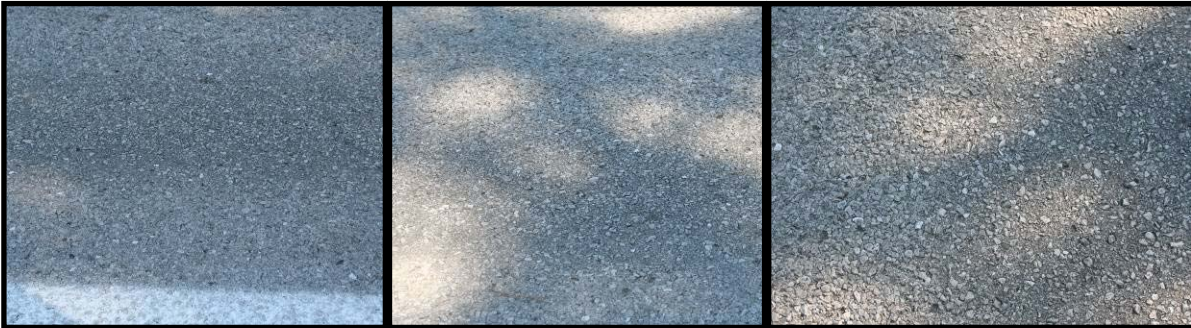
A few popouts. Wheel path was slightly darker than the rest of the pavement, but seal was in very good shape. No cracking observed; seal in a little better shape than Section 1.

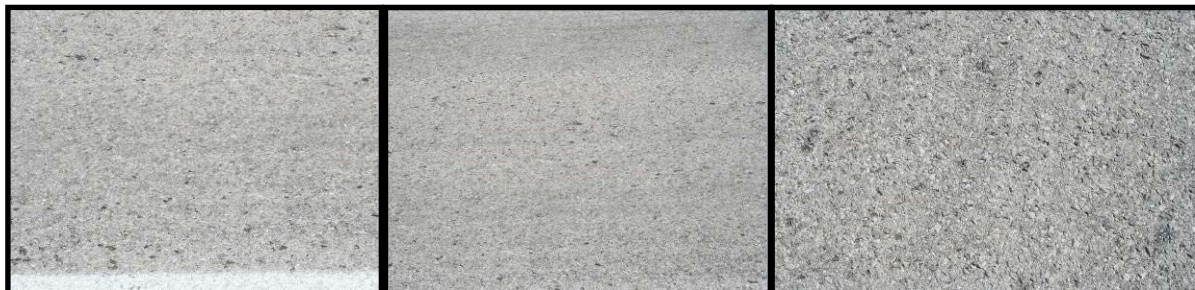
Considerable popouts. Reflective cracks were easily visible. Some longitudinal cracking, but other than the large transverse cracks, there were no major distresses other than excessive binder in a few areas that did not appear to be traffic related.

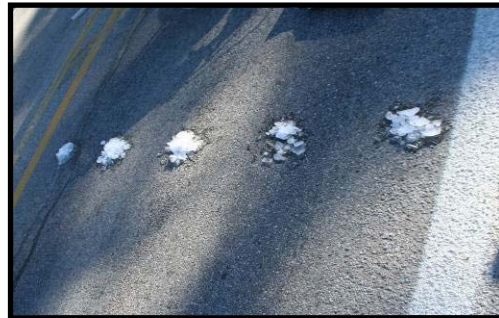
**Figure 5.23. Pre-Marked Locations With Ice Prior to Coring**

Test sections were approximately 60 m long and in the eastbound lane. Test sections had no significant distresses such as potholes or patches. Each highway had three test sections that were cored three times as per the Table 5.1 schedule; 2 highways, 3 sections, and 3 times result in 18 coring groups. Untreated cores were taken from the western most end of each section, unaged cores were taken from the eastern most end of each section, and aged cores were taken near the middle of each section since all sections were reasonably uniform and any one area was representative of the section. When cores with a chip seal were taken, ice was placed on the pavement surface to minimize damage that could occur if the chip seal stuck to the coring bit (Figure 5.23).

In the transverse direction, five core locations were marked in a row at 0.3, 0.9, 1.5, 2.1, and 2.7 m from the centerline. In the longitudinal (i.e. traffic) direction, rows of cores were spaced 3 m apart. Of the 18 coring groups: 13 took ten cores in two rows, 1 did not get cored due to rain, 1 took fifteen cores in three rows, and 3 took ten cores in two rows alongside two additional cores at 0.9 and 2.1 m from the centerline. The group that took fifteen cores allowed for some preliminary testing, and the groups that took twelve cores was as a result of finalized test plans that were ongoing at the time the other sections were cored.

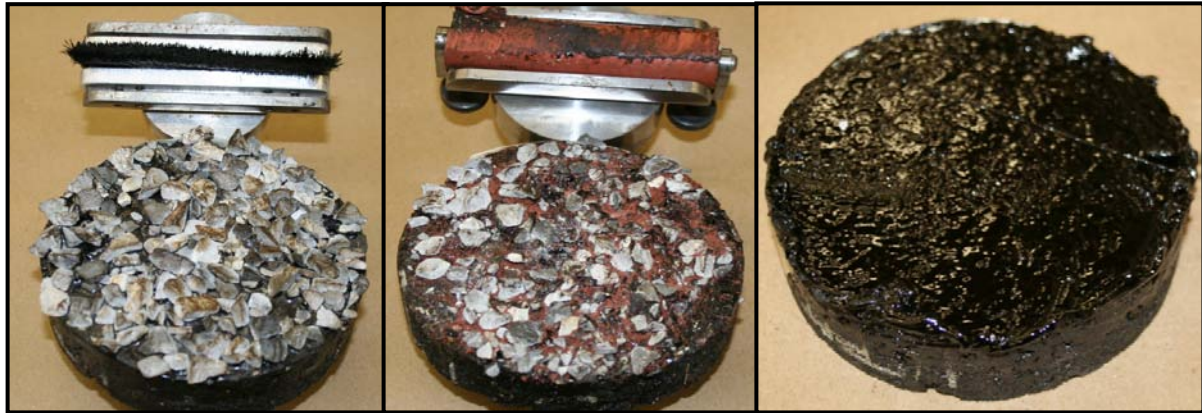
### Figure 6.7. Phase 1 LTP Testing at Modest Temperatures

In conjunction with D7000 and D3910 abrasion head initial comparisons, test temperatures were evaluated. Figure 6.7 is an example chip seal placed on the sliced face of a *Hwy 49-S1* SGC specimen that demonstrates room temperature (near 21 C) testing did not cause 100% mass loss with either abrasion head (note the damage to the D3910 hose in Figure 6.7b). The specimen tested with D3910 at 21 C was re-tested at 35 C, which did result in 100% mass loss, albeit on a specimen that had not had any embedding. Exploratory testing was also performed by conditioning specimens that had not been embedded at 85 C (C-1 protocol from Chapter 4) and also testing those specimens at 85 C using the D3910

hose. Aggregate loss approached 100% very quickly, which led to the observation that test temperatures on the order of 85 C are likely too high, especially since they would not occur to an in-service chip seal.

--Note that some of the *Hwy 366* specimens with  $T_{100\%}$  values of 900 seconds abraded the D3910 hose in a similar manner to that shown in Figure 6.7b.

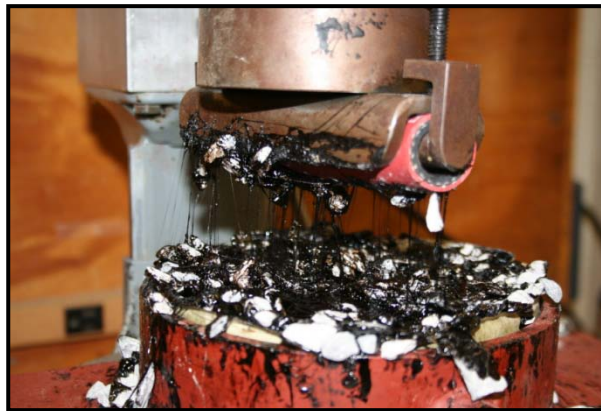
**Figure 6.9. Phase 2 Emulsion Tackiness Example**

--All specimens used Size 7, Emulsion A, 1.81 L/m<sup>2</sup>, and were tested at 52 C.

--All but 4 specimens used 11 kg/m<sup>2</sup>, and these used either 10 or 12 kg/m<sup>2</sup>.
