# Performance Oriented Guidance for Mississippi Chip Seals-Volume II

## Final Report

## FHWA/MS-DOT-RD-13-211-Volume II

December 31, 2013

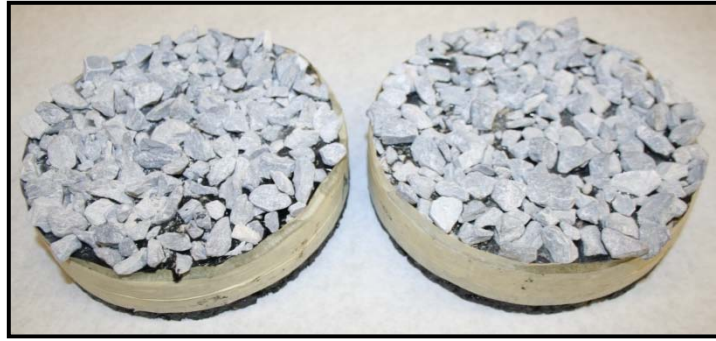
**Figure 6.11. Representative Laboratory Fabricated Size 7 Specimens Pre-Embedment**

Figure 6.11 provides representative Size 7 specimen photos post fabrication. Figure 6.12 provides representative photos of Size 7 specimens post embedment with the two most aggressive protocols used. Visually, embedment effects were very noticeable.

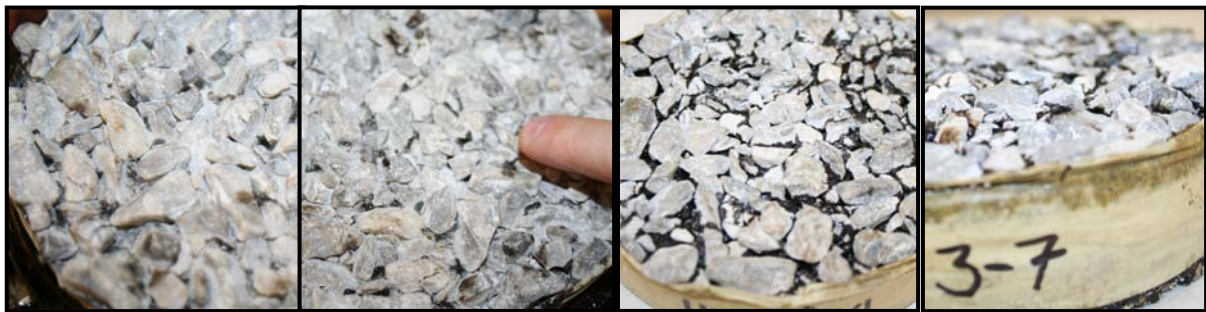
**Figure 6.12. Example Photos Showing Size 7 Aggregate Embedment**

*a) E-7 Specimen 1      b) E-7 Specimen 2      c) E-11 Specimen 1      d) E-11 Specimen 2*
