# FINAL REPORT

FHWA-WY-14/01F

## Instrumentation and Analysis of Frost Heave Mitigation on WY-70, Encampment, WY

May 2014

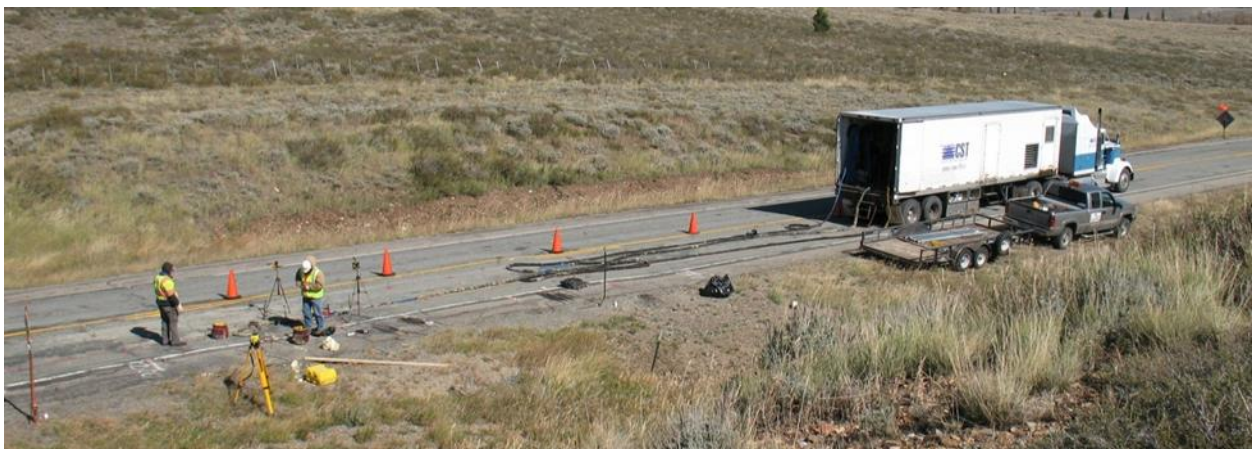
Figure 34. Photo. Site Layout showing the CST Urethane Truck, a Service Truck and Trailer, the Injection Hoses, the Leveling System and the Traffic Control

Concrete Stabilization Technologies (CST), WYDOT and the University of Wyoming (UW) personnel met at the site Monday morning, October 10, to finalize the scope of work and outline the construction procedures. Two WYDOT flaggers maintained traffic control for the duration of the construction. After the traffic was diverted to the west bound lane for a distance of about 91 m (300 ft), CST took a level survey to establish a pre-injection road profile. Figure 34 shows the working setup at the site. They then laid out a 1.8 m (6 ft) square grid pattern on the road surface from STA 1+70 to 2+40 to locate the injection points over the heave area. Holes having 19 mm (0.75 in.) diameters were drilled through the pavement to a depth of 0.5 m (18 in.) on the grid. Injection tubes 0.6 m (24 in.) long were placed in the holes that would be connected to the nozzle of the injection gun. Upon testing their equipment, CST determined that one of their material pumps for the two part Uretek 486 STAR #3 polymer was not working and needed to be replaced. The injection tubes were pulled and the semi-truck was taken back to the Saratoga maintenance shop to complete the repair. After CST left the site, UW made a final preconstruction survey to establish the pre-injection road profile.

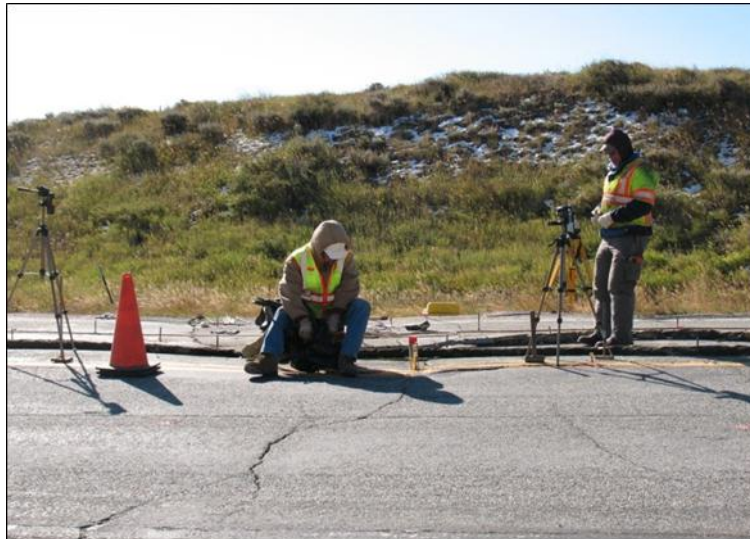
Figure 35. Photo. Injecting the Uretek at STA 2+10, the location of the dip. Also shown are some of the Injection Tubes.

CST returned to the site and reinserted the injection rods. In addition to using a laser level, string lines were set along the highway centerline and the center and south edge of the east bound lane. Injection was started at station 2+40. Figure 35 shows the injection process. The injections were performed in pairs across the road to try to produce even lifting. Lifting was also started at station 1+70. Work proceeded from both ends towards the middle. Both ends were lifted the necessary 75 mm (3 in.) so that the string line could be set on the road surface at both ends to get proper elevation of the string. Spacer blocks lifted the string an additional 75 mm (3 in.), so irregularities in the surface would not touch the string and alter the elevation. A 3.7 m (12 foot) 2X4 was also used as a straight edge. Small tapers were added to each side of the treated areas to improve the transition onto the lifted areas for vehicles. The middle section was not treated that day due to potential difficulties caused by the poor condition of the asphalt in that area which had significant cracking. Warning signs were placed to warn drivers of the hazardous condition of the roadway.

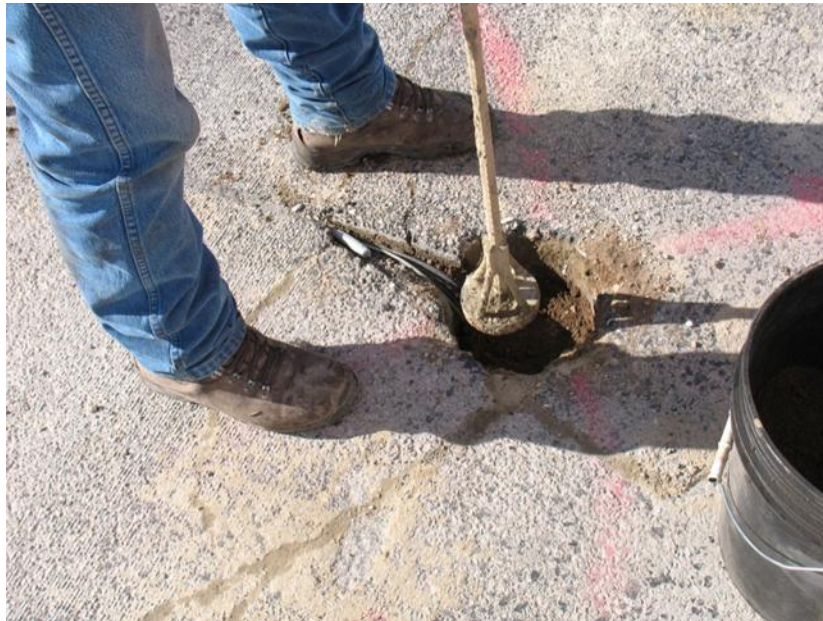
Figure 39. Photo. Kinniburgh Tamper Compacting Cold Mix to the Surface

Figure 38 shows the first probe was located 100 mm (4 in.) from the top of the molding, which was buried at a depth of 305 mm (12 in.). The final one or two thermistors were attached in the field because their location was a function of the depth to bedrock. After the hole was drilled, the depth was measured and the prepared molding was cut one foot shorter than the depth of the hole. One or two holes were drilled in the molding with the bottom thermistor located about four inches from the bottom of the hole at the top of the bedrock. The molding was placed in the hole and the cuttings were backfilled into the hole using a very effective tamper built by Scott Kinniburgh shown in figure 39. The cuttings were compacted to the top of the molding.

During the injection phase, a 200 mm (8 in.) diameter Sonotube concrete form was filled with the polymer foam to create a 1.2 m (4 ft) length of foam the diameter of the hollow stem auger hole. A 75 mm (3 in.) segment of the form was cut and placed on the backfill at the top of the molding. The foam plug was then sealed in the hole using a can of Great Stuff expanding insulation foam to fill the annulus between the plug and the borehole. This was covered by more compacted soil up to the base of the asphalt. Finally, the hole was completed with a layer of cold patch compacted to the existing road surface. The thermistor cables were routed from the borehole to the side of the pavement through grooves cut by the Saratoga shop crew using a concrete saw. The cables were then placed in PVC conduit pipe that routed the cables to the instrumentation post where the data collection box was mounted.

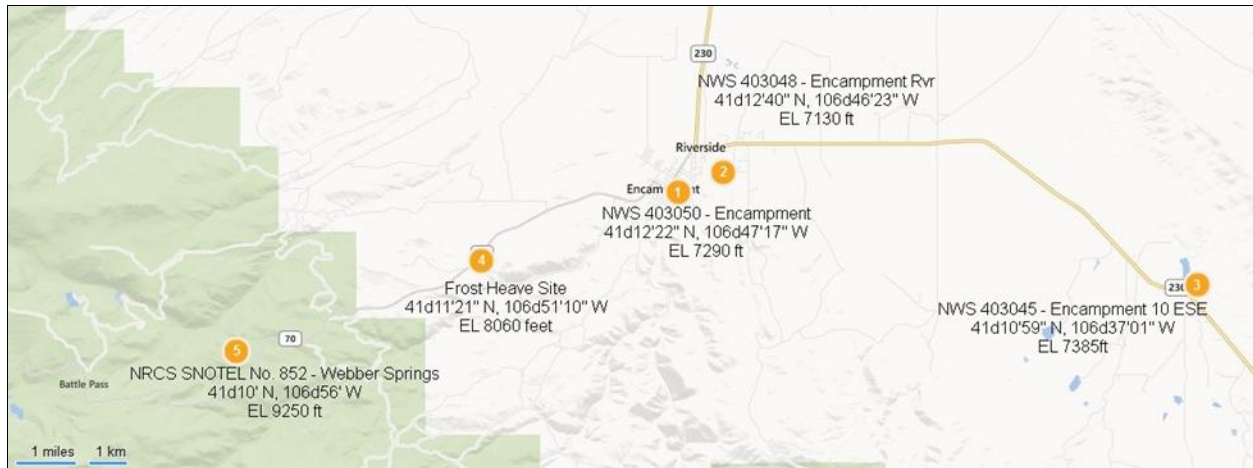
Figure 64. Map. Locations of National Weather Stations and SNOTEL Station Relative to Site.

There are three NWS weather stations in the Encampment area and the Webber Springs SNOTEL station between the site and Battle Mountain Pass shown in figure 64. Two NWS stations are in town, about 1.6 km (1 mi) apart. Formally, both stations, 483048 and 483050, are closed and do not measure temperatures, just snow data. However, Tony Bergantino of the Wyoming Water Resources Data System (WRDS) was able to locate temperature data for both stations. The data was identical between the two stations, except 483050 had a longer period of
