# **Fatigue Assessment for the Failed Bridge Deck Closure Pour at Mile Marker 43 on I-81**

Final Report VCTIR 14-R12

**FATIGUE ASSESSMENT FOR THE FAILED BRIDGE DECK CLOSURE POUR  
AT MILE MARKER 43 ON I-81**

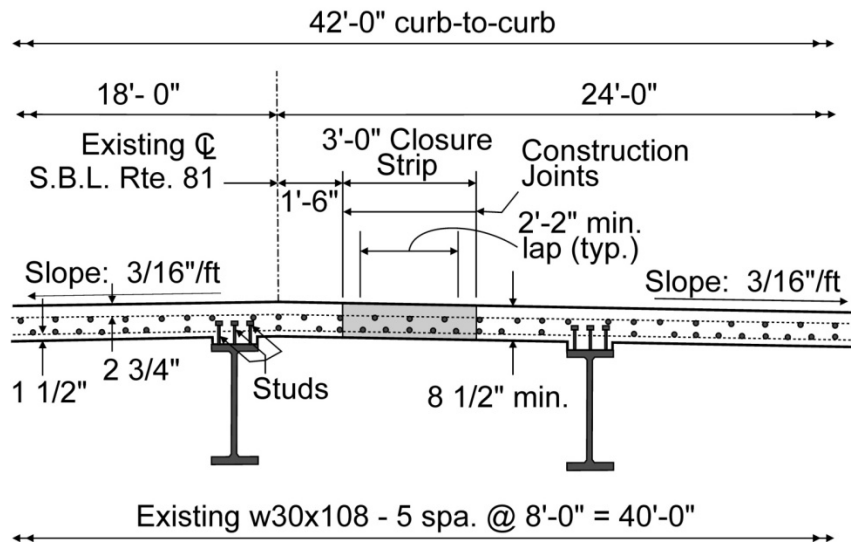
**Figure 1. Transverse Section of Bridge Deck With Closure Pour**

In 1992, several bridge decks on I-81 near Marion, Virginia, were replaced, using staged construction, as part of a bridge rehabilitation project (Sprinkel et al., 2010). Figure 1 presents a transverse section showing the width and location of the closure pour. Epoxy-coated reinforcement was used as the reinforcing steel. There was no formed keyway at the joint between the previously cast deck and the closure pour. After 17 years in service, a 3 ft by 3 ft closure pour section punched through, as shown in Figure 2. All of the bars along the closure/deck interface on both sides of the closure were severed.

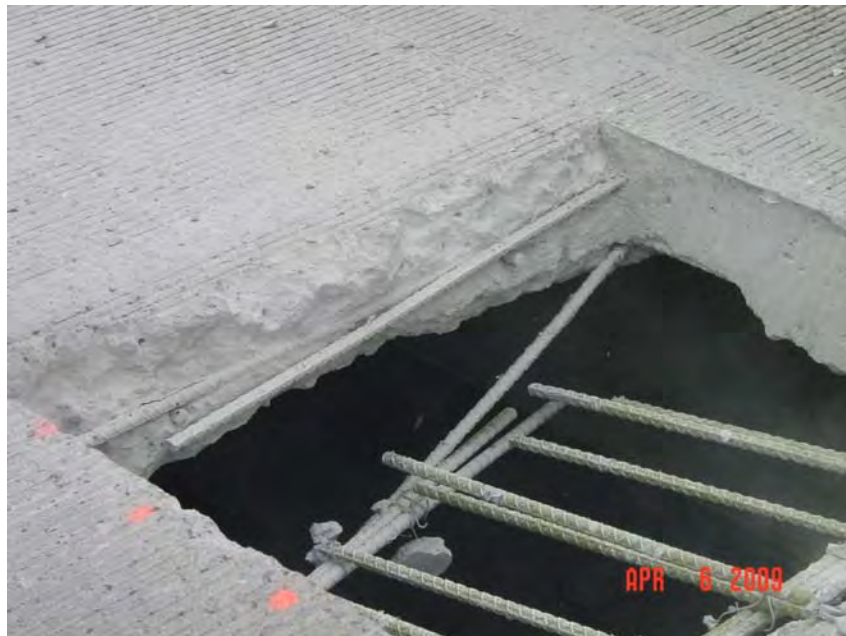
**Figure 2. Failed Section of Closure Pour**

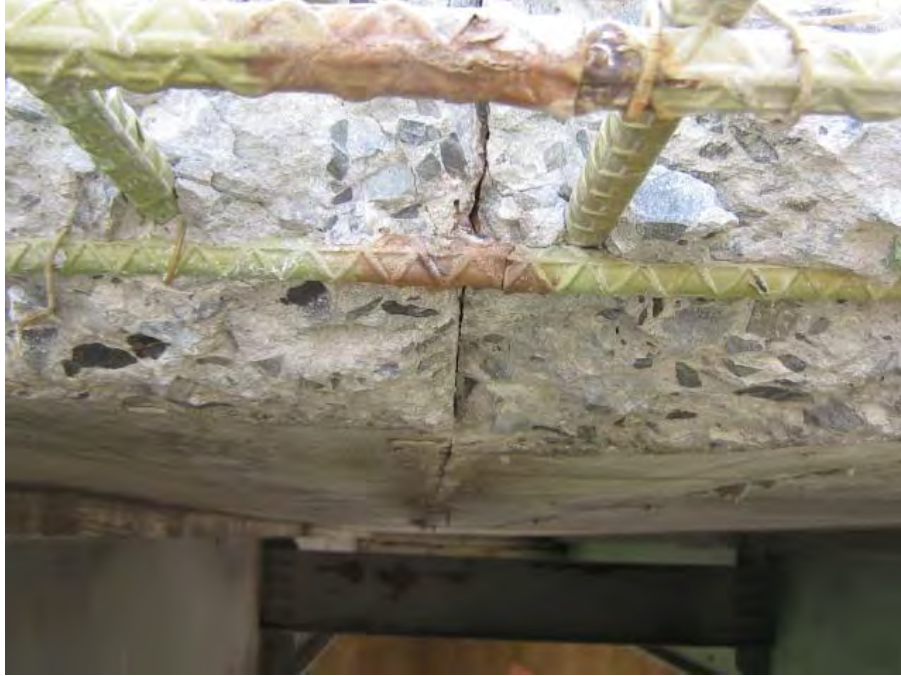
**Figure 3. Condition of Reinforcing Bars Spanning Across Joint Showing Corrosion and Vertical Break Through Bars**

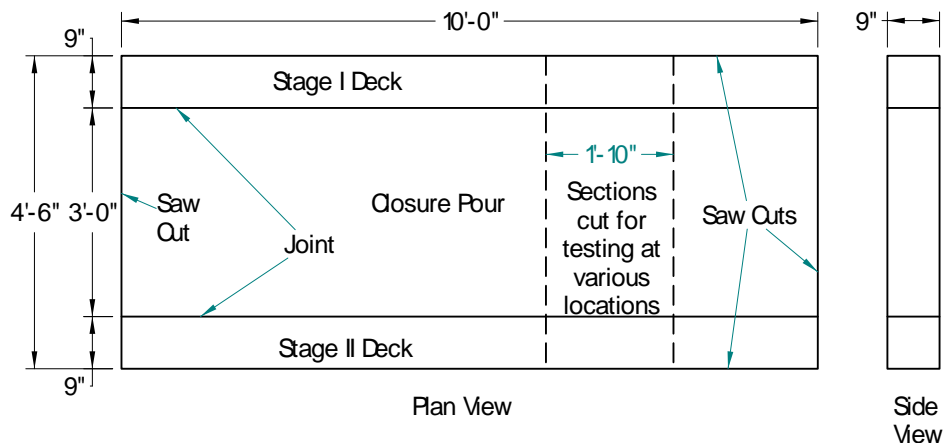
Figure 4. Approximate Dimensions of Slab Sections Showing Cuts Made to Extract Typical Test Specimen

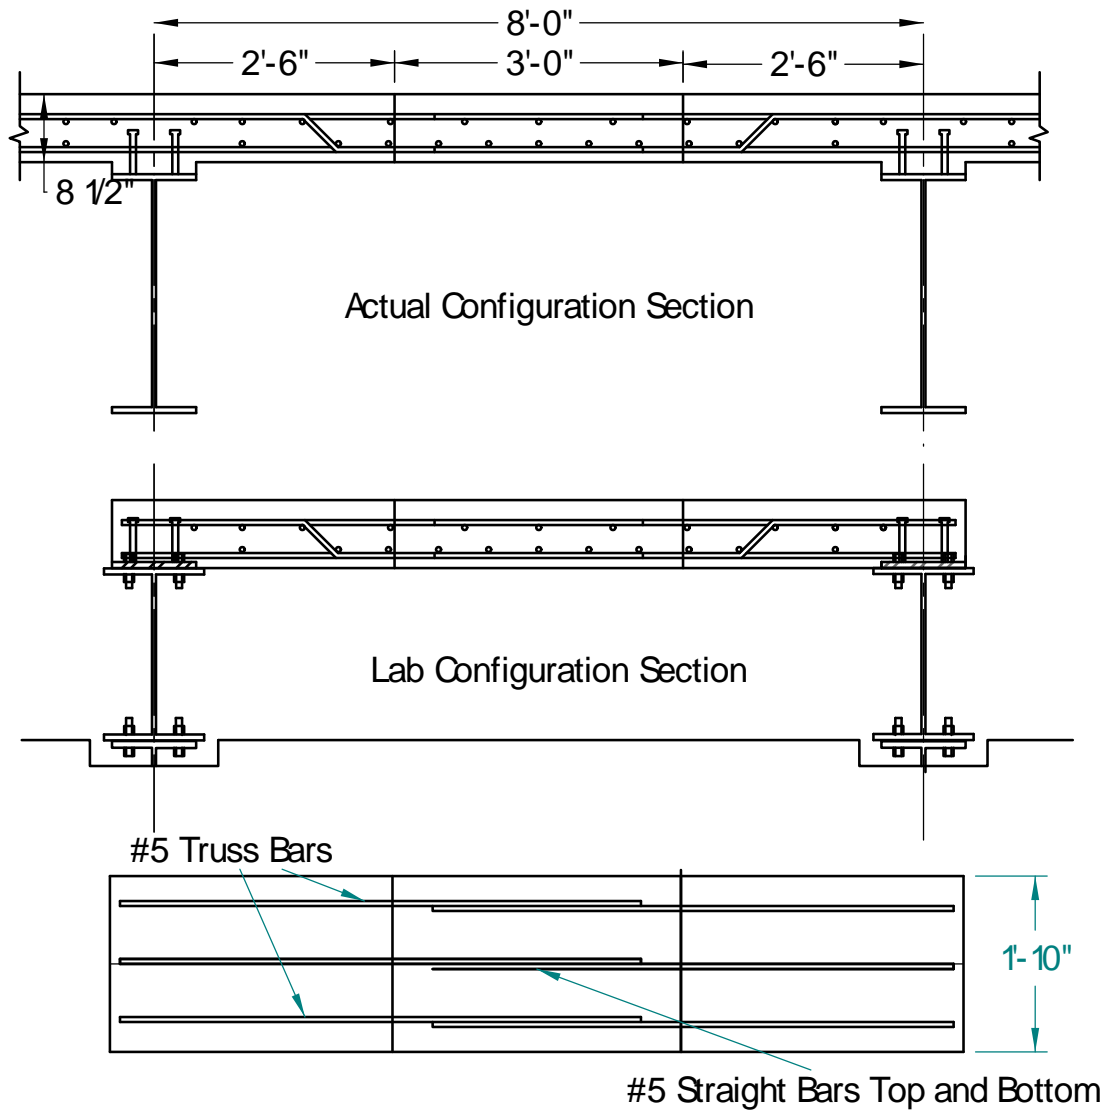
Plan View of Lab Cast Specimen

Figure 5. Lab Cast Slab Specimens Showing Reinforcing Steel Layout

As shown in Figure 5, the lab cast specimens had longer end blocks to simulate the actual 8 ft girder spacing present in the bridge. One of the three lab cast specimens was strength tested with the identical set-up shown in Figure 10. The support rollers remained at the 4 ft spacing and the longer end blocks cantilevered out on both ends. With some minor adjustment for self weight, both the I-81 and one of the lab cast slabs were all tested using the same set-up.

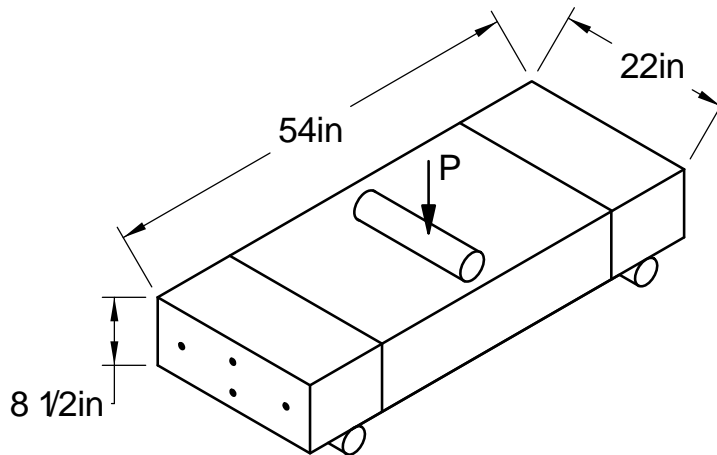
**Figure 6. Testing Configuration of 22-in Slab Specimens**

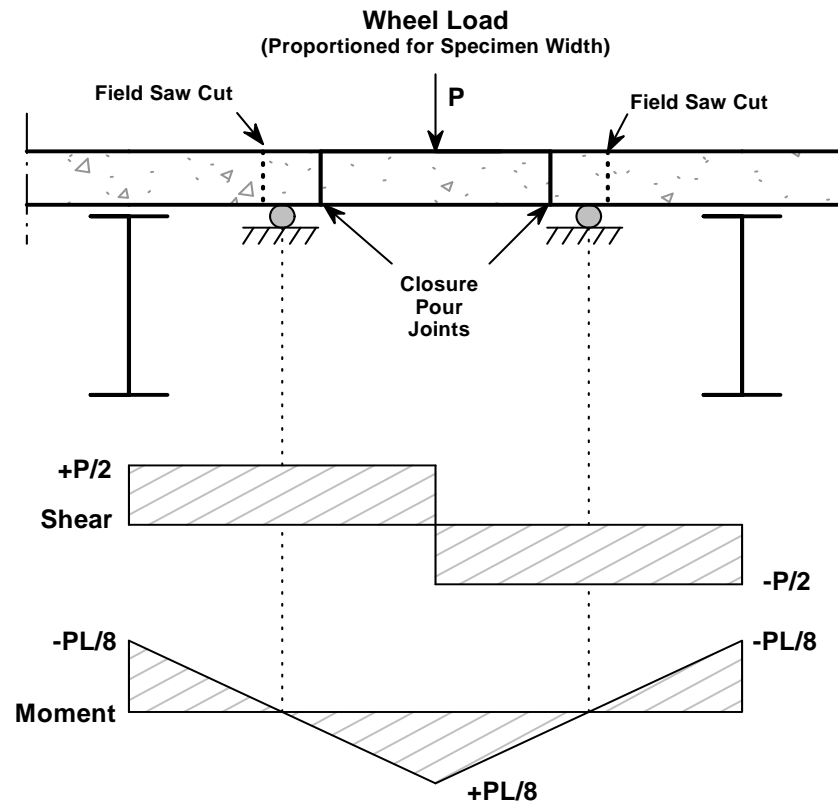
Figure 7 shows the approximate moment and shear diagrams that would be expected from a point load at the center of the closure pour in the I-81 bridge. The roller supports for the test specimens are located at inflection points in the moment diagram; therefore the moment diagram for the single span specimens approximates the moment diagram for the continuous slab. This results in moment and shear forces across the joint in the test specimens that are similar to what is expected in the actual bridge. However, this set-up does not consider any axial

**Figure 7. Comparison of Moment and Shear Diagrams for Continuous Slab in Bridge and Test Specimens**

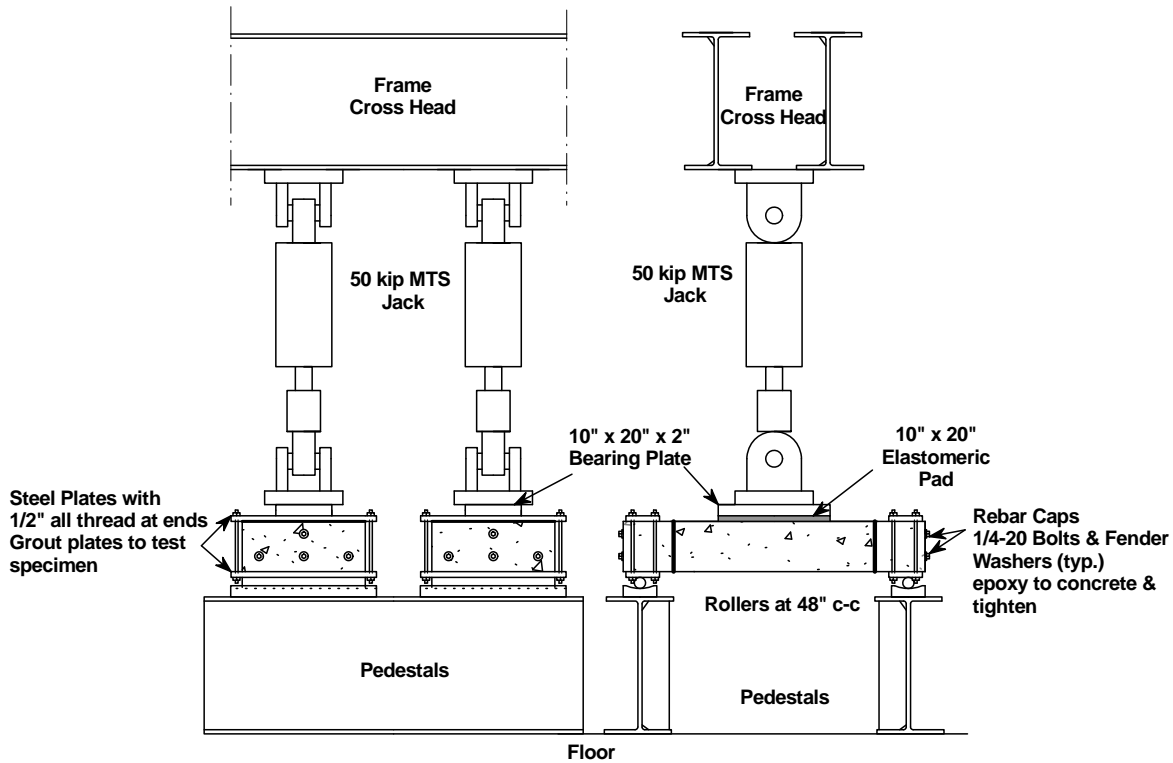
Figure 8 shows a schematic of the test set-up for both the fatigue and strength tests. Bearing plates were bolted on the top and the bottom of the end blocks to distribute the roller point load into the concrete. Because of the short length of the end blocks in the I-81 slab specimens, there was some concern that cracking and loss of development of the reinforcing steel could occur and jeopardize the test. The bearing plates helped provide confinement to the concrete. In addition, the bar ends were drilled and tapped to allow installation of end caps to improve the development strength of the bars. These measures were successful; no bar slip was observed during testing.

**Figure 8. Schematic Showing Test Set-up for Strength and Fatigue Tests**

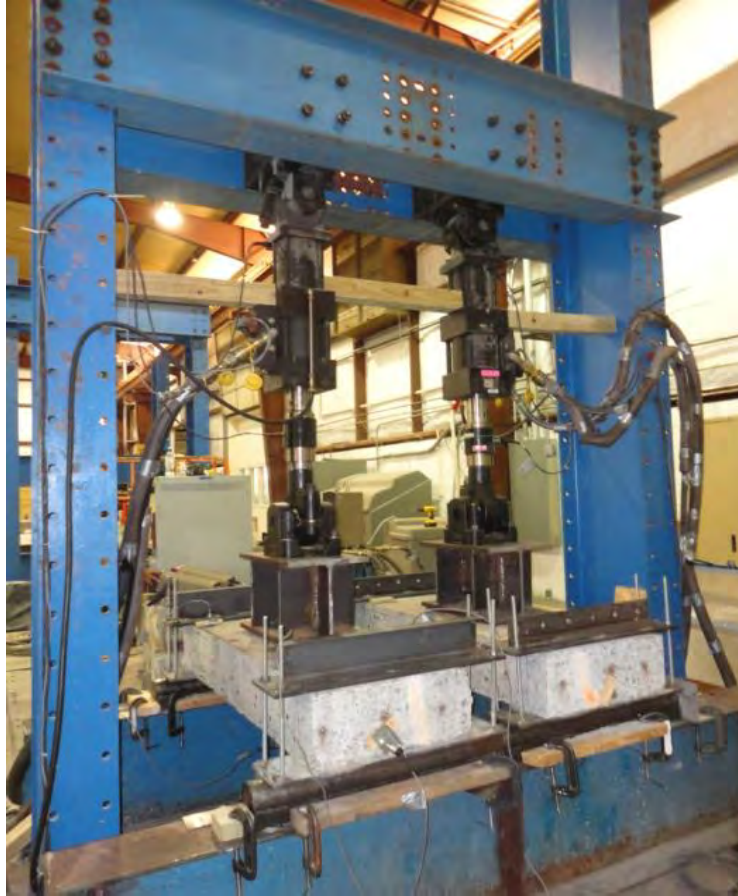
Figure 9 shows the test set-up for the fatigue tests. Two independent specimens were tested in parallel to accumulate cycles on two specimens simultaneously. The same test set-up was initially used for the strength tests. However, somewhat unexpectedly, the 50-kip MTS jacks provided insufficient force to fail the specimens. The modified set-up, shown in Figure 10, replaced the MTS jack with a 100-kip static jack. The load patch and roller boundary conditions remained identical for the two set-ups.

**Figure 9. Testing Set-up Using 50-kip Servo-hydraulic Jacks for Fatigue Tests**

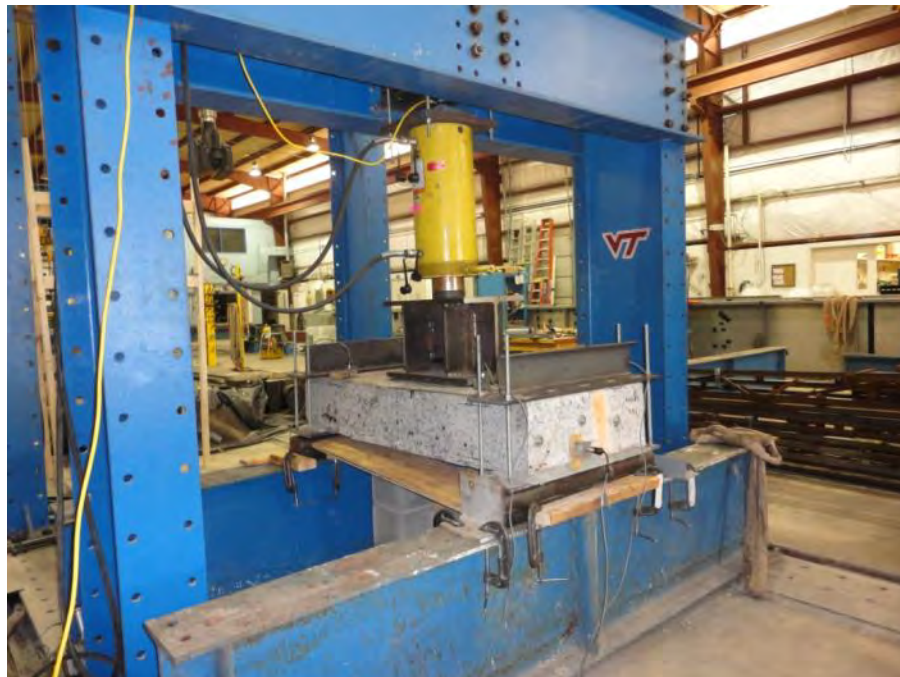
**Figure 10. Modification of Test Set-up to Enable Higher Loads to Achieve Failure in Strength Tests**

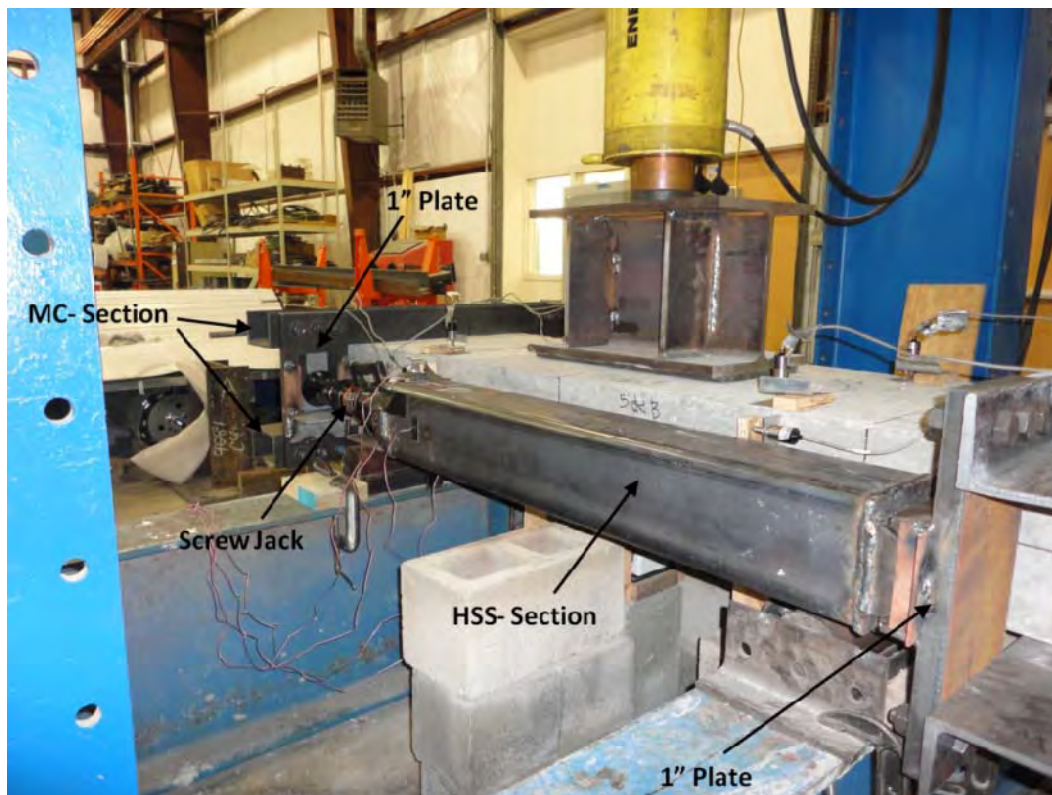
The axial force was achieved by installing jacking struts on the two sides of the specimens. This is essentially a reverse post-tensioning system that adds tension instead of the usual compression to the specimen. Jack placement on the sides prevented interference with the load actuators, instrumentation, and roller supports. The jacking struts consisted of square HSS tubes with a manual screw jack welded to one end. Prior to application of the wheel load, the screw jacks were adjusted to provide the desired level of axial force across the joint.

**Figure 11. Jacking Struts Installed on Sides of Specimens to Add Axial Force Across Joints**

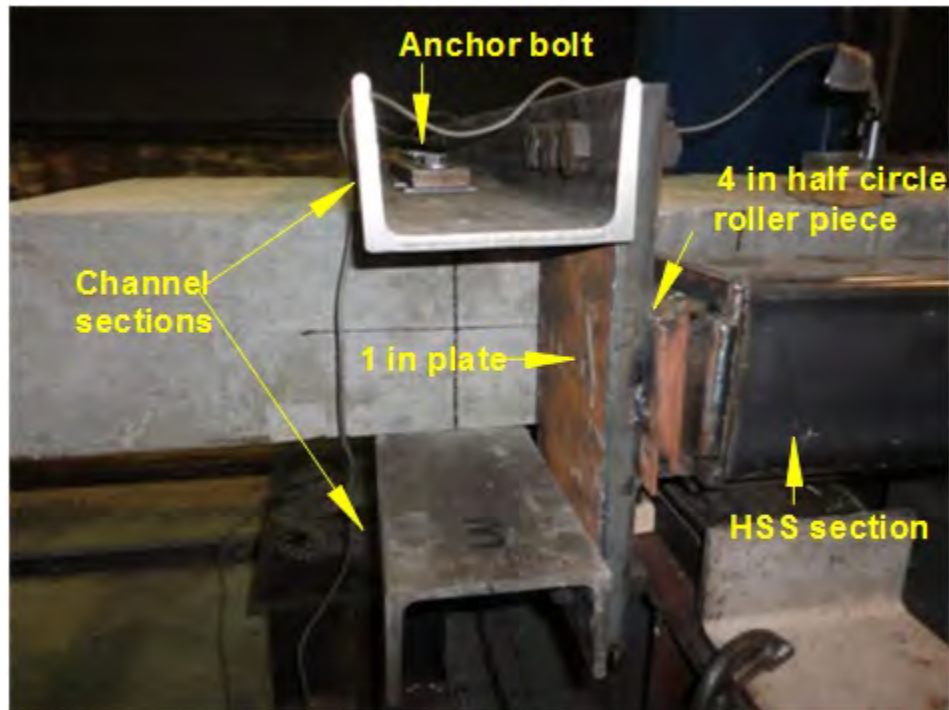
The jacking struts bear on end plate assemblies that were bolted to the concrete end blocks with concrete anchor bolts. The end plate assemblies consist of MC6x18 channels that extend past the width of the specimen as shown in Figure 12. A 1-in steel bearing plate transfers the jacking force to the channels. The screw jack has a swivel head in contact with the bearing plate and a rocker was placed on the end of the HSS tube. This allowed the anchor blocks to rotate relative to the jacking strut. Therefore, the jacking struts had minimal effect on restraining rotation of the end blocks during testing.

**Figure 12. End Bearing Block to Transfer Jacking Strut Force to Concrete End Block**

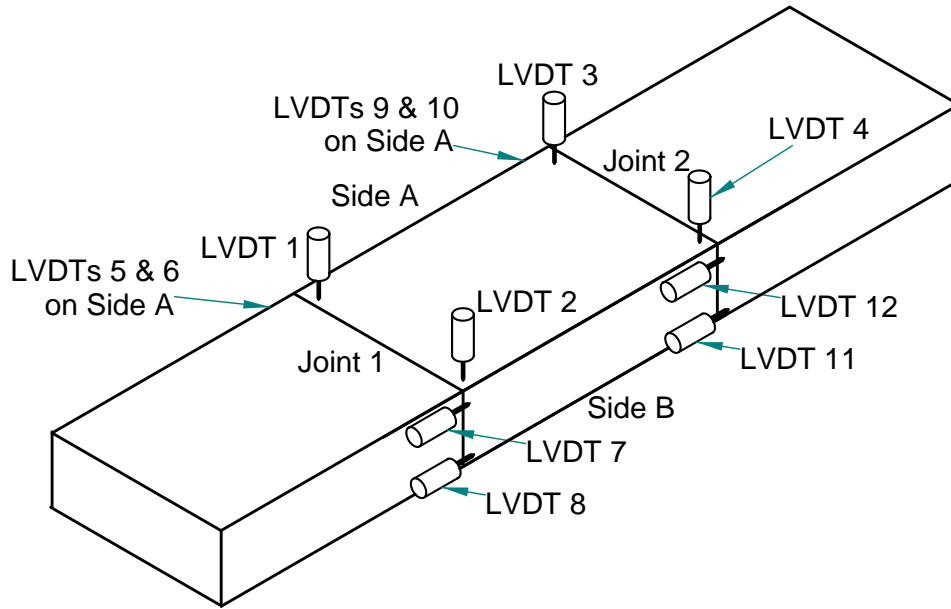
was held constant. Figure 13 shows that the DEMEC points were replaced with LVDTs for the lab cast slabs with the jacking struts to record joint opening better during the tests.

**Figure 13. Additional LVDTs Installed on Sides of Specimen B to Monitor Opening of Construction Joints**

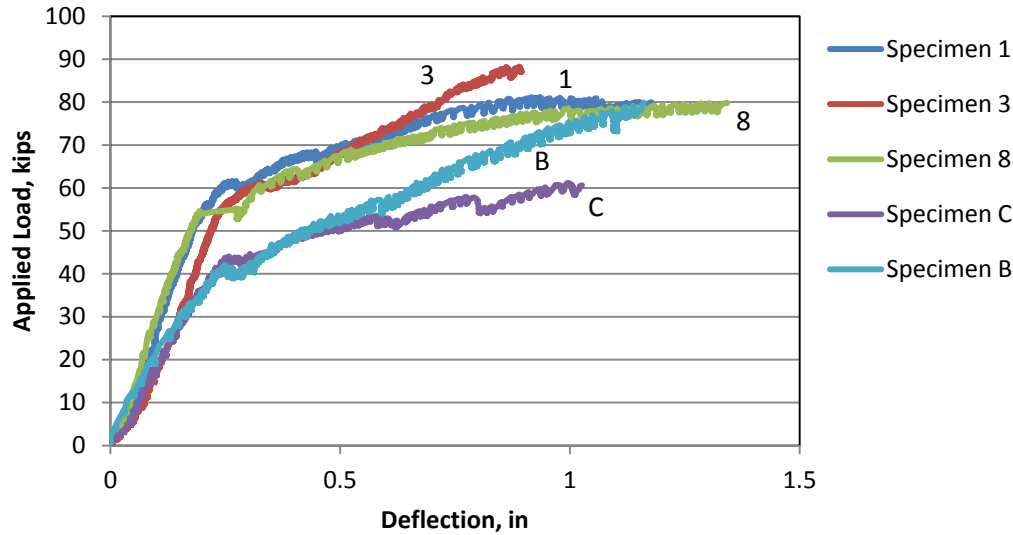
The three I-81 specimens (1, 3, and 8) all showed similar load versus displacement behavior. The shape of the curves can be described as bi-linear with a “kink” occurring between 55 and 61 kips. The initial portions of the curves have similar slopes indicating similar elastic stiffness early in the test. The slopes are again similar in the portion of the curve immediately after the kink. Greater divergence develops later in the test as the ultimate load is approached and there is significant cracking in the concrete.

**Figure 14. Load Versus Vertical Deflection for the Five Strength Tests**

Figure 14 shows that the onset of cracking (the kink) occurs at lower load for the lab cast specimens compared to the I-81 specimens. This can be largely explained by the difference in strength between the specimens. The strength of the I-81 specimens is about 21 percent greater than the lab cast specimens in the closure pour region where the failure occurred. The difference in the kink location is approximately equal to the difference in strength. The strength effect is less clear at ultimate load where the scatter in the data increases.

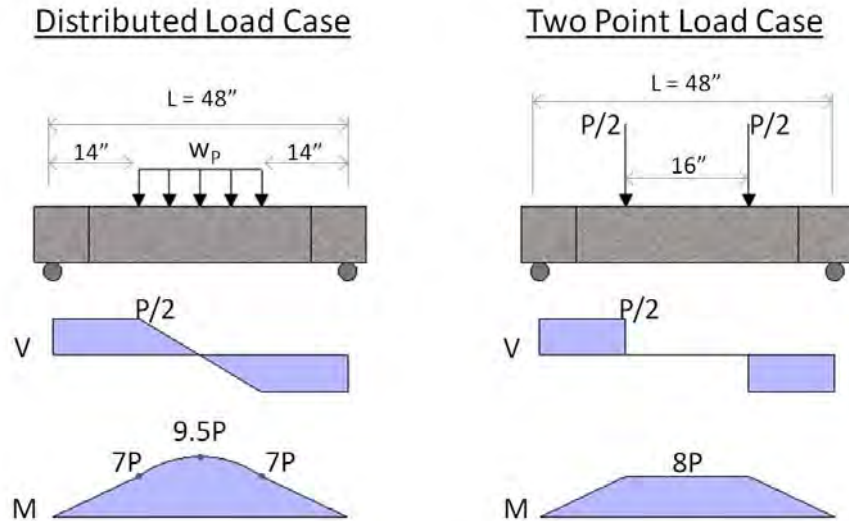
Figure 15. Two Extreme Loading Situations Resulting From Applied Wheel Load

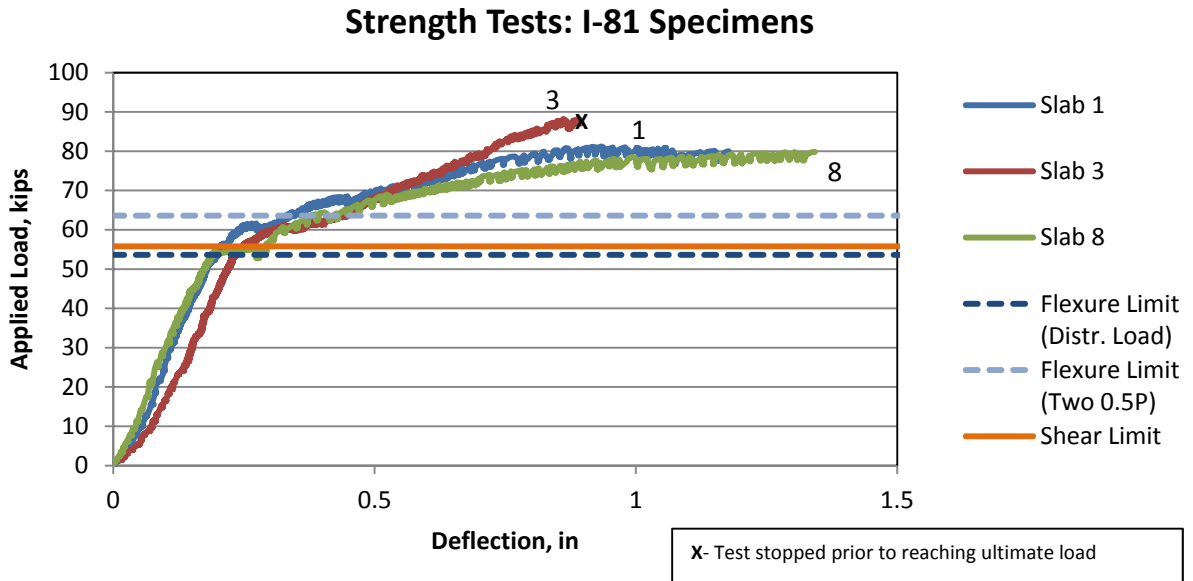
Figure 16. I-81 Load-Displacement Curves Compared to Calculated Flexural and Shear Limits

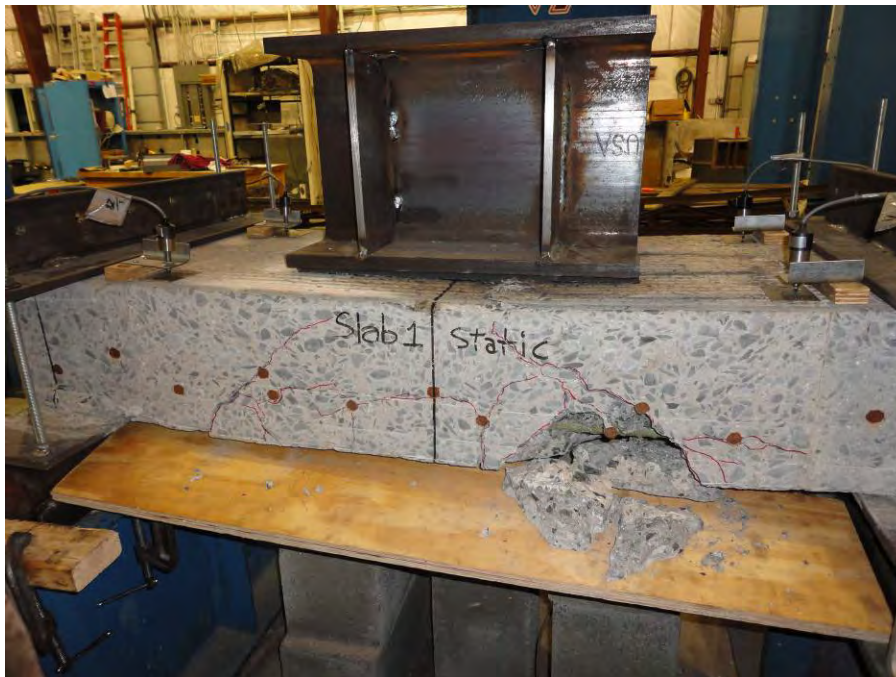
The slab specimens behaved like homogeneous beams despite the presence of the two construction joints. The typical cracking pattern shown in Figure 17 shows that the two joints are outside of the failure zone and do not significantly participate in the failure. There was no measurable differential shear displacement across the joint until severe cracking occurred in the latter stages of testing. The cracking pattern appears to be primarily shear cracking with some contribution of flexure. This looks somewhat like a one-dimensional punching shear failure of the one-way slab. There are no shear cracks closer to the roller supports even though the end block concrete has lower strength and the shear load is the same as at the crack locations. This can therefore be classified as a local “punching type” failure under the wheel load that was influenced by bending of the specimen.

Figure 17. Typical Failed I-81 Specimen with Concrete Cracking Pattern Marked In Red

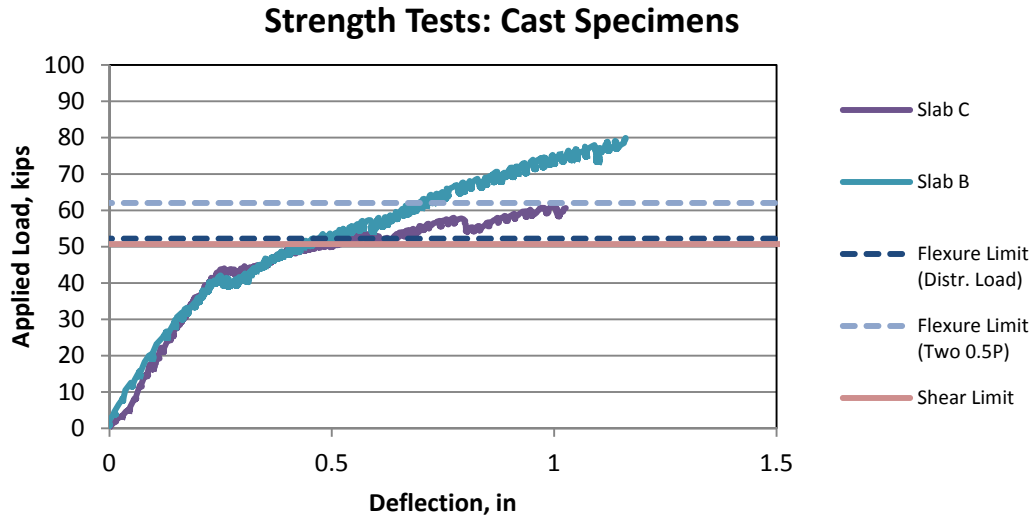
the kink are very similar between the two tests. However, once they reach the predicted shear limit the curves diverge. Specimen C, tested under the basic set-up without the jacking struts, failed close to the flexural capacity prediction for the two-point load assumption. The curve for Specimen B, tested with the jacking set-up that opened the construction joints, reached significantly higher capacity compared to Specimen C.

**Figure 18. Load-displacement Curves for Lab Cast Specimens Showing Predicted Flexural and Shear Strength**

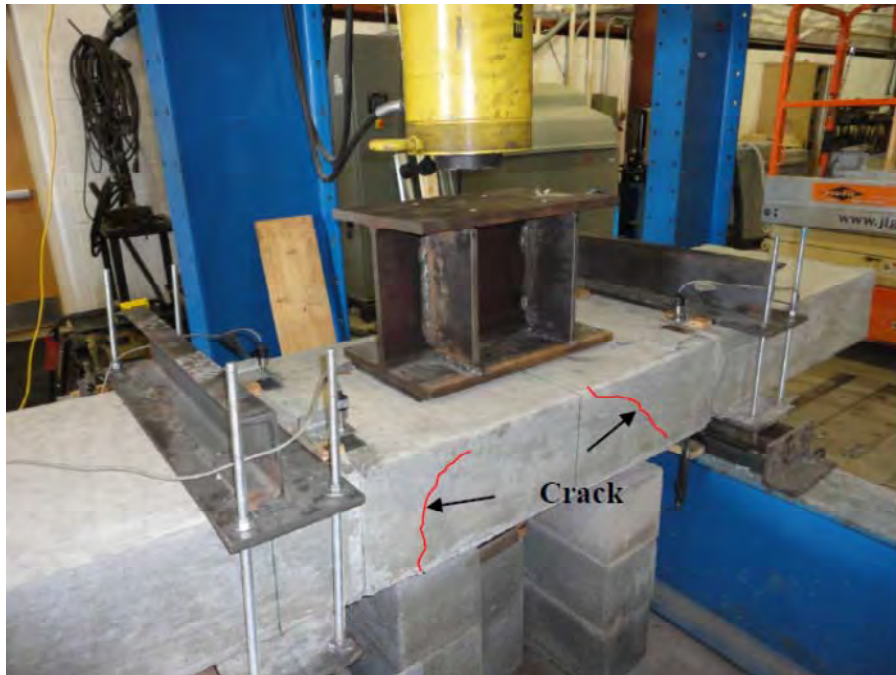
Specimen C did not have any significant differential shear deflection across the construction joints during the early stages of testing below 42 kips. Beyond that load, there was some surface spalling of the “cream” layer on top of the slab at the LVDT locations that invalidated the readings. Figure 19 shows the post-failure cracking pattern for Specimen C. Overall, there were fewer cracks compared to the I-81 specimens and less crack branching. However, the two main cracks defining the failure mode are very similar to those in the I-81 specimens. This again appears to be primarily a punching-type failure that is influenced by flexural cracking. None of the cracking occurred in the end block or around the construction joints. The failure was confined to the closure pour portion of the specimen.

**Figure 19. Failure of Specimen C Showing the Two Main Cracks That Dominated the Failure Mode**

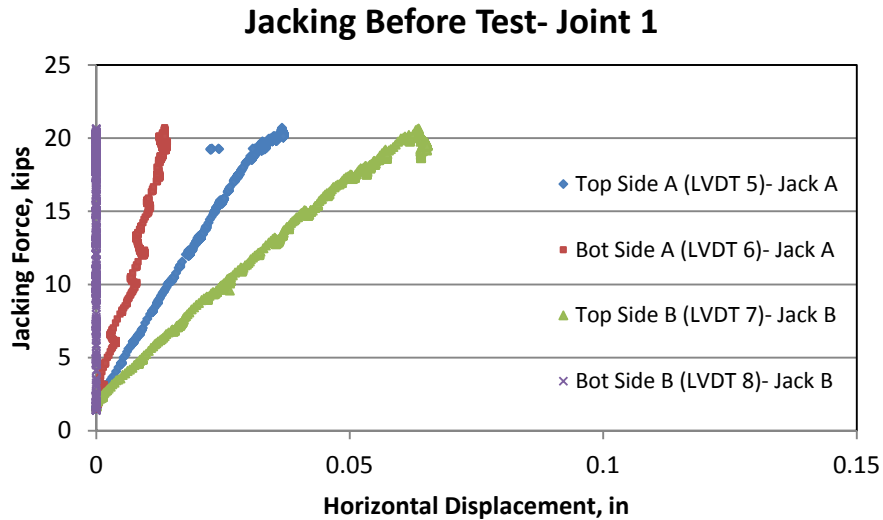
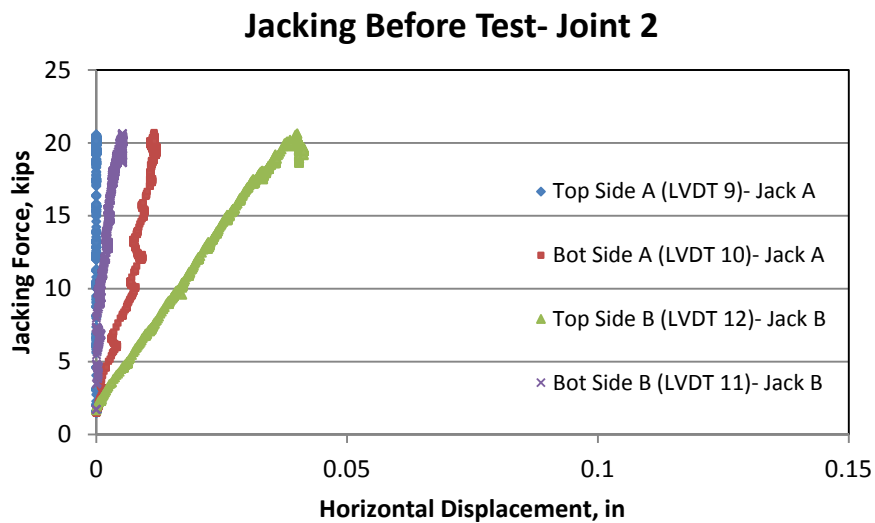
Specimen B had the jacking struts installed and the specimen was pre-tensioned prior to testing. Figures 20 and 21 show the jacking force (in each strut) versus the joint opening displacement for each of the LVDTs that are shown in Figure 13. The actual crack opening in the I-81 bridge was not recorded prior to cutting the slab and the cutting process can be expected to relax constraint allowing the joint to close somewhat. Therefore, the joints were jacked to an arbitrary load level that clearly opened the joint. The unsymmetrical pattern of the reinforcing steel creates an eccentricity across the joint where the jacking force is resisted by the reinforcing bars without any contribution from the concrete. This caused the crack to open more at the top compared to the bottom of the specimen during jacking. It appears that LVDTs 8 and 9 malfunctioned since no displacement was recorded during the test. The remaining LVDT readings show the top of the joints opening more than the bottom. The curves for all functioning LVDTs remained relatively linear indicating the reinforcing bars remained elastic during the jacking process. The jacking force was slowly increased until a load of 20 kips per strut (40 kips total axial load on the specimen). The jacking force slowly decreased during application of the wheel load during strength testing. The rate of decrease accelerated after the load exceeded about 45 kips and concrete cracking was observed.

Figure 20. Joint Opening LVDT Readings at Joint 1 During Jacking

Figure 21. Joint Opening LVDT Readings at Joint 2 During Jacking

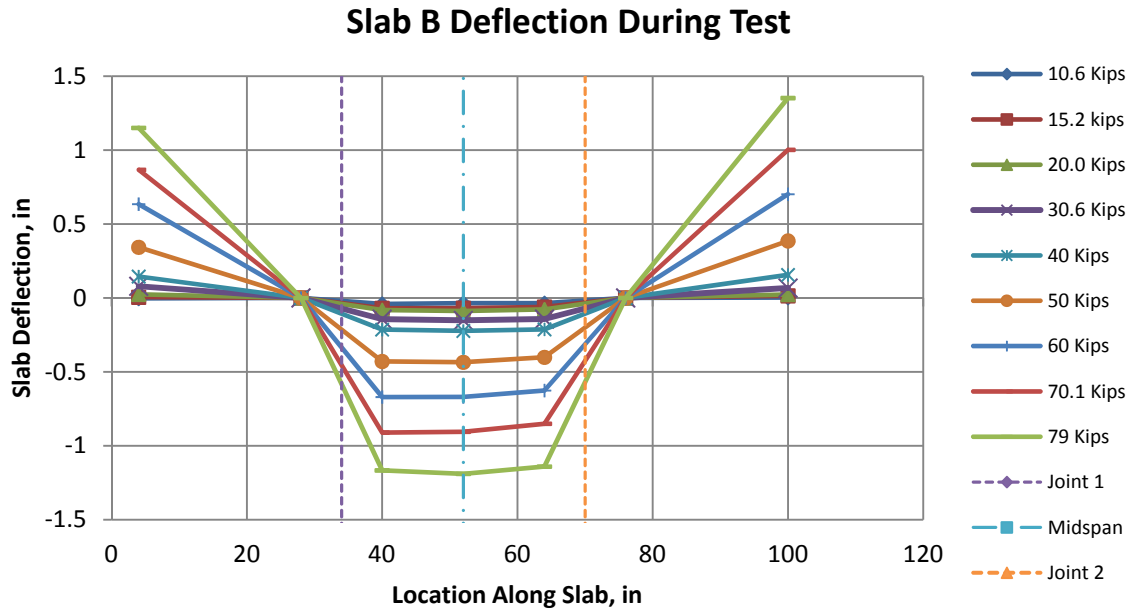
Figure 22 shows the evolution of the deflected shape for Specimen B throughout the strength test. Because the deflection is measured at only five discrete points, the shape of the deflection curves is somewhat misleading. The rise at the two ends reflects uplift of the cantilevered sections of the end blocks. The center three points show a relatively constant deflection with the center point a bit larger in magnitude compared to the quarter points. However, there is a large increase between the deflection at the quarter points compared to the roller supports. This is shown as a straight line between the points; however most of this increase was due to localized shear deformation occurring at the construction joint. This contrasts with the non-jacking tests where the differential joint deflection was essentially zero.

**Figure 22. Deflected Shape of Specimen B at Various Load Levels Up to Failure**

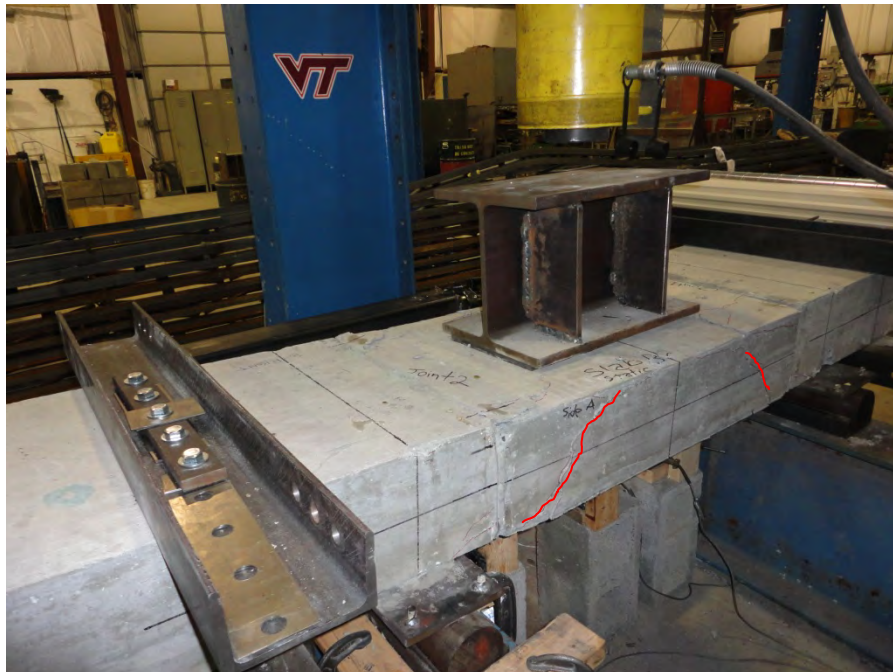
Figure 23 shows Specimen B after failure when the instrumentation and jacking struts were removed. The primary cracks defining the failure, marked in red, again show the punching-type shear failure similar to the previous tests. There is a clearly visible permanent vertical differential deflection across the two construction joints that is consistent with the shape shown in Figure 22.

**Figure 23. Failure Mode in Specimen B That Was Tested With the Jacking Struts. The vertical differential deflection across the construction joints is readily apparent.**

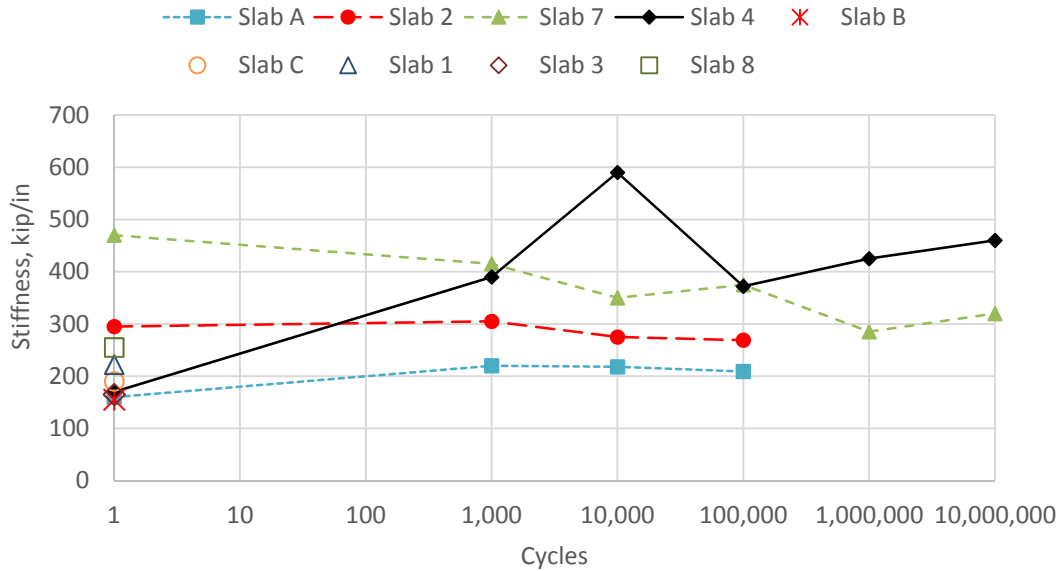
Figure 24 shows the stiffness variation of the four fatigue test specimens over the duration of cyclic testing. The stiffness of the five strength tests are plotted at  $10^0$  cycles for comparison. There is a large difference in the initial stiffness measured for the nine specimens. Some of this difference can be attributed to tolerance differences between specimens and differences in the roller support boundary conditions. However, the main cause of this difference is the non-linear nature of the load versus deflection data. The presence of the construction joints in the specimens is the main cause of non-linear response. Since the load level for fatigue cycling is well below the proportional limit observed in the strength tests, elastic material response is expected. However, this apparently does not apply to the joint interface. No clear pattern could be determined in the non-linear data that could be related to a physical event such as closure of the joint. Since the shape of the load versus displacement curve was significantly different for each stiffness measurement, there was significant variation in the correlation ( $R^2$ ) of the individual stiffness measurements.

**Figure 24. Specimen Stiffness Change in Fatigue Tests Over Duration of Testing.** The stiffness of the static test specimens is shown at  $10^0$  cycles for comparison.

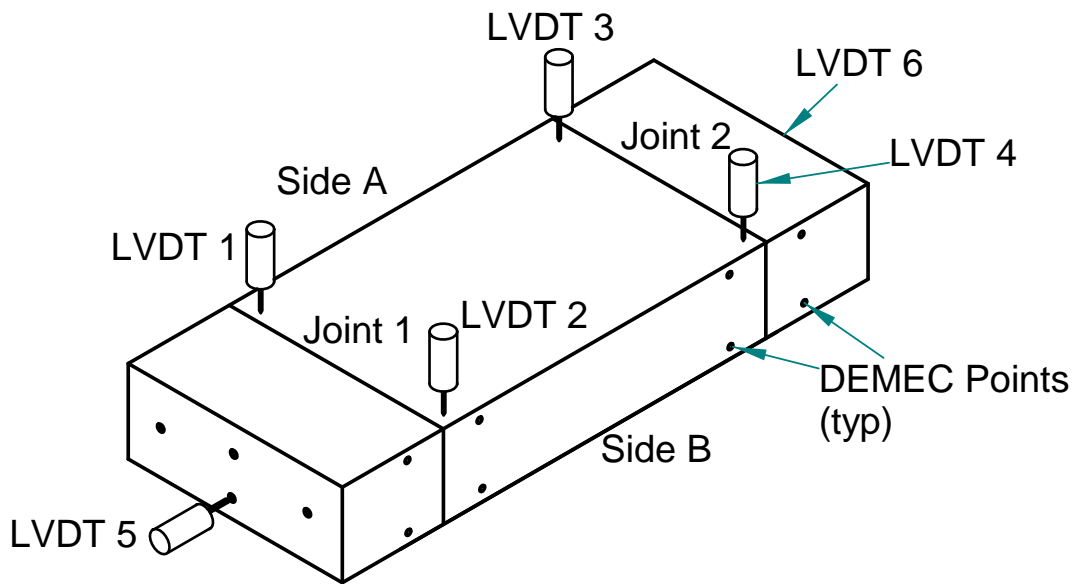
**Figure 25. Instrumentation Locations for Measuring Joint Displacement in I-81 Fatigue Test Slabs**

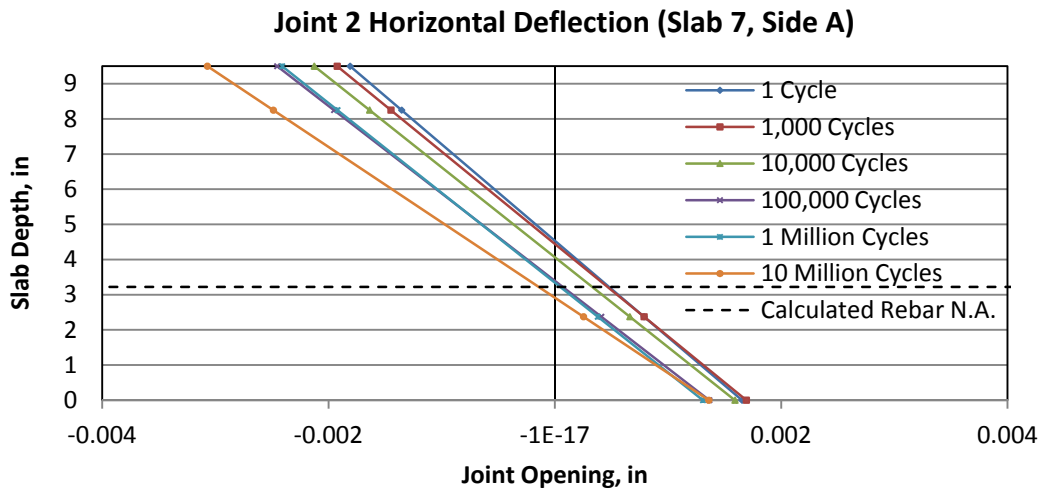
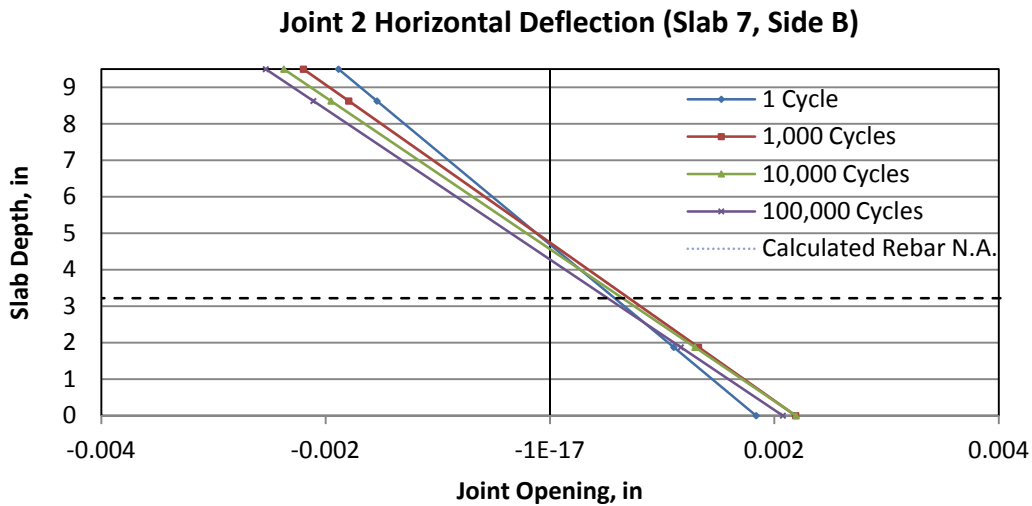
Figure 26. DEMEC Measurements for Specimen 7 (Joint 2, Side A)

Figure 27. DEMEC Measurements for Specimen 7 (Joint 2, Side B)

The DEMEC readings on the compression side (top) of the specimens show a consistent change as cycles are accumulated on the specimens. This is shown by the increasing negative reading at higher cycle counts. The DEMEC gage provides a physical reference that is unaffected by zero balance or other electronic gage abnormalities. This trend shows that the degree of concrete contact is changing during the test. The joint tends to close more after fatigue cycles are accumulated on the specimen. The mechanism for this change is unknown but it may be attributed to wearing away debris and tighter contact of the concrete on opposite sides of the joint.

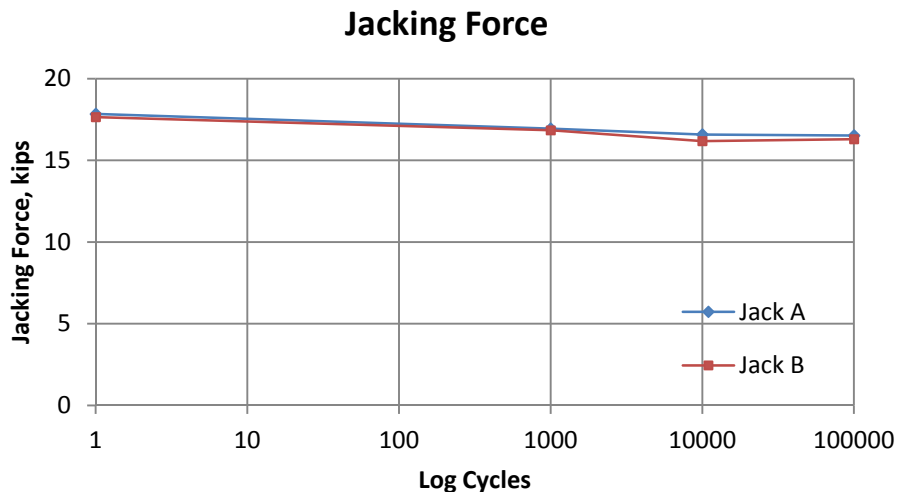
Similar to the strength test with the jacking set-up (Specimen B), the joints were jacked open before testing using the jacking struts on both sides of the specimen. Since Specimen B was opened by applying a 20-kip load on each jacking strut, the same procedure was attempted for Specimen A. However, the jacking struts became difficult to turn and the jacking force was stopped at 18 kips. Since the joints were clearly opened at the 18-kip load, this was considered sufficient. Figure 29 shows that the jacking force decreased slightly over the duration of fatigue testing but remained essentially constant.

**Figure 29. Jacking Force Over Duration of Fatigue Testing**

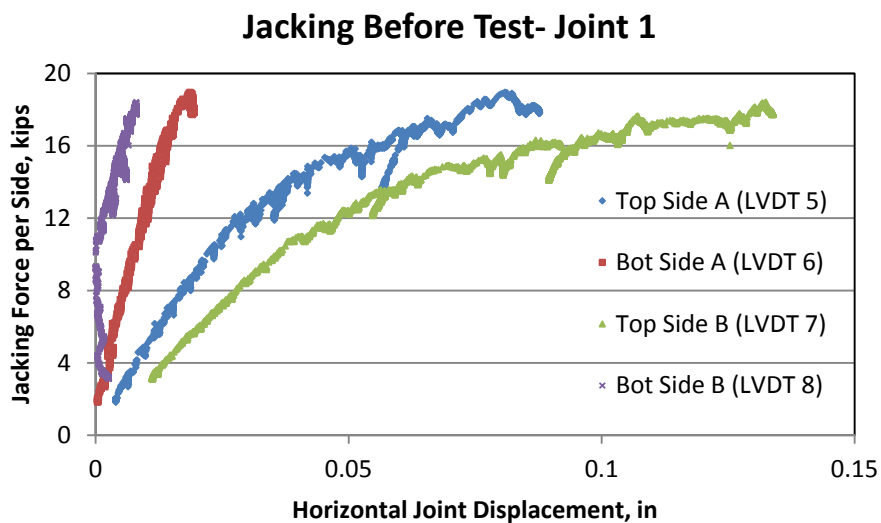
The opening of the joints was monitored while the jacking force was applied to the specimen. Figure 30 shows the joint opening displacement for Joint 1. Although the jacking force for the fatigue specimen (Specimen A) was lower than the jacking force in the strength test (Specimen B), the top of the joint showed higher opening displacement. The joint opening displacements were essentially linear in Specimen B as shown in Figures 20 and 21. However, the joint opening displacement in Specimen A was non-linear and larger in magnitude as shown in Figure 30. The difference can be attributed to differences in eccentricity of the reinforcing steel group. The jacking struts were placed at the centerline of the concrete section. Because the reinforcing steel across the joint is not symmetric (one top, three bottom bars), this creates a force eccentricity in the reinforcing steel. Apparently the eccentricity was larger in Specimen B causing an increase in force in the top bar. Calculations indicate that the top bar probably exceeded yield in Specimen B thereby causing the non-linearity. It is difficult to calculate the strain in the yielded reinforcing bar precisely since the gage length inside the joint cannot be determined.

Figure 30. LVDT Readings at Joint 1 During Jacking

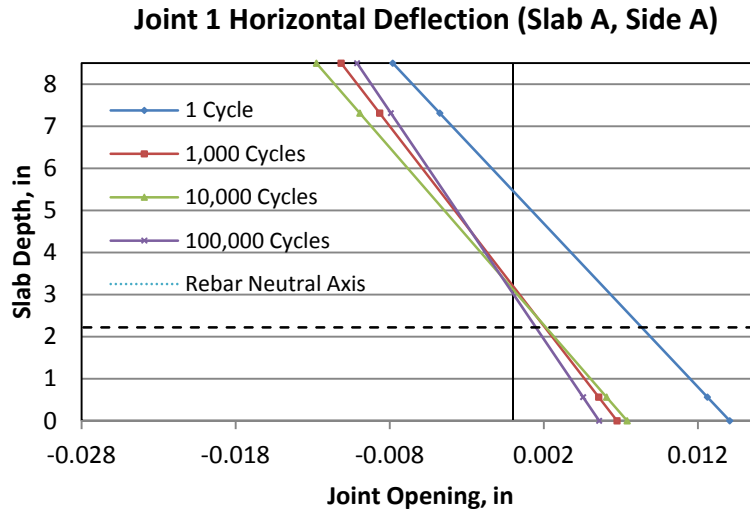
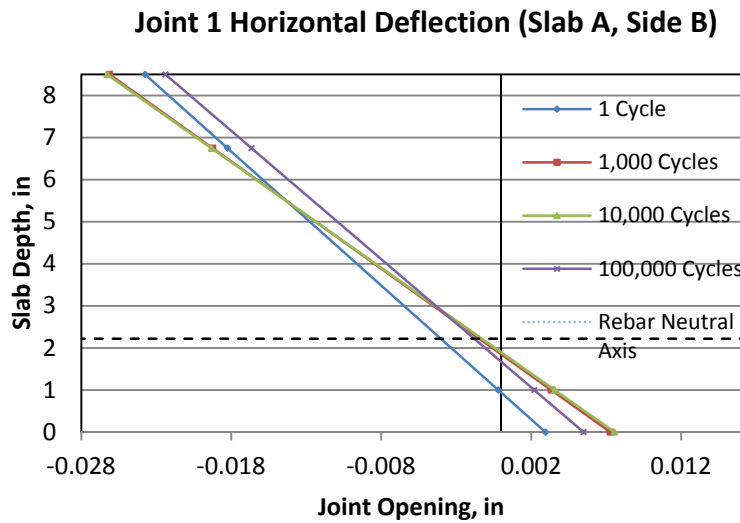
The longitudinal joint opening deflection for both sides of Joint 1 is shown in Figures 31 and 32. The magnitude is significantly larger compared to the I-81 specimens without the jacking force. This increase can be explained by the absence of concrete contact and possible local debonding of the reinforcing bars at the edges of the joint. Similar to the unjacked specimens, there is a trend toward increased joint opening as cycles are accumulated on the specimen. This is likely due to additional changes in the local bonded length of the bars adjacent to the joint. There are notable differences between the opening response at the two sides of Joint

Figure 31. Opening of Joint 1 (Specimen A, Side A)

Figure 32. Opening of Joint 1 (Specimen A, Side B)
