# **Fatigue Assessment for the Failed Bridge Deck Closure Pour at Mile Marker 43 on I-81**

Final Report VCTIR 14-R12

**FATIGUE ASSESSMENT FOR THE FAILED BRIDGE DECK CLOSURE POUR  
AT MILE MARKER 43 ON I-81**

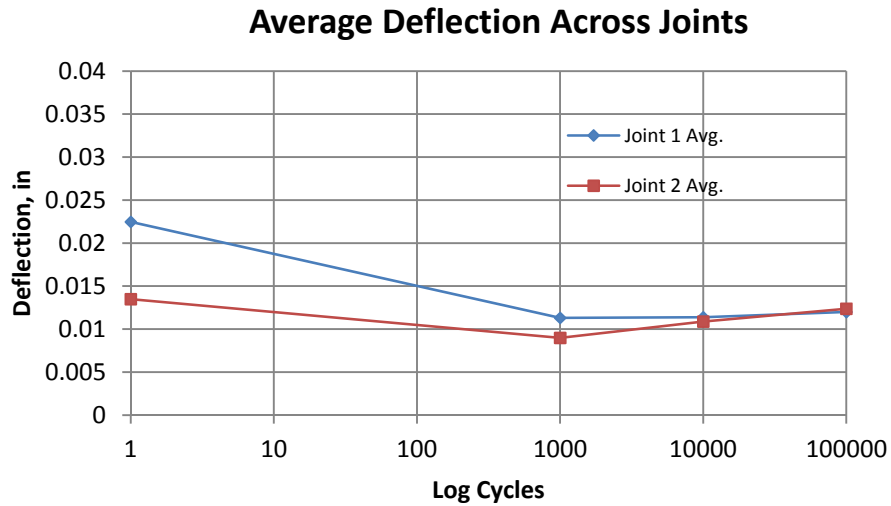
In notable contrast to the I-81 specimens, Specimen B showed significant differential vertical deflection across the joints under cyclic loading. There were also significant differential vertical deflections across the joints for strength test Specimen A with the joints jacked open. This clearly shows the difference between joints with and without concrete contact. Figure 33 shows that the differential vertical deflection decreases after the first 1000 cycles of loading and remains relatively constant thereafter. This is possibly due to initial local crushing of the concrete around the reinforcing steel in the joint area.

**Figure 33. Change in Differential Vertical Joint Deflection As a Function of Fatigue Cycling**

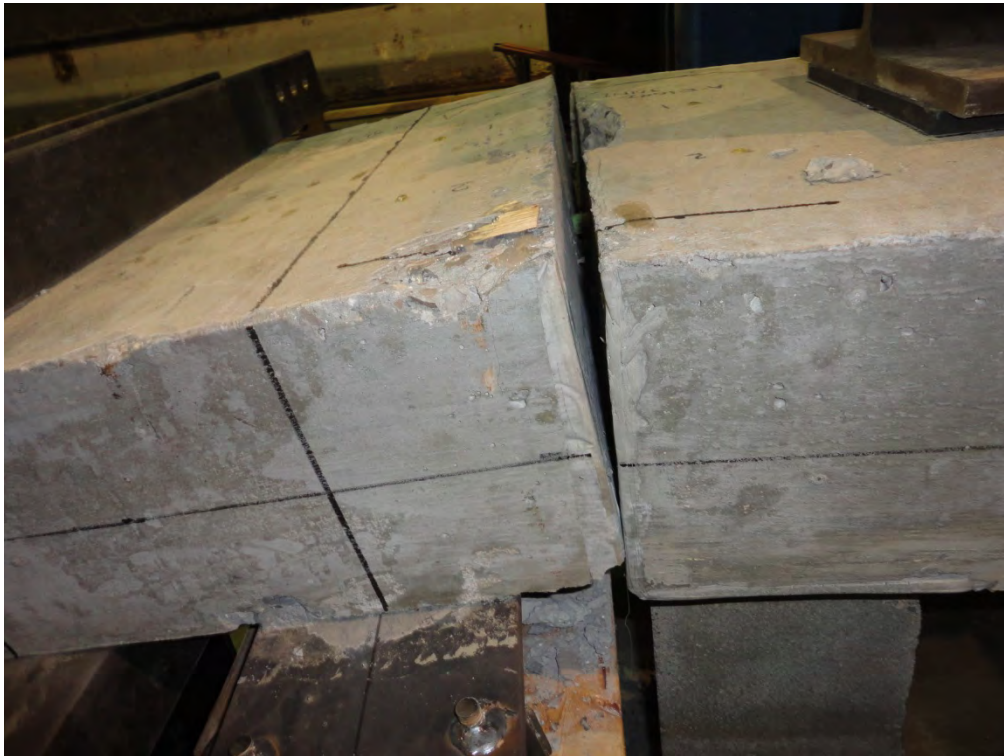
The top reinforcing bar in Specimen A failed in fatigue after 282,000 cycles under a cyclic load range of 16 kips. This contrasts with the I-81 specimens that showed no failure after 10 million cycles. The difference can be attributed to the presence of differential vertical displacement across the joints in Specimen A. Figure 34 shows the failed joint in the loading fixture after the jacking struts were removed. The break of the top bar allowed the joint to rotate open at the top. There is also an appreciable differential vertical deflection of the failed joint. In the actual bridge, the joint rotation would be restrained and only the differential vertical deflection would have been evident. Therefore the specimen failure is consistent with the observed failure in the bridge.

**Figure 34. Joint Fatigue Failure in Specimen A**

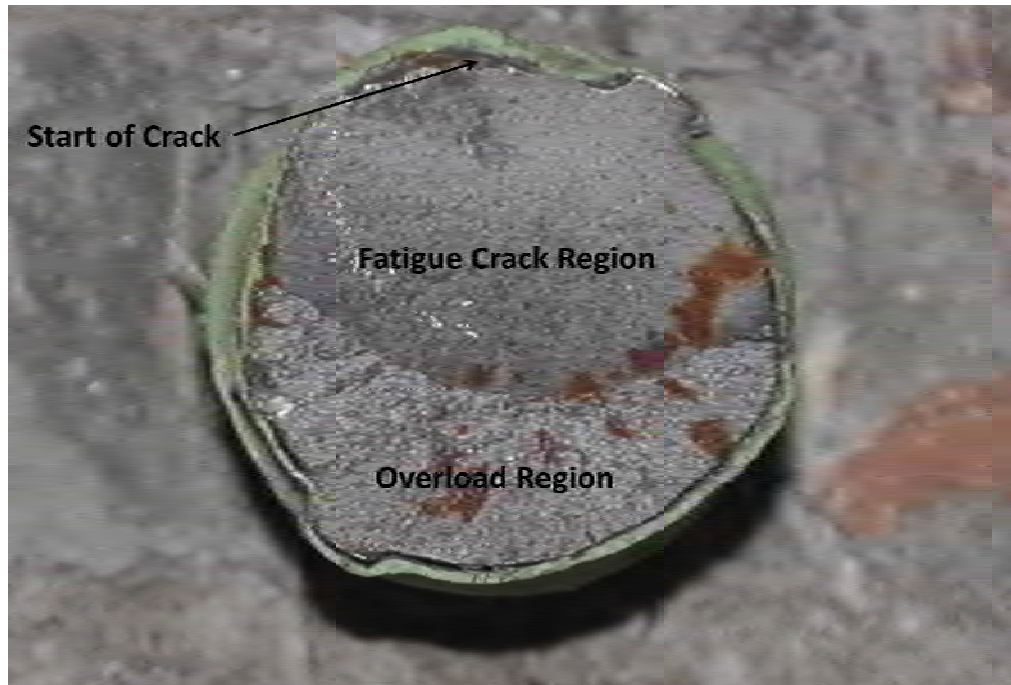
Figure 35. Fatigue Failure Surface of Top Bar in Joint 1

boundary conditions, it can be concluded that the failure surfaces of some of the bars in the I-81 bridge are consistent with the fatigue failure observed in Specimen A.

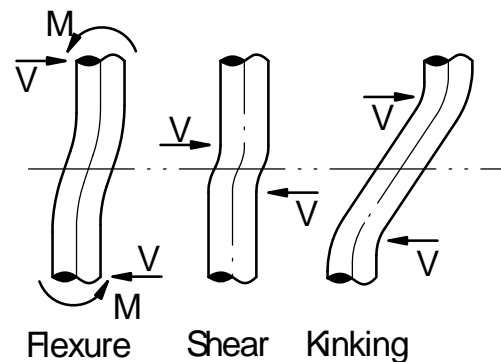
The differential vertical joint deflections (shear deformations across the joint) will add significant local stress in reinforcing bars spanning the joint. Figure 36 shows the three deformation mechanisms reported by Park and Paulay (1975). The fatigue crack initiated at the top of the bar about 0.67 in away from the plane of the joint. This location is consistent with the location of maximum stress caused by either the bending or kinking mechanism under the differential vertical displacement of the joint. Some localized concrete crushing must have occurred around the reinforcing bars to allow formation of either of these mechanisms.

Figure 36. Three Force Transfer Mechanisms for Dowel Action across a Concrete Joint (after Park and Paulay, 1975)
