Applied Research and Innovation Branch

EVALUATION OF BRIDGE DECK SEALERS

Report No. CDOT-2014-6

June 2014

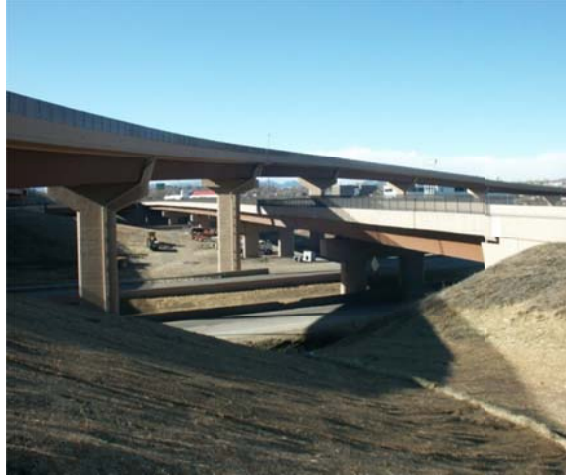
Fig 3.2 Side view of Bridge E-17-QM

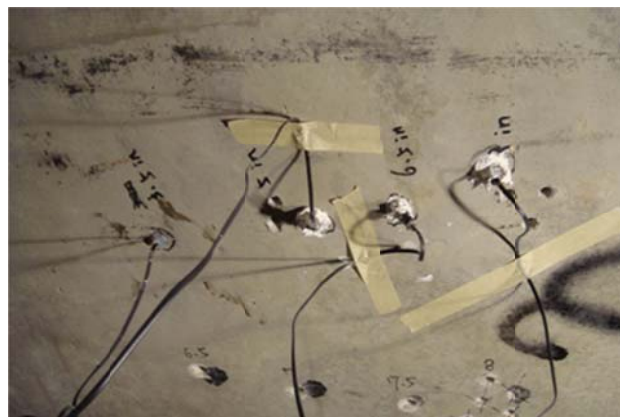
Fig 3.14 Integrated sensors installed in the deck.

The total depth of the bridge decks is approximately 9.5 in and the written numbers next to sensors in Fig 3.14 represent the drilling distances. For example, the third number from the left, 6.5 in means that the depth of the sensor is 3 inches from the top surface. The variation of internal moisture and temperature in deck is mainly caused by the environmental conditions at the surface of the bridge deck. All comparisons and analysis of those readings are based on the distance from the deck surface to the location of the sensors.

Although the example shown above is for evaluating the permeability of concrete, it can also be used for evaluating the permeability of concrete covered by a chemical sealer. All sensors were installed from underneath the decks inside the steel box girder, and the holes were drilled upwards into decks for installing the sensors (Fig 3.14).

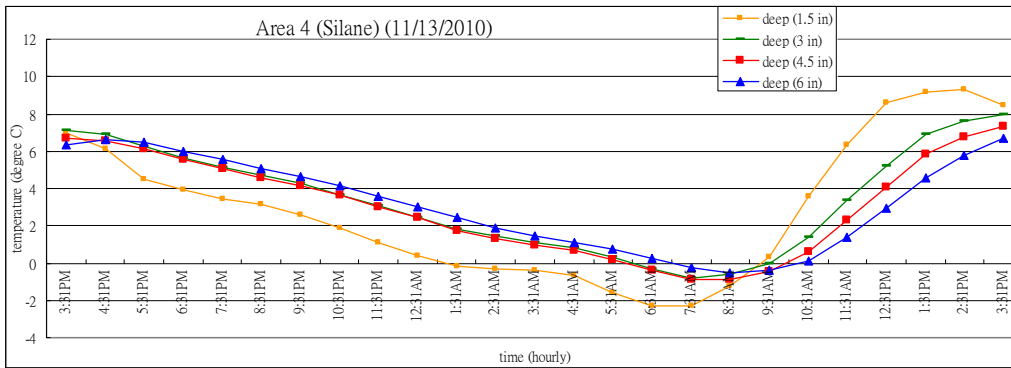
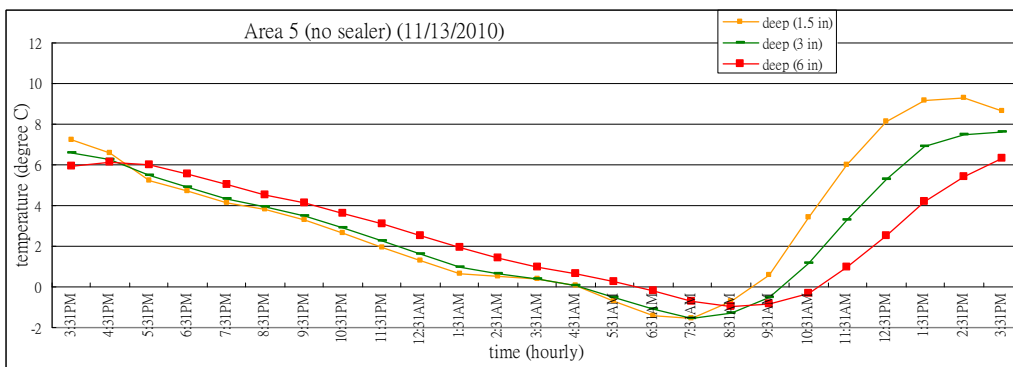
Fig 5.6 Comparison of temperature variations at different depths over 24 hrs. (HMWM)

Fig 5.7 Comparison of temperature variations at different depths over 24 hrs. (Epoxy 1)

Fig 5.8 Comparison of temperature variations at different depths over 24 hrs. (Epoxy 2)

Fig 5.9 Comparison of temperature variations at different depths over 24 hrs. (Silane)

Fig 5.10 Comparison of temperature variations at different depths over 24 hrs. (no sealer)

Figs 5.6 - 5.10 show hourly readings for the five testing areas over a 24-hour period starting from 3:31 pm on 11/30/2010. Again, the temperature difference at different depths is important.

From these five figures, we can observe that:

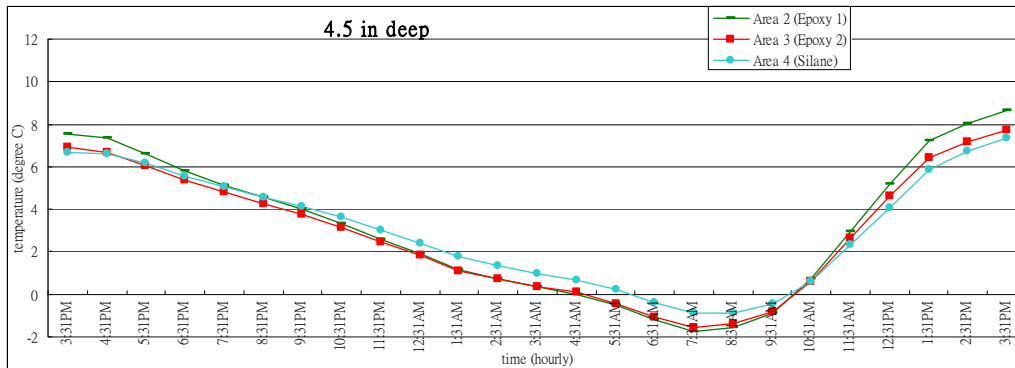
Fig 5.11 Comparison of different sealer areas at the depth of 1.5 inches

Fig 5.12 Comparison of different sealer areas at the depth of 3.0 inches

Fig 5.13 Comparison of different sealer areas at the depth of 4.5 inches

Fig 5.14 Comparison of different sealer areas at the depth of 6.0 inches

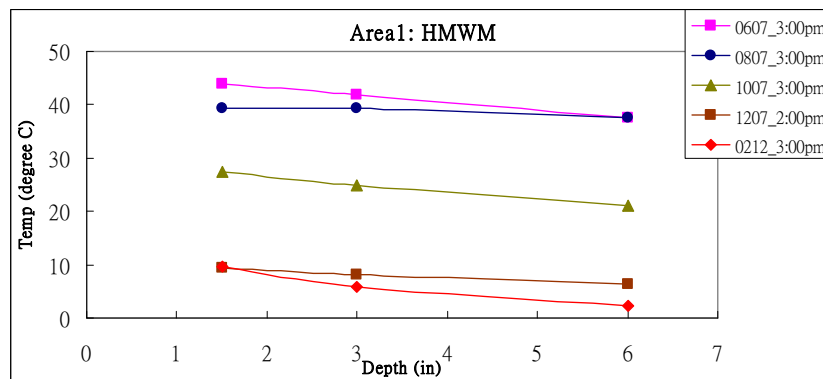
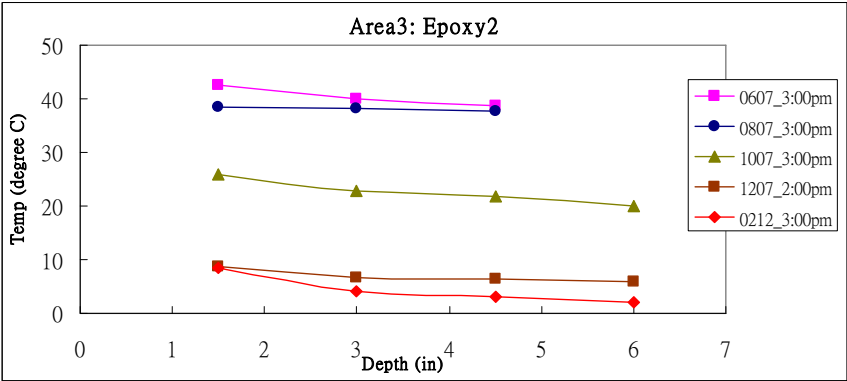
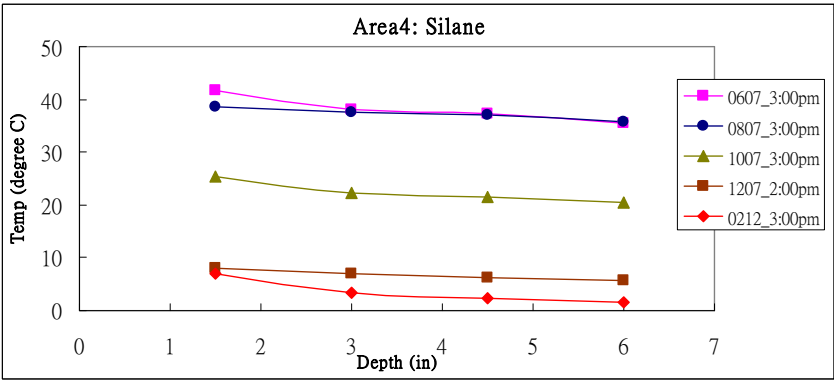
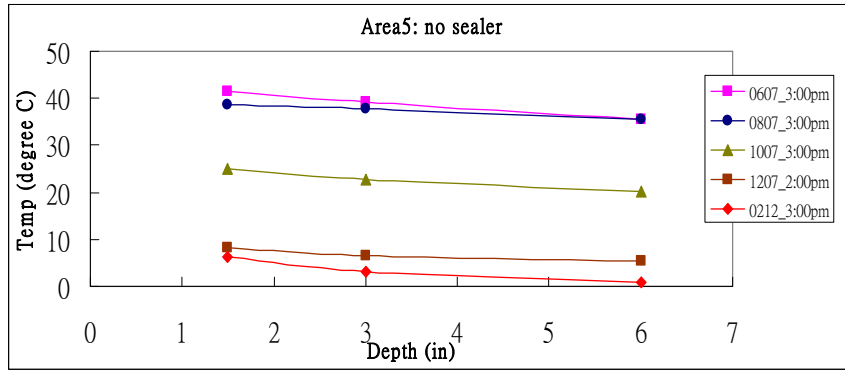
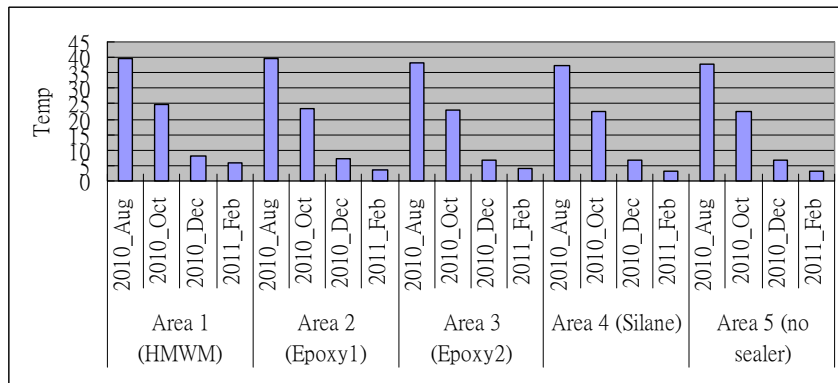
Fig 5.15 Comparison of bimonthly temperature profiles (HMWM)

Fig 5.16 Comparison of bimonthly temperature profiles (Epoxy 1)

Fig 5.17 Comparison of bimonthly temperature profiles (Epoxy 2)

Fig 5.18 Comparison of bimonthly temperature profiles (Silane)

Fig 5.19 Comparison of bimonthly temperature profiles (no sealer)

Fig 5.20 Summary of bimonthly temperature profiles

- (1) The highest temperatures and lowest temperatures are in July and February.
- (2) Near rebar location, the temperature varies between 3-40°C.
- (3) The largest temperature variation is in the testing area 2 (Epoxy 1).
- (4) In the summer, the order of temperature range is Silane < no sealer < Epoxy2 << HMWM < Epoxy1.
- (5) In the winter, the order of temperature range is no sealer < Silane < Epoxy1 < Epoxy2 <<HMWM.

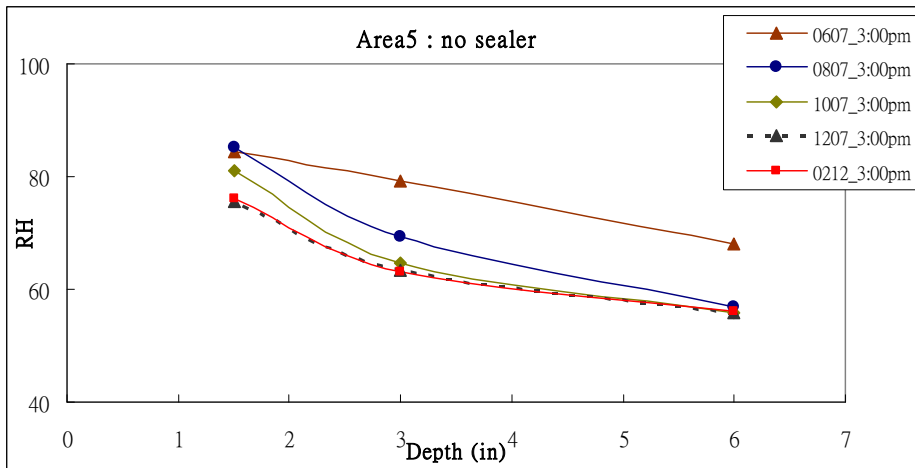
Fig 6.10 Comparisons for bimonthly readings (no sealer)

Fig. 6.10 shows the moisture profile in the unsealed testing section. The curves exhibit typical moisture profiles due to moisture diffusion in concrete. The boundary condition at the top surface is the environmental moisture variation. As explained earlier, the moisture level on the top surface is very high when there is a precipitation. The boundary condition at the bottom surface inside the steel box girder is a constant RH value (about 40%). The moisture distribution in between looks like those curves shown in Fig. 6.10: higher RH on the left (toward the top surface) and lower RH on the right (toward the bottom surface). The variation of profile depends on the amount of precipitation of the year. At the depth of rebar, about 2 in., the steady state moisture levels are about 70% to 85% in the deck, which is high enough to start the steel corrosion process if all other necessary conditions are available, such as high chloride and oxygen concentrations and low pH value in pore solution (Suwito and Xi 2008).
