Virginia Center *for* Transportation
**INNOVATION
& RESEARCH**

Nondestructive Measurements Using Mechanical Waves in Reinforced Concrete Structures

Final Report VCTIR 14-R8

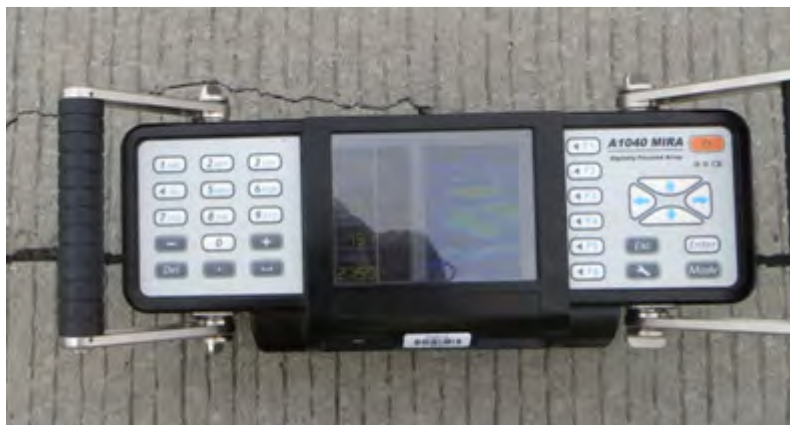
Figure 1. MIRA Ultrasonic Tomographer

UST was evaluated for use on plain or reinforced concrete (Figure 1). As discussed earlier, UST is an ultrasonic pulse echo system that can provide real-time images (Edwards and Mason, 2011) based on measurements using ultrasonic shear-wave energy.

The UST device is equipped with an array of piezoceramic transducers that alternately send and receive low-frequency ultrasonic waves into a concrete test specimen. As the ultrasonic signal reflects off various elements within the concrete, the arrival times of the signal are measured and analyzed to reconstruct an image of the specimen interior. For this study, although a range of frequencies is available (25 to 85 kHz), UST was operated at 45 kHz. Scans may be performed at multiple points throughout an area of concrete and subsequently aggregated to form a 3D model of the concrete interior, revealing the locations of reinforcement, voids, and other distresses within by reflections (echoes) of the ultrasonic shear-wave pulse energy operated as a phased array.

The associated software package with the UST device used includes a modeling program (IdealViewer) that was used to "stitch together" consecutive scans to form 3D volume renderings of the internal pavement structure, which then are tomographical models of the condition of the pavement (Germann Instruments, 2011).

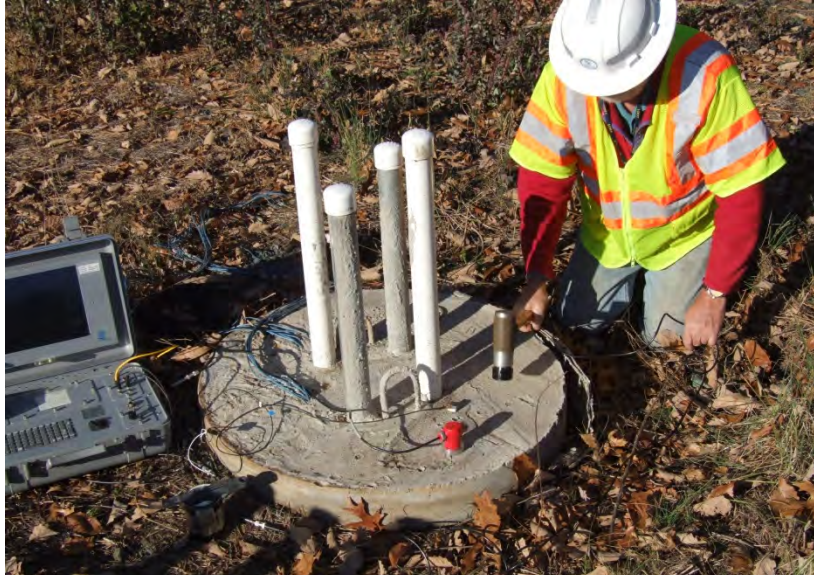
Figure 4. Sonic Echo–Impulse Response Testing at VDOT’s Boyd Tavern Area Headquarters

For this study, SE/IR was used for integrity testing of the drilled shafts at Boyd Tavern AHQ. The shafts were placed solely for the purpose of testing the performance of NDE methods in void detection. Researchers were interested in the effectiveness of SE/IR testing at detecting the depth and location of predetermined voids within the test shafts. The testing method and equipment are shown in Figure 4.

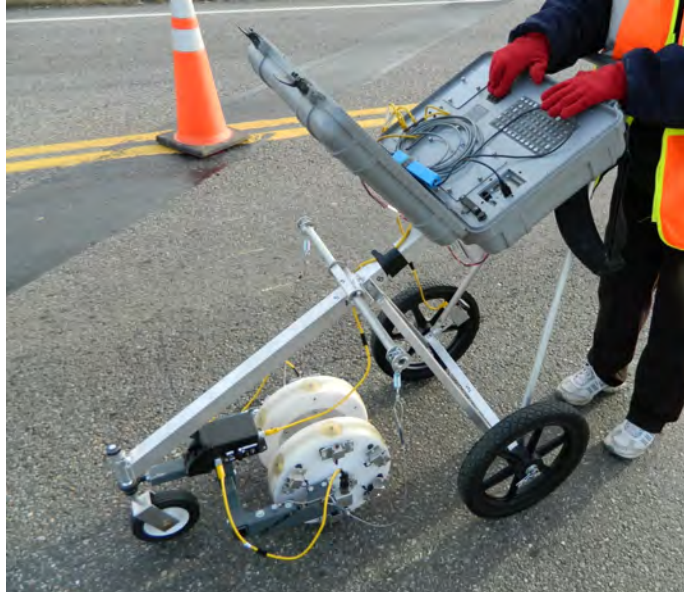
Figure 5. Photograph of Bridge Deck Scanner. Impactor solenoids on sides of wheels and brass displacement transducers spaced every 6 in aligned for impact echo test and spectral analysis of surface waves test.

2007, 2008). This design change from the traditional stationary method uses an optocoupler on the central wheel that tracks the distance the IES has moved linearly. This feature permits the moving IE testing process and enables a more rapid mapping for voids and delaminations. Moreover, even though the presence of several mats of steel can have an influence on the data, this influence is not as deleterious as compared to the results when traditional ground-penetrating radar is used. The equipment was operated in accordance with the guidelines provided by the equipment manufacturer (Olson Instruments, Inc., 2007).

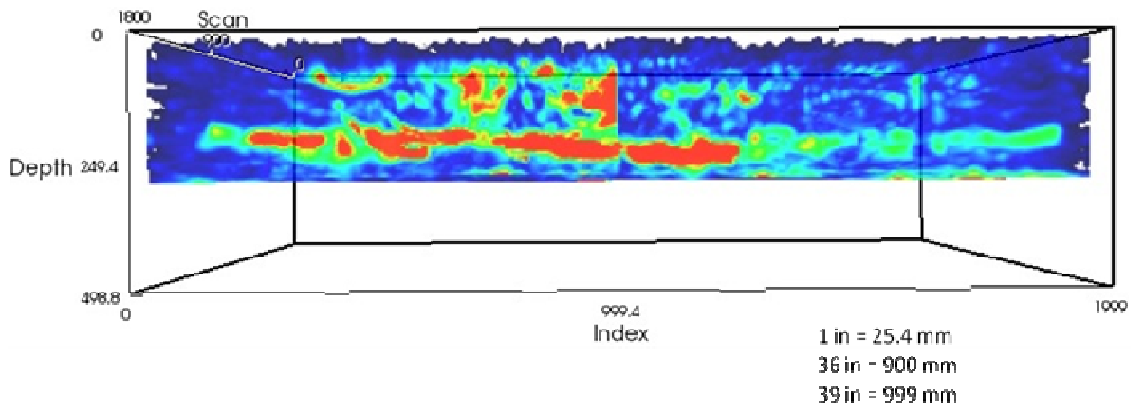
Figure 7. UST Section View of Delamination (red/yellow in color image; slightly darker gray encapsulated by light gray in grayscale)

Figure 7 depicts another section view generated by the UST software package but this time of an area of pavement with evidence of voids created by the delamination of concrete at the steel reinforcement level. These delaminations were later verified by a corresponding core from the same location, as shown in Figure 8.

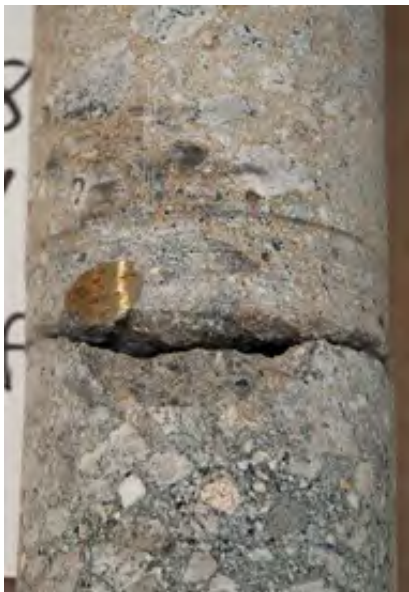
Figure 8. Actual Core Associated With Figure 7 Confirming Predicted Delamination

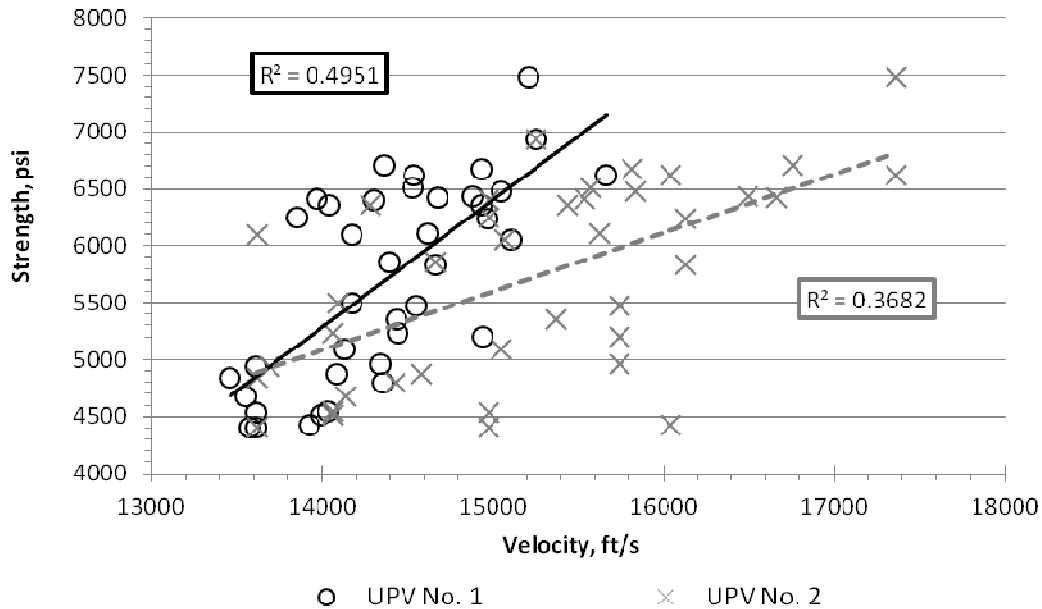
Figure 10. Comparison of Velocities for Two Ultrasonic Pulse Velocity (UPV) Devices. Trend lines and R² values are based on linear best fits.

A comparison of two UPV systems, shown in Figure 10, revealed variability between the two systems, especially with regard to higher strength samples. The difference in velocity is attributed to the difference in the sensitivity of the equipment, which does not appear to be as large at the lower limit of the strength where both devices show similar results. This strong overlap is in the region of the graph that is above the 28-day acceptance minimum value of 4,000 psi. Therefore, both devices would give similar responses in this region; however, it would be interesting to evaluate the response in a follow-up research project of the two devices for concrete specimens with strengths below 4,000 psi.

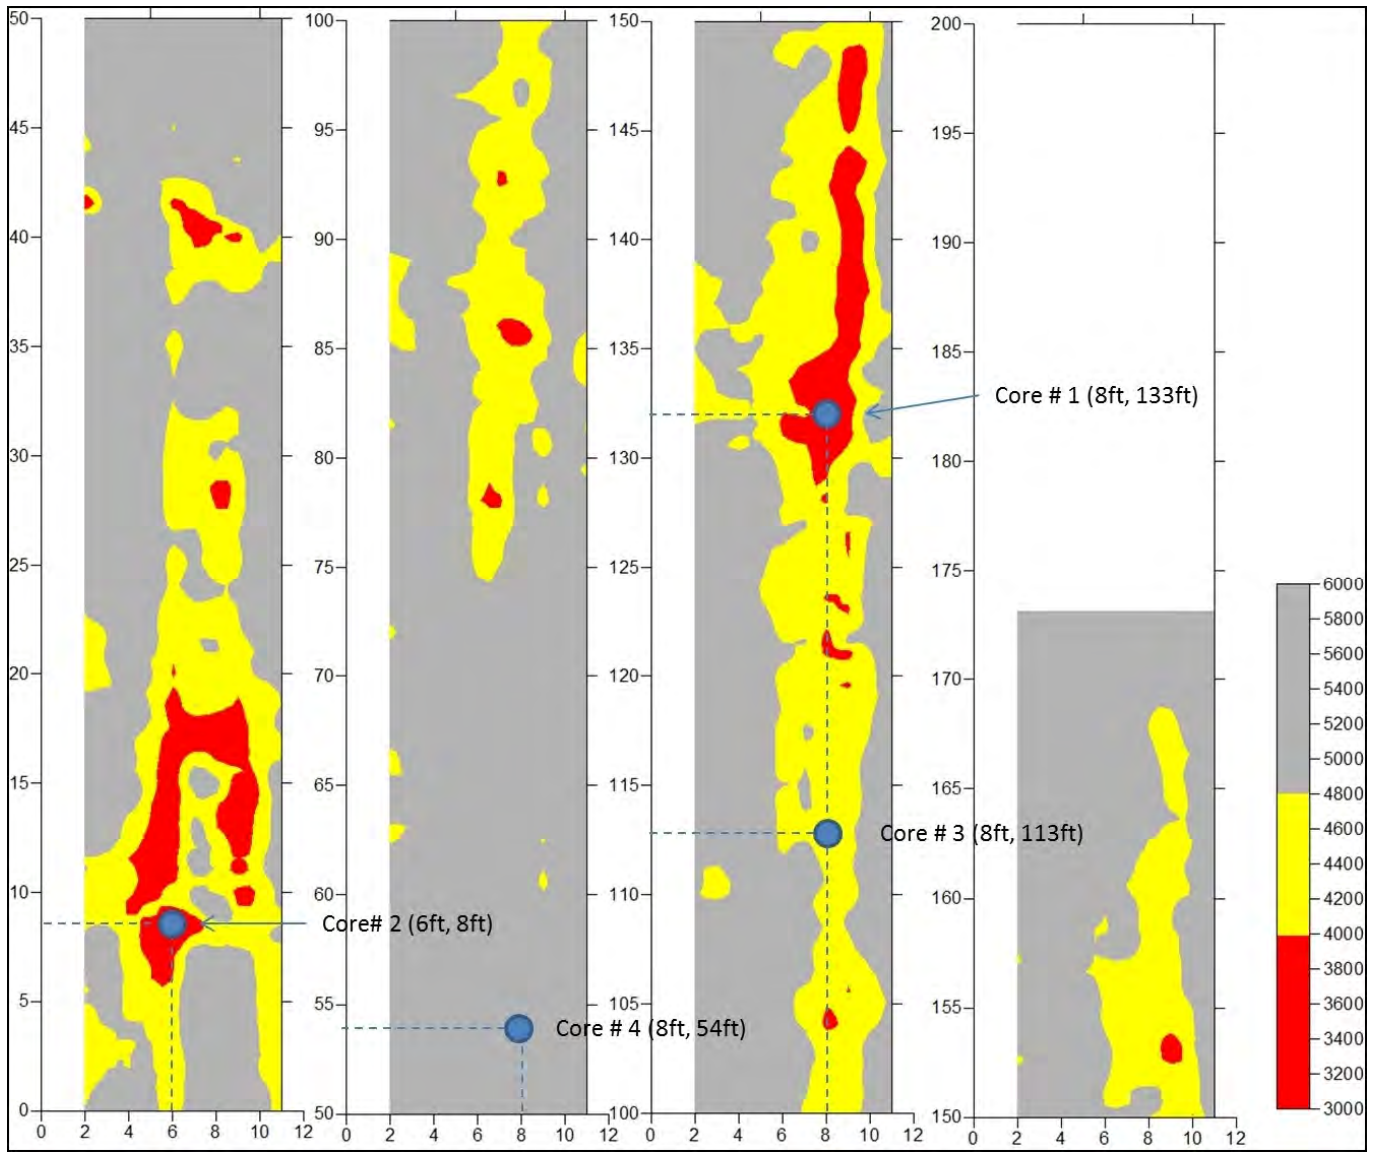
Figure 14. Illustration of Results of Spectral Analysis of Surface Waves. Designated locations, indicated as core numbers, are overlaid (surface wave velocity scale in ft/sec on *right*) (poor responses are yellow/red in color and lightest/darkest gray in grayscale). Gray in the color version indicates sound concrete.

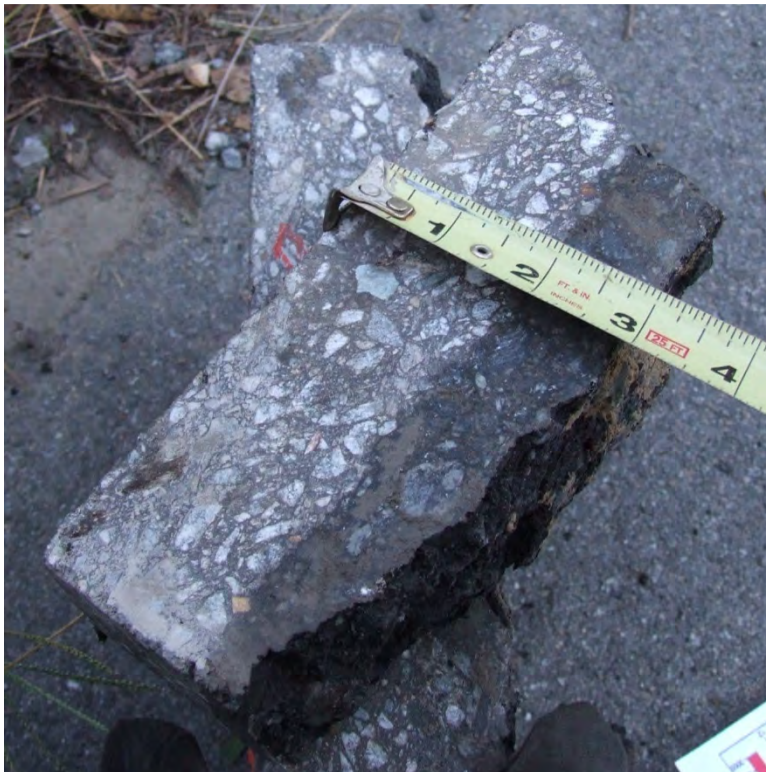
Figure 19. Asphalt at Location 4 Showing 1-in of Moisture Along Bottom, Which Was Adjacent to Overlay

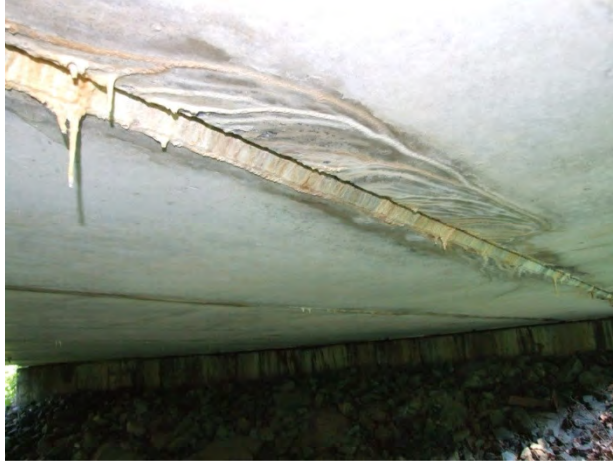
Figure 20. Result of Moisture Penetrating Between Two Box Beams

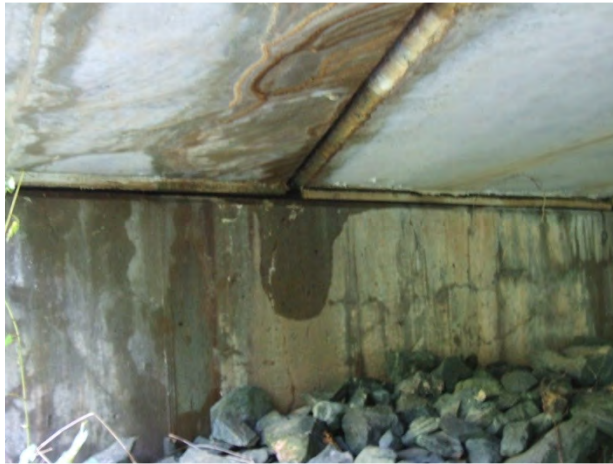
Figure 21. Evident Moisture Penetration on Abutment

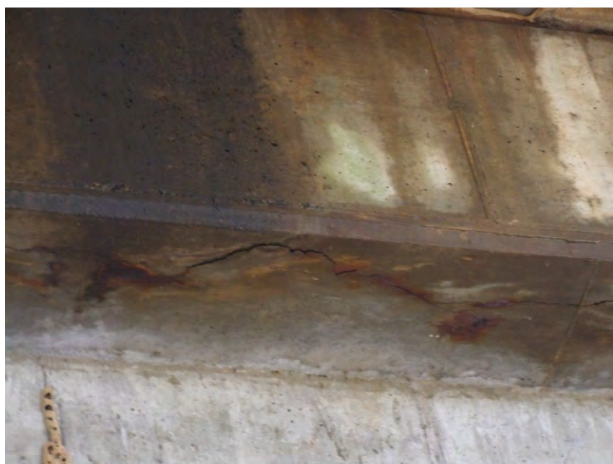
Figure 22. Evident Corrosion Along Bottom of Pier Cap Initiating Spalling of the Concrete

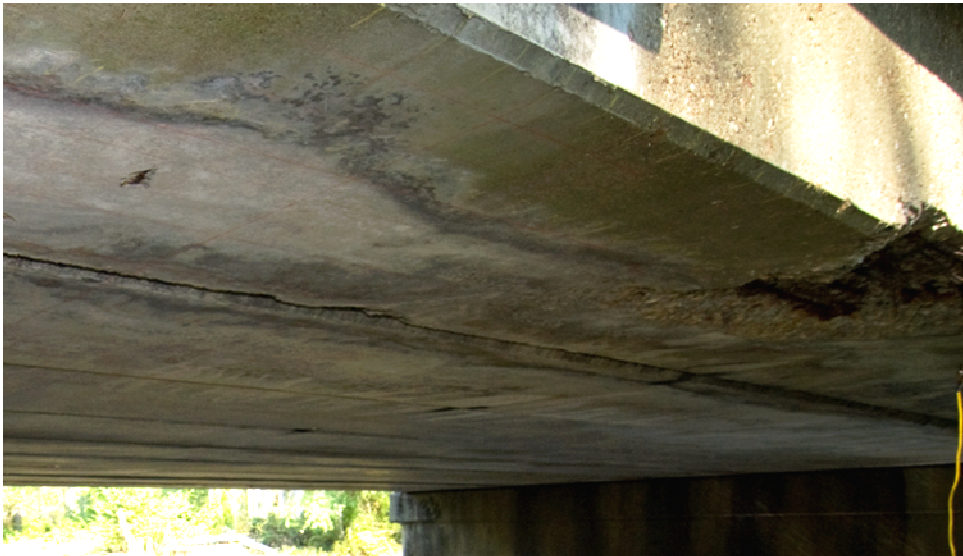
Figure 25. Bottom Side of Box Beams Showing Smooth Finish That Is Ideal for Use of Impact Echo Scanner

This finding was followed up with a separate research effort that studied the influence of different surface conditions on IES measurements and demonstrated that if surface conditions were acceptable, valuable information could be extracted from cast concrete elements (Lewis and Sharp, 2013). This work demonstrated that the IES, although not applicable for every application, can offer benefits for use in the field as long as the surface of the concrete is suitable.

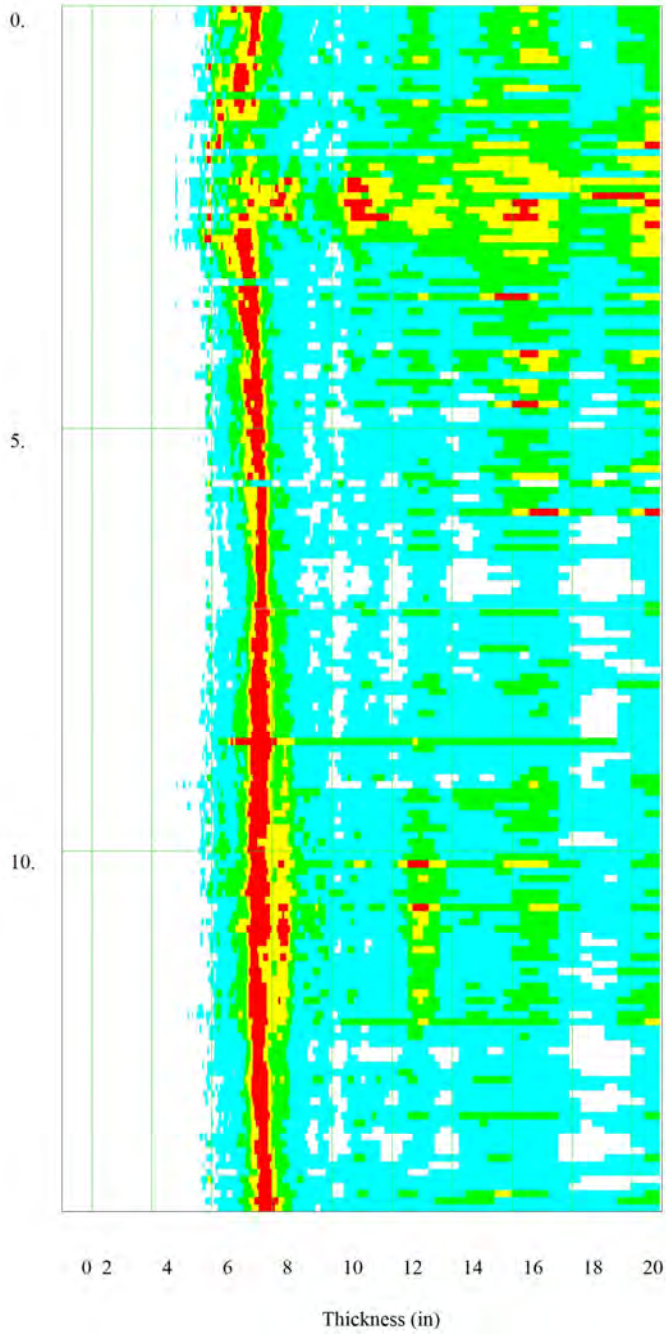
Figure 27. Impact Echo Scanner Results, Beam 8, Line 3, Indicating Damage at About 2.5 ft

The IES, similar to IE, is used to determine the presence of voids and delaminations in reinforced concrete on the basis that both of these defects create a transition in materials (concrete to air). Initially, work with the IES focused on using it to determine if consolidation was adequate around the reinforcing steel in concrete parapets (Figure 23). The IES had difficulties performing this task of identifying voids, which was attributed to the roughened surface broom finish (Figure 24). Subsequent work to detect delaminations on reinforced concrete elements with smoother form-finished surfaces showed more favorable results. IES scans on the form-finished box beam surface (Figure 25) provided useful information on the degree of delamination present on two box beams, Beams 8 and 9, as shown in Figures 26 through 29. In Figures 26 and 27, damage is apparent in the 2.5-ft region for Beam 8; in Figures 28 and 29, damage is occurring at the two ends of Beam 9 (first 2.5 ft and last 2 ft of scan).
