**ACCELERATED BRIDGE CONSTRUCTION  
UTILIZING PRECAST PIER CAPS  
ON  
STATE HIGHWAY 69 OVER TURKEY  
CREEK, HUERFANO COUNTY, CO**

**IBRD RESEARCH PROJECT 102470**

**Report No. CDOT-2014-8**

**July 2014**

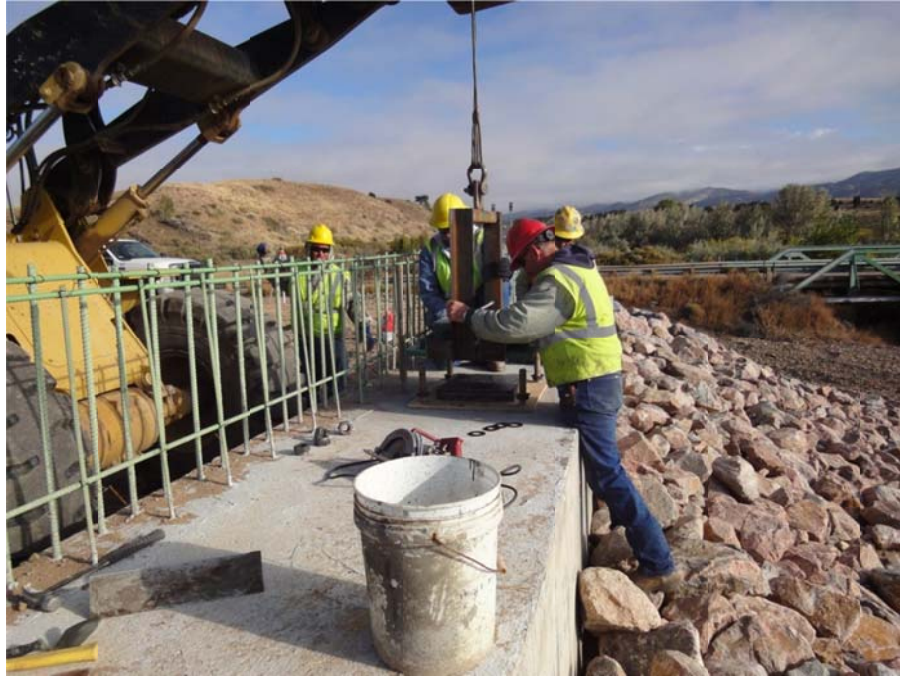
**Figure 15 – Setting of Bearings**  
**(Note: A special clamping bar was used to lift the bearings.)**

It took two hours to set three bearings at the west abutment and just one hour to set three bearings at the east abutment after everyone became familiar with the process (See Figure 15). Likewise, it took four hours and twenty minutes to set the cap beam at the west abutment and just two hours to set the cap beam at the east abutment (See Figure 16).

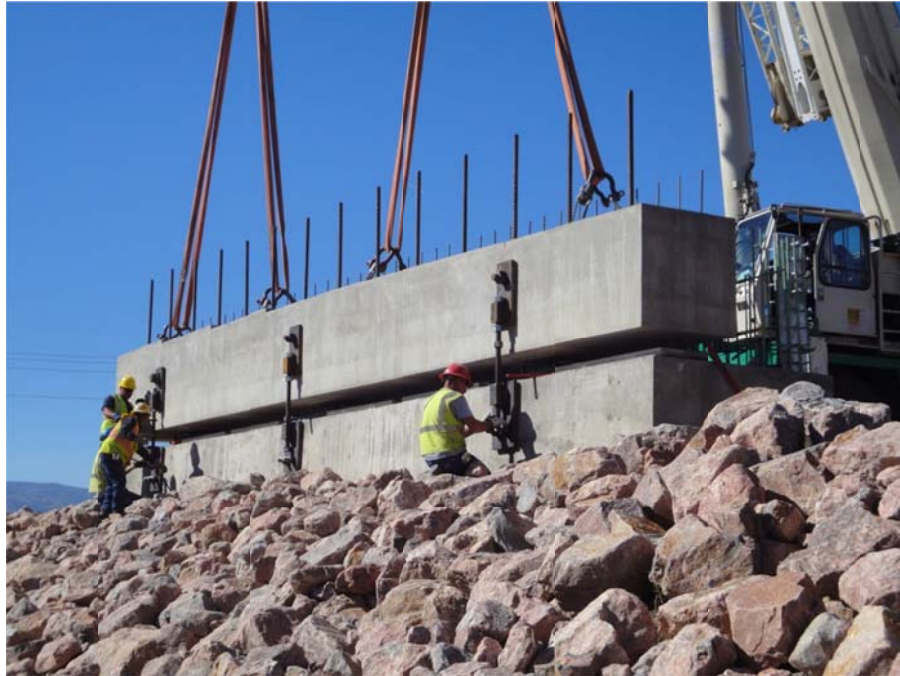
**Figure 16 – Setting of cap beam**  
**(Note: The crane supported some of the cap's weight while the stays were connected and hand tightened.)**

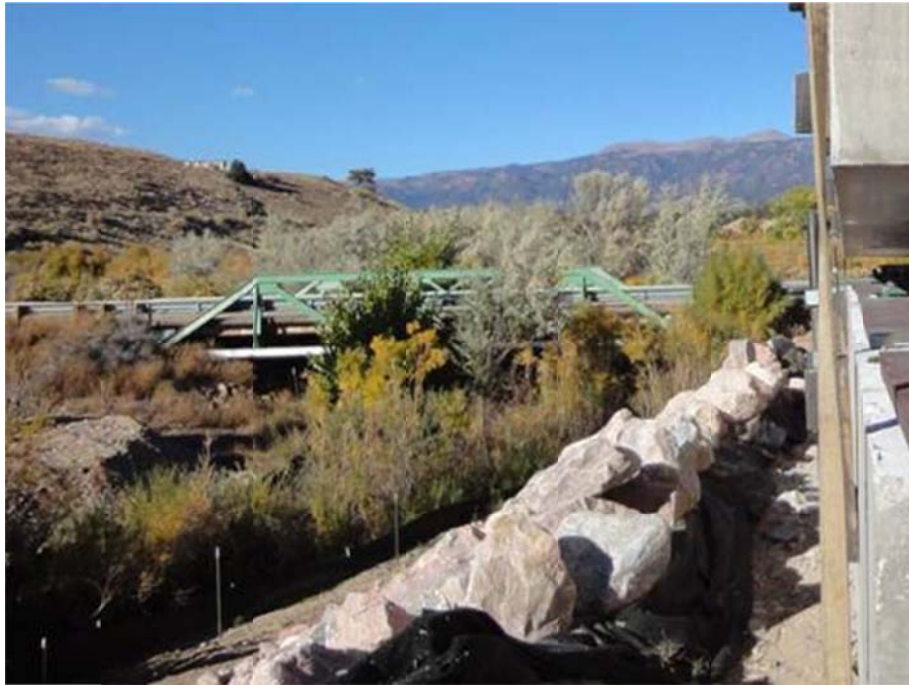
Structure N-16-L at mm 18.9 on SH-69 northwest of Walsenburg was built in 1923.

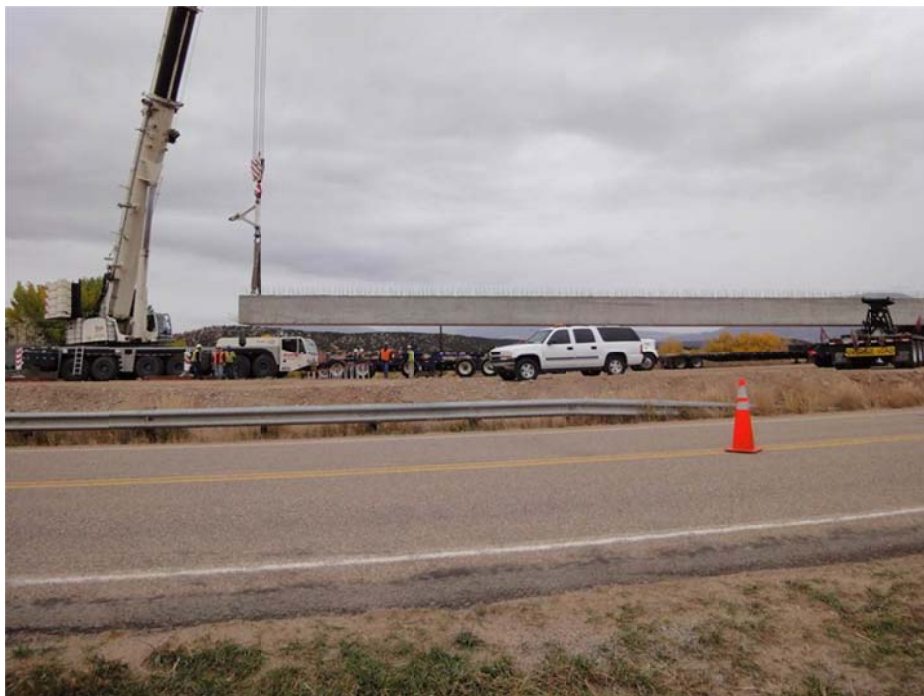
Girders for the replacement structure, N-17-Q arrived at the site on trucks. The span was too wide for a single crane to set the girders so a pair of cranes, one at each end of the structure, positioned the girders. The east end of a girder was lifted from its truck by the crane at the west abutment.

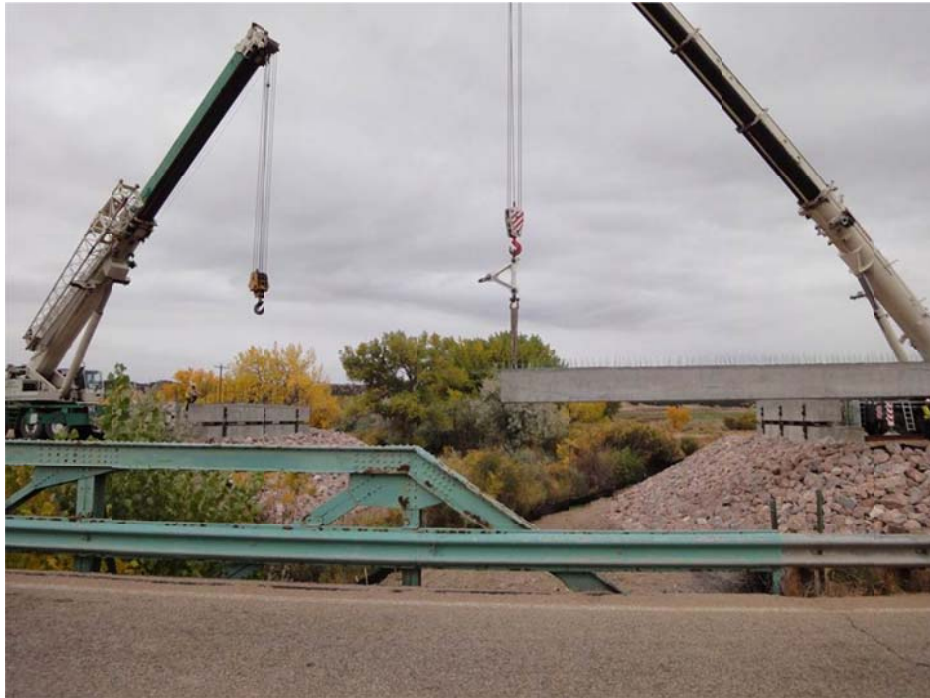
The crane at the west abutment swung the east end of the girder out over Turkey Creek to the point where the crane at the east abutment could assume the load by hooking the triangular lifting device as shown in the following pictures.

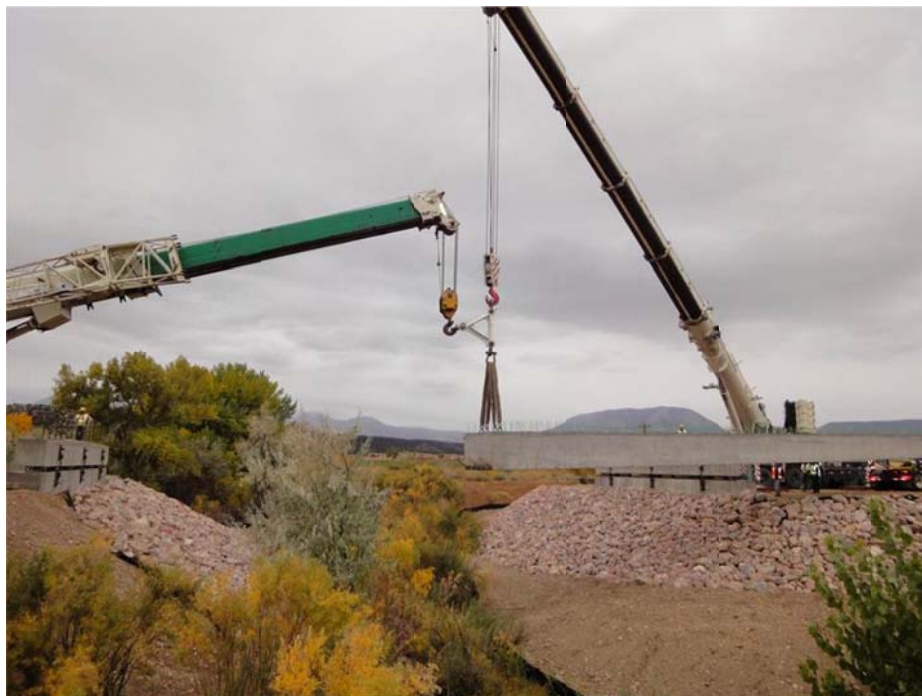
The eastern crane hooked the open shackle on the triangular lifting device.

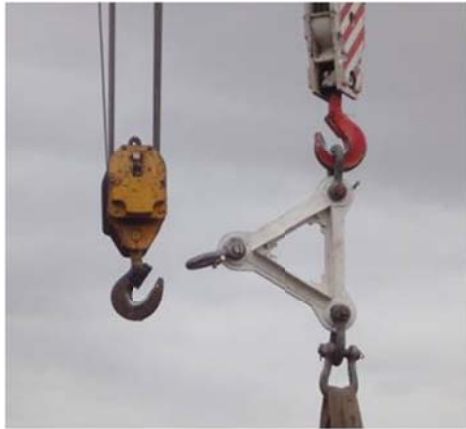
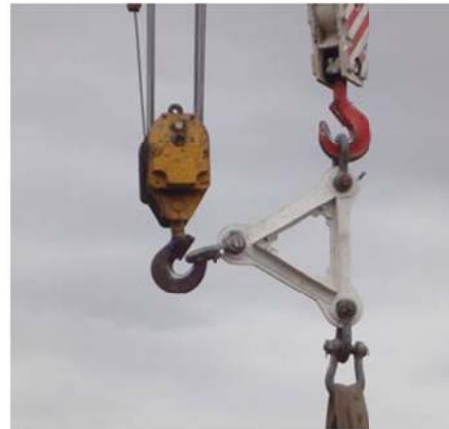
While the western crane held the east end of the girder, the eastern crane hooked the open shackle on the lifting device and slowly lifted it to assume the load.

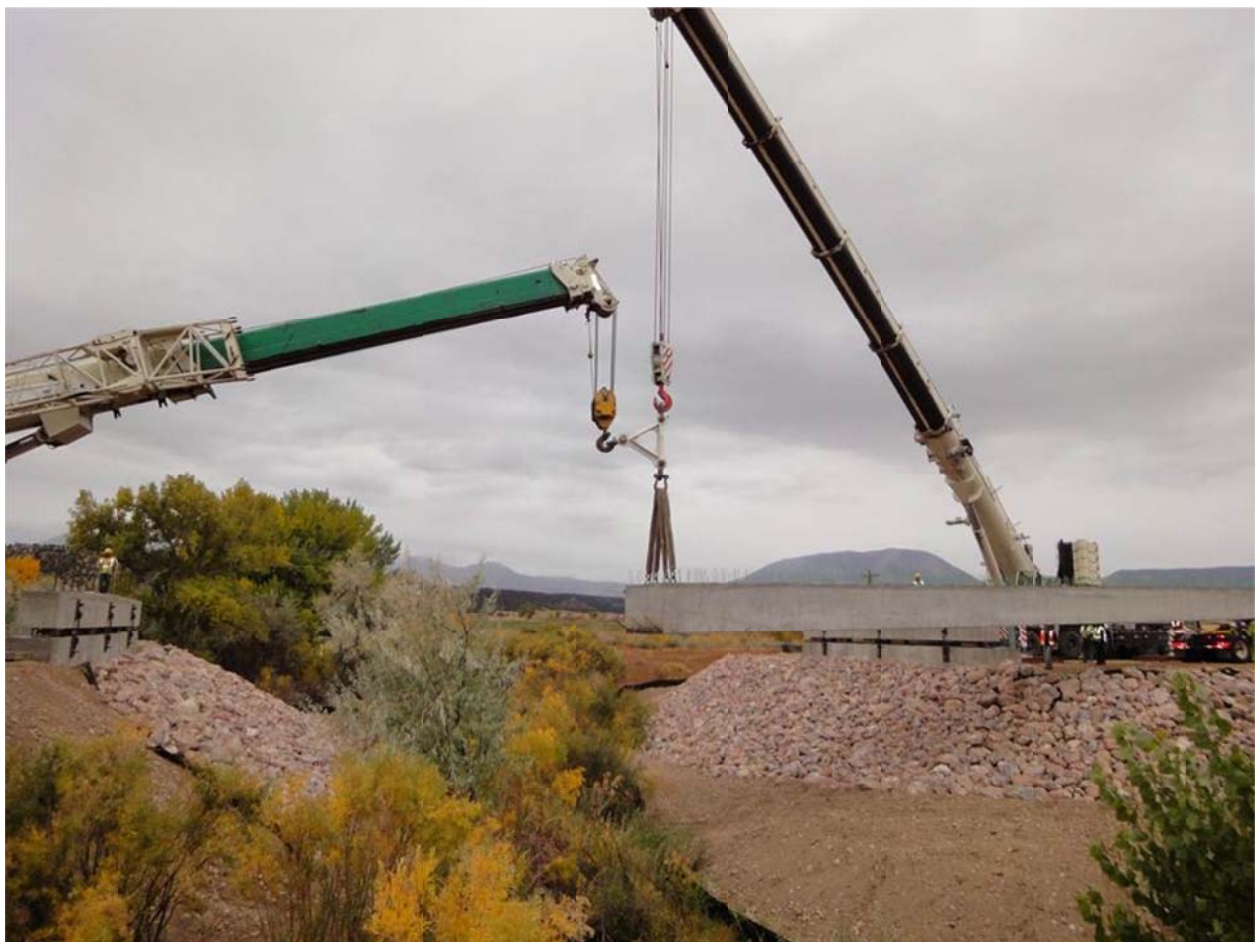
The eastern crane began to assume the load.

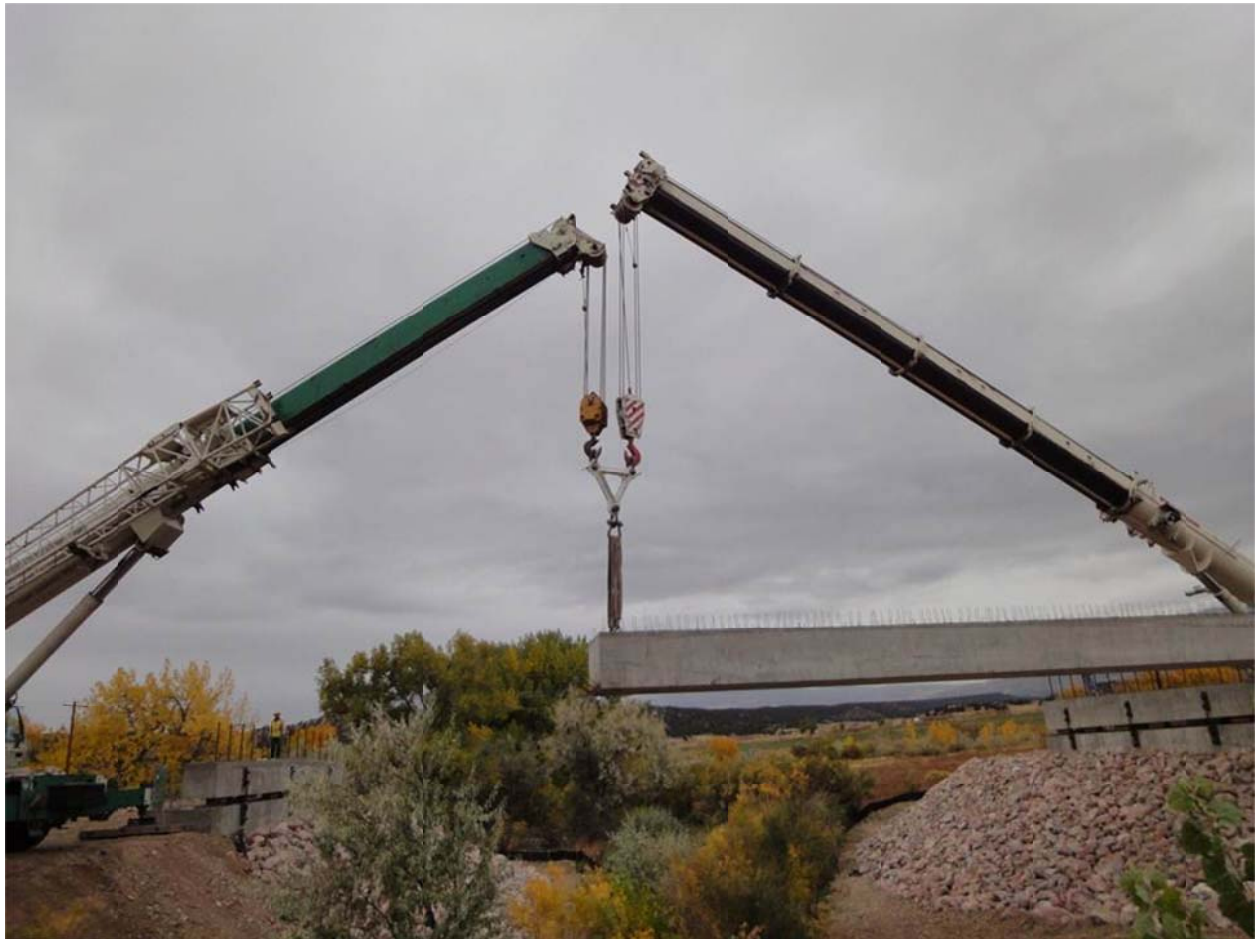
Once the open shackle was hooked, the eastern crane slowly raised its hook to take the load. The western crane slowly lowered its hook to transfer the reaction at the east end of the girder to the eastern crane.

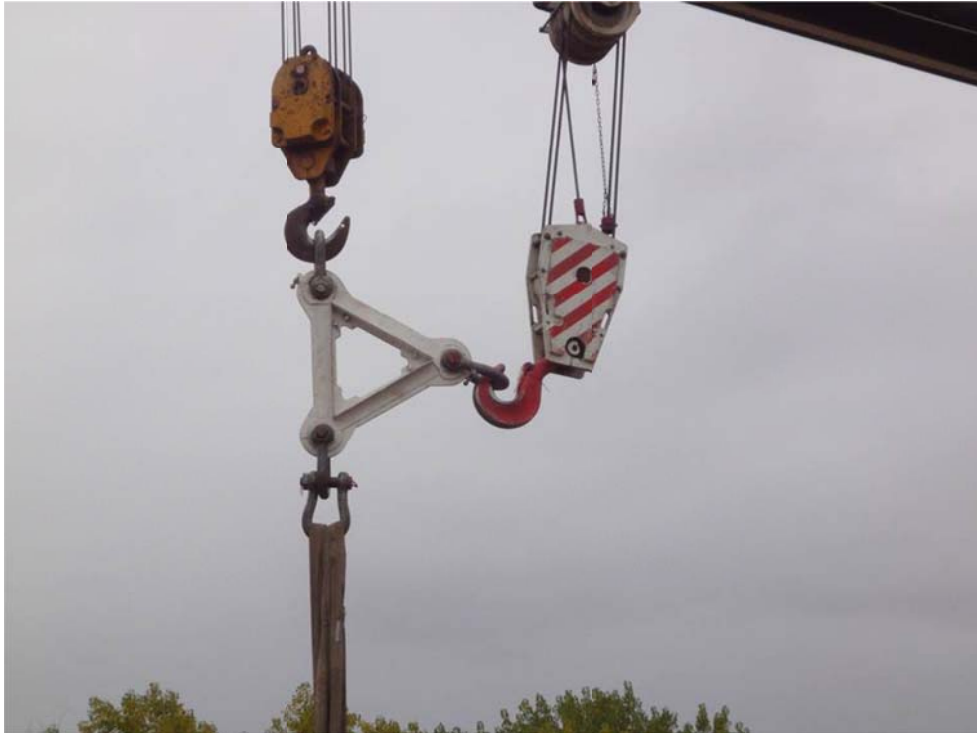
Once the eastern crane assumed the reaction at the east end of the girder, the western crane slowly lowered its hook and disconnected from the triangular lifting device.

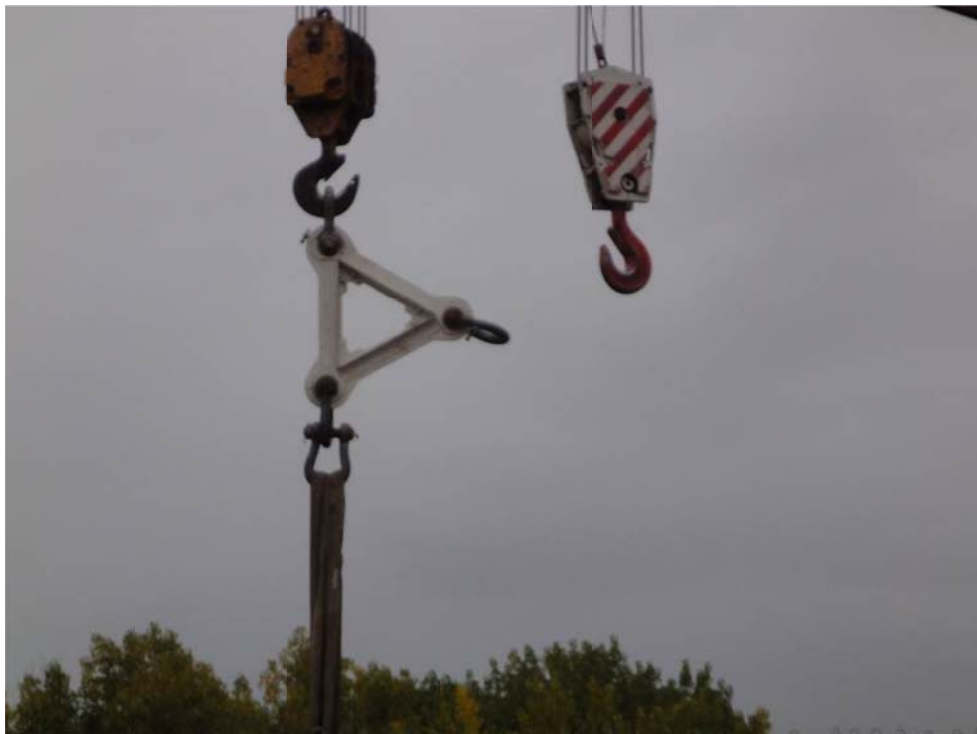
All of the load was on the eastern crane.

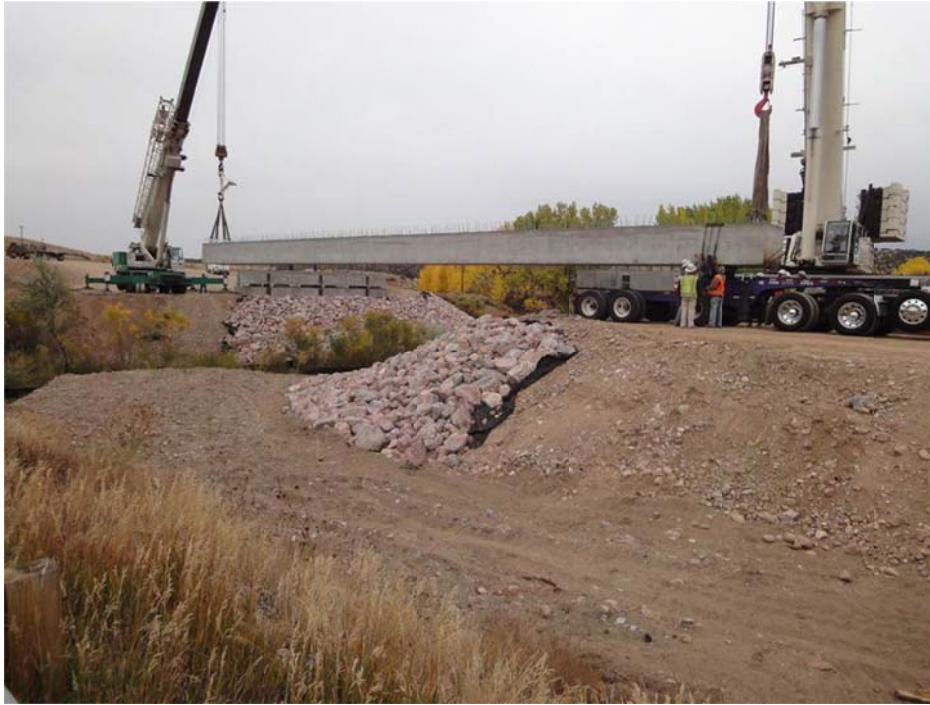
With the eastern crane supporting the east end of the girder, the western crane swung back and lifted the west end of the girder from its truck and the two cranes set the girder in position.

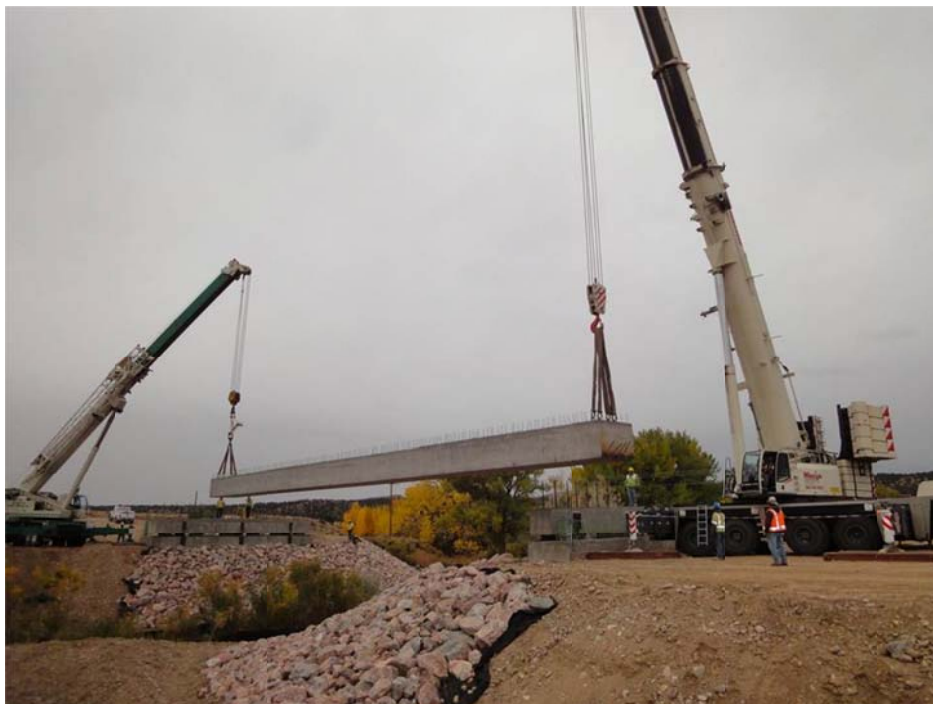
Both cranes begin to lower the girder onto the abutments.
