Report No.
SSRP-05/01
Final

**SEISMIC TESTING OF PRECAST
SEGMENTAL BRIDGES
PHASE III: BRIDGE SYSTEM TEST**

Final Report Submitted to the California Department of
Transportation (Caltrans) Under Contract No. 59A0337

June 2005

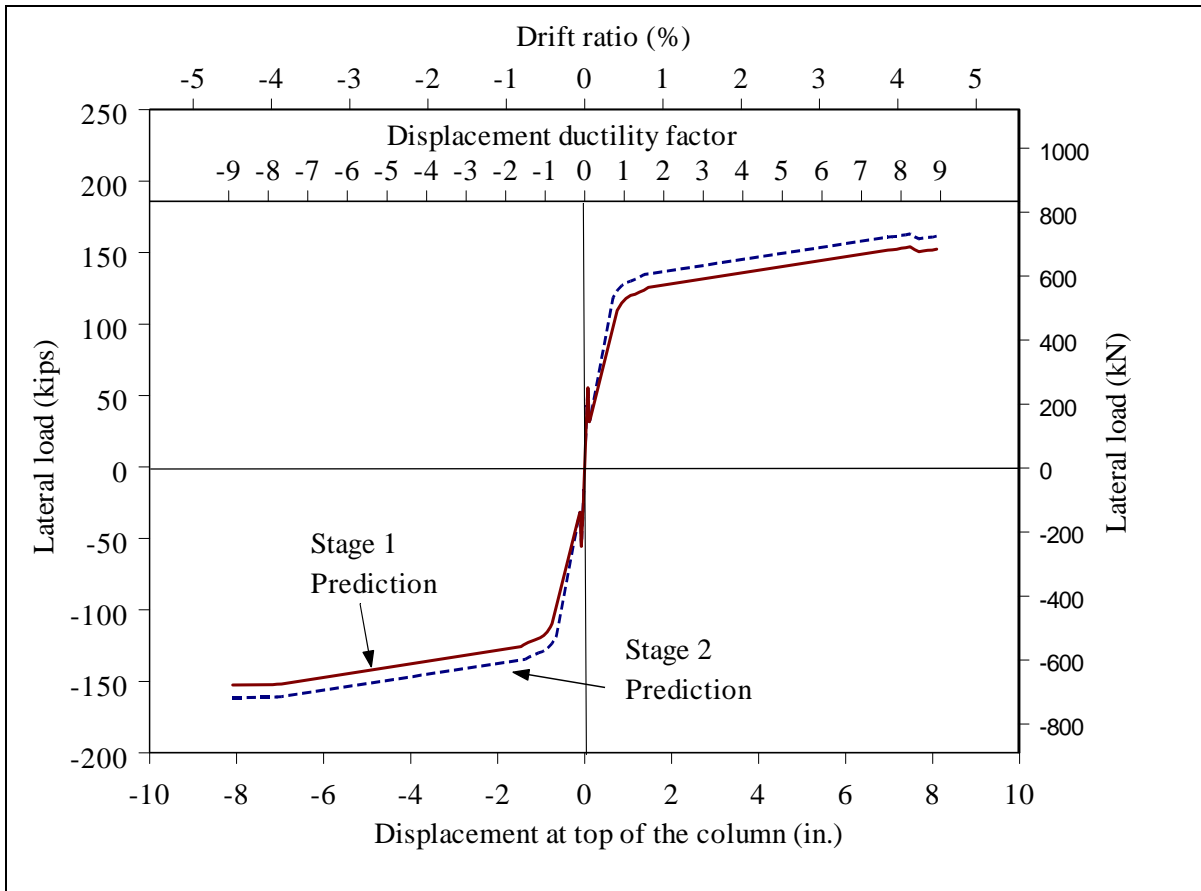
Figure 5.6 Force-displacement prediction for test unit

Where D^* is the confined concrete section depth, d_b is the diameter of reinforcing bar, and the constant α is assumed to be 0.30. The force-displacement predictions for the test unit are shown in Figure 5.6.

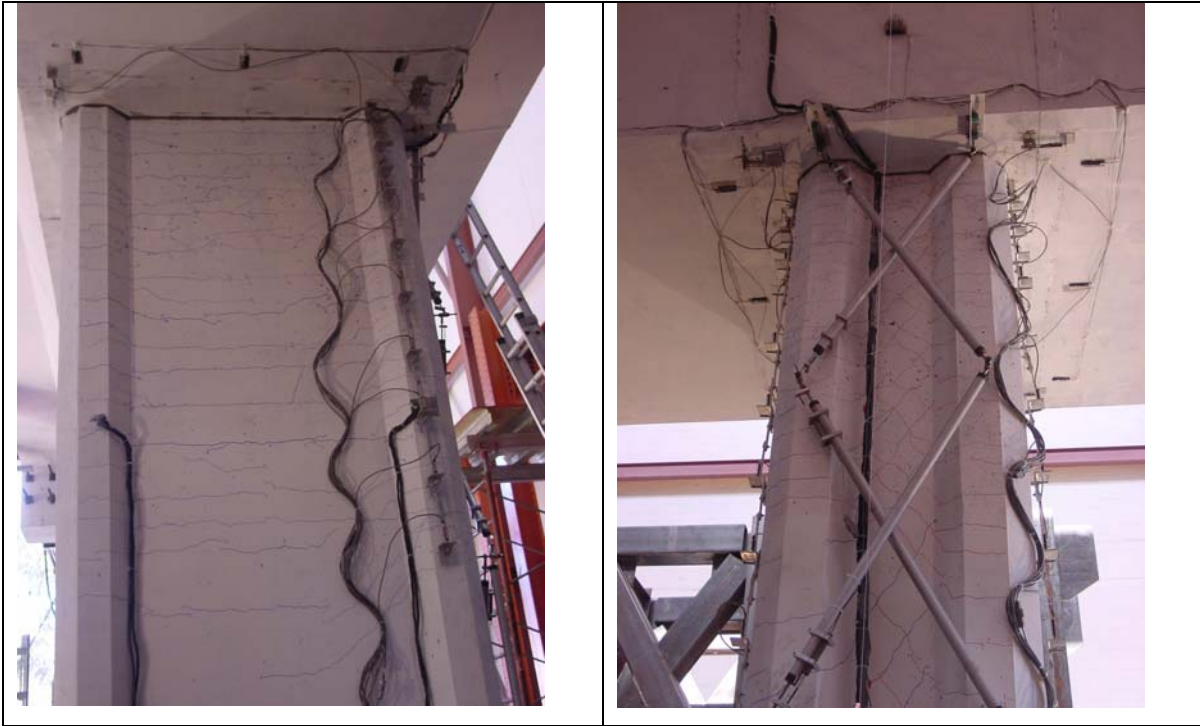
Figure 6.2 Marked crack pattern on north and west faces of column at $\mu=2$

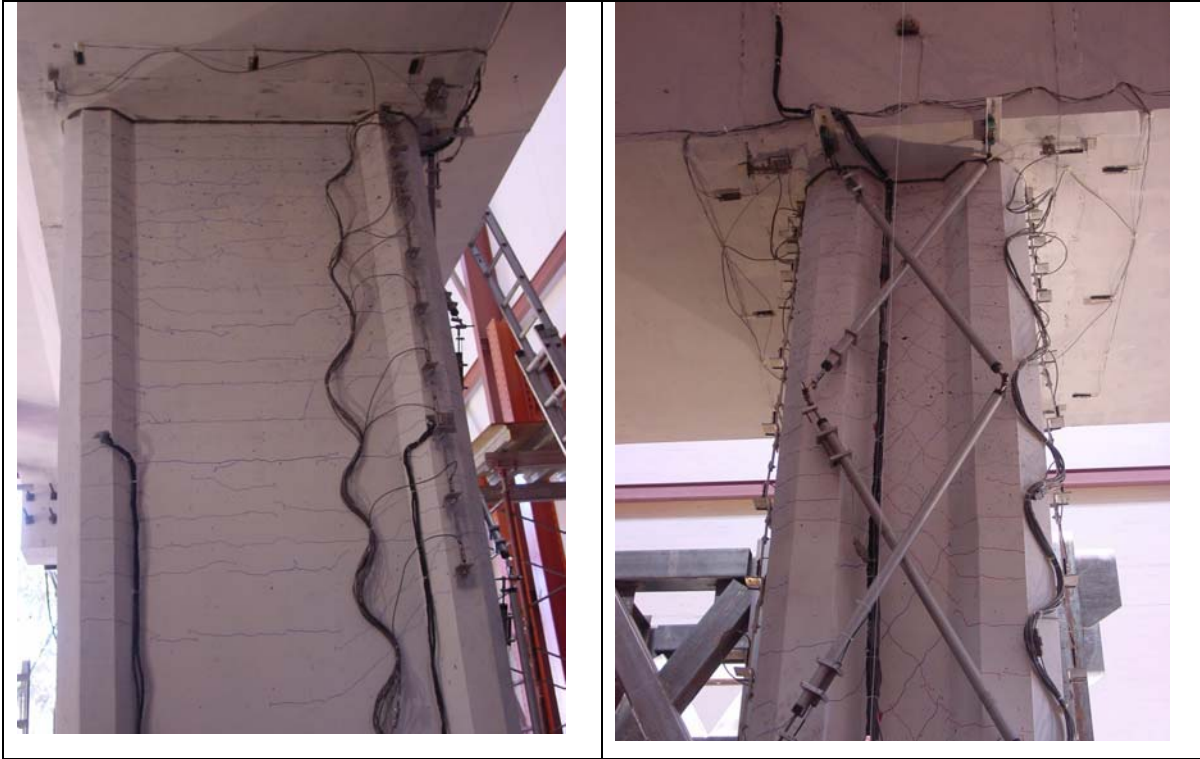
Figure 6.3 Marked crack pattern on north and west faces of column at $\mu=4$

system. At $\mu=4$ there was significant flexural cracking throughout the column shown with and without marked cracks (Figure 6.3 and Figure 6.4). There was not yet any spalling of the concrete at $\mu=4$. The initiation of short vertical cracks running between the large tensile flexural cracks near the top on the corners signified the initiation of spalling, but none had yet occurred. This was significantly different from the testing of a similar column in a severe bi-directional loading path [7] in which spalling began before $\mu=4$ was reached.

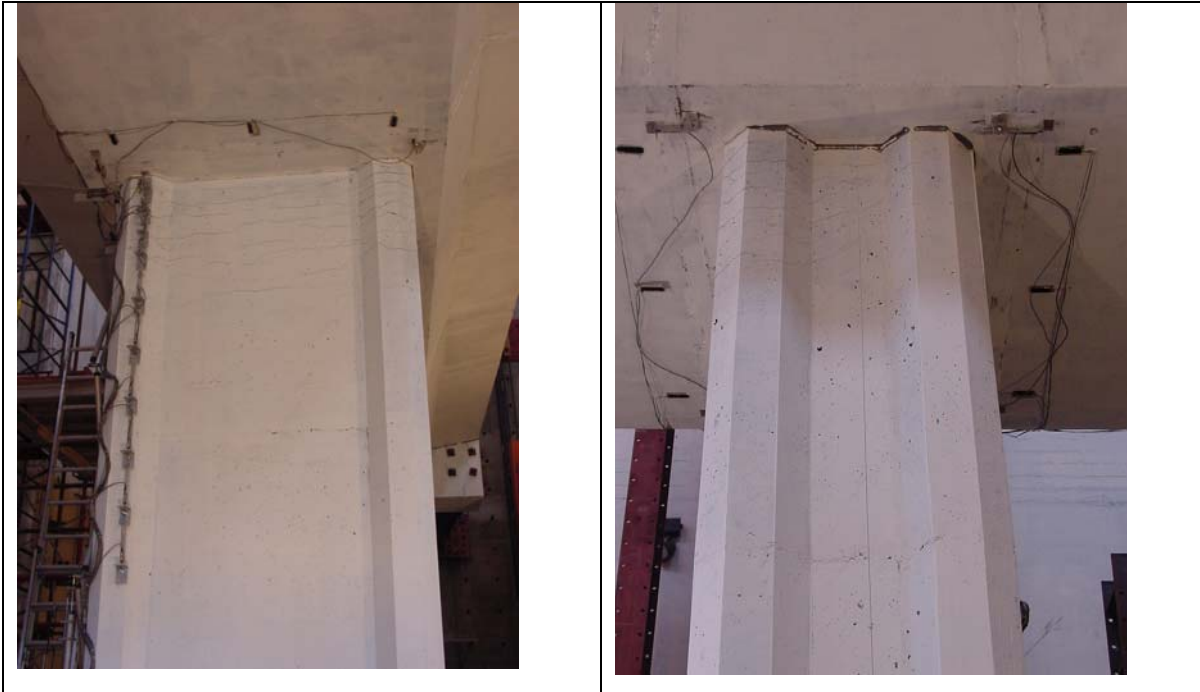
Figure 6.4 Unmarked crack pattern on south and east faces of column at $\mu=4$

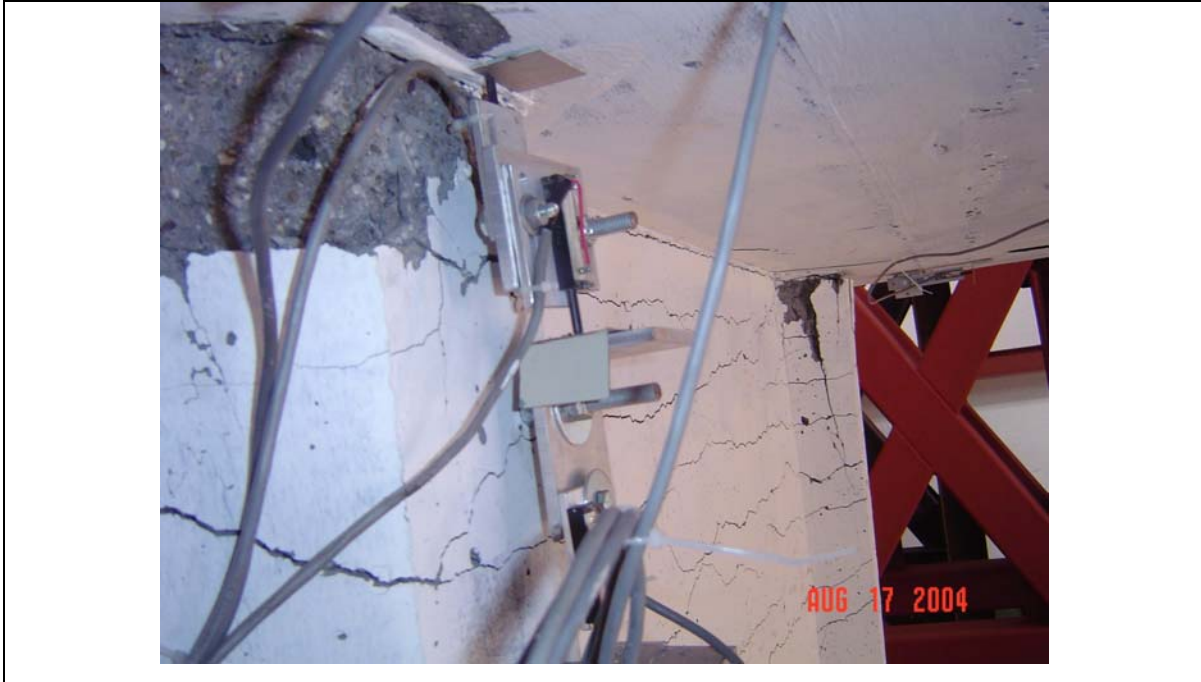
Figure 6.6 Spalling of column south face corner regions at $\mu=5$

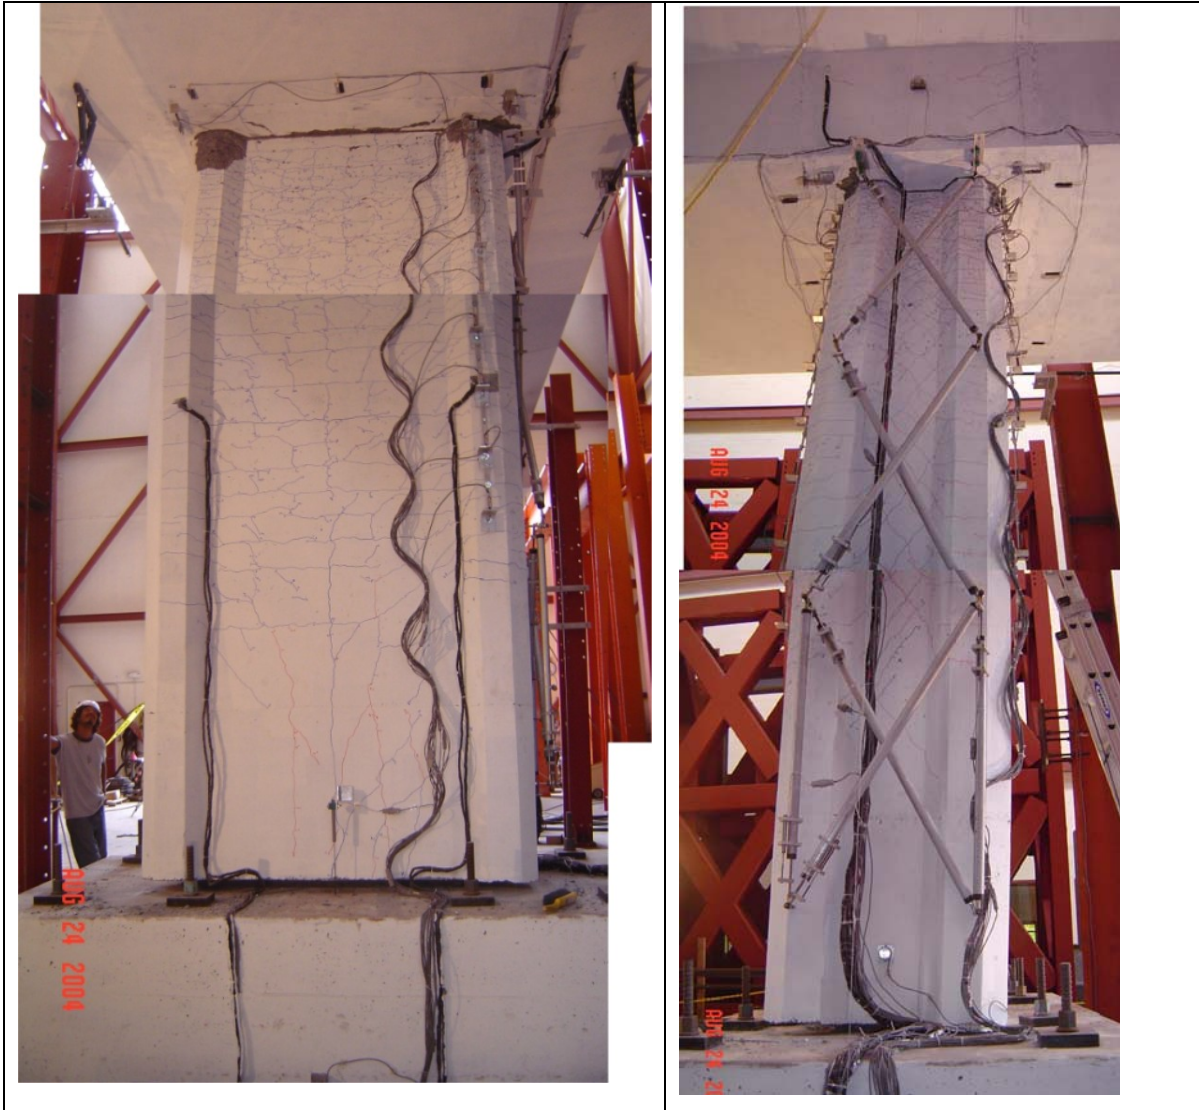
Figure 6.8 Marked crack pattern on north and west faces of column at $\mu=8$

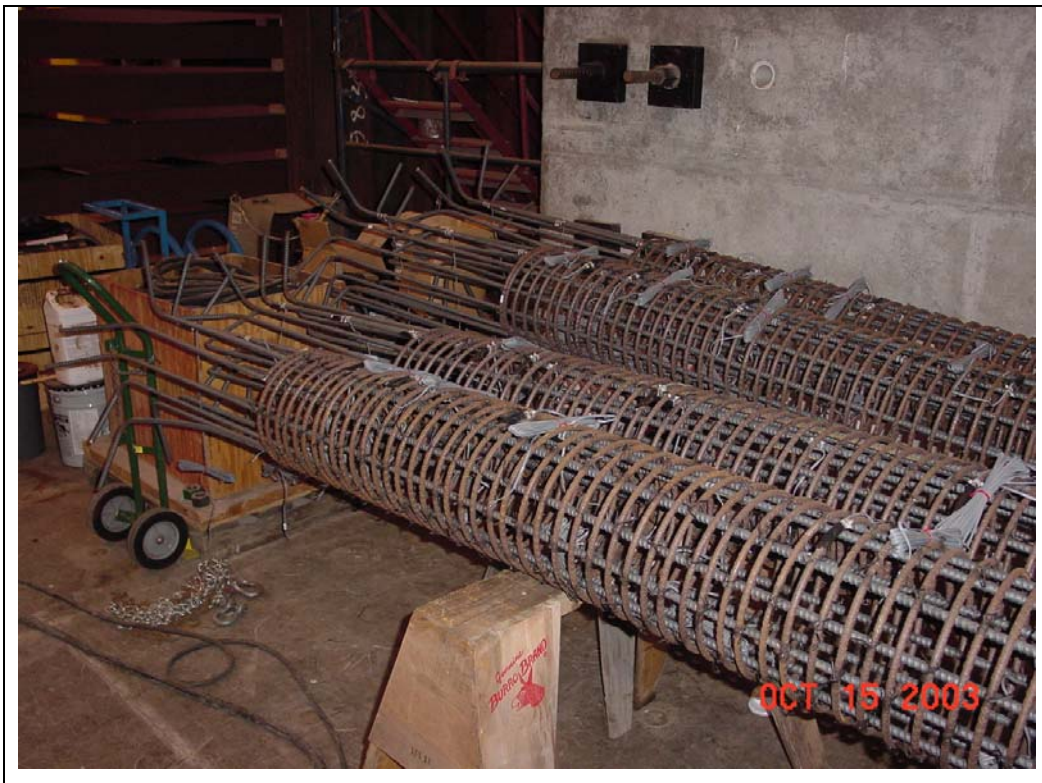
Figure 9.2 Corner spirals with gauges in place

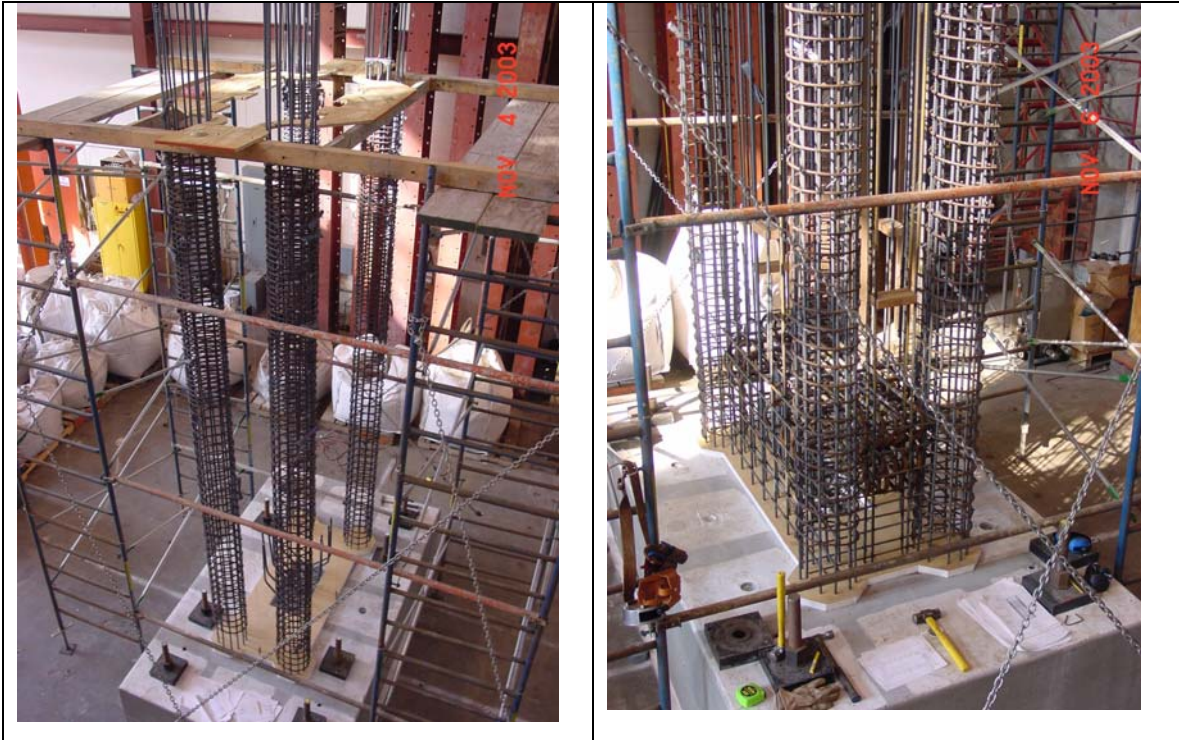
Figure 9.3 Placement of corner spirals and bottom of column reinforcement

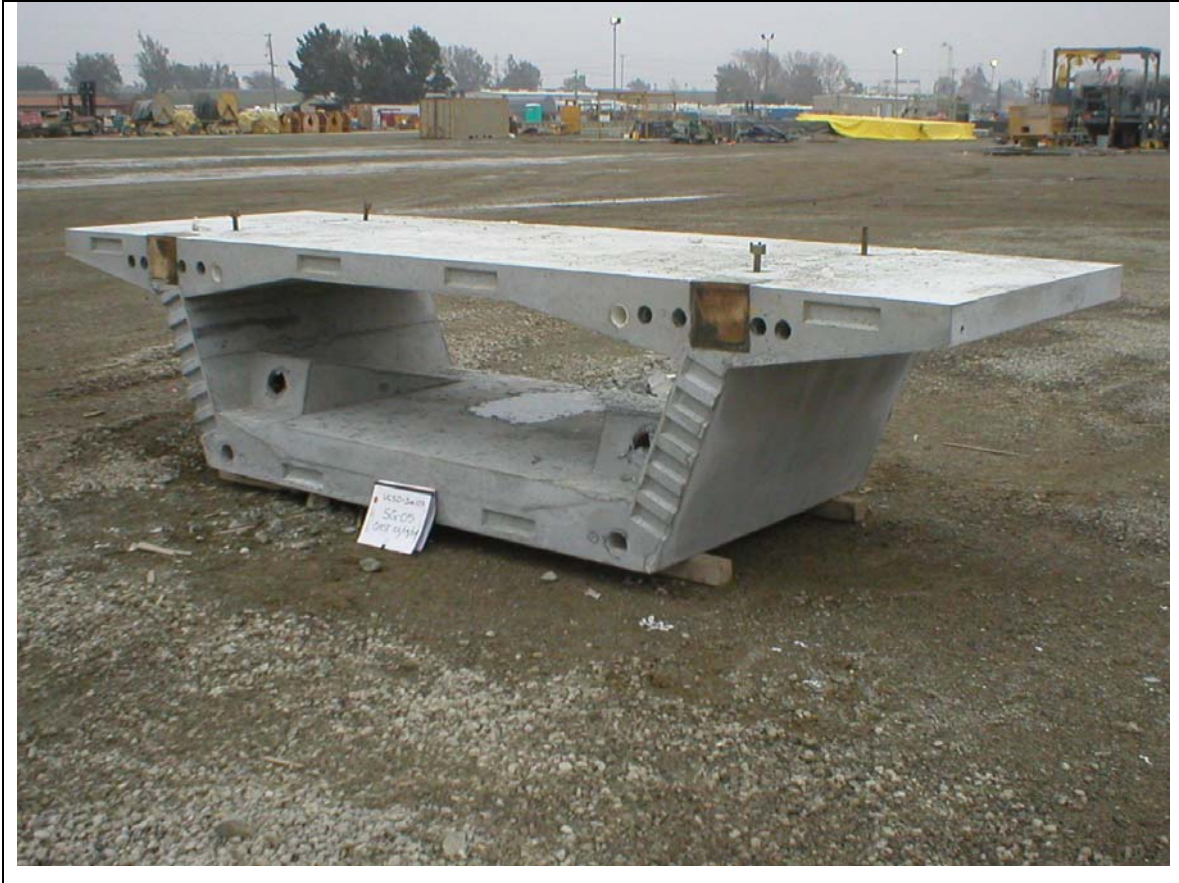
Figure 9.11 First completed segment (later scrapped because the bottom blisters are backwards)

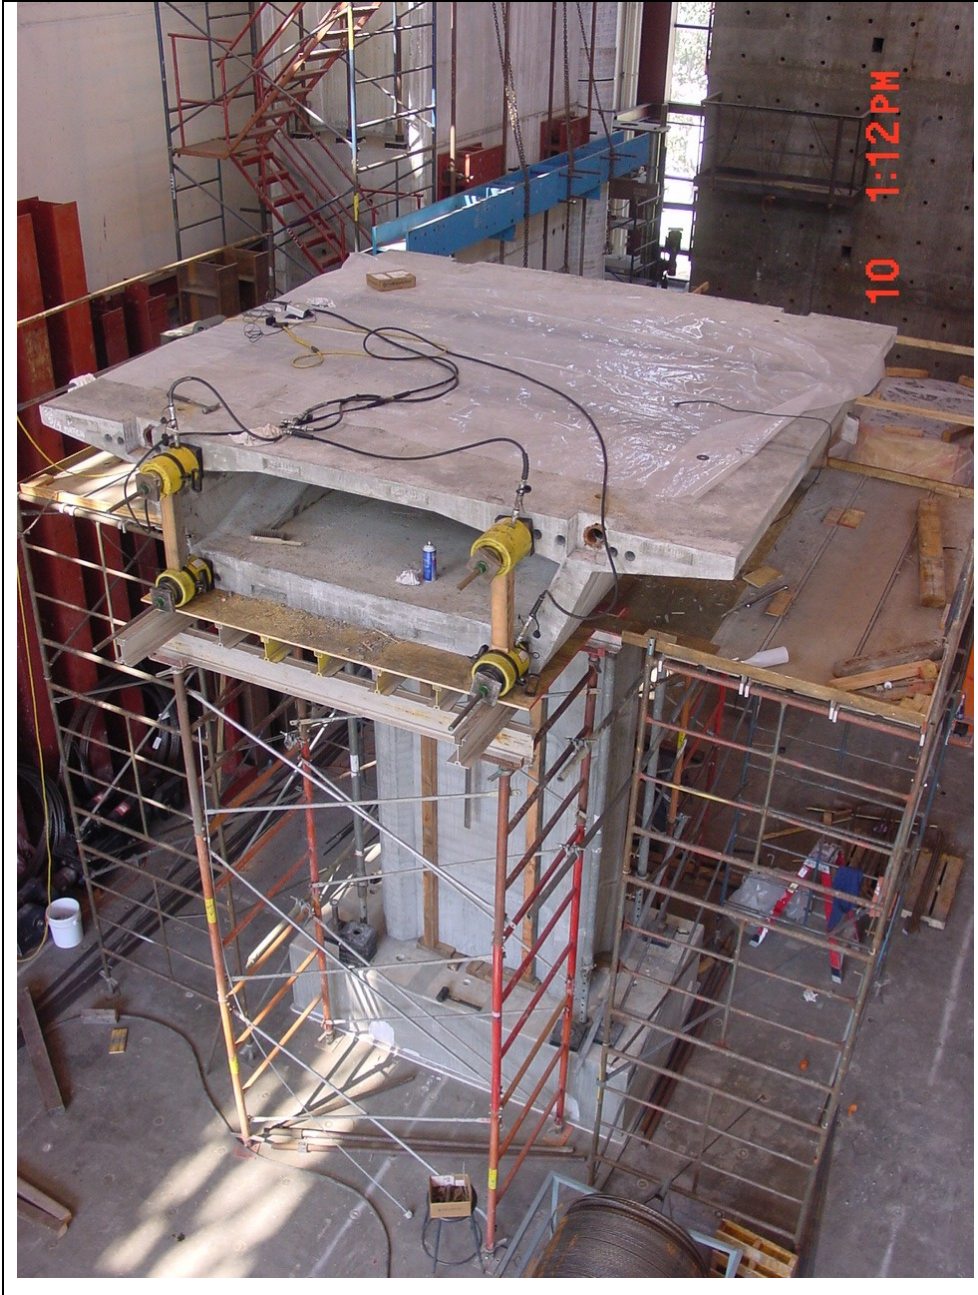
Figure 9.16 1st pair of segments in place and epoxied with temporary prestressing bars

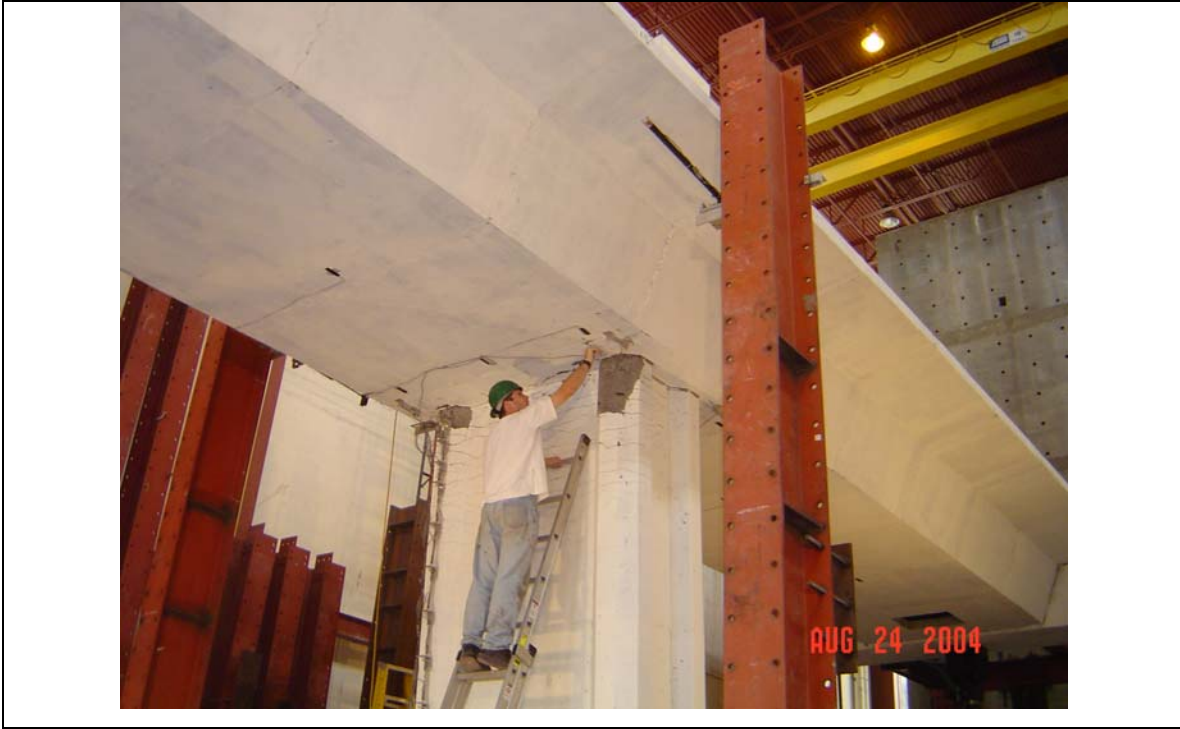
Figure 9.24 Damaged test unit after final testing cycles

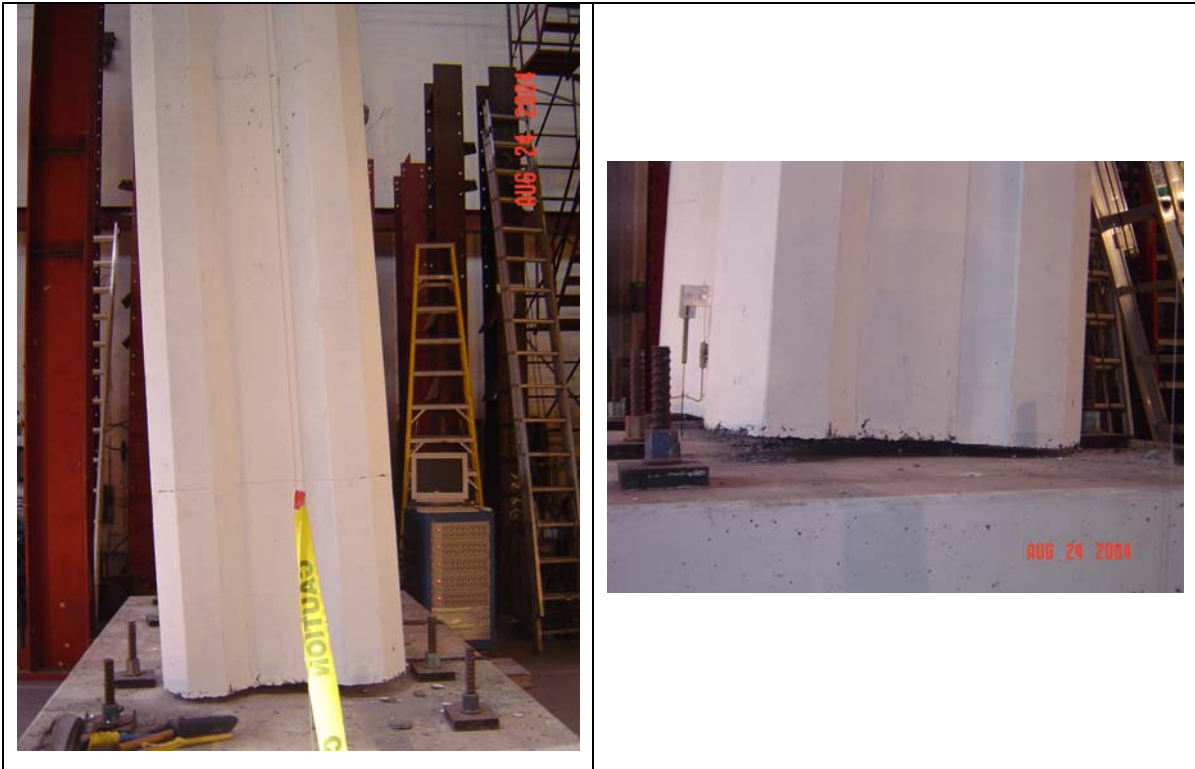
Figure 9.26 Column displacement and pin rotation close-up
