1. REPORT NUMBER <b>CA12-1741</b>	2. GOVERNMENT ASSOCIATION NUMBER	3. RECIPIENT'S CATALOG NUMBER
4. TITLE AND SUBTITLE <b>WATER JETTING FOR THE MITIGATION OF DEFECTS IN DRILLED SHAFTS - A LABORATORY INVESTIGATION OF JETTING EFFECTIVENESS IN DIFFERENT DELETERIOUS MATERIALS</b>		5. REPORT DATE <b>September 2012</b>

# WATER JETTING FOR THE MITIGATION OF DEFECTS IN DRILLED SHAFTS - A LABORATORY INVESTIGATION OF JETTING EFFECTIVENESS IN DIFFERENT DELETERIOUS MATERIALS

Final Report

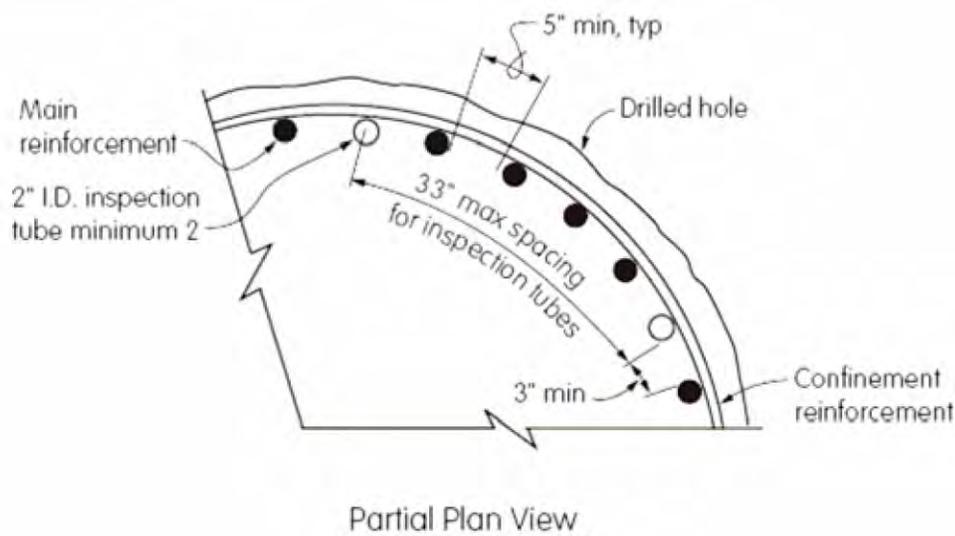
Access tubes are placed around the perimeter of the drilled shaft and inside the outermost spiral or hoop steel reinforcement. A minimum 3-inch clear spacing is provided between the access tubes and adjacent vertical steel reinforcement, as noted on Figure 2.1. The maximum center-to-center spacing between adjacent access tubes is 33 inches as measured along an effective diameter passing through the inspection tube centers (Caltrans 2008). For accurate results, Caltrans specifies that the tubes be kept parallel to the axis of the drilled shaft and as vertical as possible during construction.

**Figure 2.1 - Spacing Requirements for Longitudinal Reinforcement and Inspection Access Tubing in Drilled Shafts (Caltrans, 2008)**

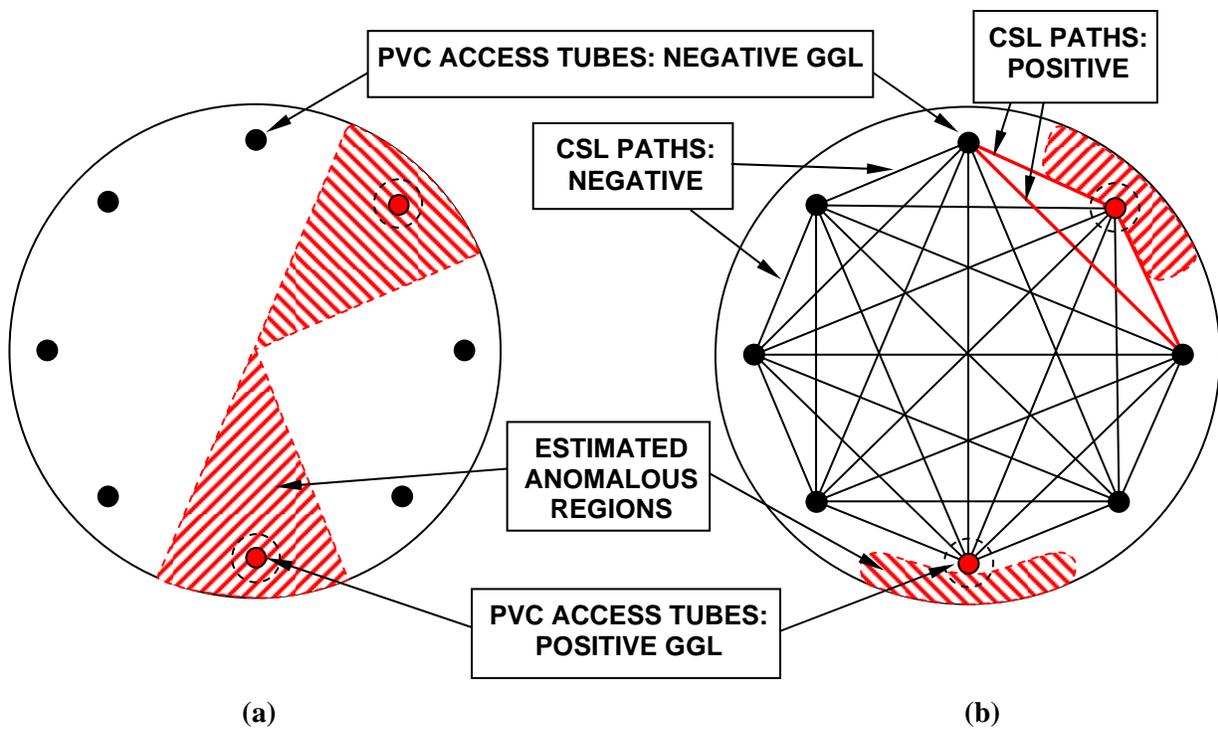
If an anomaly is detected during GGL, the designer will use the relative sample method to approximate a maximum affected cross section. For example, if an anomaly is positively detected in two of eight inspection tubes, the engineer assumes that 2/8 (or 25 percent) of the cross-section is compromised, as illustrated on Figure 2.2(a). When GGL and CSL testing are combined, the two methods can provide a comprehensive means for detecting and quantifying anomalies within drilled shafts. Figure 2.2(b) illustrates how the size of an anomaly can be more accurately estimated when combining positive test results from GGL and CSL. It is noted that the vertical extent of anomaly can be difficult to determine using these methods. Further, the transition between deleterious materials and uncontaminated (i.e. "good") concrete will not necessarily be distinct.

**Figure 2.2 - Quantifying Anomalies in Drilled Shafts using: (a) GGL Results; (b) GGL and CSL Results**

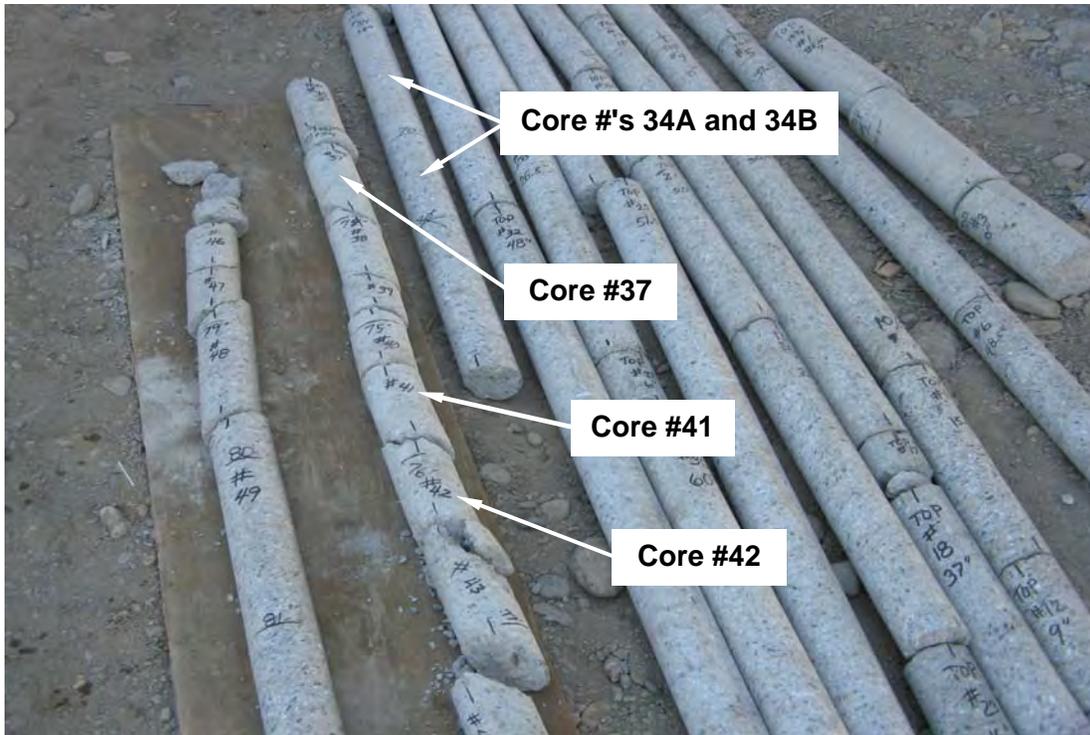
Shown on Figure 2.3 is a photograph of several core sections taken from the Thomes Creek drilled shaft. Core numbers corresponding to those summarized in Table 2.4 are noted on the photograph. The photograph shows that the core was significantly fractured in the area of the detected anomaly. Inspection of these core sections showed that the anomalous materials contained significantly less coarse aggregate than the sound concrete.

**Figure 2.3 - Photograph of a Concrete Core Sections Retrieved from the Thomes Creek Bridge Site (photo provided by Jason Wahleithner)**

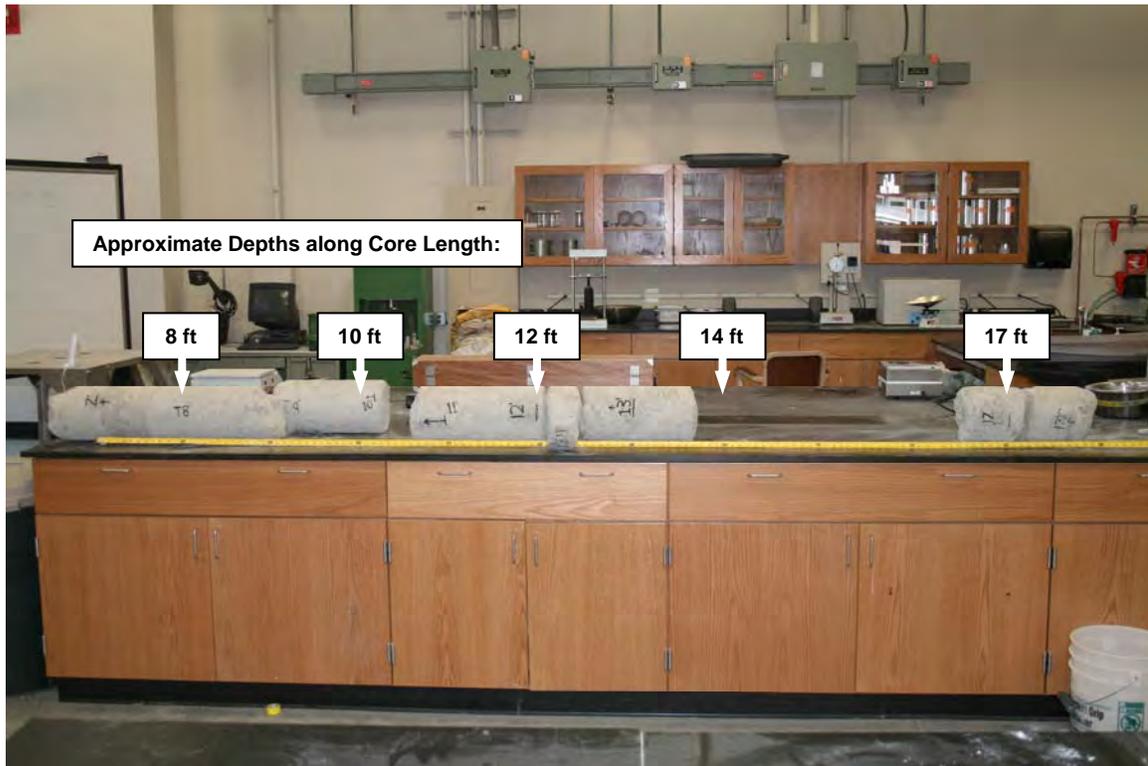
**Figure 2.4 - Photograph of a Concrete Core Retrieved from Drilled Shaft #3 at the Jacklin Road Undercrossing**

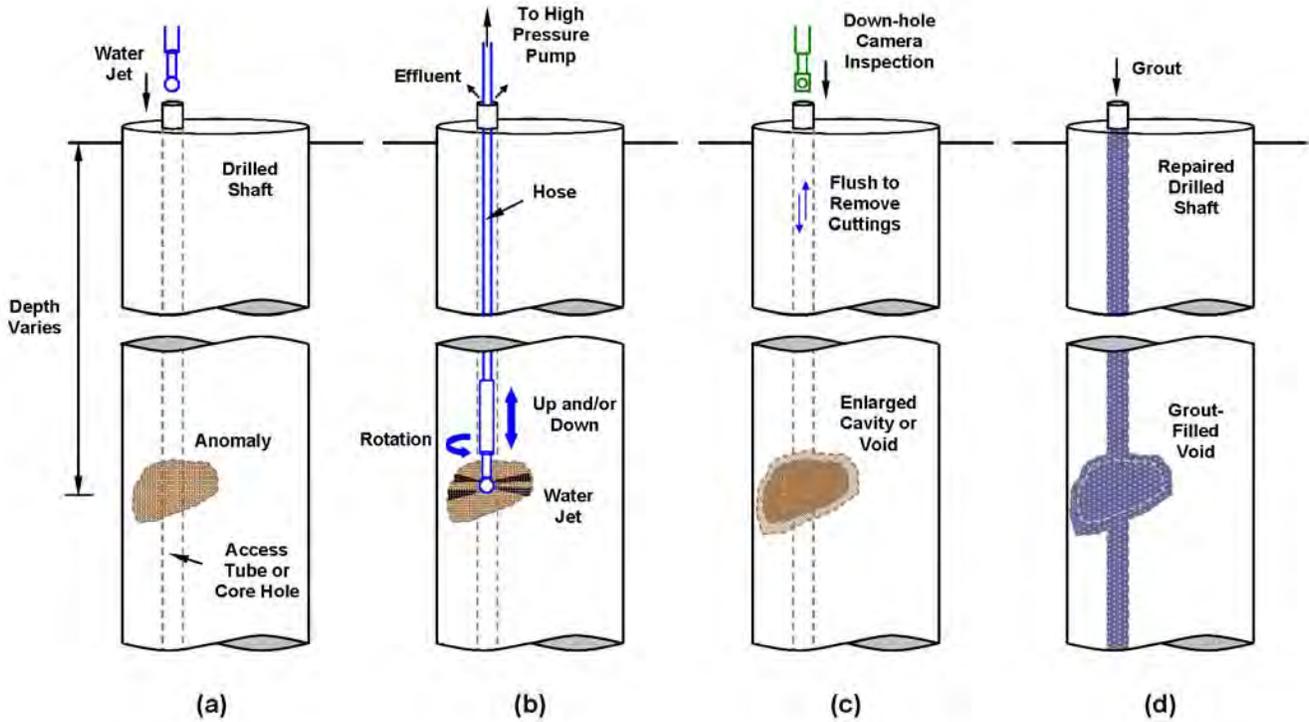
In 2007, the West Coast Chapter of the International Association of Foundation Drilling (ADSC), in cooperation with Holdrege & Kull Consulting Engineers and Caltrans, proposed a Standard Mitigation Plan for the repair of defects in drilled shaft foundations (ADSC West Coast Chapter 2007). Included in this plan is a general description of the procedure for water jetting a defect. This procedure is illustrated on Figure 2.5. The Standard Mitigation Plan is described in some detail in the following section of this report.

**Figure 2.5 - Typical Water Jetting Process to Repair Defects in Drilled Shafts:  
 (a) Introduce Water Jet; (b) Jet Anomaly; (c) Flush Cuttings and Inspect Void  
 Space Left by Jetting; and (d) Grout Void Space**

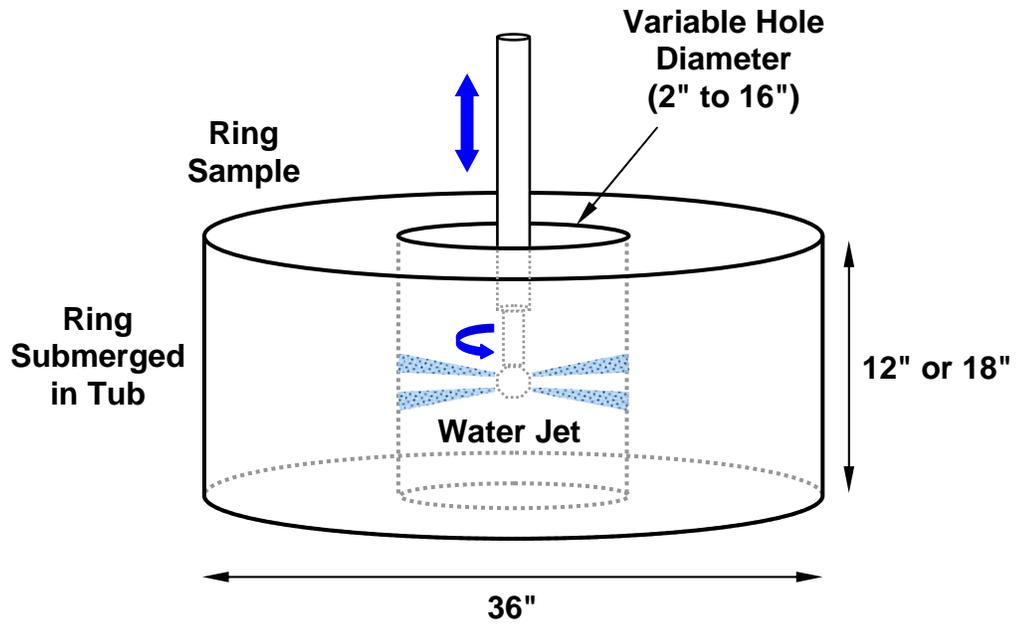
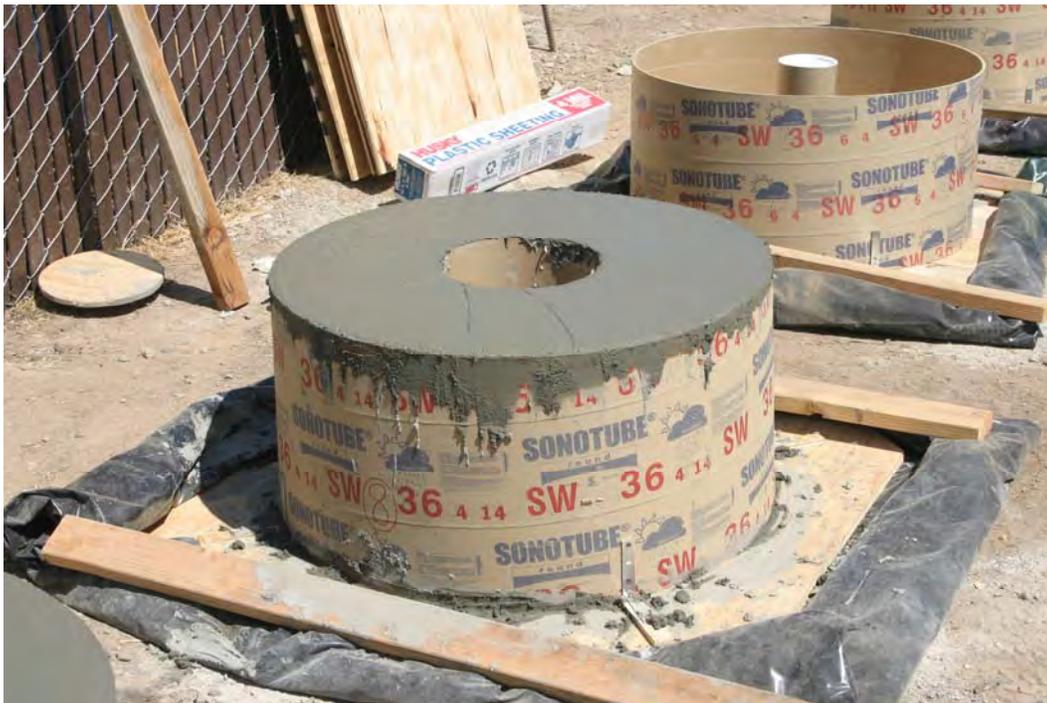
The outside diameter of each ring specimen was approximately 36 inches, and the height was typically 18 inches. The large diameter provided a measure of safety during jetting since blowout of the sample was a concern. A sample height of 18 inches provided room for the water jet to be safely moved up and down during testing while still providing adequate cover. During initial testing the research team constructed ring samples with 12 inch heights; however, this configuration ended up providing inadequate cover at the top and bottom of the specimen.

**Figure 3.1 - Ring Samples used during Water Jetting: (a) Illustration of the Concept; (b) Construction Photo for 6- and 12-inch Diameter Samples**

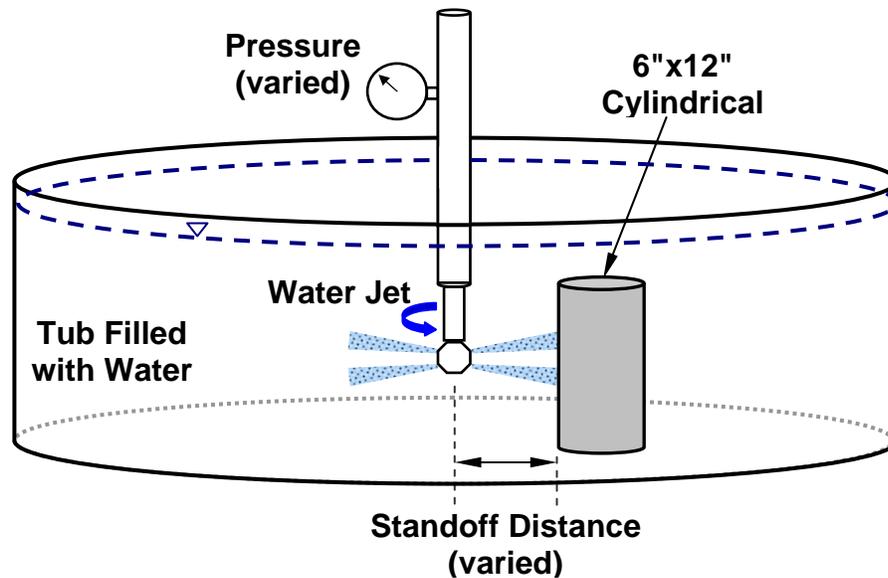
Figure 3.3 shows a typical cylindrical sample with the surrounding test apparatus. In these tests, 6-inch by 12-inch cylindrical samples were positioned at standoff distances (from the water jet) ranging between 1.5 and 16 inches. The samples were constructed in general accordance with ASTM procedures for the preparation of compression test cylinders.

Figure 3.3 - Illustration of a Typical Cylindrical Sample and Testing Concept

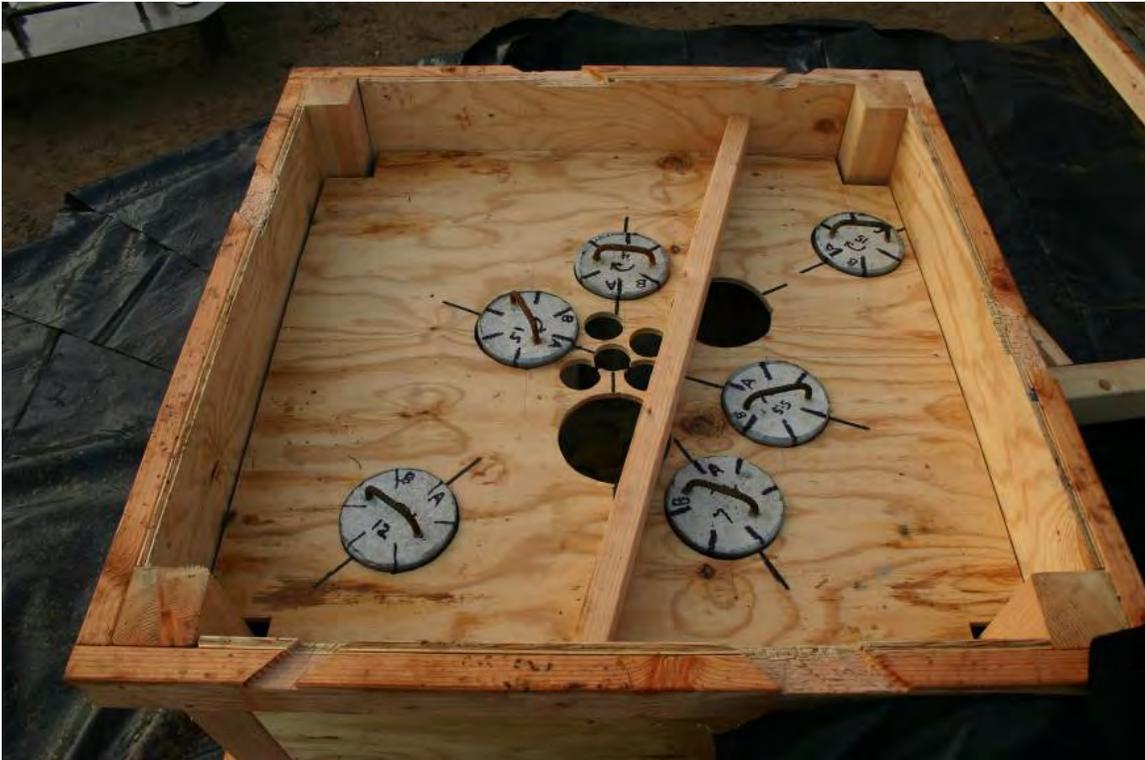
As shown on Figures 3.4 and 3.5, a wood frame secured the cylinders and water jet during testing. Circular cutouts in the top and bottom of the frame held the cylinders in their prescribed locations for the duration of the test, which allowed for simultaneous testing of multiple specimens at different standoff distances. The research team fitted each cylindrical specimen with a rebar "handle" at the top, as shown. The handle allowed for easier placement of the cylindrical specimens in the frame apparatus.

**Figure 3.4 - Photograph of the Frame Apparatus used to Secure Cylindrical Test Cylinders**

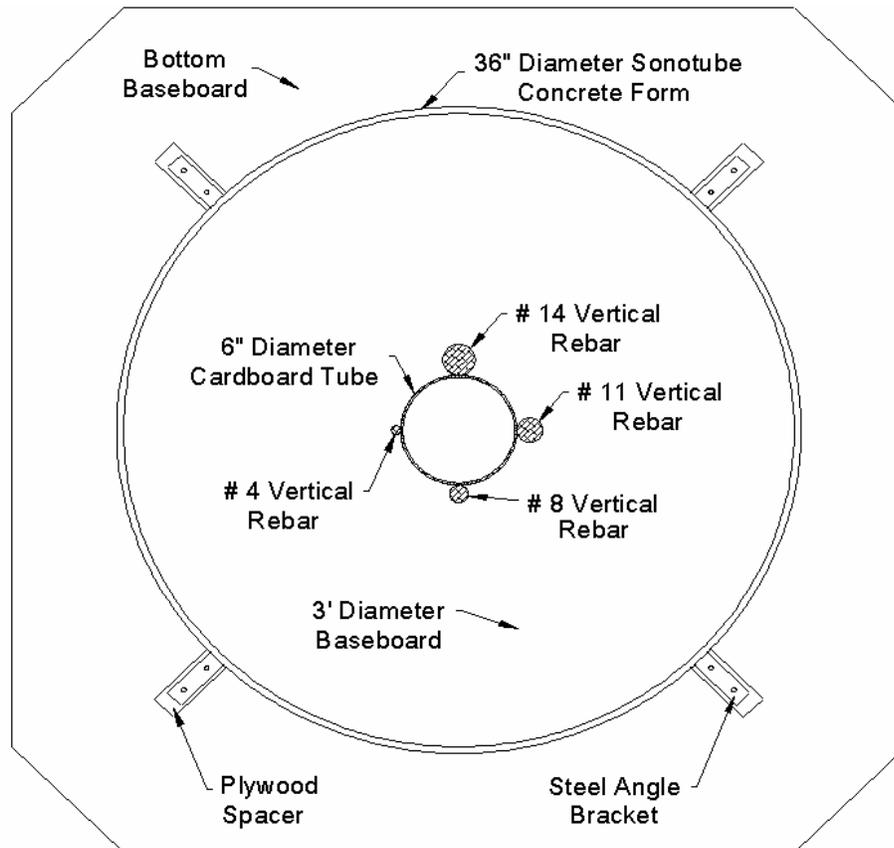
The research team cast four ring specimens with reinforcing steel to evaluate the influence the steel has on water jetting effectiveness in drilled shafts. Four ring samples were cast with longitudinal and transverse reinforcing steel bars. These ring samples had the same overall dimensions as those described earlier. Figure 3.6 shows, in plan view, a reinforcing steel layout that included four longitudinal (vertical) steel bars. The bars were evenly spaced around the inside diameter of a 6-inch sample ring. Plywood forms at the top and bottom of the sample fixed the bars in place during material placement and curing. The research team selected #4, #8, #11, and #14 bars because of their typical use as steel reinforcement in drilled shafts. Two identical ring samples were prepared using this sample arrangement.

**Figure 3.6 - Plan View of a 6-inch Inner Diameter Ring Sample with Discrete Longitudinal (Vertical) Bars**

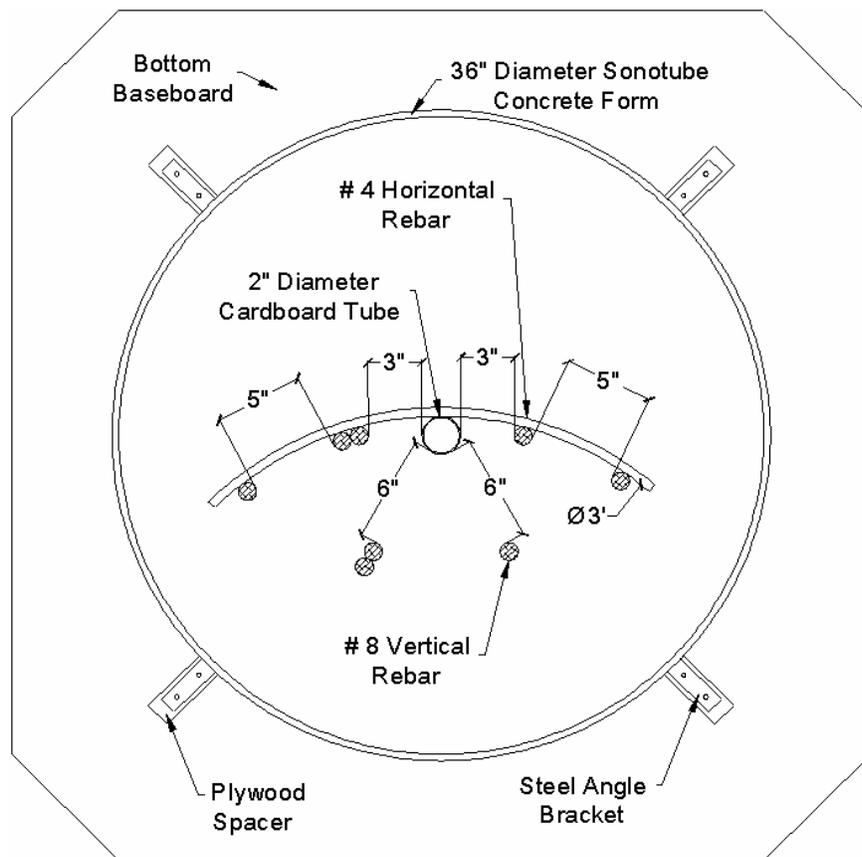
Figure 3.7 illustrates the second reinforcing steel layout used in this study. With this layout, the research team recreated (approximately) a portion of a typical reinforcing steel cage designed for a 3-foot diameter drilled shaft. Access for water jetting was provided through a 2.25-inch diameter hole at the center of the ring. This hole was designed to represent the hole created by a typical PVC access tube. Three-inch clear spacings were provided between the access hole and adjacent steel bars, as per the minimum spacing requirements stipulated by Caltrans. Other clear spacings between bars were based on typical drilled shaft designs. One curved transverse (horizontal) reinforcing bar was tied to the longitudinal steel at approximately the mid-height of the ring. In addition, the research team bundled some of the bars and added additional longitudinal steel at two locations (6 inches from the access hole) to further study the influence of reinforcing steel on water jetting effectiveness.

**Figure 3.7 - Plan View of a 2-inch Inner Diameter Ring Sample Designed to Simulate a Section of a 3-foot Diameter Drilled Shaft (including #8 Longitudinal Reinforcement and #4 Transverse Reinforcement)**

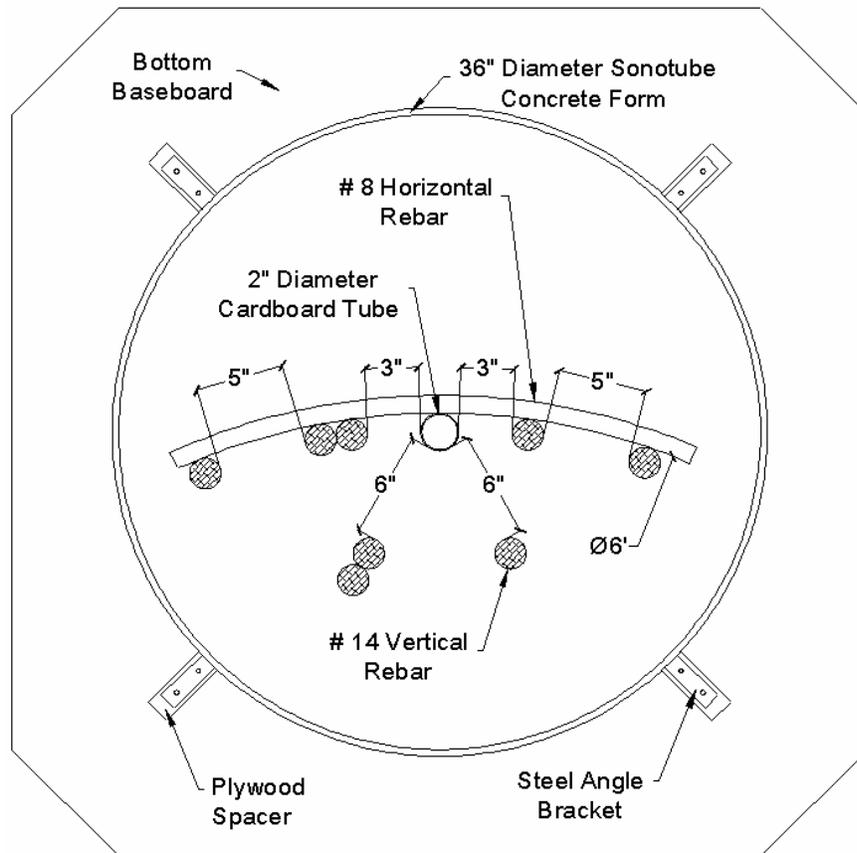
Figure 3.8 illustrates the third reinforcing steel layout examined as part of this study. This layout was similar to the layout illustrated on Figure 3.7. However, in this new case, the research team recreated (approximately) a portion of a typical reinforcing steel cage designed for a 6-foot diameter drilled shaft. As before, the research team bundled some of the bars and added additional longitudinal steel at two locations (6 inches from the access hole) to further study the influence of reinforcing steel on water jetting effectiveness

**Figure 3.8 - Plan View of a 2-inch Inner Diameter Ring Sample Designed to Simulate a Section of a 6-foot Diameter Drilled Shaft (including #14 Longitudinal Reinforcement and #8 Transverse Reinforcement)**

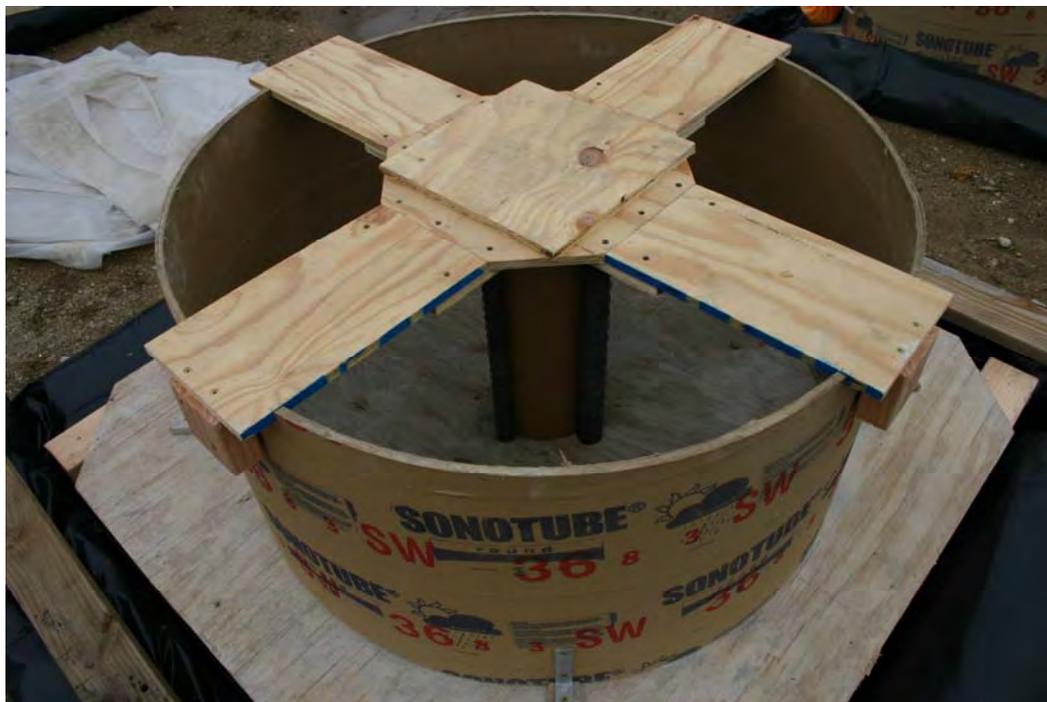
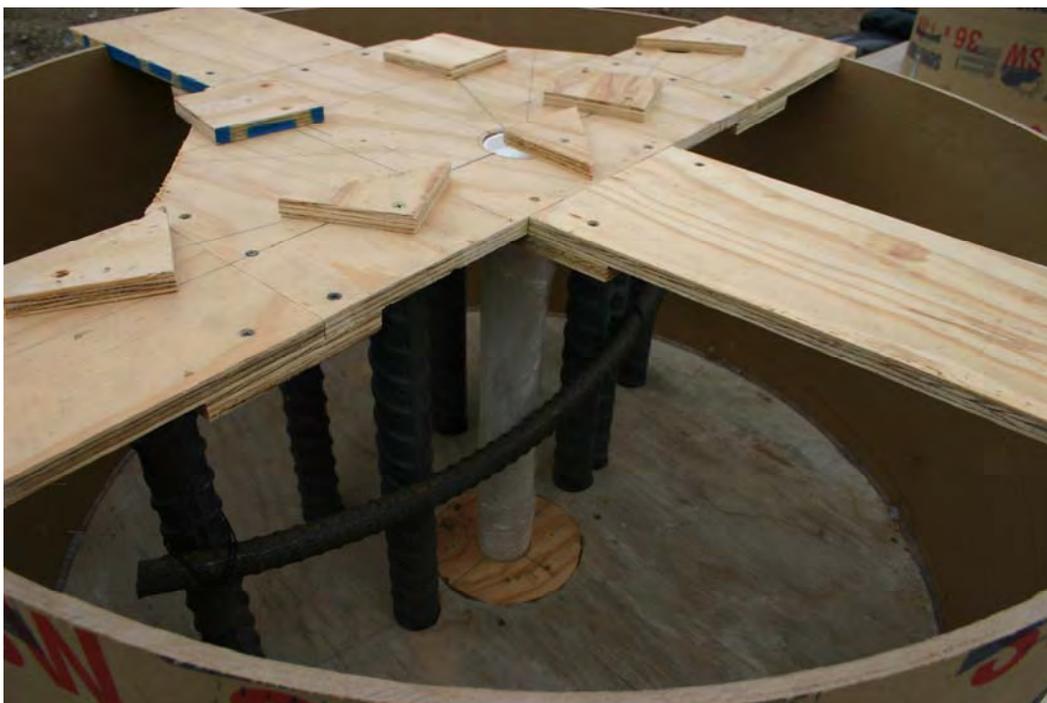
Shown on Figure 3.9 are photographs of the two ring samples that incorporated reinforcing steel. Note the presence of the plywood forms at the top of each ring. The forms held the longitudinal steel bars in place during material placement and curing.

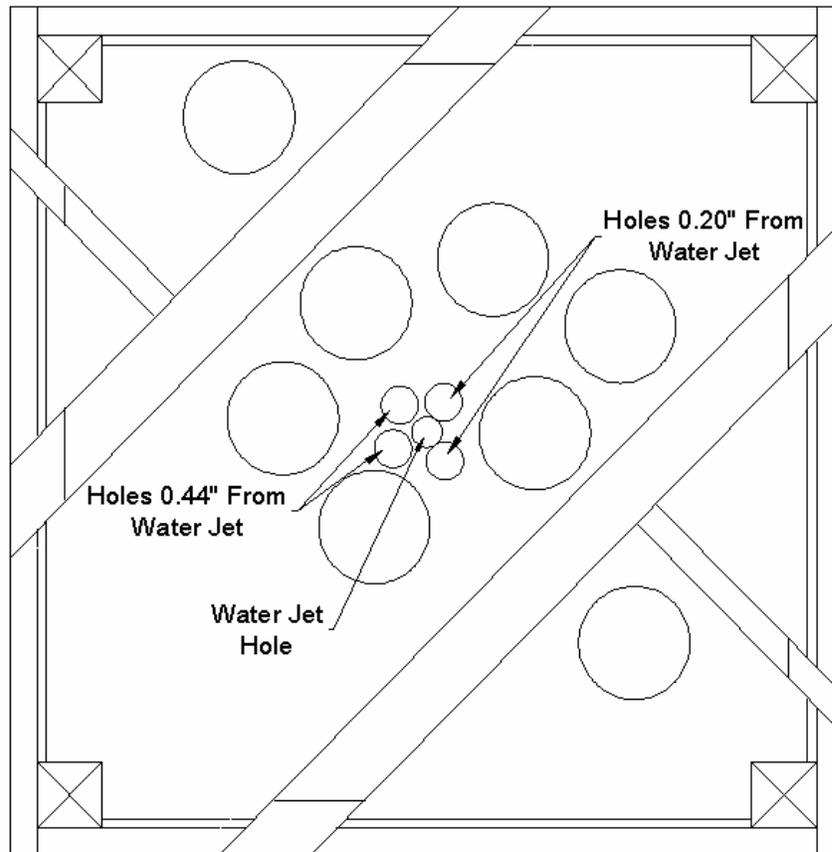
The research team performed additional tests to assess the erosion characteristics of PVC tubing. Sections of Schedule 40, 2-inch inside diameter PVC tubes similar to those used as access tubes in typical drilled shaft construction were fixed next to the water jet at standoff distances of approximately 0.20 and 0.44 inches. One would expect a standoff distance in this range for a water jet lowered within a 2-inch inside diameter inspection tube. The research team mounted PVC specimens (vertically) in the test frame used during the cylindrical sample tests, as illustrated on Figure 3.10. The ends of the PVC tubes were affixed to the test frame and held in place during water jetting.

**Figure 3.10 - Sketch of Test Frame and Holes used to Mount PVC Specimens**

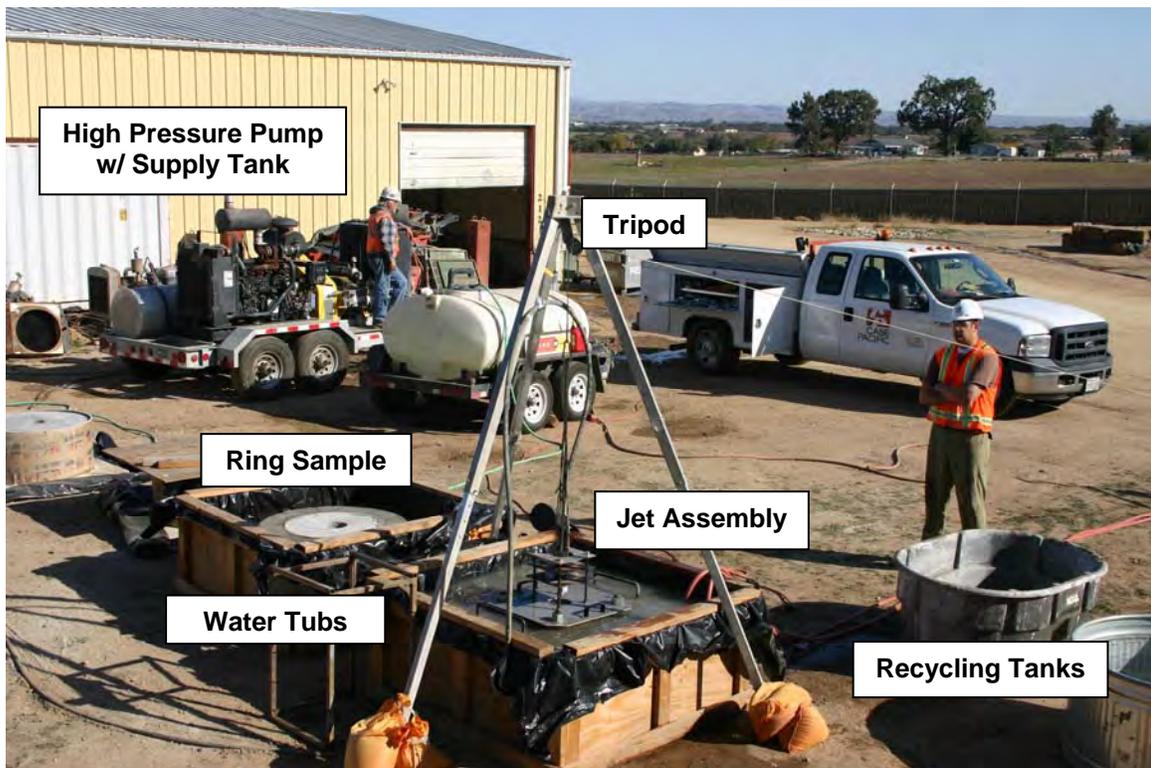
The photograph on Figure 3.11 illustrates the equipment and test arrangement used during this research program. The essential components included a high-pressure pump, a water jet, high-pressure hoses, a water storage tank, recycling tanks, and water tubs. The water tubs consisted of wood frames and plastic sheeting, which were built around the test samples and filled with water prior to water jetting. When the cylindrical specimens were tested, the previously described test frame was submerged within a water tub.

**Figure 3.11 - Photograph Showing the Water Jetting Test Equipment and Layout**

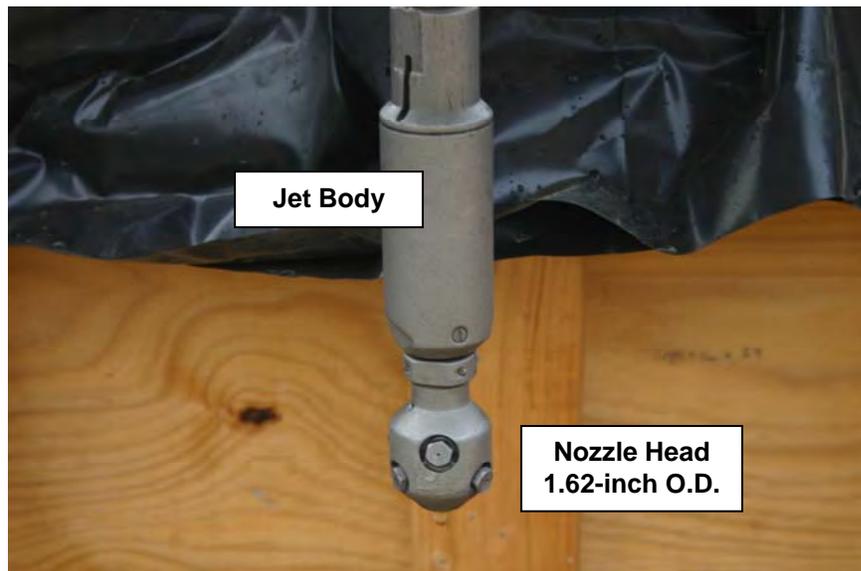
**Figure 3.12 -Photograph Showing the Self Rotary Water Jet and Nozzles**

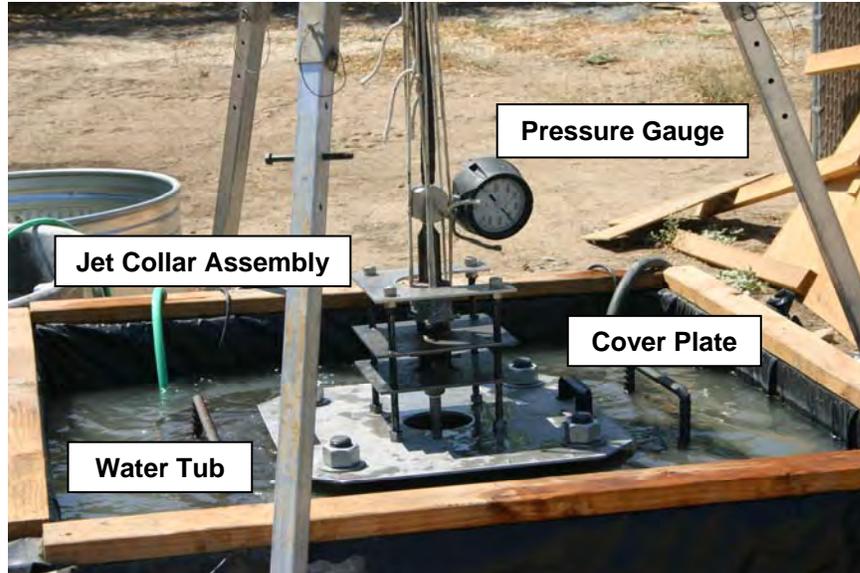
Shown on Figure 3.13 is a detail of the water jet collar. Prior to water jetting, a 0.25-inch thick steel plate with a 14-inch diameter access hole was fastened to a ring sample (or to the frame used during testing of the cylindrical specimens and PVC access tubes). The collar assembly attached to this plate and centered the water jet nozzle horizontally. The collar could be fixed in the vertical direction, or it could be left free to move up and down along four guide rods. A rope, pulley, and tripod system centered over the test sample allowed the research team to raise and lower (i.e. cycle) the collar and water jet over a vertical distance of 6 inches. The tripod and collar are illustrated on Figure 3.11. As noted on Figure 3.13, the research team included a pressure gauge in the water line directly behind the water jet and a 12-inch extension. The gauge allowed for direct measurement of water jetting pressure during testing.

**Figure 3.13 -Photograph Showing the Jet Collar Assembly and Cover Plate Attached to a Ring Sample during Testing**

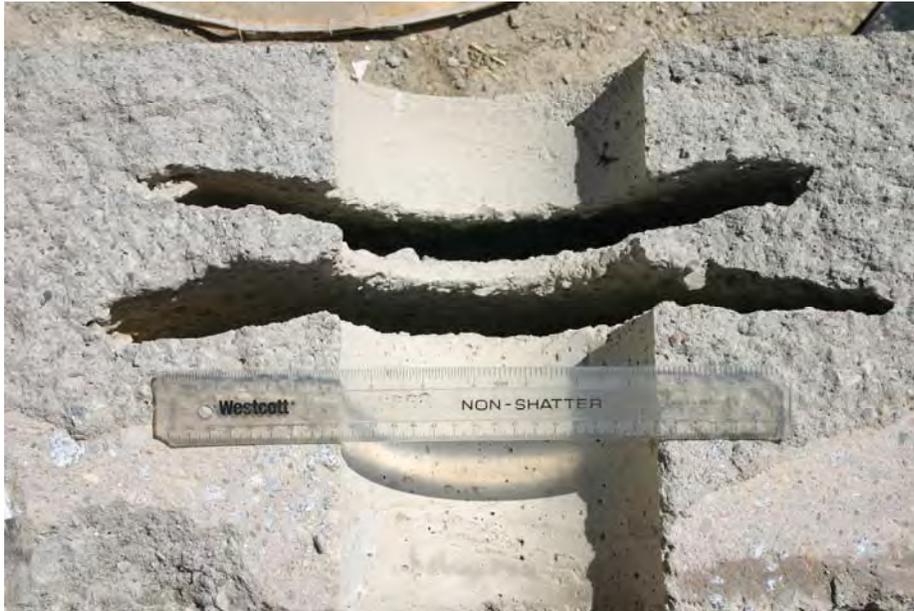
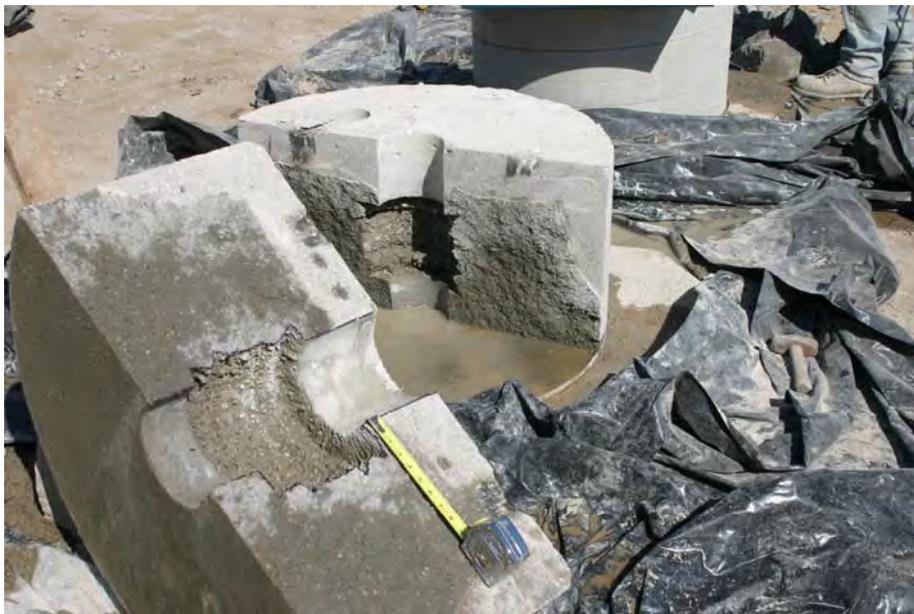
**Figure 3.14 - Post-Test Photographs of 6-inch Diameter Ring Samples:  
(a) Jet Held Stationary; (b) Jet Cycled Up and Down**

(a)

(b)

At the end of a water jetting time interval, jetting was stopped and the collar assembly was removed. The water inside the ring sample was then removed so the jetted surface could be examined and erosion measurements could be made. Figure 3.14 includes post-test photographs showing the general pattern of erosion observed during the "stationary" and "cycled" experiments. The x-shaped erosion pattern shown on Figure 3.14(a) occurred due to the angled orientation of the water jets on the rotating nozzle. The cavity-shaped pattern on Figure 3.14(b) occurred due to the cycling of the water jet up and down over the 6-inch vertical distance. The research team observed a similar cavity-shaped erosion pattern during the post-test examination of ring samples water jetted according to the "steady upward" approach.

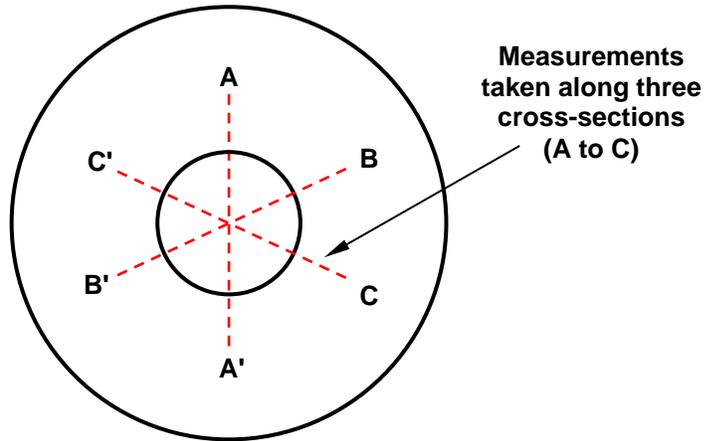
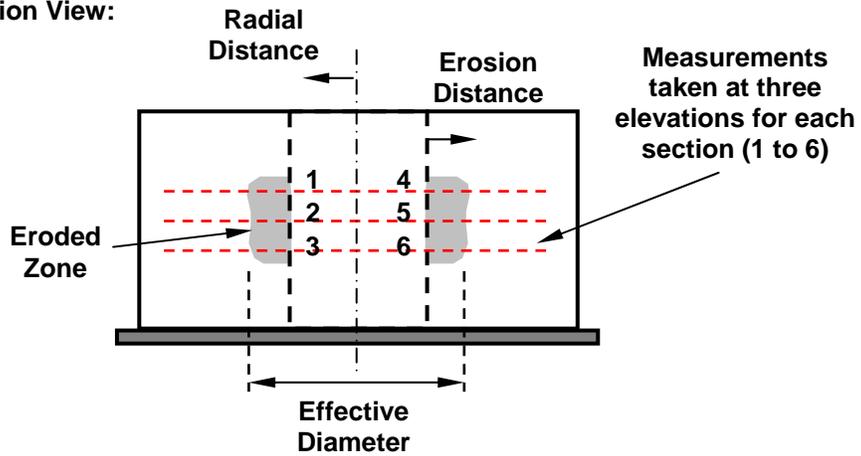
The team measured erosion distance at eighteen different points within a ring sample for three cross-sections and three elevations (each spaced 3 inches apart). Figure 3.15 illustrates the measurement schedule. For cases where the water jet was stationary, the team measured erosion distances within the well-defined incisions apparent on Figure 3.14(a), and not according to the guide illustrated on Figure 3.15. In all tests, erosion measurements were manually recorded to the nearest 1/16-inch. The un-jetted inside portion of a ring served as the "zero" reference for these measurements.

**Figure 3.15 - Illustration of Erosion Measurements taken during Water Jetting:**  
(a) Plan View; (b) Section View

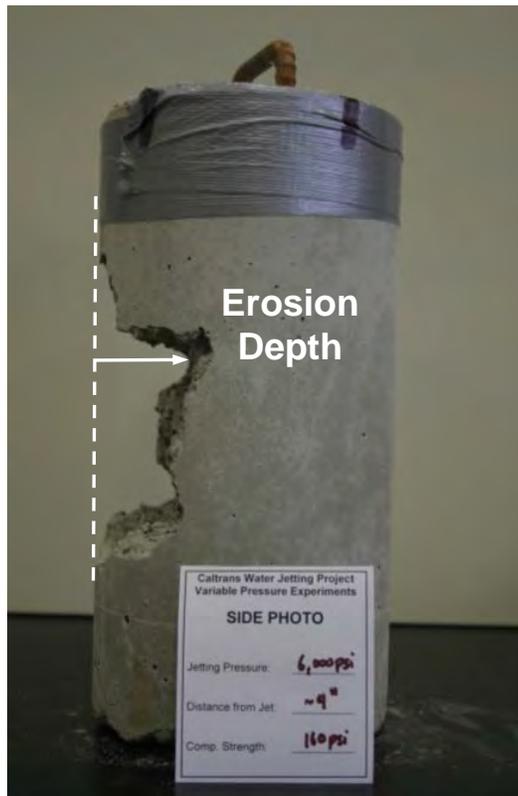
Once data were recorded, the research team prepared another set of concrete cylinders for water jetting. These cylinders were tested at the same standoff distances and a different jetting pressure. Extensively eroded cylinders were replaced with new ones for each new test. However, if erosion was slight, a cylinder was reused by rotating it such that the subsequent water jetting impacted an unaffected face. Several sets of cylinders were tested to examine erosion effects for standoff distances between 1.5 and 16 inches and water jetting pressures between 2,400 and 10,700 pounds per square inch. For example, the cylinder shown on Figure 3.16 had an unconfined compressive strength of 160 psi and was tested at a standoff distance of 4 inches for a jetting pressure of 6,000 psi.

**Figure 3.16 - Example of an Eroded Cylindrical Sample after Water Jetting**

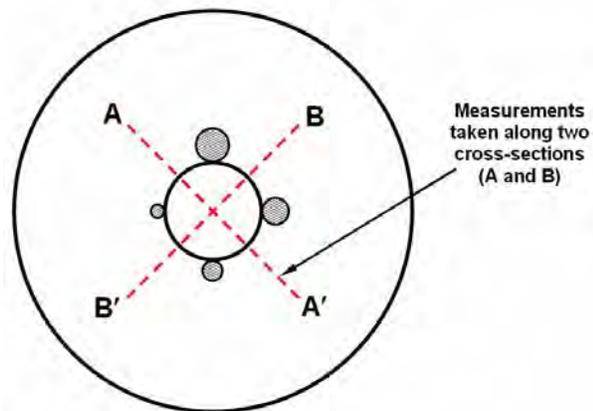
The research team followed the water jetting procedure described previously when testing the ring samples cast with reinforcing steel bars. Both "cycled" and "steady upward" approaches were employed. The research team modified its procedure for taking erosion measurements to accommodate the reinforcing steel present in the ring samples. Erosion distances for the 6-inch inner diameter ring samples were measured at twelve different points for two cross-sections and three elevations (each spaced 3 inches apart). Figure 3.17 illustrates the measurement schedule in plan view only.

**Figure 3.17 - Erosion Measurement Locations for Ring Samples Cast with Reinforcing Steel Bars**

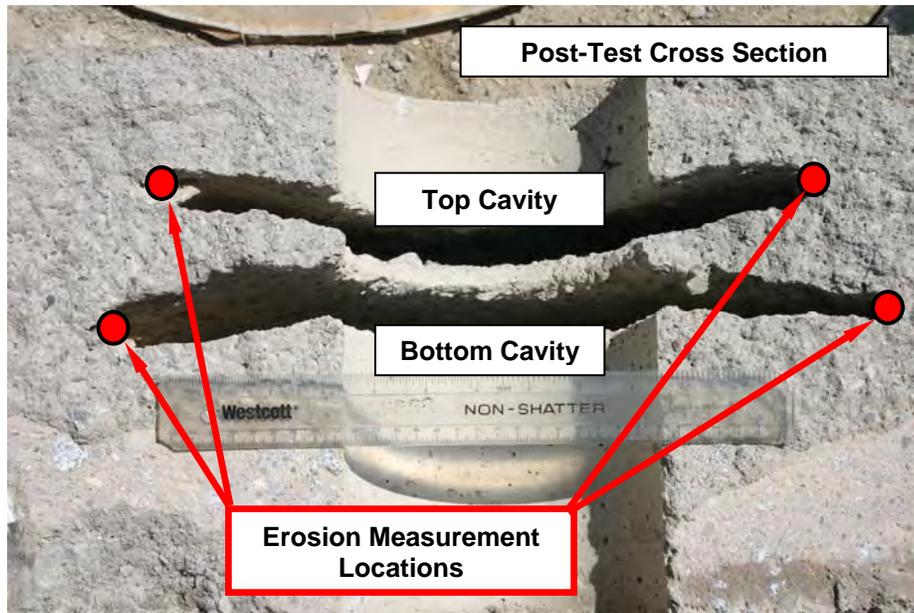
ring, and recorded depth measurements. Depth measurements were made by using a simple hand-held probe and were recorded to the nearest 1/16-inch.

**Figure 4.1 - Post-Test Photograph of the 6-inch Diameter Ring Sample, SCM-01 Test Series; Erosion Measurement Locations Noted**

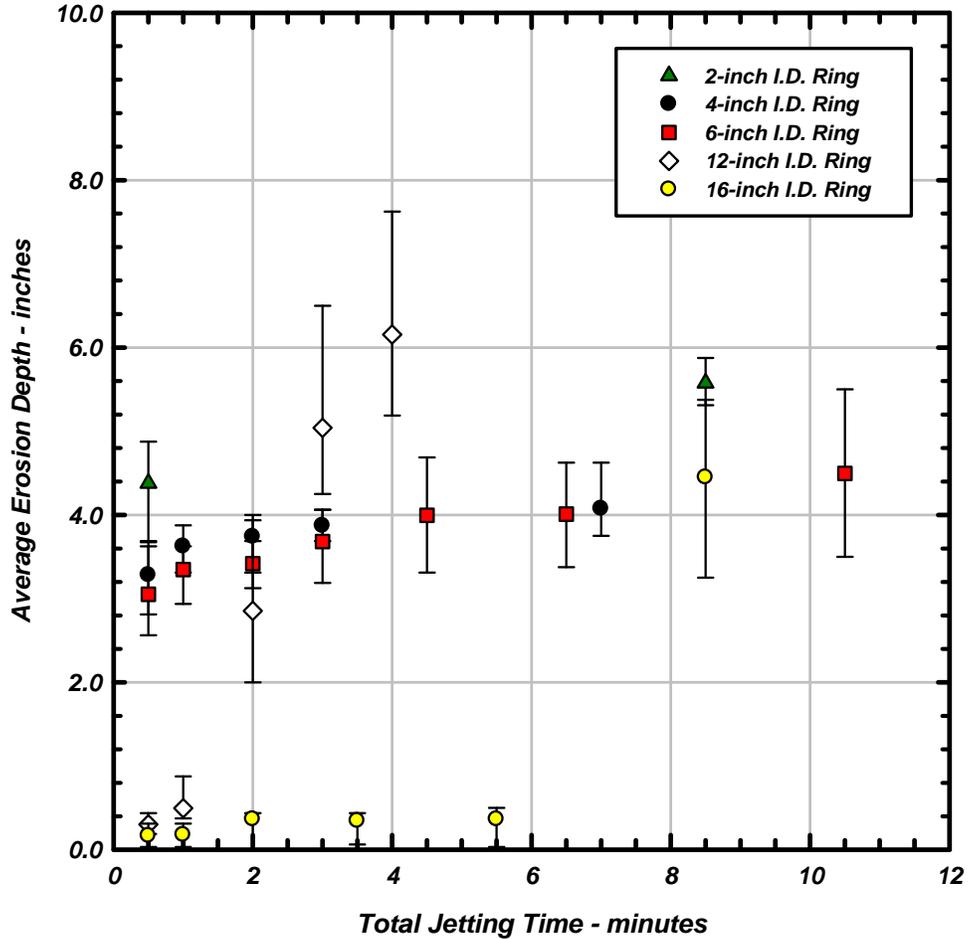
**Figure 4.2 - Average Erosion Depth with Minimum and Maximum Error Bars Measured for the SCM-01 Test Series**

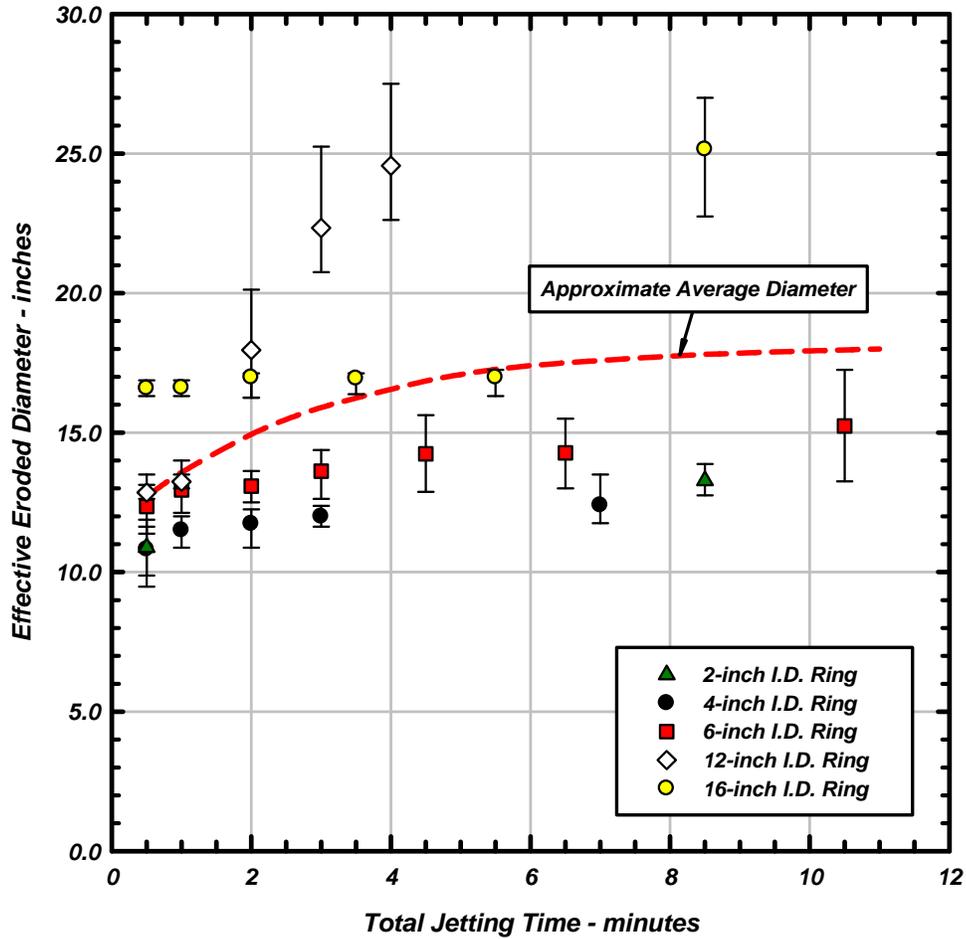
Figure 4.3 illustrates the variation of effective eroded diameter as a function of total jetting time for the five ring samples examined during test series SCM-01. Effective eroded diameter is defined on Figure 3.15 and represents the sum of the initial ring diameter and twice the average erosion depth. This dimension approximates the size of the eroded cavity that forms around the water jet during jetting. The graph on Figure 4.3 shows average eroded diameter with minimum and maximum diameters included as simple error bars. Also shown is a hand-drawn trendline (based approximately on the reported data), which illustrates how average effective eroded diameter increases with jetting time. This trendline has a peak effective eroded diameter of 18 inches.

**Figure 4.3 - Effective Eroded Diameter with Minimum and Maximum Error Bars Measured for the SCM-01 Test Series**
