1. REPORT NUMBER <b>CA12-1741</b>	2. GOVERNMENT ASSOCIATION NUMBER	3. RECIPIENT'S CATALOG NUMBER
4. TITLE AND SUBTITLE <b>WATER JETTING FOR THE MITIGATION OF DEFECTS IN DRILLED SHAFTS - A LABORATORY INVESTIGATION OF JETTING EFFECTIVENESS IN DIFFERENT DELETERIOUS MATERIALS</b>		5. REPORT DATE <b>September 2012</b>

# WATER JETTING FOR THE MITIGATION OF DEFECTS IN DRILLED SHAFTS - A LABORATORY INVESTIGATION OF JETTING EFFECTIVENESS IN DIFFERENT DELETERIOUS MATERIALS

Final Report

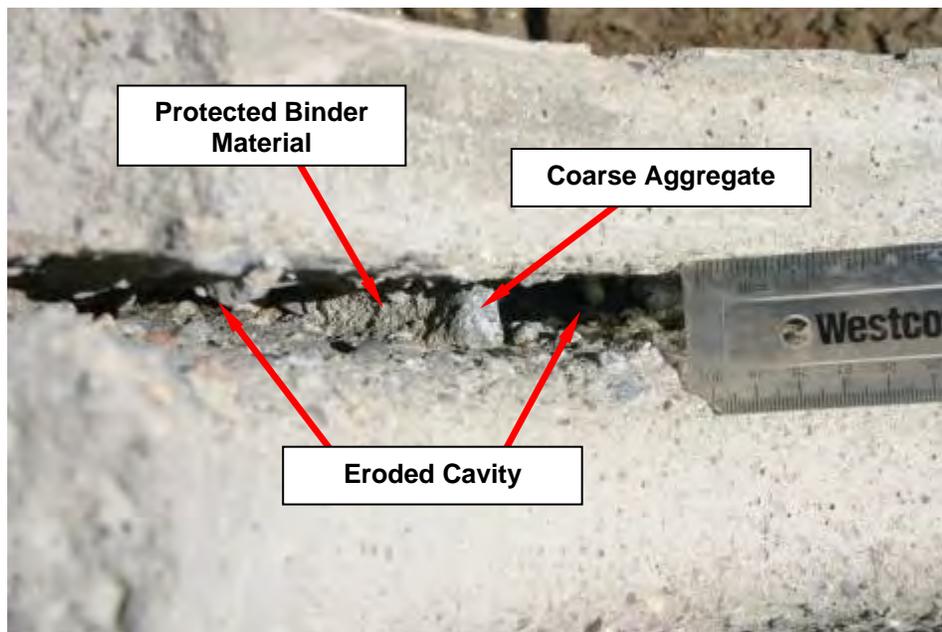
very little binder. When examining jetted surfaces in the concrete samples, the research team observed that larger, protruding aggregates often created small zones of protected or "shadowed" concrete where jetting effectiveness was reduced and binder materials were less easily eroded. Such zones occurred on opposite sides of the aggregates from the water jet. In the field, downhole camera inspection of water jetted drilled shafts has revealed these shadow zones adjacent to longitudinal and transverse reinforcing steel bars (Liebich 2008). Figure 4.4 shows an incident of shadowing observed during the SCM-01 test series.

**Figure 4.4 - Photograph Showing Protected Binder Material and Shadowing Observed during Test Series SCM-01**

When examining jetted surfaces in the concrete samples, it was observed that larger aggregates often created small shadow zones where jetting effectiveness was reduced and binder materials were less easily eroded. These shadow zones have been observed adjacent to reinforcing steel bars during water jetting of drilled shafts in the field. In experiments conducted as part of this study, shadow zones of deleterious material were observed behind reinforcing steel bars. Rebar were found to influence erosion levels and water jetting effectiveness by interfering with the jet path. The most pronounced shadow effects occurred behind bars with larger diameters and behind longitudinal-transverse bar arrangements with tight spacings. Shadow effects were more prominent the farther the rebar were positioned from the water jet.

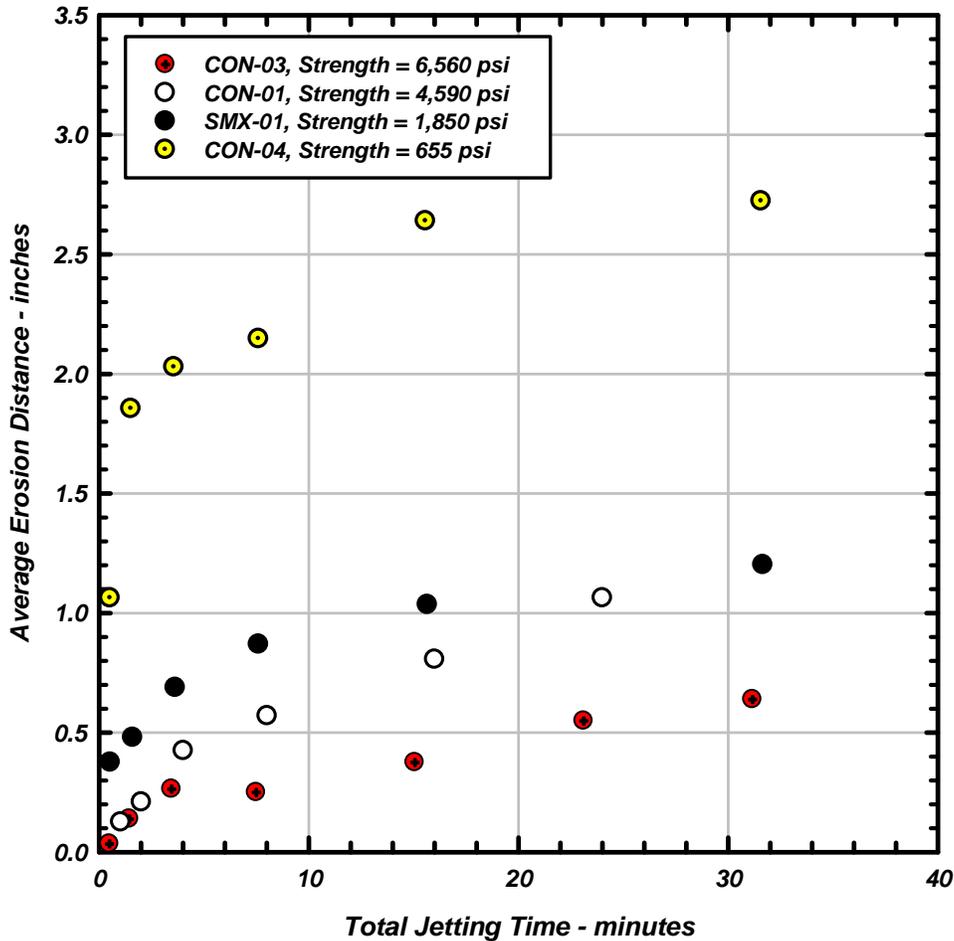
**Figure 4.5 - Average Erosion Measured for 6-inch I.D. Concrete Ring Samples**

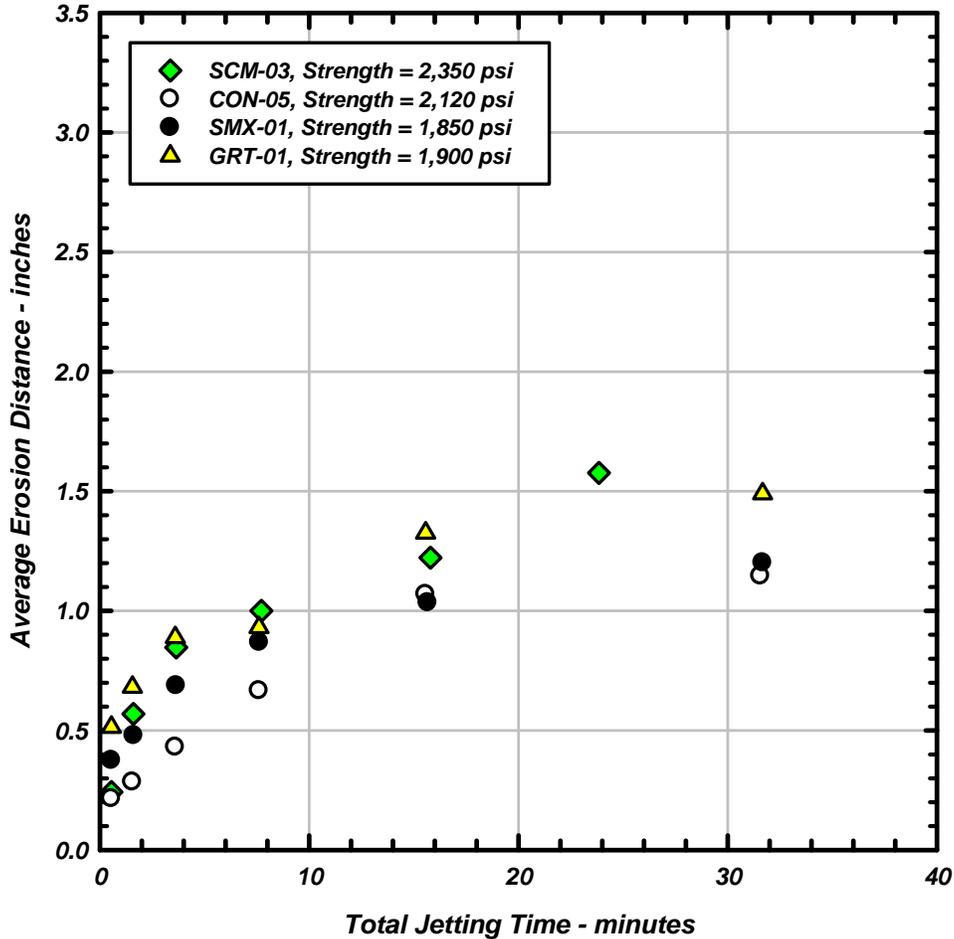
Figure 4.6 shows average erosion distance as a function of jetting time for tests SCM-03, CON-05, SMX-01, and GRT-01. Results are shown for tests conducted using 6-inch ring samples. The materials used in these tests had similar compressive strengths but different aggregate characteristics. The results on the figure suggest that aggregate characteristics, including particle size and angularity, do not strongly influence jetting effectiveness. This includes the shadowing of concrete behind large aggregates which, while noticeable, did not affect the overall erosion results. Average erosion distances on Figure 4.6 are similar for all four materials at similar time intervals. Further, the removal rates are consistent and show diminishing water jetting effectiveness after about 15 to 20 minutes of jetting.

**Figure 4.6 - Average Erosion Measured for 6-inch I.D. Ring Samples with Similar Compressive Strengths**

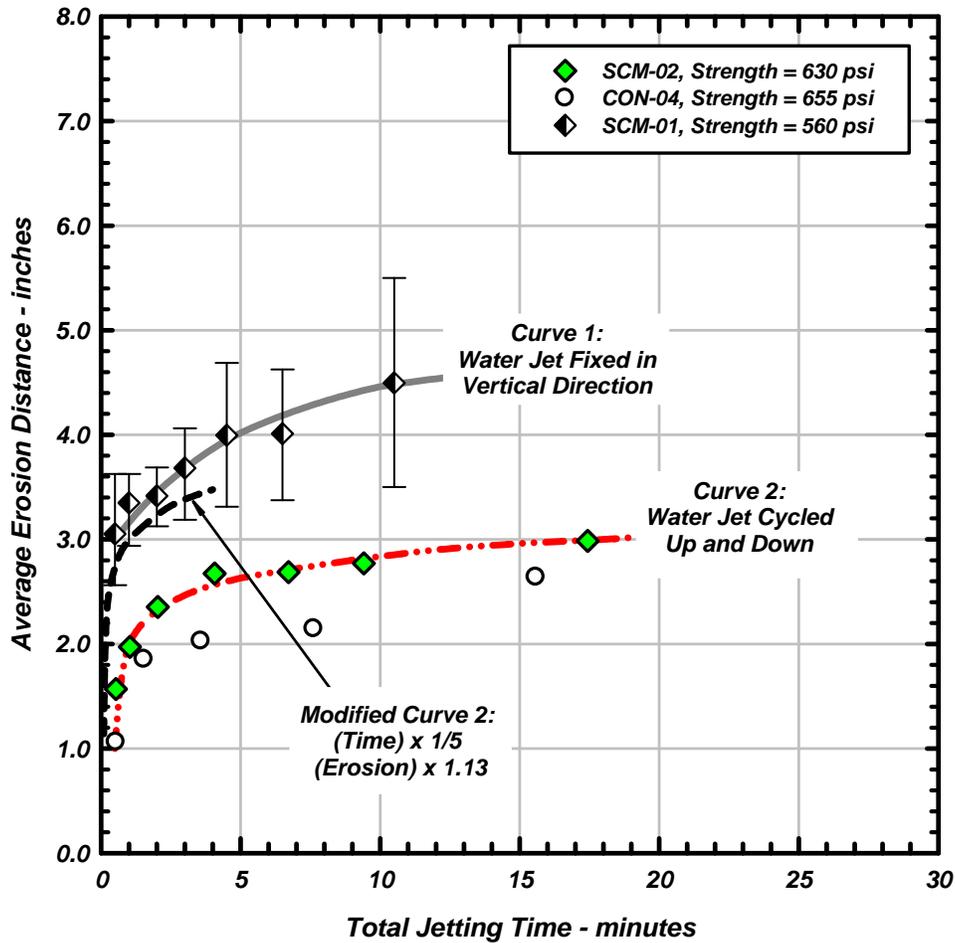
Curves 1 and 2 on Figure 4.7 represent trendlines for the erosion distances measured during tests SCM-01 and SCM-02, respectively. Also included on Figure 4.7 is a modified version of Curve 2: the time values of this curve were divided by five (to account for jetting time differences between SCM-01 and SCM-02) and the erosion values were increased by 13 percent (to account for differences in compressive strength between SCM-01 and SCM-02). As apparent, the modified curve falls within the range of data measured during SCM-01. This result further illustrates the influence of compressive strength on water jetting effectiveness. In addition, the result suggests that contact time during water jetting has some influence on jetting effectiveness and erosion rate.

**Figure 4.7 - Average Erosion Measured for 6-inch I.D. Low Strength Concrete Ring Samples Subject to Stationary and Cyclic Jetting**

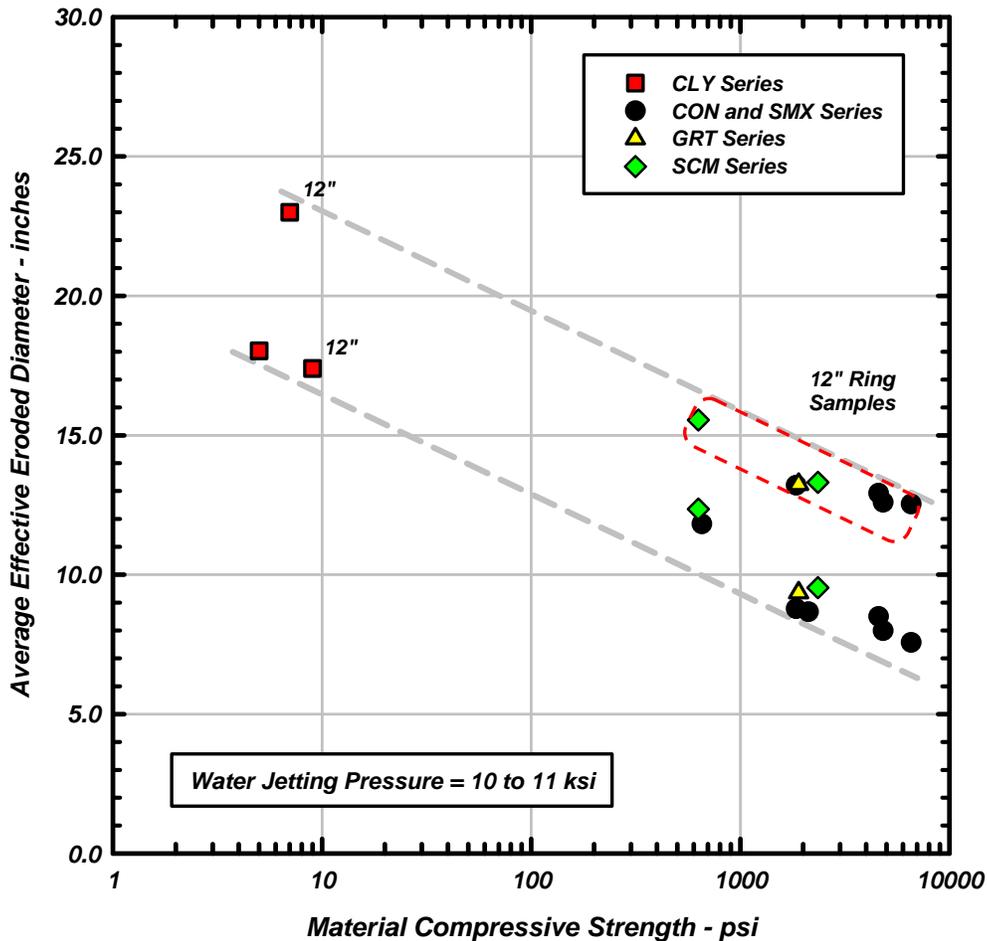
Average final effective eroded diameters in Table 4.2 are plotted as a function of compressive strength (on a logarithmic scale) on Figure 4.8. The results further demonstrate the influence of compressive strength on water jetting effectiveness. An effective eroded diameter of approximately 23 inches was observed for one of the bentonite-cement samples, representing the largest effective eroded diameter reported. Figure 4.8 shows that effective eroded diameters are larger for the 12-inch ring samples, in comparison with the 6-inch samples. This result provides further evidence that the size of the void space surrounding the water jet influences jetting effectiveness.

Figure 4.8 - Average Effective Eroded Diameter for 6- and 12-inch I.D. Ring Samples

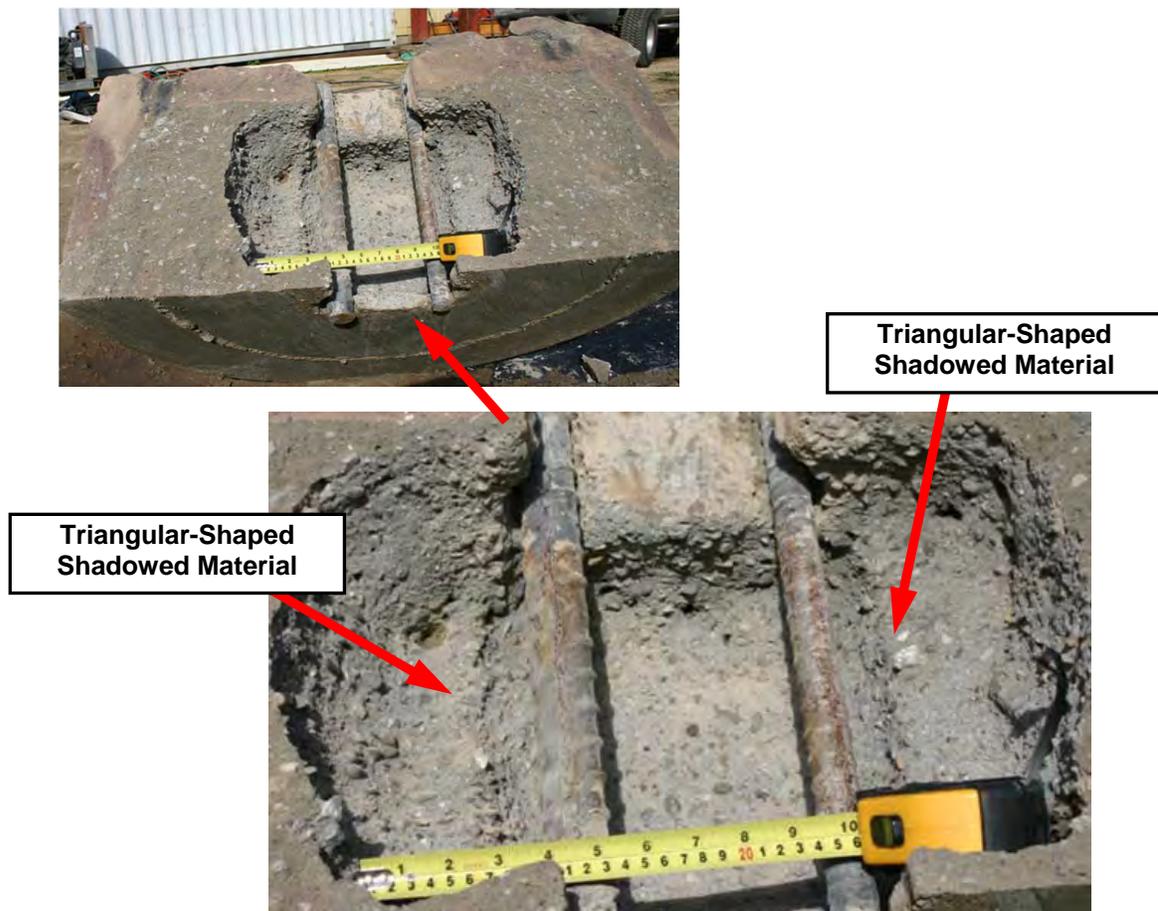
Figure 4.9 - Post-Test Photographs of Test SCM-04

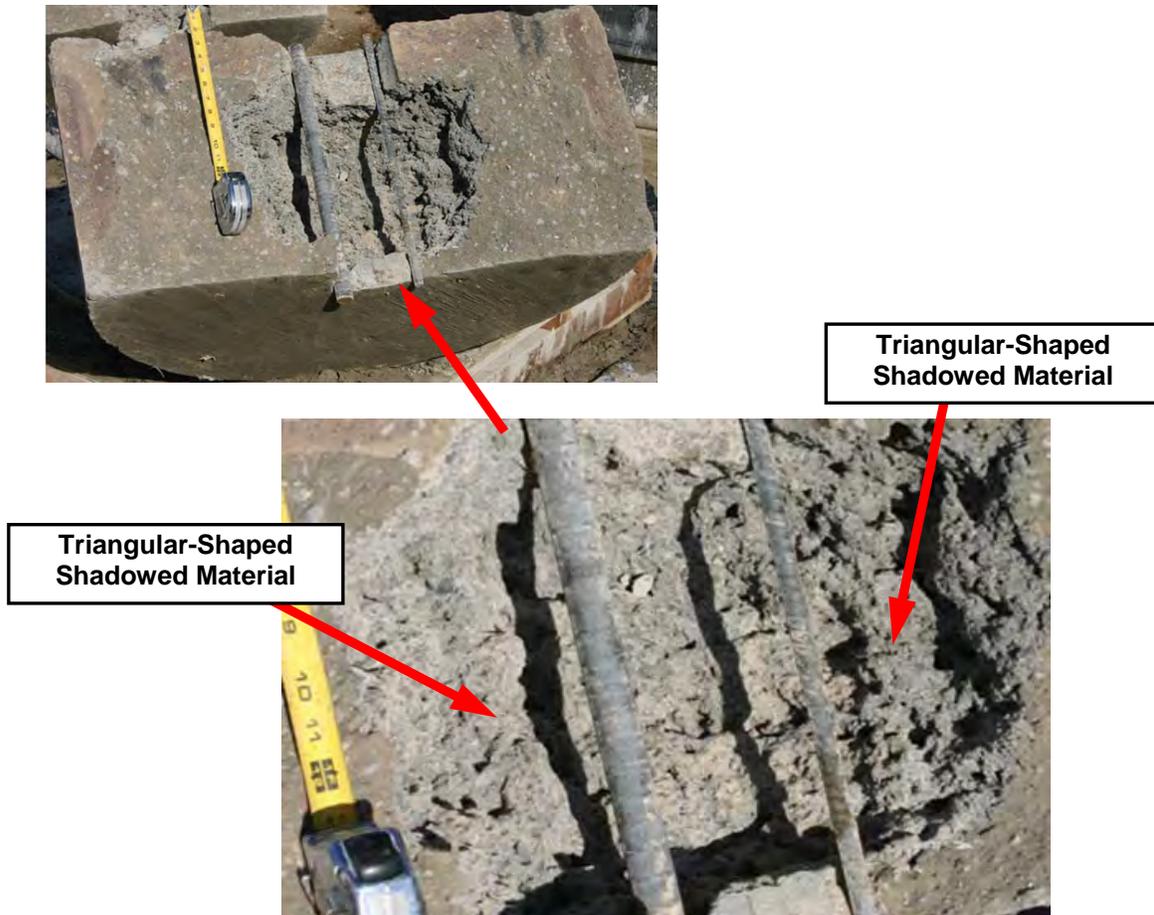
**Figure 4.10 - Post-Test Photographs of Test SCM-05**

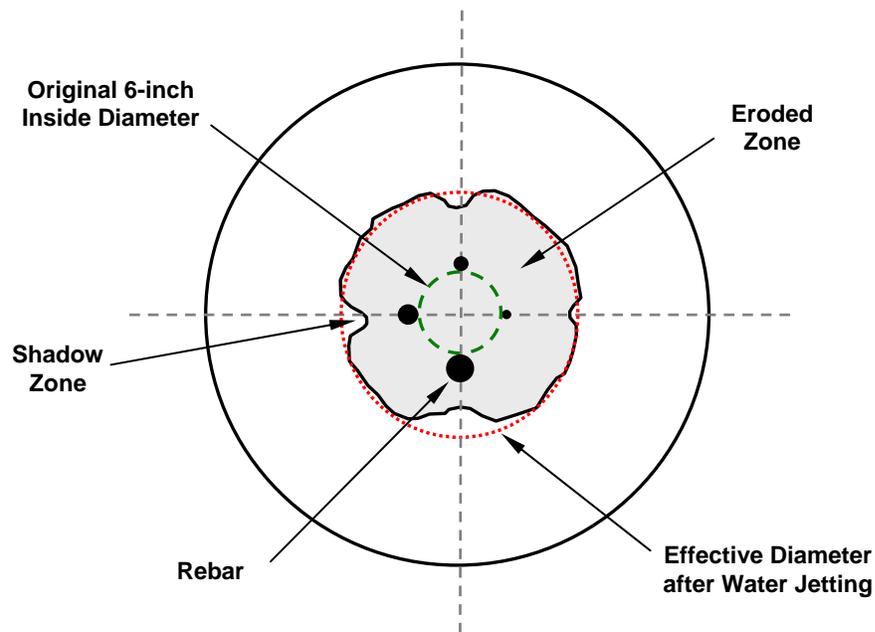
**Figure 4.11 - Plan View Illustration of Shadow Effects Observed during Water Jetting of the SCM-04 and -05 Samples**

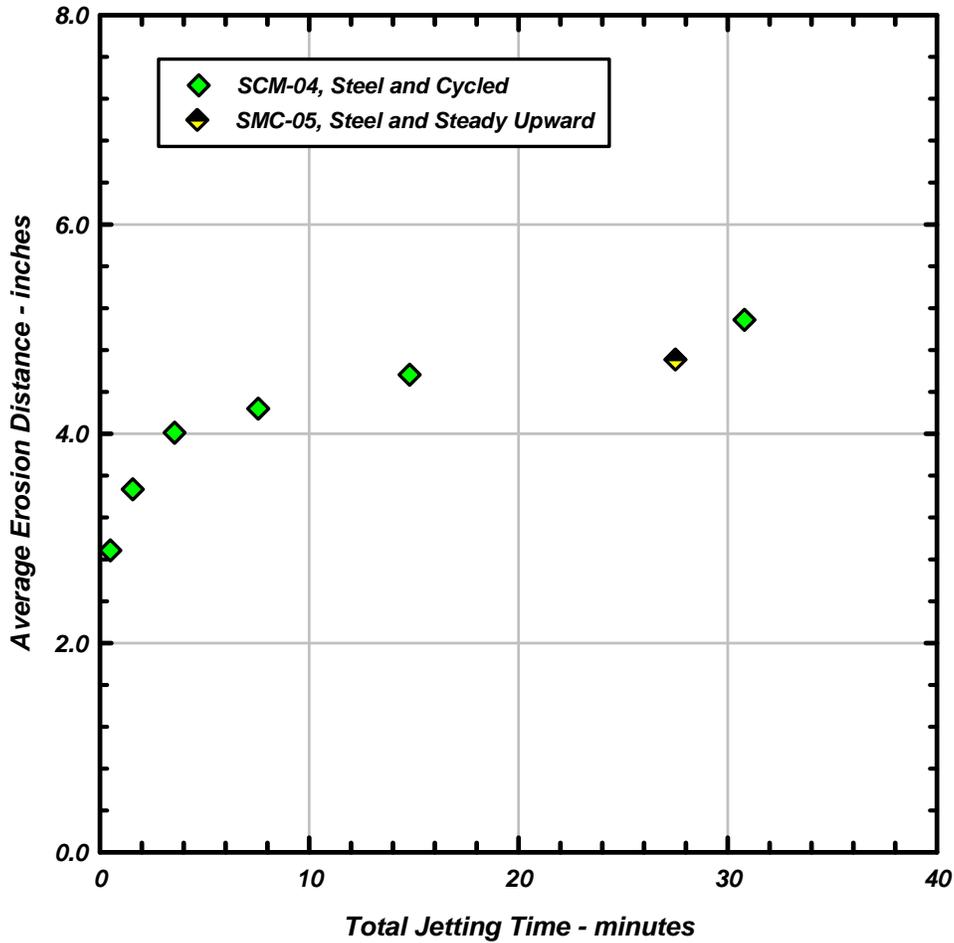
**Figure 4.12 - Average Erosion Measured during Tests SCM-04 and SCM-05**

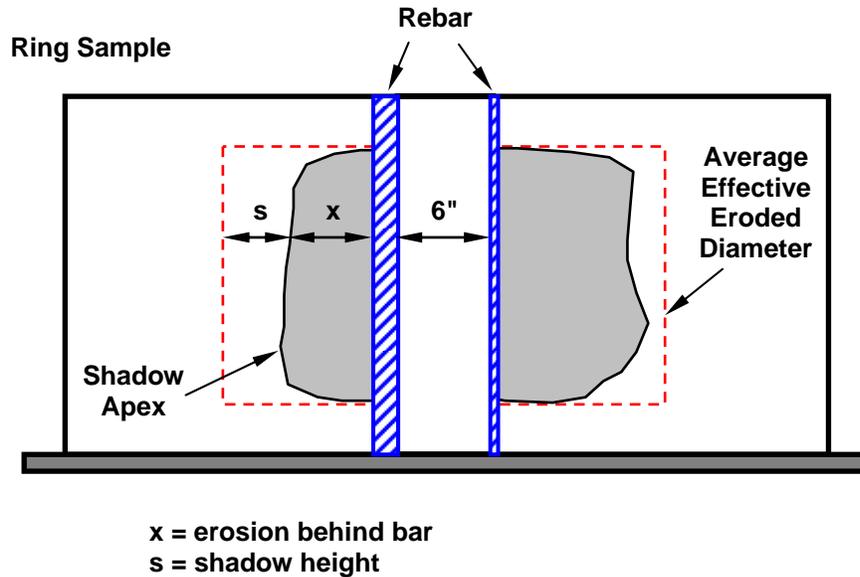
**Figure 4.13 - Explanation of Shadow Height Measurements for Tests SCM-04 and SCM-05**

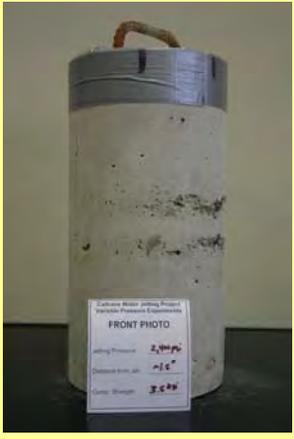
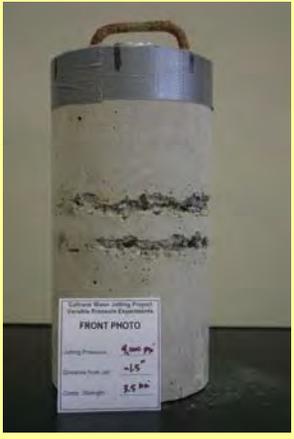
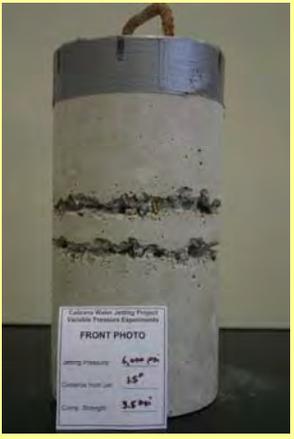
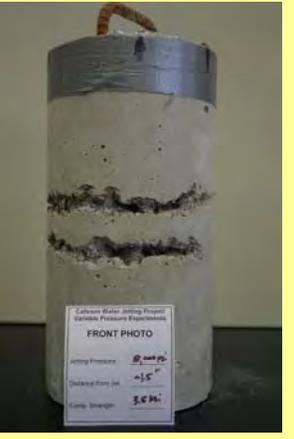
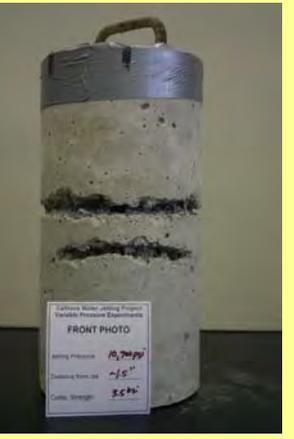
<p><b>(a) Jetting Pressure:</b> <b>2,400 psi</b></p>	<p><b>(b) Jetting Pressure:</b> <b>4,000 psi</b></p>	<p><b>(c) Jetting Pressure:</b> <b>6,000 psi</b></p>	<p><b>(d) Jetting Pressure:</b> <b>8,200 psi</b></p>	<p><b>(e) Jetting Pressure:</b> <b>10,700 psi</b></p>
<p>Jetting Interval: 1-2 minutes</p>	<p>Jetting Interval: 1-2 minutes</p>	<p>Jetting Interval: 1-2 minutes</p>	<p>Jetting Interval: 1-2 minutes</p>	<p>Jetting Interval: 1-2 minutes</p>
<p>Maximum Erosion Depth: 0 in.</p>	<p>Maximum Erosion Depth: 0.28 in.</p>	<p>Maximum Erosion Depth: 0.63 in.</p>	<p>Maximum Erosion Depth: 0.91 in.</p>	<p>Maximum Erosion Depth: 1.16 in.</p>

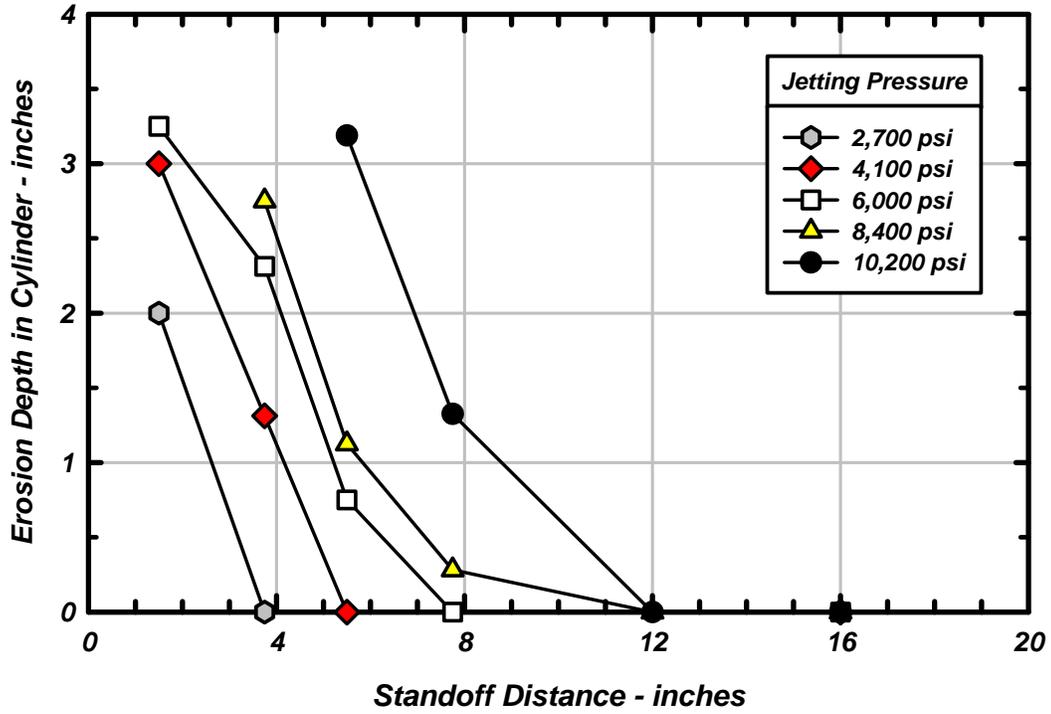
Figure 4.14 - Cylinder Erosion Depth as a Function of Jetting Pressure and Standoff Distance for SCM-06 (compressive strength = 160 psi)

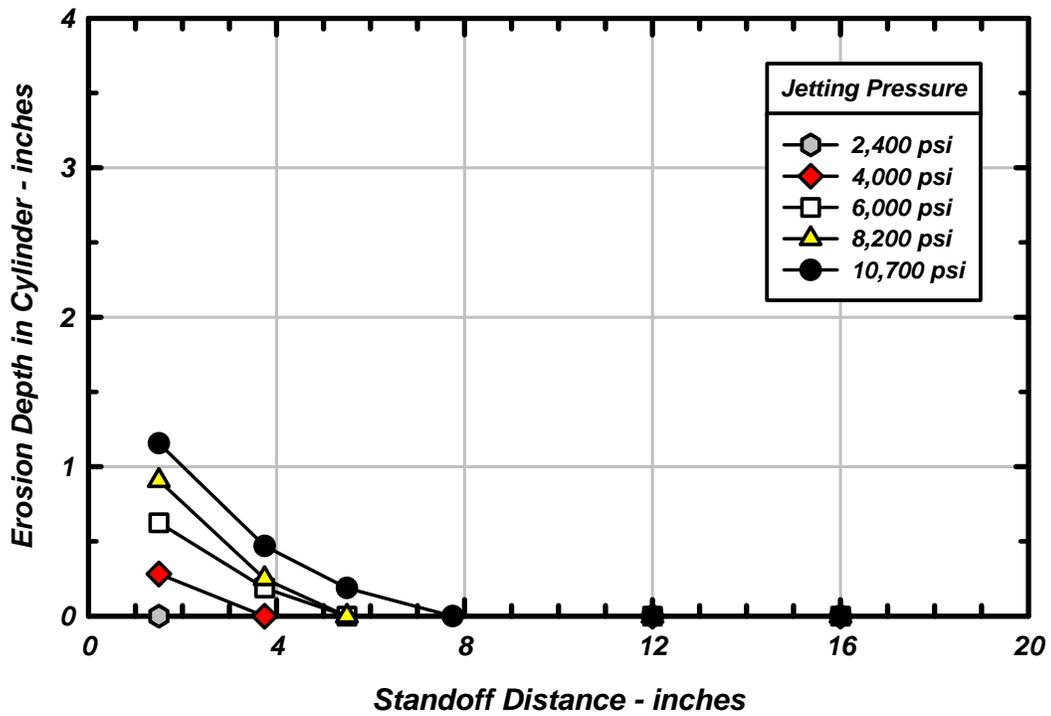
Figure 4.15 - Cylinder Erosion Depth as a Function of Jetting Pressure and Standoff Distance for CON-06 (compressive strength = 3,600 psi)

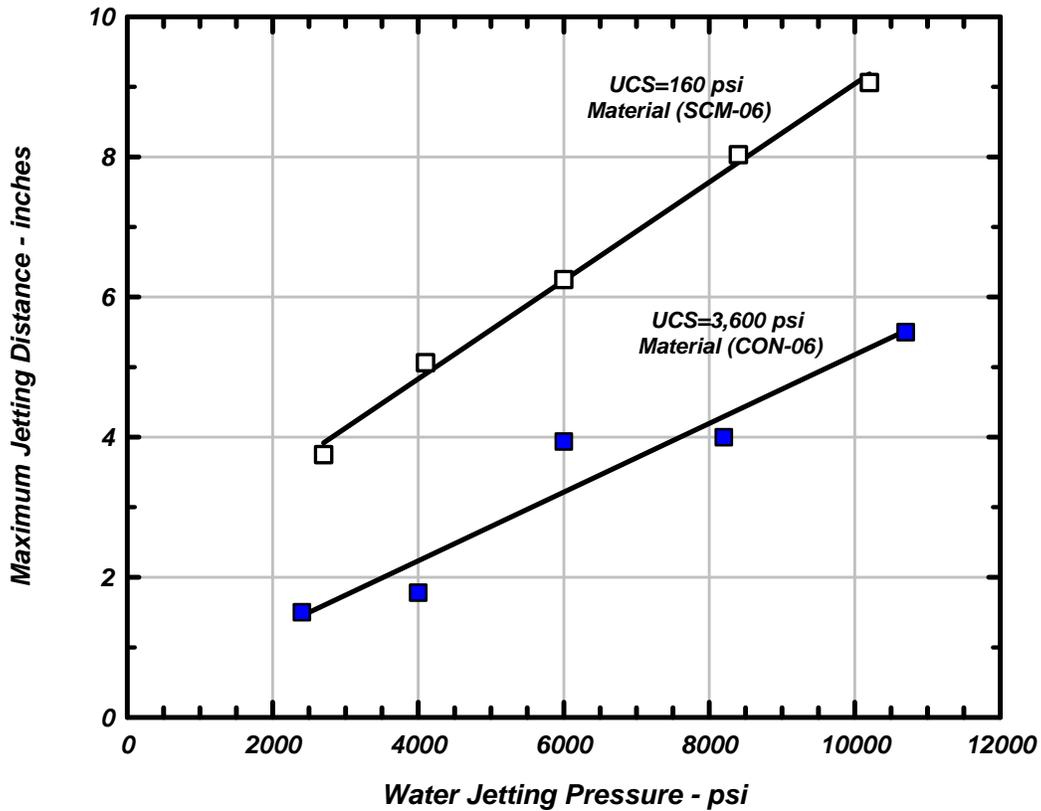
**Figure 4.16 - Maximum Jetting Distance as a Function of Jetting Pressure for the 160 psi (SCM-06) and 3,600 psi (CON-06) Cylinder Tests**

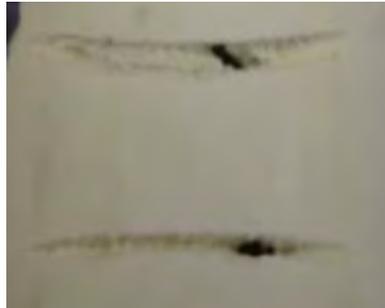
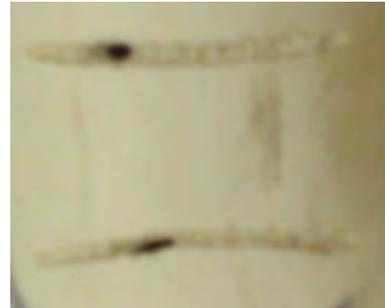
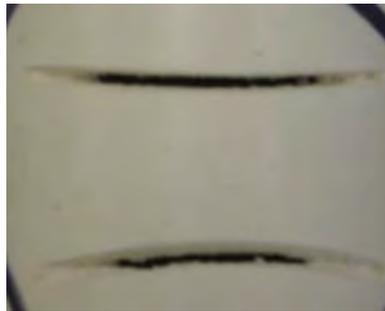
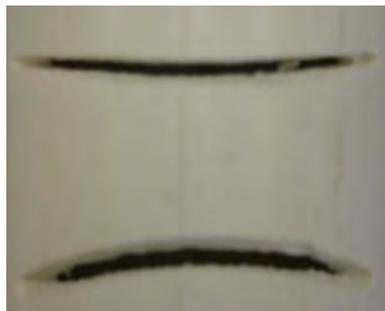
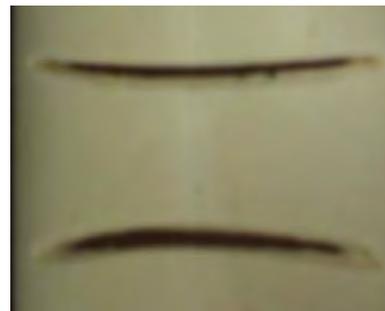
**(a) 4,200 psi at 0.20 inches**

**(b) 4,200 psi at 0.44 inches**

**(c) 6,000 psi at 0.20 inches**

**(d) 6,000 psi at 0.44 inches**

**(e) 8,000 psi at 0.20 inches**

**(f) 8,000 psi at 0.44 inches**

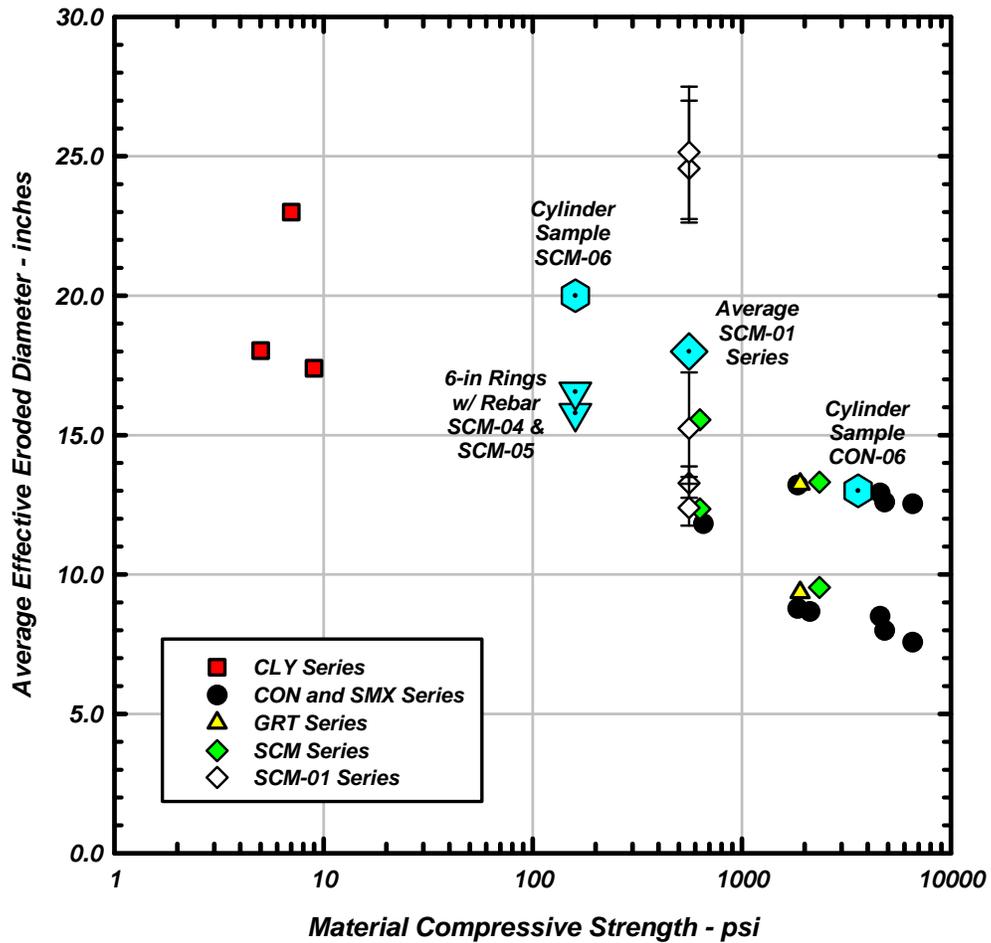
Figure 4.18 - Average Effective Eroded Diameter for all Material Samples

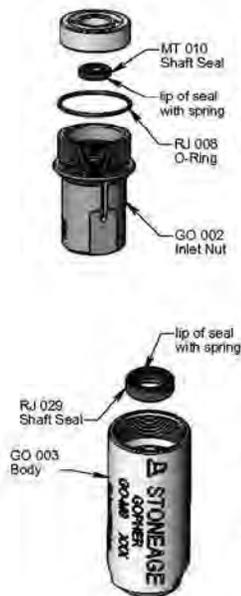
1. Install O-Ring (RJ 008) over the threads of the Inlet Nut (GO 002). Install Shaft Seal (MT 010) into the Inlet Nut; the lip with the spring faces down in this view.
2. Install Shaft Seal (RJ 029) into Body (GO 003); the lip with the spring faces up in this view. Apply grease or Armour-All to the lips of the seals.

3. Install Bearing (RJ 007) on Shaft (GO 001); this is a thrust bearing and must be installed with the wide inner race facing toward shoulder on Shaft.

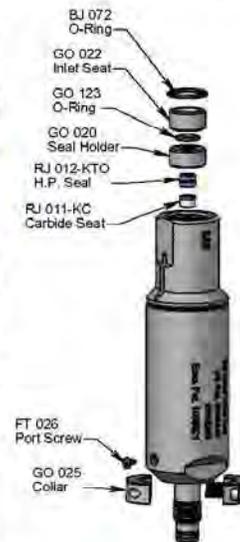
10. Install the Collar (GO 025) onto the Shaft end.

11. Install the high pressure seal components as described in the Maintenance Section.
12. Fill the swivel with oil as shown in the Maintenance Section. Install the Port Screw (FT 026).
