# Evaluation of an Automated Bridge Anti-icing System

# **Final Report**

Report No. FHWA-NH-RD-13733G

# EVALUATION REPORT, JUNE 2005 TO JUNE 2008 AUTOMATED BRIDGE ANTI-ICING SYSTEM I-89, LEBANON, NH

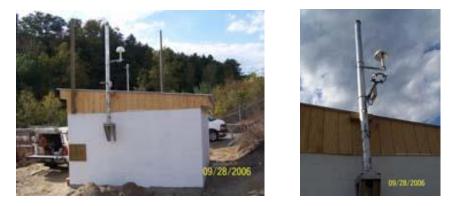
Roadway Weather Information System is installed at pump house. The system measures ambient air temperature, relative humidity and rainfall.
