# On-Board Sound Intensity (OBSI) Study

Phase 2

**FDOT Project No. #BDT06**

## **Final REPORT**

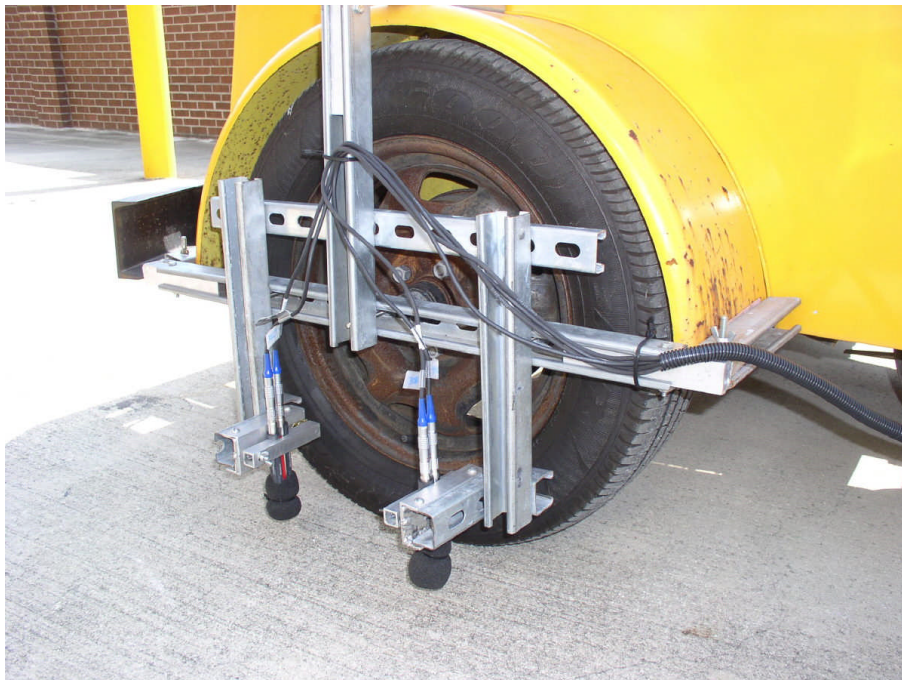
Figure 1. Prototype Test Rig With Intensity Probes, Phase 1

A prototype rig (see Figure 1) was developed in Phase 1 and with an adapted sound analyzer system and proved very successful in measuring the tire/pavement interface noise using the OBSI method. Table 1 provides a summary of the test locations measured in Phase 1. These locations, primarily in the Central Florida area, provided information to form the first pavement ranking for the noise generation of surface textures for the Florida Department of Transportation (FDOT). Figure 2 shows these rankings. Wayside measurements (passby measurements along the side of the road) were also accomplished in Phase 1 as a matched pair to the OBSI measurements. Figure 3 shows these rankings for the measurement location 50 feet (15 meters) from the centerline of the measured lane and 5 feet (1.5 meters) above the pavement surface. To make a direct comparison, the wayside measurements were then reordered to match the rankings from the surface texture OBSI measurements as shown in Figure 4. It can be seen in Figure 4 that the rankings are very different. Further analysis showed this to be related to the pavement surface where sound absorption and scattering could occur at different rates.

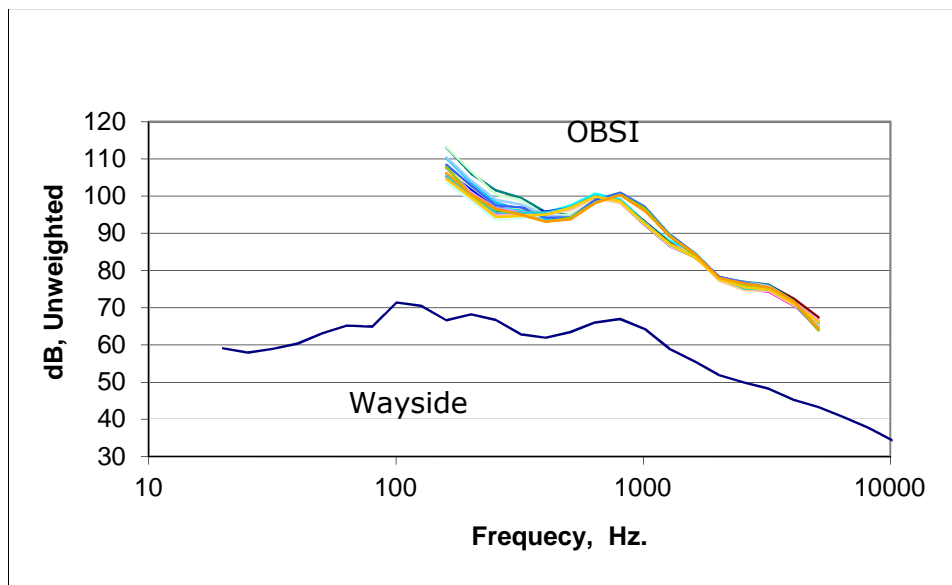
Figure 5. Example of OBSI and Wayside Spectra [un-weighted] from Phase 1

The frequency spectra differences between at the tire/pavement interface (OBSI) and the wayside caused by propagation effects were revisited. Figure 5 shows an example of these results. As seen in Figure 5, multiple OBSI measurements were made, as for all locations, to validate repeatability as a quality control method. It can also be seen that the trends of the two frequency patterns are very similar, although offset due to the difference in amplitude. A closer examination shows that there are changes in the lower frequencies, beginning at approximately 400 Hertz (Hz.). It can be seen that there are dips in the wayside measurements that do not occur in the OBSI. Unfortunately, OBSI measurements are limited on the lower frequency ranges because of wind noise and cannot be used. Fortunately, the human ear does not hear these frequencies well. Even with the frequency limitation of all OBSI systems, the trend is evident. These wayside dips are characteristic of ground effects or in this case the effect on the wave propagation over the pavement surface. This led to the recommendation to further review this phenomenon. Phase 2 was then based on these results, findings, and recommendations from Phase 1.

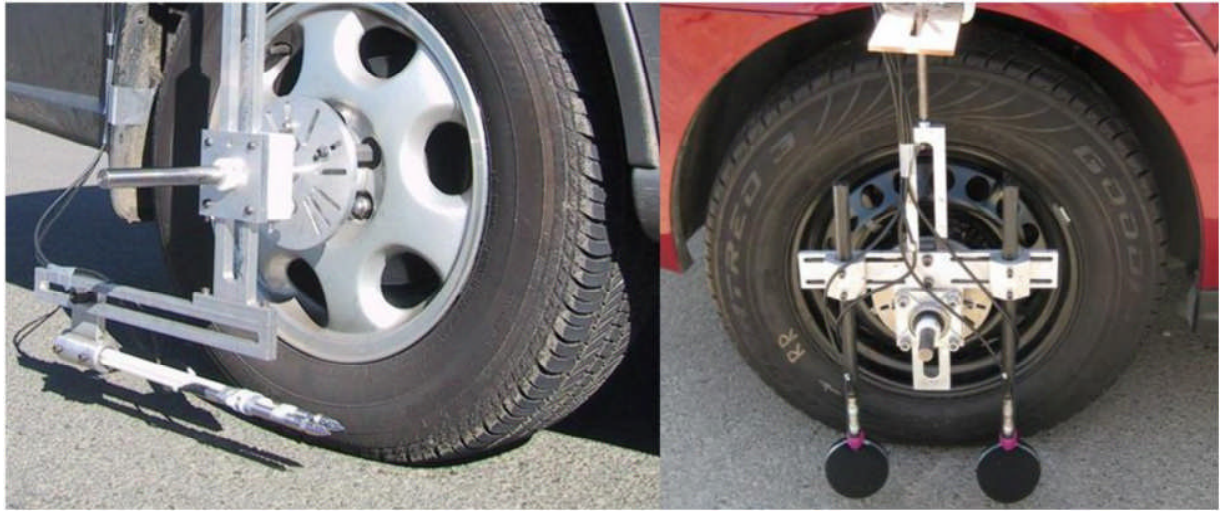
a. Horizontal configuration (single probe)      b. Vertical configuration (dual probe)

Figure 6. Examples of Intensity Probes for Tire/Pavement Sound Measurements<sup>8</sup>

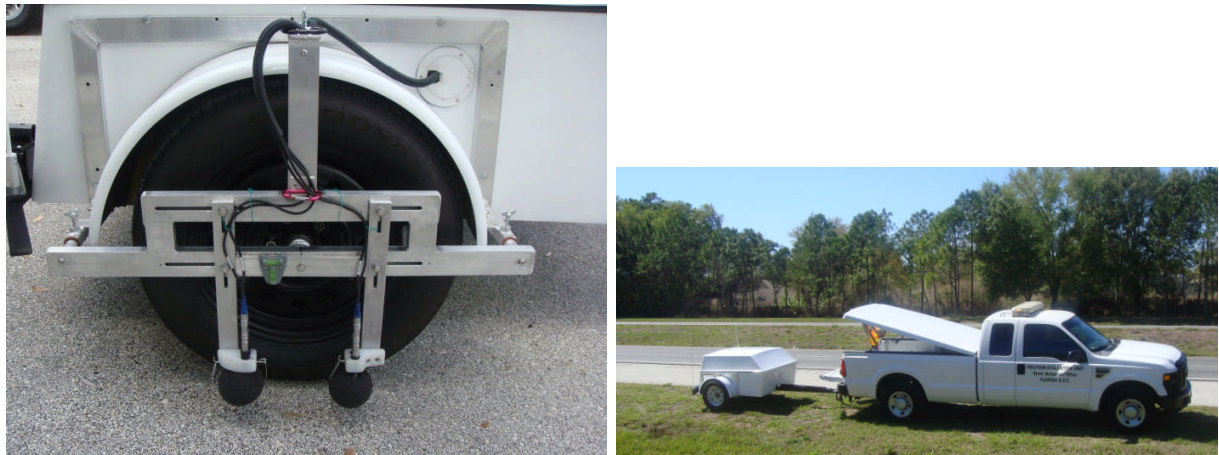
Figure 7. Final Rig, Intensity Probes, and Overall Vehicle System, Phase 2

As shown in Figure 7, the rig holds the preamplifiers and microphones in sets (test probe) which are connected via the cables shown to the analyzer. Exact location of the microphones is crucial and follows the standard established by the American Association of State Highway and Transportation Officials (AASHTO).<sup>6</sup> Figure 8 shows the critical distances from the AASHTO standard.

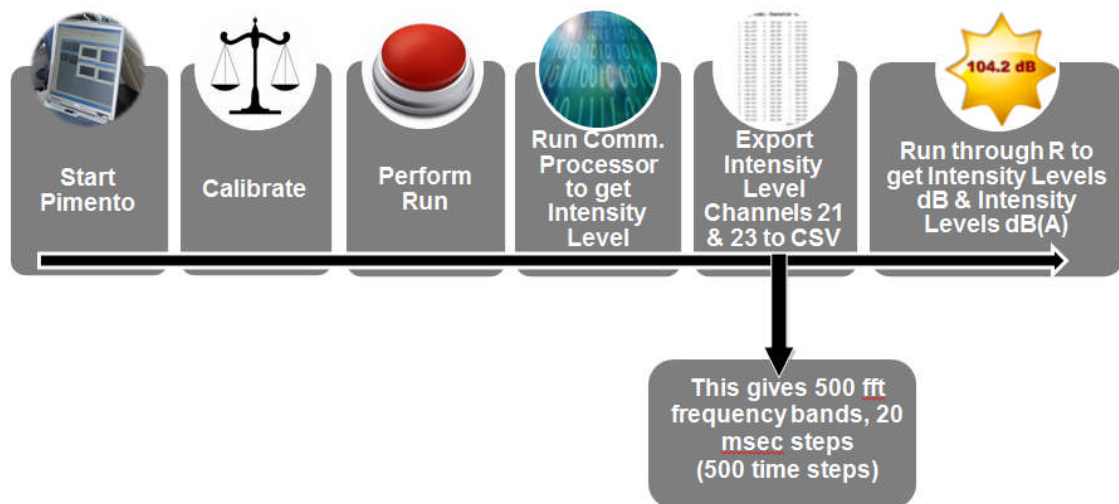
Figure 10. Overview of Measurement Process [CSV refers to comma separated values a common computer term. R is a computer program. The term fft is a mathematical process, fast Fourier transform. The term msec is milliseconds.]

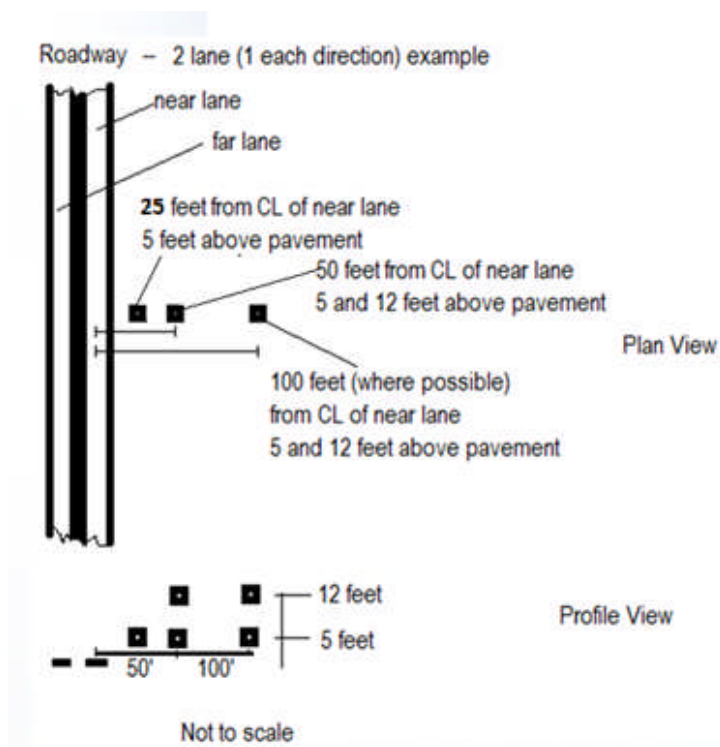
Figure 12. Layout of Desired Sound Level Analyzer Array for Wayside Measurements

Wayside measurements were performed near the center of the OBSI test section to avoid any possible end effects of the location. Sound level analyzers were set at varying distances and heights from the roadway to form an array. Figure 12 shows a diagram of the desired test locations that were measured when possible. In some cases local conditions prevented all locations from being measured. However, the location five feet above the pavement surface and 50 feet from the centerline of the test lane was always included when wayside measurements were taken. This location is the standard test position in the U.S. when reference energy mean emission levels (REMELs) are measured.<sup>8</sup> REMELs are used as the building block for transportation noise models.

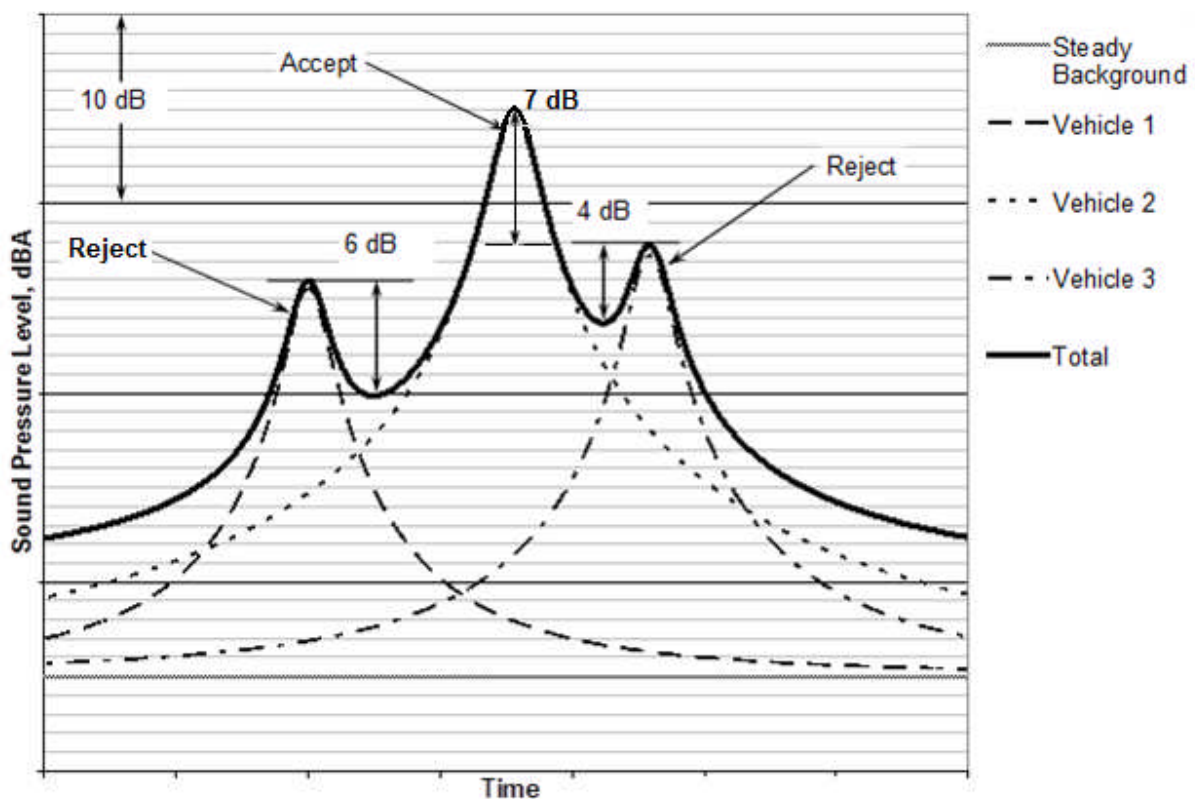
Figure 13. Idealization of Multiple Vehicle Passes and Acceptable Passby  
(Note: 10 dB was goal but 7 is acceptable)

During quality control, only “clean passbys” were included in the wayside data base. A clean passby requires vehicle separation from all other vehicles, including both sides of the highway, sufficient for at least a 7 dB(A) difference in SPL from the passby and all other noise sources. This required careful observation of the traffic and when a quality passby was thought to occur, the time, vehicle type, measured speed, and comments were recorded. These passbys were later reviewed using custom software created for this project to determine if the criteria were met to allow inclusion in the final data base. Figure 13 shows graphically how the criteria are applied to vehicle passbys. While 7 dB(A) is acceptable, a goal of 10 dB(A) was also included and information stored based on both criteria. The project concentrated on the vehicle class known as automobiles of the Traffic Noise Model<sup>9</sup> (4 tires and 2 axles) but good passby events of other vehicle types (medium trucks, heavy trucks, motorcycles and buses) were also included in the data base for comparative purposes although not discussed in this report.

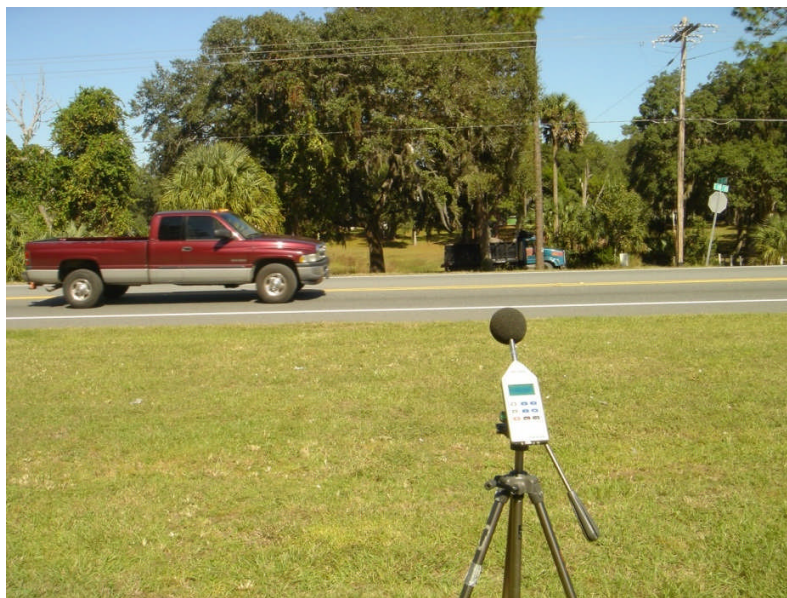
Figure 15. Nearby Passby Microphone Location During Tire/Pavement Test

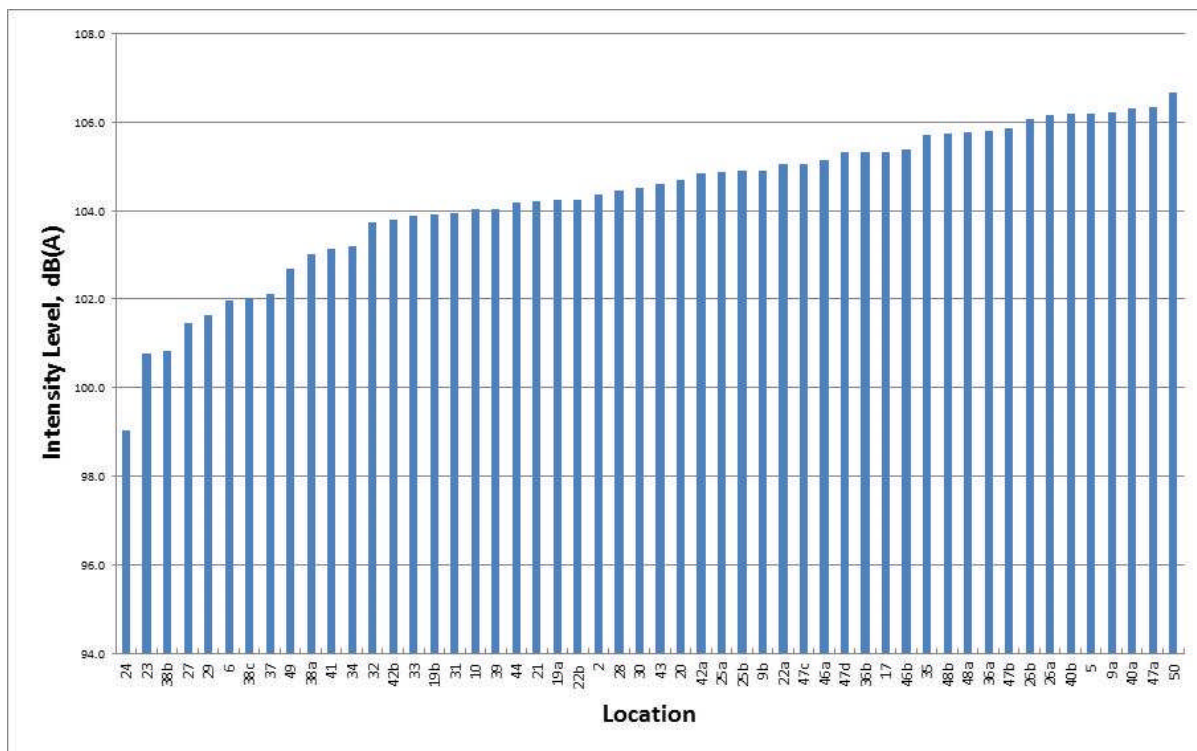
Figure 18. Ranking by Location Number, OBSI Levels

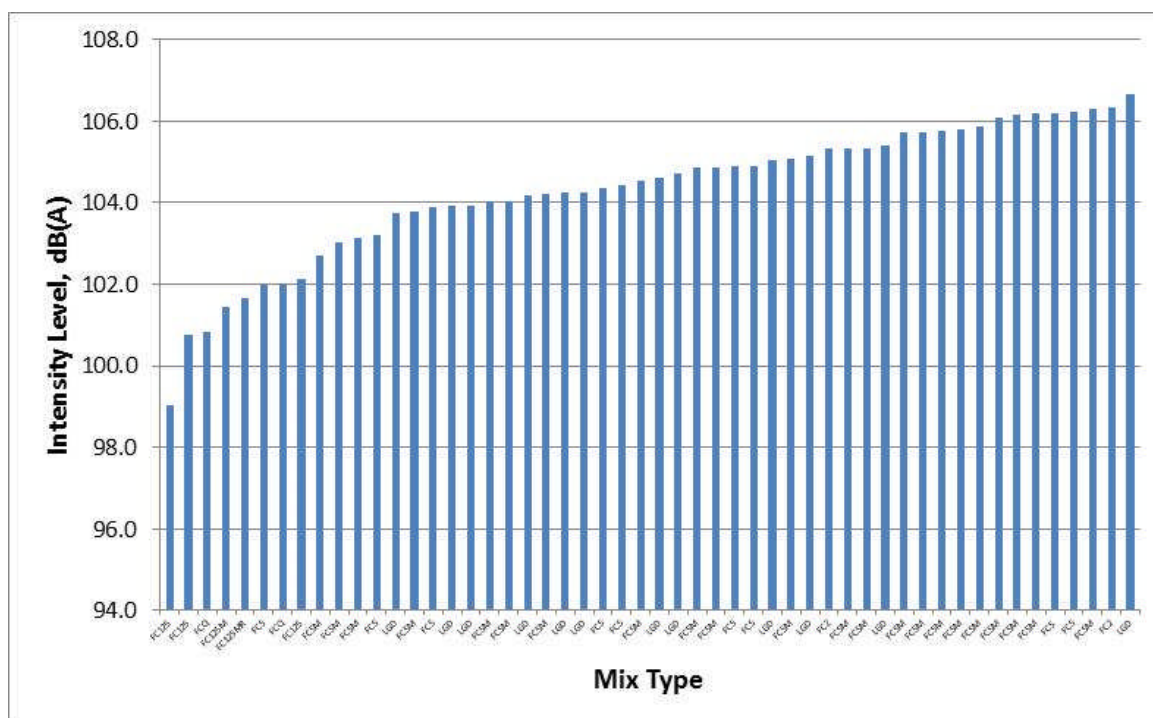
Figure 19. Ranking Shown by Surface Mix Type, OBSI Levels

Obvious from the rankings in Figure 19 is that there are groupings of mix types. The loudest pavement is a rigid pavement (LGD mix type). A closer review shows that while all rigid pavements are somewhat scattered in the top three-quarters of the rankings with a range from 103.7 to 106.7 dB(A). On a numerical average of the 51 pavement textures included in the analysis, LGD surfaces ranged from 13 to 51 with an average of 27.1. This would tend to indicate that of the pavement types measured, rigid pavements are often louder than flexible pavements, but this is not always the case as indicated by some lower rankings.

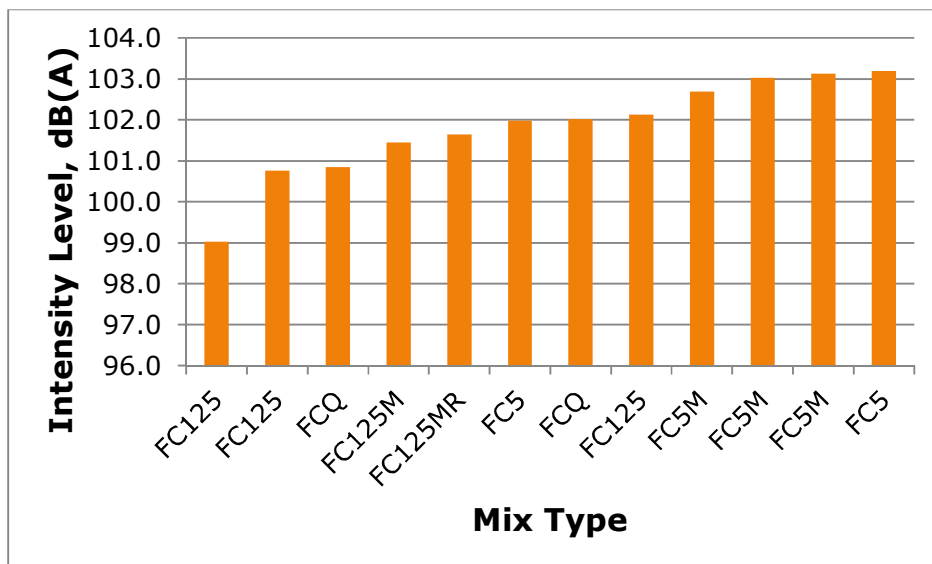
Figure 20. Twelve Quieter Surfaces Selected for Detailed Analysis Based on Initial Results

This makes these twelve quieter pavement surfaces of particular interest and results are better shown in Figure 20. As can be seen in Figure 20, of these surfaces five are FC125, five are FC5 (actually four because we eliminate Location 49), and two are FCQ (an open graded surface with a different aggregate characteristics). Of note is that some have modified binders designated with an M. As shown in Figure 19, of the quieter pavement surfaces, open graded surfaces (FC5s) tend to be louder while dense graded surfaces (FC125s) tend to be quieter at the tire/pavement interface. Tables 5 and 6 show more detail of the mix for these 12 pavement surfaces.

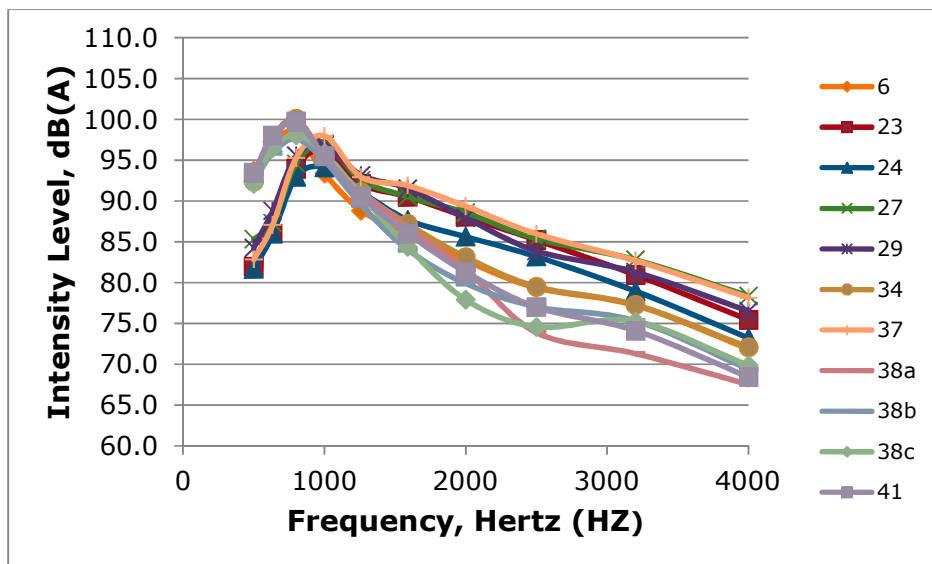
Figure 21. Frequency Comparison of Quieter Pavements

As can be seen in Figure 21, there would appear to be two distributions when the twelve quieter pavement surfaces are reviewed. To further explore these results, a comparison was made by plotting individual types of FC5, FC125, and FCQ. Figure 22 shows these results.

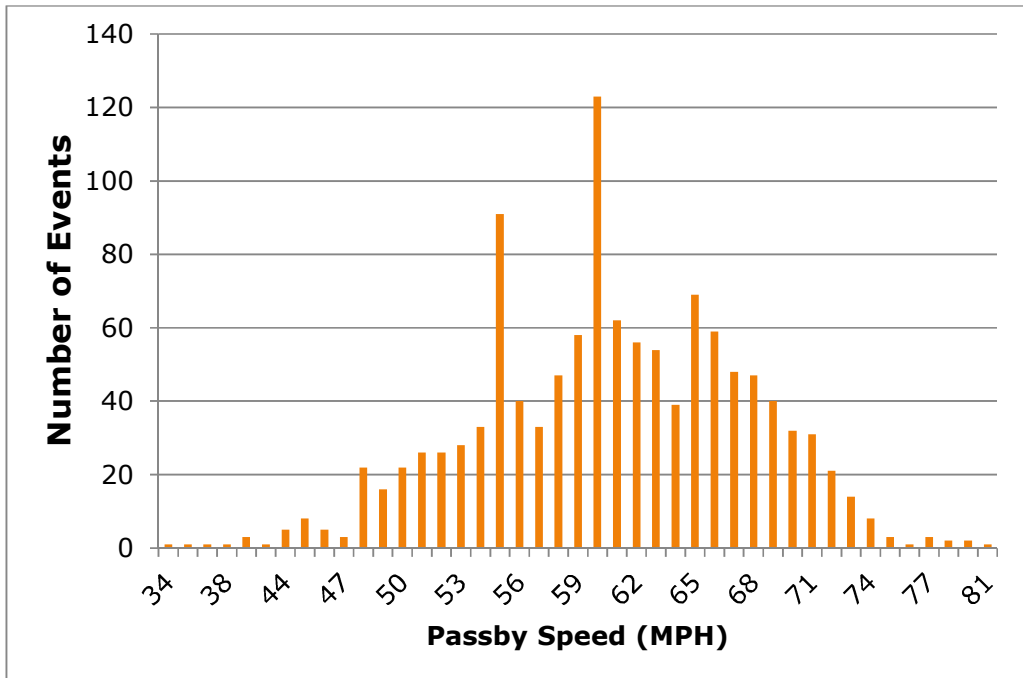
Figure 25. Measured Vehicle Speed Distribution

Additionally it should be noted that the passby data in the final data base did not all occur at 60 MPH (97 kph). To determine the needed values at or near 60 mph as shown in Table 9, a regression analysis was required at each location based on multiple events. Figure 25 has been included to show the real speed variation. All data were statistically analyzed with regression techniques to determine the average 60 mph sound pressure level which is reported and used in this analysis. The two peaks in the results are due to events at the test speed from the test vehicle that was measured to provide a quality control among final data for frequency analysis.

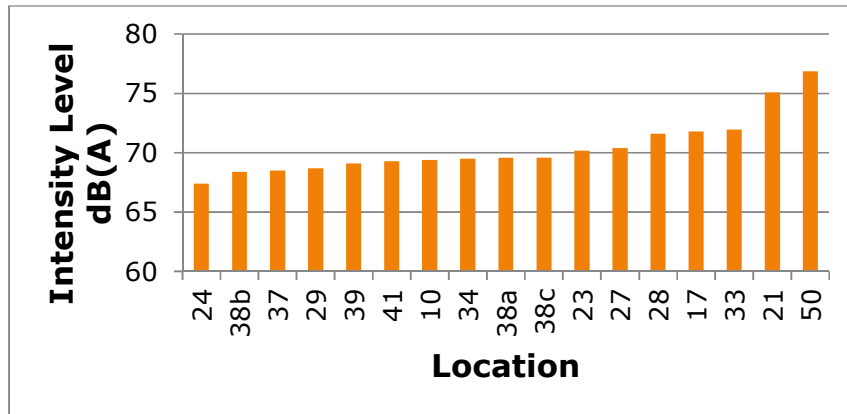
Figure 26. Ranking of Wayside Locations

The first thing that is evident is that the ranking does not follow the same order as the OBSI results. This is shown in Table 11. While relative rankings remain somewhat constant for many of the surfaces, there are some notable changes. The most noticeable are Locations 23 and 27. These FC125 surfaces were among the quieter surfaces at the tire/pavement interface but at the wayside this is no longer true. The greatest possibility is that as reported in the literature, the dense graded surface does not absorb the same energy and results in a greater reflective path contributing to the overall sound level at the side of the roadway resulting in increased sound levels. This phenomenon, but in reverse, seems to be occurring at Locations 10 and 39 which are FC5M surfaces. In these cases, the open graded structure of the surface is absorbing and scattering the reflective wave resulting in a reduced level at the wayside. The same trends were observed in Phase 1.

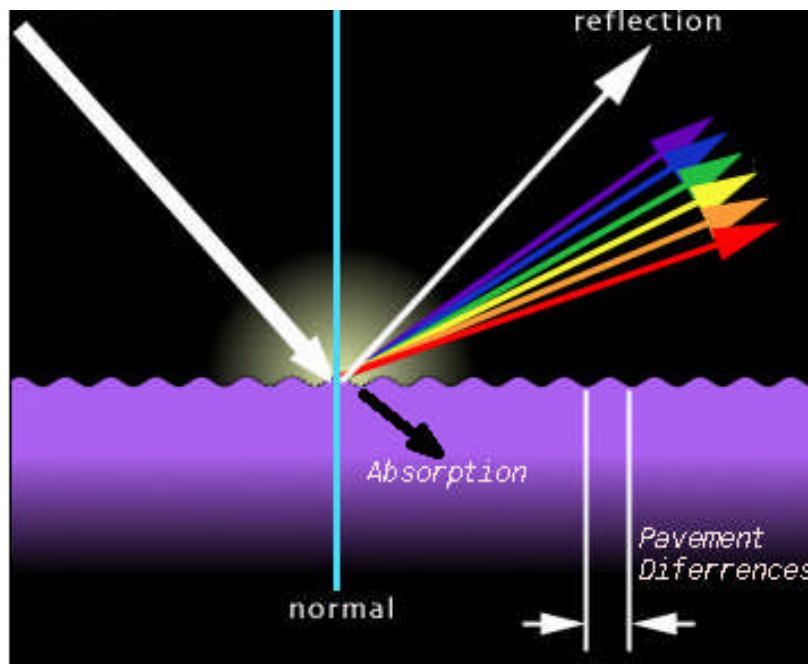
Figure 27. Illustration of Reflective Wave Interaction With Surface

To place this in context, consider Figure 27. There is a direct wave path from the tire/pavement interface to the side of the road (not shown), but there is also a reflective wave path. The surface differences affect the reflective wave causing different amount of scattering and absorption to occur. At the side of the road, this results in less energy arriving at a position and reduced sound levels. This is a frequency dependent phenomenon related to the characteristics of the surface.

In Figure 27 it was illustrated how a reflective wave interacts with the pavement surface. But we must also consider the direct path as well. Consider the two possible paths from a source (the tire/pavement) traveling to a receiver (wayside) as shown in Figure 32.

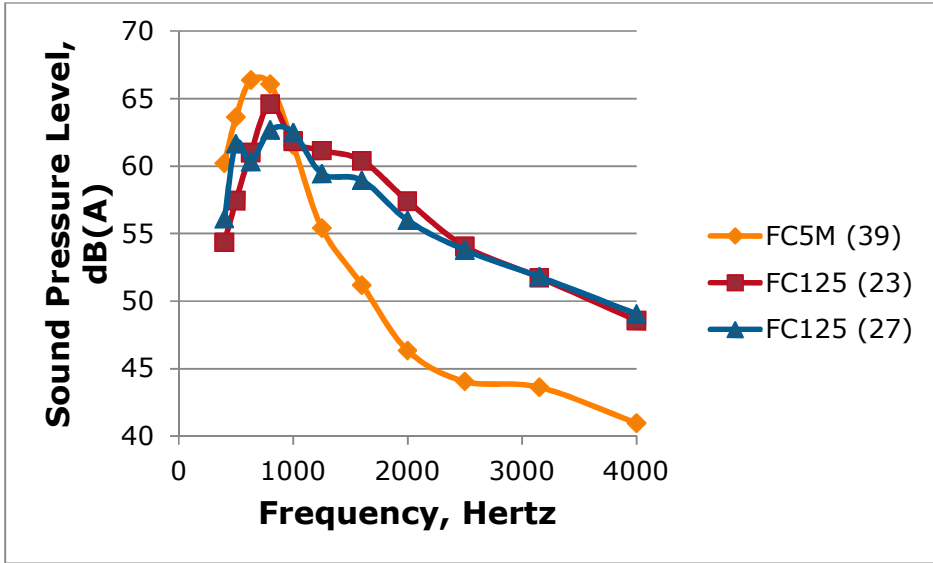
Figure 28. Comparison of Open Graded and Dense Graded Spectra at Wayside

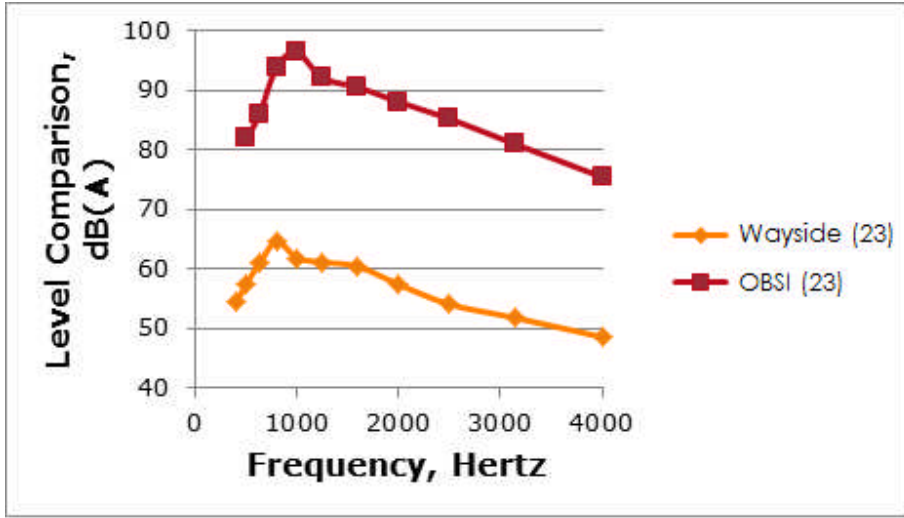
Figure 30. Comparison of Wayside to OBSI at Location 23 (Dense Graded)

To further investigate, these three locations were compared to the measured OBSI spectra at the same locations. Results have been plotted in Figures 29, 30, and 31. The effect of the scattering and absorption is readily apparent in these three figures. The open graded mix causes a dip in the higher frequency components while the dense graded mix show a much more linear falloff.

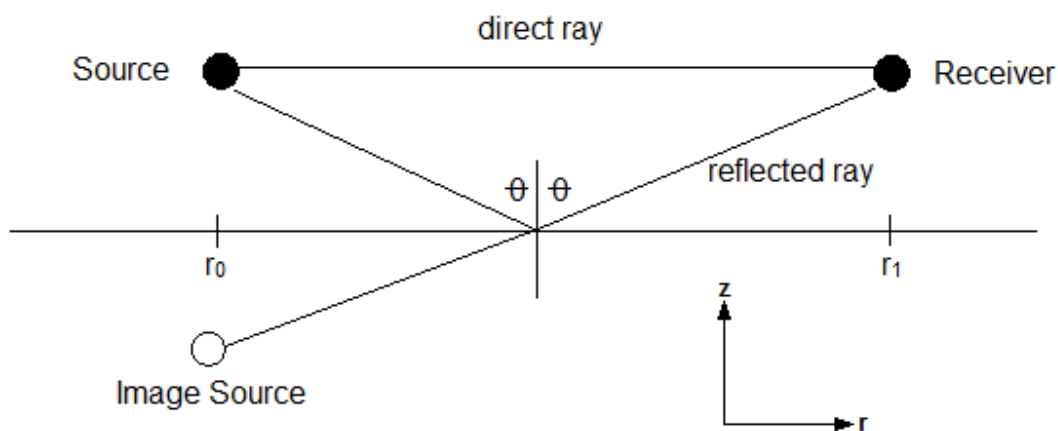
Figure 32. Direct and Reflected Path, Tire to Receiver

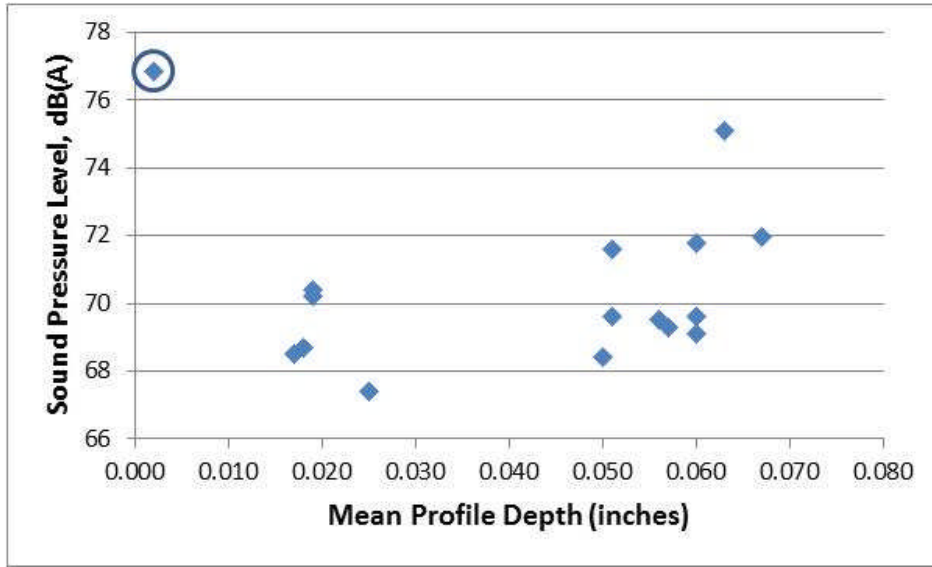
Figure 33. Mean Profile Depth Compared with Wayside Levels

To begin the process, individual parameters were reviewed using the wayside data. Graphical results are shown for MPD, friction number and aggregate size in Figures 33, 34 and 35. The sand patch tests and/or other void space values were not available and as such were not considered. The binder type and content was attempted to be used for flexibility but did not seem to show any trends. Consistency in the wear course thickness resulted in very similar numbers for all surfaces was not considered.

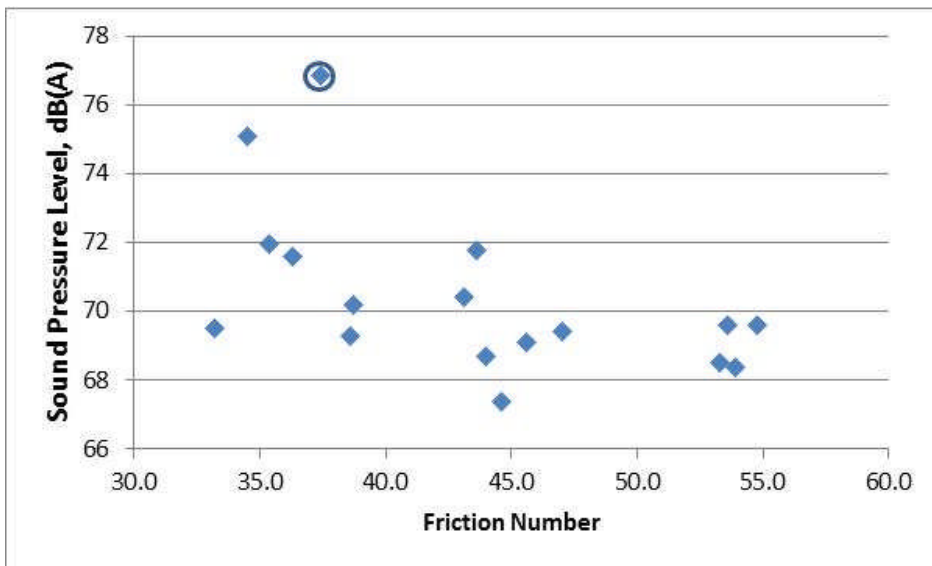
Figure 34. Friction Number Compared with Wayside Levels

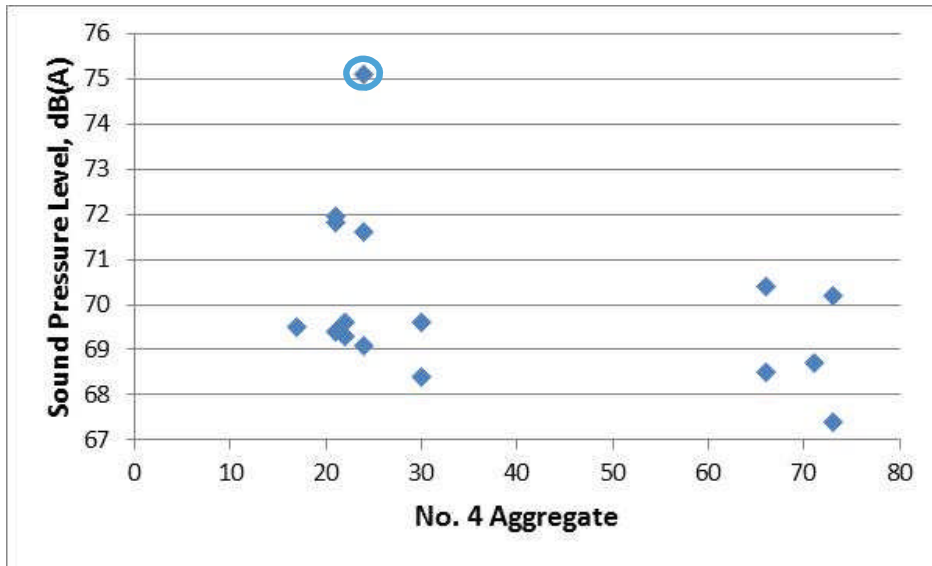
Figure 35. Aggregate Compared to Wayside Levels

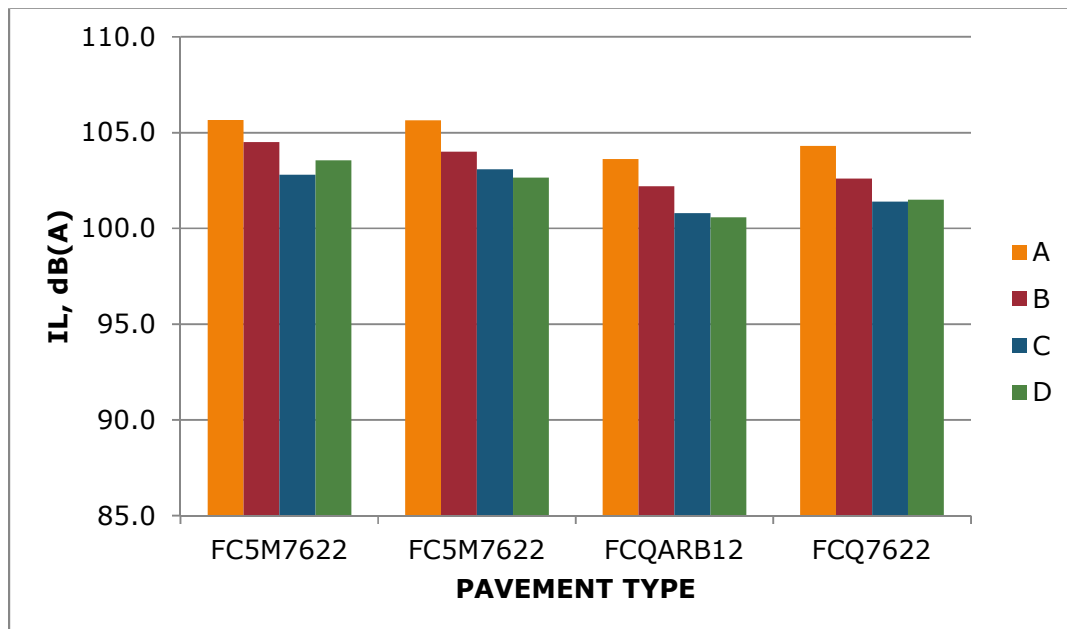
Figure 36. General Results of Rodeo

Figure 36 presents the final results from the four test sections. As can be seen, the Florida OBSI test trailer was slightly higher than the other systems. While there is no absolute method to show accuracy of all systems, follow up testing with a newly created OBSI calibrator system showed Test Team B to be best match these results. If this is indeed the case, then the Florida system is approximately 1 dB(A) higher and this is the same amount was shown when the newly created calibration system was applied to the FDOT OBSI Trailer.

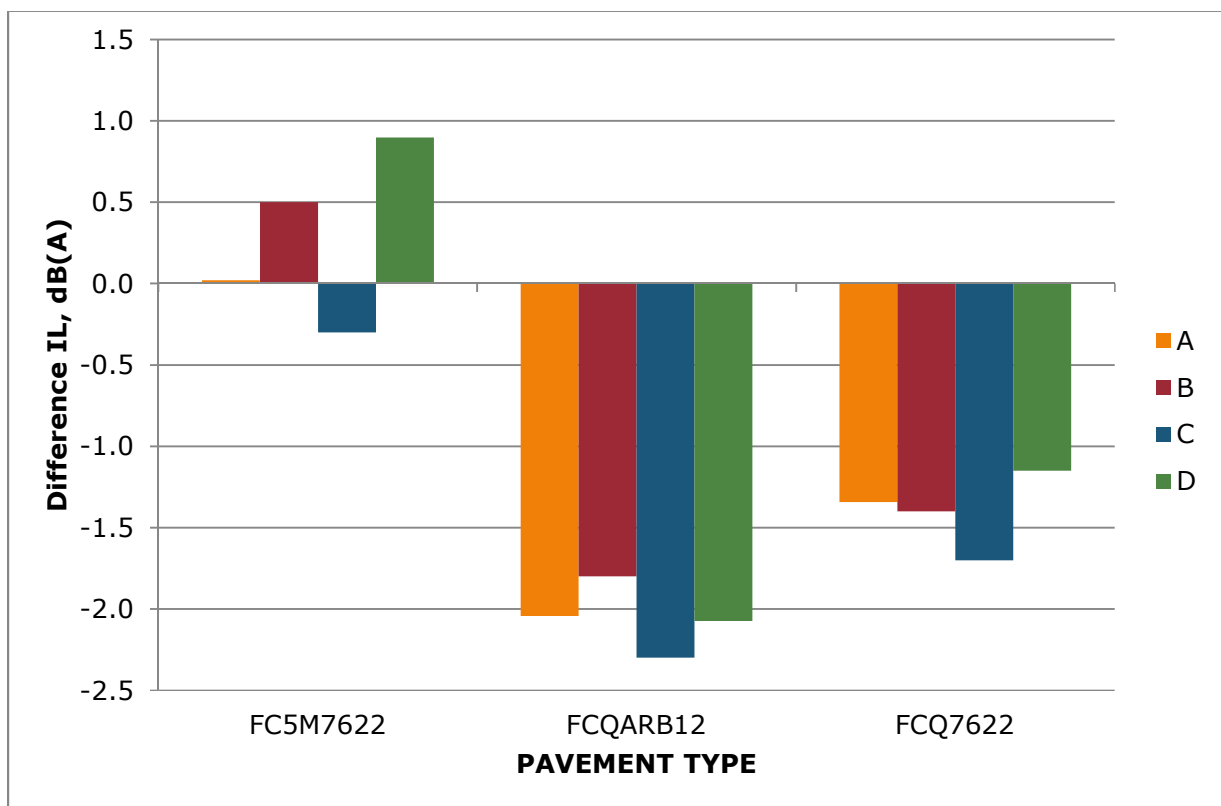
Figure 37. Results of Rodeo Comparing to the FC5M7622 Surface

This analysis was taken further by assuming the surface texture designation FC5M76-22 test section is a reference pavement surface for Florida. Figure 37 shows the results when all are compared to the reference test section. This clearly shows that all systems would have rated the pavement surfaces the same way. It can be concluded that while we strive for absolute accuracy, pavement general ranking appear correct as the different systems respond in a like manner.

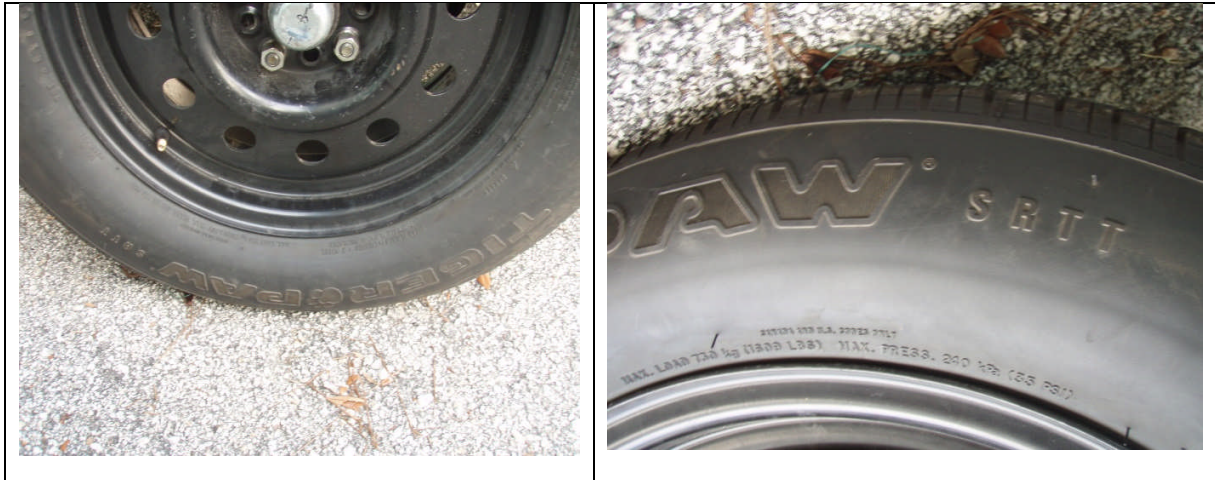
Figure A.1.2. Identifying test tire

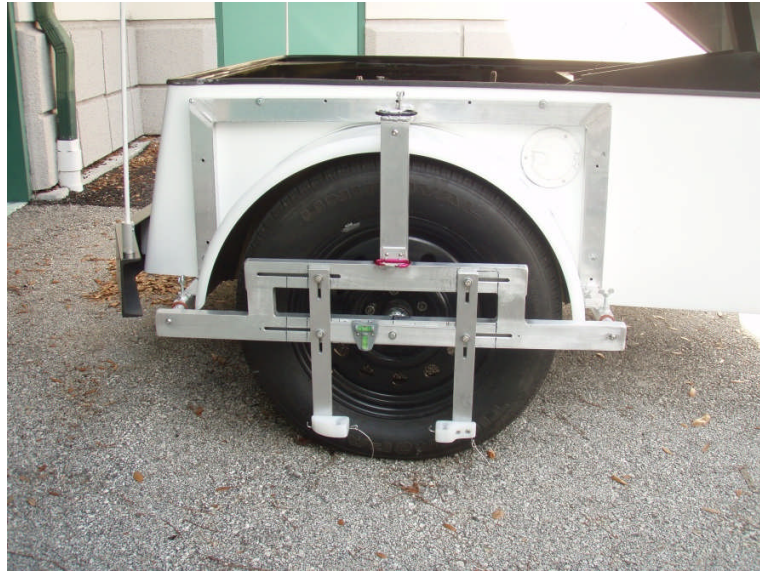
Figure A.1.4. Test rig mounted to trailer

Figure A.1.4 shows the test rig mounted.

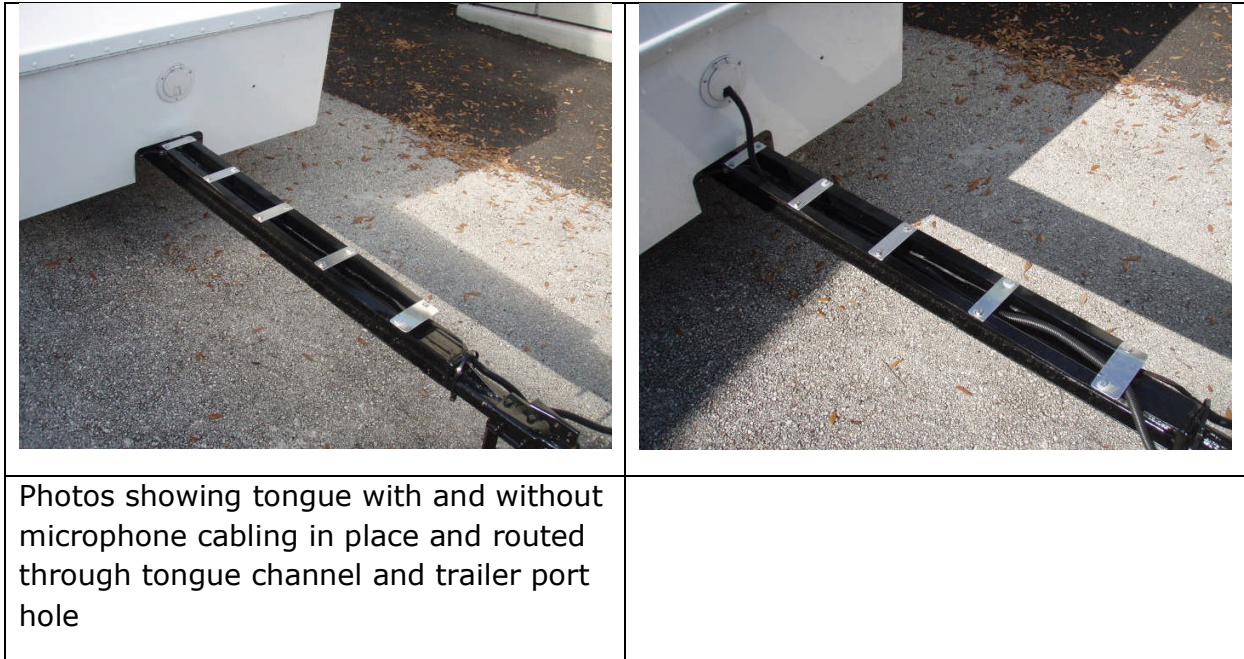
Figure A.1.7. Cable routing on tongue of trailer

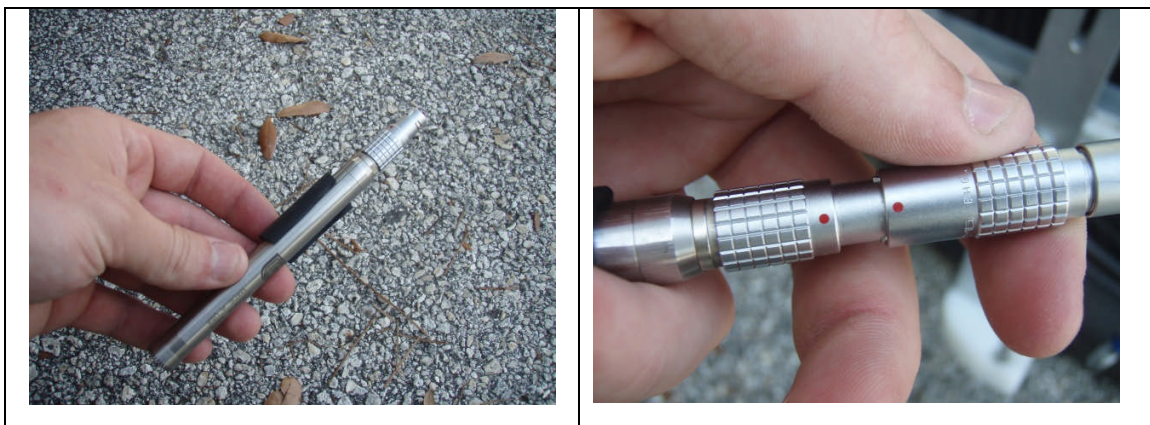
Figure A.1.8. Microphone/preamplifier assembly (left) and proper connection of cable (right)

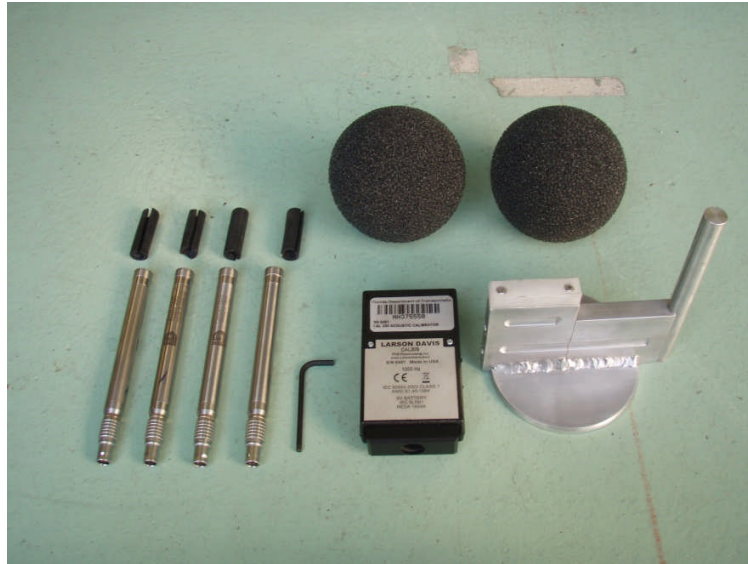
Figure A.1.10. Microphone/preamplifiers (previously attached), neoprene inserts, allen wrench, calibrator, windscreens, windscreens, and probe location tool.

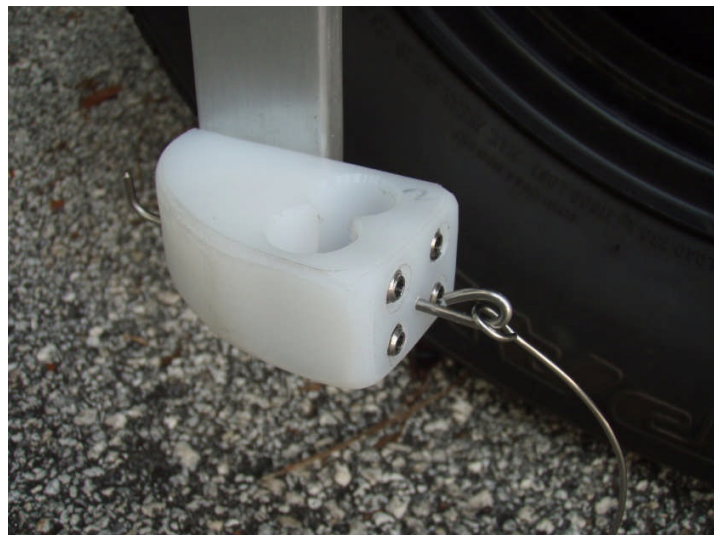
Figure A.1.16. Nylon mounting brackets for the microphone/preamplifier assembly

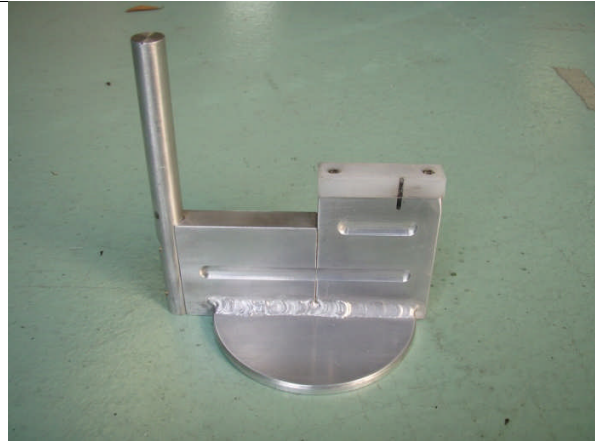
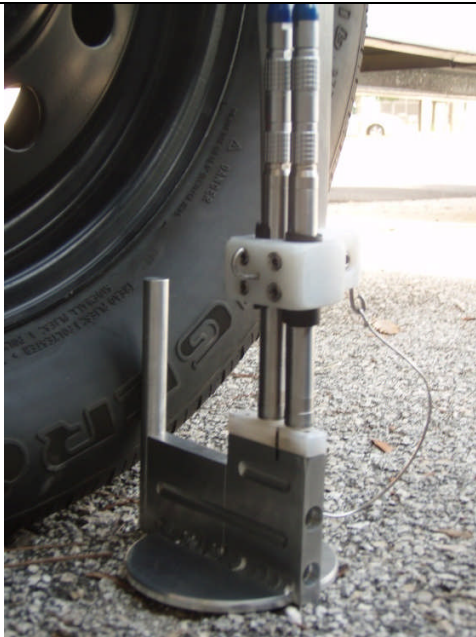
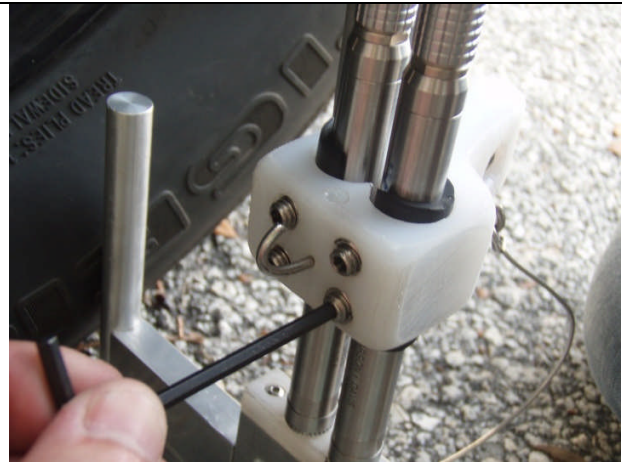
Figure A.1.17. Mounting of Microphone/Preamplifiers

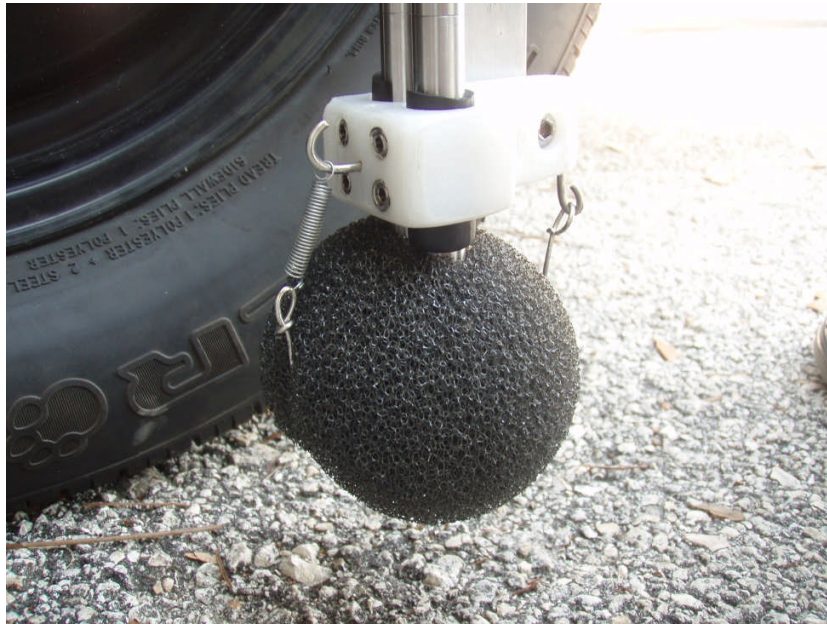
Figure A.1.18. Windscreen placed and secured over two microphones that comprise an intensity probe
