# On-Board Sound Intensity (OBSI) Study

Phase 2

**FDOT Project No. #BDT06**

## **Final REPORT**

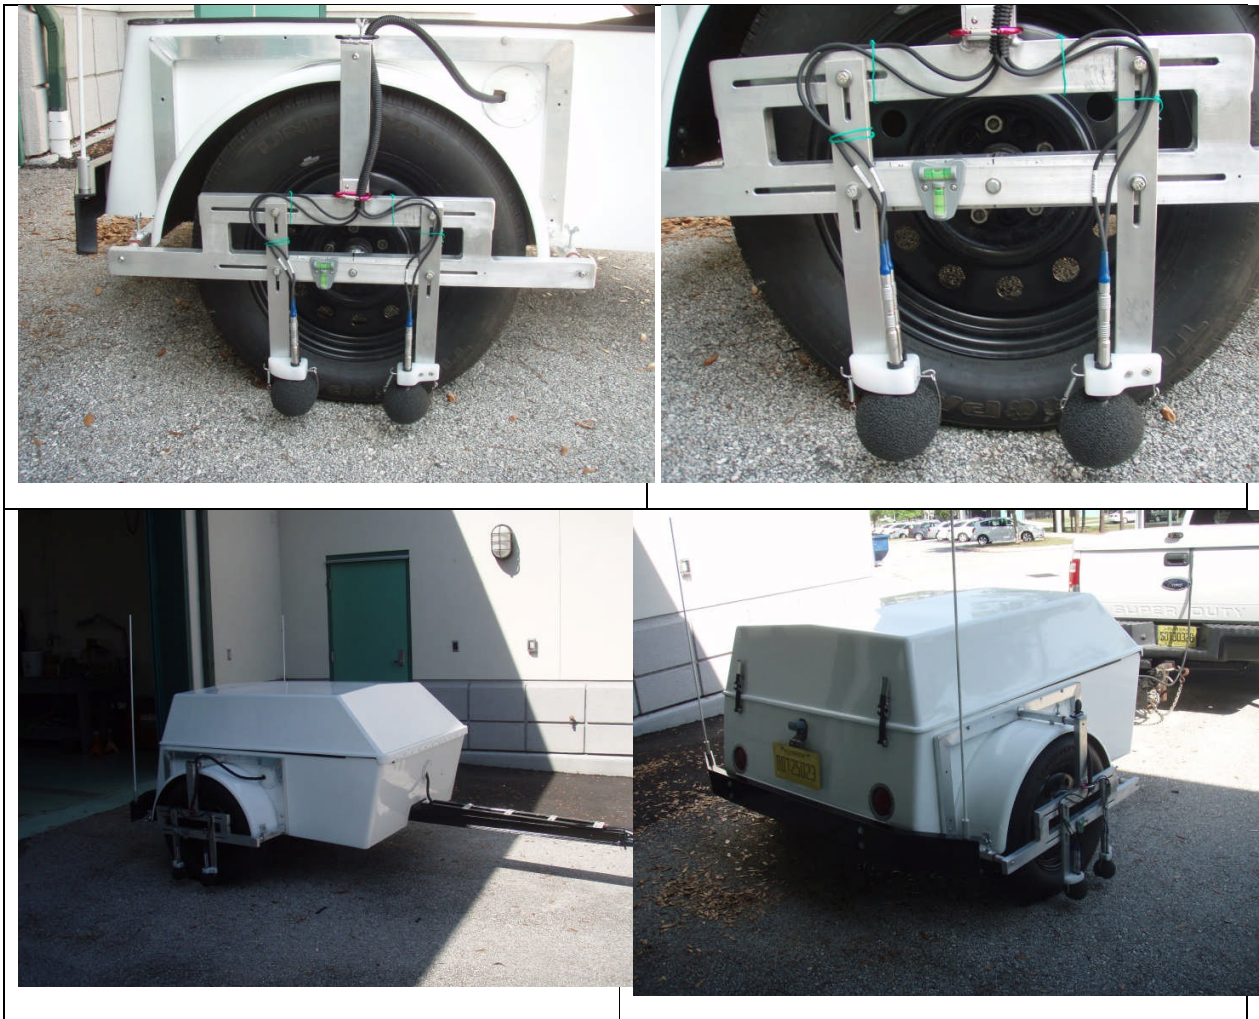
Figure A.1.19. Final mounting completed (calibration previously completed)

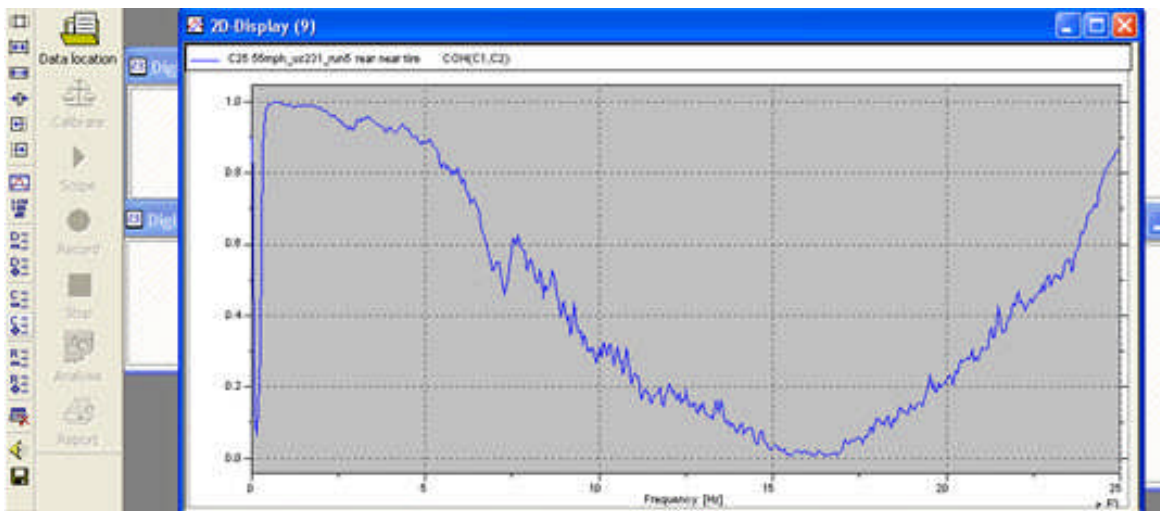
Figure A.3.1. An example of good data with coherence shown to be above 0.8 for up to 5 kilo-Hertz
