LiDAR Testing Under Heavy Tree Canopy and in Steep Terrain

March 2014

FHWA-AK-RD-14-03

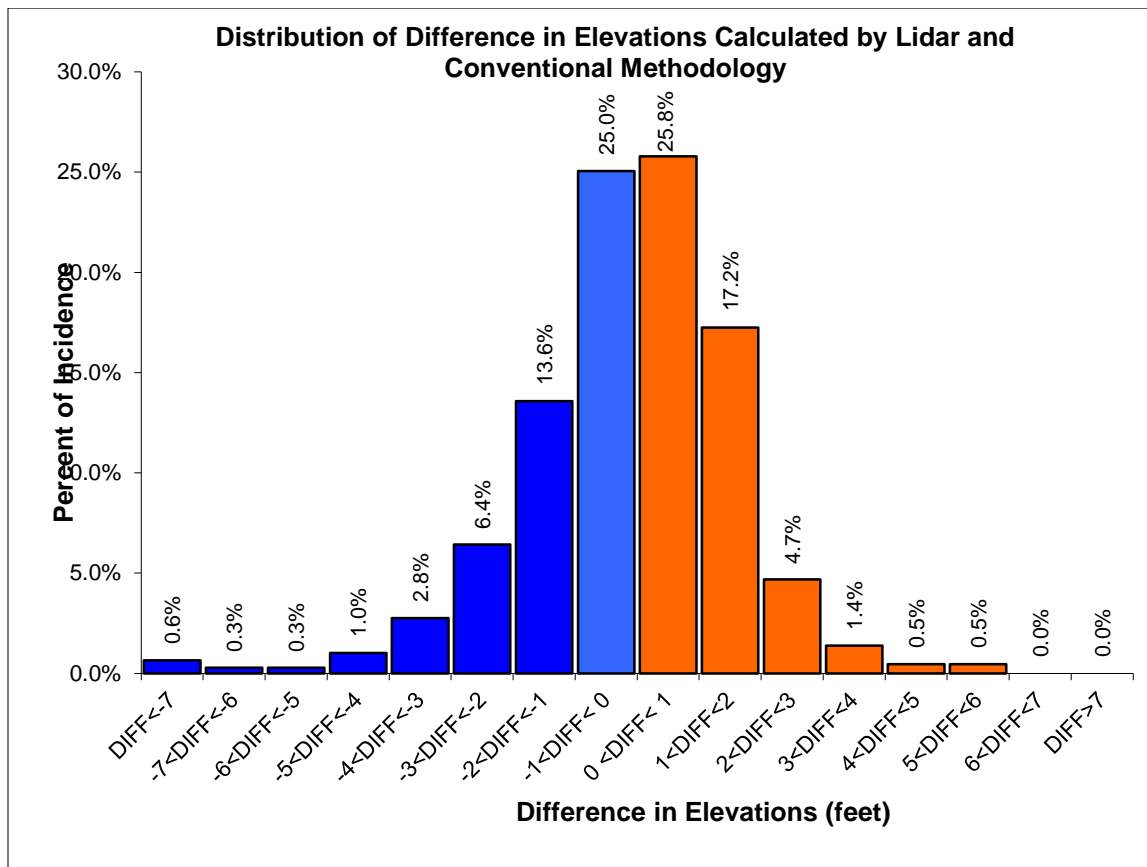
Figure 1. Percent of incidence for difference (DIFF) between elevations surveyed conventionally and using LiDAR. Elevation points were measured conventionally at several locations along the Juneau Access alignment (Proj. #71100). The elevation at each point was subtracted from the corresponding LiDAR elevation at the same point.

The difference in elevation between the two data sets (conventional and LiDAR) was tabulated into sixteen categories and the Percent of Incidence was calculated by dividing the number of sampled points in each category by the total sample (n=1090). 81.6% of the points were within the target range of + - 2 feet. The LiDAR elevations were higher than the conventional elevations 50% of the time and lower than the conventional elevations 50% of the time, however the histogram is skewed slightly to the left (i.e. LiDAR elevations slightly lower than conventional).

The majority of these survey points were stream site surveys located in steep terrain characterized by deep gorges and valleys. Vegetation was moderately tall and somewhat thick, typical of Northern Lynn Canal. It should be noted that timber in this region has very little marketable value due to high winds and salt spray creating scrubby and somewhat scraggly trees. Because this sample data set was biased towards steeper terrain the results are not completely indicative of the project as a whole. One of the 30 sites was markedly different and of the 145 survey points that came from the area known as “Antler Flats” 96.6% of these shots fell within the +/- 2 foot target range. Antler Flats is located in a very flat area between the Antler River and the Lace River in Berners Bay. Aside from being flat, the area is mostly covered in cotton wood and alder trees that were in leaf-off condition at the time of LiDAR acquisition. The graph in Figure 1 illustrates that a large percentage of ground surveyed points agree well with the LiDAR produced elevations. The graph also shows good symmetry in that roughly half of the time the LiDAR elevations were low while half the time they were high.

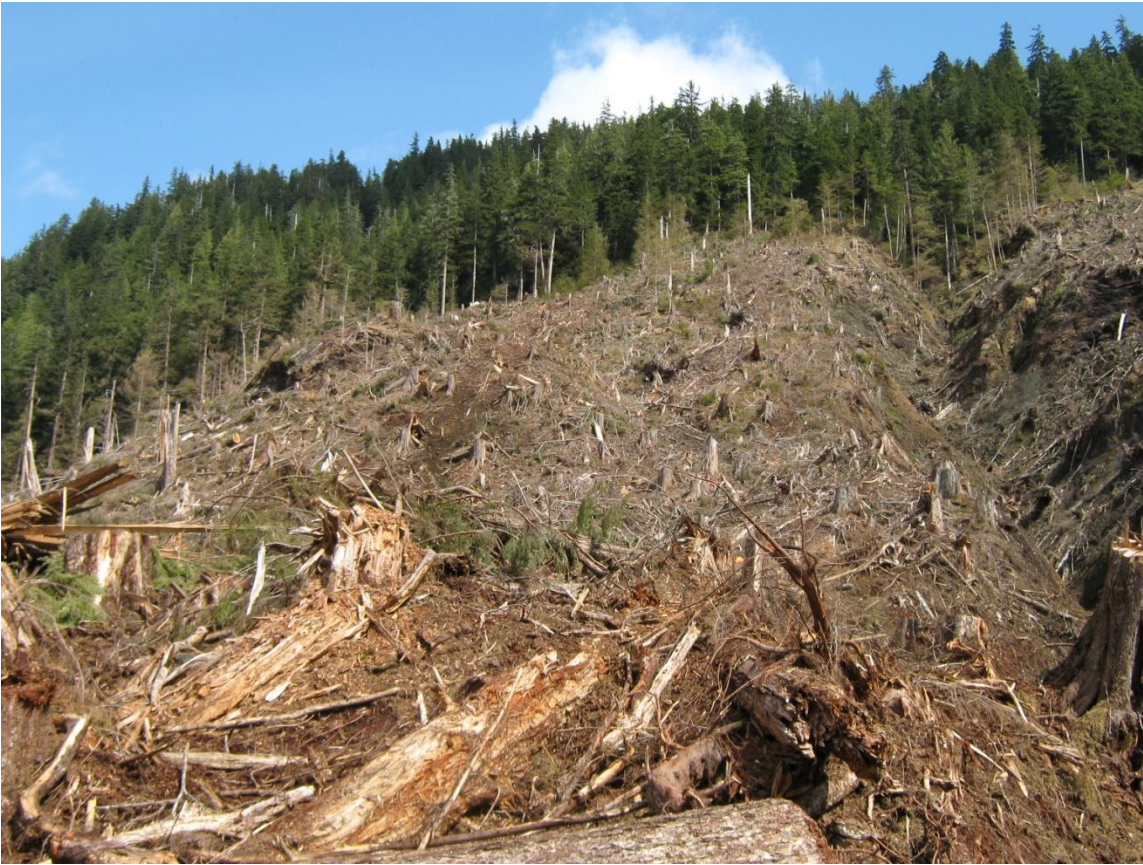
Figure 10. Photograph of T3V3 area after logging. Notice thickness of vegetation in background.

Figure 10 is a photograph of the existing conditions of the T3V3 area. Figures 11 and 12 are screen captures from QT Modeler depicting ground shots in red overlayed on the LiDAR point cloud.

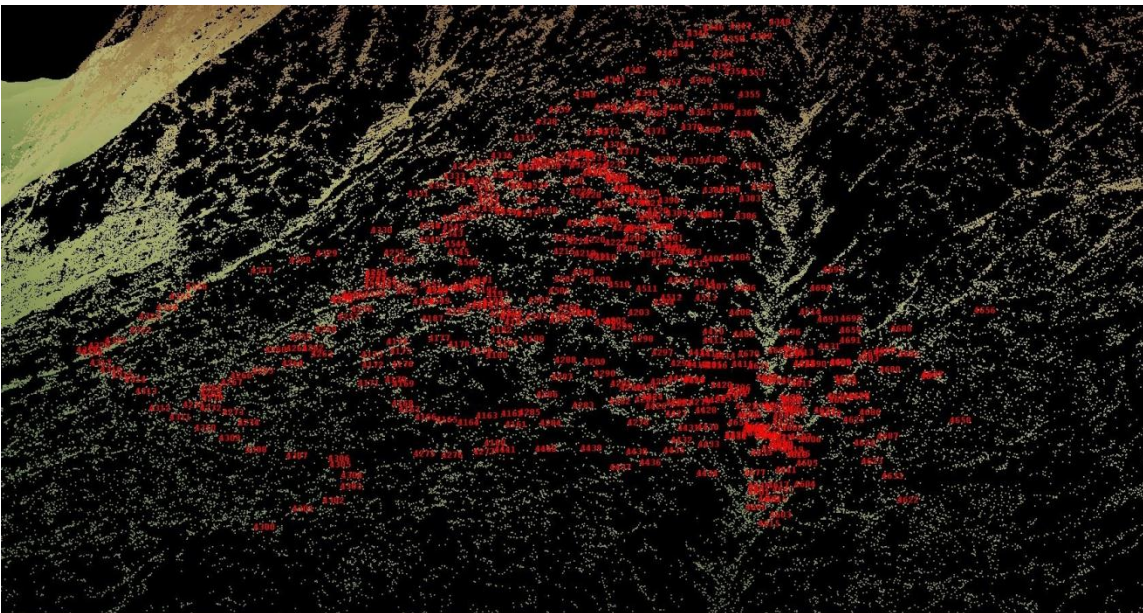
Figure 11. Overview of ground shots over LiDAR point cloud.
