CENTER FOR TRANSPORTATION INFRASTRUCTURE AND SAFETY

Air-Launched GPR Evaluation for Rapid Assessment of MoDOT Bridge Decks

**NUTC
R369**

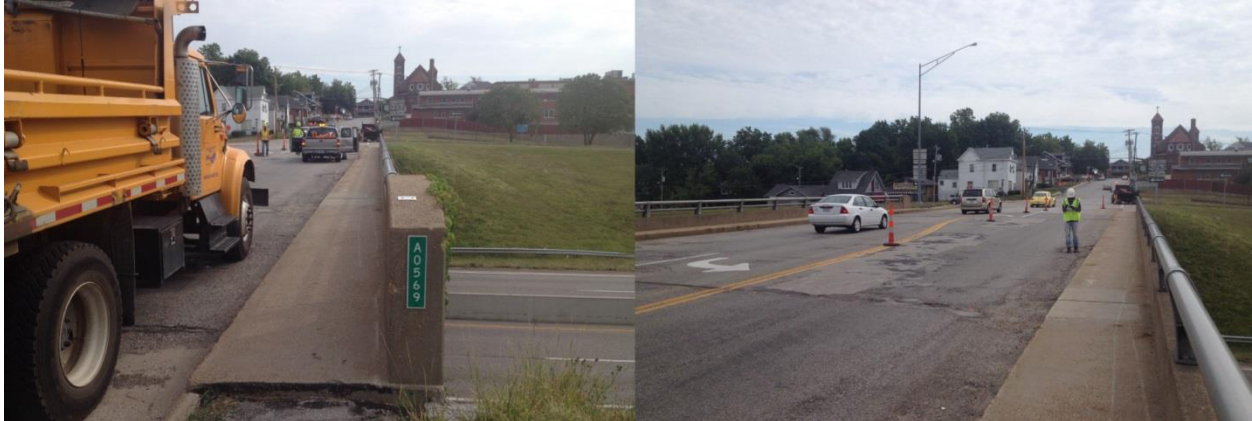
Figure 2-1 Bridge A0569 Overview of Bridge Deck Observed During Field Investigation

Figure 2-1 shows an overview of Bridge A0569 during the deck investigation. Details of Bridge A0569 are summarized in Table 2-1.

Nearest City	Jefferson City
County	Cole
Roadway Carried	Clark Avenue
Feature Intersected	U.S. 50
Year Constructed	1959
Reconstructed Year	Never Reconstructed
Number of Driving Lanes	3
Direction of Traffic	Two-Way
AADT	6,927
AADT Truck Percent	10%
Structure Length	139 ft. – 0 in.
Total Deck Width	57 ft. – 8 in.
Curb to Curb Br. Width	48 ft. – 10 in.
Main Structure Material Type	Concrete
Main Structure Construction Type	Frame
Number of Main Spans	1
Number of Approach Spans	0
Deck Material	Concrete CIP
Designed Slab Thickness	6.5 in.
Wearing Surface	Bituminous
Orientation of Top Reinforcement Layer	Transverse
Designed Depth to Top Transverse Reinforcement	1.75 in. (without asphalt overlay)
Slab Reinforcement, Transverse Direction	#5 @ 6 in. o.c. top and bottom main span, #5 @ 5 in. o.c. top and bottom abutments
Slab Reinforcement, Longitudinal Direction	#5 top and bottom main span and abutments, spacing varies
Other Information	Asphalt wearing surface was extensively deteriorated at the time of the NDE investigation. Many locations of asphalt rutting and shoving were observed, along with many cracks and potholes.

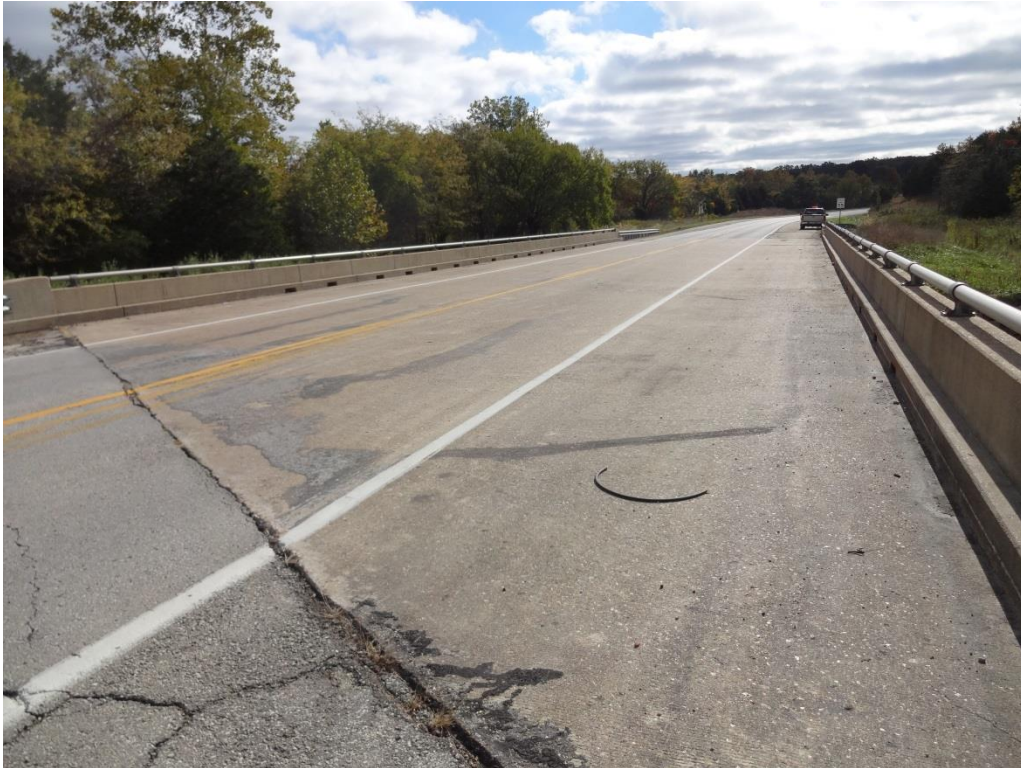
Figure 2-2 Bridge A3405 Overview of Bridge Deck Observed During Field Investigation

Figure 2-2 shows an overview of Bridge A3405 during the deck investigation. Longitudinal and transverse cracks were noted on the top surface of the deck were. Most of the cracks had been filled with asphalt. Some concrete patches were also observed. Details of Bridge A3405 are summarized in Table 2-3.

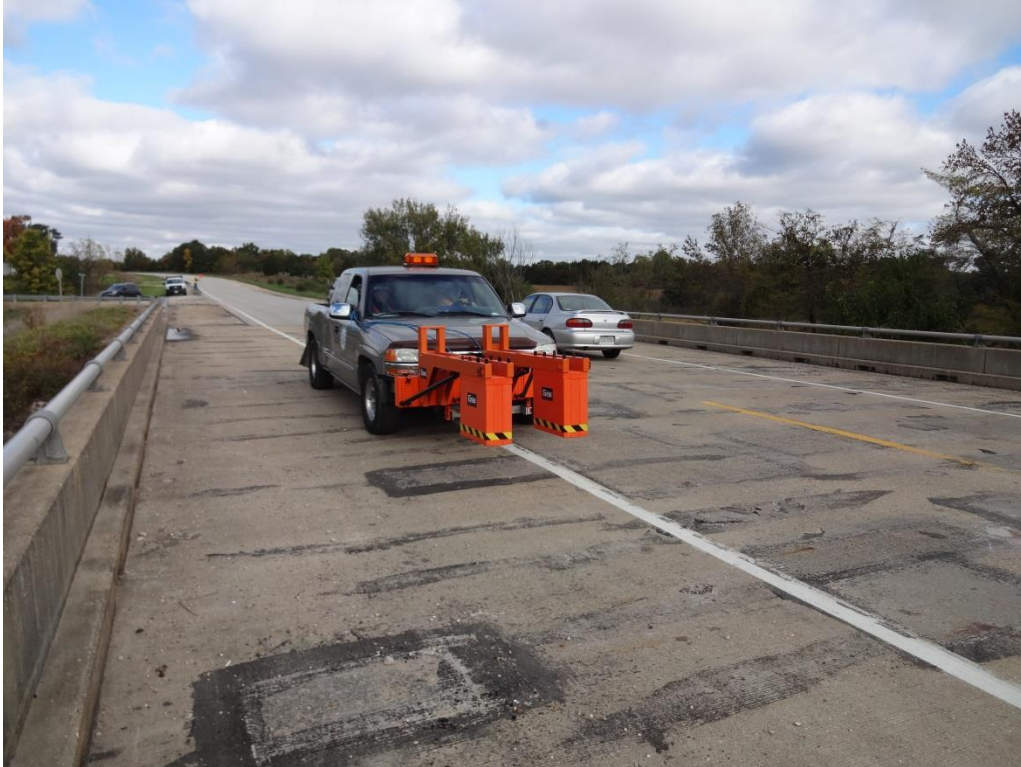
Figure 2-3 Bridge A3406 Overview of Bridge Deck Observed During Field Investigation

The top surface of the deck of Bridge A3406 appeared to be heavily deteriorated. Numerous transverse cracks and concrete patches were observed. The majority of the cracks were filled with oil or bitumen. Figure 2-3 shows an overview of the deck during the field investigation. Details of Bridge A3406 are summarized in Table 2-4.

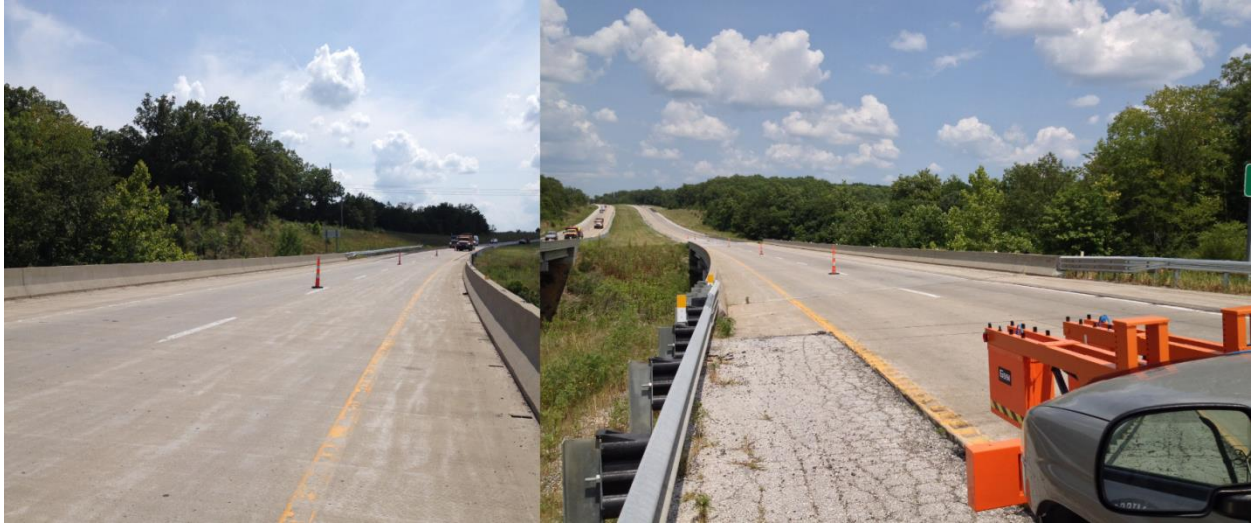
Figure 2-4 Bridge A4780 Overview of Bridge Deck Observed During Field Investigation

Figure 2-4 shows an overview of Bridge A4780 during the deck investigation. Details of Bridge A4780 are summarized in Table 2-5.

Other Information	2013 reconstruction consisted of half soled repair, along with an epoxy polymer concrete overlay with a minimum thickness of 0.25 in.

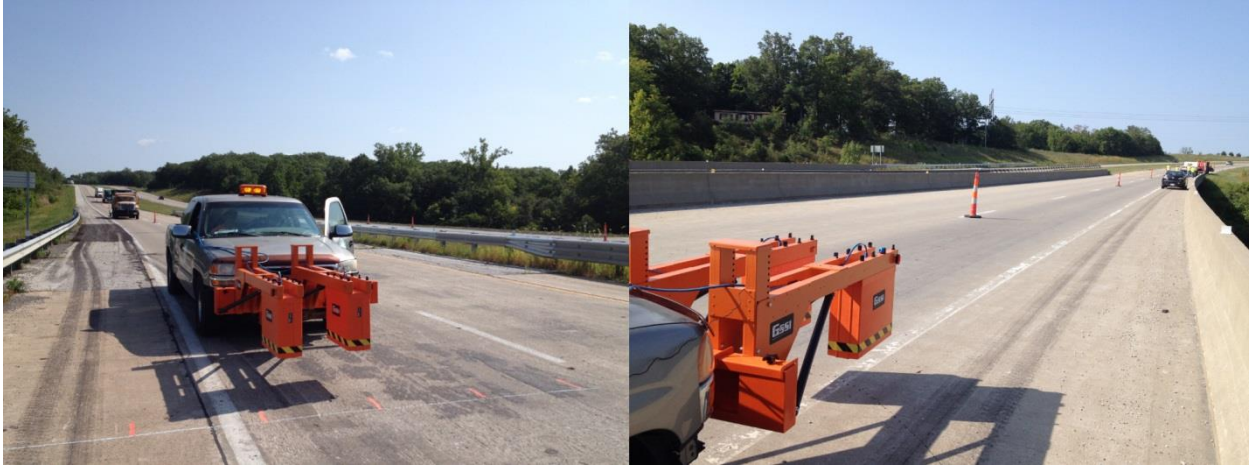
Figure 2-5 Bridge A4781 Overview of Bridge Deck Observed During Field Investigation

Figure 2-5 shows an overview of Bridge A4781 during the deck investigation. Details of Bridge A4781 are summarized in Table 2-6.

Other Information	2013 reconstruction consisted of half soled repair, along with an epoxy polymer concrete overlay with a minimum thickness of 0.25 in.

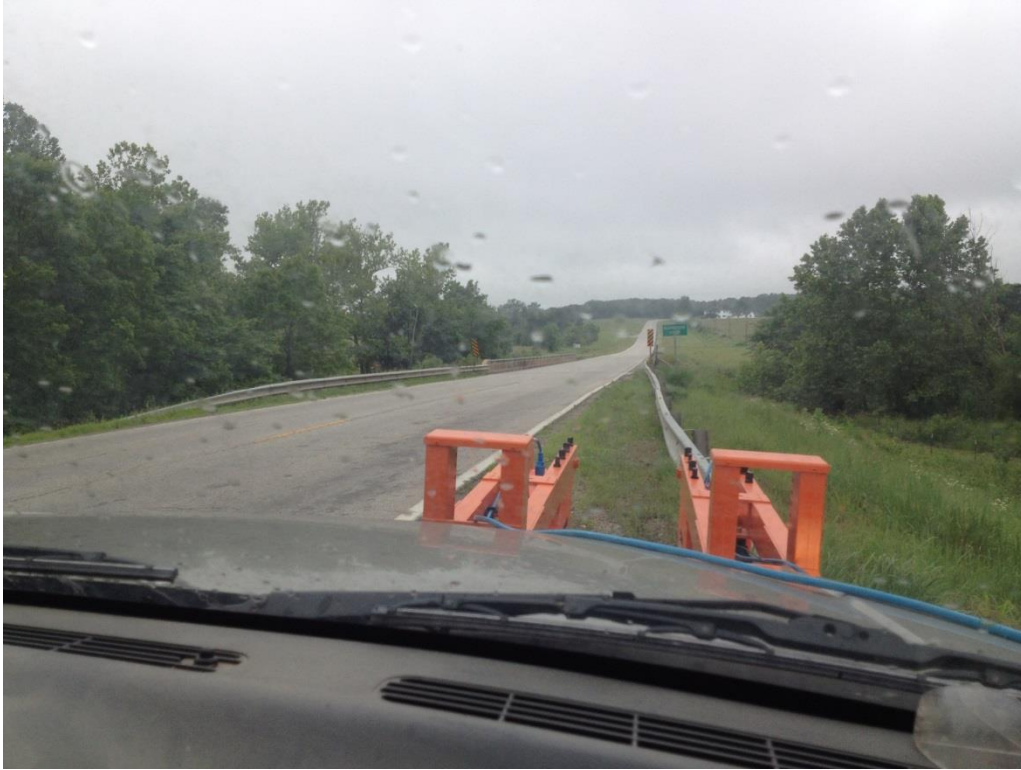
Figure 2-6 Bridge K0197 Overview of Bridge Deck Observed During Field Investigation

Figure 2-6 shows an overview of Bridge K0197 during the deck investigation. Details of Bridge K0197 are summarized in Table 2-7.

Other Information	1984 reconstruction consisted of half soled and full depth repair, along with an asphalt overlay with a minimum thickness of 1.5 in. At the time of the NDE investigation, the asphalt was approximately 2.5 in. thick and appeared to be in good condition based on visual inspection.

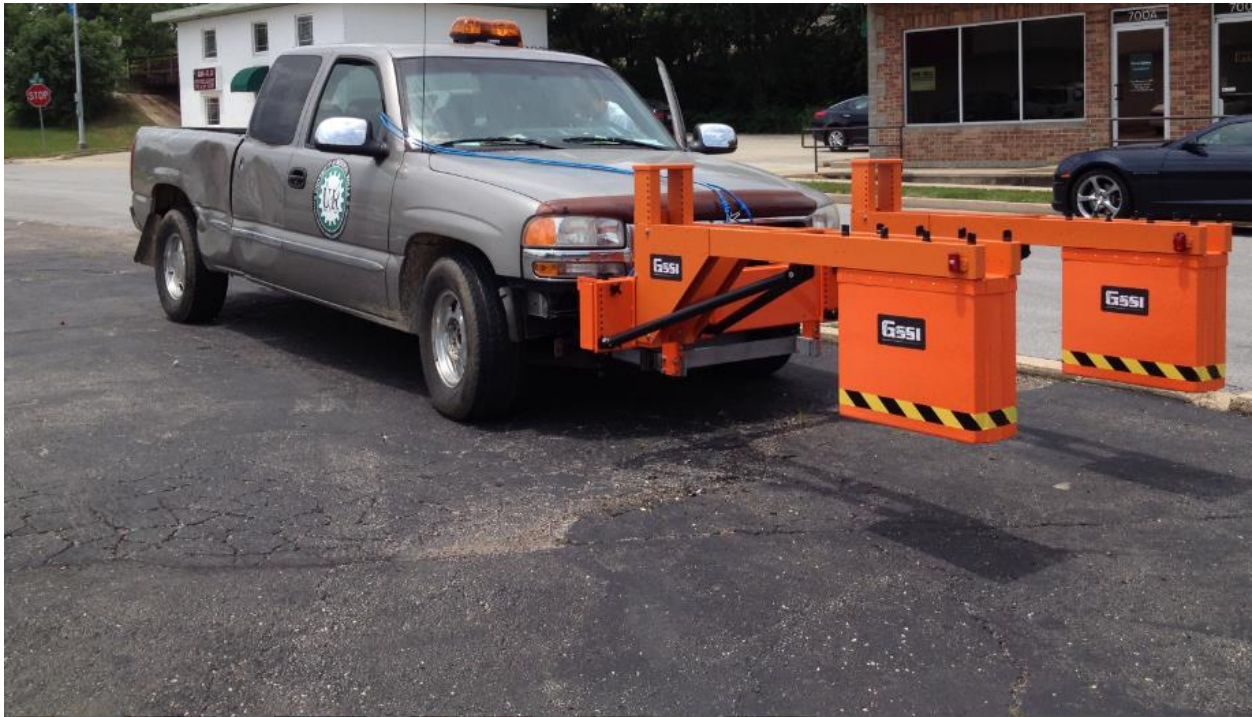
Figure 3-1 Photo of 2.0 GHz GSSI Antennae Mounted to Vehicle

Two air-launched 2.0 GHz GPR antennae mounted to a vehicle were used to investigate each bridge deck. The GPR antennae are shown in Figure 3-1. The primary objective the GPR investigations was to evaluate the capability of the GPR tool to rapidly and reliably assess the condition of the bridge deck.
