# Transportation Research Division

## **Technical Report 05-6**

*Full Depth Reclamation with Cement along  
Rt. 2A in Reed Plantation*

*Construction and First Interim, February, 2007*

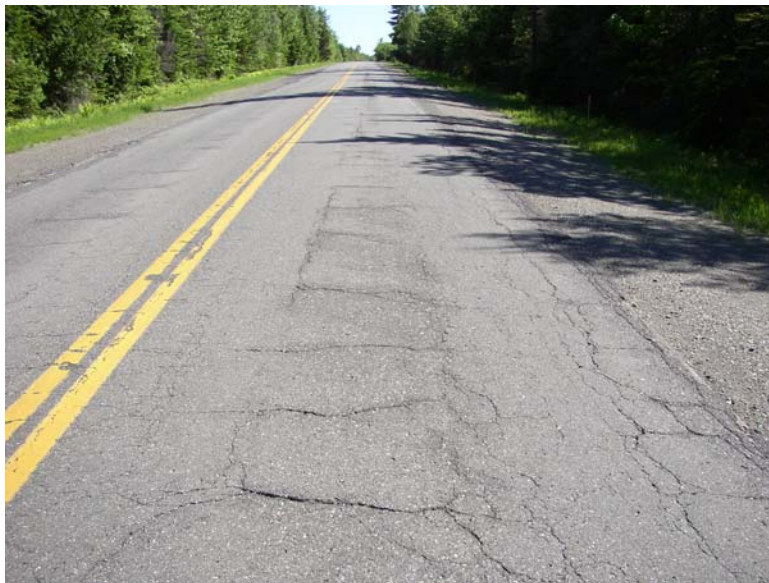
Photo 1: Typical Cracking in the North Lane

Project Identification Number (PIN) 11326.00 is located in Aroostook County on US Route 2A between the townships of North Yarmouth Academy Grant and Reed Plantation (Figure 1). The project is 5.02 miles in length and is scheduled for Highway Rehabilitation with drainage and safety improvements. Annual Average Daily Traffic is somewhat low at 700 in 2005 with 38 percent heavy trucks. Table 1 contains current (2005) and future (2017) traffic data. Prior treatments include a resurfacing in 1995 and a thin overlay of maintenance mix in 2001. The project has many areas with transverse, alligator, and block type cracks as displayed in Photo 1.

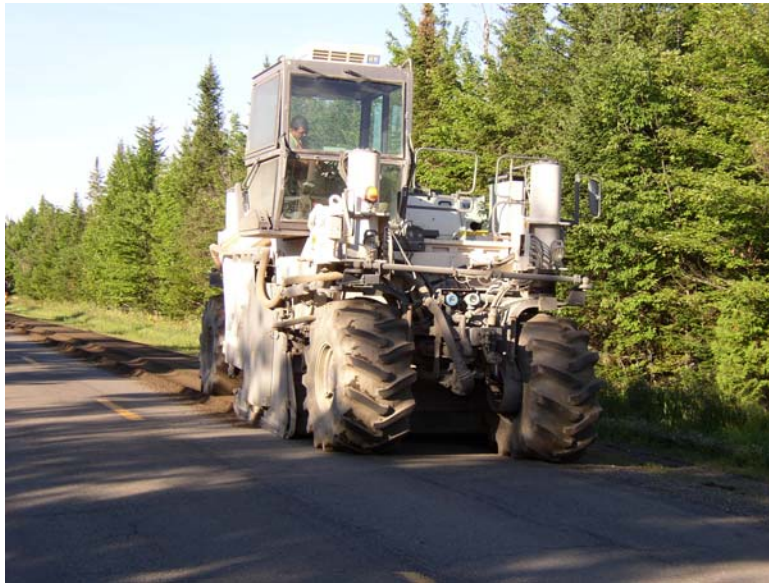
Photo 2: First Pass with the Wirtgen 2500 Recycler

The contractor reclaimed 2500 feet per day. Each 2500 foot section was split into two subsections of equal length. Traffic was diverted to the right side of the roadway. The contractor began with reclaiming at an offset of 5 feet left to 13 feet left of centerline (Photo 2) for a distance of 1250 feet. Water was added and the RAP was pre-compacted with a vibratory pad foot roller (Photo 3). The recycler set back to the beginning of the section and the second pass was at an offset of 2 feet right to 6 feet left of centerline for 1300 feet. Water was added and the RAP was again pre-compacted with a vibratory pad foot roller. After pre-compaction, RAP is graded from centerline to 15 feet left then compacted with a vibratory steel drum roller. Water was added if necessary for proper compaction. After a short curing period traffic was diverted to the left side of the roadway and the recycler set back to the beginning of the section and reclaimed at an offset of 1 foot right to 9 feet right of centerline. The RAP was watered and pre-compacted with the pad foot roller. The final pass of the recycler in this section was at an offset of 5 feet right to 13 feet right of centerline. This pass was also watered and compacted with the pad foot roller. The RAP was graded from centerline to an offset of 15 feet right, watered and compacted with a vibratory steel drum roller.

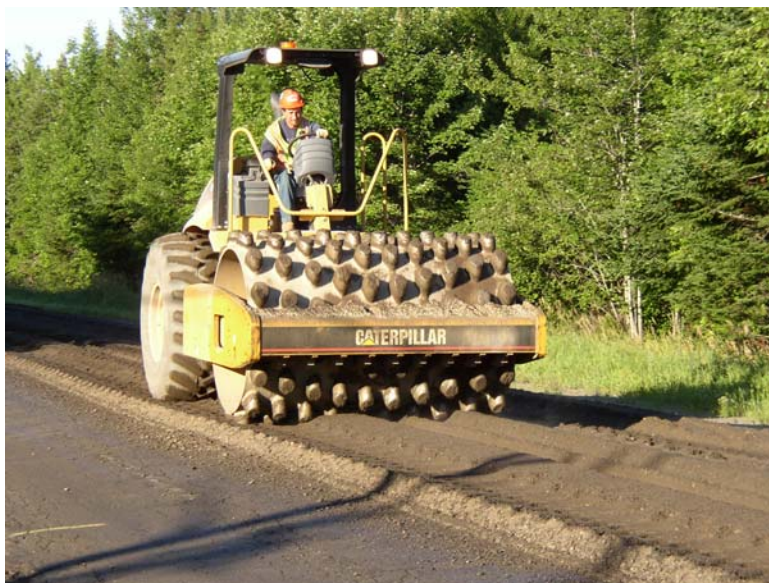
Photo 3: Pad Foot Vibratory Roller

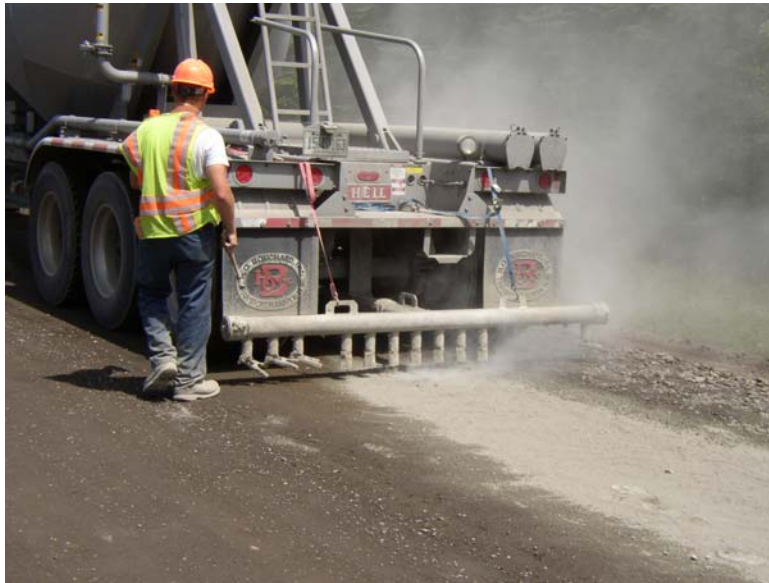
Photo 4: Cement Delivery System

Cement stabilization begins with applying water to the RAP ahead of the cement delivery vehicle. Cement was delivered to the roadway using a cement truck with a bar and nozzles attached to the end of the truck (Photo 4). A canvas tube was attached to the end of each nozzle to reduce the distance the cement had to travel to coat the roadway and minimize the amount of cement dust. Air pressure was used to force cement out of each nozzle. The nozzles and bar frequently plugged and the truck had to make many stops to correct the problem. Even with the canvas tubes this type of delivery system created clouds of cement and a health hazard for the employees and nearby foliage (Photo 5). Another type of delivery system that can accurately dispense cement and reduce or eliminate the amount of cement dust should be considered for future projects.

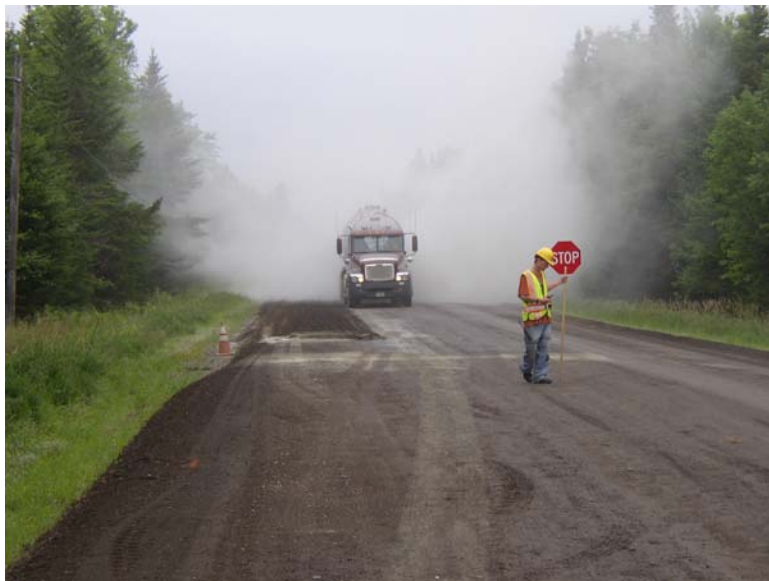
Photo 5: Cement Cloud Hazard

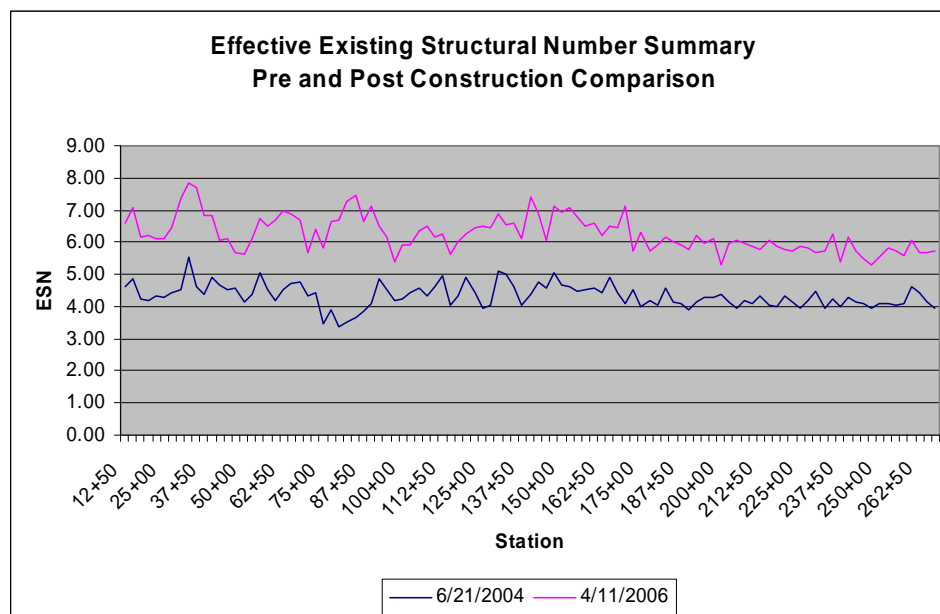
Figure 3: Pre and Post Construction Structural Number Comparison

Figure 3 contains a summary of the test results. Cement stabilized RAP structural numbers that were collected in April are on average 44 percent higher than pre-construction values.
