Technical Report 05-6

Full Depth Reclamation with Cement

Second and Third Interim, December, 2008

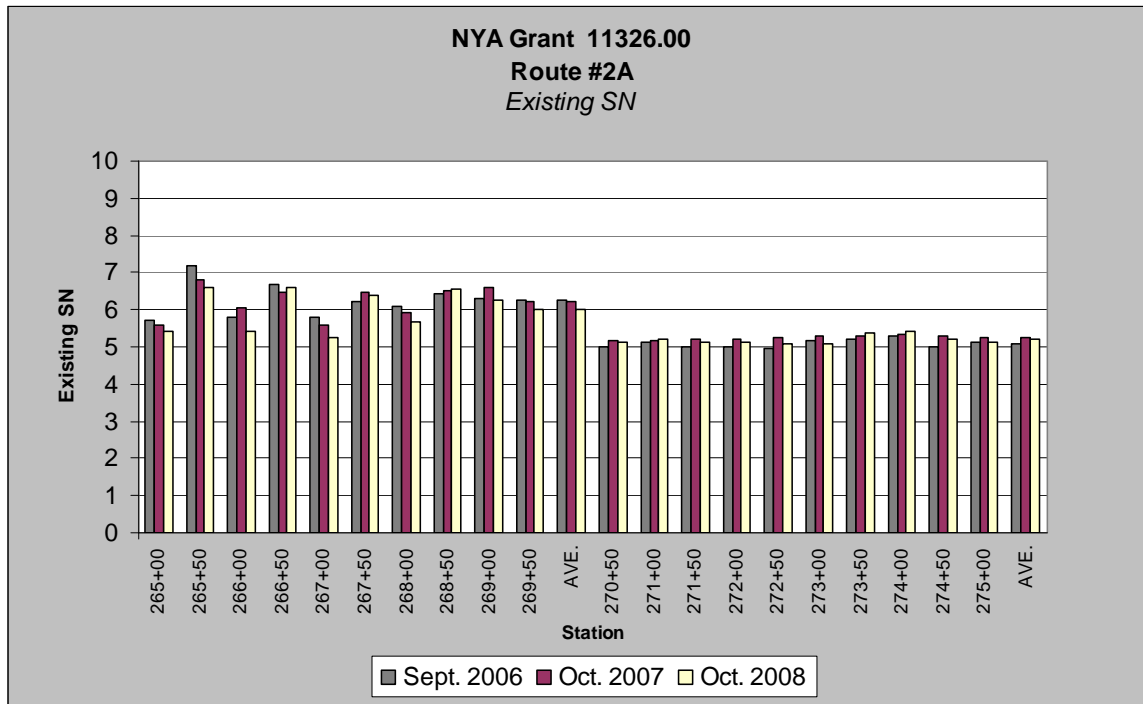
Structural strength measurements were collected in October of 2007 and 2008 utilizing the Departments FWD. Readings were taken at 50 foot intervals in both the experimental and control sections. FWD data was then analyzed using DARWin Pavement Design software to develop Existing Structural Numbers for each test location. Comparisons were then completed for 2006-2007 and 2007-2008 to determine levels of weakening or strengthening within the two areas.

The Experimental area had a 2006 average ESN of 6.242. In 2007, that number decreased by 0.22 percent to 6.228. The 2008 ESN decreased an additional 3.6 percent to 6.01, an overall decrease in strength of 3.82 percent.

The Control section actually showed an increase in strength from 2006 to 2007. The average ESN for 2006 was 5.088. For 2007, that number increased 3.1 percent to 5.252. In 2008, the ESN decreased approximately 1 percent to 5.194.

Overall, the experimental section continues to be stronger than its control counterpart by almost 14 percent.

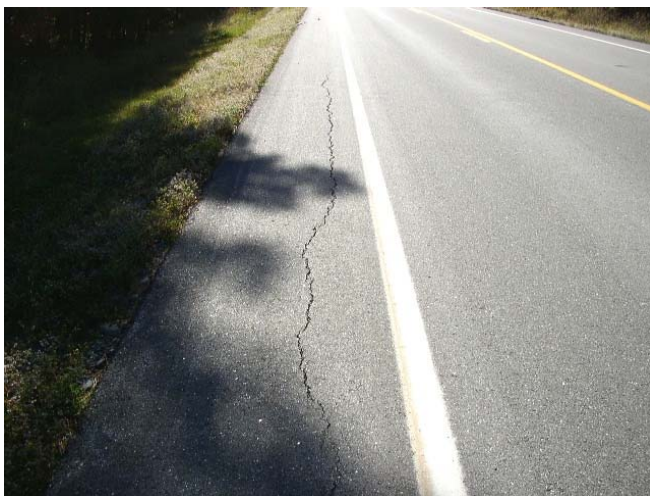
In addition, a crack was identified in the northbound shoulder of the Control section as part of the 2007 evaluation. This crack measured approximately 24 feet in length and less than 1/2 inch in width. The 2008 evaluation found the crack had extended to 45 feet in length and approximately 1 inch in width. This crack is outside the typical evaluation area of the travel lanes and is noted for the purpose of documentation. Photos 2 and 3 show the crack as it was in the 2007 and 2008 inspections.

Photo 2: Shoulder Crack – 2007

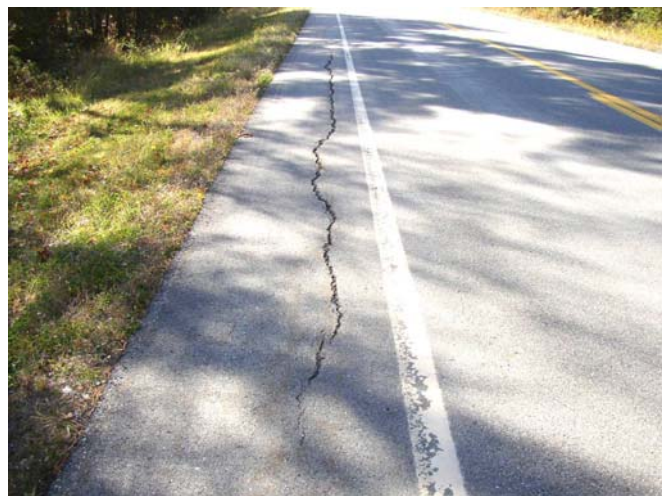
Photo 3: Shoulder Crack – 2008
