Technical Report 05-07

*Utilizing a Hot Applied Snowmobile Crossing
Mat to Eliminate HMA Abrasion*

Final Report, October 2009

Evaluation

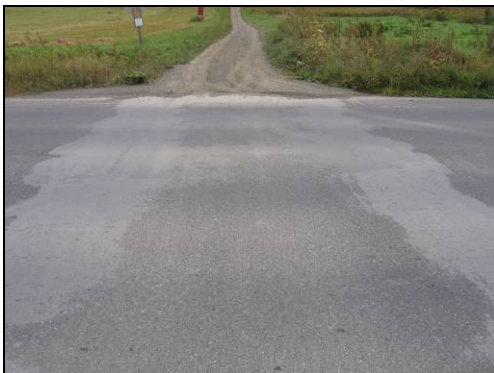
Photo 1 – Looking South

The State Route 167 crossing in Presque Isle has reached its useful service life. Photos 1 thru 3 show that most of the material has worn away in the center of the mat, exposing the pavement. It is interesting to note that the shoulder area, see Photo 2, is wearing much better.

As mentioned in a previous report, anecdotal information gathered from area residents indicates this crossing may be subjected to significantly higher snowmobile traffic volumes than the other two crossings.

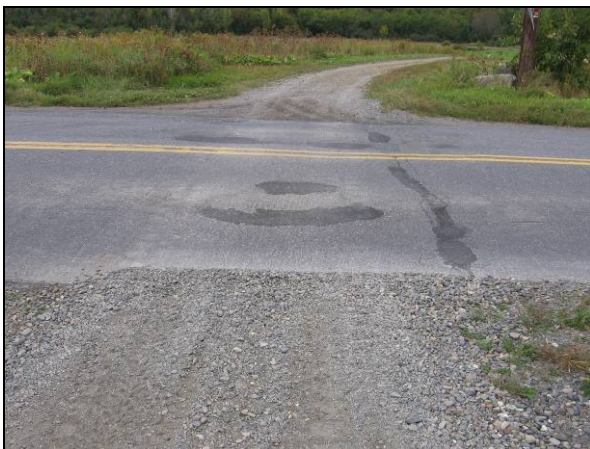
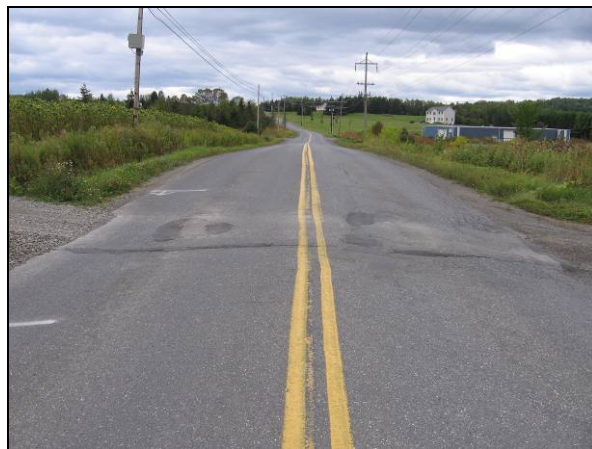
The 2008 evaluation found several patched areas and areas in need of patch. As with the Route 167 experimental crossing, the north end of this crossing has an uphill approach and appears to be sustaining the most damage.

Photos 4 and 5 were taken during this 2009 inspection.

The Control section continues to sustain damage from snowmobile traffic. Each year, more and more wearing surface is eroded requiring additional patch material. Damage near the pavement edge, caused by accelerating snowmobiles is an on-going problem. To date, it appears maintenance crews patch this section at least once annually.

The Control section was last paved in 2001 according to the Presque Isle Public Works Dept. It is in need of re-paving at this time.

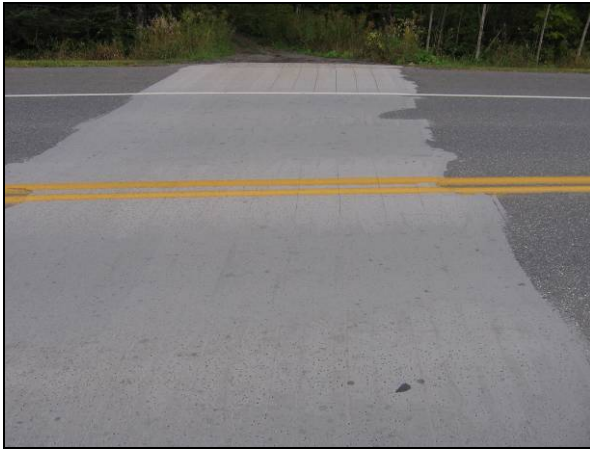
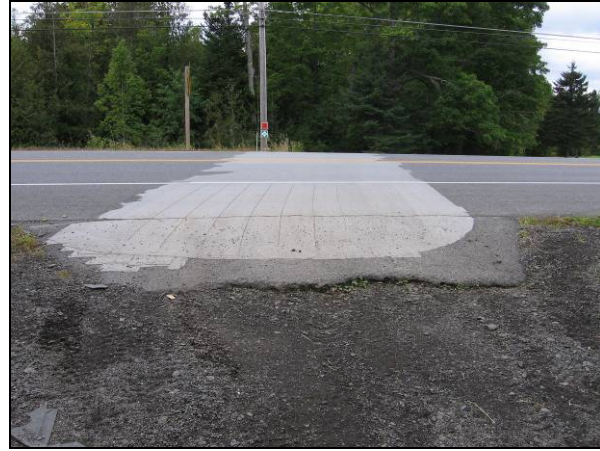
The 2009 evaluation found this section to be in generally good condition compared to the Presque Isle crossing. Plow wear is evident at high spots in the roadway. Both photos below show that the roadway shoulder area is wearing much better than the travel lanes. Obviously the combination of plowing and snowmobile traffic has a significant impact on the durability of this material.

After four years of exposure, this section continues to perform quite well. The Cleanosol product remains mostly intact in the areas of primary snowmobile travel. It is uncertain how the snowmobile traffic volume of this section compares to the other sections.

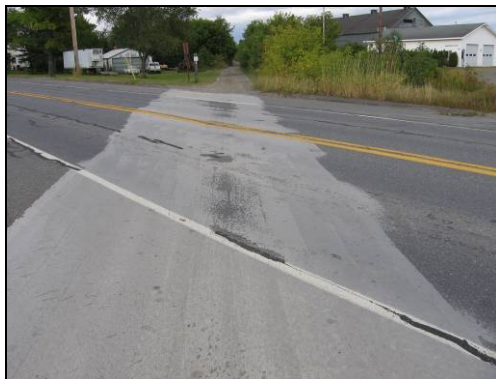
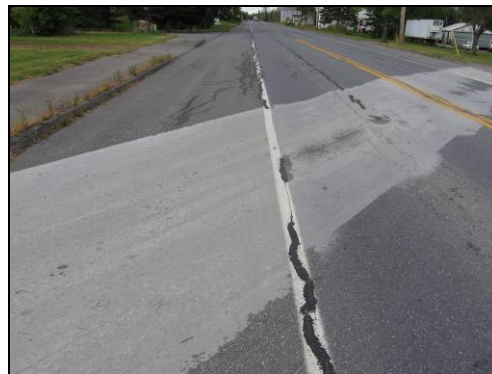
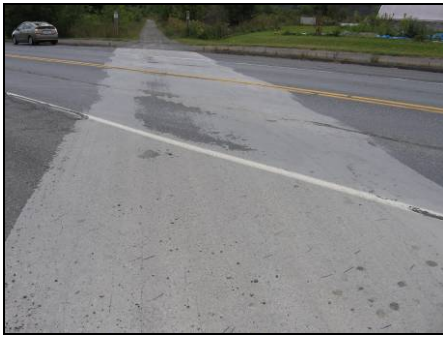
For the 2007 and 2008 inspections, this section was found to be in good condition. However the 2009 inspection shows significant wear in the center of the mat and more pronounced leading edge wear from snow plows. This crossing is very near the end of its service life. Snowmobile traffic volumes on this section are believed to be the second highest of the three under evaluation, with the Presque Isle crossing seeing more traffic.

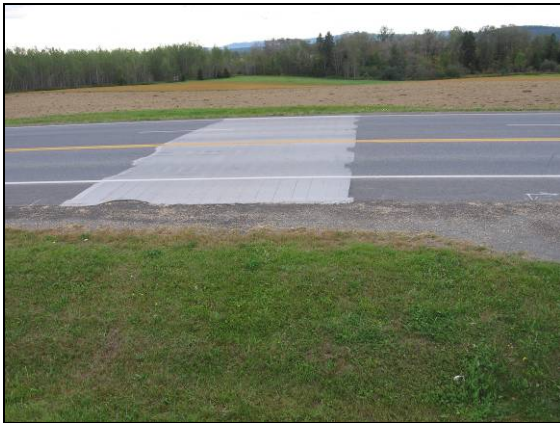
Photo 11 – Near Convention Center

The Rt. 1/ITS 88 crossing has basically reached its service life after only two winters. This crossing experiences roughly the same amount of snowmobile traffic as the Rt. 167 crossing. The Convention Center crossing is in good condition but does not have much traffic.
