**CATHODIC PROTECTION
EVALUATION**

Final Report

ODOT CONTRACT PSK28885

Oregon Department of Transportation
Bridge Preservation Unit
4040 Fairview Industrial Drive SE, MS 4
Salem OR 97302-1142

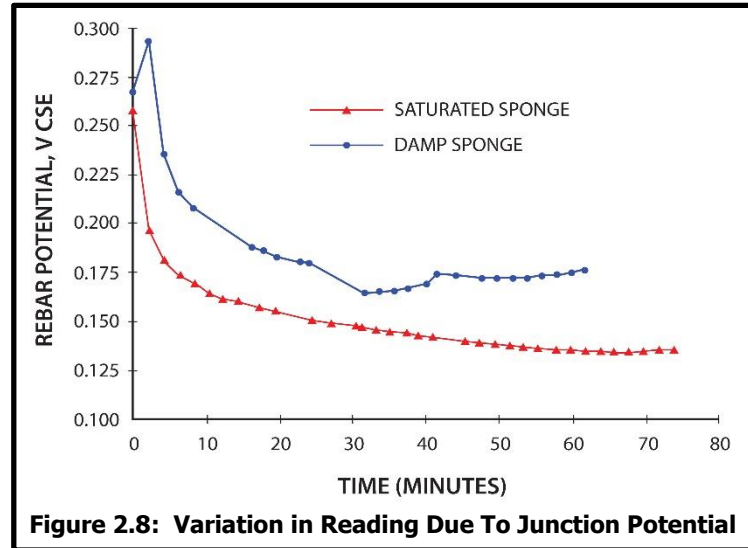
Figure 2.8 shows how the potential changes over time from the moment the sponge is placed on the concrete surface. Note the difference in behavior between the saturated sponge and damp sponge. In addition to the relative wetness of the sponge, or other conductive contact material, the concrete surrounding the rebar also plays a behavior role that is largely governed by moisture content (Tinnea, 1991).

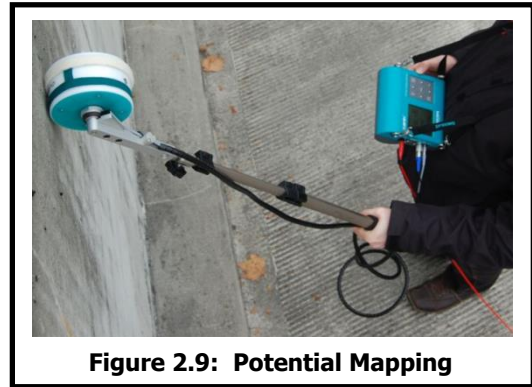
Figure 2.9: Potential Mapping

To identify localized corrosion activity requires mapping rebar corrosion potentials on a relatively close interval of 6 to 12 inches. To obtain this data by chalking a grid on the surface, recording the voltage measurements by hand, and then entering the data into a mapping software program would be extremely tedious and expensive. Figure 2.9 shows a wheeled reference electrode and data logger used for data collection. If parallel lines are marked on the concrete surface, then the wheel electrode can be run along the surface of the concrete and the data automatically recorded at pre-set intervals that are measured using the shaft encoder and the diameter of the reference electrode wheel. The data so collected can be used to produce potential maps useful in identifying areas of corrosion activity and for locating reference electrodes useful in monitoring cathodic protection systems.

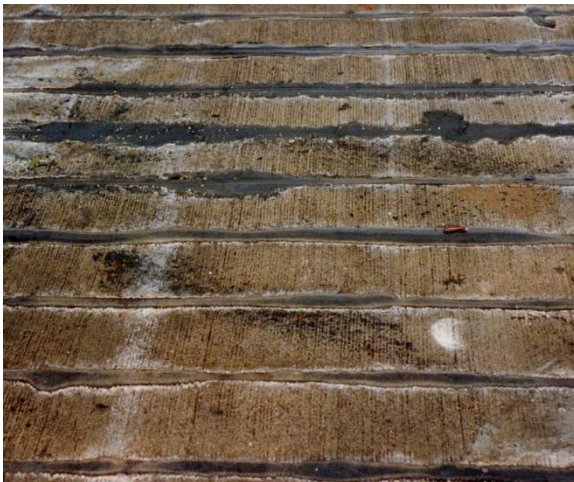
FIGURE 2.19a: ICCP System

In areas generally protected from repeated washing by direct exposure to rain, you can actually see the chloride building-up on the structure surface. Figure 2.19a shows a deck with a carbon-base anode saw slot ICCP system. The saw slot anodes run left and right. Perpendicular to the saw slots are white deposits that exactly align with the upper rebar in the top mat in the deck. In Figure 2.19b, white deposits can be seen around primary anodes on the Cape Creek Bridge. In both cases lab testing confirmed the white deposits principal anion was chloride.

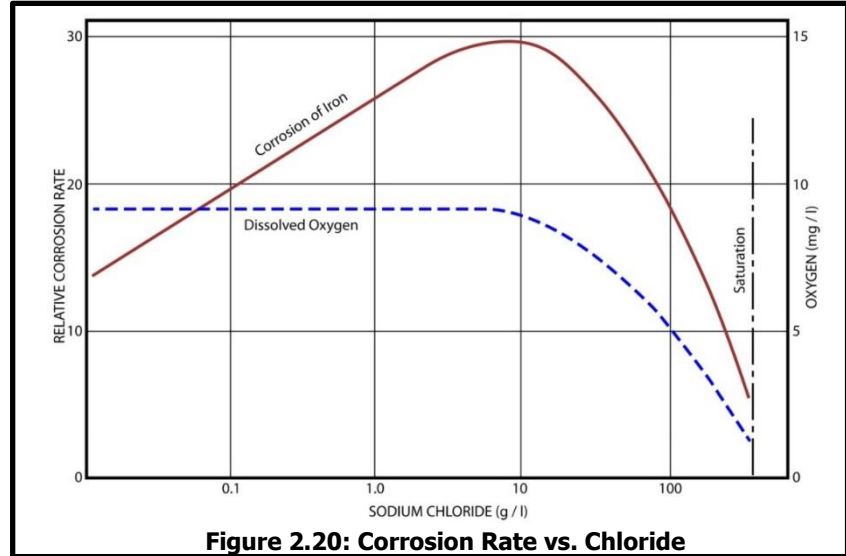
Figure 2.20: Corrosion Rate vs. Chloride

In the general case for concrete, the chloride threshold for steel corrosion depends on pH of the concrete pore water, oxygen availability, chloride concentration, and temperature. In total, this is difficult to graph, so Figure 2.20 shows a plot of the reinforcement corrosion rate as a function of sodium chloride concentration in neutral solution (Fink, 1960). Note in Figure 2.20 that at NaCl concentrations just under 10 g/l, that oxygen solubility starts to drop. Also note that as the oxygen solubility starts to drop, so too does the relative corrosion rate of iron, the principal ingredient of steel.

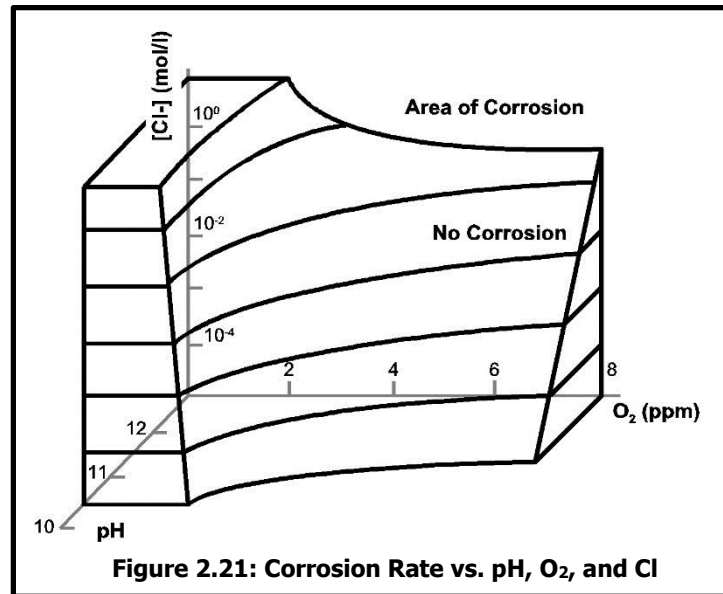
Figure 2.21: Corrosion Rate vs. pH, O₂, and Cl

Work at the National Institute for Standards and Testing (NIST) has shown that the corrosion of steel in concrete is dependent upon pH, the availability of oxygen and the presence of chloride ions, or other aggressive ions such as carbonate (Escalante, 1984). NIST prepared a chart showing the relationship between oxygen concentration, chloride ion concentration, and pH. Figure 2.21 shows the relationship between pH, oxygen concentration, and chloride content and corrosion of steel reinforcement. Note that an increase in oxygen or chloride concentrations and reductions in pH will increase steel corrosion activity.

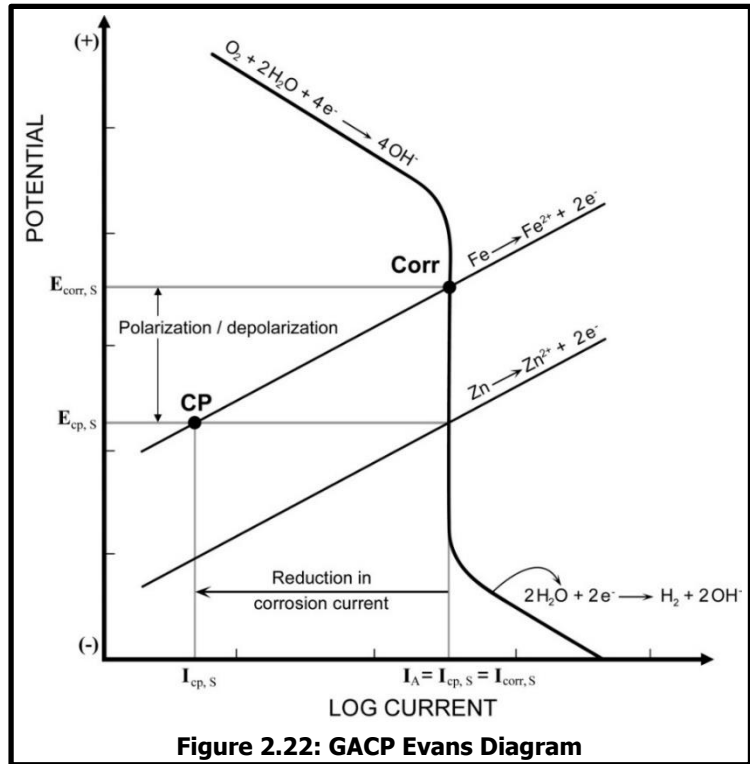
Figure 2.22: GACP Evans Diagram

When CP is properly applied to a metal, the application of the CP current shifts the potential of the protected metal in a negative direction. That potential shift is accompanied by a reduction in the rate the metal is corroding through a decrease in the corrosion current. If the change in potential is plotted against the log of the corrosion current, the result is generally linear behavior unless there are impediments in the transport of reactions (e.g. availability of oxygen at the metal surface). In soil and seawater applications of CP, the slope of this line is typically less than 100 mV/decade of current. The mV/decade is referred to as the anodic Tafel slope, β_a . Therefore, in traditional applications of CP, a polarization of 100 mV will reduce the corrosion rate by over an order of magnitude. Figure 2.22

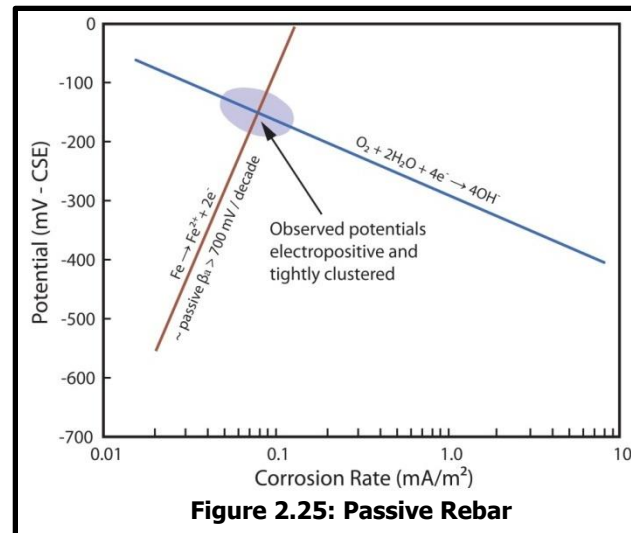
Figure 2.25: Passive Rebar

Figure 2.25 (after Glass, 2001) shows an Evans diagram for embedded rebar in a passive state. Note that the Tafel slope β_a for iron corrosion is 700 mV/decade. Also note that the observed potentials are tightly clustered about where the anodic Fe → Fe⁺⁺ line intersects the cathodic O₂ + 2H₂O + 4e⁻ → 4OH⁻ line.

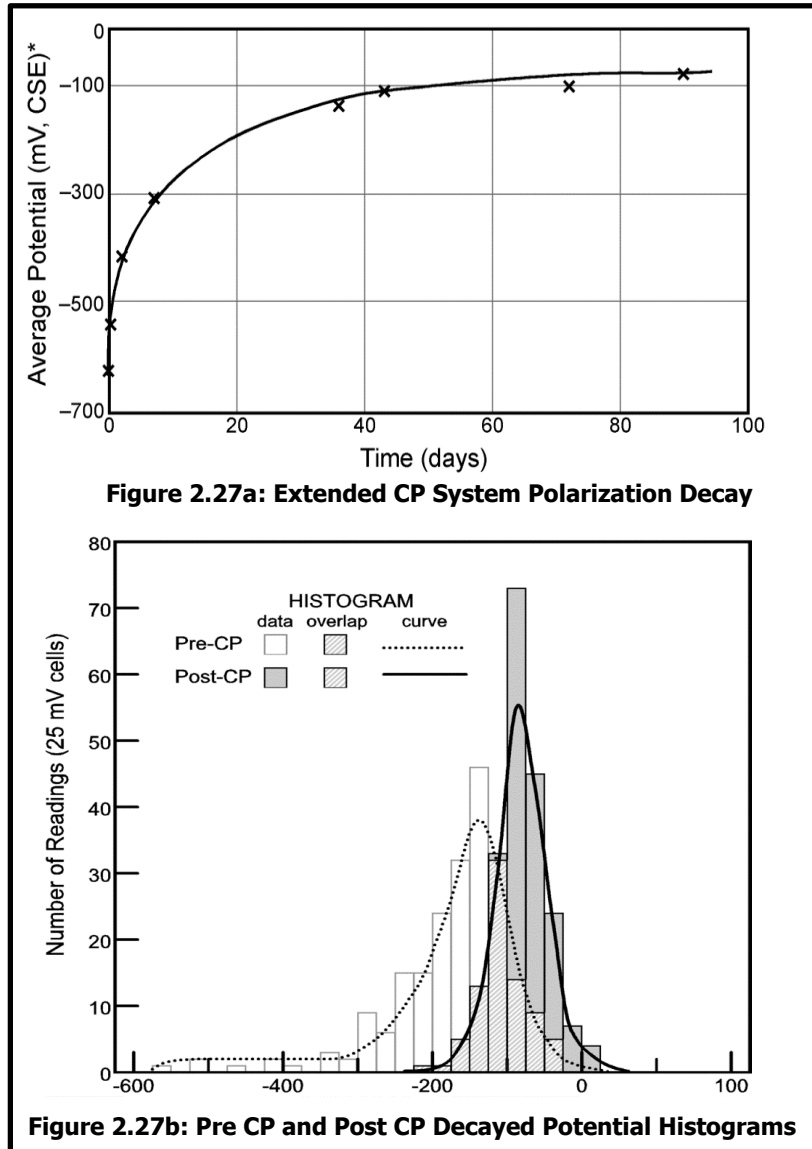
After a reinforced concrete CP system has been energized for several years, it can take months to fully depolarize. Figure 2.27a shows a plot of the average reinforcement potential obtained over a three month period after the system was turned off (*Broomfield & Tinnea, 1992*). Each average reading is comprised of over 200 readings taken on a 5-foot grid over an entire zone. The first data point is the average of “immediate off” readings obtained 0.5 seconds after interrupting the rectifier with a programmable interrupter. After the “immediate off” readings were obtained, the rectifier was actually turned off and additional data sets collected at 3 hours and 2, 7, 36, 43, 72, and 90 days. Note that after about a month after the CP system was turned-off the rebar potentials reflect values ASTM C876 identifies with passive rebar and even after 90 days off the potentials are showing no sign of returning to active corrosion.

Figure 2.27b shows histograms of rebar potentials obtained before the CP system was energized. Also shown is a histogram of the post-CP 90-day depolarized data. Note that the pre-CP corrosion potential histogram is much broader, and includes substantially more negative potentials than does the 90 day depolarized data. This behavior follows what was shown in Figures 2.26a and 2.26b, above.

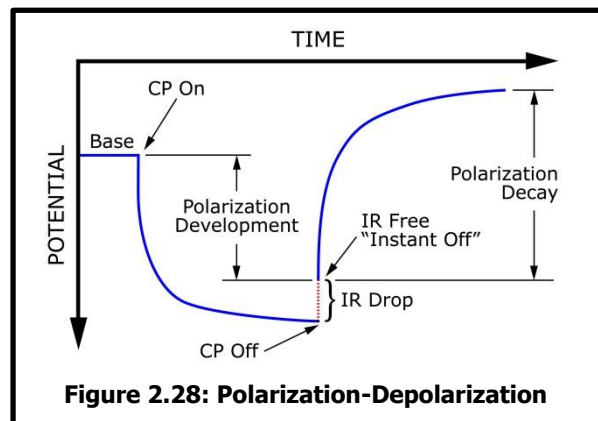
Figure 2.28: Polarization-Depolarization

NACE SP0290 calls for a minimum of 100 mV polarization from native potentials, or 100 mV depolarization from an “Instant Off” reading. The duration of the test can have a clear impact on the values recorded. Per SP0290 the “Instant Off” reading is typically read between 0.1 and 1.0 seconds after the rectifier is interrupted. Readings at times less than 0.1 seconds often include reactive components that have nothing to do with CP. If one waits more than one second, the observed change will be understated. Figure 2.28 provides a stylized diagram. Starting on the left with the base potential before CP is applied the polarization is shown, whereby the steel potential is polarized in a negative, cathodic direction. About midway, the rectifier is turned off and the potential shifts in a positive direction. The area between ‘CP Off’ and ‘Instant Off’ include IR error and reactive transients resulting from interrupting the CP current. At a point between 0.1 and 1 second is the start of the depolarization.

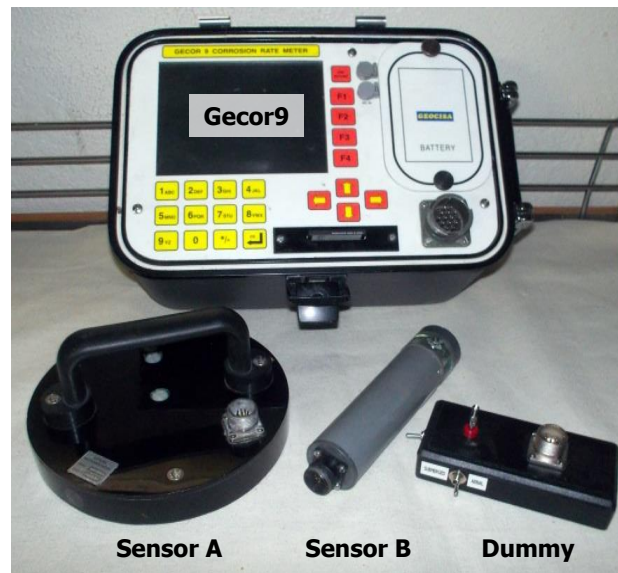
Figure 3.1: Gecor 9 Components

Sensor C: Use for measurements in submerged or very wet concrete (not used).

Dummy: A dummy cell to check on Gecor operation

Figure 3.1 shows the equipment used in this investigation. Sensor A was used to conduct measurements of rebar corrosion rate at Coos Bay and Yaquina Bay Bridges. It was also used to evaluate the effectiveness of the ICCP system at Coos Bay and the GACP system at Lint Creek. Sensor B was used to measure rebar corrosion potentials, concrete resistivity, and make estimates of corrosion risk. Sensor B was used to obtain pre-CP baseline data at Coos Bay and as part of the corrosion condition evaluation at Yaquina Bay.

The main body of Sensor A is 7 inches in diameter and 1½ inches high and is made from methyl methacrylate. It has a handle on the back that extends about 2 inches out from the main body (see Figure 3.1).

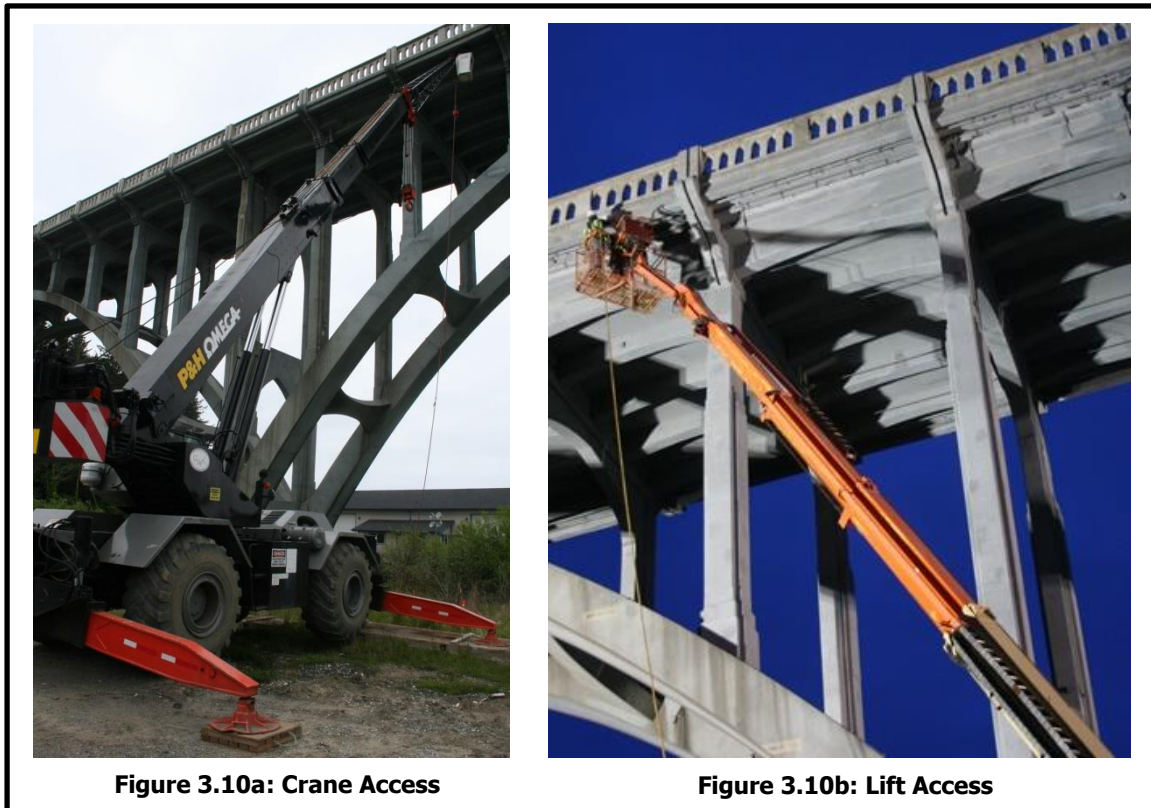
Figure 3.10a: Crane Access

At Coos Bay a 120' basket lift and a 160' crane fitted with a bucket were employed to gain access to most of the test locations. Some locations low on the arches and piers could be accessed on foot or with a ladder. Figures 3.10a and 3.10b show the team members using the crane and lift respectively.

Moving the access equipment at Coos Bay also presented challenges. Note in Figure 3.10a that the support pads of the crane are set on timber. The southernmost two arches, Spans 13 and 14, reach over designated wetlands. The team had to exercise special care when inspecting in this area so that our access equipment did not damage the soft soil. The presence of the wetlands and need to move and place timbers for each access rig setup considerably slowed inspection efforts in that area. Accordingly, we tried to cluster test locations so that more than one test site could be accessed from a single lift rig setup.

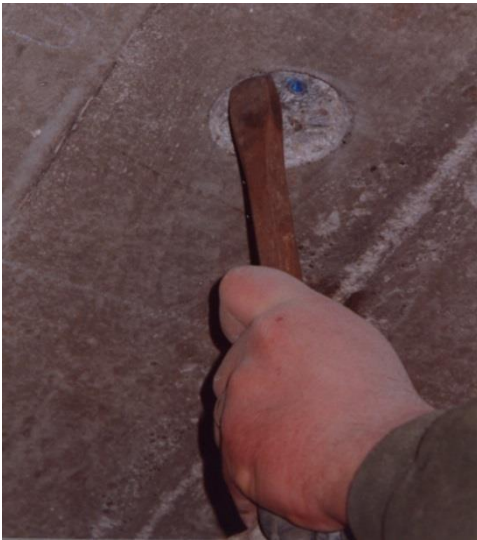
FIGURE 4.2a: Cut Recess for Primary

The TS zinc coating applied to the concrete surface operates as a distributed anode. The TS zinc coating is connected to the positive terminal of a rectifier that powers the system through what is known as a primary anode. A primary anode is a piece of brass set in a recess cut into the concrete in such a manner so as to insure the outer brass surface is flush with the surrounding concrete surface. The primary anode is installed before the zinc coating is applied. Spraying the zinc over the brass surface shorts the distributed zinc to the primary anode. A wire is then connected to the primary anode and run to the rectifier. This connection to the primary anode also is connected to the distributed zinc anode.

Figure 4.2 shows the installation steps of a primary anode through spraying with zinc.
