Maine Department of
Transportation
**Transportation Research
Division**

*Experimental Construction Report ME 00-20
First Year Interim Report on Experimental
Utilization of Tire Shreds to Enhance Highway
Drainage
June 2001*

*First Year Interim Report on Experimental Utilization of
Tire Shreds to Enhance Highway Drainage*

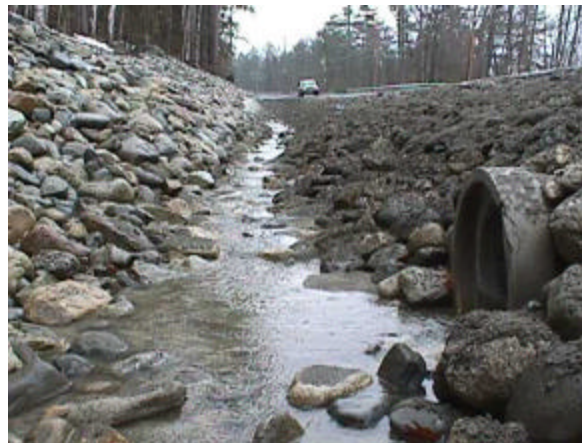
This cover photo of this report shows the ditch and the cross culvert inlet at the lower end of the experimental section. In that section the water level in the drain at OW-2 was almost 2 feet. This represents significant storage capacity. The photo taken on April 12, 2001.

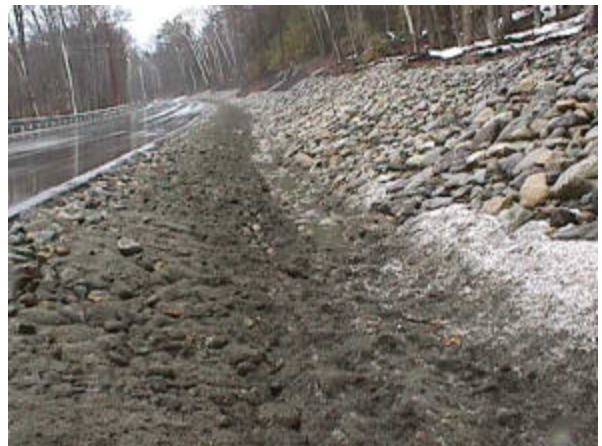
In the summer of 2000 shredded tires were used in an experimental project on a full highway reconstruction project in the town of Rome. Shredded tires were used to construct a subgrade French drain in the ditch profile. The picture at right shows the completed ditch and shoulder area during the spring of 2001. The French drain is located beneath the riprap on the road side of the ditch.

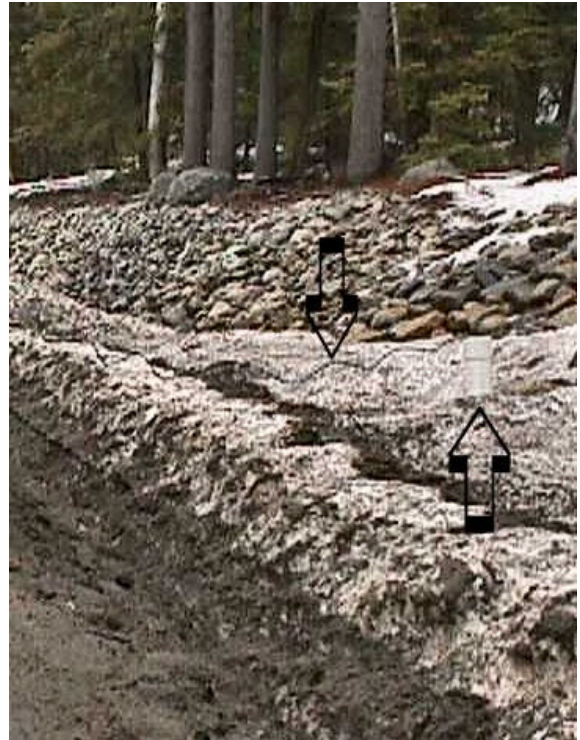
In the photo at right, the arrows indicate the riser pipe and the thermocouple leads. The riser pipe can be seen at the far right. The wire thermocouple leads, which are normally stored inside the riser pipe have been pulled out and are just visible leading towards the road. A handheld digital thermometer was used to record the ground temperatures

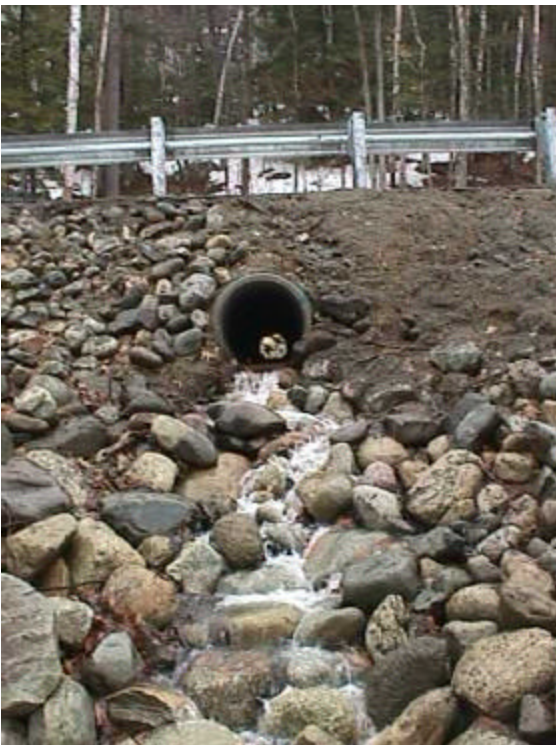
The photo at left shows the cross culvert and outfall at the end of the French drain.

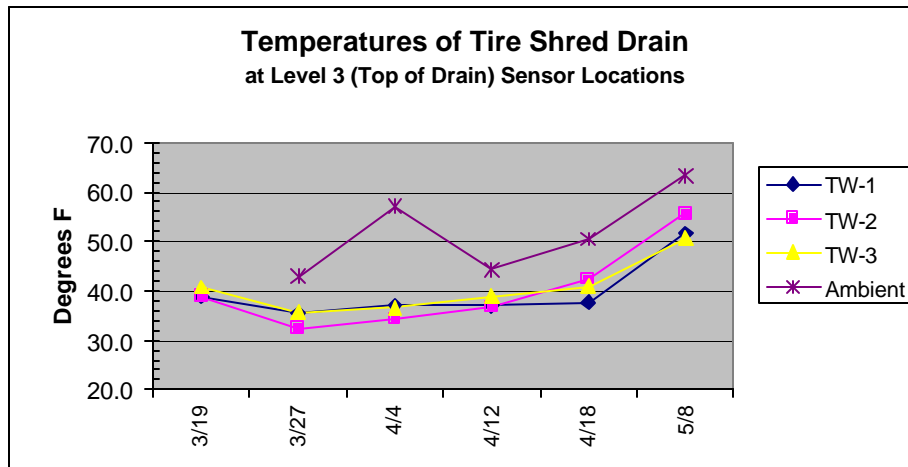
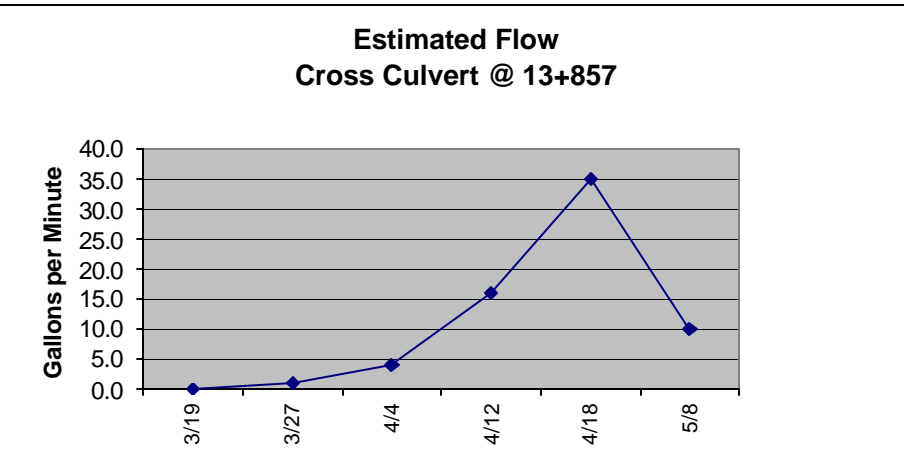
The results show that the drain performed very well during the past spring. The temperatures within the drain never reached the freezing point, a large amount of water flowed from the system. The large amount of snowfall may have help prevent ditch freezing due to the insulating effect of the snowpack. Groundwater geologists have reported that in many areas of Maine the ground never really froze this past winter due to the snow depth. The unfrozen ground more easily absorbed water from the melting snow. In this regard this past spring may not have been a representative winter and spring from an evaluation standpoint. One of the main goals of this experimental construction technique is to see if the tire shreds will prevent freezing, thereby preventing ice formation and clogging during spring runoff. Weather conditions this past spring did not present the kind of conditions to really test the effectiveness of the system. Future monitoring will yield additional information during a variety of weather conditions. The following series of charts graphically show the results.

During spring of 2001 freezing temperatures did not occur within the French drain profile. In addition, water levels in the drain range from a low of 0.17 feet up to almost 2 feet. The estimated flow out of the drainage system including both intercepted subsurface flow together with surface runoff ranged from 1 gpm to 35 gpm (estimated not measured).
