# High-Mast Light Poles Anchor Nut Loosening In Alaska

An Investigation Using Field Monitoring and Finite-Element  
Analysis

September 2014

DOT&PF Report No. 4000117

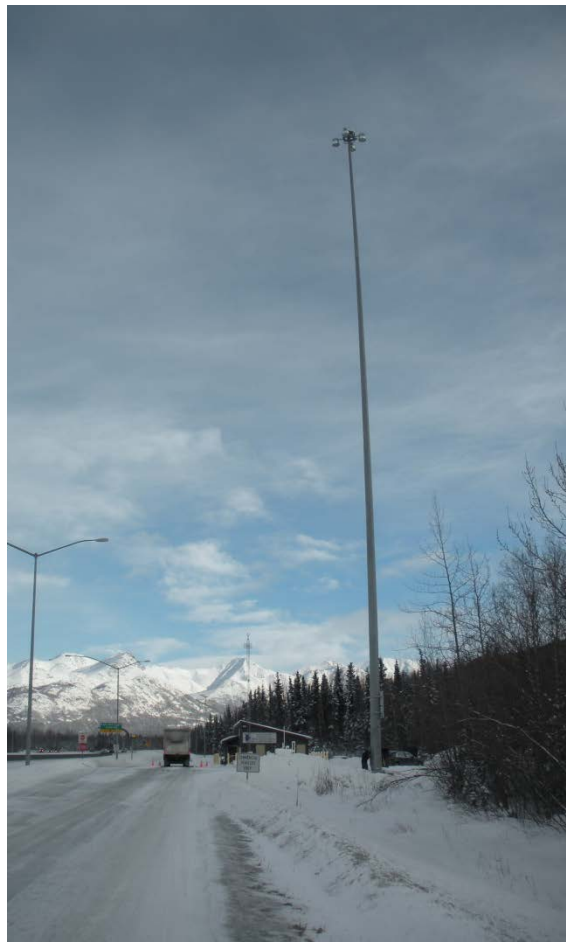
**Figure 1.1:** A High-mast Light Pole on the Glenn Highway in Alaska

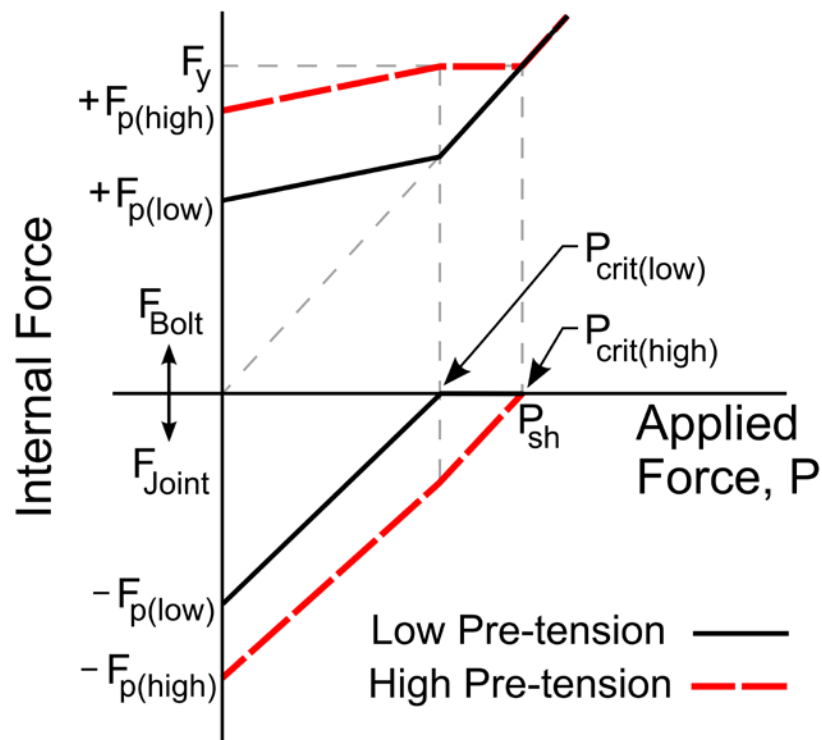
**Figure 2.2:** Mild steel response to Tensile Load in high and low pretension bolts

plate is unloaded prior to yielding, while the “high” pre-tension rod yields before the plate is completely unloaded. Figure 2.2 illustrates that prior to yielding of the rod; the joint can absorb an external force equal to  $F_p$ , while the rod can absorb a force equal to  $(F_y - F_p)$ . Summing these terms indicates that prior to rod yielding, the largest force that the bolted joint interface can absorb is  $F_y$ , the strength of the rod. Because of this,  $P_{sh}$ , the external load required to initiate strain hardening, will always be equal to  $F_y$ , the yield strength of the rod, regardless of the initial pre-tension.

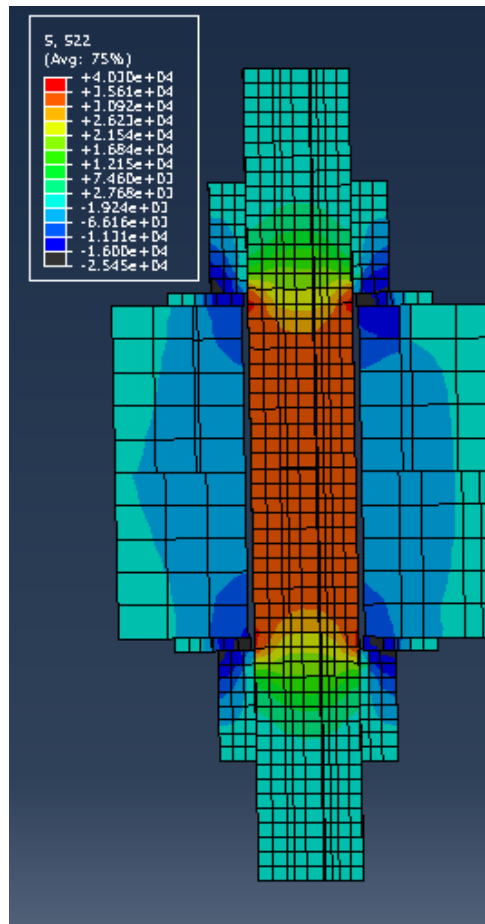
**Figure 2.8:** Flange-Flange Pretension

interface and the nut-bottom flange interface are bonded to reduce calculation time. Modelling the bolt and plate as 3D solid elements instead of line and plate elements allows for higher accuracy and a more easily visualized stress distribution. Figure 2.8 shows the cross section of a pre-tensioned bolted joint where all parts are 3D solid elements and flange-flange interaction is represented by surface-surface contact.

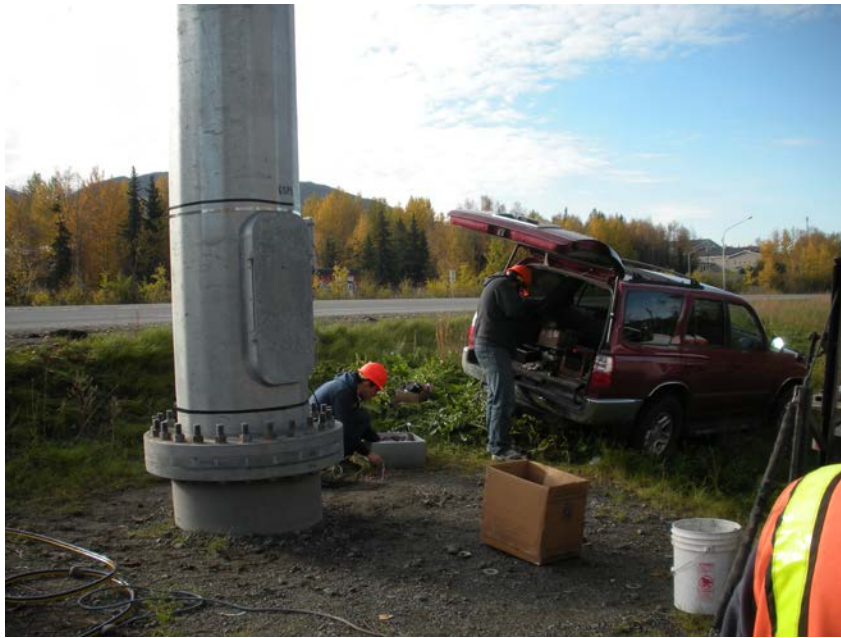
**Figure 3.2:** HMLP foundation connection at Peter's Creek

mitigate the anchor nut loosening. This pole is located on southbound side of the Glenn-Highway at the Peter's Creek South exit at 61° 29' 27.53" N, 149° 26' 45.28" W. The pole's foundation, shown in Figure 3.2, contains twenty-four 1½ in (38mm) diameter F1554 grade 55 steel threaded rods that clamp three 2.25 in (57 mm) plates together. These plates are the base plate, welded to the pole, the flange plate, welded to the driven steel pile, and a spacer plate.

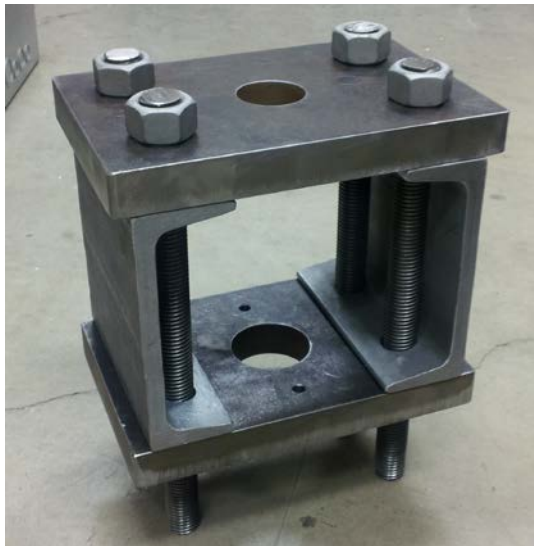
**Figure 4.2:** Universal Test Machine Adapters for 1.5 inch Anchor Rods

An hydraulic universal testing machine by MTS Systems, Inc. with a 110 kip (500 kN) capacity was used to calibrate the voltage output of the embedded strain gages to a applied axial load on the anchor rods. Custom-built steel adapters, shown in Figure 4.2, were used to mount the anchor rods in the test machine. These adapters were necessary because the anchor rods were too large for the normal grips. In addition, traditional grips do not allow space for the internal strain gage wire that was protruding from one end of the anchor rods.

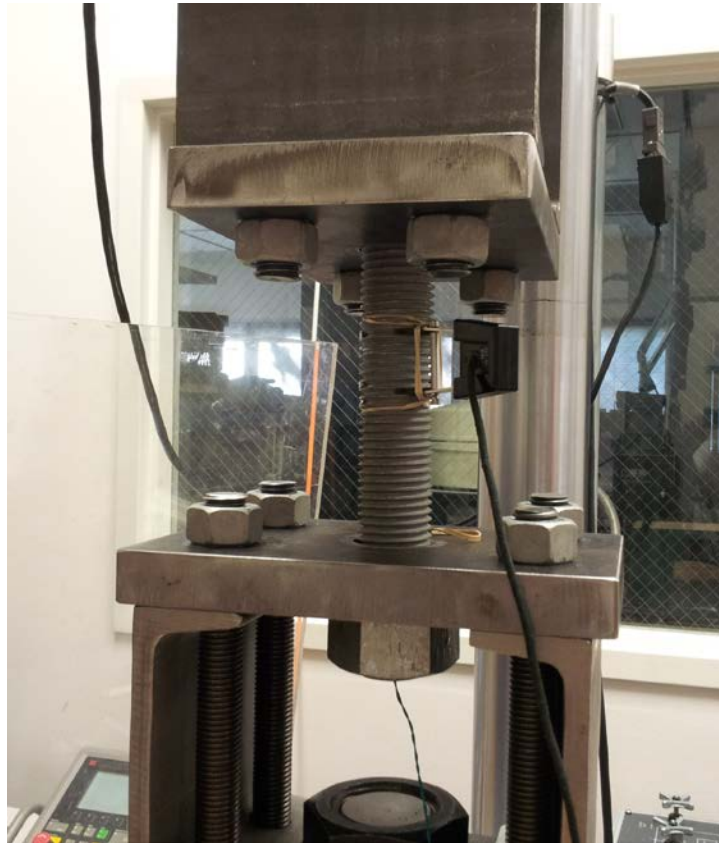
**Figure 4.3:** Anchor Rod Calibration in Universal Testing Machine

kip (67 kN). The strain gauges were connected to a Wheatstone bridge using a  $\frac{1}{4}$  bridge configuration and excited with 10 volts DC. The output voltage was monitored using an NI-9205 cDAQ module. The resulting linear relationship between load and the strain gage output voltage was determined for each anchor rod and subsequently used in the field to calculate the pre-yield axial force applied during tightening.

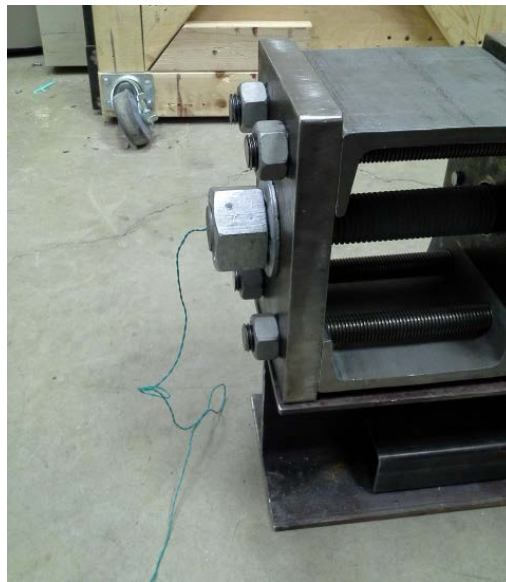
**Figure 4.5:** Direct Tension Indicator (DTI) Washer Calibration

Direct tension indicator (DTI) washers rated for 54 kips were supplied by Applied Bolting Technology. Prior to installing them in the field, a verification of their rating took place in the lab. Figure 4.5 shows a 1.5 inch threaded rod with an internally embedded strain gage through the center of the test apparatus, which was used to measure the rod tension as torque was applied. Figure 4.6 shows the final test apparatus prior to applying torque to the nuts. Note the box wrench to the left was used as counter torque and the entire assembly is clamped to an I-beam to resist the torsion. Torque was applied using a hydraulic wrench, and controlled using the hydraulic pressure in the system.

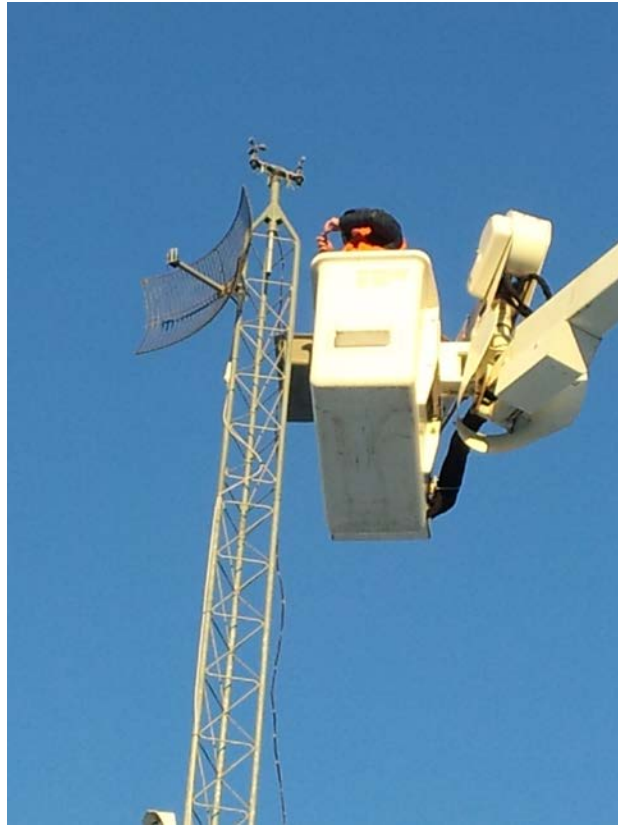
**Figure 4.8:** Anemometer Installation on Radio Tower at Weighstation

The wind speed and direction was measured using an RM Young Wind Sentry from Cambell Scientific, which was mounted to the top of a radio tower adjacent to the Weighstation structure, as shown in Figure 4.8. At 40 feet tall, the radio tower is above the tree line and approximately 100 feet from the HMLP. A second system consisting of a Labjack U3 data acquisition unit and a laptop computer running Labview was housed inside the weighstation structure and attached to the anemometer. It was powered by the weighstation's grid power.

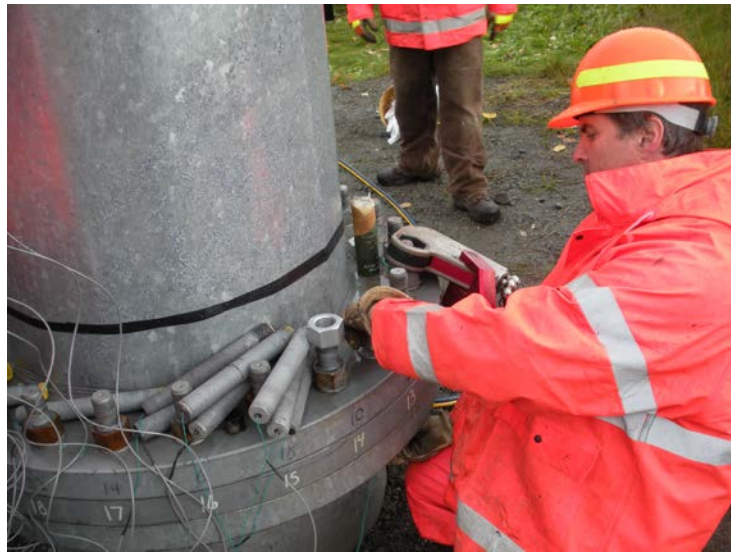
**Figure 4.13:** Installation and Tightening of Anchor Rods at Peter’s Creek HMLP

As will be shown in Chapter 5, the tightening procedure used at the Weighstation HMLP resulted in large pre-tension scatter. In order to reduce this scatter, several special provisions were adopted. They include the following changes:

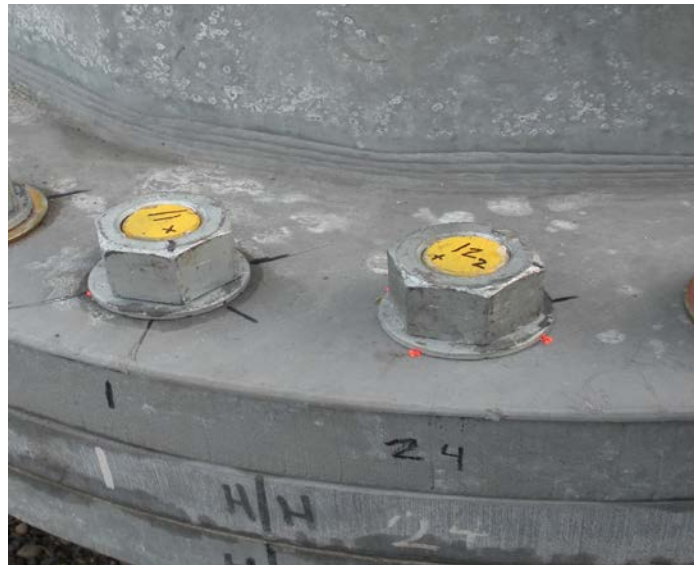
**Figure 4.14:** DTI Washers indicating full pre-tension during installation

On May 26, 2014, at the end of the study, the personnel returned to the Peter's Creek HMLP and re-applied torque to each anchor rod. A wrench was used to keep the bottom nut from turning and the pressure in the hydraulic wrench was increased until movement was detected in the top nut. The hydraulic pressure was translated to an applied torque, which was then converted to an approximate internal force using equation 4.1.

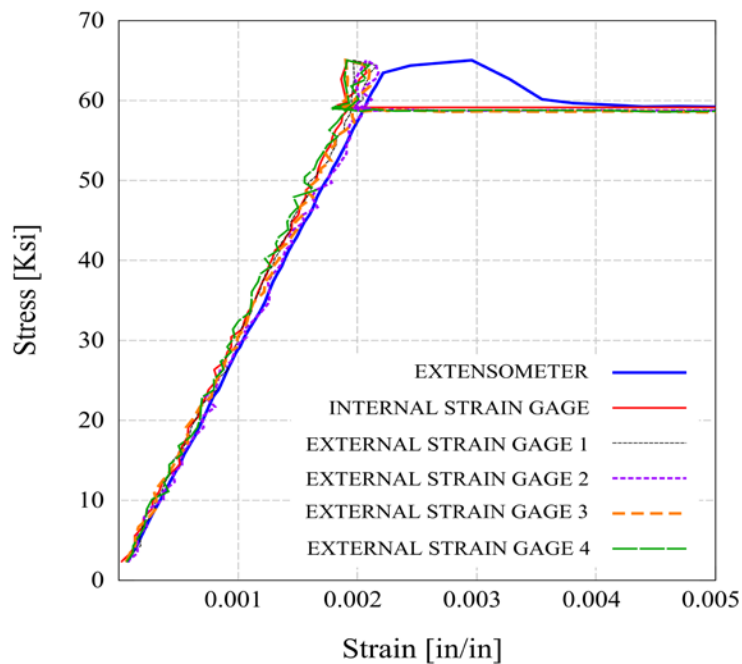
**Figure 5.2:** Elastic Stress-Strain Response of F1554 Threaded Rod

The elastic response was measured by four externally applied strain gages, an internal strain gage, and an extensometer. The results are shown in Figure 5.2. The resulting modulus of elasticity ranged from 29,150 to 31,580 ksi with an average of 30,160 ksi. The internal strain gage measured an elastic modulus of 30,180 ksi, which is almost exactly the average. The external strain gages were within  $\pm 5\%$  of the average indicating an insignificant amount of bending in the specimen. The result of the full test is shown in Figure 5.3, which clearly shows that this material is a mild steel with a clearly defined yield. Yield was measured at 64.0 ksi, the maximum strength was 84.5 ksi, and the rupture strain was 0.27.

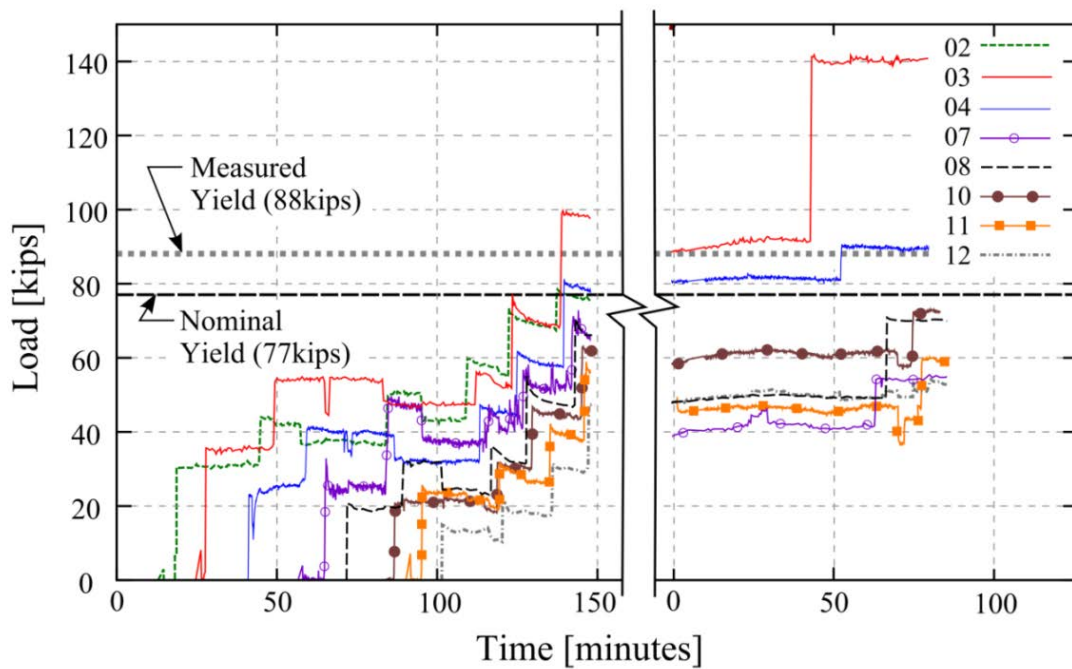
**Figure 5.6:** Axial Force in Anchor Rods during the Tightening Procedure and Re-tightening

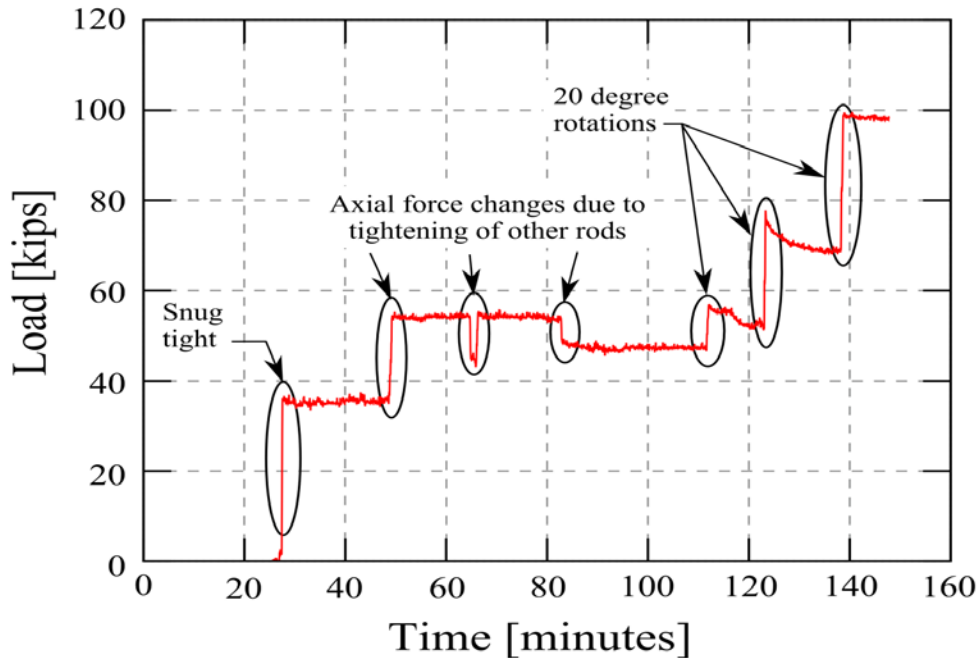
**Figure 5.7:** Tightening of Anchor Rod #3

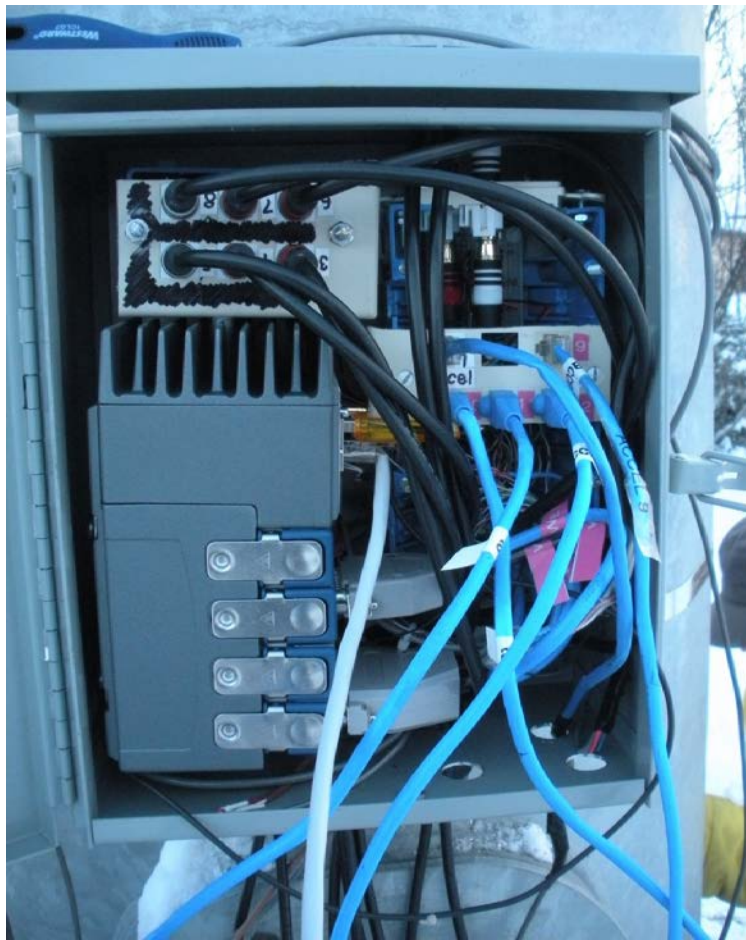
**Figure 5.11:** Weigh Station HMLP cRIO DAQ

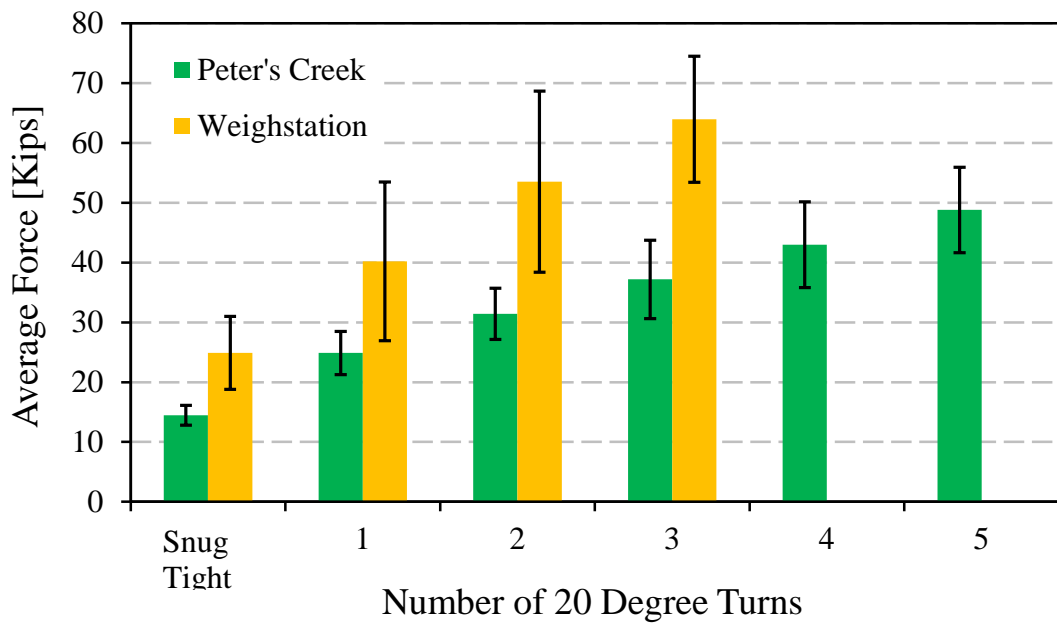
**Figure 6.1:** Average Axial Forces Developed in Anchor Rods during Tightening

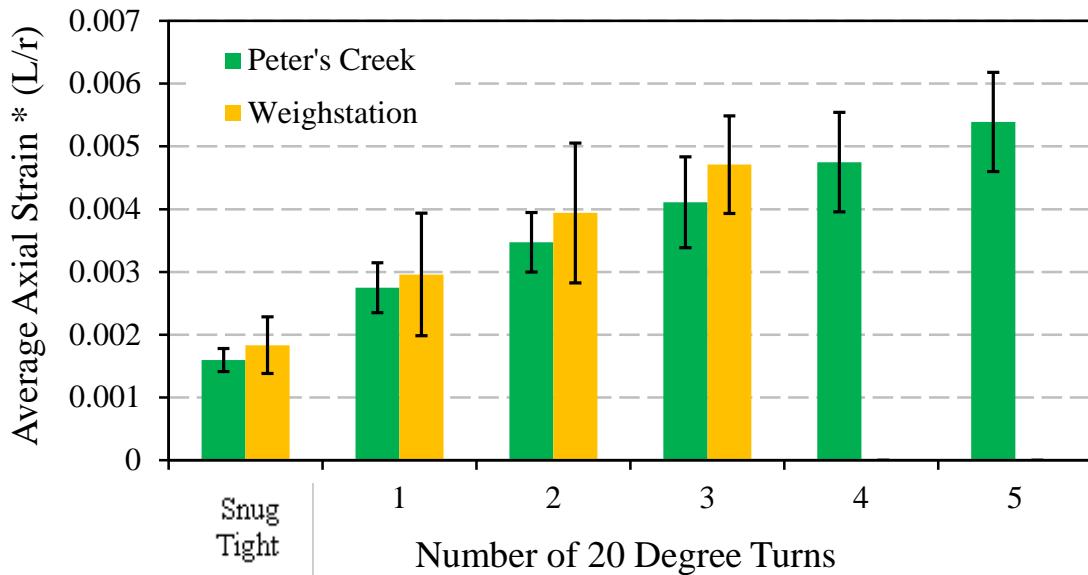
**Figure 6.2:** Normalized Axial Strain Developed in Anchor Rods during Tightening

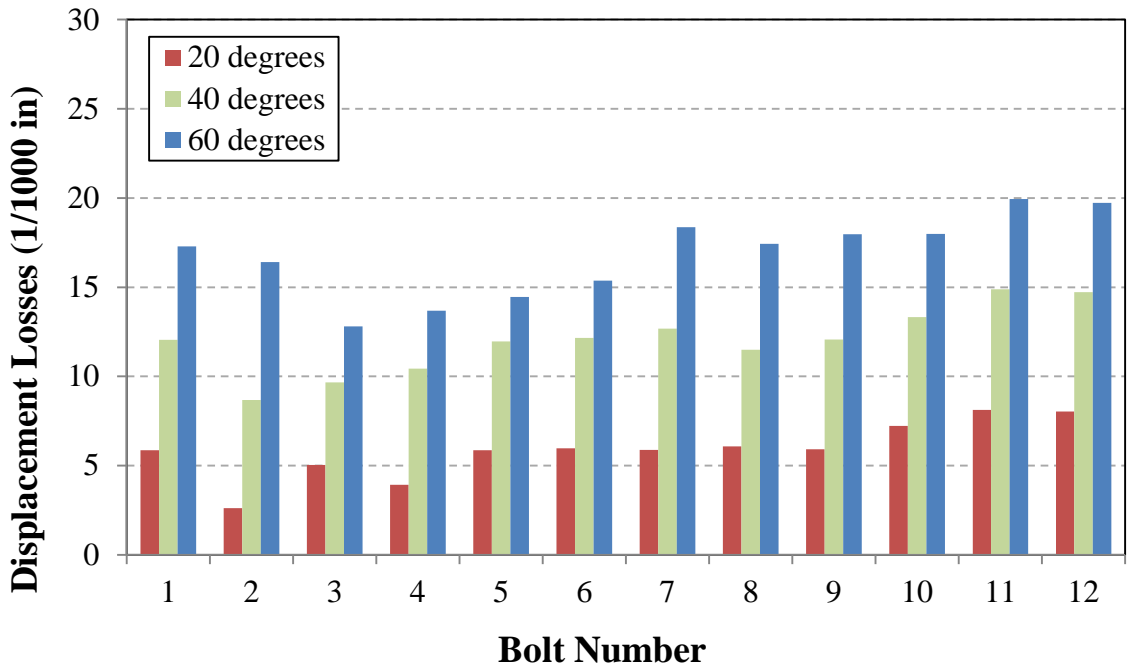
**Figure 6.3:** Displacement Losses at Weighstation during Tightening

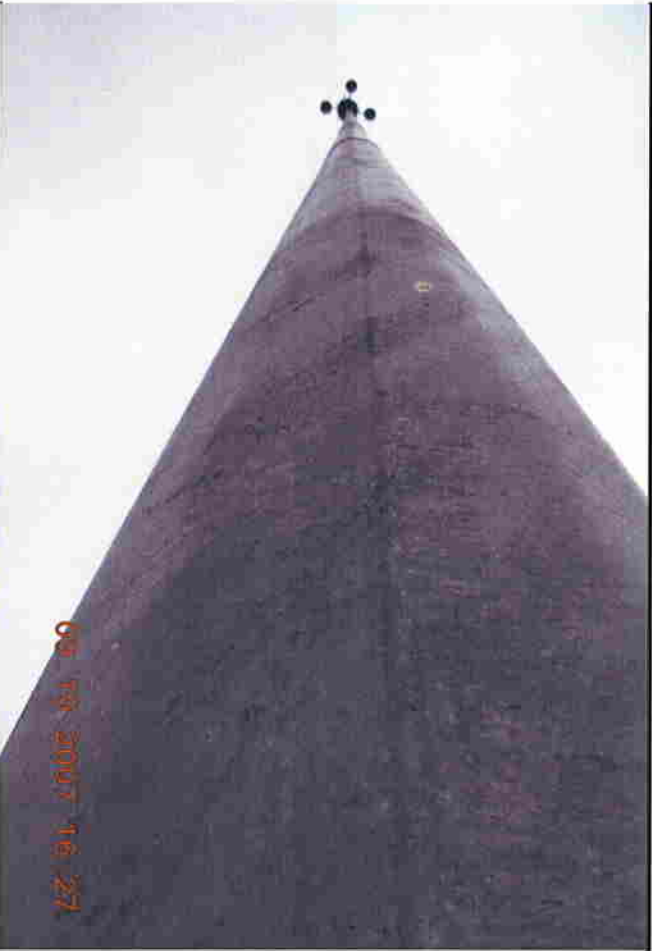
Number **GW1** Structure **Glenn Hwy-Weigh Sta** Date **09/19/07**  
Roll No. **5** Inspectors **Higgs / Stelbach** Frame **175**  
Coating above Rod **13**

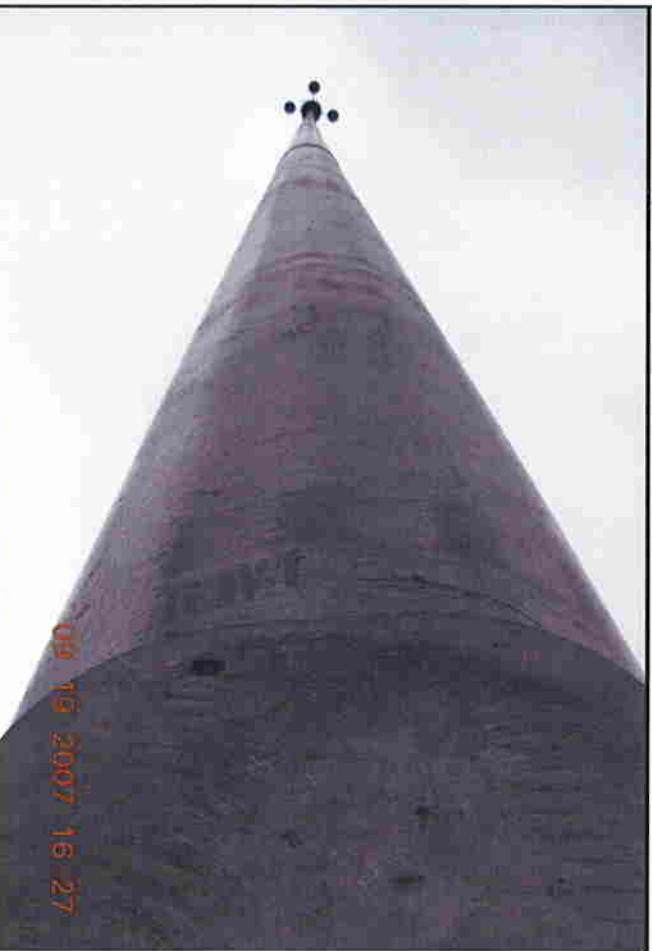
Number **GW1** Structure **Glenn Hwy-Weigh Sta** Date **09/19/07**  
Roll No. **5** Inspectors **Higgs / Stelbach** Frame **176**  
Coating above Rod **1**

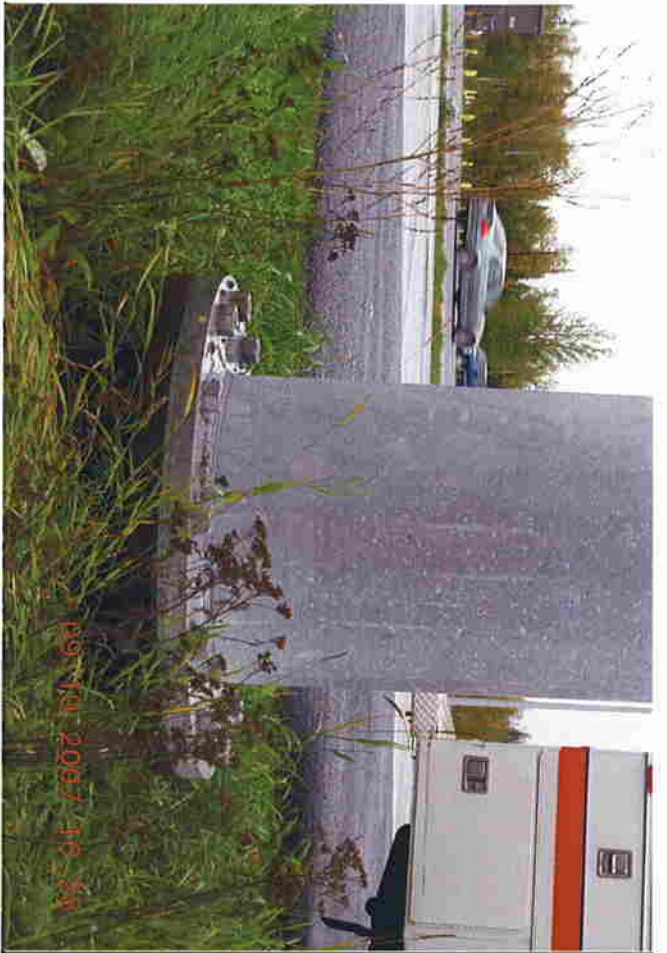
Number **GW1** Structure **Glenn Hwy-Weigh Sta** Date **09/19/07**  
 Roll No. **5** Inspectors **Higgs / Stelbach** Frame **177**  
**Backside of Foundation**

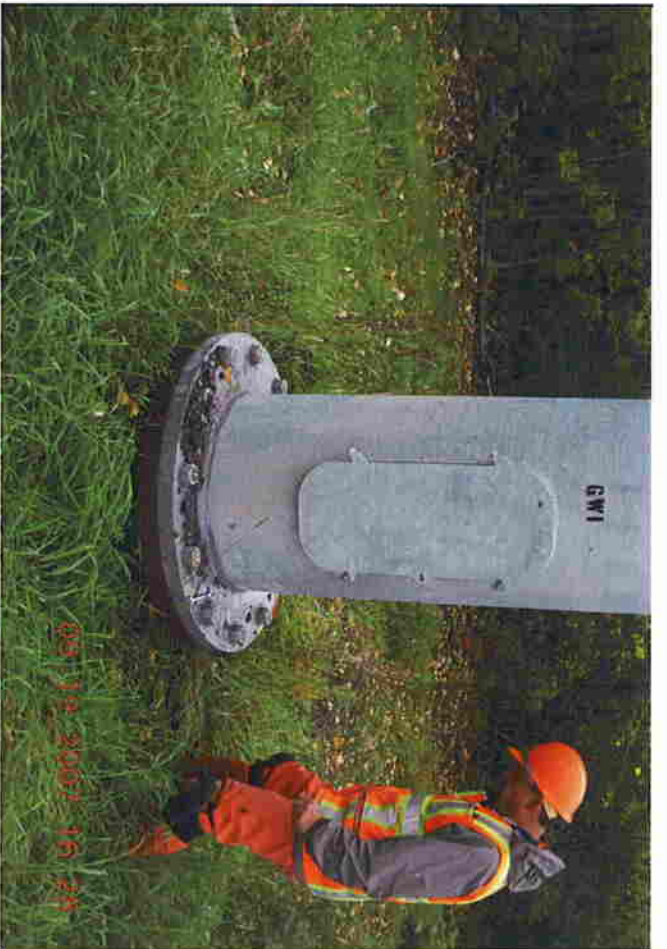
Number **GW1** Structure **Glenn Hwy-Weigh Sta** Date **09/19/07**  
 Roll No. **5** Inspectors **Higgs / Stelbach** Frame **178**  
**Frontside of Foundation**
