Structural Characterization of UHPC Waffle Bridge Deck and Connections

Final Report
July 2014

Sponsored by
Iowa Highway Research Board
(IHRB Project TR-614)
Iowa Department of Transportation
(InTrans Project 09-362)

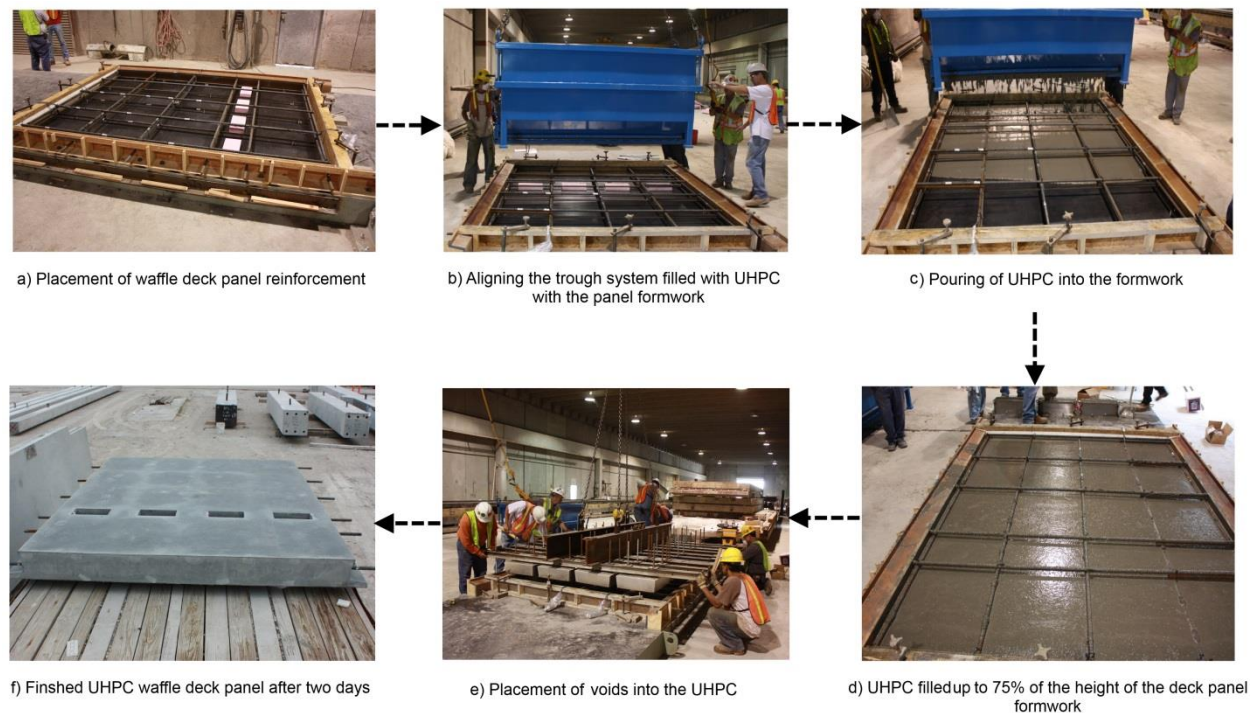
Figure 2.9. Construction sequence used for the UHPC waffle deck panels at the precast plant

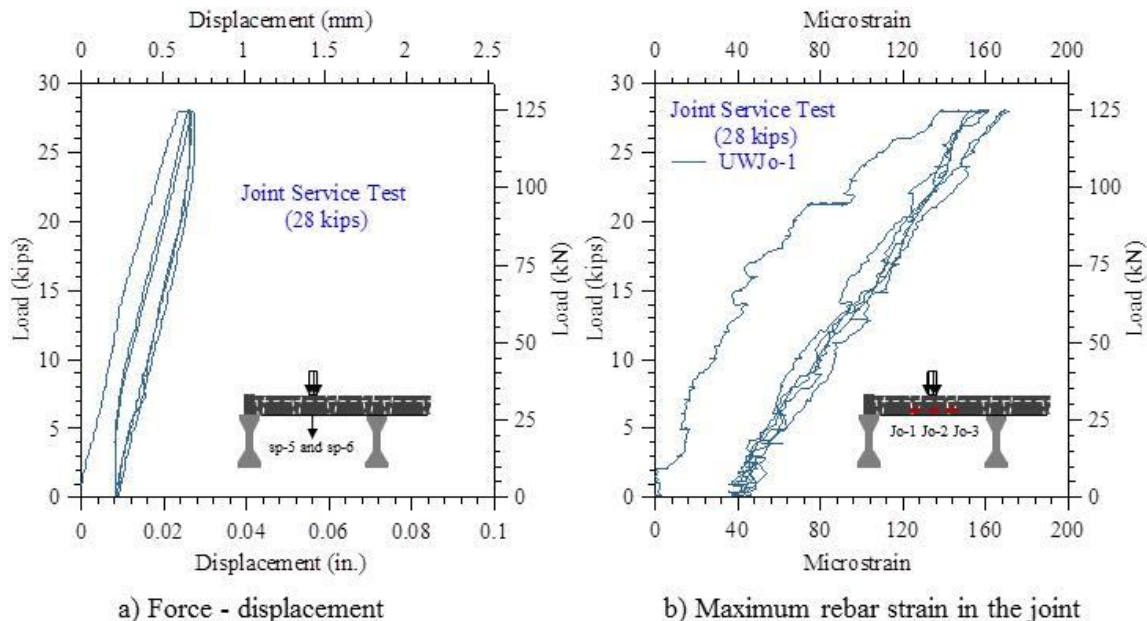
Figure 2.21. Measured force-displacement response and peak rebar strain at the center of the joint at the service load

the center of the joint is shown in Figure 2.21a. Again, a linear response was obtained with a maximum deflection reaching only 0.022 inch during the first load cycle. This deflection corresponds to $L/4000$, which is 20% of the specified AASHTO limit of $L/800$ (see Section 9.5.2 in AASHTO [2007]) for continuous spans with pedestrian traffic under the serviceability condition.

The load vs. strain plot for the gauge recorded for the maximum strains and the strain variation along a bottom reinforcement in the joint are shown in Figure 2.21b and Figure 2.22, respectively. The peak recorded strain in the joint bottom reinforcement was $17 \mu\epsilon$, indicating significant reserve capacity of the joint. The strain variations obtained for the bottom reinforcement in the transverse rib TR2 of panels UWP2 and UWP1 are shown in Figure 2.23 and Figure 2.24, respectively. Both figures show comparable strain demands, indicating that the applied joint load was evenly distributed to both panels. Figure 2.25 shows the variation of strains at the center of the rib across the transverse ribs of panel 1, indicating their relative contribution. No cracking was observed at 21.3 kips load. At the peak load of 28 kips, however, a single hairline crack having width less than 0.002 inch was observed on the transverse ribs forming the joint (see Figure 2.26). Given that this crack is significantly smaller than 0.0118 in. (0.3 mm) (see Figure 2.20) corresponding to initiation of fiber pullout and strength degradation of UHPC in tension, it was concluded that the overall behavior of the transverse joint subjected to service load was outstanding. The test results also indicated that the system performance satisfied the deflection and crack width requirements recommended for the serviceability condition by AASHTO (AASHTO 2007).

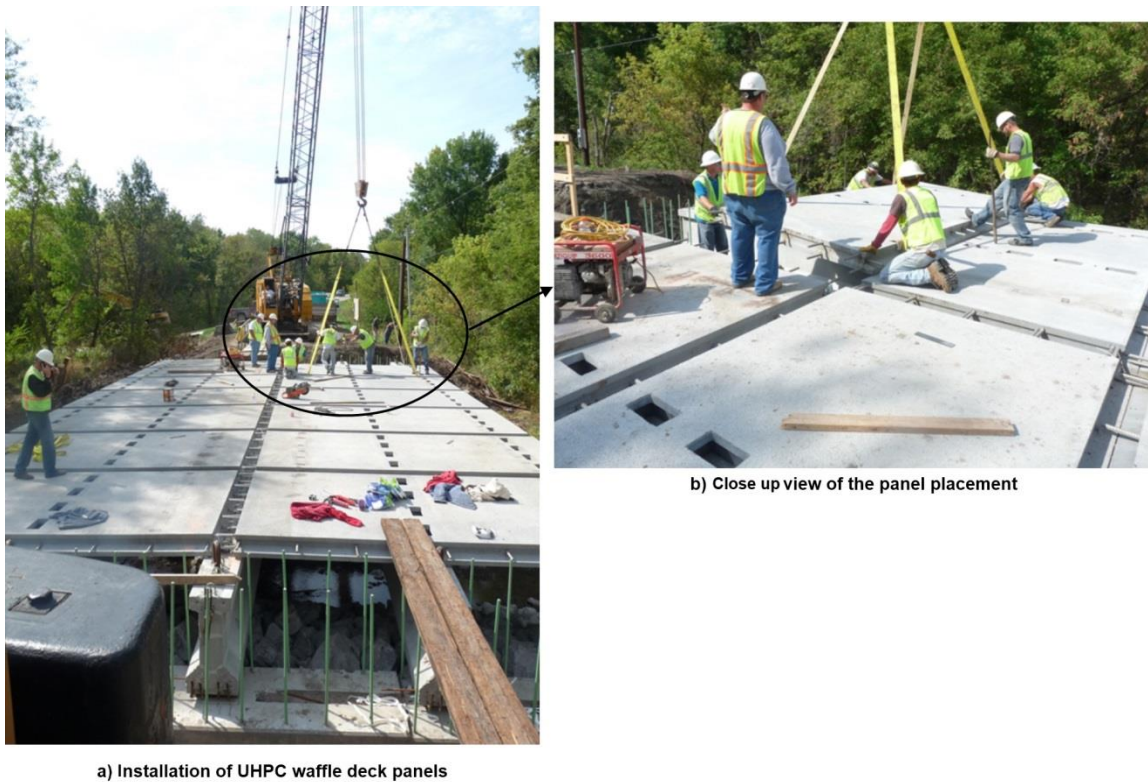
Figure 3.5. Placement of UHPC waffle deck panels on the prestressed girders

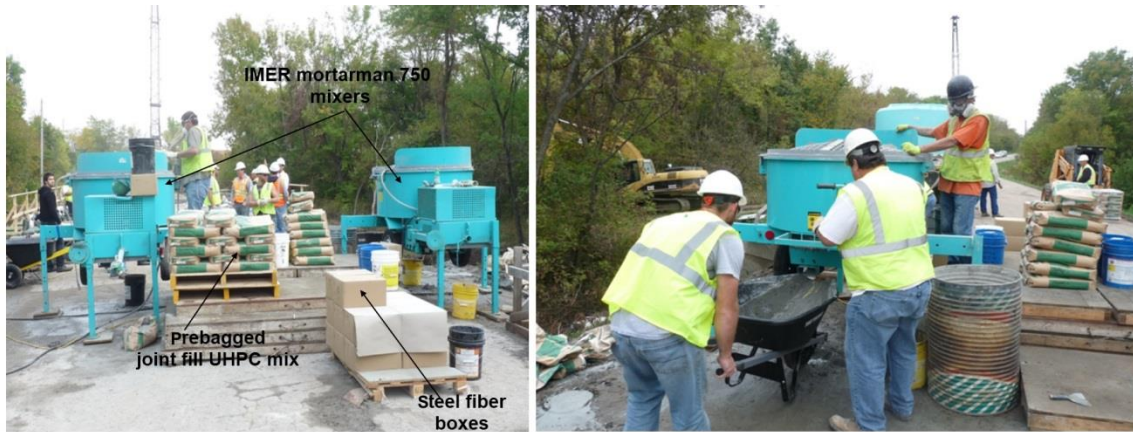
Figure 3.8. Batching of UHPC joint fill using IMER Mortarman 750 mixers at the bridge site

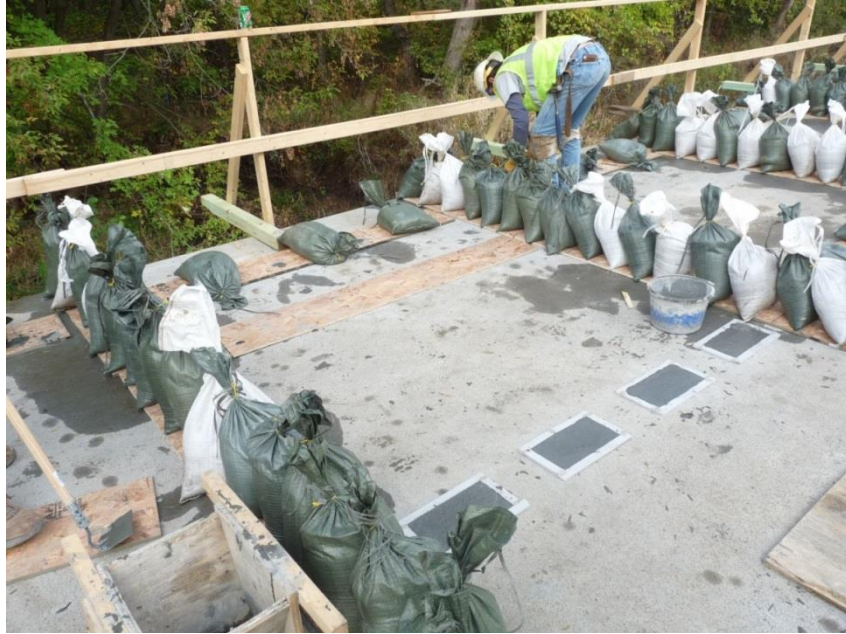
Figure 3.10. Finished transverse joints (panel-to-panel joint) covered with plywood
