PARTIALLY POPULATED CATALOGUE OF MEASURED PROPERTIES OF FIELD SECTIONS

Product 0-6674-P3
Project 0-6674

Project Title: Improving Fracture Resistance Measurement in Asphalt Binder Specification with
Verification on Asphalt Mixtures Cracking Performance

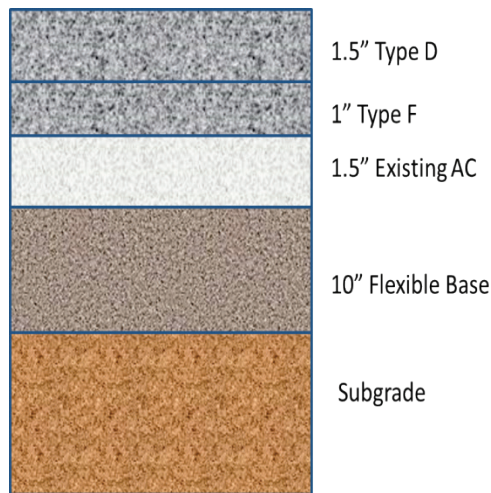
The existing pavement was asphalt concrete pavement with some transverse and longitudinal cracking. The GPR data were collected before the milling work and showed that the existing AC pavement thickness was about 2.5 inches. After that about 1 inch of the existing pavement was milled and was replaced with 1 inch type F mix. No obvious transverse cracks were observed in the shoulder or the milled surface during construction. Figure 1 shows the pavement structure of the SH 15 test sections.

Figure 1. Pavement Structure of SH 15 Test Sections.

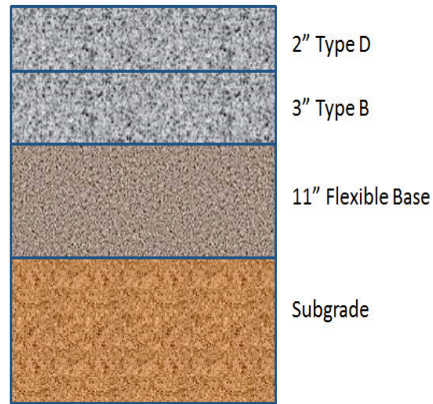
The previous pavement structure was 8 inches asphalt pavement plus 11 inches flexible base. These 8 inches pavement was fully milled down and replaced with 2 inches type D mix and 3 inches type B mix. The paving of the 2 inches type D mix of these test sections was conducted on October 3, 2013. Figure 2 shows the pavement structure of the US 62 test sections.

Figure 2. Pavement Structure of US 62 Test Sections.

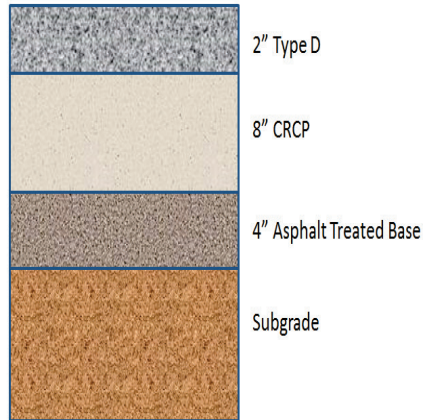
The existing pavement of Loop 820 is continuously reinforced concrete pavement with lots of fine cracks; the estimated cracking gap is around 5–6 feet. Figure 3 shows the pavement structure of the Loop 820 test sections.

Figure 3. Pavement Structure of Loop 820 Test Sections.

The overlay mix for each test section is illustrated in Figure 3, from inside lane to outside lane. The thickness of all test sections is 2 inches.
