RESEARCH RESULTS
FRA OFFICE OF RAILROAD POLICY & DEVELOPMENT

RR 14-14 | June 2014

Part 2: Heavy Axle Load Revenue Service Mega Site Testing 2005–2012

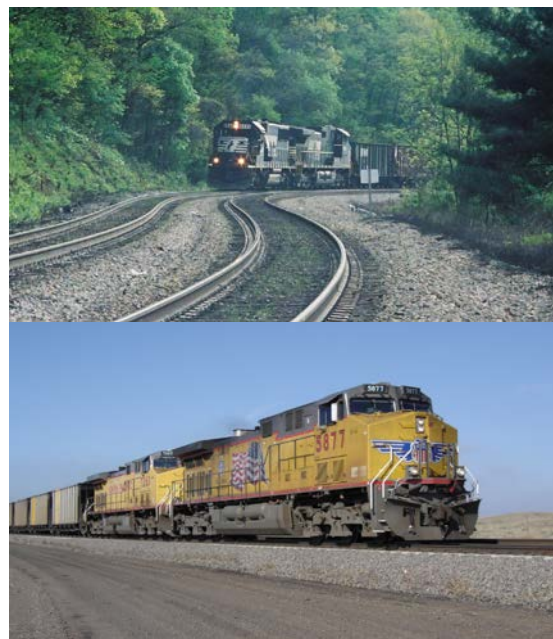
Figure 1: Eastern (top) and Western (bottom) Mega Sites

Two revenue service mega sites (see Figure 1) were established for this research: one in the East near Bluefield, WV, and the other in the West near Ogallala, NE. In comparison, the eastern mega site typically has sharp curves (up to 12 degrees) and steep grades (up to 1.4 percent), wood ties, open deck steel bridges, 20 to 40 mph operating speeds, and 55 megaton (MGT) per year tonnage. The western mega site typically has shallow curves (1 to 2 degrees), concrete ties, ballast deck bridges, 40 to 60 mph operating speeds, and tonnage up to 250 MGT per year.
