U.S. Department of  
Transportation

Federal Railroad  
Administration

## Construction Loads Experienced by Plastic Composite Ties

1. AGENCY USE ONLY (Leave blank)	2. REPORT DATE July 2014	3. REPORT TYPE AND DATES COVERED Technical Report January 2010–June 2011	
4. TITLE AND SUBTITLE Construction Loads Experienced by Plastic Composite Ties		5. FUNDING NUMBERS DTFR53-00-C-00012 Task Order 241

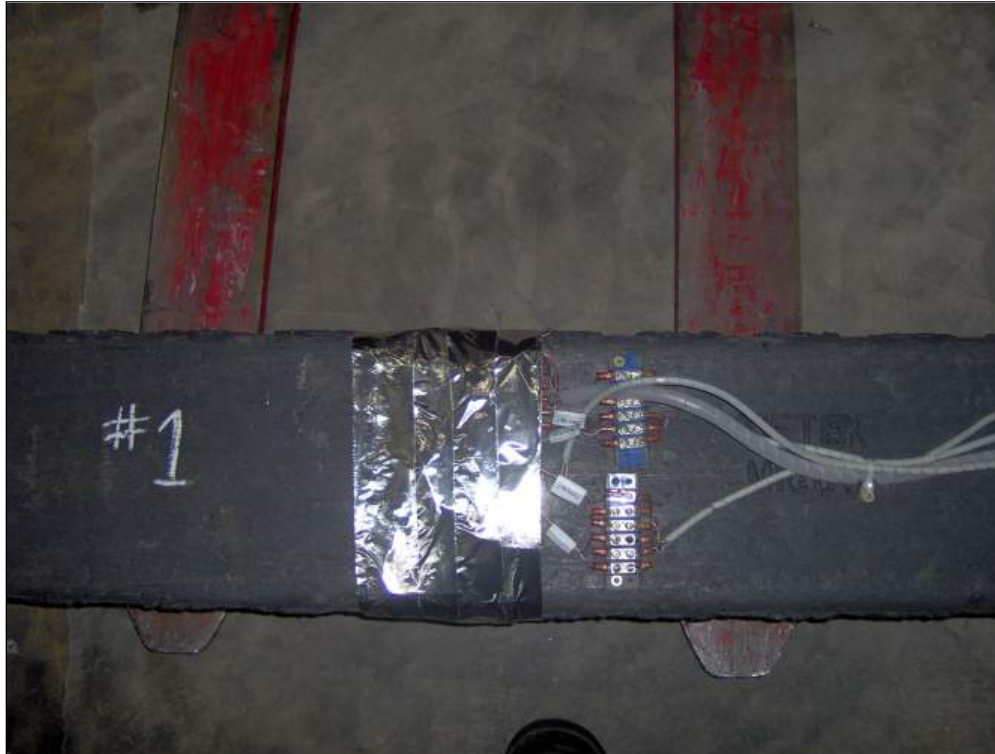
**Figure 2. Example of strain gage wiring at the tie center. The strain gages were protected under tape, with the wires leading to the end of the tie to allow data collection.**

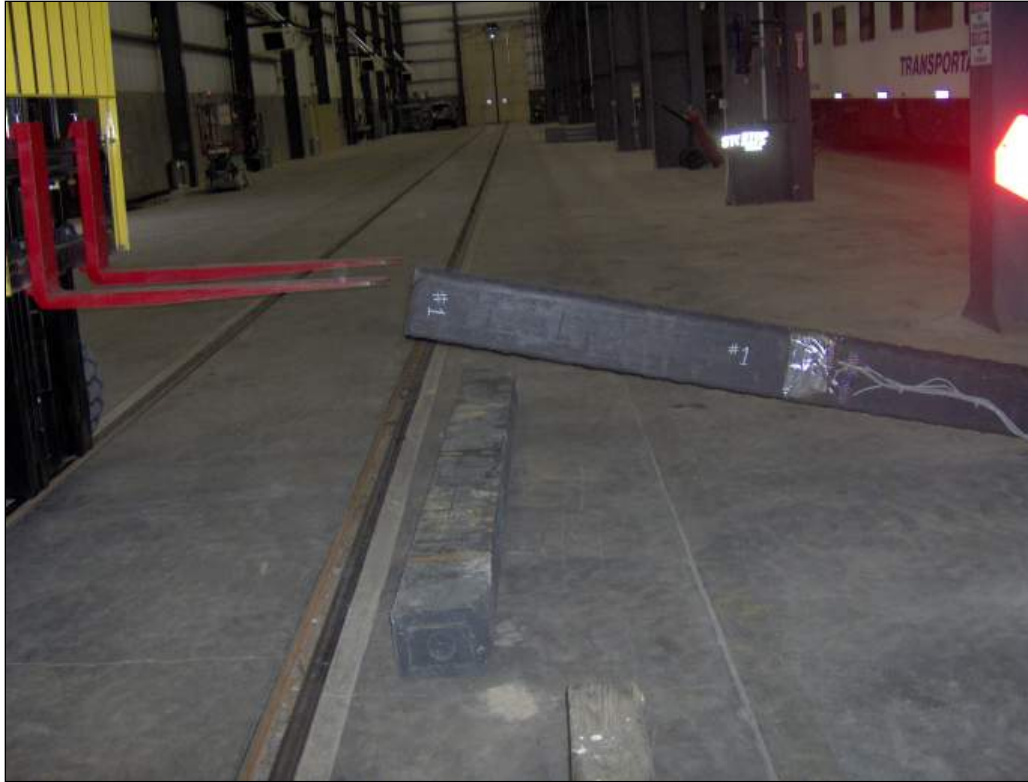
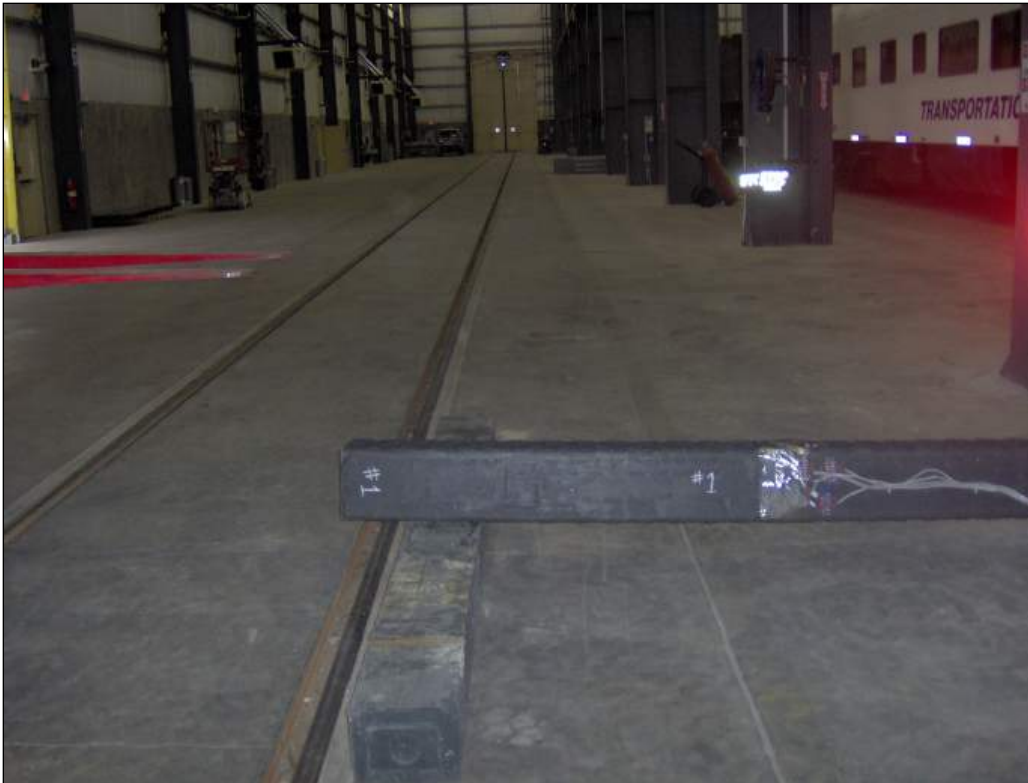
**Figure 6. Configuration 1: (Top) Immediately after release, during tie falling. (Bottom) As tie impacts the bottom, fixed tie.**

Configuration 1, depicted in Figures 5 and 6, represents a condition where a plastic composite tie is tipped onto another plastic composite tie (or object), with one end of the tie on the ground and the other end falling from various heights. To safely conduct this test, the end of the tie was supported by a forklift at the desired height, then the forklift was quickly backed away to drop the tie. As the drop height increased, the tie tended to bounce in different directions, and some

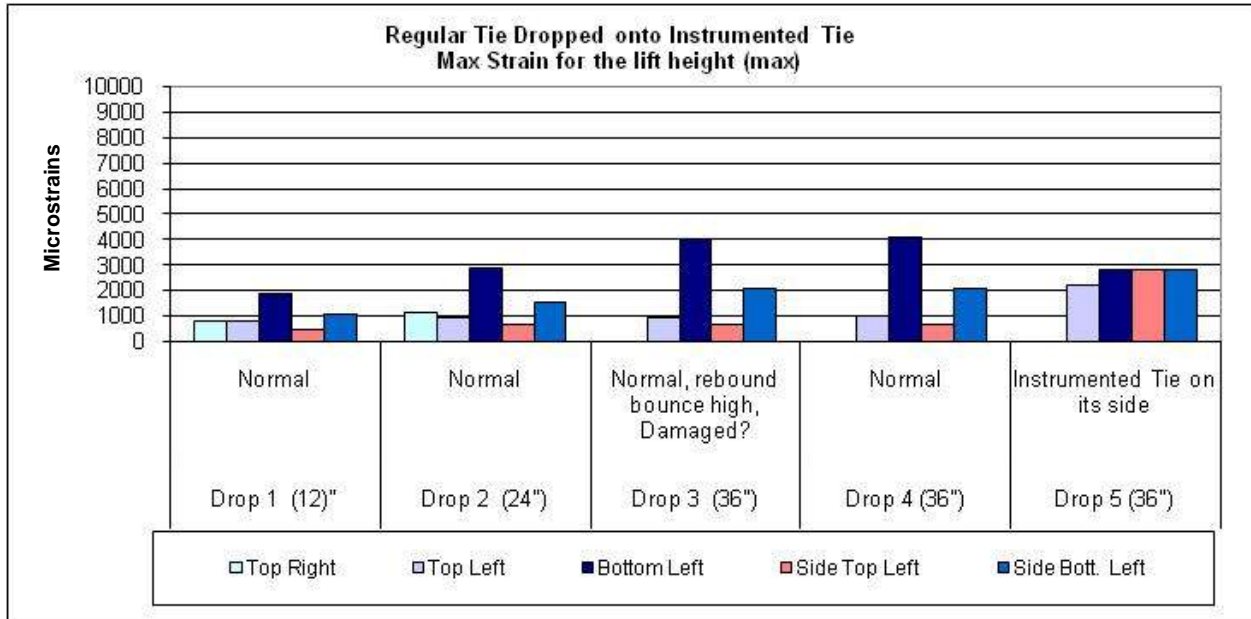
**Figure 9. Summary of center bending strains for Configuration 2, a tie being struck by partial load. This configuration produced low center bending loads.**

To determine typical peak center bending strains for a plastic composite tie already placed on the ground and struck by a falling plastic composite tie, two configurations were evaluated. Configuration 2 is depicted in Figure 8, which measures how a plastic composite tie striking off center would apply a partial load during impact. Figure 9 summarizes loading observed for Configuration 2.

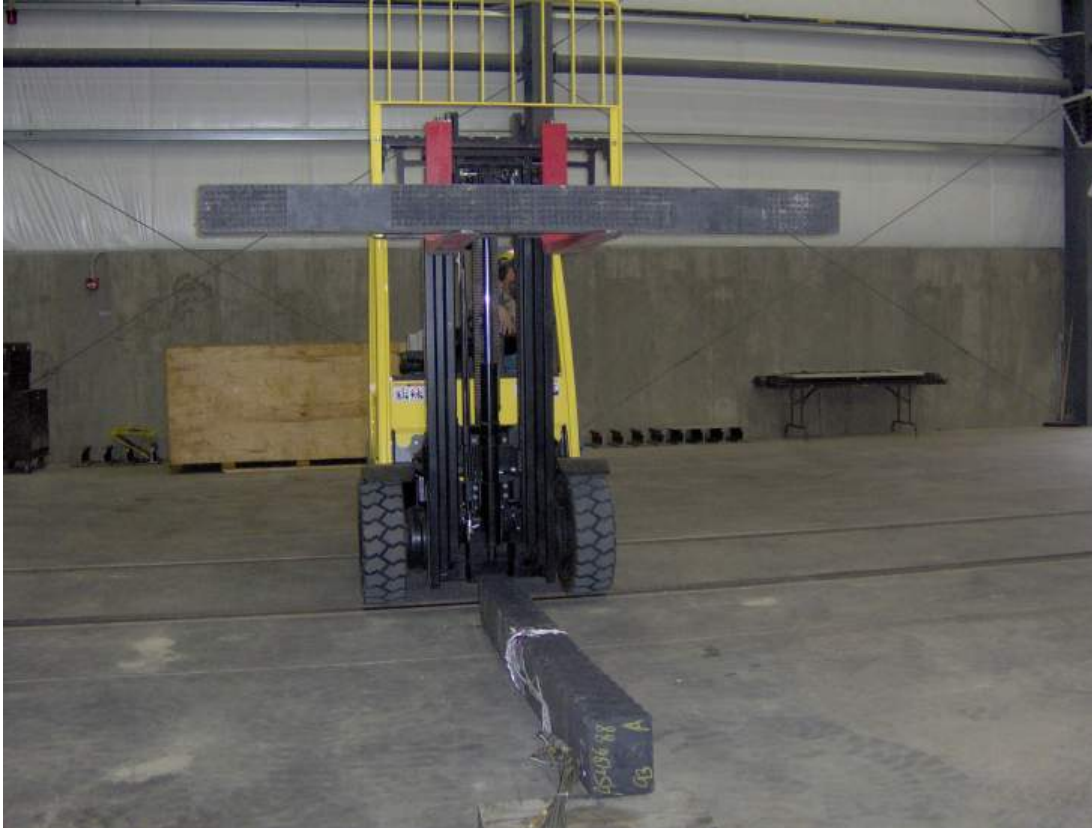
**Figure 11. Configuration 3: (Photograph) Full load about to be dropped on an instrumented plastic composite tie.**

The maximum loads were generated when the full plastic composite tie was dropped onto another plastic composite tie. This was simulated by dropping a plastic composite tie in such a way that the full weight struck at the center of an instrumented plastic composite tie (see Figures 10 and 11). Figure 12 summarizes the impact strain data.

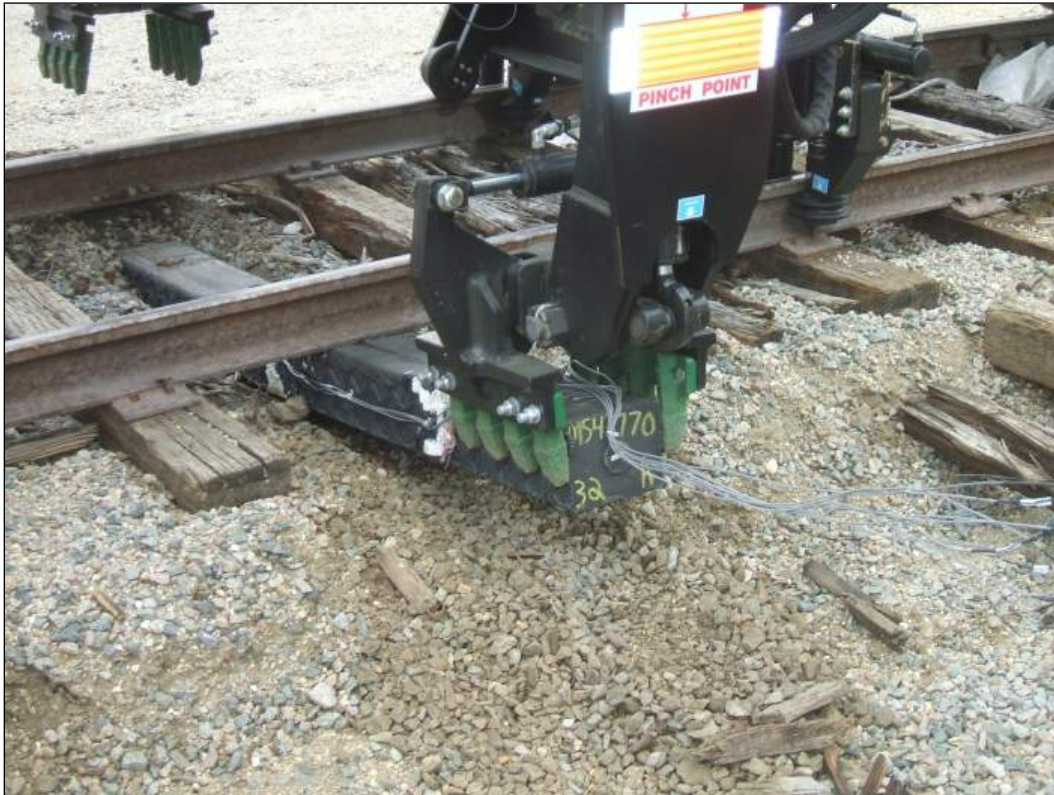
**Figure 14. Tie insertion. The tie is bent while digging into the ballast at the far end and being pulled upward against the near rail.**

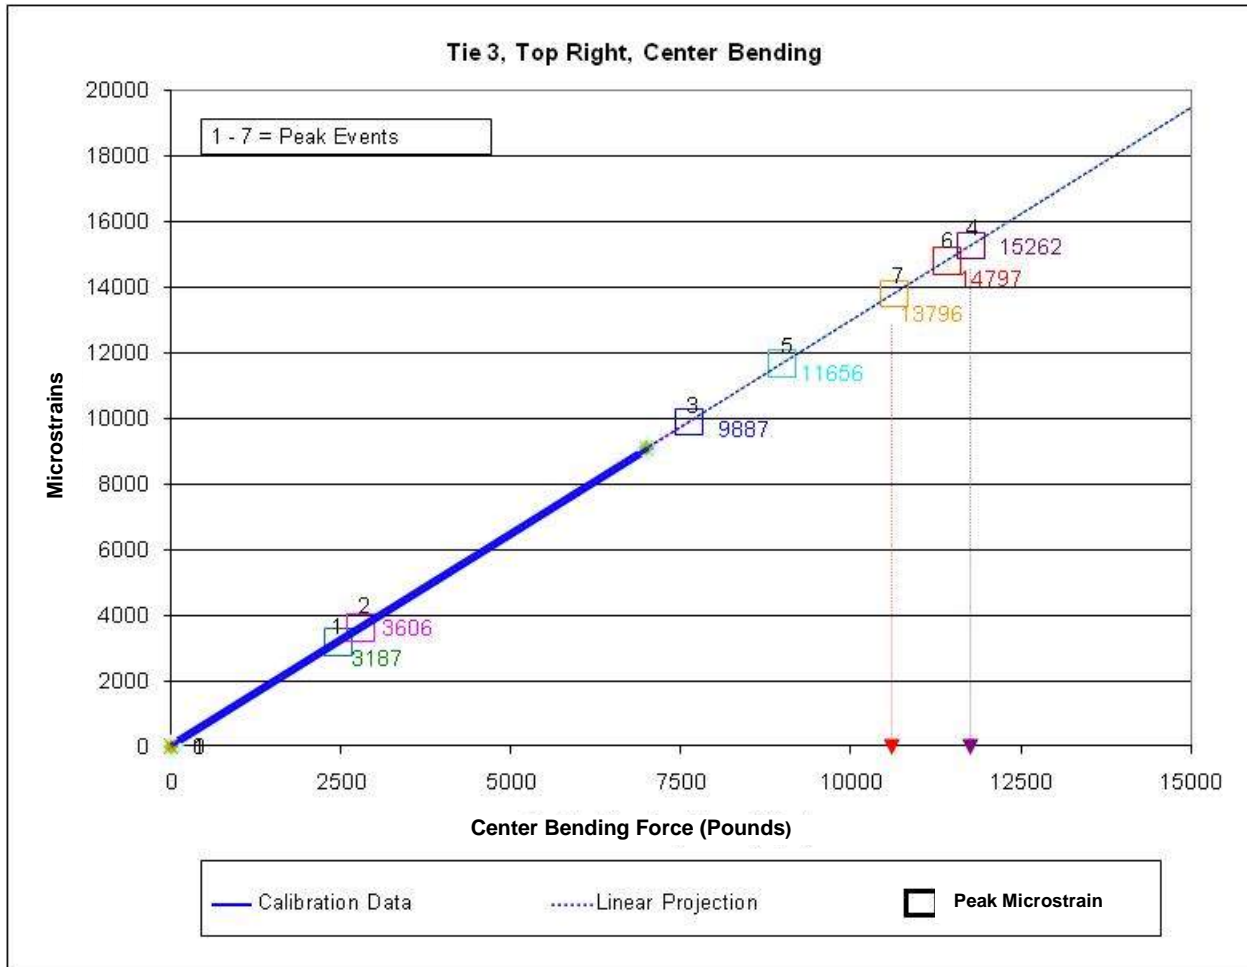
**Figure 17. Peak strains during key events, with associated extrapolated bending forces. Events 1, 2, 3, 4, 5, and 6 occurred during tie insertion when pushing against ballast and/or lifting against rail. Event 7 occurred during nipping (10,640 pounds), and event 4 occurred during installation, when the ties were jammed against the rail (11,800 pounds).**

Figure 17 shows a summary of peak bending strains observed (for one of the many strain gages installed on the tie) during tie installation. Data shown is for the top right side of the tie, which indicated the highest bending strains of all the strain gages during the various operations.

The force values shown in Figure 17 represent the center bending load required to generate the strains observed when the tie is supported over a 60-inch span. A number of events earmarked in Figure 17 represent occasions during installation when peak loads were noted. The highest equivalent center bending force that occurred while pushing the tie during installation is shown as event 4; the highest center bending force that occurred during nipping and spiking is shown as event 7.

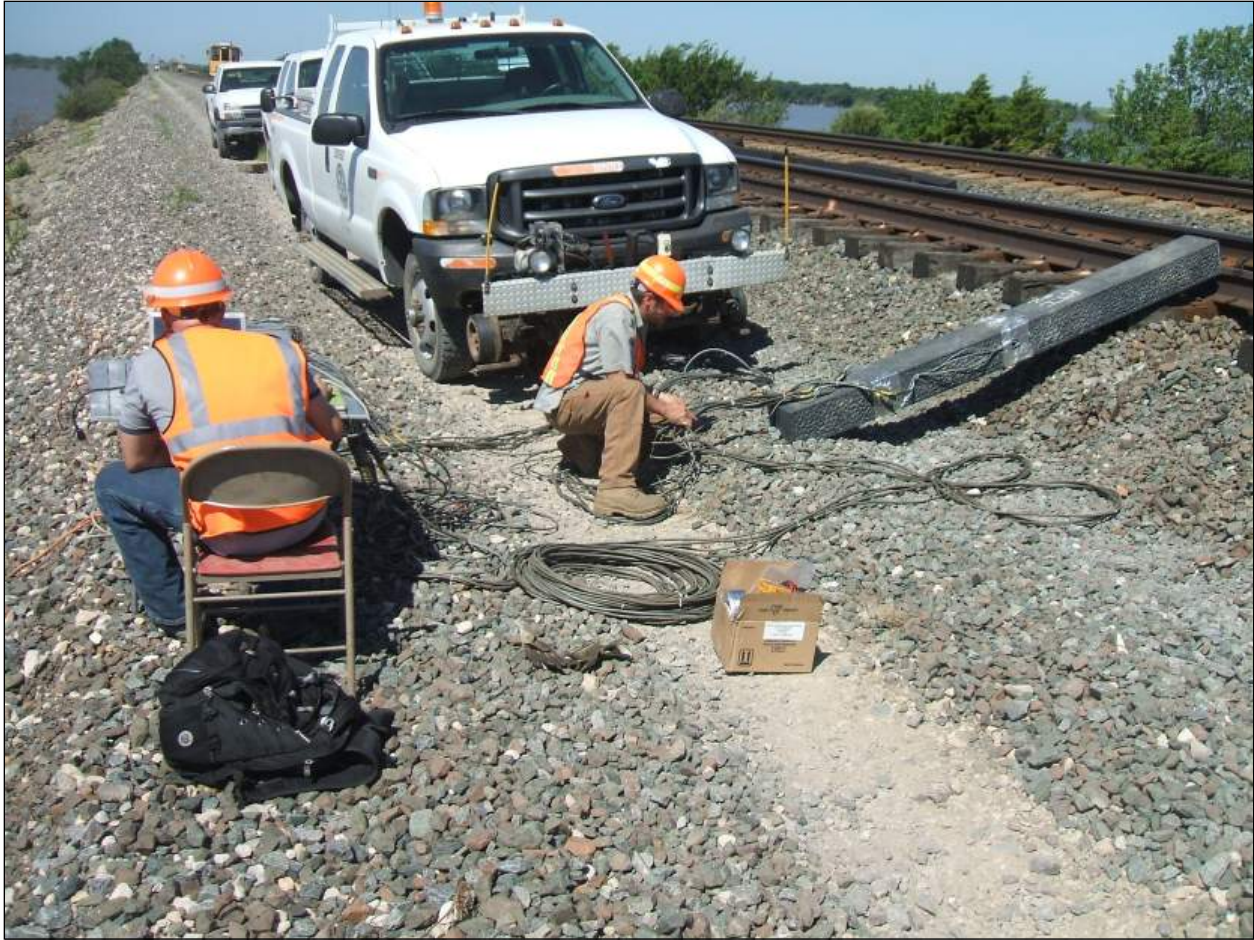
**Figure 18. Instrumented tie being prepared for installation at BNSF site.**

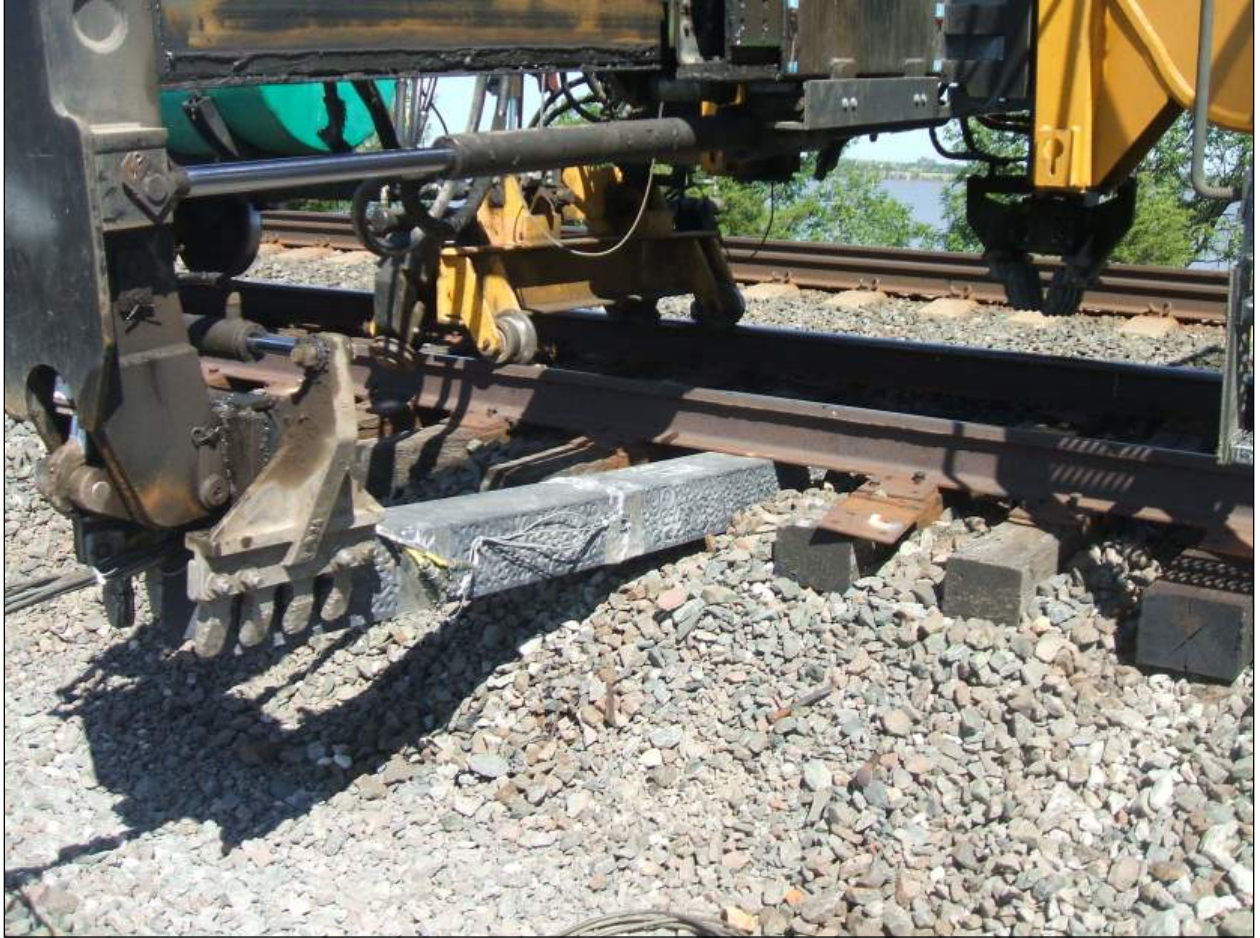
**Figure 19. Instrumented tie during insertion at the BNSF site.**

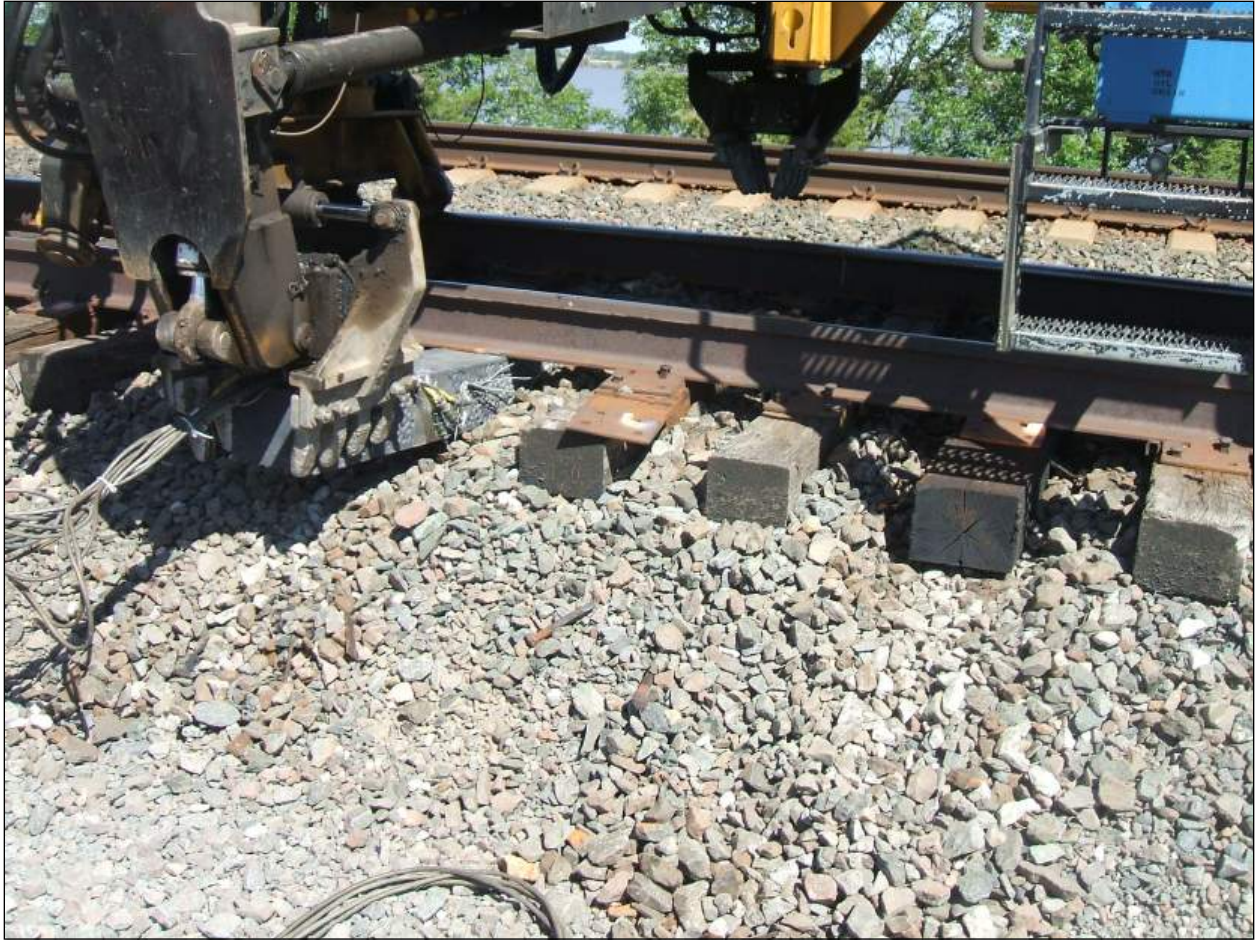
**Figure 20. Maximum bending during tie installation.**

As with the CSX site, after completing the tie installation on the BNSF, peak forces were determined by evaluating time history plots of the strains from each strain gage location, then comparing the maximum strain with the projected calibration data. This process was repeated for each strain gage location. Figures 18 and 19 show an example of a tie being laid out in advance of the crew, then being inserted at the BNSF site. Figure 20 shows an example of how much one tie bent while being inserted.

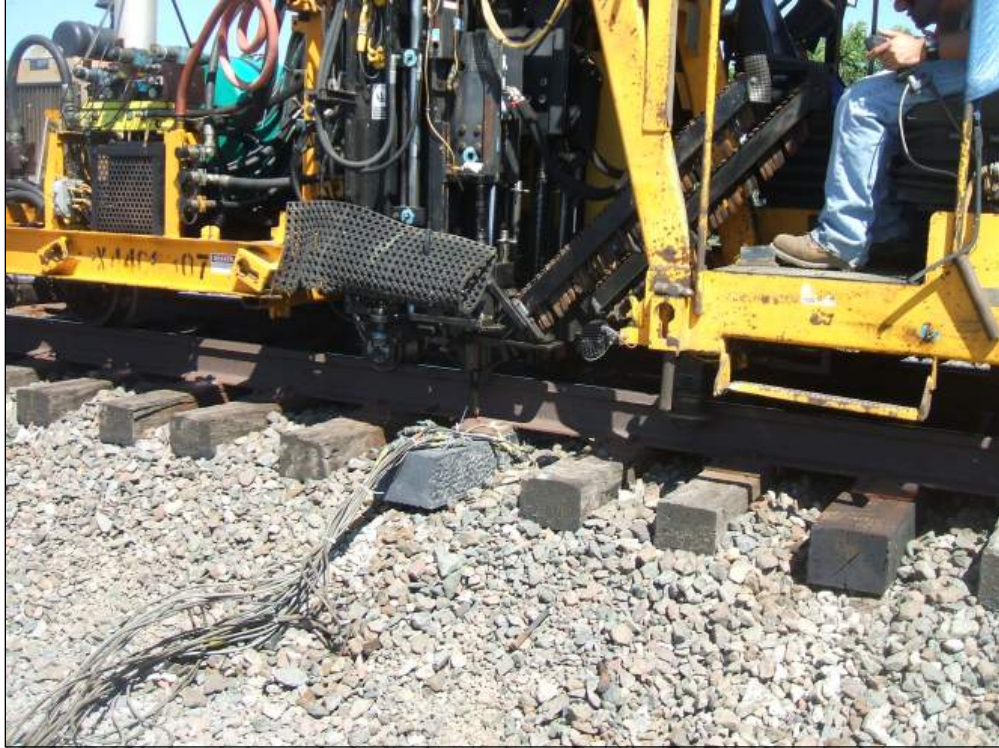
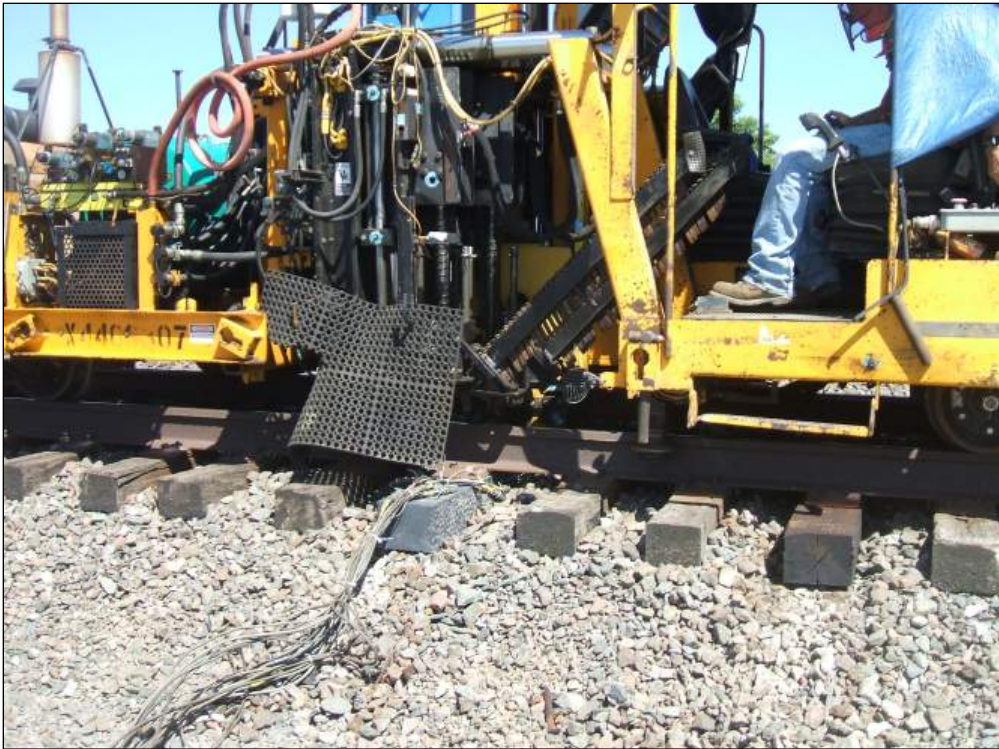
**Figure 21. Nipping and spiking operation. The top photo shows the end of the tie bent upwards prior to nipping; the bottom photo shows the tie being straightened out by the nipping and spiking operation.**

Forces applied to these ties during installation caused an upward bend around the rail seat. The tie remained bent after the insertion machine departed. This bend was removed, and the tie straightened out, by reverse forces being applied during the nipping operation, which holds the tie tightly upward against the bottom of the rails (see Figure 21).

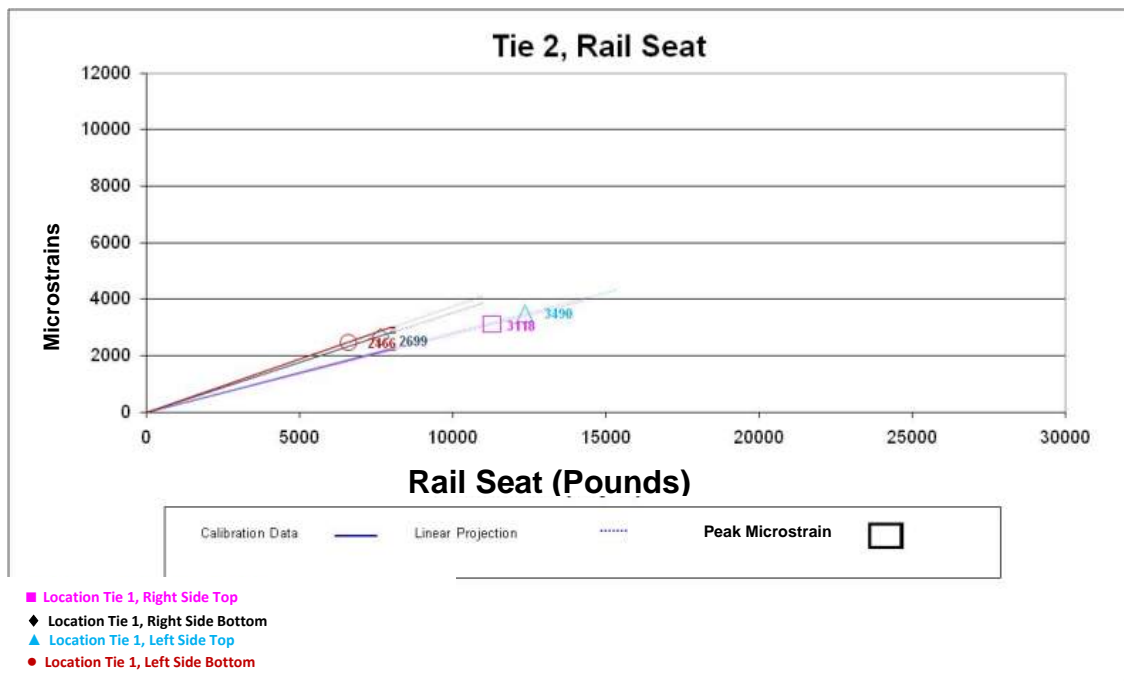
**Figure 25. Peak rail seat bending for tie 2 during installation.**  
 A peak strain of 3,490 micro-strain was observed on the top left of the tie, producing an equivalent load of 12,361 pounds.

Figures 24 and 25 show strain data collected at the rail seat during the same time periods. The data show that rail seat peak loads of about 27,000 pounds for tie 1 and 12,400 pounds for tie 2 were attained. The single very high load observed during the installation of tie 1 was originally thought to be the result of debonding of the strain gage; however, subsequent rail seat strain data collected during nipping operations showed that the strain gage was operating normally and producing data within the range of the other strain gages.

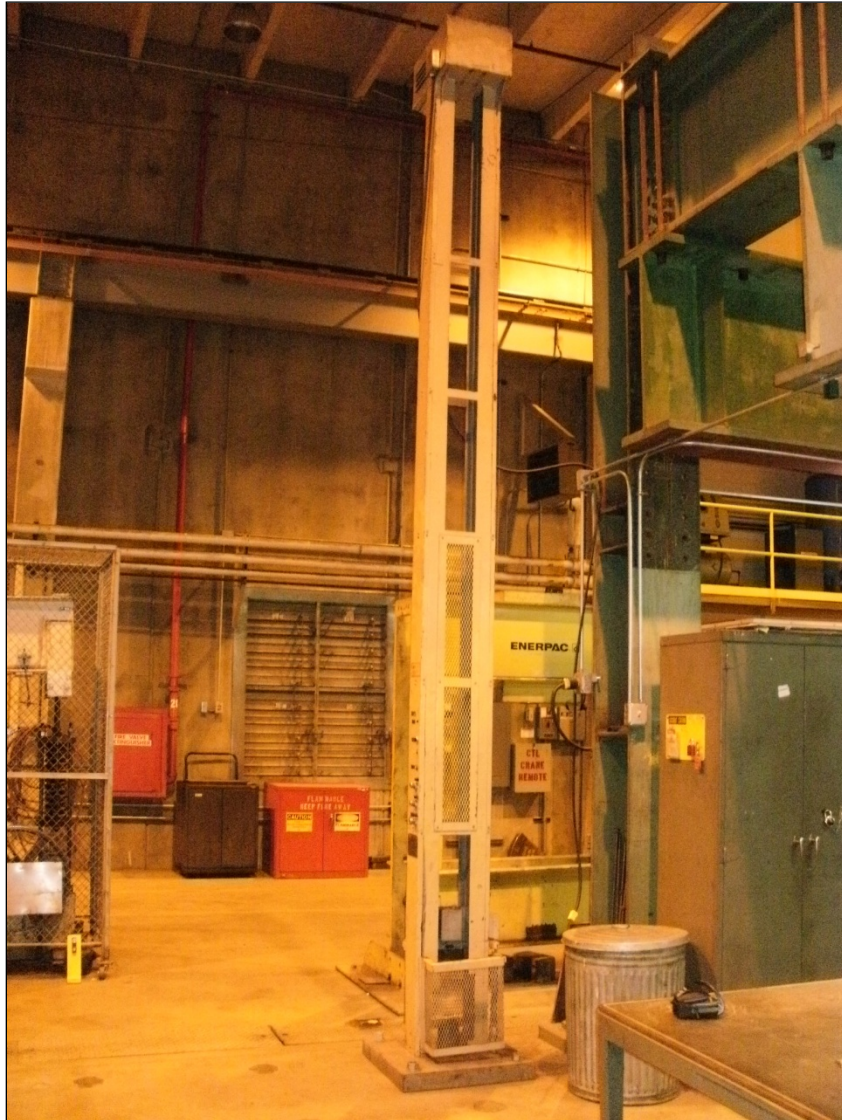
**Figure 28. Drop load fixture located at TTC in the Component Test Laboratory.**

The weight drops from a given height and is kept on course by a vertical retaining shaft. The drop weight strikes the test sample at the bottom of the shaft. However, the current fixture provides only a small opening (Figure 29), which limits the width of a sample. Thus, some ties can only fit when placed sideways (shown in Figure 30); this simulates a tie being struck on its side, not top.

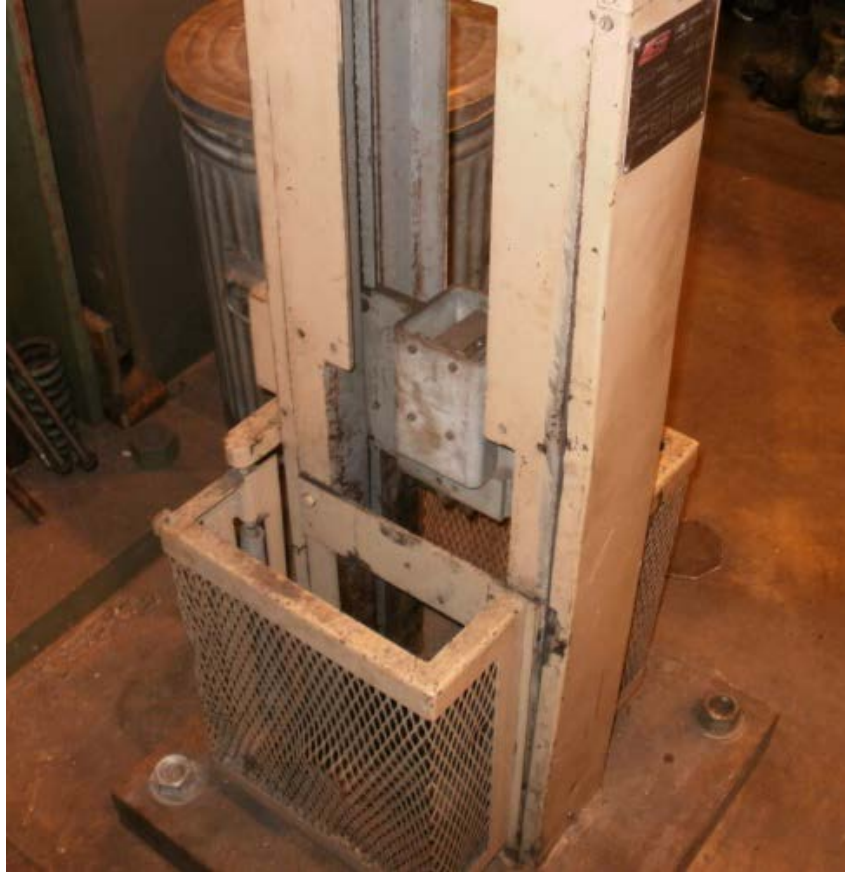
**Figure 29. Drop load fixture showing opening at bottom and vertical drop load.**

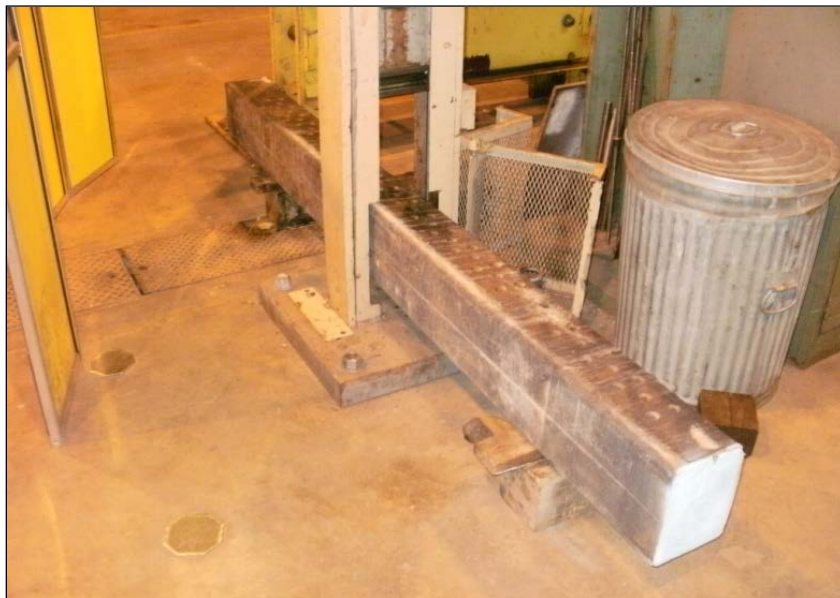
**Figure 30. Drop fixture with tie placed on its side. Note the supports are still spaced at 60 inches apart, simulating the loading of other AREMA tests.**

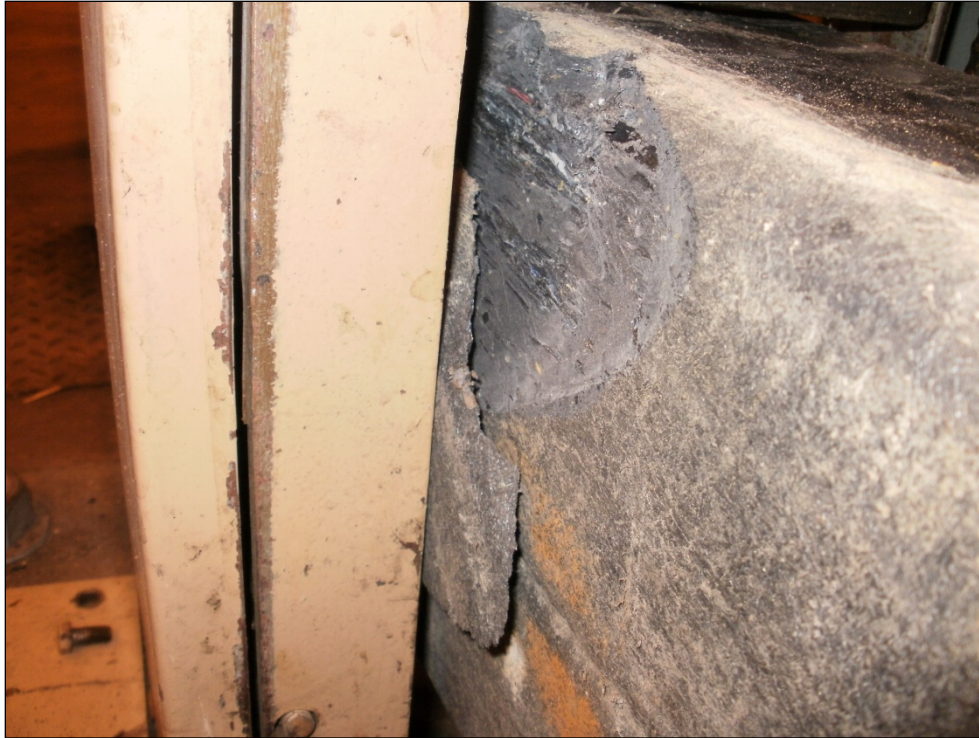
**Figure 31. Surface damage (large chip) on tie after drop test, room temperature.**

It should be noted that these samples, although “new, old stock” and never installed, were all 2–4 years old at the time of testing and represent state of the art from 2003 to 2006. Newer designs of these ties may have updated materials or configurations and produce different performance. As Figure 31 shows, one tie suffered surface chipping when the weight was dropped on its side.
