Using Wheel Temperature Detector Technology to Monitor Railcar Brake System Effectiveness

1. AGENCY USE ONLY (Leave blank)		2. REPORT DATE December 2013		3. REPORT TYPE AND DATES COVERED Technical Report
4. TITLE AND SUBTITLE Using Wheel Temperature Detector Technology to Monitor Railcar Brake System Effectiveness			5. FUNDING NUMBERS DTFR53-00-C-00012 Task Order 252

9. SPONSORING/MONITORING AGENCY NAME(S) AND ADDRESS(ES) U.S. Department of Transportation Federal Railroad Administration Office of Research and Development Washington, DC 20590			10. SPONSORING/MONITORING AGENCY REPORT NUMBER DOT/FRA/ORD-13/50

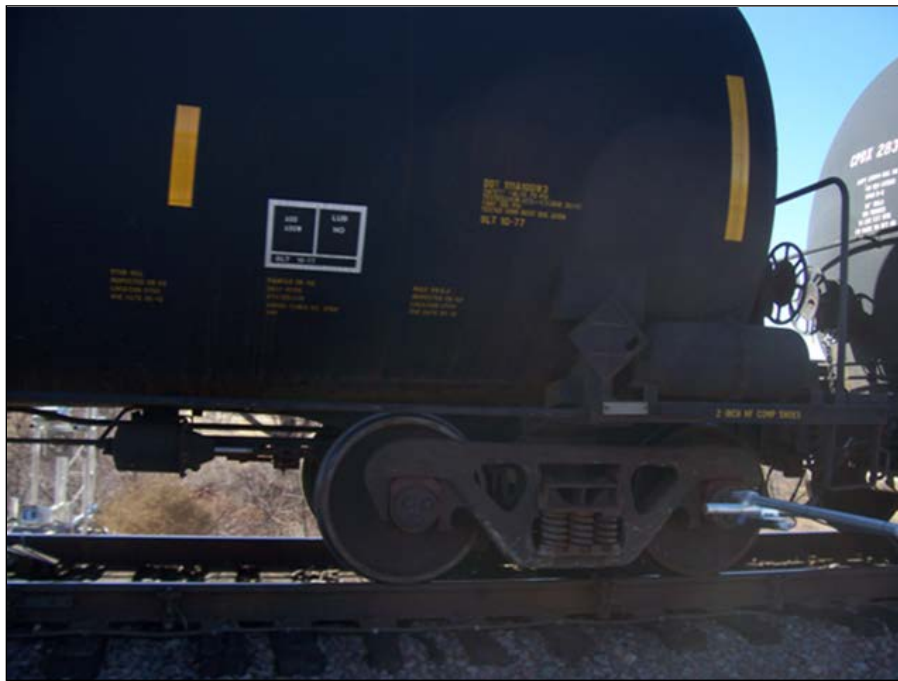
Figure 1. Braking Tank Car with Proper Piston Travel

Brake effectiveness is normally evaluated by railroads during the Class 1 (initial terminal) and subsequent Class 1A (1,000-mile) brake inspections. This routine inspection and evaluation is based on a visual check of the brake rigging and piston travel as prescribed above. Figure 1 shows an example of proper piston travel. In addition, the nominally designed retarding force has a hold-time component that is currently accounted for by the 3-minute allowance for a Class 1 or Class 1A retest. However, there is no measurement of brake force. By using wheel temperature detector technology to assess wheel temperatures as a train with applied brakes passes a sensor, Transportation Technology Center, Inc. (TTCI) submits that an indirect measurement of brake force can be made, thus providing a better indication of brake effectiveness that also accounts for true revenue service hold-time.

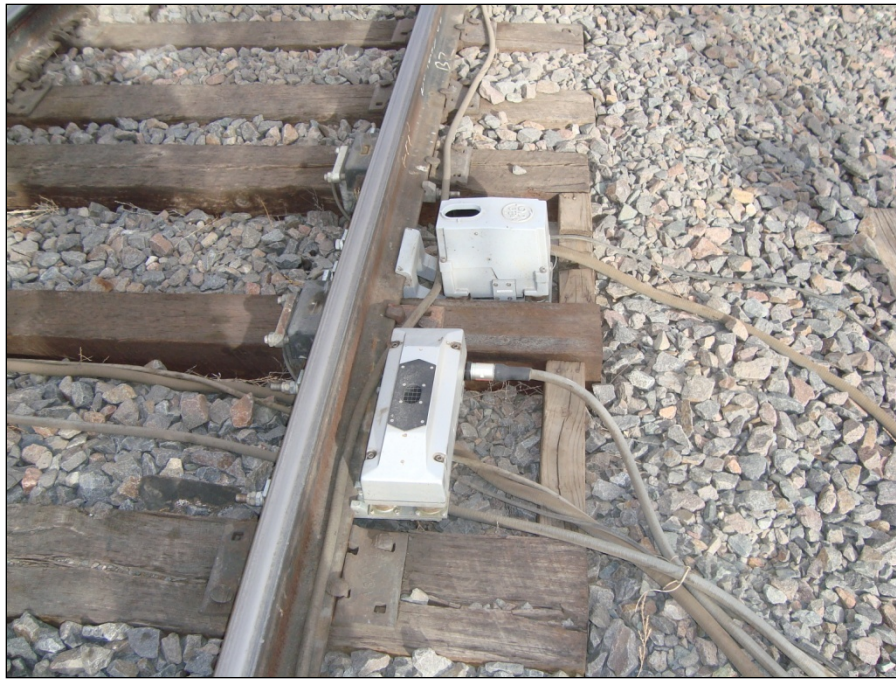
Figure 4. Wheel Temperature Detector Installation at FAST

A wheel temperature wayside detector previously installed at FAST was used for this demonstration test. The wheel temperature detector was provided by the Inspection and Information Systems Division of Progress Rail Services. Figure 4 shows the wheel temperature detector in track at FAST.

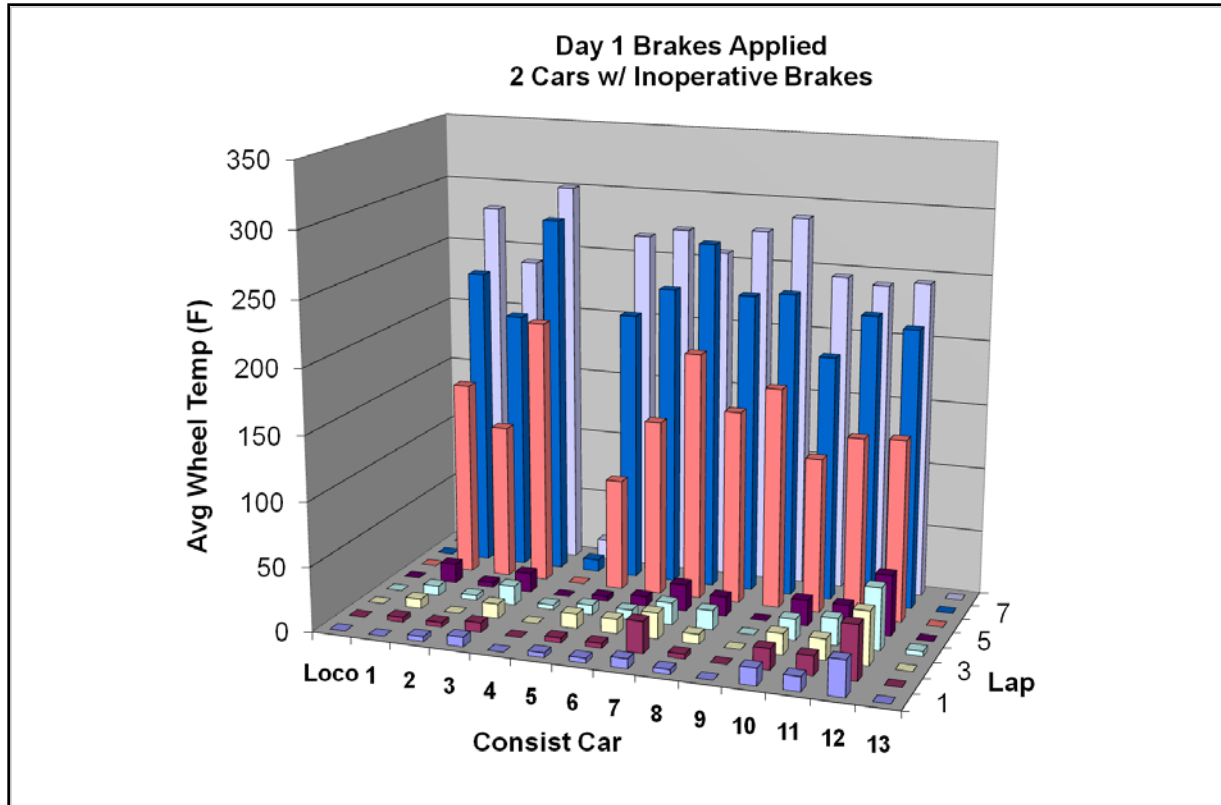
Figure 5. Proof-of-Concept Test Data—Day 1 Results

laps. The wheel temperature was monitored with each pass. After three laps at 40 mph with brakes set, wheel temperature detector data indicated that the wheels had reached the predetermined safe temperature limit. The brakes were released, and the first day of the test was concluded. The test train was stored overnight so that the wheels in the consist could cool for the second day of testing. Figure 5 shows the results from the first day of testing.

The data shows an increase in wheel temperatures once a brake application was made and for each subsequent lap for the cars with known operating brakes. Little or no wheel temperature increase is seen for the cars with known inoperative brakes.

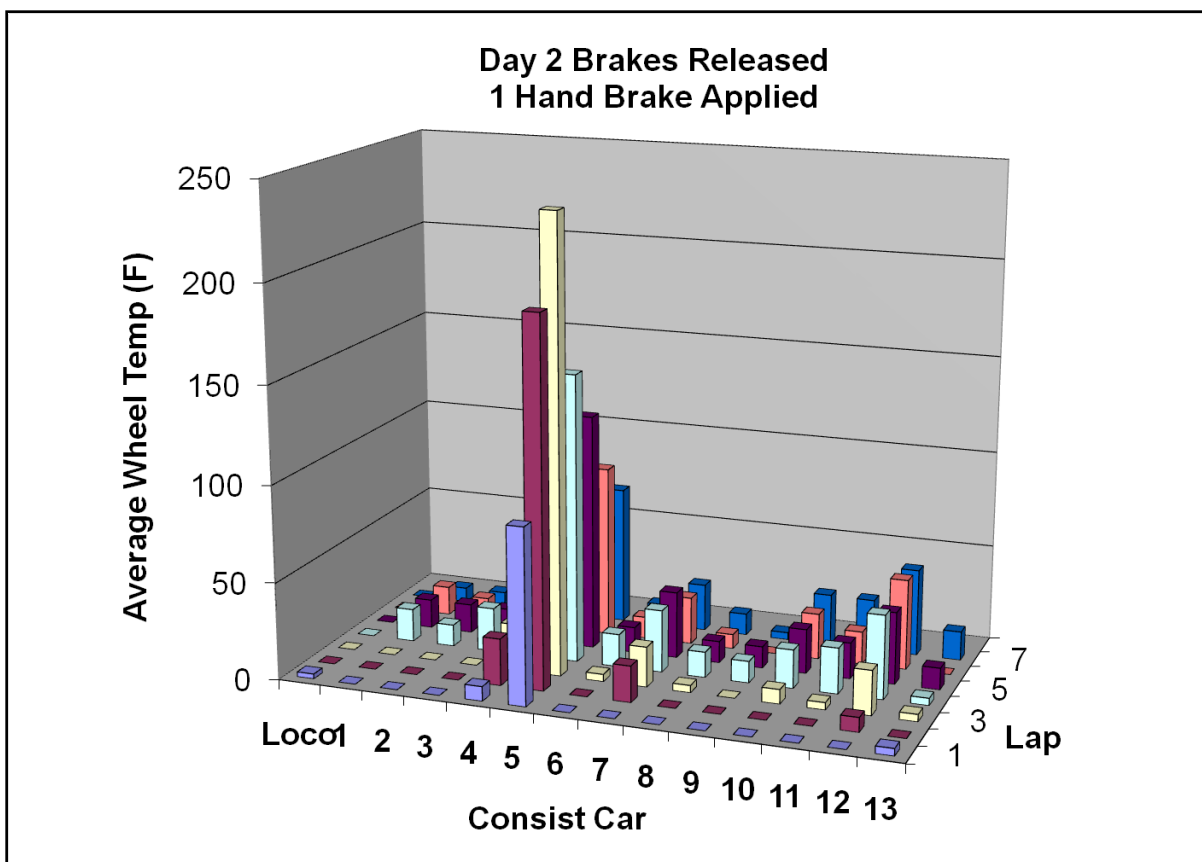
Figure 6. Proof-of-Concept Test Data—Day 2 Results

For the second day of the test, all of the brakes were cut in and operative. Before testing began, a hand brake was set on the fifth car of the test train. The train was then taken through a TCR and operated at 40 mph for several laps past the wheel temperature detector. Wheel temperatures were closely monitored. When wheel temperatures on the sixth car reached the predetermined safe temperature limit, the train was stopped, and the hand brake was released. The train was started again and completed two more laps past the detector. Figure 6 shows the results from the second day of testing.

The data shows increasing wheel temperatures for the car with the applied hand brake on each subsequent lap until the hand brake is released. Wheel temperatures decrease on this car on each subsequent lap once the hand brake is released. Wheel temperatures for the remaining cars in the consist increase somewhat during the course of the test. These results prompted the idea to conduct a test that would let the wheels reach a steady-state operating temperature before making a brake application.

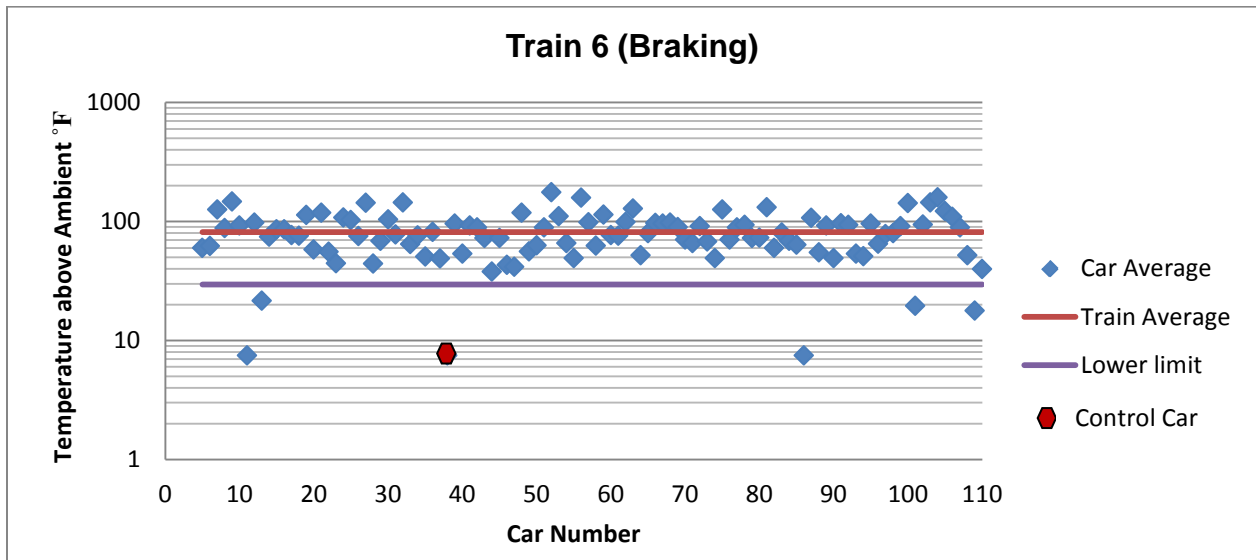
Figure 12. Loaded Test Train 6—Day 2 Results

Data for Train 6 again shows that six cars fall below the lower limit threshold, indicating possible ineffective brake conditions. Four of these six cars also showed an ineffective brake condition on both trains in the previous tests. Of the remaining two cars, one is the car that was purposely cut out for the test, and one is a car that was not in the test train during the previous test. The two additional cars that fell below the threshold in the previous tests were still in the consist but did not fall below the threshold during this test.

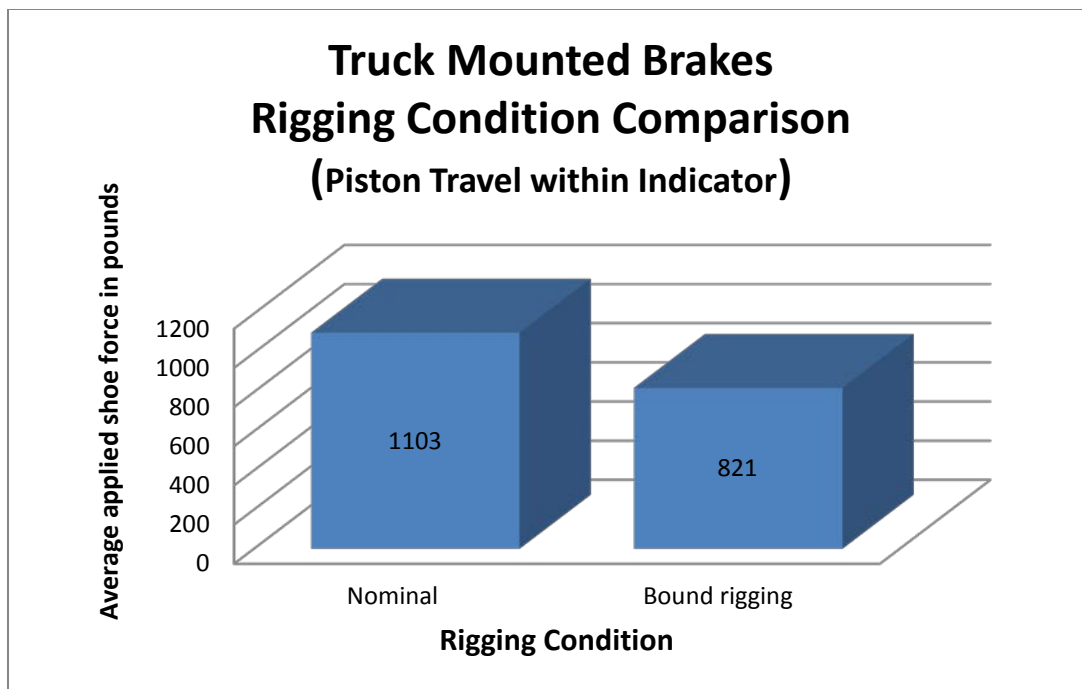
Figure 18. Truck-Mounted Brakes—Rigging Condition Comparison (nominal piston travel with 20-psi brake pipe reduction)

Force measurements were taken and recorded for the car with truck-mounted brakes in the nominal condition and with a bound brake beam. The piston travel indicator was within range for both of the brake applications. Figure 18 shows the results.

Bound rigging reduced brake shoe force by approximately 25 percent, whereas the piston travel indicator stayed within the acceptable range.
